The World Trade Center Disaster: Analysis and Recommendations

Jeremy Abraham Kirk

MASTER OF ENGINEERING  
IN CIVIL AND ENVIRONMENTAL ENGINEERING  
AT THE  
MASSACHUSETTS INSTITUTE OF TECHNOLOGY

JUNE 2005

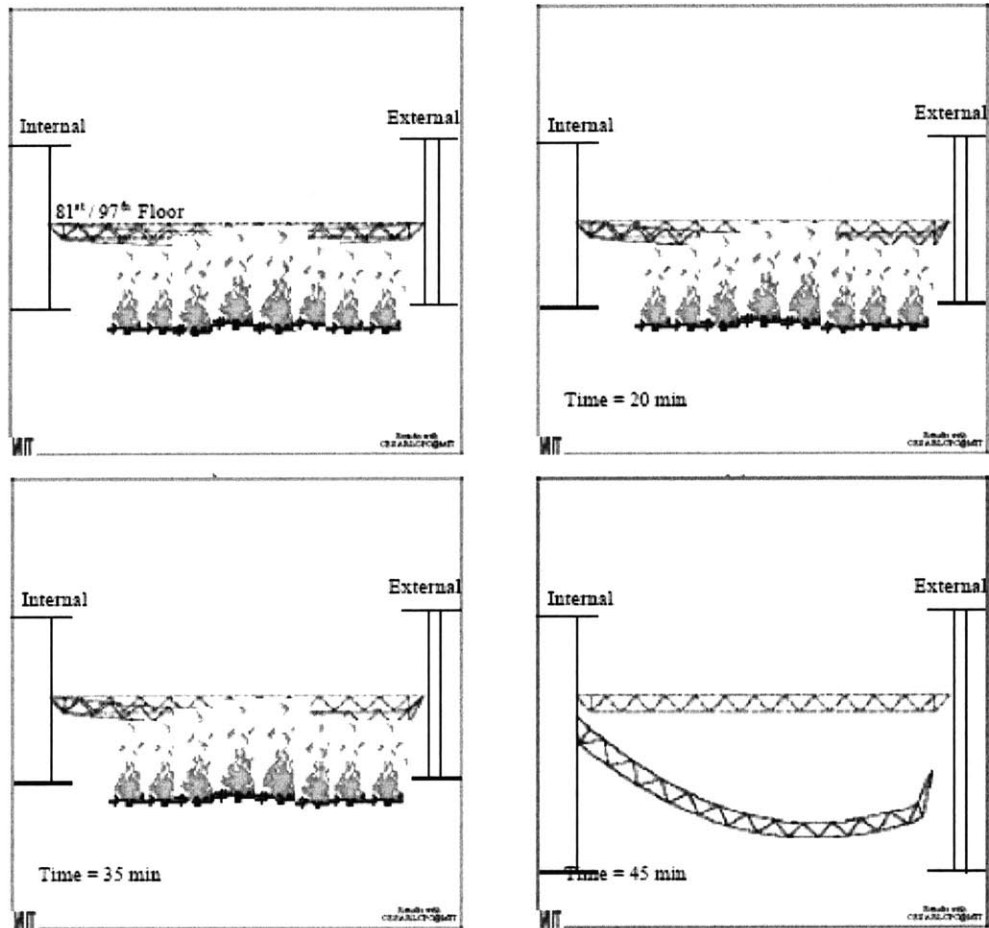
One failed truss would be insufficient to bring down an entire floor. If several adjacent trusses lost support at one end, and were hanging from the concrete slab (due to the composite nature of the deck/truss system), they would spread their load laterally to adjacent trusses. This may lead to overloading of adjacent trusses and cause a zipper effect of truss support failures across a large floor area. Thus a large portion of floor slab might fall onto the floor below. If the floor below had already been overloaded with debris from the impact, this additional floor (with its associated impact force) would probably be enough to fail the lower floor, and initiate a progression of collapse.

Figure 9. MIT's finite element analysis (Kausel et al 2002).

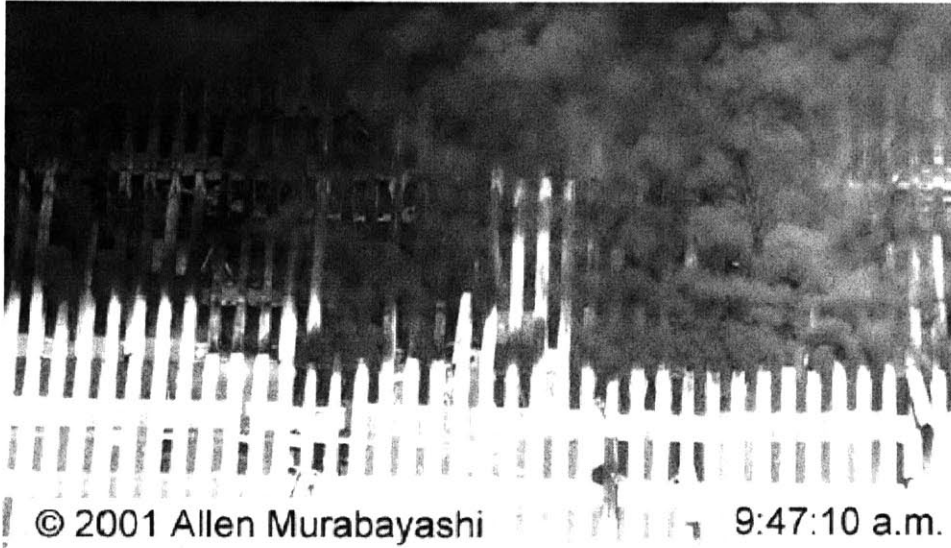
## Photographic Evidence of Hanging Floor Slab

East Face of WTC 2. Image shows what appear to be a floor slab from the 83rd floor hanging across window opening over a large portion of the 82nd floor.

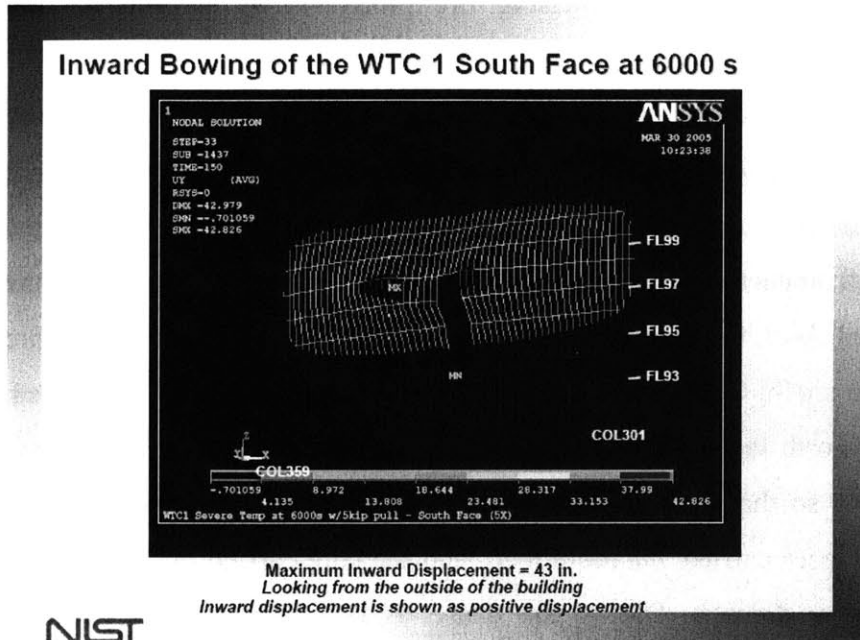
The most current theory of collapse put forth by NIST (2005b) is as follows. The sequence differs slightly between the north and south towers, but both follow a progression through three stages: impact damage, fire damage, and collapse initiation. In the north tower (WTC 1), the damage from the initial aircraft impact included severed columns from floors 93 to 98 in the exterior tube framing, damaged floor framing, and damaged core columns through the entire width of the core from north to south. One column on the exterior south face was also severed. The perimeter structure on the north face above the impact zone sagged down after the impact. Loads redistributed immediately so that the north and south faces of the tube carried 7% less gravity load, the east and west faces carried 7% more load, and the core carried only 1% more. The ensuing fires caused further damage. During the phase of fire damage, core columns experienced a net negative strain (shortening). The thermal expansion in these columns was overcome by high thermal creep and elastic strains. The loads produced by the axial shortening were distributed up to the hat truss and transferred to the perimeter tube structure. The redistribution of loads in this stage resulted in a 10% increase of the loads carried by the north and south faces of the building, a 25% increase in the east and west faces, and a 20% reduction of load in the core. The increases in load were still not significant enough to fail the columns. This thermal degradation phase also affected the floor assembly. Sagging of floors 95-99 occurred. These floors then contracted on the north side as the fire cooled in this area. Fires reached the south side later in the event, causing similar sagging in the floors there. Seat connections were weakened by the fire, and about 20% of the connections failed on floors 97 and 98 as the floors pulled inward on the columns. The columns on the south face bowed in due to the tension in the floors as well as temperature differentials within the columns themselves (see Figure 11). The collapse initiation phase began as the perimeter columns on the south face bowed and lost stability. Load was removed from the south wall and resolved to the core through the hat truss, and also around the perimeter corners to the east and west walls of the tube by means of the spandrel beam. The structure above the impact zone tilted rigidly 8° to the south. Column instability rapidly progressed from the south face to the east and west faces. The change in potential energy produced by this motion was more than could be absorbed by the structure, and collapse ensued.

**Figure 11. Inward bowing of perimeter columns on the south face of WTC 1 (NIST 2005a).**

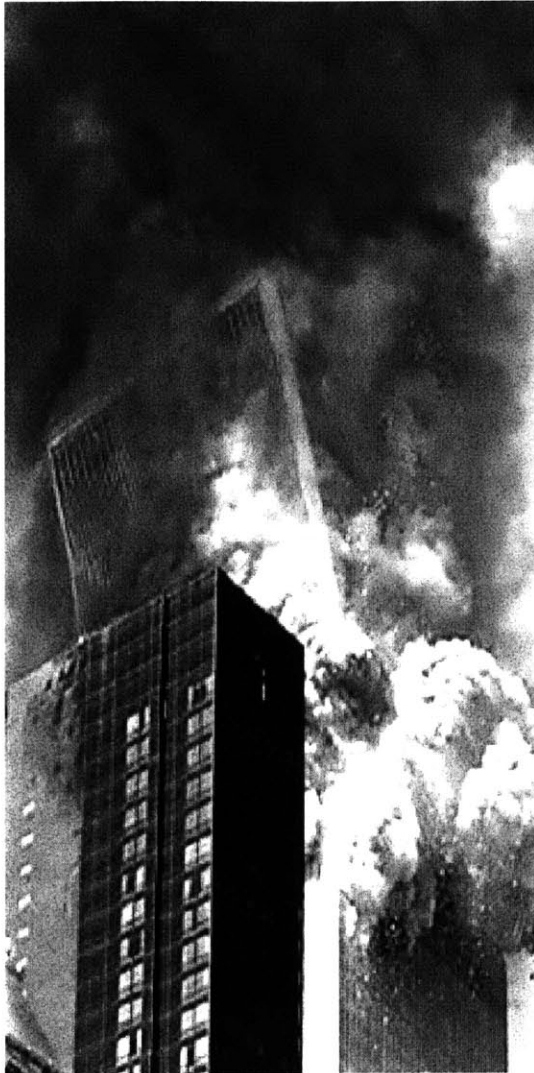
upper structure tilted rigidly  $8^\circ$  to the east and  $4^\circ$  to the south, and then tilted still further as global collapse began, rotating as much as  $25^\circ$  to the east (see Figure 12).

**Figure 12. Tilting of WTC 2 at collapse initiation (Kausel et al 2002).**
