STABILITY OF AN EMBANKMENT ON
A PARTIALLY CONSOLIDATED FOUNDATION - INTERSTATE 95

Submitted in partial fulfillment
of the requirements for the degree of
Master of Science in Civil Engineering

Massachusetts Institute of Technology
February, 1975

A test fill was built on a section of the I-95 embankment north of Boston in an effort to resolve the uncertainties involved in selecting strength parameters of Boston Blue Clay for stability analyses. Predictions of the fill elevation to cause failure, made before the field test began, are based on Unconfined Compression, Unconsolidated Undrained triaxial, field vane and SHANSEP (Stress History and Normalized Soil Engineering Properties) undrained strength. The Simplified Bishop and the Morgenstern-Price procedures of stability analyses are utilized for the predictions which are compared with the actual field test results.

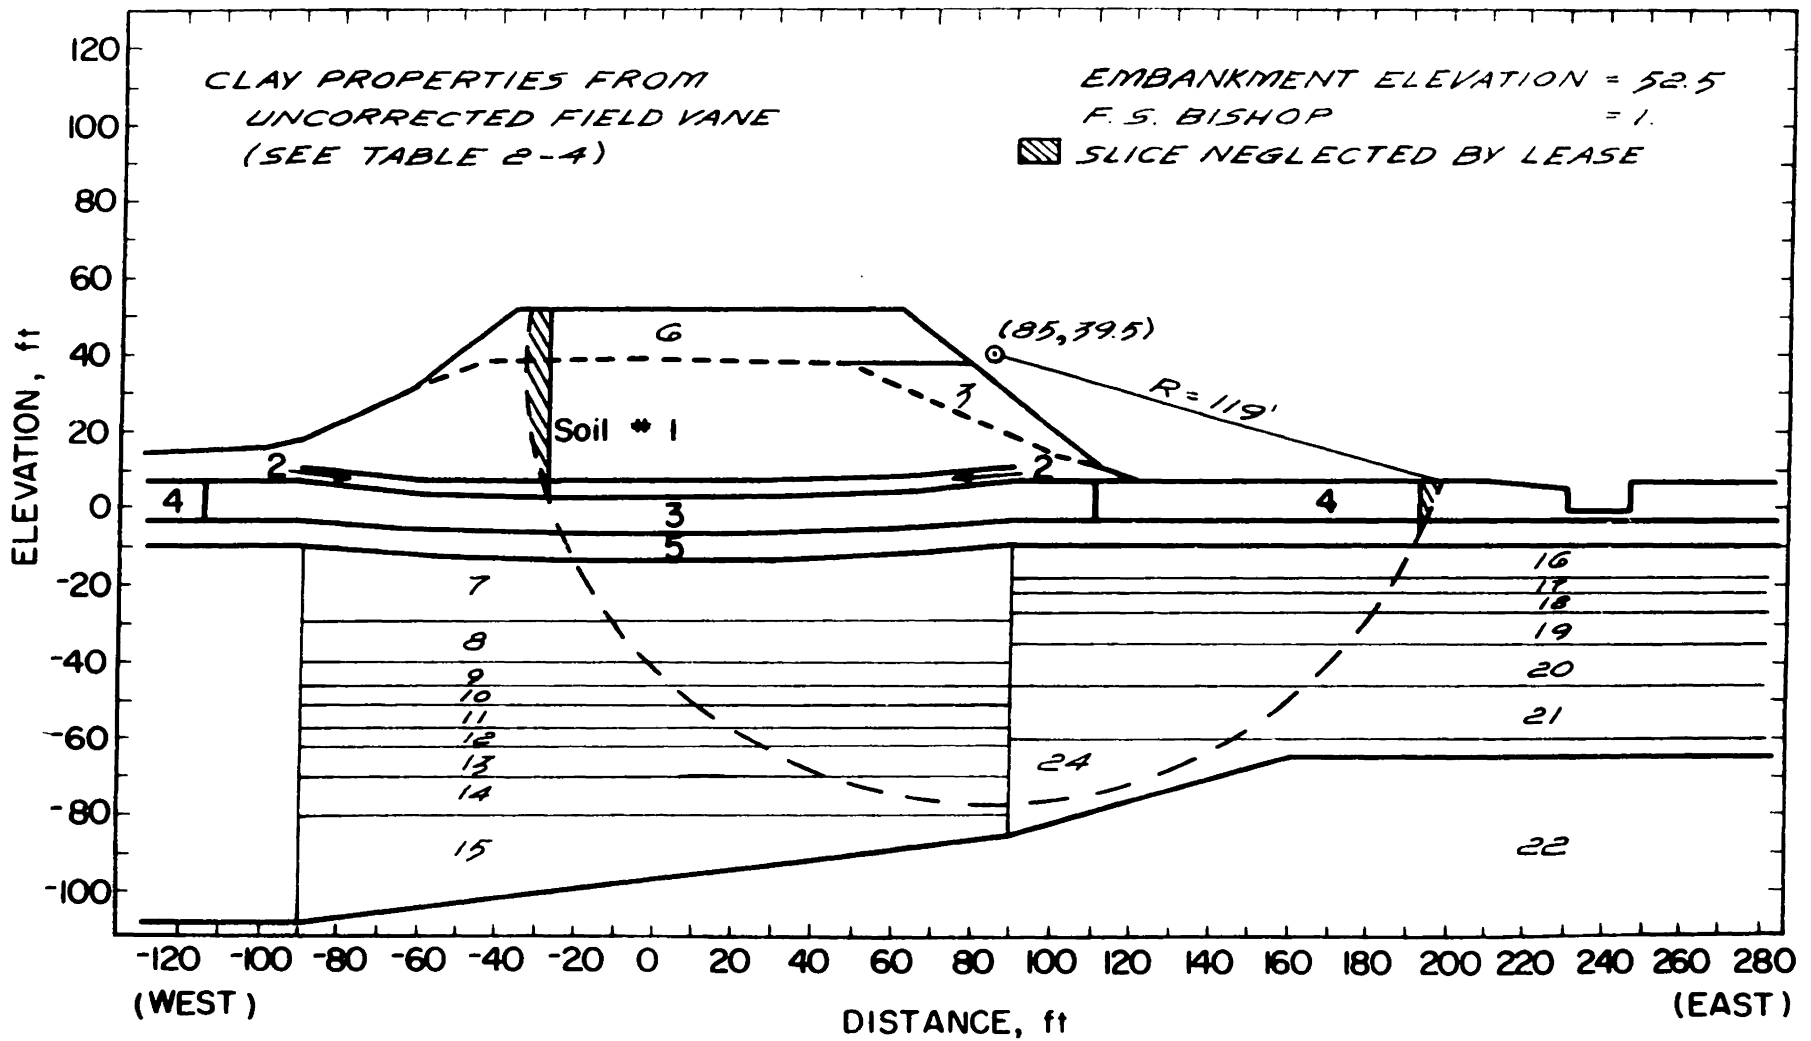
STABILITY ANALYSES I-95 STATION 263
FIGURE 2-11

The strength profile represented by the solid lines in Fig.2-9 was the basis for the computer model shown in Fig.2-11. The sliding mass was divided in slices 5 ft wide. LEASE ignores the two end slices but for the station 263 test section the additional resistance through the peat layer and the nearly vertical failure plane in the sand would be very small.

FS=1 is 52.5 ft with the failure surface shown in Figure 2-11.

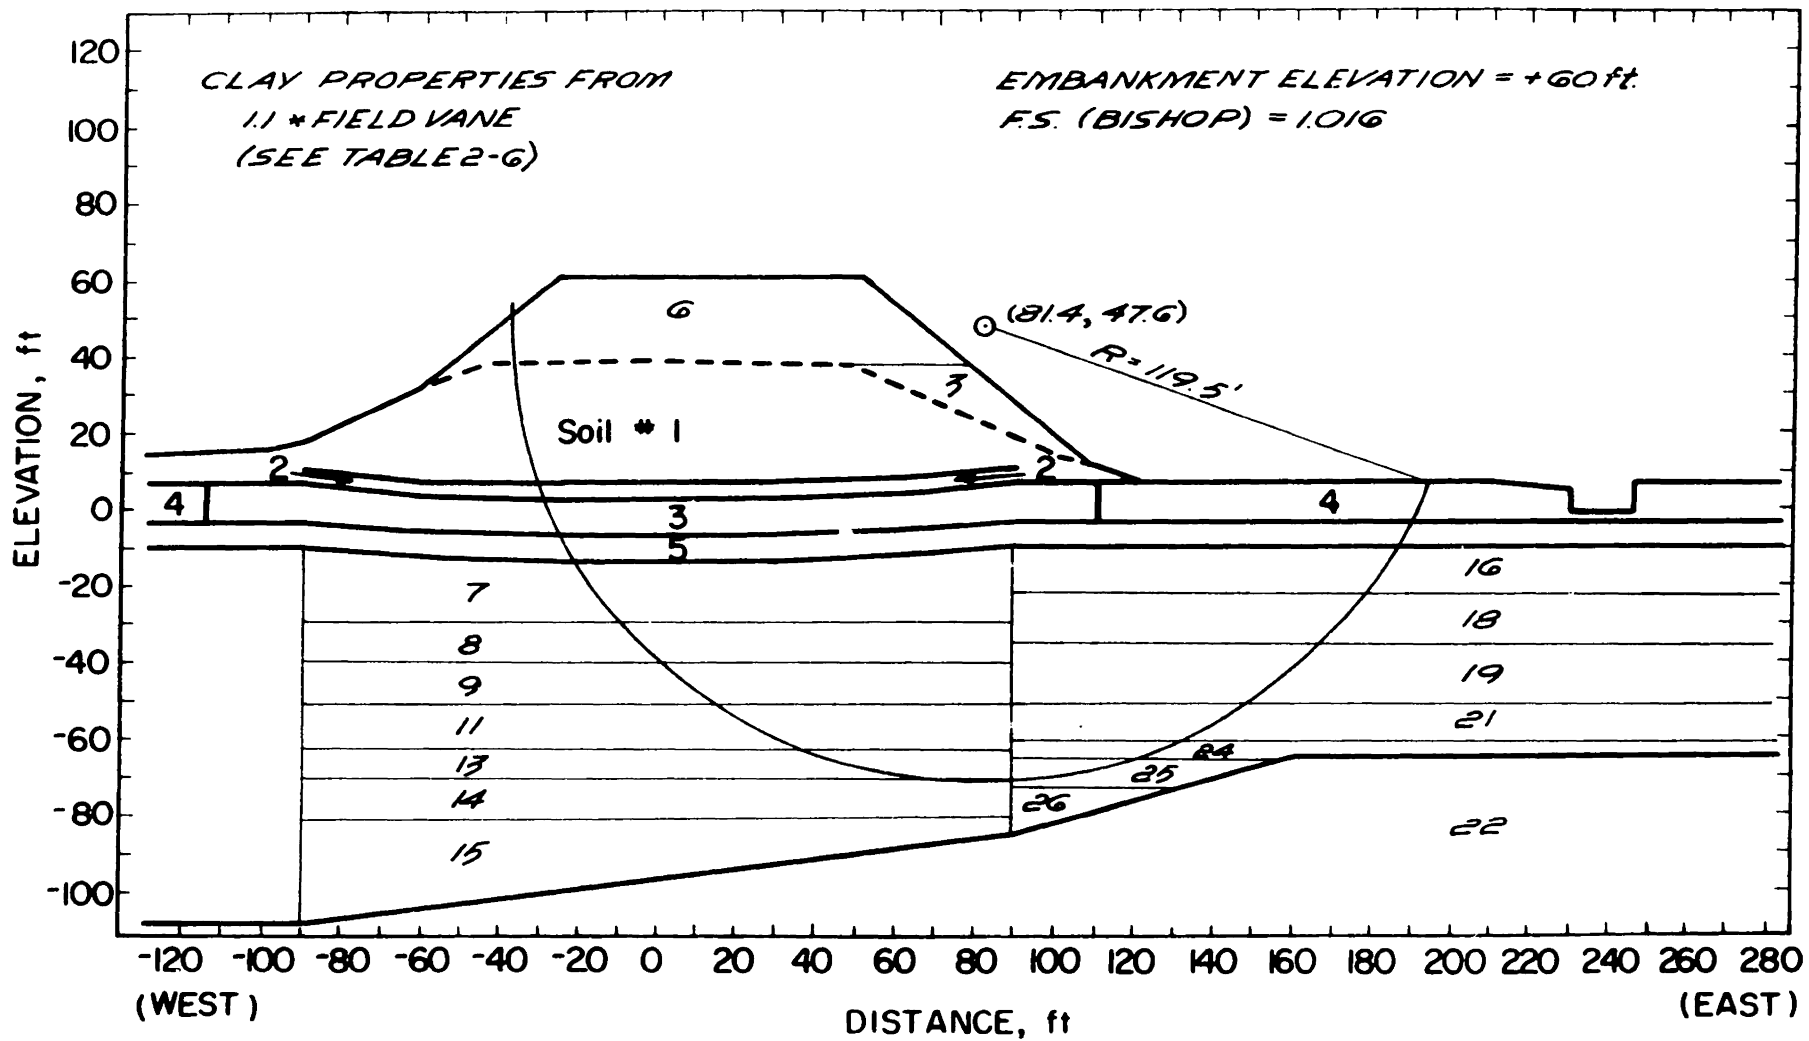
STABILITY ANALYSES I - 95 STATION 263
FIGURE 2-14

The results of the FV \times 1.1 analysis are plotted in Figure 2-15. The failure elevation predicted is +61.1 ft. Figure 2-14 presents the analysis and critical failure surface for an embankment elevation of 60 feet. In addition to the analysis of the east slope, the west side of the embankment at elevation +60 was examined with the 1.1 \times F.V properties. The computed factor of safety was 0.977. Since this is somewhat lower than the safety factor for the east side at the same embankment elevation, it was an indication of the possible need for preventive measures during construction to force the failure to the east side, where the majority of the instrumentation had been installed.

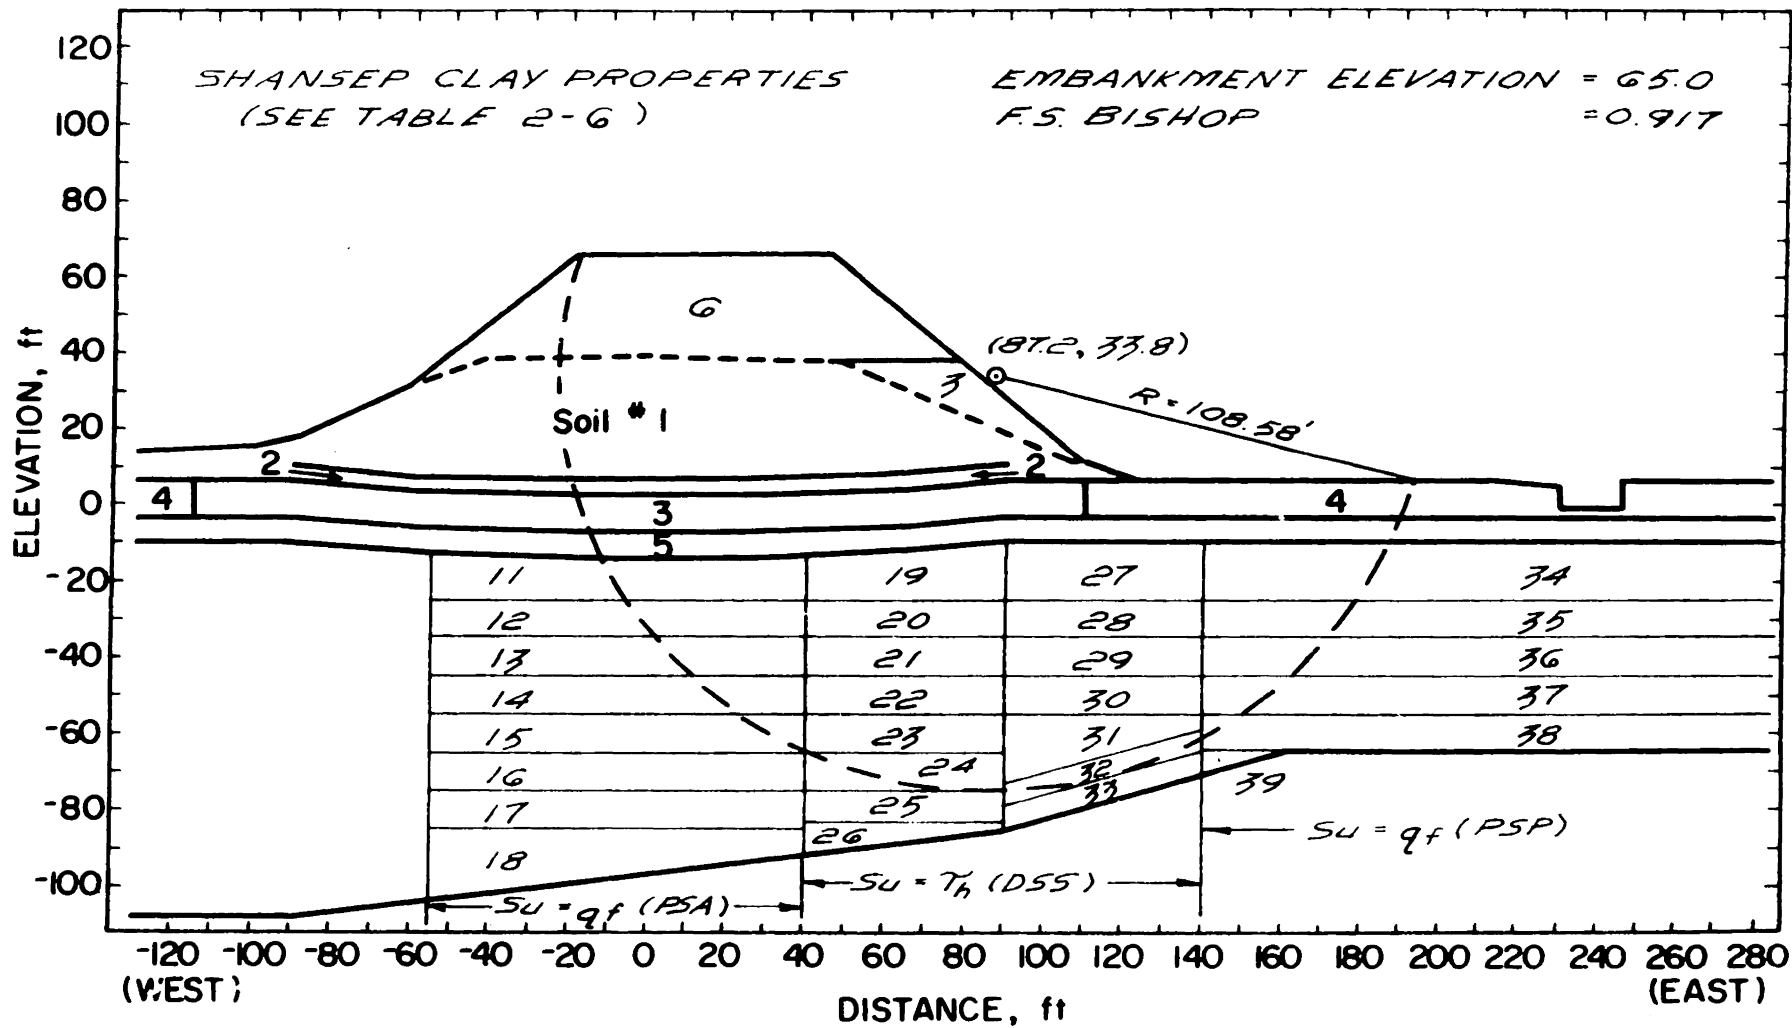
STABILITY ANALYSES I-95 STATION 263
FIGURE 2-19

The result of the LEASE-SHANSEP analysis for the embankment at elevation +65 feet is shown in Figure 2-19. The factor of safety computed was 0.917. As shown in Figure 2-20, the fill elevation for FS=1 was estimated to be 59 feet using only the analysis at +65 feet. A formal prediction was not made using the LEASE-SHANSEP approach for two reasons: 1) the analyses would involve a time consuming trial and error procedure to obtain the correct value of S_u on the different segments of the critical surface. 2) Since the problem geometry suggests a non circular failure surface, the more sophisticated Morgenstern-Price analysis was considered to be suitable to use with the more sophisticated SHANSEP approach.

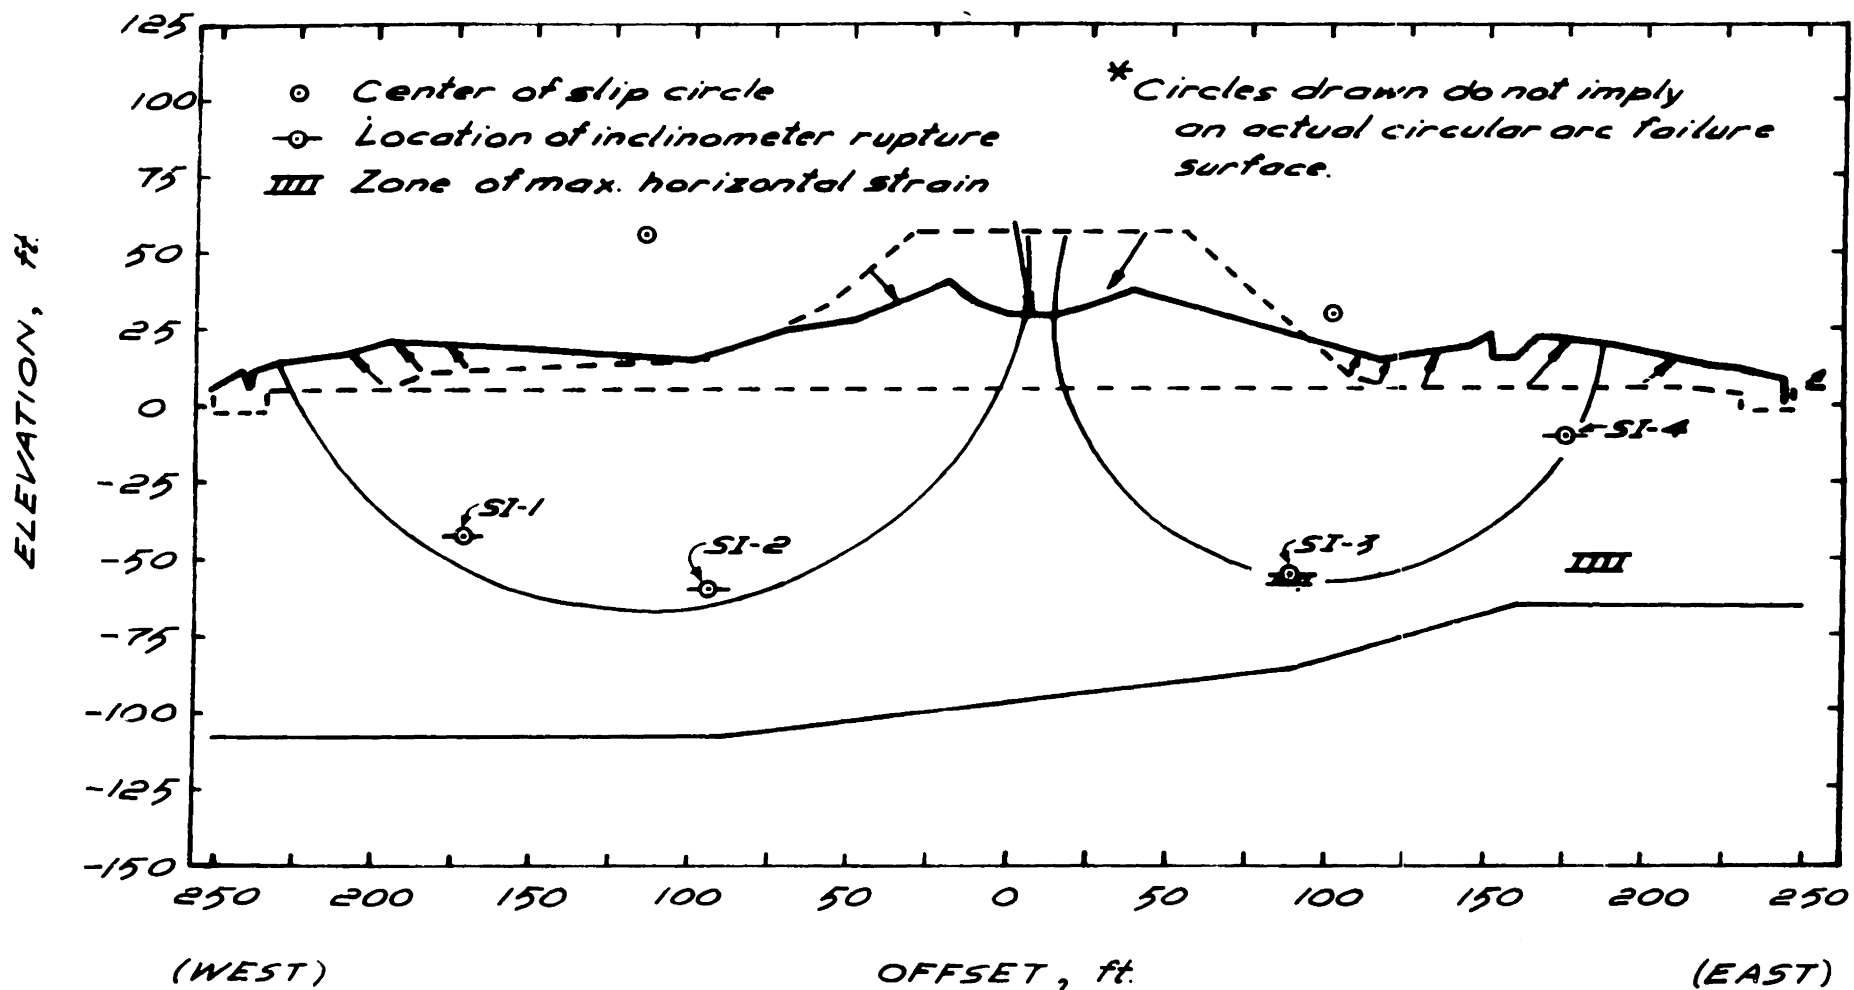
FIGURE 3-12

Failure occurred to both sides as shown in Figure 3-12. A single frame of an unsuccessful time-lapse film made during the failure indicates failure occurring to both sides simultaneously. Also shown in Figure 3-12 are the depths at which the inclinometer ruptured as indicated by probing after the failure and the zones of maximum horizontal strain up to the day before failure. The horizontal strain data was obtained from inclinometer data presented by Hawkes (1975).

STATION 263 TEST SECTION BEFORE AND AFTER FAILURE

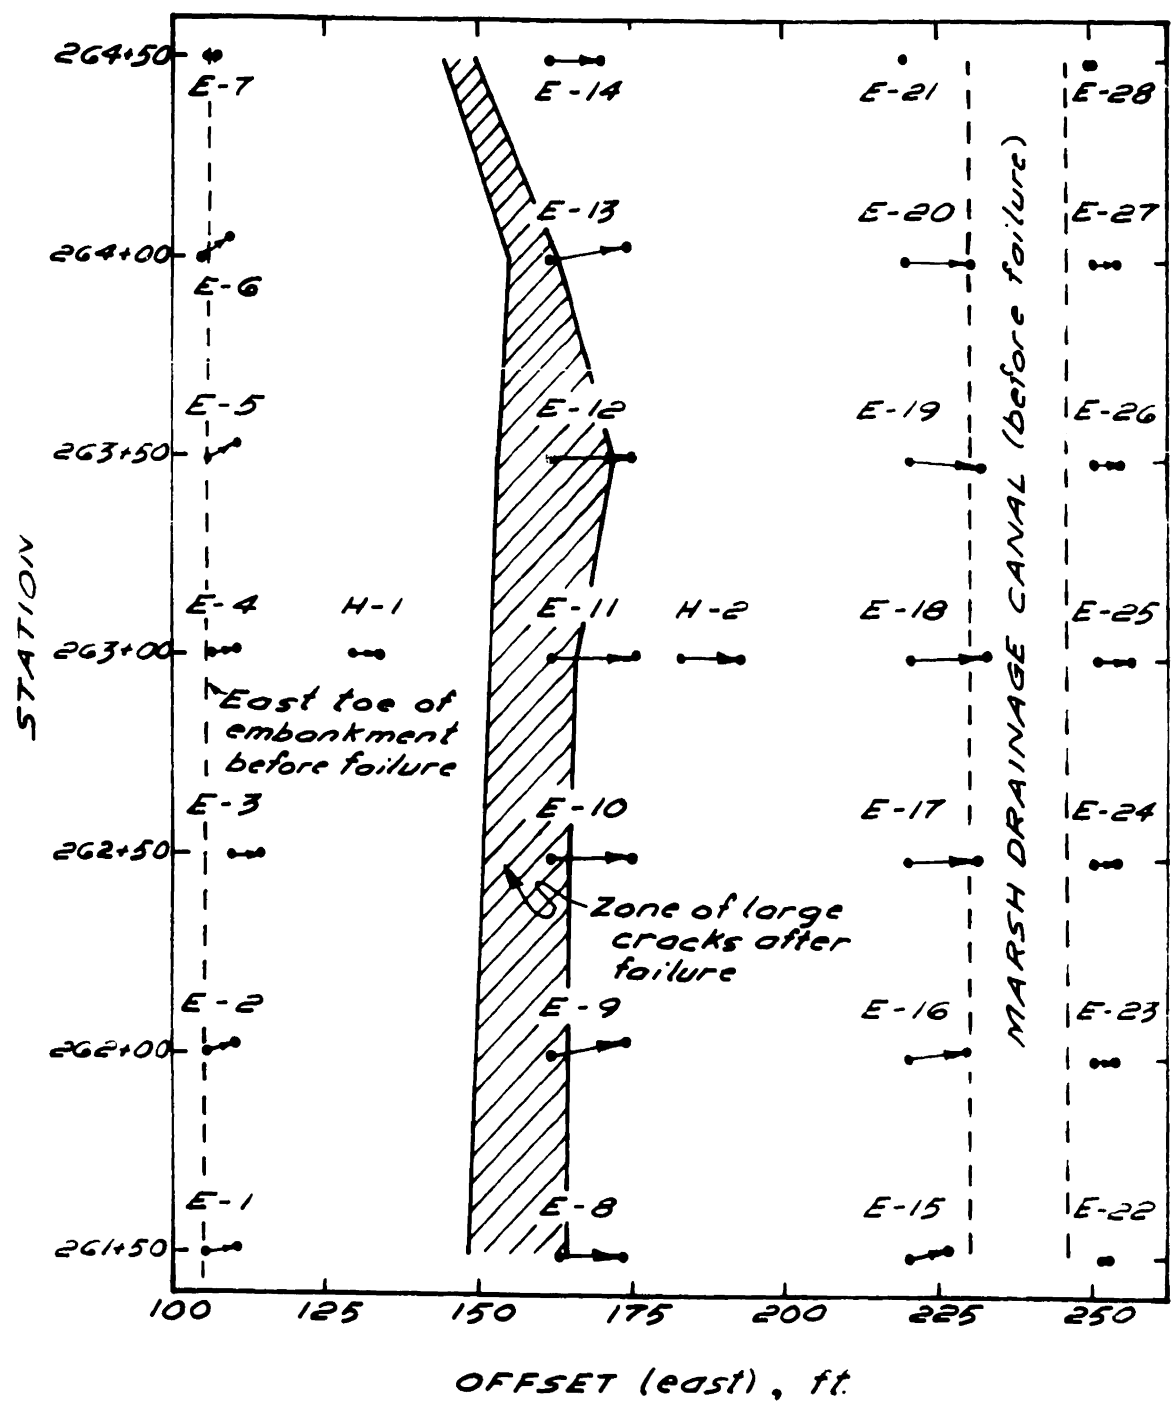
FIGURE 3-13

HORIZONTAL DISPLACEMENT OF SURFACE STAKES
