Improving the Finish Quality of Large Commercial Air Conditioners

David J. Wirth

Master of Science in Management
and
Master of Science

in conjunction with the
Leaders for Manufacturing Program
at the
Massachusetts Institute of Technology

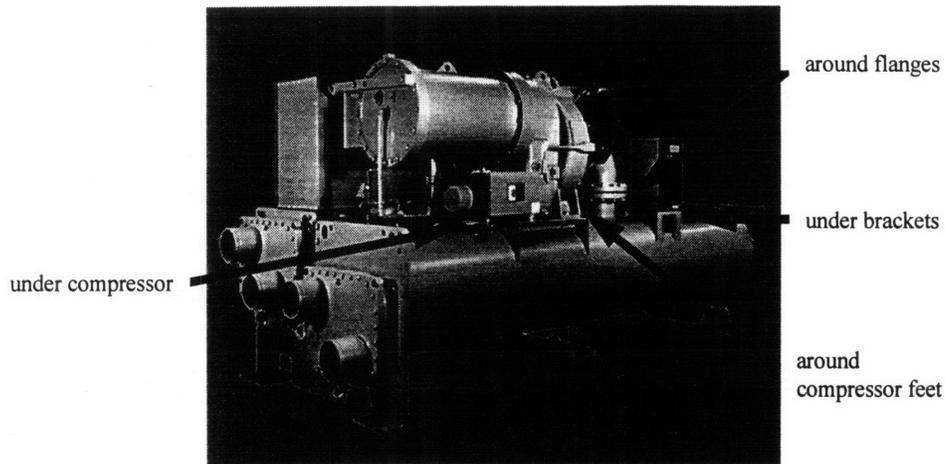
Figure 2 Frequently rusted areas on the 19XL chiller

The rust does not appear in all places on all products, even though painting process is the same for all products. The rust problem is much worse on 19XL and 19XR's than on 19EX and 23XL chillers. While the amount of rust is highly variable from unit to unit, the rust tends to be localized in the following areas: underneath the compressor, around the flanges, around the compressor feet and underneath brackets. The 19XL is assembled on two production lines. No difference in the amount of rust that forms on 19XL's made on the different lines has been observed. The rust tended to either come through the paint or was on top of the paint. No sign of paint adhesion failures were indicated by the coating peeling off the chiller. Figure 2 shows the rust prone areas on a 19XL.

Rust is most commonly found at these locations on 19XL chillers.

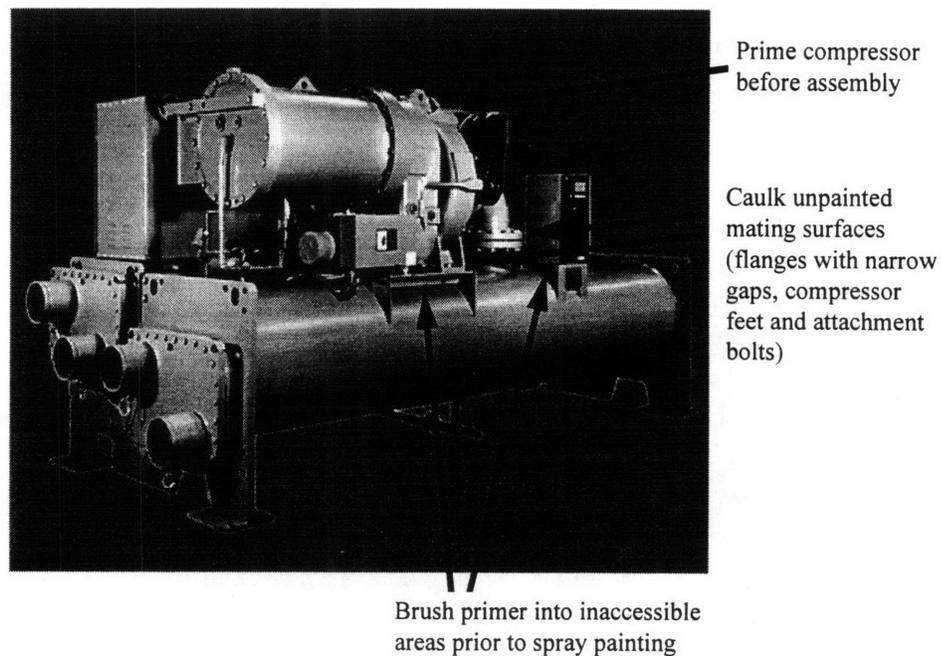
Figure 7

Process Changes

One practical solution to this problem was developed. Applying a caulking compound to the gap after assembly sealed the unpainted surfaces from the surrounding environment. When this material is applied, water cannot enter the gap and cause the unpainted surfaces to rust. An acrylic latex caulk already used to

seal gaps in the insulation on these chillers was chosen for this application. Shop trials with this material showed that the caulking performed as desired.

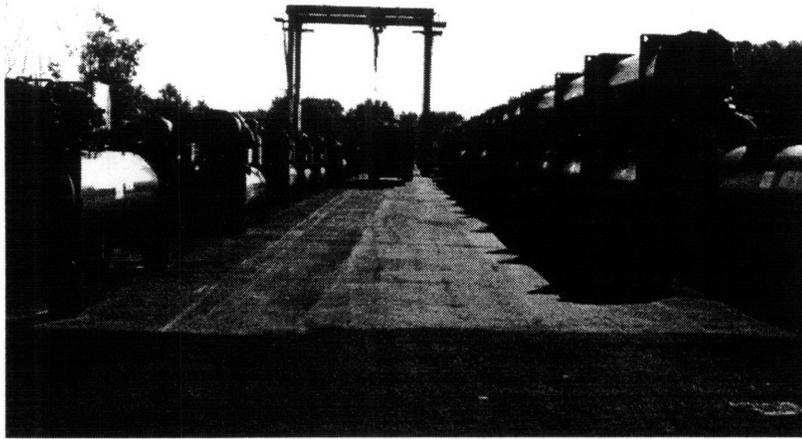
Figure 11

Shang-ri-la

The finished chillers are stored in a converted parking lot. Exposure to the elements during storage in Shang-ri-la causes significant amounts of corrosion on chillers before they are shipped to customers. Approximately 90% of the chillers stored for more than two weeks have sufficient corrosion damage to

A long term plan is being developed to eliminate the outdoor storage of completed chillers. The plan would convert unused space inside of TR-1 into a storage area. This would eliminate the transportation charges between the plant and storage area, as the plant's overhead cranes could move the chillers instead of flatbed trucks. Weather related damage would be greatly reduced with indoor storage. Other policies are being modified to reduce storage times.
