ENGINEERING GEOLOGY PROBLEMS
AT AMBUCLAO DAM SITE
BOKOD, BENGUET, PHILIPPINES

SUBMITTED IN PARTIAL FULFILLMENT OF THE
REQUIREMENTS FOR THE DEGREE OF
MASTER OF SCIENCE
AT THE
MASSACHUSETTS INSTITUTE OF TECHNOLOGY
(1953)

ENGINEERING GEOLOGY PROBLEMS AT AMBUCLAO DAM SITE

BOKOD, BENGUET, PHILIPPINES

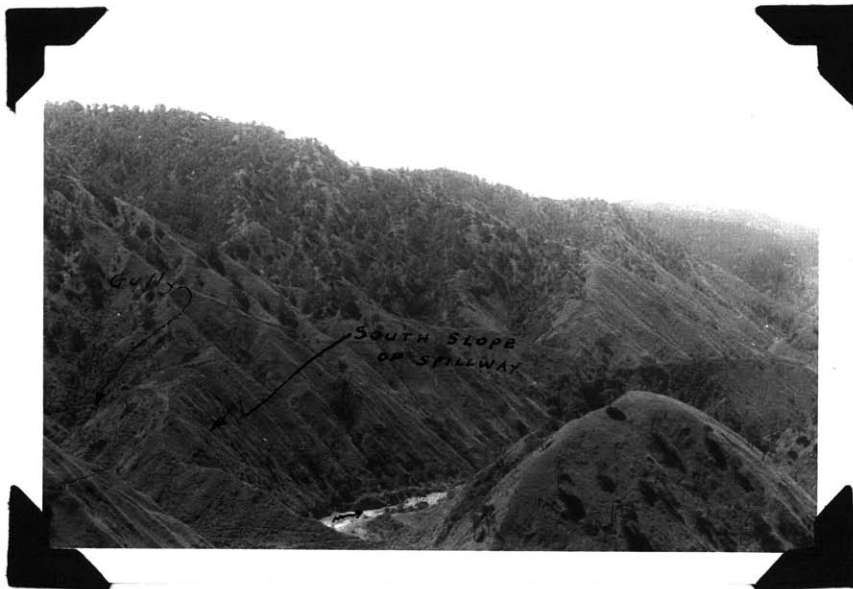
B. View on Downstream Side. Note
south steep slope of Spillway.

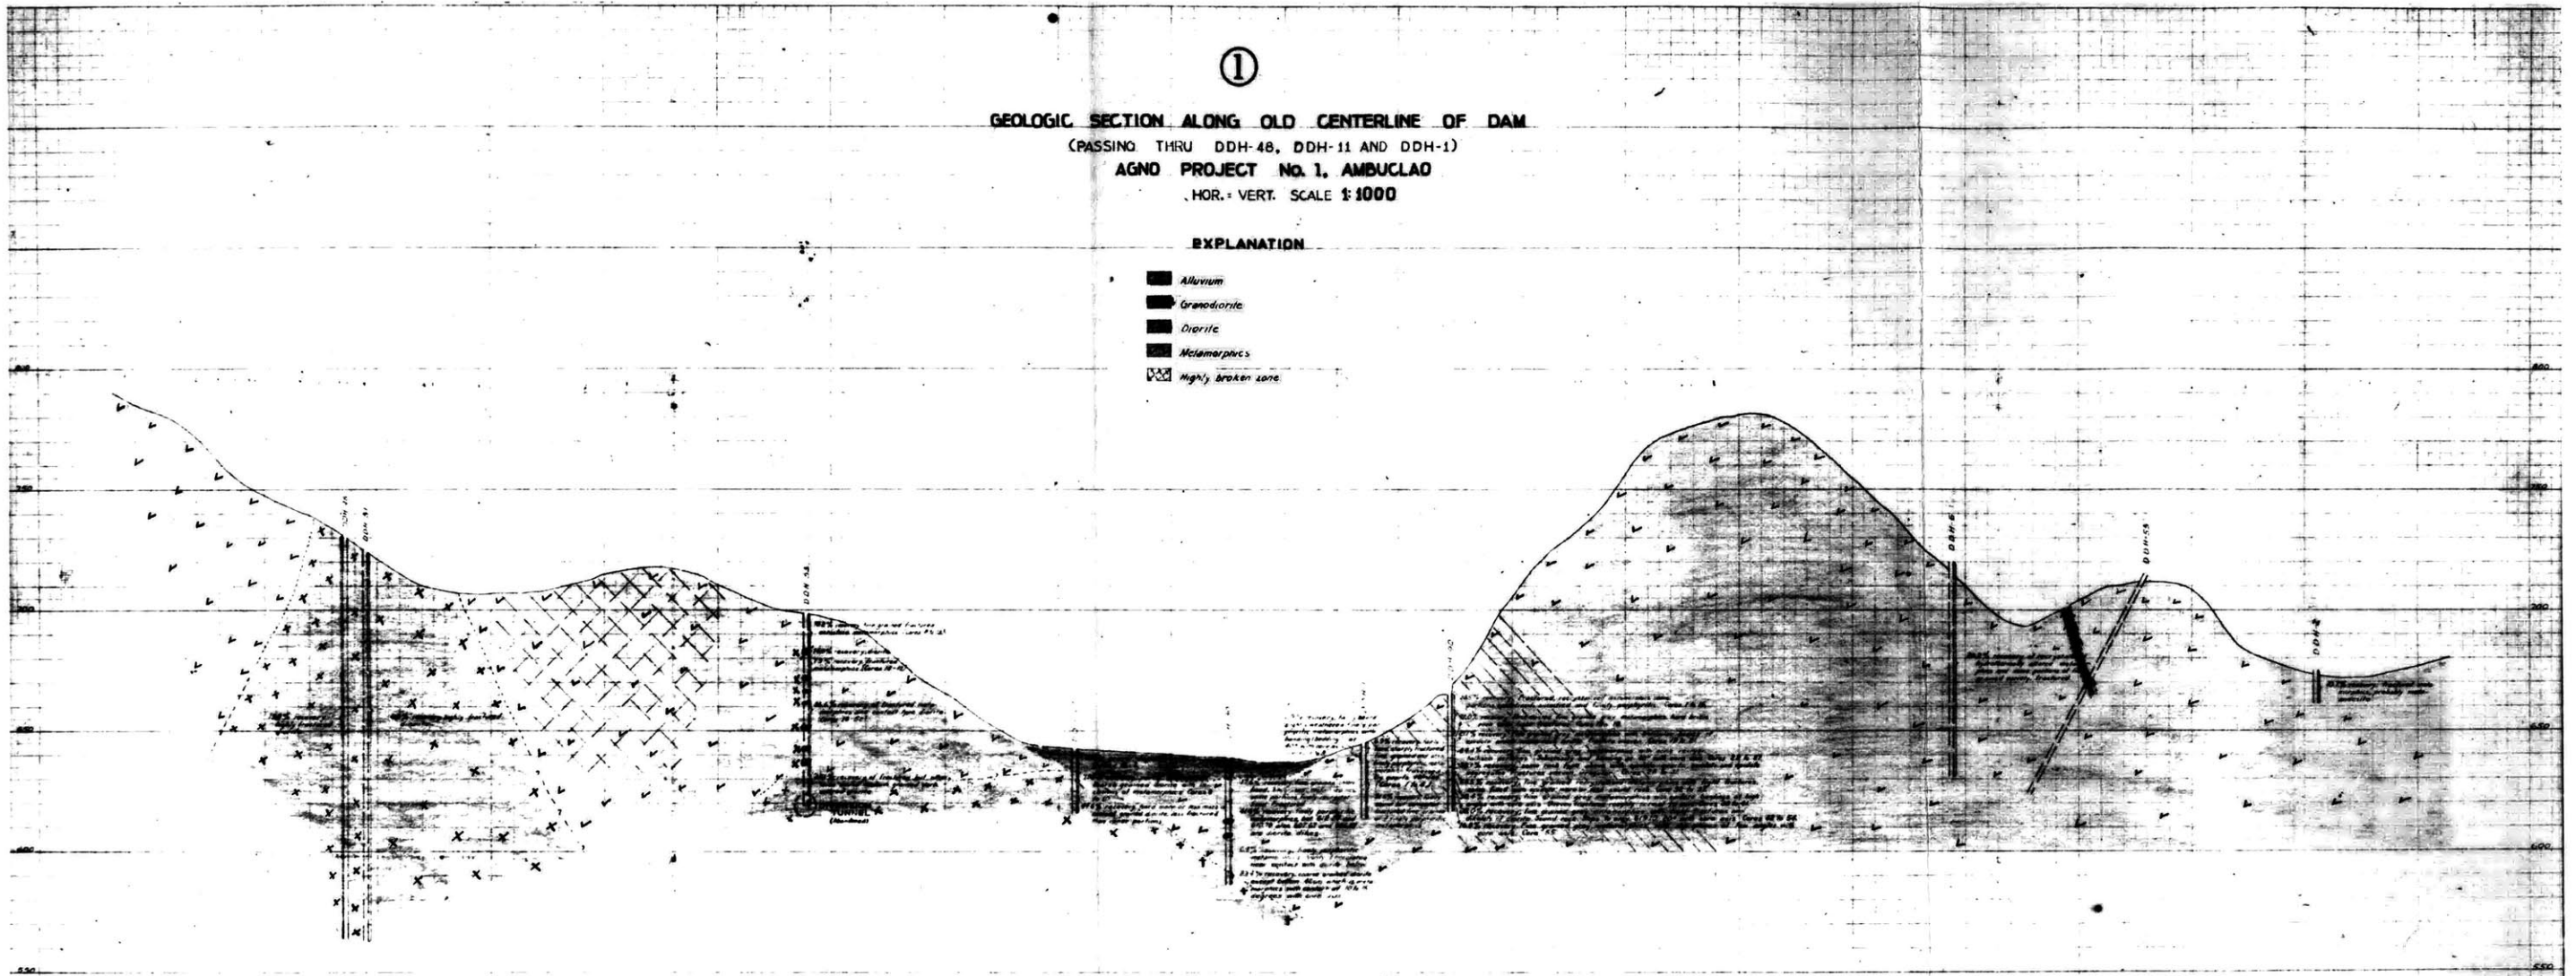
PLATE IX-A

It was pointed out that the metamorphics at the right abutment are severely fractured and those in the gully area are sheared and partly disintegrated (Plates IX-A to IX-E). The sheared zone has a maximum breadth of 130 meters (see Plate X) and extends from the upstream toe on the right bank of the river to the gully and spillway areas on the left abutment ridge (Plate III). Undisturbed specimens obtained from the test pit in drill hole 38 slake in water at a very slow rate and crumble easily under a slight pressure after the specimen had been exposed to the atmosphere.

It will be necessary, therefore, to protect the fractured abutment and the sheared zone under the impervious clay core. Long exposure to the atmosphere should be avoided during construction. It is not known whether the sheared metamorphics possess sufficient bearing strength to sustain the combined load of the fill materials and the overlying column of water. Tests should be made to determine the compressibility and plastic properties of the gougy material in drill hole 38.

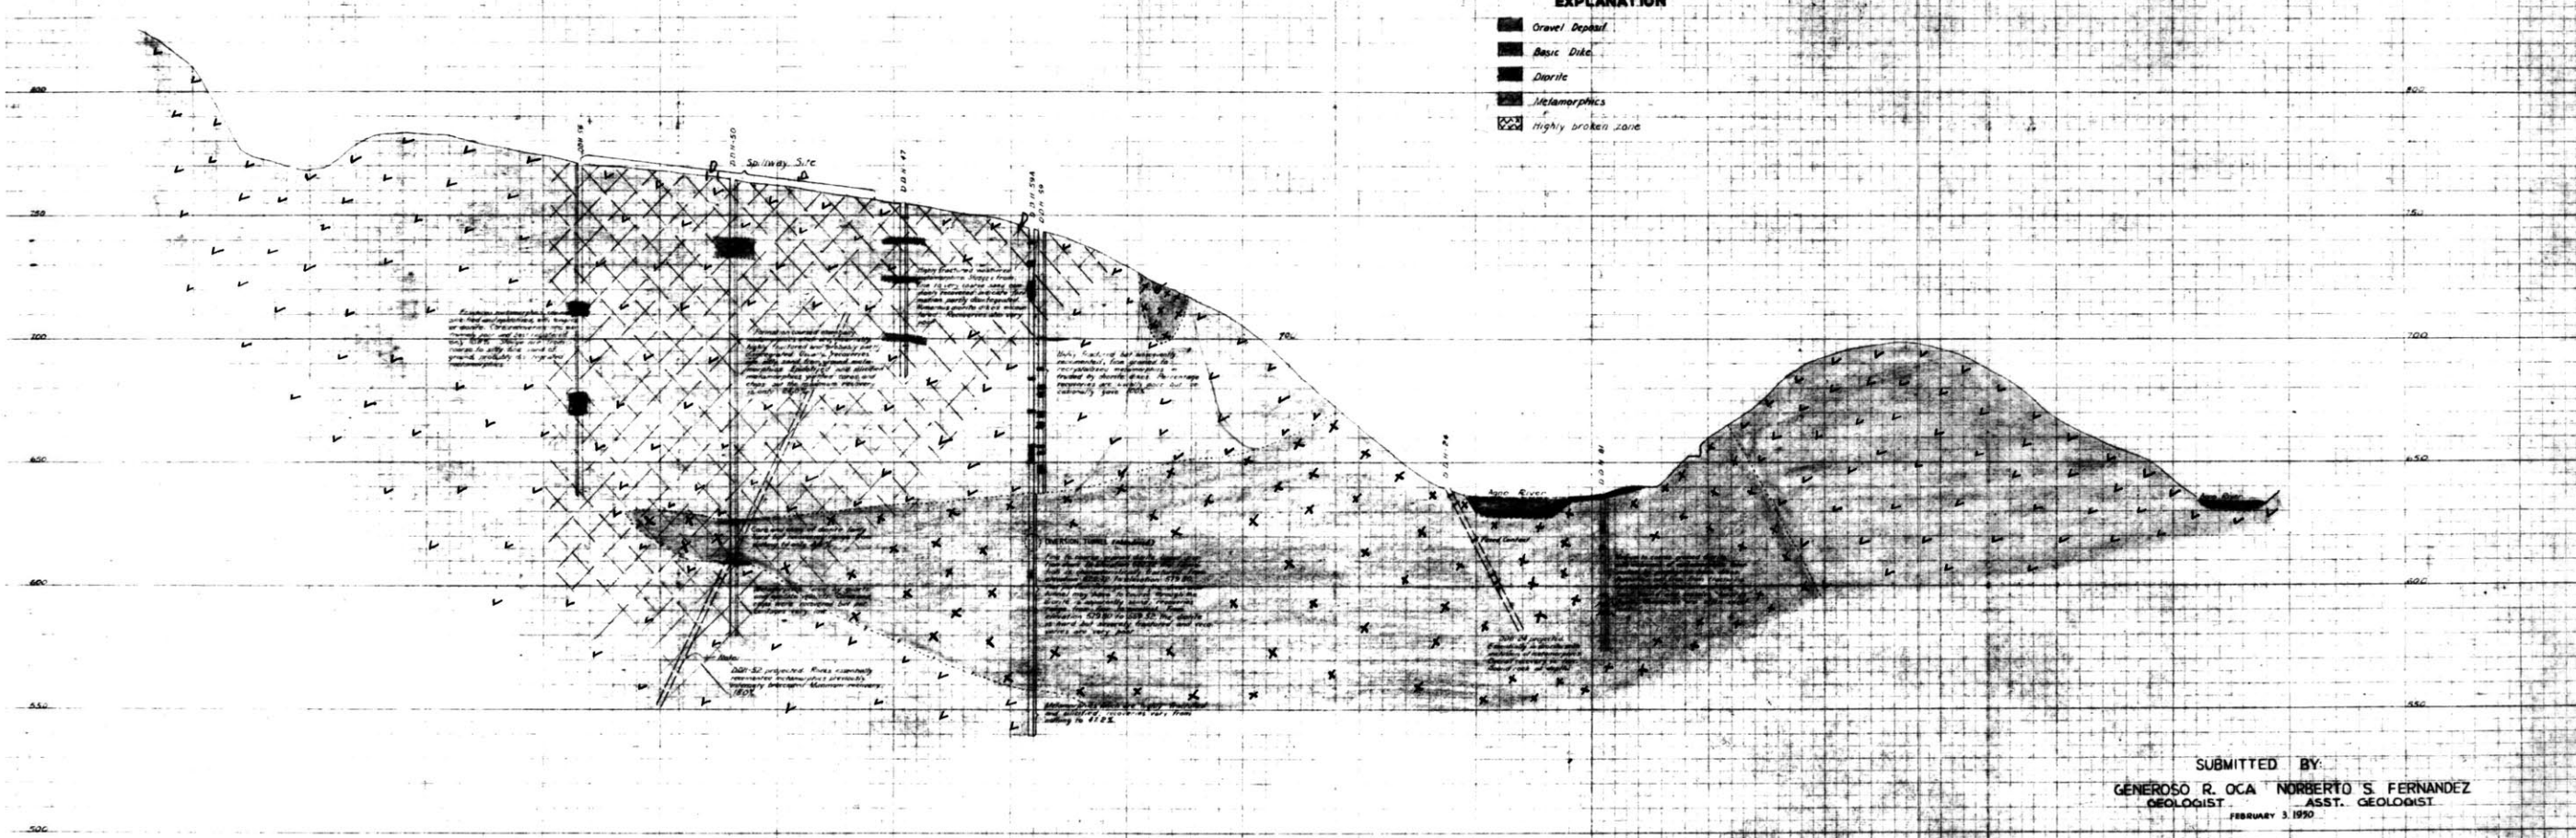
PLATE IX-B

The spillway structure is located on fractured and partly disintegrated metamorphics (Plate IX-B). A

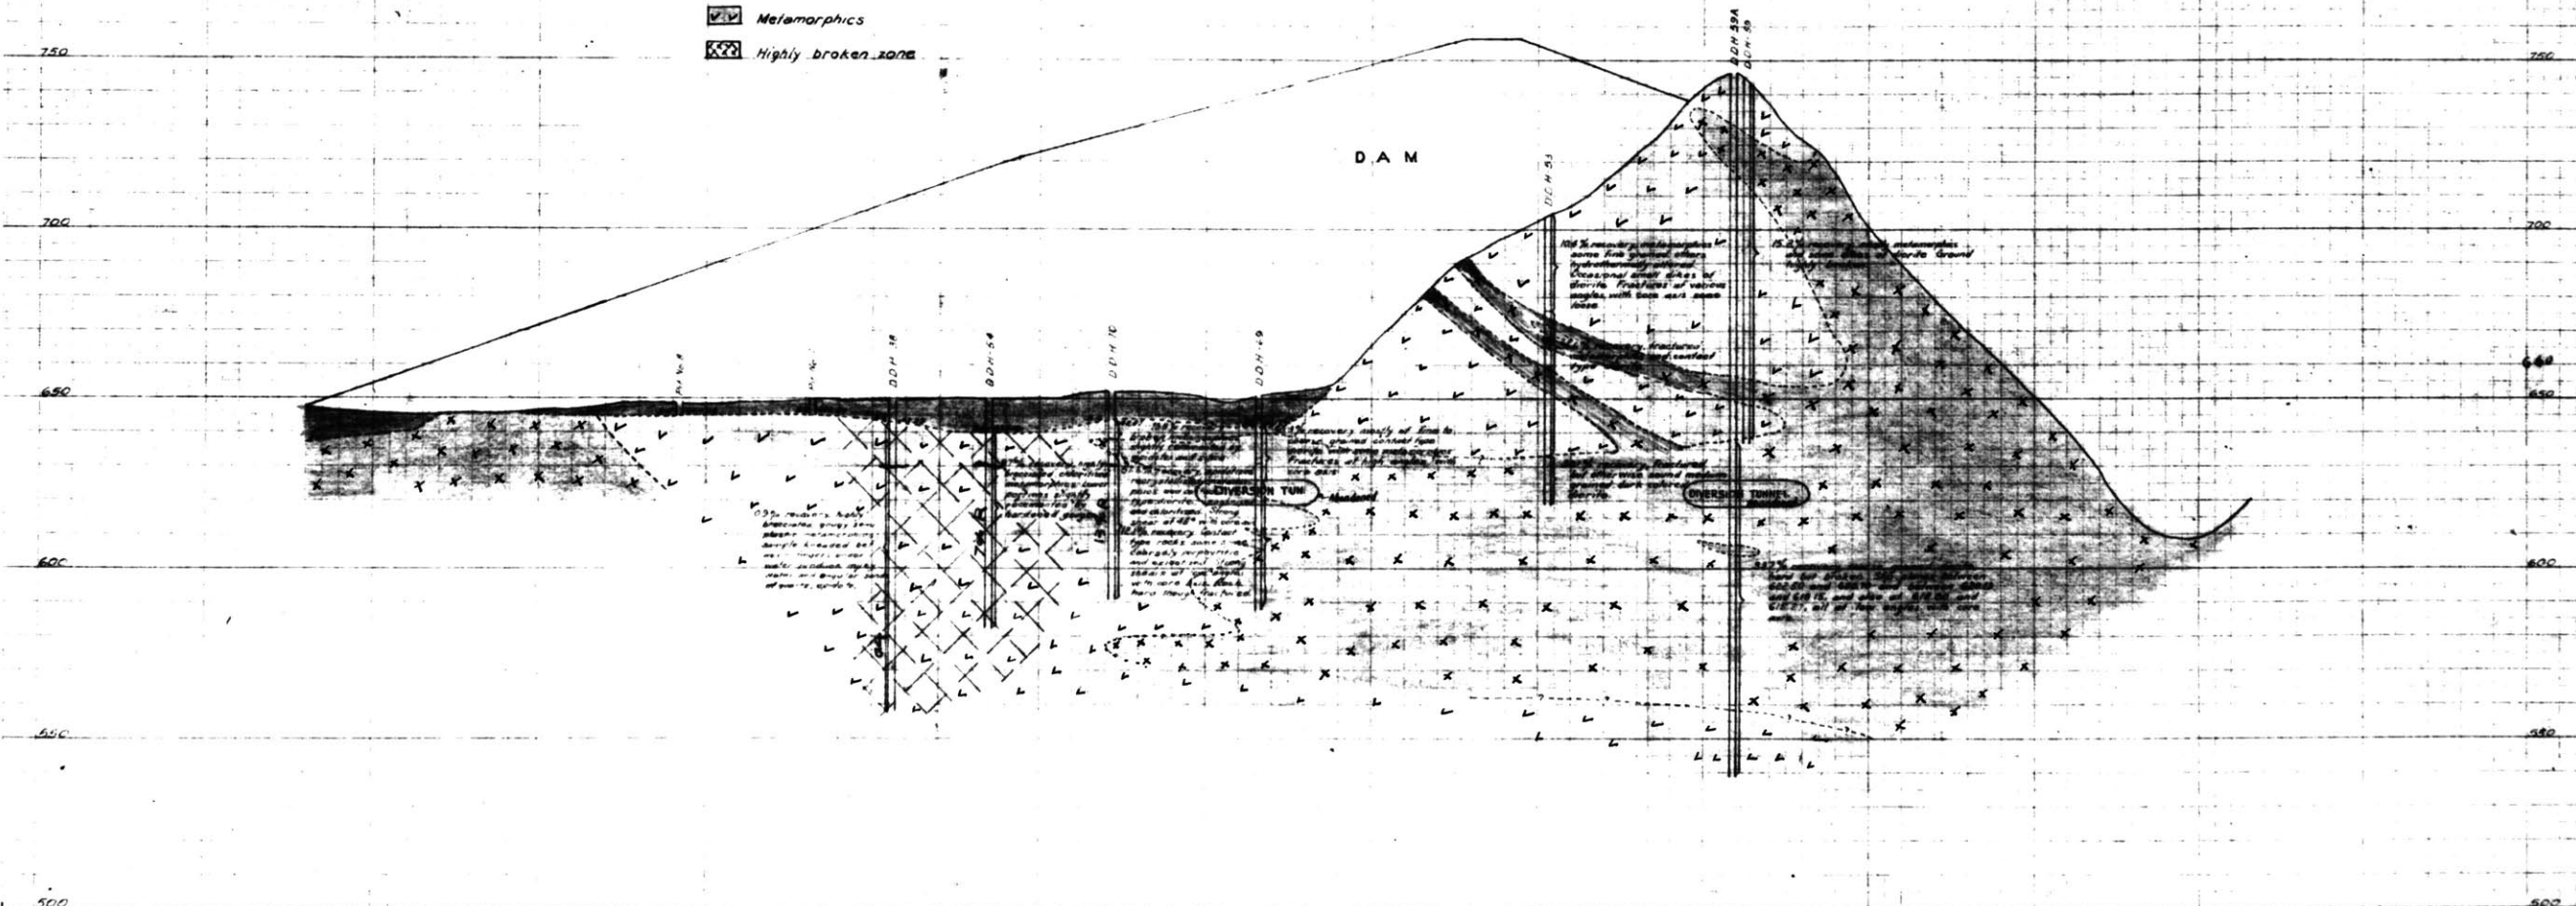
PLATE IX-E

The metamorphics at the spillway site are deeply weathered, particularly along the north slope of the ridge. However, diorite crops out high up on the south slope (Plate IX-E). The diorite is a stronger foundation rock for it is less weathered than the metamorphics.

rock is likely to be scoured. Hence, it is recommended that a concrete pavement be provided which will act as a cushion for the overflowing water. It is also important to anchor the concrete sufficiently deep into the diorite, and to safeguard against sliding, concrete dowels should be provided. In addition, the upstream slope of the spillway must be water tight in order to prevent undermining or piping at the base of the concrete pavement. Grouting procedure to be followed is the same as outlined for the dam proper.

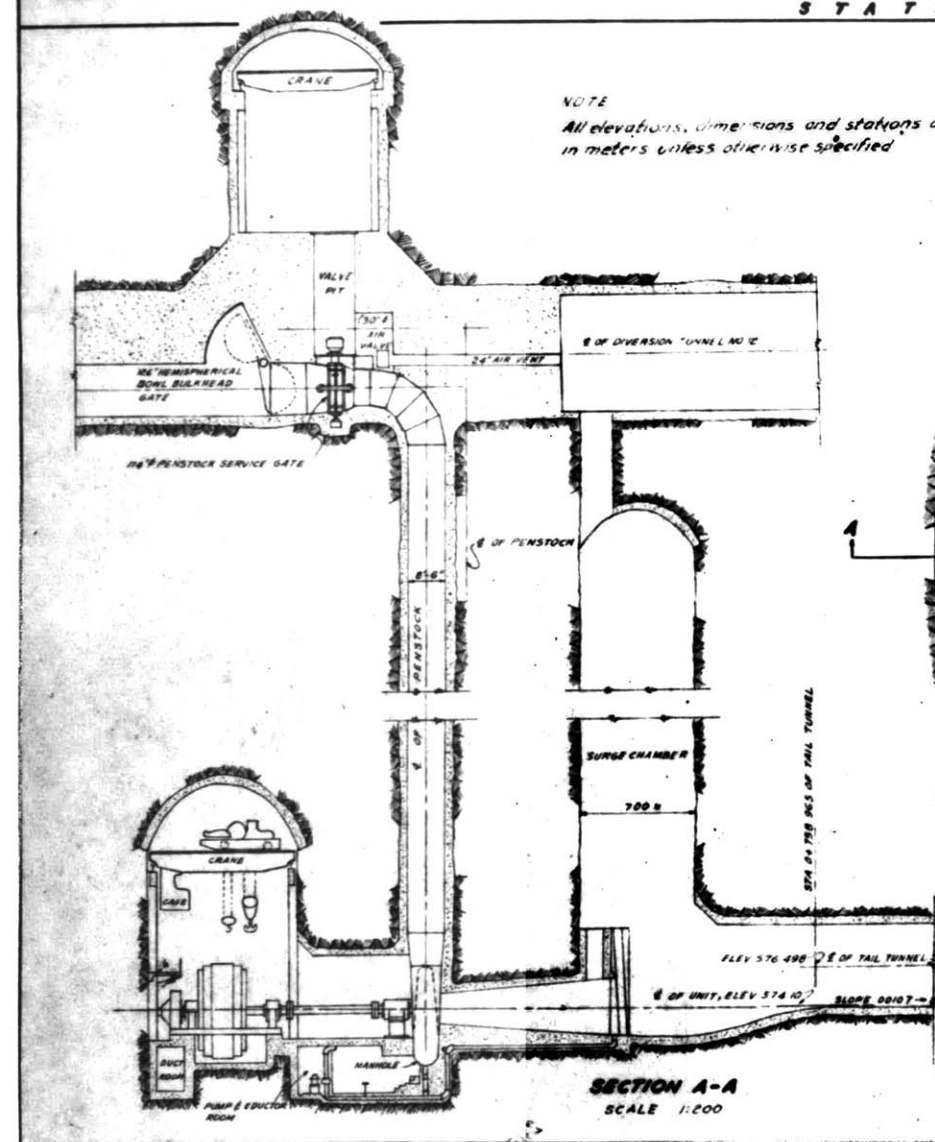
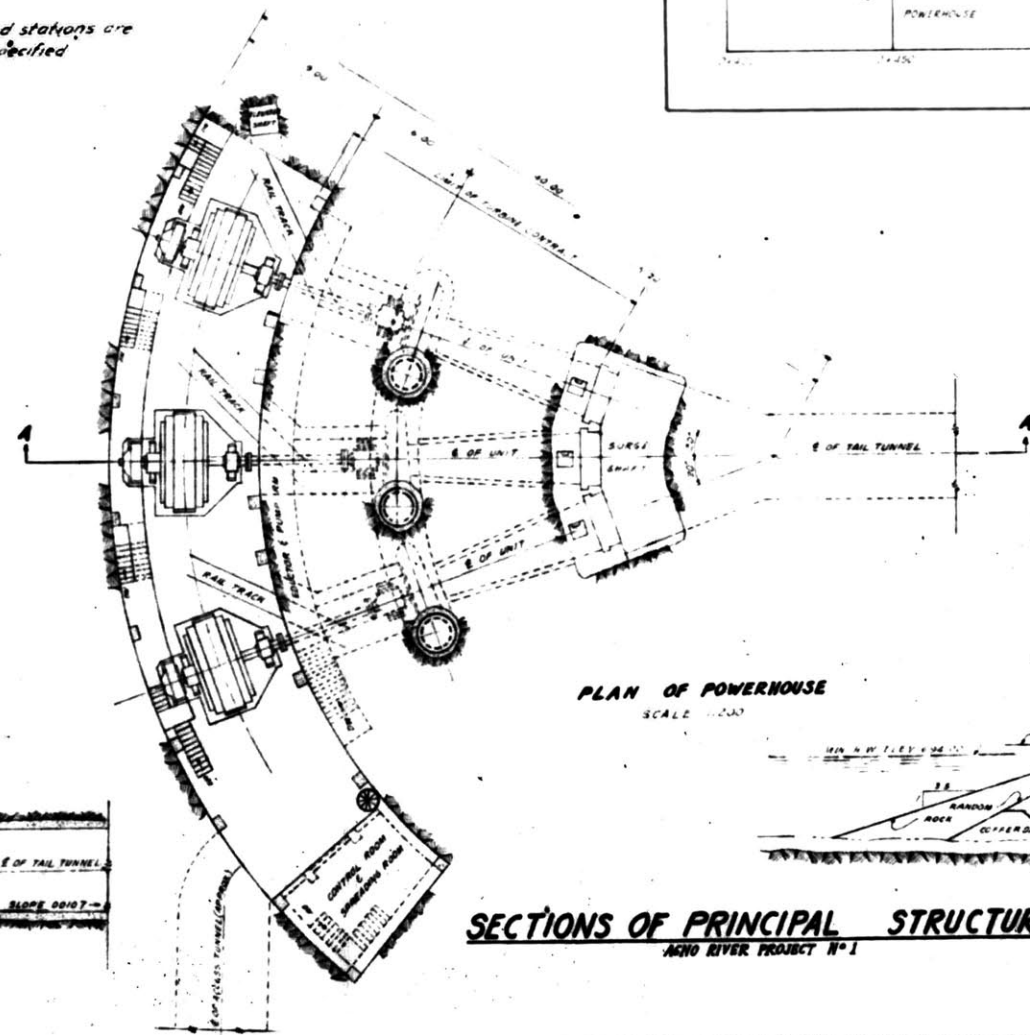
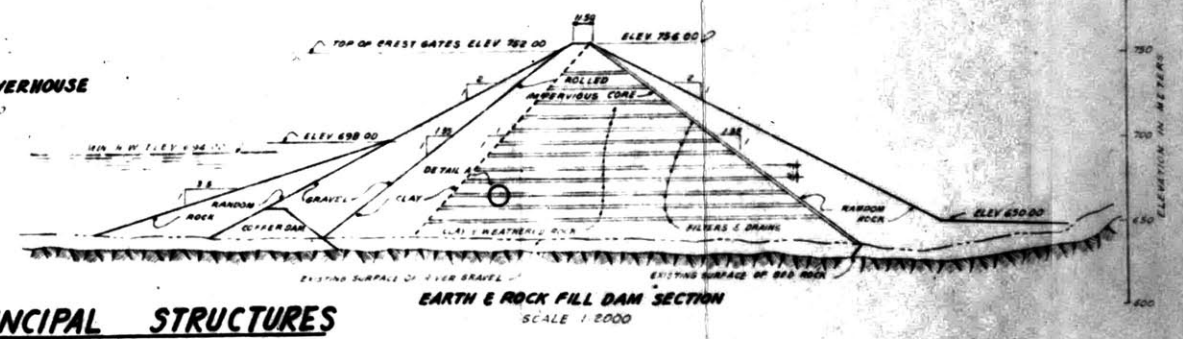
SECTIONS OF PRINCIPAL STRUCTURES
AGNO RIVER PROJECT No. 1

It will be noted that the control chamber has a minimum back of only 10.5 meters of diorite below its contact with the metamorphics (Plate XI). This will require strong provisions for support of the roof of the chamber. Extreme care must be exercised during excavation to avoid undue shattering of the rock at the roof and sides of the chamber. Grouting operations should follow the procedure outlined under "Diversion Tunnels".
