# A System Theoretic Safety Analysis of U.S. Coast Guard Aviation Mishap involving CG-6505

Jon Hickey

Master of Science in Engineering and Management  
at the  
Massachusetts Institute of Technology

May 2012

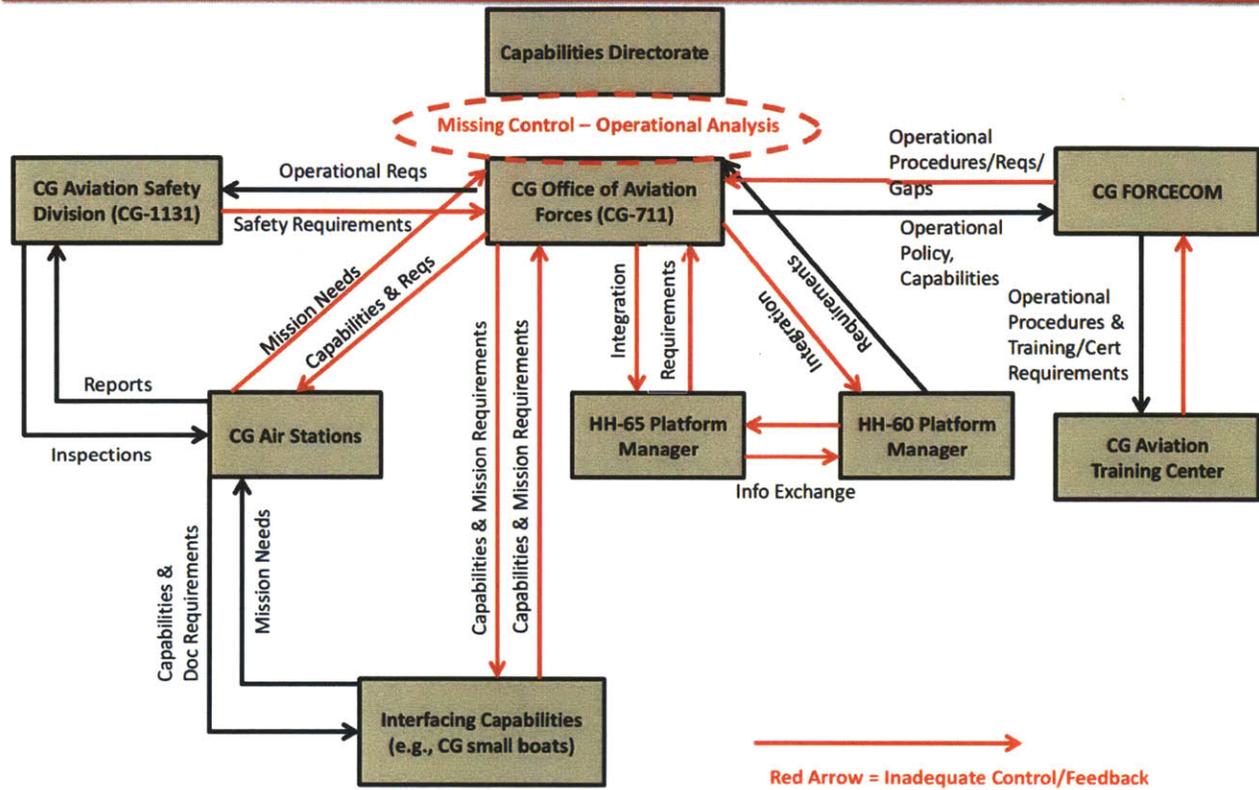
**Figure 5.16 – Capabilities Management – Inadequate Control/Feedback**

## Capabilities Management – Control/Feedback Inadequacies

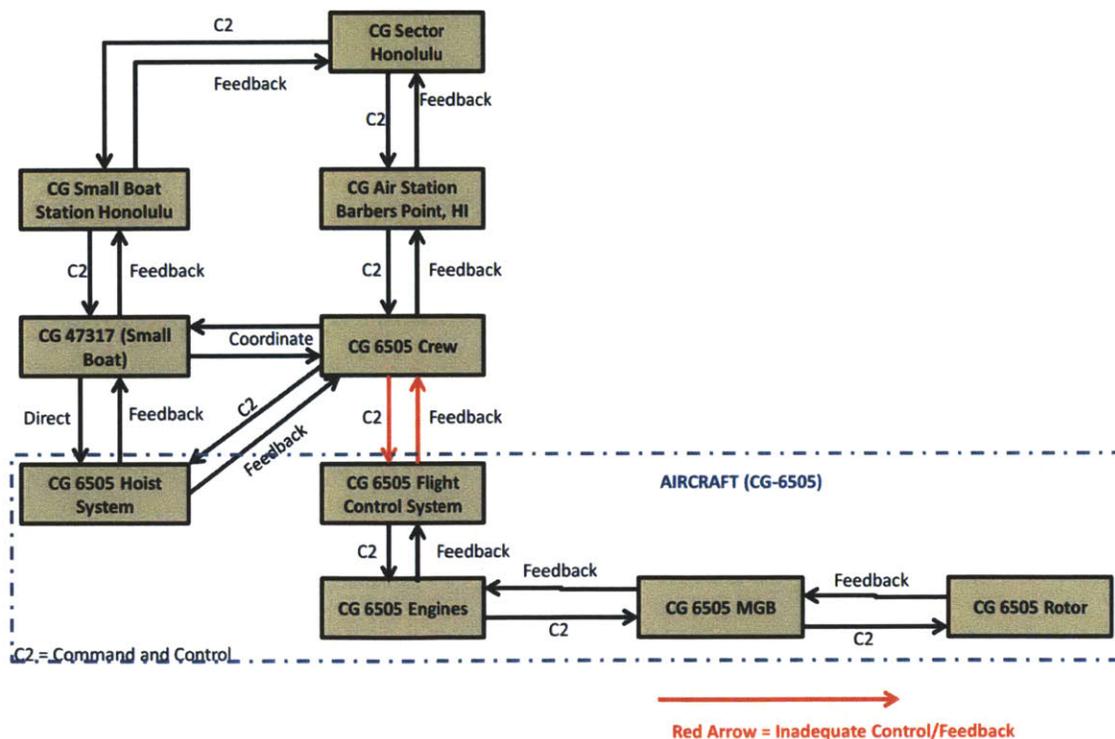
### Pilot & Flight Control System in Hover – Control/Feedback Inadequacies

Inadequate Control/Feedback – Lack of Control/Feedback of Hoist System and Lack of Communications between Air/Boat Crews – Due to inadequacies in the hoist system (e.g., lack of dynamic slip clutch, sub-optimal location of shear control for remote hoisting operations) and communications (e.g., inability of boat crew to communicate directly with air crew resulting in sub-optimal control/feedback), CG-6505/CG-47317 were not able to adequately control the hoist system to prevent entanglement and damage to the aircraft post-hoist entanglement. Additionally, lack of sensors on the hoist system resulted in inadequate feedback to the air crew regarding entangled status.

- Additional warning signals to alert pilot to snagged hoist condition and additional communications capabilities between air/boat crews – The Coast Guard should take action to add a sensor system to the hoist to inform the pilot/crew when the hoist is entangled and/or overloaded. Additionally, the Coast Guard should pursue acquisition of capabilities or implementation of tactics, techniques, and procedures to enable direct communications between the aircrew and boat crew. Both of these steps will improve the aircrew’s ability to detect hoist entanglements and quickly implement “hoist fouled/damaged” emergency procedures.

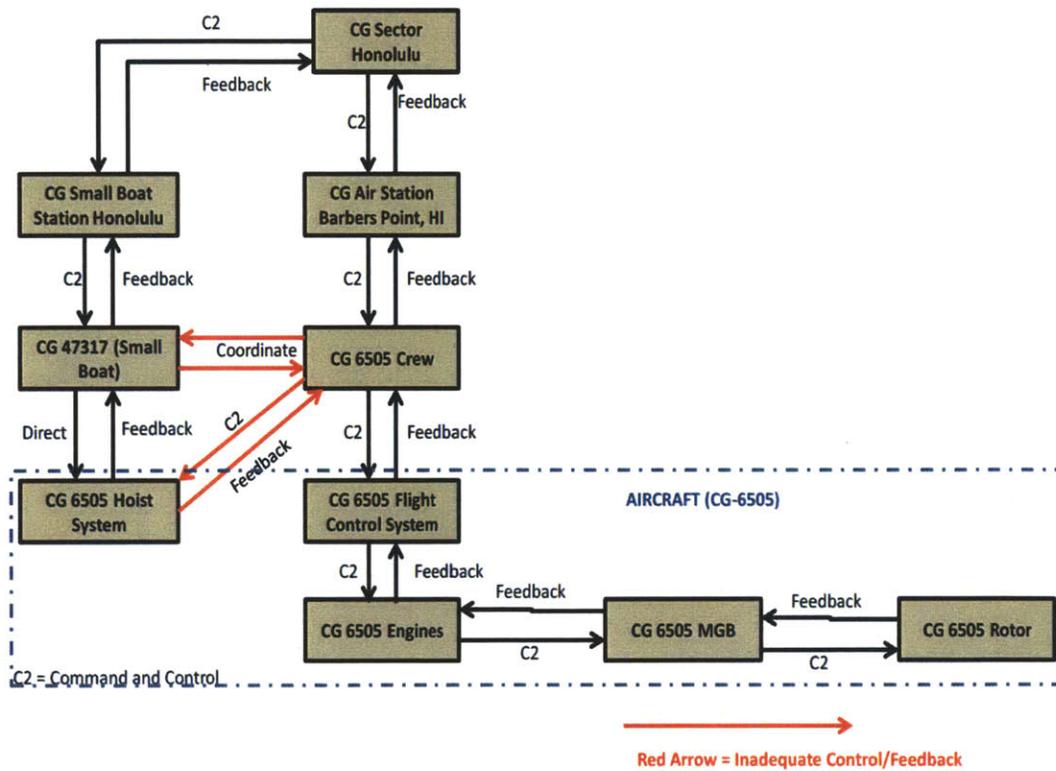
### Hoisting Operations – Control/Feedback Inadequacies

Inadequate Control/Feedback – Lack of Standardized Ditching Training – Lack of standardized training (observation and reporting) of ditching procedures.

Inadequate Control – Lack of emphasis on Ditching & Paramount Importance of Life Safety – Lack of emphasis on importance of ditching an aircraft following severe damage.
