System Theoretic Safety Analysis of the Sewol-Ho Ferry
Accident in South Korea

by
Yisug Kwon

Submitted to the System Design and Management Program in
Partial Fulfillment of the Requirements for the Degree of

Massachusetts Institute of Technology

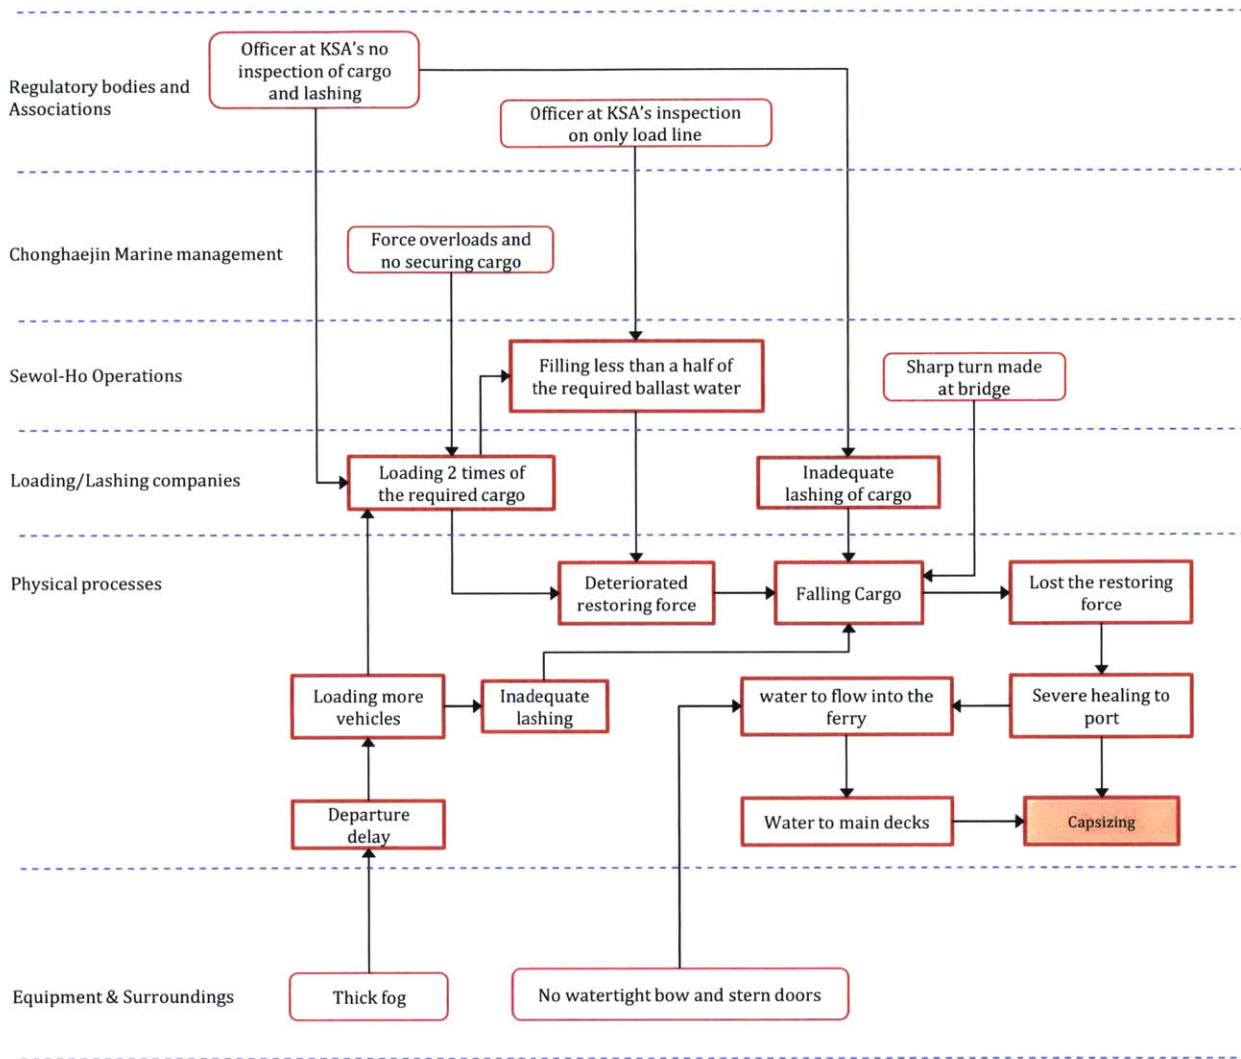
Figure 6 Graphical Summary of Process 1: Safe operations of the ferry

Figure 6 shows a graphical summary of the events causing the ferry's capsizing.

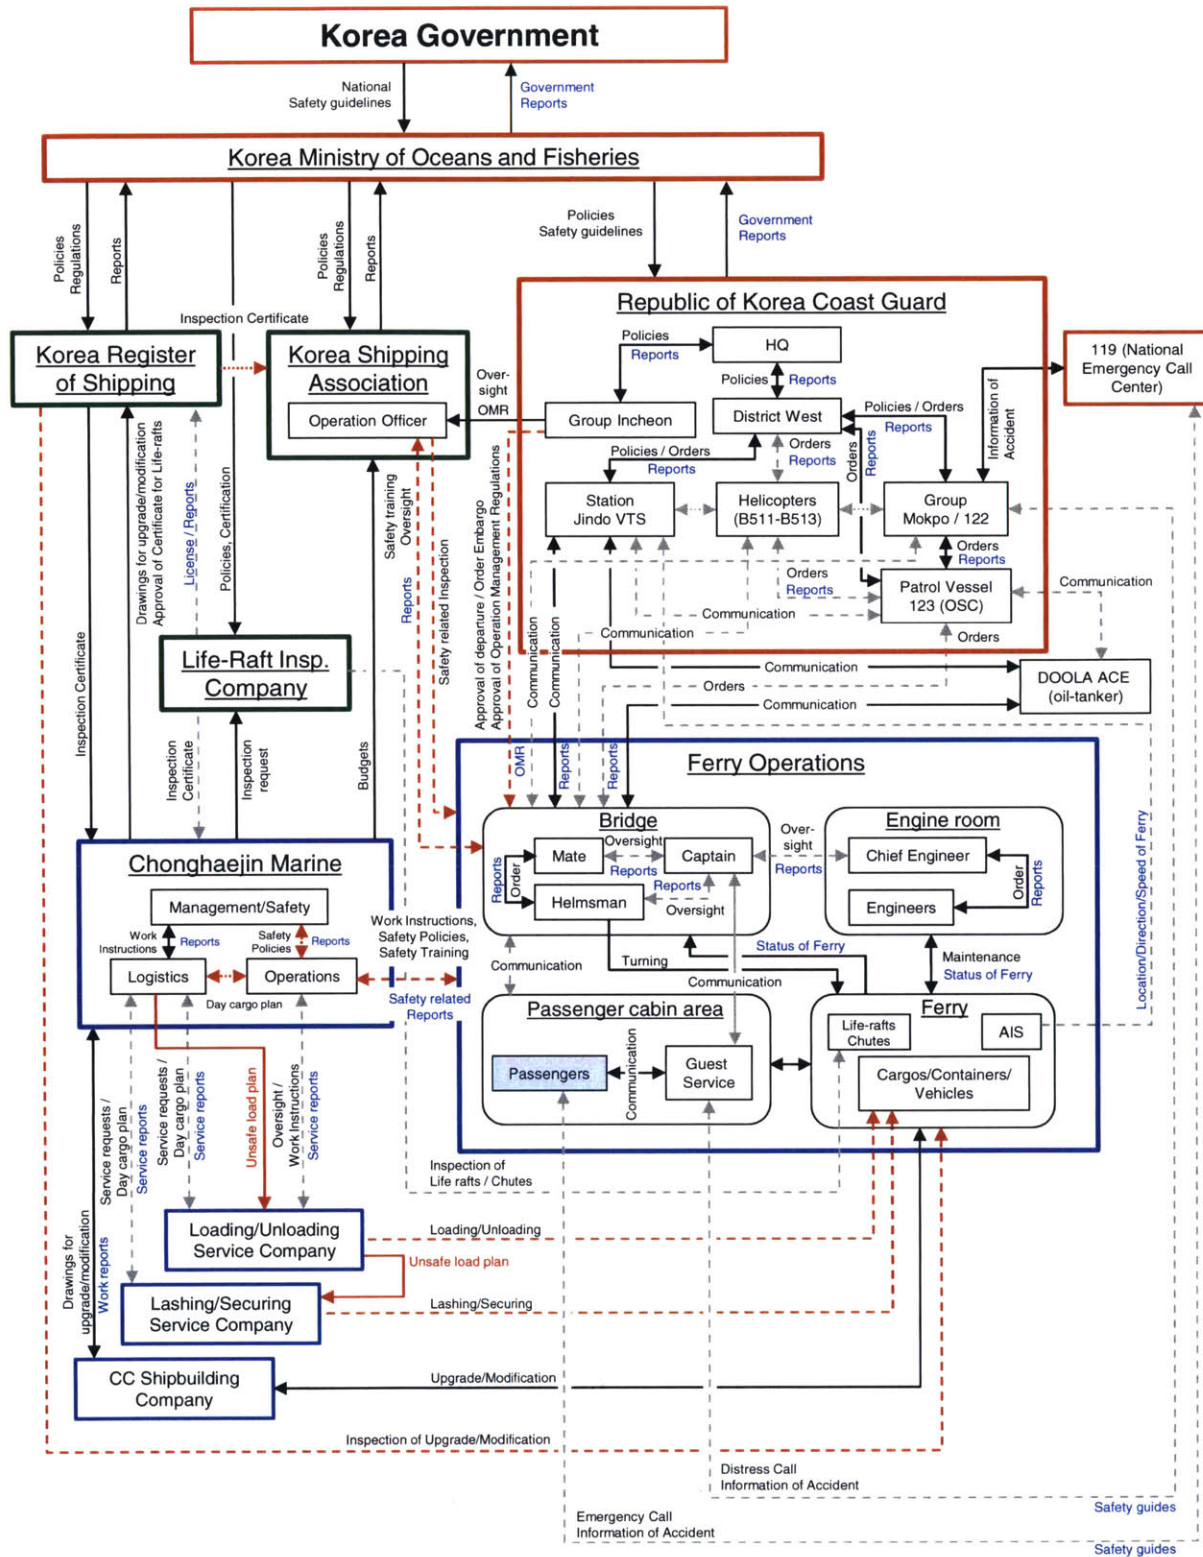
Figure 9 Actual state of Safety Control Structure for Process 1 of “Safe operations of the ferry”

Figure 9 shows the actual state of Safety Control Structure for Process 1 of “Safe operations of the ferry.” The red dot lines in Fig. 9 highlight control actions, controlled variables, measured variables, and control feedback that were either missing or incomplete in the actual Safety Control Structure. And the red line arrows in Fig. 9 highlight the bypassed or unsafe control actions. They should be corrected to prevent the bypassed or unsafe control actions from occurring in future. The bi-directional arrows indicate control actions in black letters to down direction and feedback in blue letters to up direction.

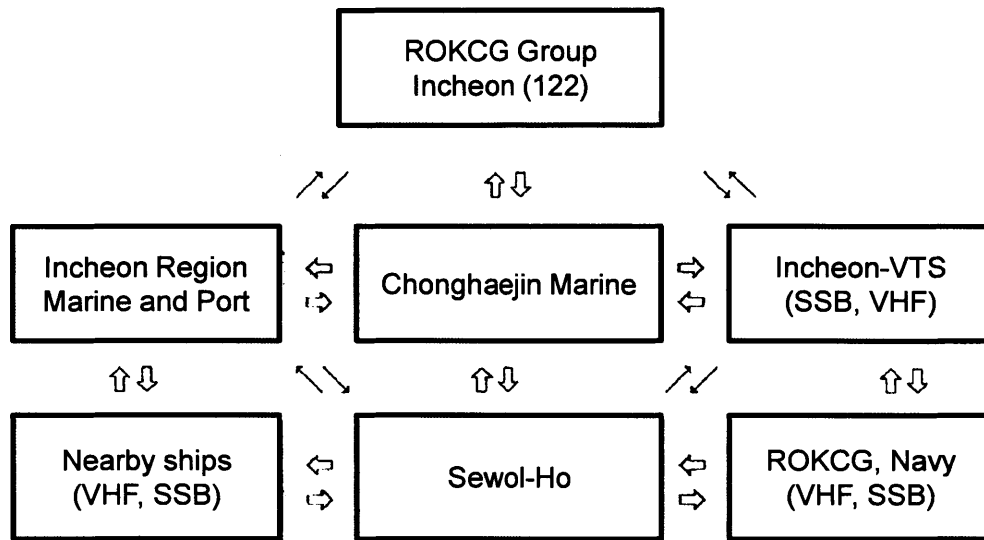
Figure 10 Emergency Contacts of the ferry's Operation Management Regulations Document (OMR)

The Safety Director and Management did not provide and oversee safety training and evacuation drills for the crew other than an exercise practiced for the preparation of ROKCG's safety audit. The budget for safety training per a crew at the company for a year was US \$2, which was used to buy a piece of certificate paper.

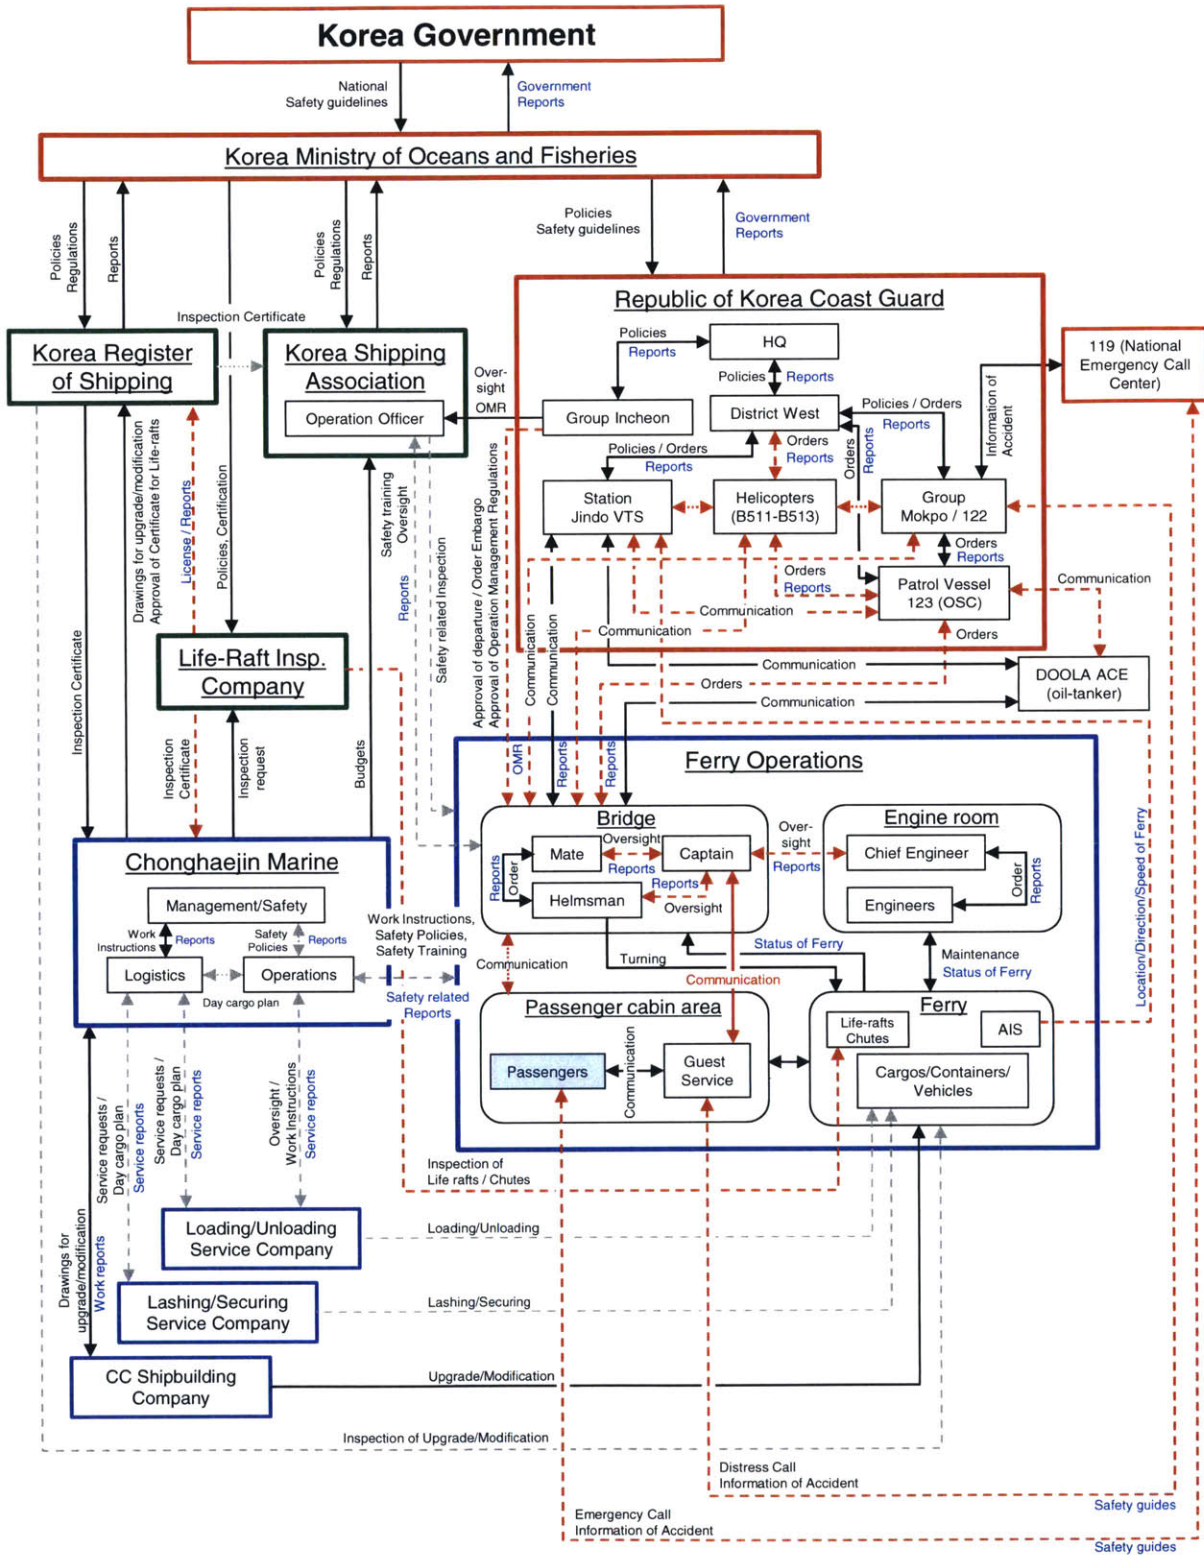
Figure 11 Actual state of Safety Control Structure for Process 2 of “Rescue operations of people on the distressed ferry”

Figure 11 shows the actual state of Safety Control Structure for Process 2 of “Rescue operations of people on the distressed ferry.” The red dot line arrows in Fig. 11 highlight control actions, controlled variables, measured variables, and control feedback that were either missing or incomplete in the actual Safety Control Structure. Moreover, the red line arrow between the Captain and the Customer Service Desk in Fig. 11 highlights the unclear control feedback. They should be corrected to prevent the unsafe control actions and feedback from occurring in future. The bi-directional arrows indicate control actions in black letters to down direction and feedback in blue letters to up direction.
