### *Lessons from accidents during tunnel construction*

**Citation:** Sousa, Rita L and Einstein, Herbert H. 2021. "Lessons from accidents during tunnel construction." *Tunnelling and Underground Space Technology*, 113.

# Lessons from Accidents during Tunnel Construction

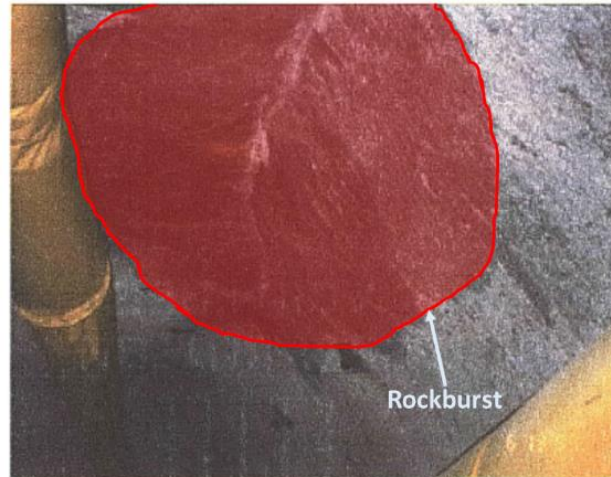
**Figure 14 Rockburst at the crown in a in a waterway tunnel in Korea (adapted from Lee et al., 2004)**
