# DRAFT!! The Loss of a Milstar Satellite

Nancy G. Leveson

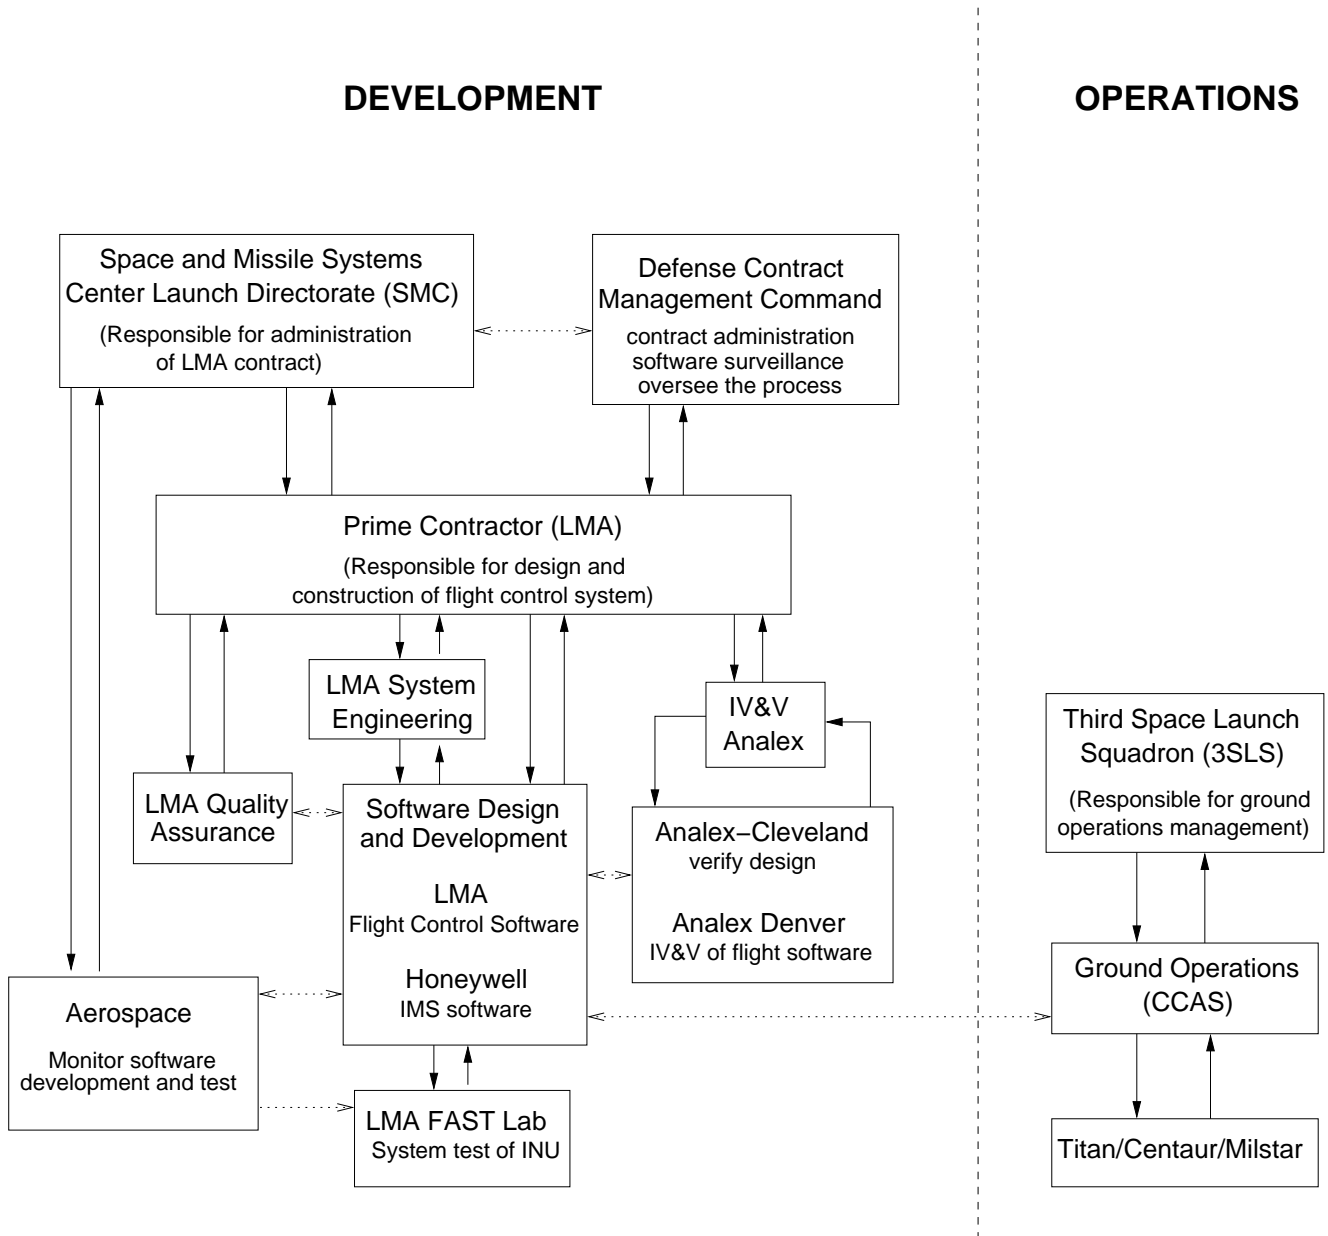
Figure 1: Hierarchical Control Structure

Figure 1 shows the hierarchical control model of the accident, or at least those parts that can be gleaned from the official accident report.<sup>1</sup> Besides SMC and LMA, the Defense Contract Management Command (DCMC) played some type of oversight role, but the report is not clear about what exactly this role was beyond a general statement about responsibility for contract management, software surveillance, and overseeing the development process.

LMA designed and developed the flight control software, while Honeywell was responsible for the IMS software. This separation of control, combined with poor coordination, accounts for some of the problems that occurred. Analex was the IV&V contractor, while Aerospace Corporation provided independent monitoring and evaluation. Ground launch operations at Cape Canaveral Air Station (CCAS) were managed by the Third Space Launch Squadron (3SLS).

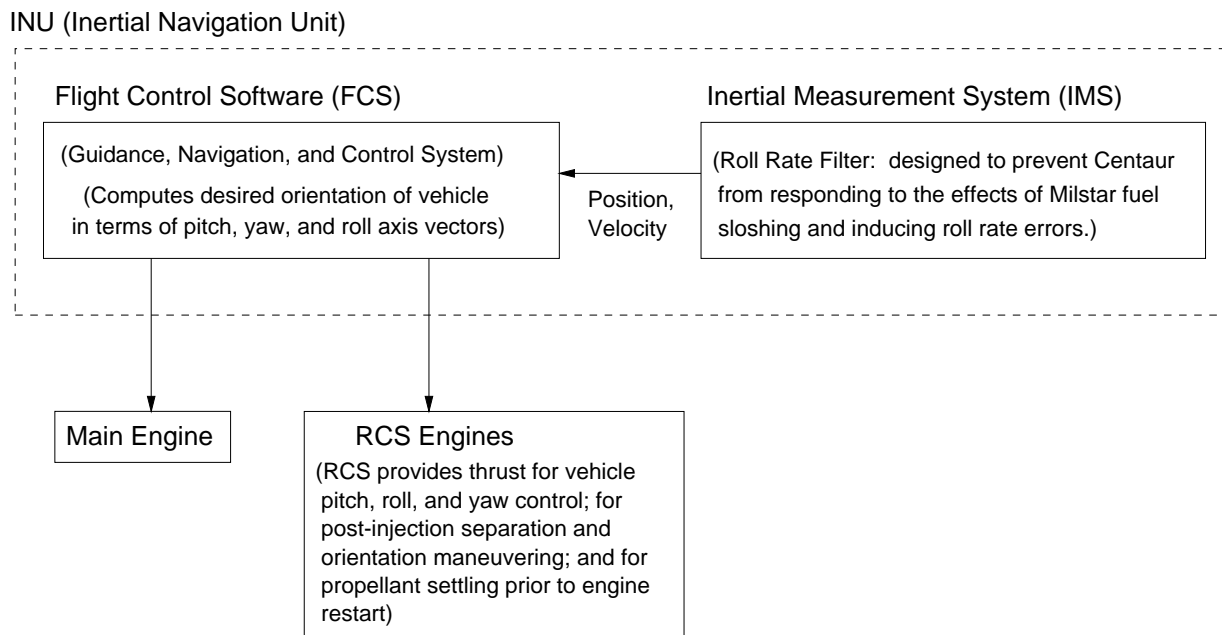
Figure 2: Technical Process Control Structure for IN

**Description of Process Controller** The Inertial Navigation (Figure 2): (1) the Guidance, Navigation, and Control System (the Flight Control Software or FCS) and (2) an Inertial Measurement System (IMS). The Flight Control Software computes the desired

orientation of the vehicle in terms of the pitch, yaw, and roll axis vectors and issues commands to the main engines and the reaction control system to control vehicle orientation and thrust. To accomplish this goal, the FCS uses position and velocity information provided by the IMS. The component of the IMS involved in the loss is a roll rate filter, which is designed to prevent the Centaur from responding to the effects of Milstar fuel sloshing and thus inducing roll rate errors.

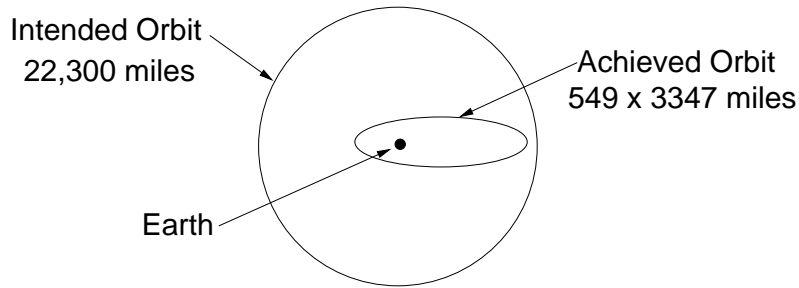
Figure 3: Achieved Orbit vs. Intended Orbit

*Third Burn:* The goal of the third burn was to circularize the Centaur in its intended geosynchronous orbit. The FCS started the third burn at two hours, thirty-four minutes, and fifteen seconds after liftoff. It was started earlier and was shorter than had been planned. The vehicle tumbled throughout the third burn, but without the RCS there was no way to control it. Space vehicle separation was commanded at approximately two hours after the third burn began, resulting in the Milstar being placed in a useless low elliptical orbit, as opposed to the desired geosynchronous orbit (Figure 3).

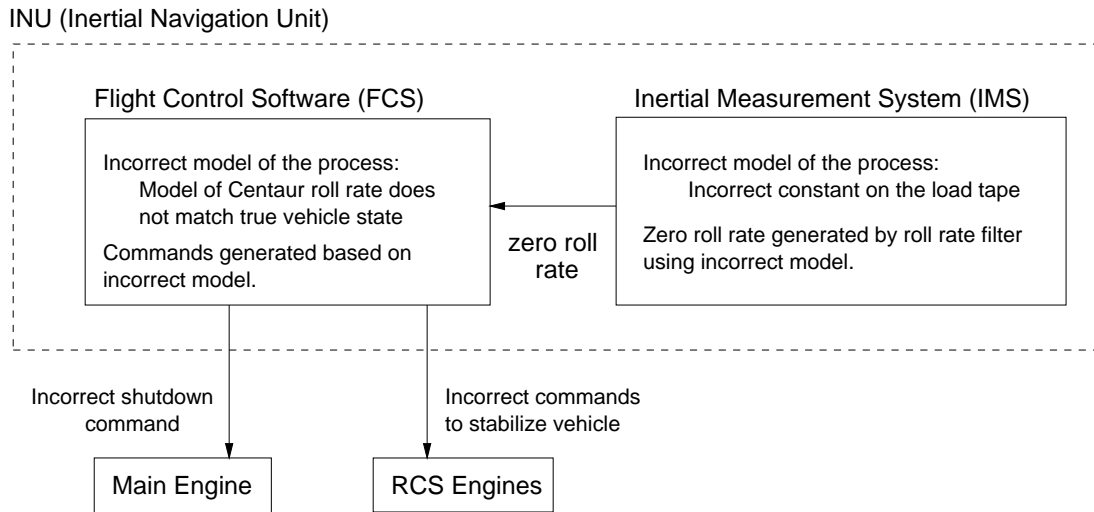
Figure 4: Control Flaws at the Physical Process Level

Figure 4 shows the automated controller flaws leading to the accident. The Inertial Measurement System algorithm was incorrect, specifically, there was an incorrect roll rate filter constant in the IMS software file (Figure 4) that led to a dysfunctional interaction with the flight control software. However, the algorithm operated as designed (i.e., it did not fail).

The Flight Control Software operated correctly (i.e., according to its requirements). However, it received incorrect input from the IMS, leading to an incorrect internal FCS software model of the process. The process was thought to be zero or near zero when it was not. Thus there was a mismatch between the FCS internal model of the process state and the real process state. This mismatch led to the RCS issuing incorrect control commands to the main engine (to shutdown early) and the RCS engines.

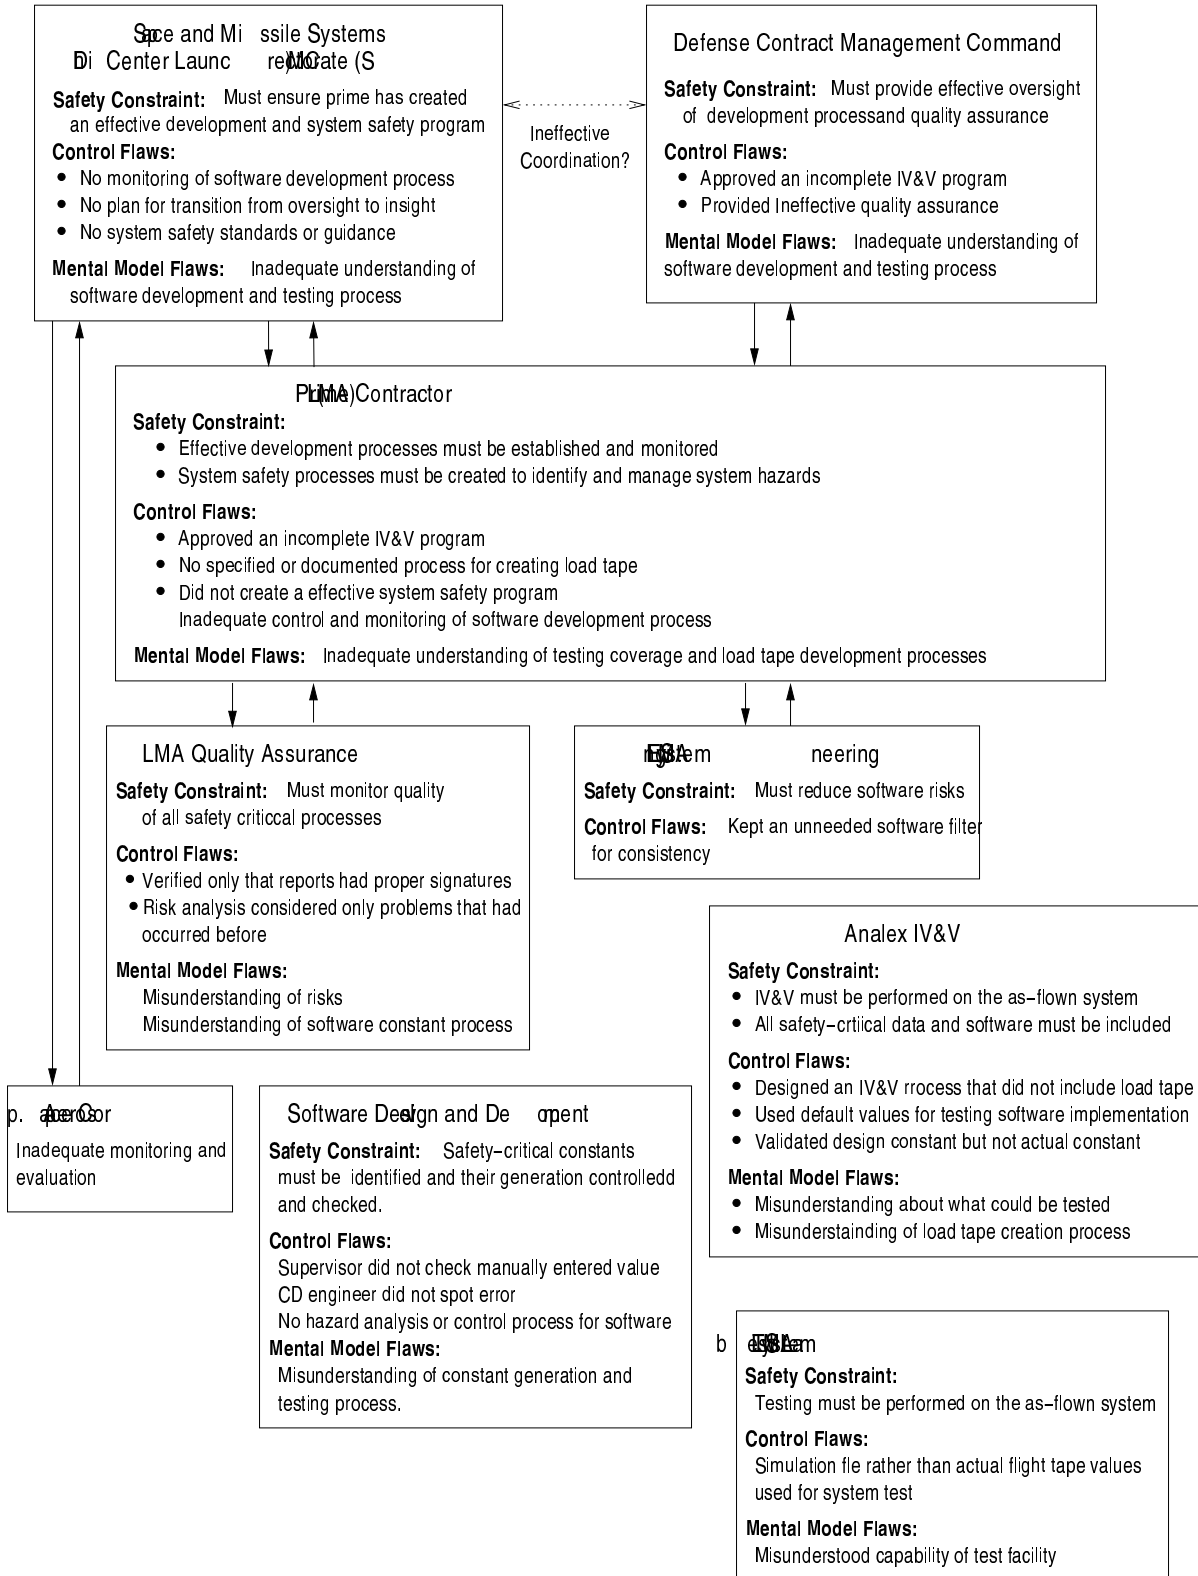
Figure 5: STAMP model of Development Process

This level of explanation of the flaws in the process (the vehicle and its flight behavior) as well as the conditions that led to the error provides a description of the information about the factors involved to prevent reoccurrences. Simply fixing that particular flight error is not enough. The higher levels of the control structure for that. Figures 5 and 6 summarize the information in the rest of this paper.

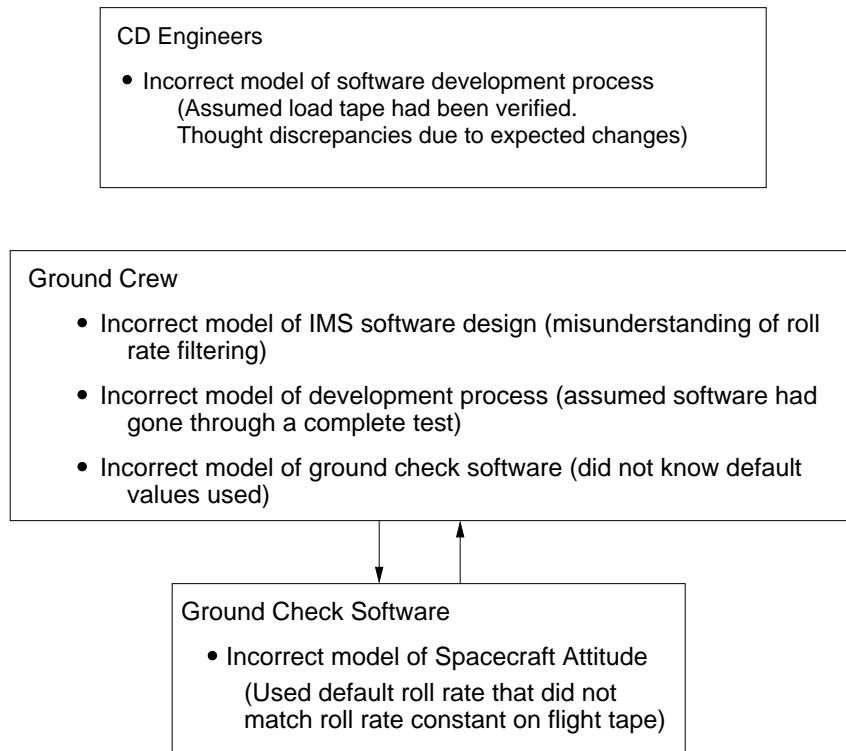
Figure 7: The Flawed Process Models used by the Ground Personnel and Software

Five models are involved here (see Figure 7):

1. Rate check software: The software used to do a rate check on the day of launch used default constants instead of the actual load tape. Thus there was a mismatch between the model used in the rate checking software and the model used by the IMS software.

2. Ground crew models of the development process: Although the report does not delve into this factor, it is very possible that complacency may have been involved and that the model of the thoroughness of the internal quality assurance and external IV&V development process in the minds of the ground operations personnel as well as the LMA guidance engineers who were informed of the observed anomalies right before launch did not match the real development process. There seemed to be no checking of the correctness of the software after the standard testing during development. Hardware failures are usually checked up to launch time, but often testing is assumed to have removed all software errors and therefore further checks are not needed.

3. Ground crew models of the IMS software design: The ground launch crew had an inadequate understanding of how the roll rate filters worked. No one other than the control dynamics engineers who designed the I1 roll rate constants understood their use or the impact of filtering the roll rate to zero. So when discrepancies were found before launch, nobody at the launch site understood the I1 roll rate filter design well enough to detect the error.

4. Ground crew models of the rate check software: Apparently, the ground crew was unaware that the checking software used default values for the filter constants.

5. CD engineers' model of the flight tape change: The control dynamics lead engineer at the launch site and her supervisor at LMA Denver thought that the roll rate anomalies were due to known changes in the flight tape. Neither went back to the engineers themselves to check this conclusion with those most expert in the details of the Centaur control dynamics.
