Observation of Joule Heating-Assisted Electromigration Failure Mechanisms for Dual Damascene Cu/SiO₂ Interconnects

C.W. Chang, C.L. Gan, C.V. Thompson, K.L. Pey, W.K. Choi

Index Terms—Electromigration, Joule heating, failure mechanism.

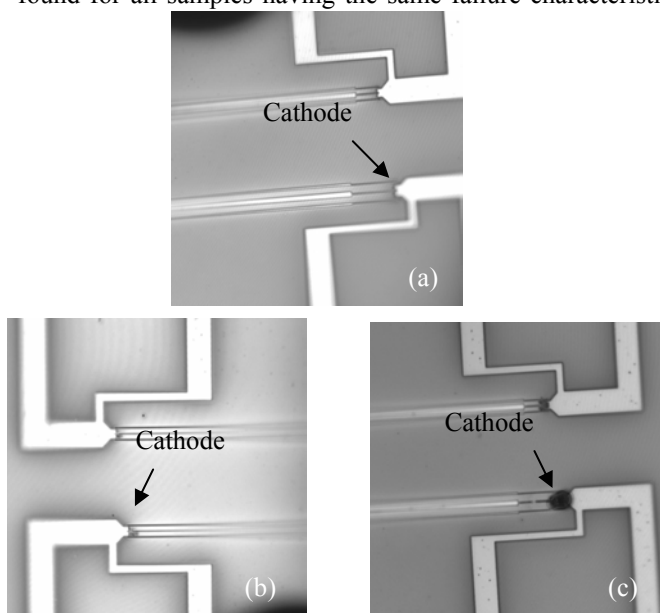
Three types of failure characteristics observed under the confocal microscope. Figure 1 shows some of the observed failure sites. A 32% (29 out of 90) of the total samples showed large black dots right at the cathode, 24% (22 out of 90) showed black patches of ‘melt’ at the cathode, and no damage observed for the rest. No correlation was found between the observed failure characteristics with the test structure’s width ratio and length ratio. The times-to-failure of the observed samples were also random.

Fig. 1. (a) Cathode without damage observed. (b) ‘Melt’ at cathode. (c) Large black dots at cathode. Magnification: 400x.

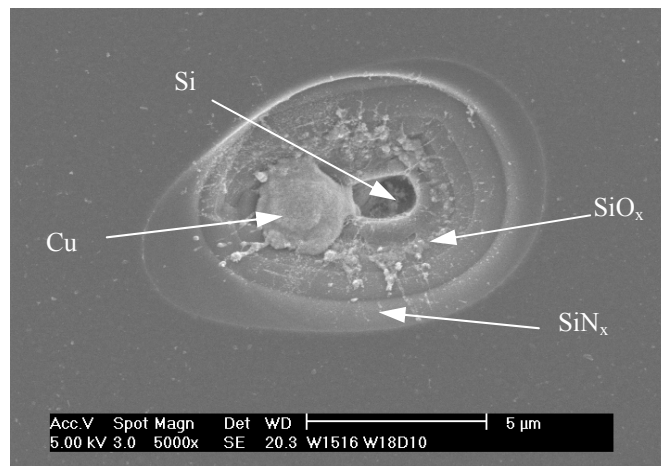
When inspected under SEM, no irregularity was found for the samples with black patches of ‘melt’. Figure 2 shows an SEM image of a sample with large black dot at cathode end. A crater was found with a hole where the via is directly located beneath. The Si₃N₄ passivation layer was opened up entirely with splashes of materials around the hole. Traces of Cu were detected by EDX near the hole. Craters were also found for all samples having the same failure characteristics.

Fig. 2. SEM image of crater at cathode end. The element was confirmed by EDX.

The existence of the crater suggests that an eruption might have taken place at the cathode end during the EM stressing probably just before the line failed, leading to an open failure. Joule heating could be a possible factor for the eruption. When void is nucleated and material is drained away from the cathode during EM stressing, the cross-sectional area is reduced, and current density increased. It may come to a stage where the material left behind is so thin that the high current density induced Joule heating that raises the temperature locally high enough and melts the remaining metal. The weak passivation layer may then erupt and a crater is created. If the passivation layer did not break away, the melted metal would spread under the nitride layer at the failure site. The following experiments were designed to proof if the above postulation is valid.

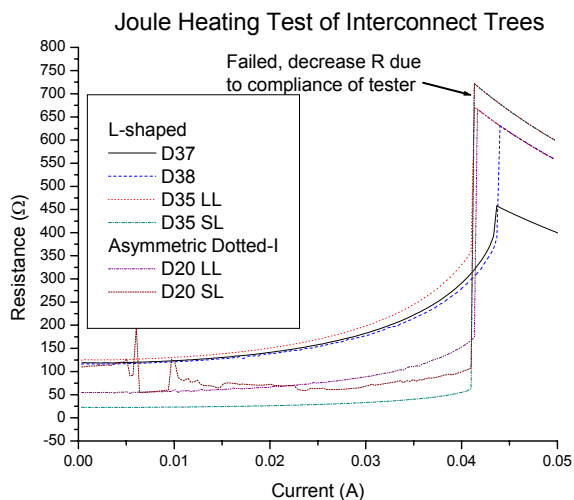
The resistance of the interconnect trees as a function of current is shown in Figure 3. For D37 and D38, only the $500\mu\text{m}$ long limbs of the L-shape interconnect trees were stressed. For D35, the $50\mu\text{m}$ short limb was also stressed in addition to the long limb. For D20, which is the asymmetric dotted-I line, both the $200\mu\text{m}$ long-limb and the $100\mu\text{m}$ short-limb were stressed. For D37 and D38 (single limb stressed), the lines failed at about 44mA while D35 and D20 (both limbs stressed) failed at about 41mA . All the lines showed almost instantaneous increase in the resistance, indicating a sudden open failure in the lines. The reduction of the resistance after the maximum point was due to the compliance of the parameter analyzer.

According to Figure 3, the maximum resistance when the failure occurred could be as high as 725Ω . If the resistance of the interconnects follow linear temperature dependence model $R=R_0(1+\alpha\Delta T)$ with the thermal coefficient of the resistance (α) for Cu of 0.0034K^{-1} , using $R = 174\Omega$ and $R_0 = 54\Omega$ for D20, the temperature in the line before failure was only 679°C , far below the Cu melting point of 1085°C . This temperature is not high enough to cause the eruption. But when open failure

Fig. 3. Plot of interconnect resistance vs. current for Joule heating.

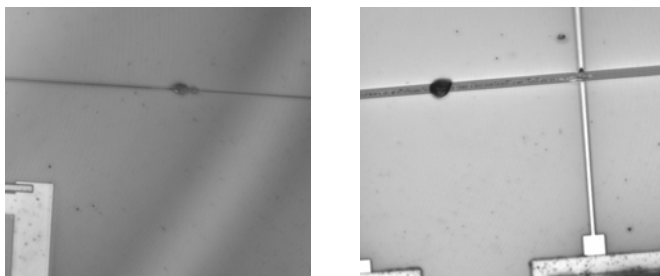
Fig. 4. Con-focal image of (a) L-shape interconnect of D37 (b) Dotted-I interconnect of D20. Magnification: 400x.

occurred and the Cu metal was depleted in the interconnect, all the current would shunt through the thin Ta barrier layer. The high current density in the Ta layer would cause very high temperature in the void and melted Cu in the vicinity due to the high resistivity of Ta ($13\mu\Omega\text{-cm}$ for bulk material, compare to $1.7\mu\Omega\text{-cm}$ for Cu). The melted Cu would create very high pressure in the line and burst the weak Si_3N_4 passivation layer, hence created the crater. However, when observed under a confocal microscope, melt and black dot were found not directly at the cathode via but at about half of the liner length, at which SEM inspection showed similar eruption mechanism. Figures 4 and 5 show the confocal and SEM image of the damages respectively.

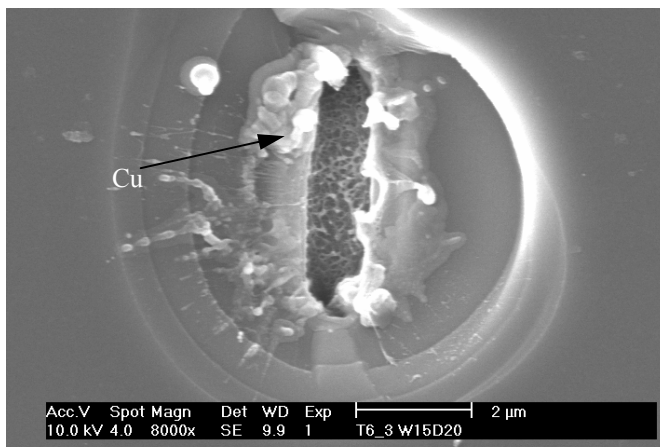
Fig. 5. SEM image of dotted-I interconnect failure site of D20.

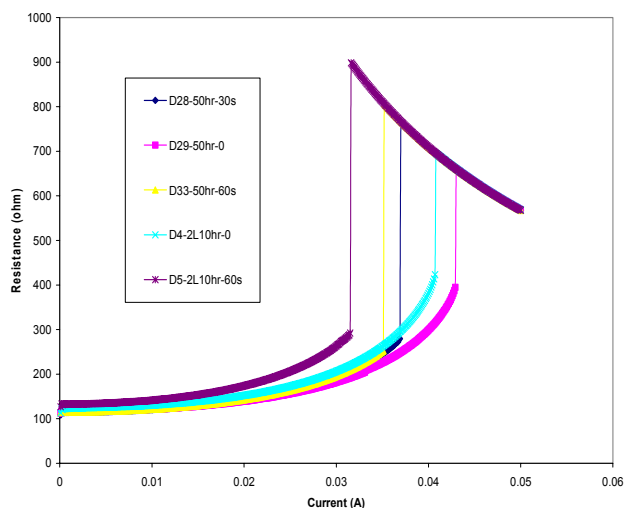
A plot of the interconnect resistance versus current is given in Figure 6. For D28, D29 and D33, only the $500\mu\text{m}$ long limb was EM pre-stressed before conducting joule heating test, and only the long limbs were stressed for Joule heating. For D4 and D5, both limbs were EM pre-stressed, while only the long limbs were stressed for Joule heating. No delay between current ramping steps was set for D29 and D4,

Fig. 6. Plot of interconnect resistance against current for EM + Joule heating.

Without delay, the samples failed at about 40mA, similar to Joule heating without EM pre-stress. With delay of 30s, the current before open failure significantly reduced to 35mA. With delay of 60s, minimum failure current of 31.5mA was recorded. When observed under the confocal microscope, all samples Joule-heated without delay had failure sites similar to the melt patches at about half of the liner length. With delay of 30s and 60s, the failure sites shifted to about 1/4 of the liner length from the cathode end, though no failure site was observed right at cathode end. No crater was found for all samples. Figure 7 shows the confocal image of a failure site in D4 in the line middle. Figure 8 shows the SEM image of a failure site in D28 located close to the cathode. Note there are cracks at the nitride layer.

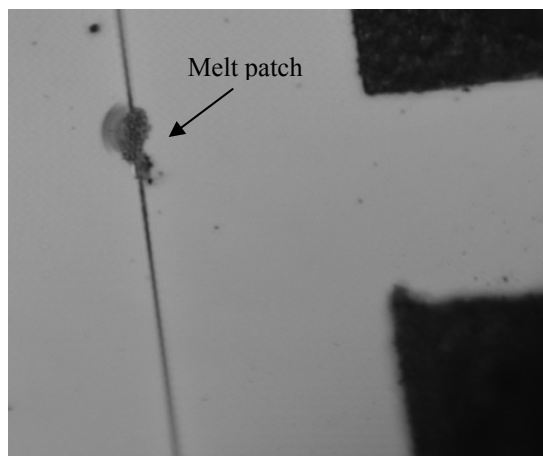
The absence of crater in this experiment was probably due to the fact that different structures may have different thickness of passivation layer though the samples were from the same lot, as thin or weak passivation layer may form crater easier. Another reason may be due to the probabilistic nature of the crater formation as only 32% of the total EM stressed samples

Fig. 7. Confocal image of L-shape interconnect with EM + Joule heating. Magnification: 400x.

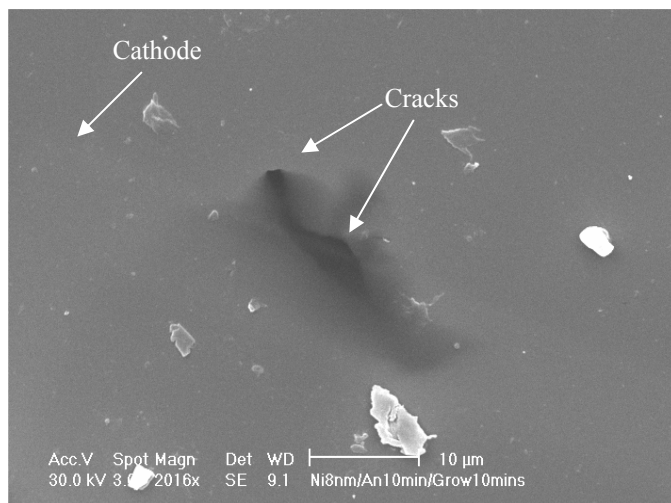
Fig. 8. SEM image of L-shape interconnect with EM + Joule heating. 60s delay between current ramping steps.

The shift of failure sites from middle of line to location closer to the cathode end when delay was set could be due to an equilibrium temperature has been reached that caused failure to occur at voided location in the line. Without the delay, though void existed in the line, the ramp of current was so fast that high heat was generated along the whole line in a short time. The middle of line could be the hottest part as it is furthest away from the vias where heat could be conducted away easily, and as a result, failure occurred at the location. If delay was set, as current ramped up slowly, the voided location of the line with the highest current density could be the hottest part where failure could occur. This may represent the actual failure mechanism for EM stressed samples.
