Hardware Variability Corrective Action in Boeing 777 Final Assembly

Kenneth S. Gayer

Submitted to the Sloan School of Management and the
Department of Chemical Engineering
in partial fulfillment of the requirements for the degrees of

Abstract

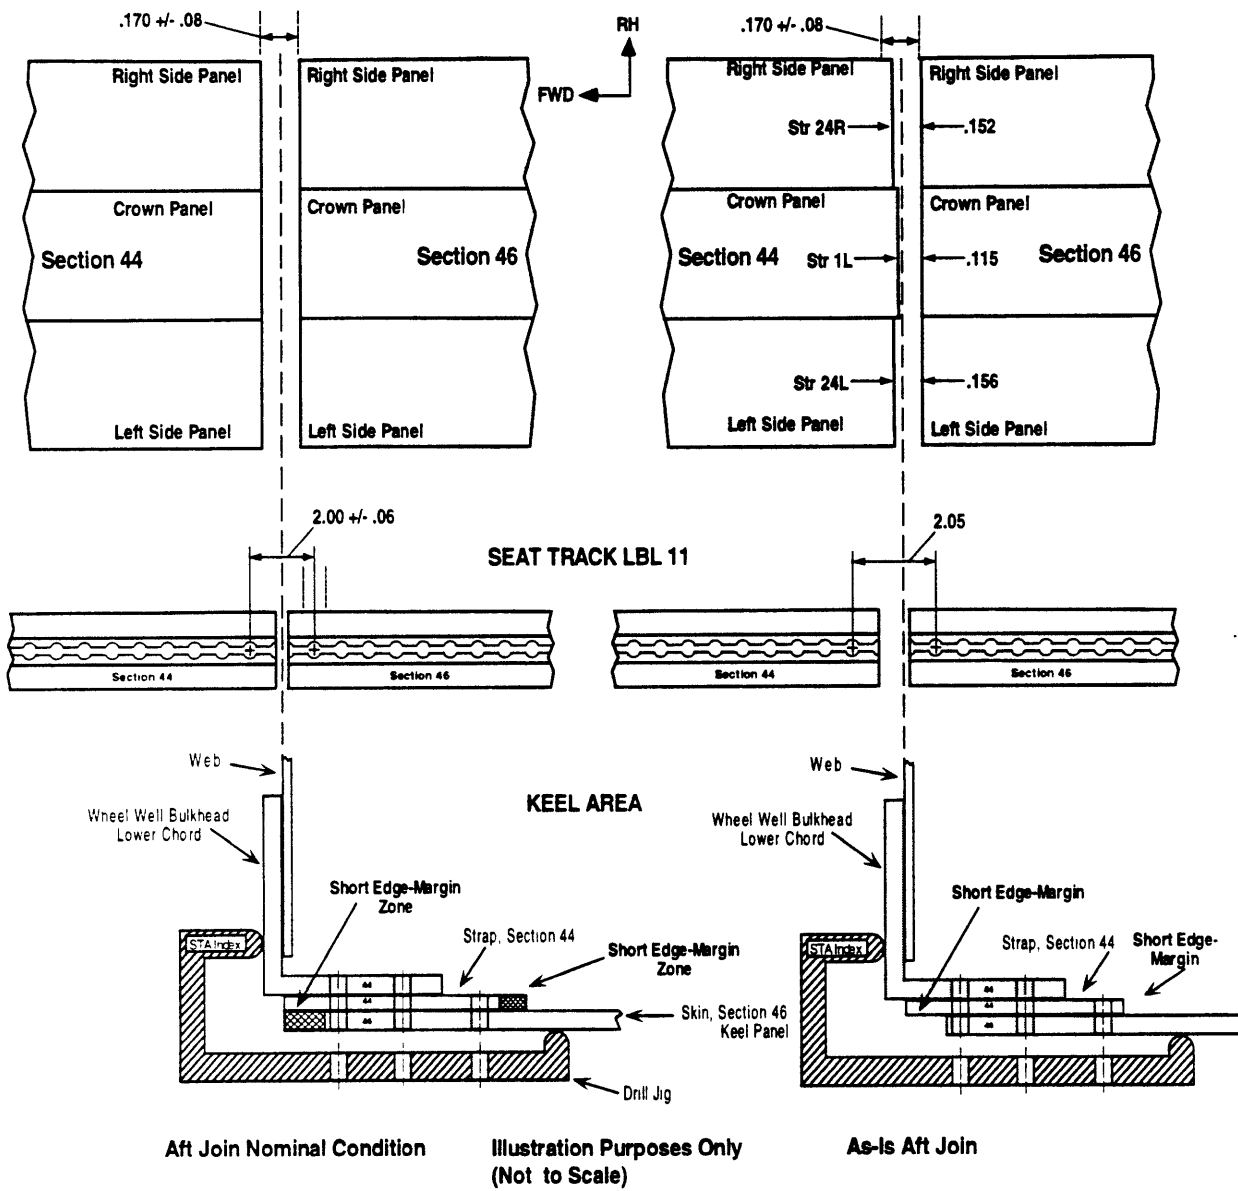
Figure 3.5 Comparison between nominal and typical aft joins

On the right side of Figure 3.5 is depicted the condition of a typical join. The gap between the body panels is tighter than nominal and the section 44 body panels appear closer to the dashed line that represents station 1434. Also, the crown panel is misfaired aft relative to the side panels. At the same time the seat track gaps are wider than nominal and there is a frequent occurrence of short edge margin at the keel.

There are many explanations of how such a condition could result because the fit between section 44 and section 46 depends on features of both sections. One hypothesis is that section 44 body panels are longer than nominal. If this is true the skin gaps would be expected to close to the lower tolerance limit before the seat tracks and keel edges reach their nominal positions. This is exactly what is shown in the as-is join on the right side of Figure 3.5.

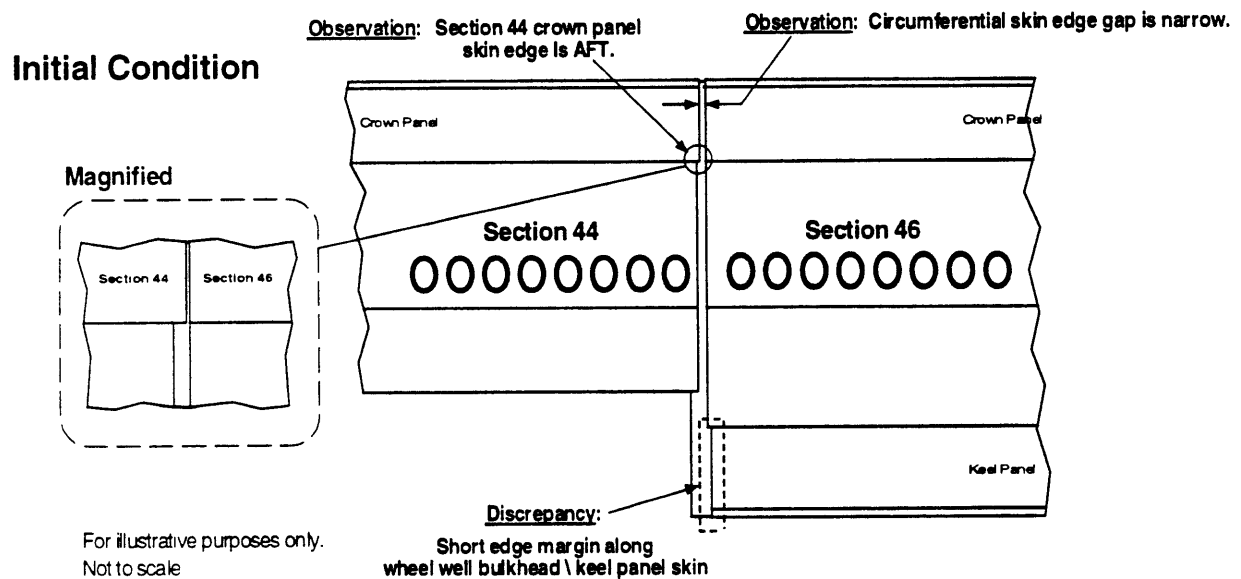
Figure 3.6 Initial condition of aft join in September 1997 event

The problem situation occurred in the aft join of FBJ where the forward end of section 46 is joined to the aft end of section 44. Section 44 crown panels protruded aft beyond the side panel assembly skin edge by 0.030 to 0.120 inches. This condition complicated the aft join due to:

Non conformance reject tags were written on airplanes in June of 1997 (L/N 351) and September 1997 (L/N 377) both of which precipitated trimming rework in FBJ (see 3.2.2.1 for problem chronology through June 1997). The activity in September of 1997 resulted in the loss of one [M] day of production. Process engineers Schweigert and Watters prepared the visual description of the situation as it appeared in September 1997. This is shown in Figures 3.6 and 3.7.

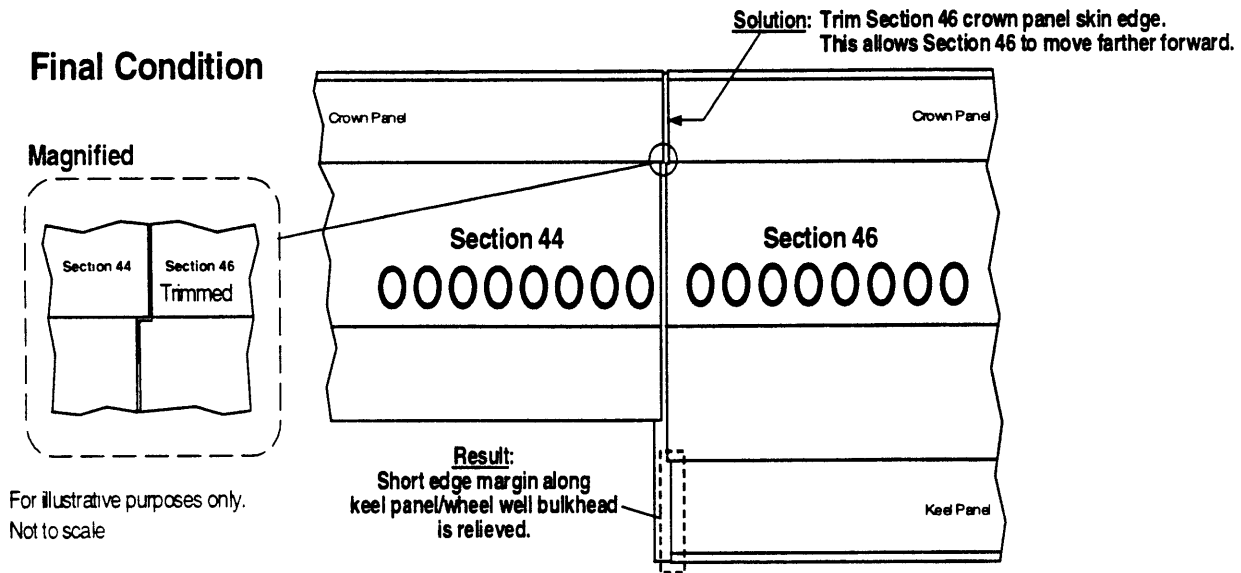
Figure 3.7 Rework to correct section 44 aft crown skin protrusion in September 1997

During the June 1997 rework it was noted that there was considerable risk of damage to the crown ring which is flush beneath the aft skin edge of section 44 (see the STA 1434 crown frames in Figure 3.2). Accordingly, in the September 1997 event the aft join was separated and the section 46 forward skin edge was trimmed to remove the interference. This is illustrated in Figure 3.7.

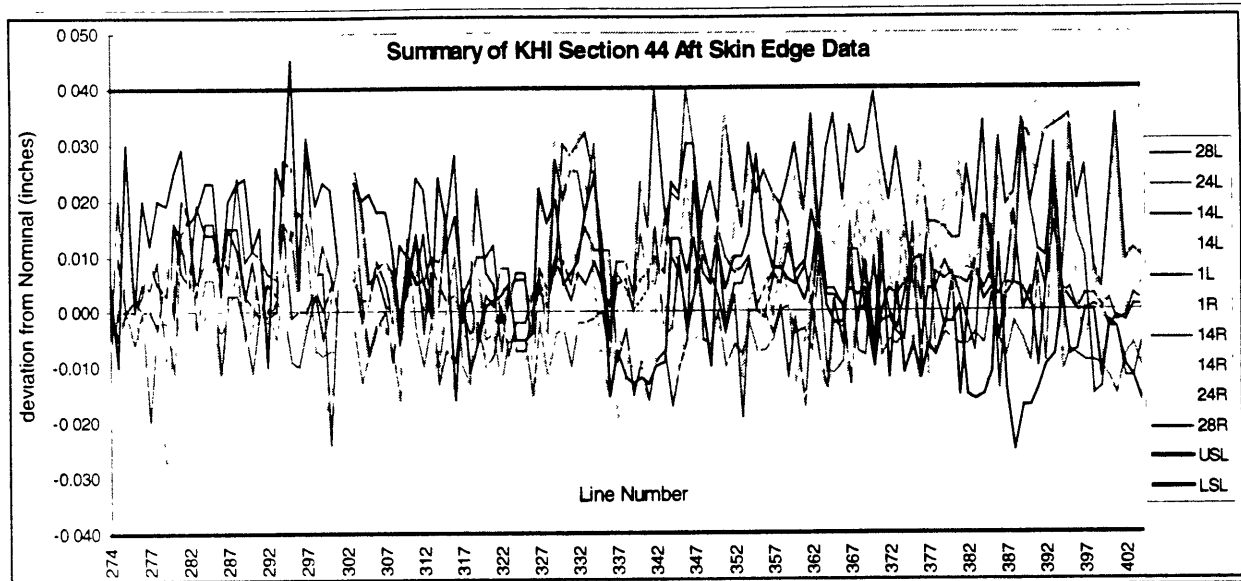
Figure 4.1 Summary of KHI KC measurements on section 44 aft skin edge

- Ten points measured on over one hundred and thirty one airplanes are difficult to analyze on a single plot.
- Only one point of 1310 is outside of engineering tolerance.
- The data do not explain how crown to side panel misfits as large as those observed by final body join could occur (FBJ observed up to 0.120 inch differences, see Section 3.2.1).

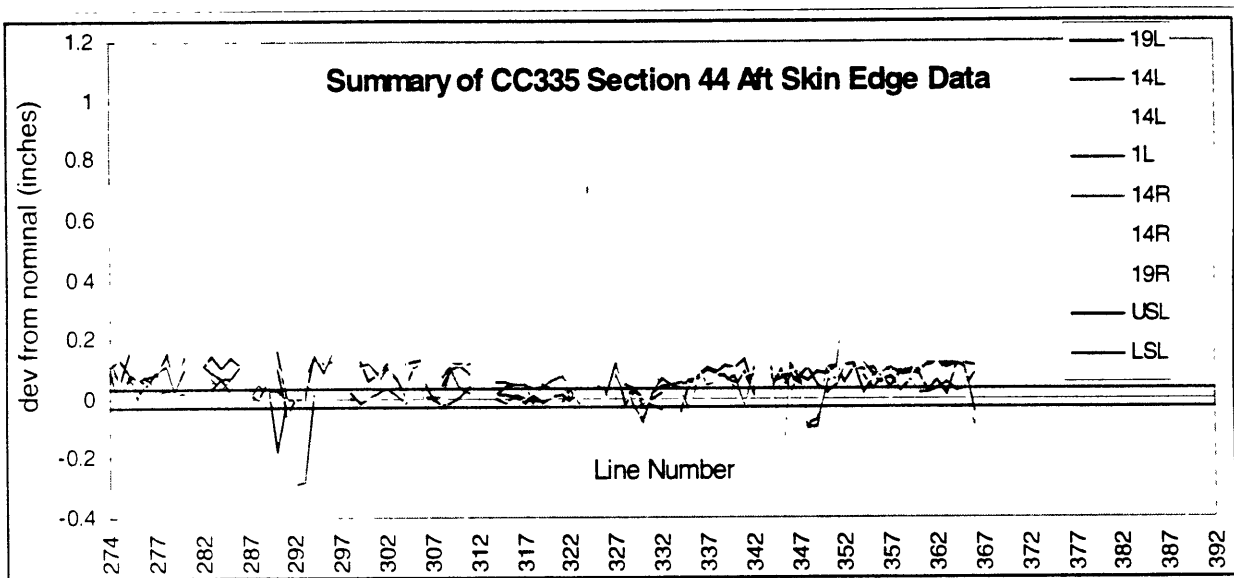
Figure 4.6 Summary of CC335 HVC data for section 44 aft skin edge station

Since the data are in conflict with direct observations made during the internship, it is concluded that data after L/N 364 are corrupt.

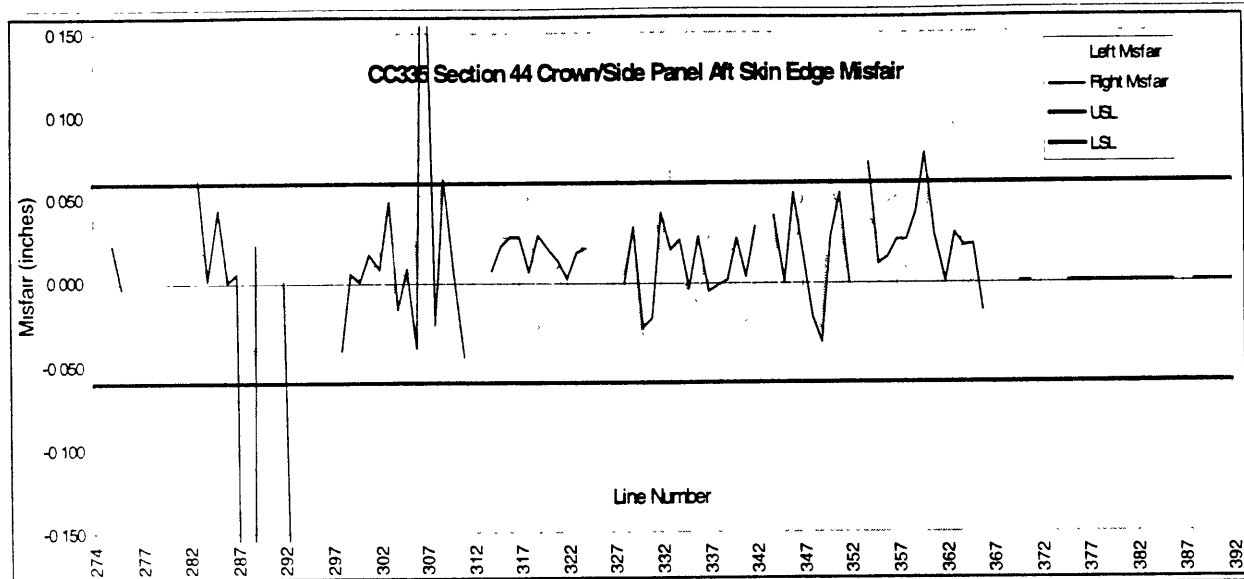
Figure 4.10 Section 44 crown to side panel length mismatch based on CC335 KC data

The part to part relationship between crown and side panels can be analyzed by subtracting the side panel KC from that of the crown (both measured at stringer 14) as was done in Section 4.3.3.2. This is shown in Figure 4.10. Note that these data represent the condition of the section after fastening and therefore should be representative of what final body join observes. Disagreement between KHI and CC335 part to part data can be explained on the basis of measurement errors, suspect data, violation of indexing schemes, or some combination. After panel integration in CC335, however, relative movement between crown and sides is infeasible and conflicts between data sets in CC335 and final body join must be due to either measurement error or suspect data.

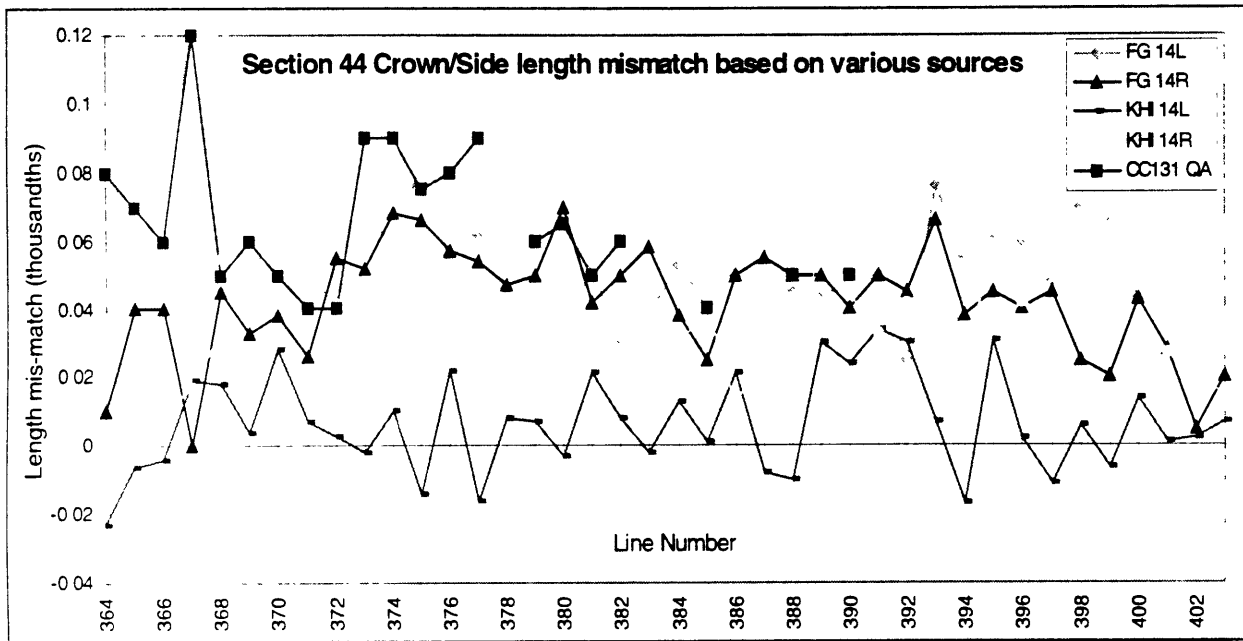
Figure 5.2 Section 44 Crown Panel length in excess of Side Panel at stringer 14L and 14R

Thus, misfair at 14L and 14R could be explained even with perfect indexing if the skin edges were not straight but instead had a slight curve. This situation was observed several times during the course of the investigation where crown and sides were indexed exactly at nominal and misfairs on the order of 0.020 were observed at the laps.

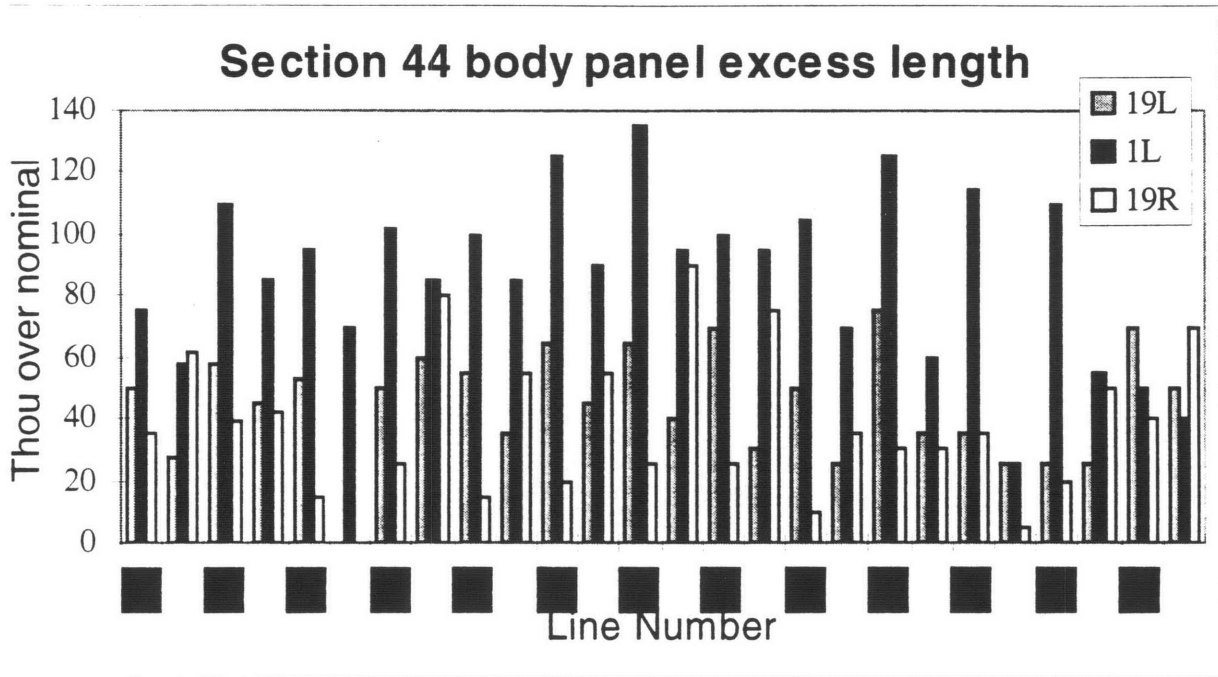
Figure 5.4 Section 44 body panel excess length based on CC335 FAJ features

It should be noted that Figure 5.4 shows overall excess panel length from the forward to the aft end. Final body join is most concerned with aft end panel protrusion beyond nominal. Table 5.4 shows that panel station deviation in the aft direction is slightly less than the total excess length implying a small forward bias in indexing. This point is subtle but important because if the panel lengths are corrected to nominal overall but the build process causes a shift forward, the aft end will then be short of nominal due to the forward bias.

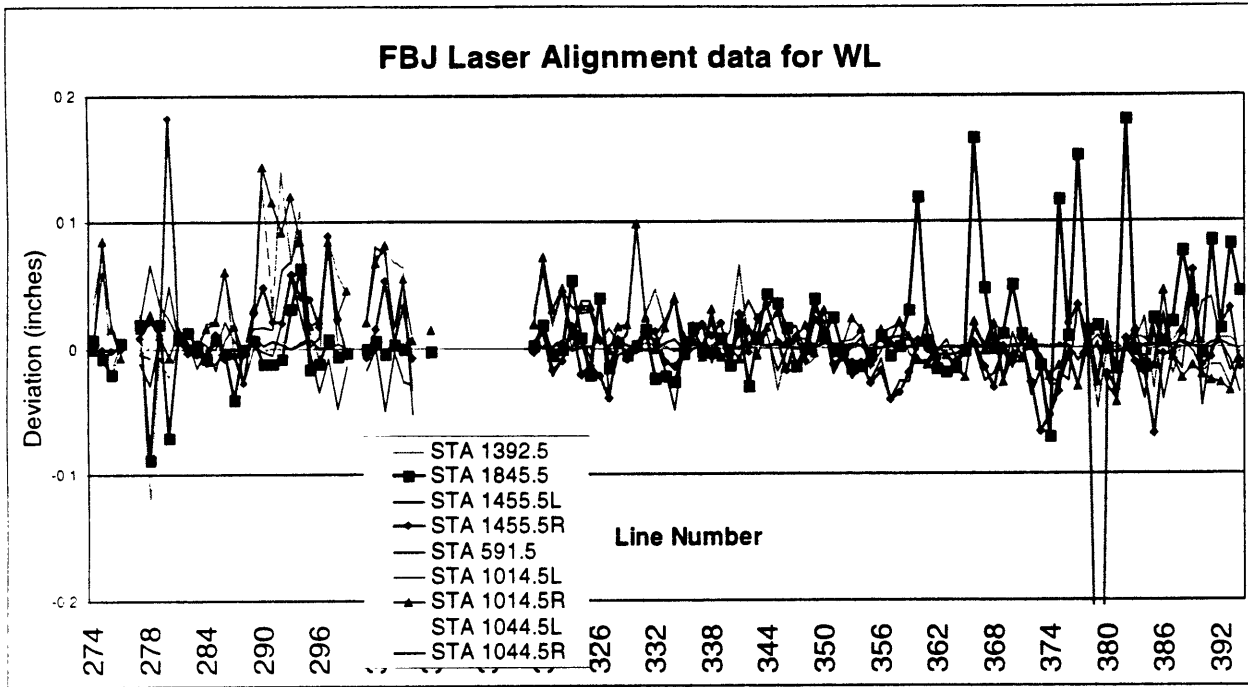
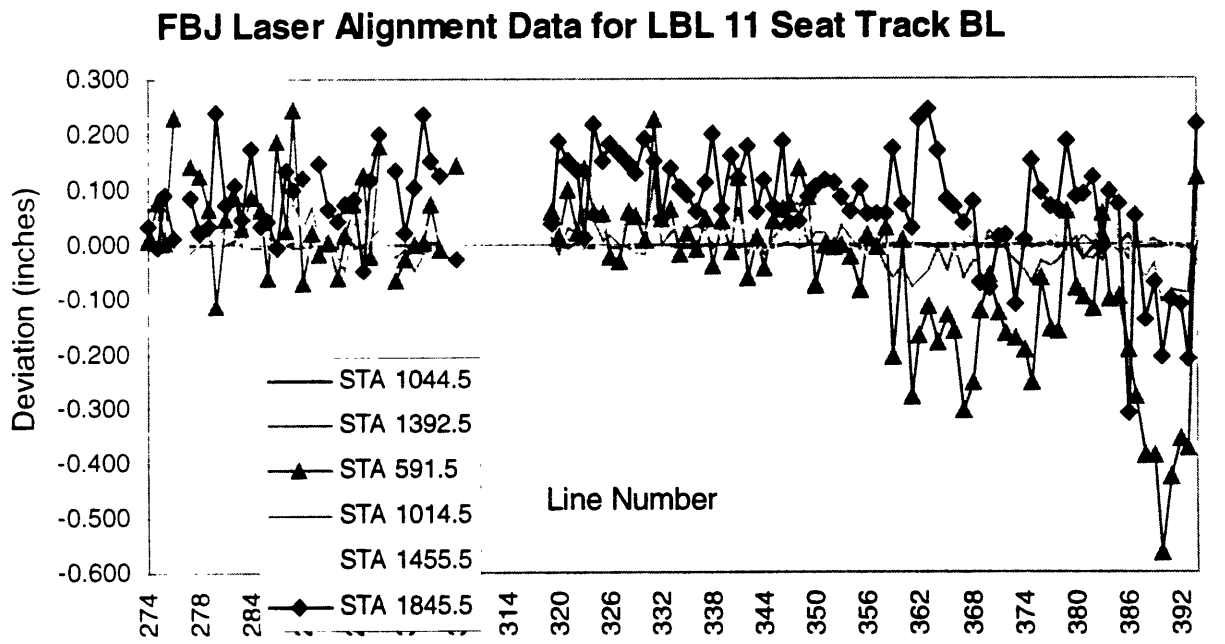
Figure 5.7 and Figure 5.8 show the result of the above manipulations for WL 200 and LBL 11. For WL 200 it is apparent that the most recent deviations from nominal are at STA 1845 which is due to FBJ manipulating the after body WL to meet skin gap and seat track QA requirements. The HVC data base lists an engineering specification of +/- 0.03 for the laser measurement and it is apparent that the process is not capable of meeting it. The reader is referred to Figure 2.1 for a diagram of major body sections and station locations. It is easy to demonstrate that the tail depression measured by the laser tracker at station 1845.5 (given that the pivot point is the section 44/46 body joint at station 1433) equates to a drop of the tail at the aft-most point on the airplane (STA 2570) equal to 2.75 times the values shown in the plot. Thus the maximum deviations are 0.4 to 0.5 inches at the tail. Note also that the top of the crown skins are located at WL 340 so the skin gap effect of the deviations shown in Figure 5.7 is $(340-200)/(1845.5-1433) = 0.339$. Thus the skin gap opens by about one third of the deviation shown in the figure which puts the maximum skin gap effect of moving the tail at around 0.050 inches to 0.060 inches. This assumes that the pivot point is the seat tracks. If the pivot point is taken at the crown skins then the seat track gap can be closed by 0.050 inches while the skin gap remains constant.

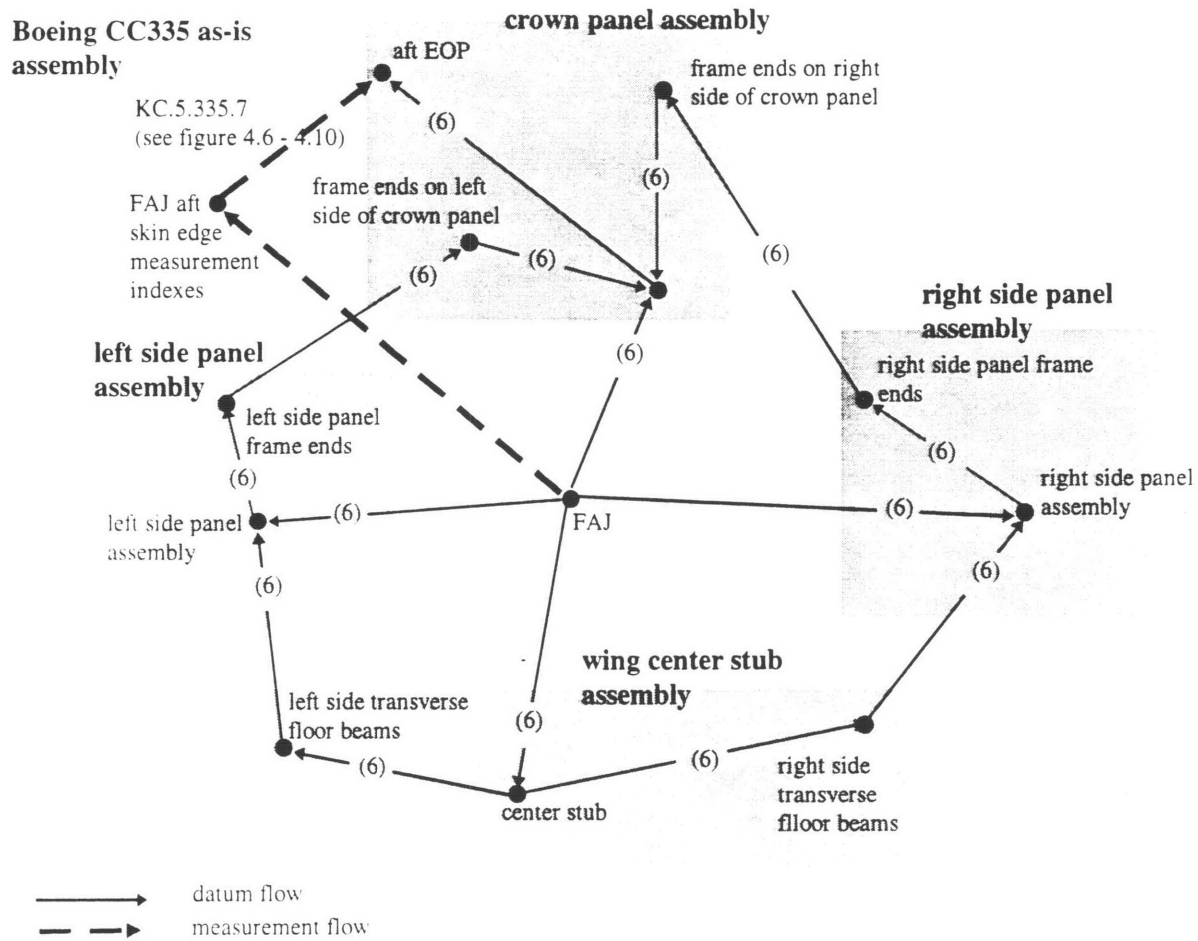
Figure 6.6 CC335 as-is datum flow for section 44 crown panel assembly

Two possibilities are cited. The first is incorrect fabrication, e.g. the vendor trims the body panels too long, and the other is due to the as-is datum flow used in CC335. Evidence was presented earlier that supported the former notion of misfabrication. In the case of CC335 as-is indexing, the shop begins with the design process depicted above. They then “best fit” the body panels to minimize shimming at transverse floor beams and frame splices. Per local consensus they move body panels within a +/- 0.030 window. The as-is datum flow is shown in Figure 6.6.
