# Analysis of Crane and Lifting Accidents in North America from 2004 to 2010

Ray Addison King

MASTER OF ENGINEERING  
IN CIVIL AND ENVIRONMENTAL ENGINEERING

MASSACHUSETTS INSTITUTE OF TECHNOLOGY

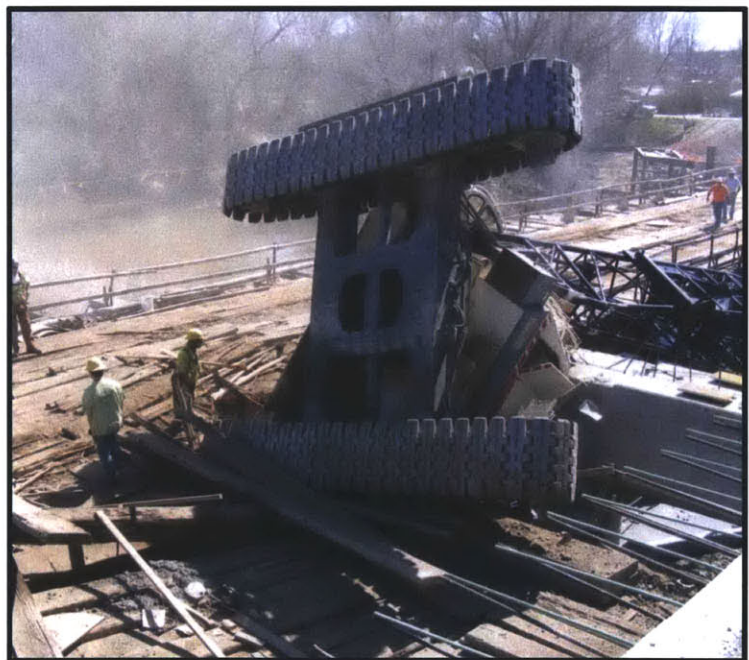
**Figure 1.1: Crane stability failure after crawler punches through a surface. (Haag Engineering Co.)**

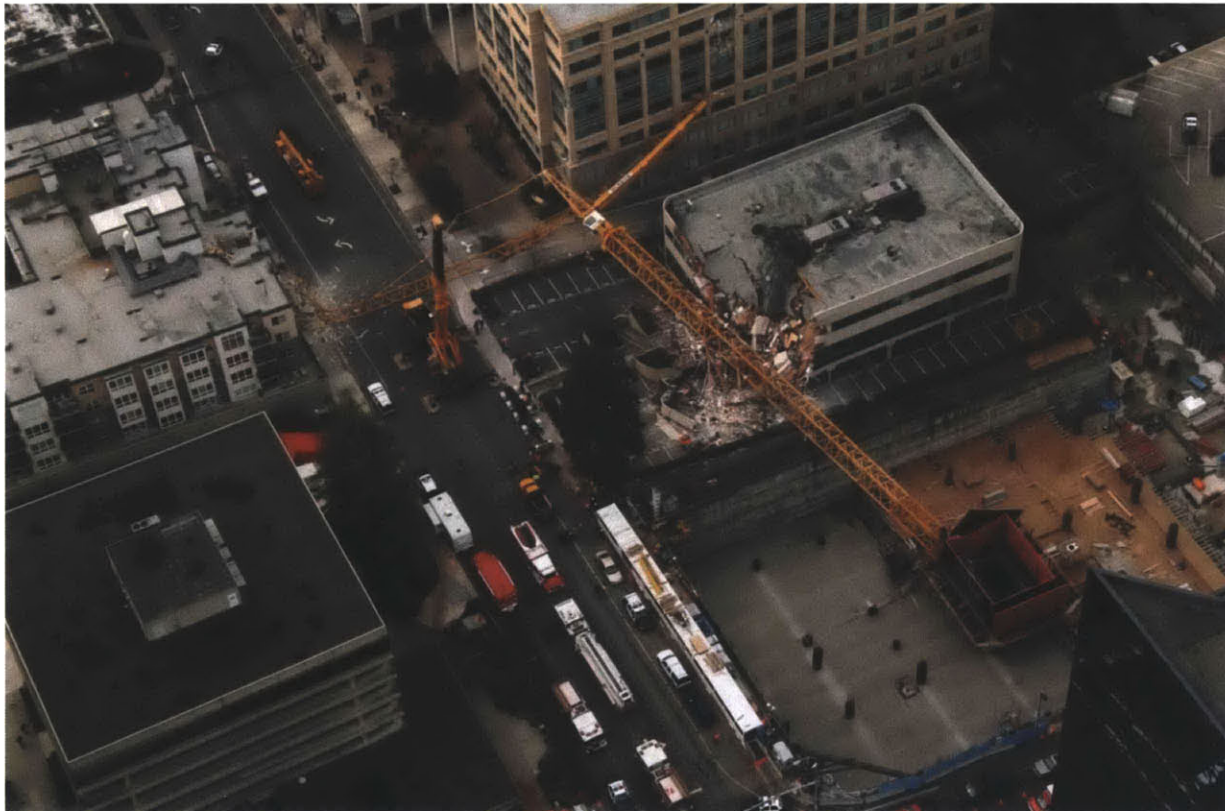
**Figure 1.2: A tower crane collapses in Bellevue, Washington.  
(Haag Engineering Co.)**

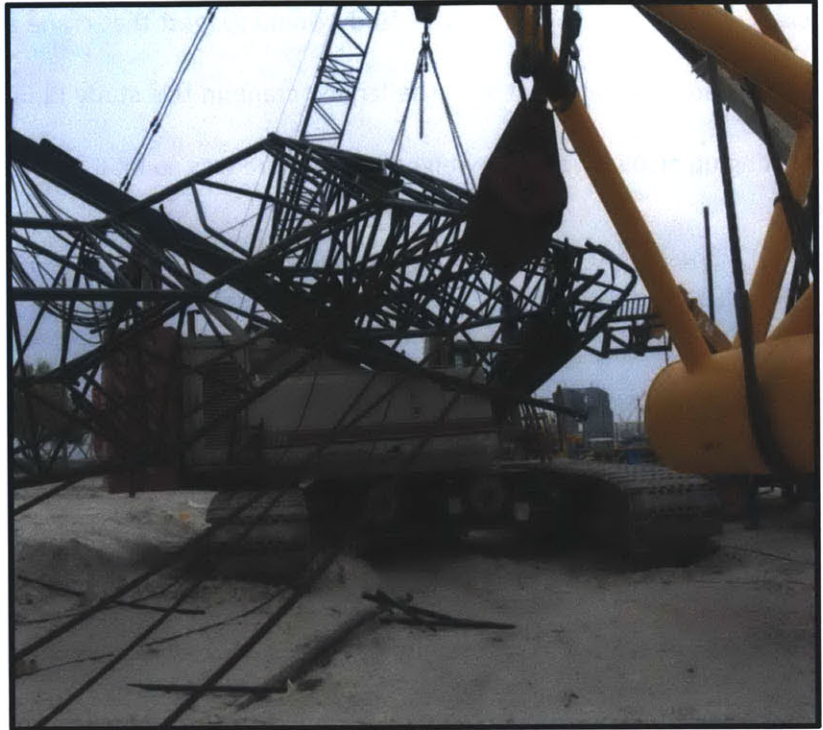
The goal of the “physical issue” analysis was to determine what physically goes wrong with cranes during accidents. Cranes experienced structural failures on a number of occasions (usually the boom). The structural failures were caused by overloading and/or maintenance neglect, further emphasizing the importance of proper operation and upkeep of the cranes. **Figure 5.1** shows an example of a structural boom collapse.

**Figure 5.1: A collapsed lattice boom. Categorized as a “physical issue.” (Haag Engineering Co.)**

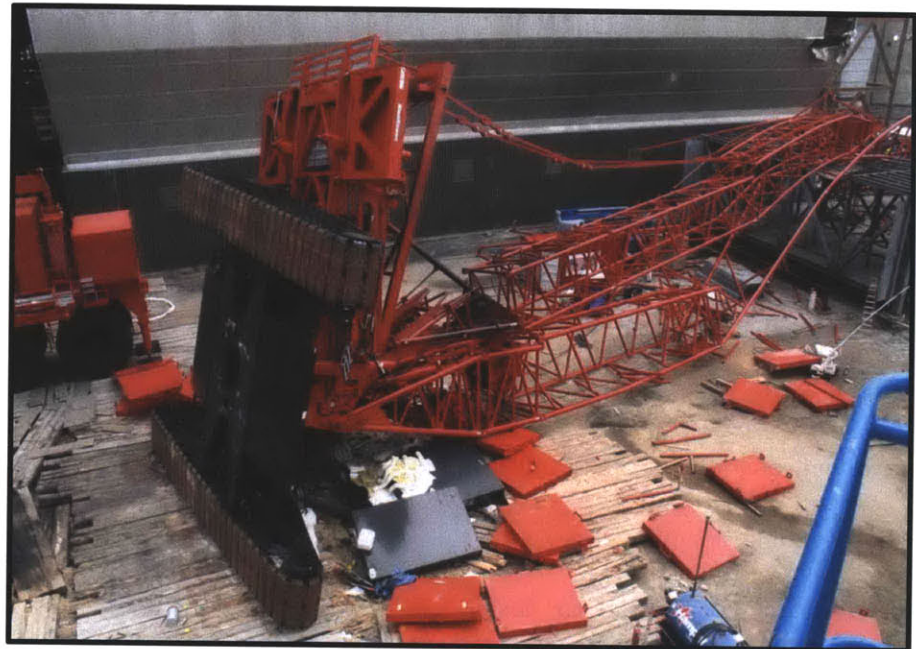
Stability failures were found to be far more common in this study than in previous statistical data. **Figure 5.2** shows the aftermath of a stability failure of a mobile crawler crane. These failures are particularly dangerous because they have a high tendency to result in the most commonly identified category in this study, “worker contact”. Having the wrong information about the load weight and misreading the load chart were trends in this category. Ground conditions and outrigger set-up contributed to other stability failures. Again, these issues should have always have been addressed before the lift ever took place.

**Figure 5.2: Stability failure of a mobile lattice crawler crane.  
(Haag Engineering Co.)**

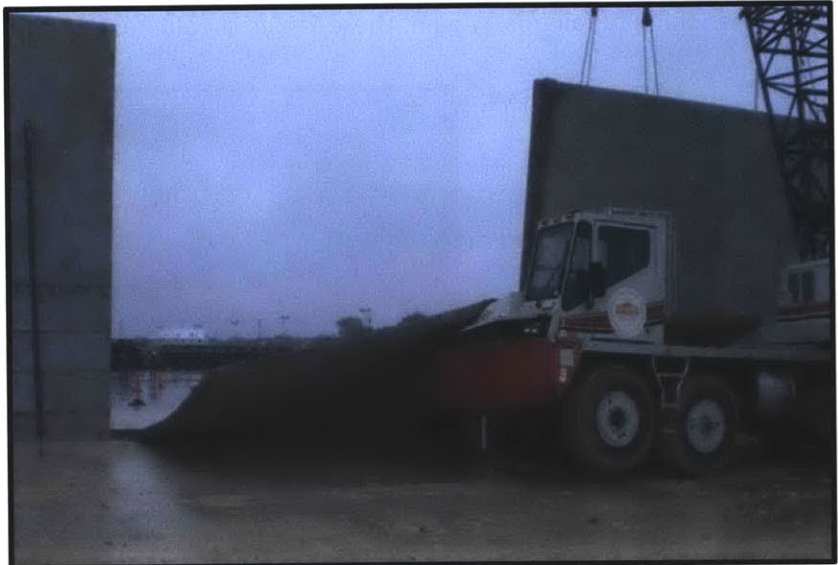
**Figure 5.3: Tilt-up wall falls on crane during erection.  
(Haag Engineering Co.)**
