*Lessons from accidents during tunnel construction*

**Citation:** Sousa, Rita L and Einstein, Herbert H. 2021. "Lessons from accidents during tunnel construction." *Tunnelling and Underground Space Technology*, 113.

# Lessons from Accidents during Tunnel Construction

Rita L. Sousa\*<sup>1</sup>, Herbert H. Einstein<sup>2</sup>

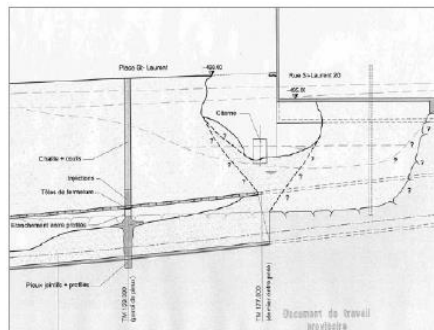
| Description of the occurrence: | A tunnel collapse on Lot 1200 consisting of the 306 m-long Saint-Laurent tunnel between Flon and Riponne stations and the 272 m-long Viret tunnel between Riponne and Bessières stations displaced a huge amount of material – soil + water (1400m <sup>3</sup> ) into the tunnel and caused extensive damage as it cratered towards the surface in the busy St. Laurent's commercial district. | |

Drawing of the collapse

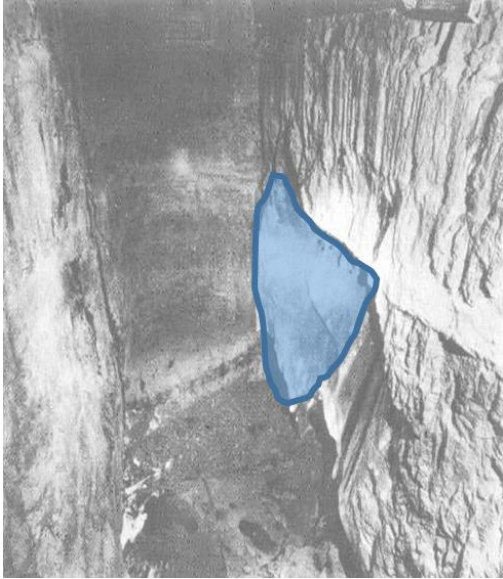
**Figure 7 Photo of the collapsed area (adapted from Rocha, 1977)**

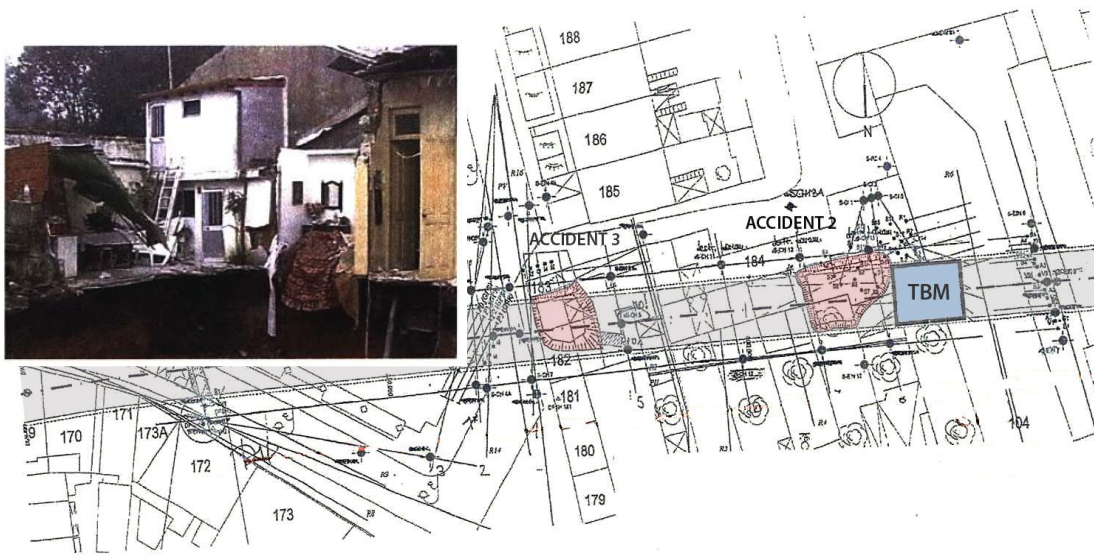
As mentioned before, most events occur in the heading (face and or crown) area of the tunnel, but some behind the face. This was the case in the Porto Metro accident (Project ID 9). On January 12, 2001 the foundation underneath a building collapsed suddenly in just a few minutes, resulting in the death of one person inside the building and causing a crater at the surface with a net volume of around 250 m<sup>3</sup> (Figure 10). The TBM had passed under building between December 16 and 18, it was stopped 50 m ahead since December 28, 2000. The stoppage was due to excessive settlements at the surface and the need to fill a cavity of around 15 m<sup>3</sup> due to over-excavation (accident 2 in Figure 10). The above-mentioned major accident is accident 3 in Figure 10.

**Figure 10 Collapse of Porto Metro line C in January 2001 (adapted from Forrest, 2006 and private correspondence)**

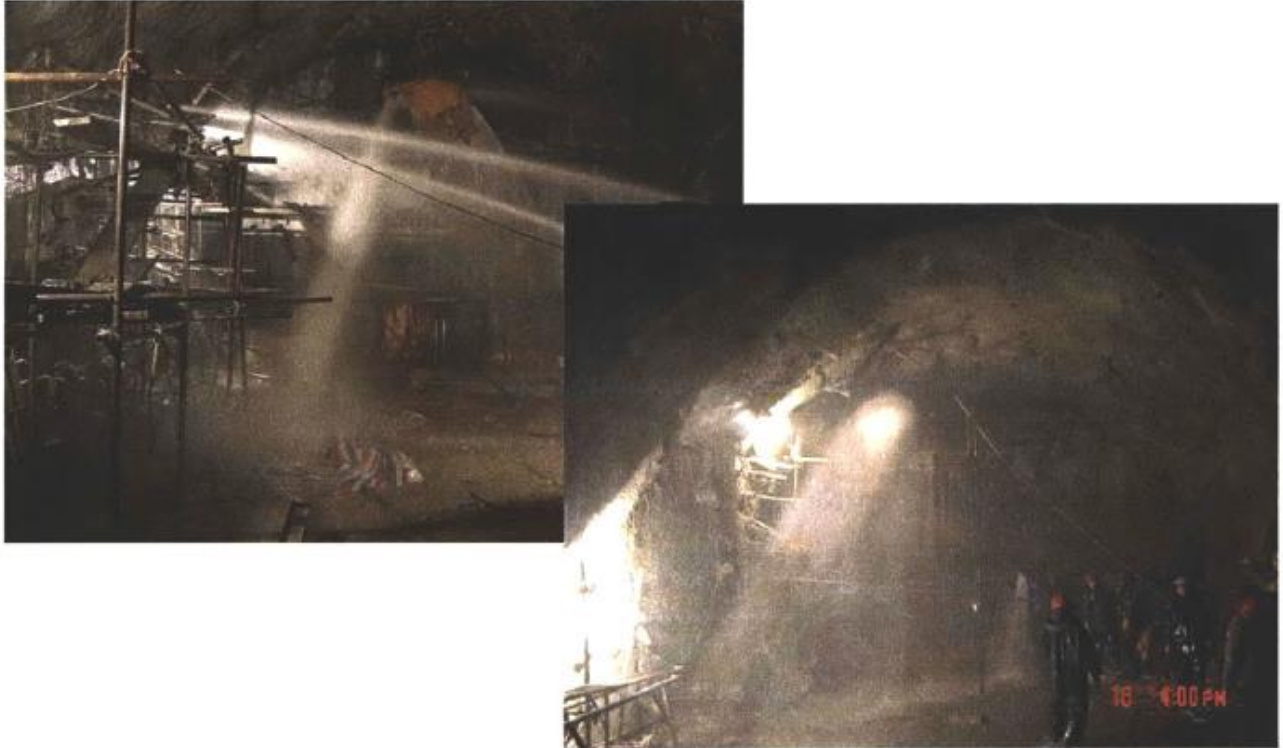
A special case of water inflow is water burst which consists of water inflow under pressure in the tunnel. Figure 12 shows water bursts that occurred in a tunnel in China.

**Figure 12 Water burst resulting in flooding, China (private correspondence)**

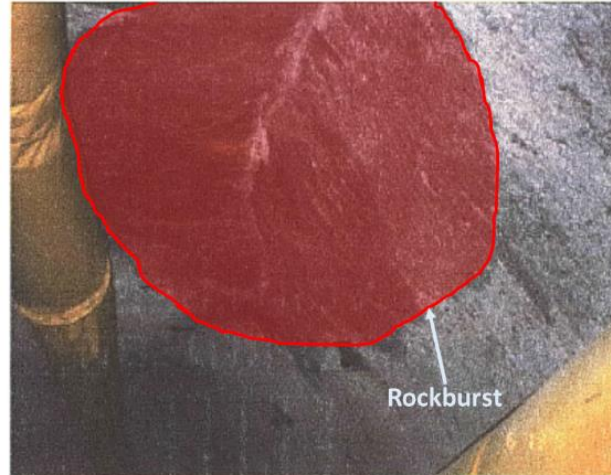
**Figure 14 Rockburst at the crown in a in a waterway tunnel in Korea (adapted from Lee et al., 2004)**

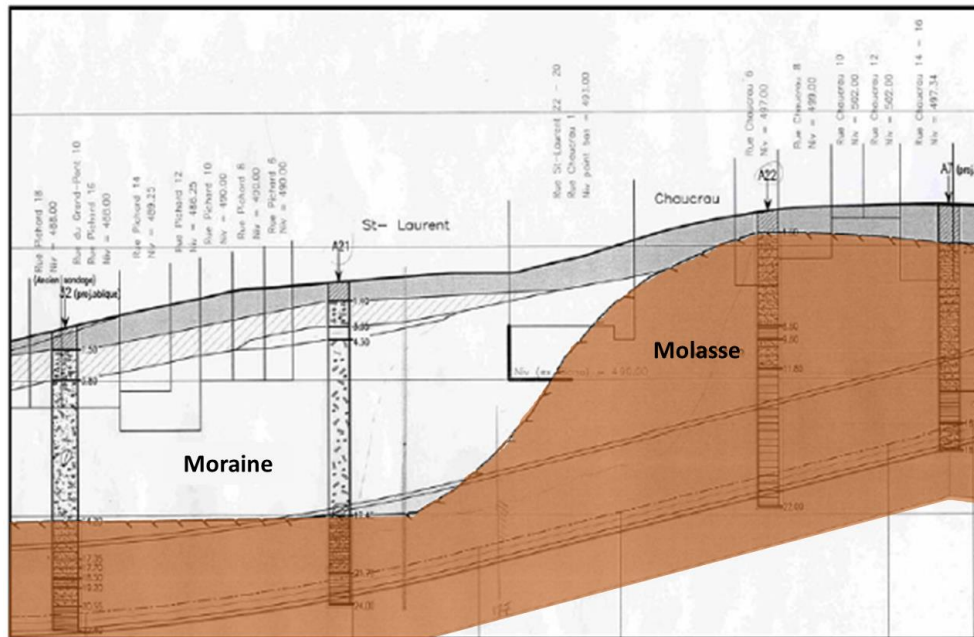
Figure 29 Ground conditions in the final design documents (adapted from Seidenfuss, 2006)

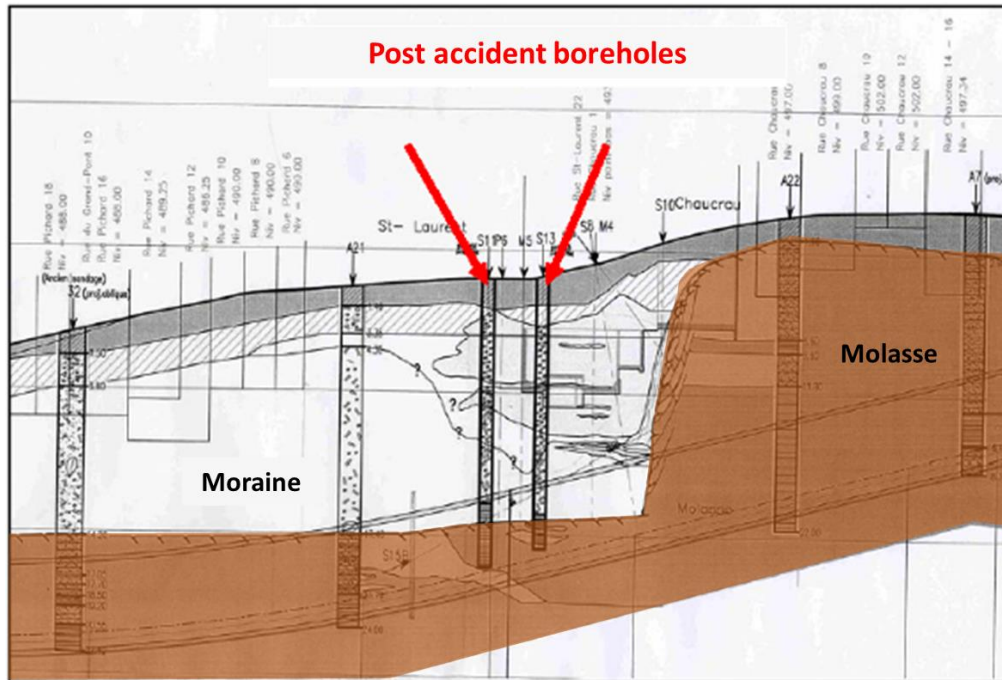
Figure 30 Actual ground conditions after collapse (adapted from Seidenfuss, 2006)

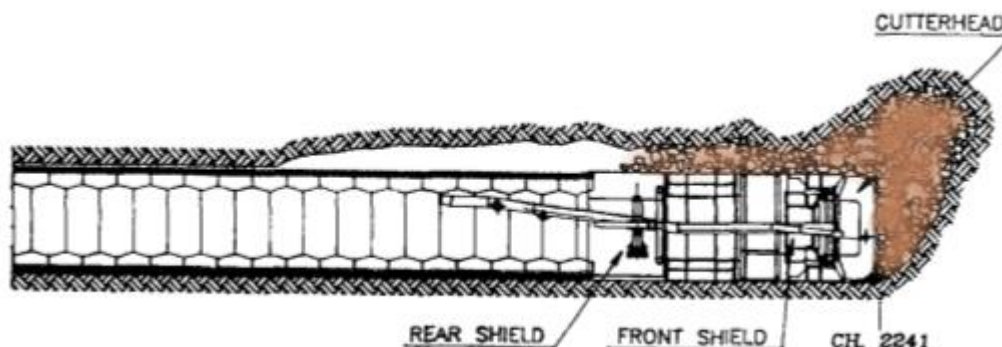
The case of Evinos-Mornos Tunnel (Project ID 49) in Greece (Figure 31) is an example where several (Grandori et al. 1995) problems, ranging from small continuous collapse of the face, squeezing ground and some larger collapses were caused by faults. In some of these situations when the TBM cutterhead is pulled back for ground treatment after the collapse, loosening happens creating a larger collapse dome (Grandori et al., 1995)

Figure 31 Collapse at the face of the TBM, Evino Mornos, Greece (adapted from Grandori et al., 1995)

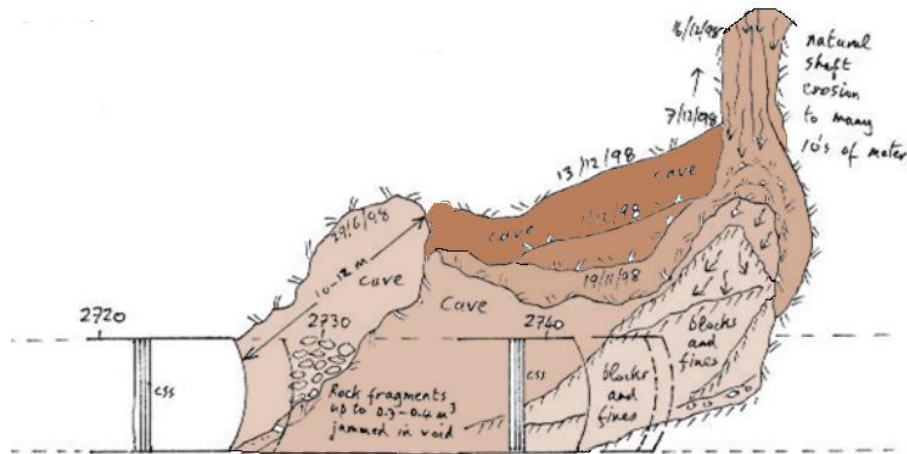
The Pont Ventoux (Project ID 69) continuous collapses presented in Figure 32 is a good example where adverse water pressure was the most important cause with respect to the cutterhead getting stuck in the various fault zones. In this tunnel, the high (non-vertical) major principal stress, and very high-water inflows, were very adverse to the stability in fault zones full of clay, silt, sand and crushed rock.

**Figure 32 Continuous collapses due to the ‘fault shaft’, assisted by water and/or water pressure. These sketches are super-imposed on one sheet, from the geologist’s daily logs. TBM was stuck for 6 months in this location (adapted from Barton, 2006)**

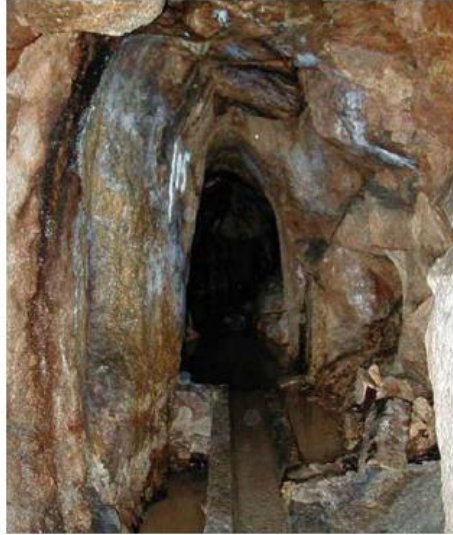
This was the case in the Porto Metro (Project ID 9), in Portugal, where many old wells and “minas” (old and small handmade water tunnels) were present in the area and uncharted due to their ancient nature. They modified the hydro-geological characteristics of the ground, such that the groundwater moved not only in the porous medium and fractures, but also along the preferential channels represented by the “minas”, which strongly influenced the underground water circulation (Grasso et al., 2003). Figure 33 shows a man-made water mine beneath the city of Porto.

**Figure 33 Man-made tunnels (“minas”) in Porto, Portugal (from Forrest, 2006)**

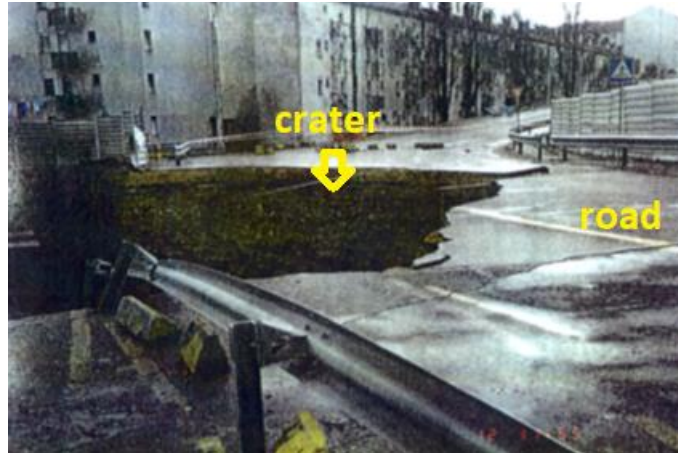
Adoption of incorrect geomechanical design parameters and use of inappropriate models were some of the errors that occurred in the case of Olivais metro (Project ID 10) in Lisbon (Figure 34), where the geomechanical parameters used in the design numerical calculations were overestimated (Appleton, 1998).

Figure 34 Collapse that occurred in Olivais Station, Lisbon, Portugal (adapted from Appleton, 1998)
