An Analysis of Possible Microbiologically Influenced Crevice Corrosion of 316 Stainless Steel in a Seawater Environment

MASTER OF SCIENCE IN OCEANOGRAPHIC ENGINEERING
at the
MASSACHUSETTS INSTITUTE OF TECHNOLOGY
and the
WOODS HOLE OCEANOGRAPHIC INSTITUTION

SEPTEMBER 1996

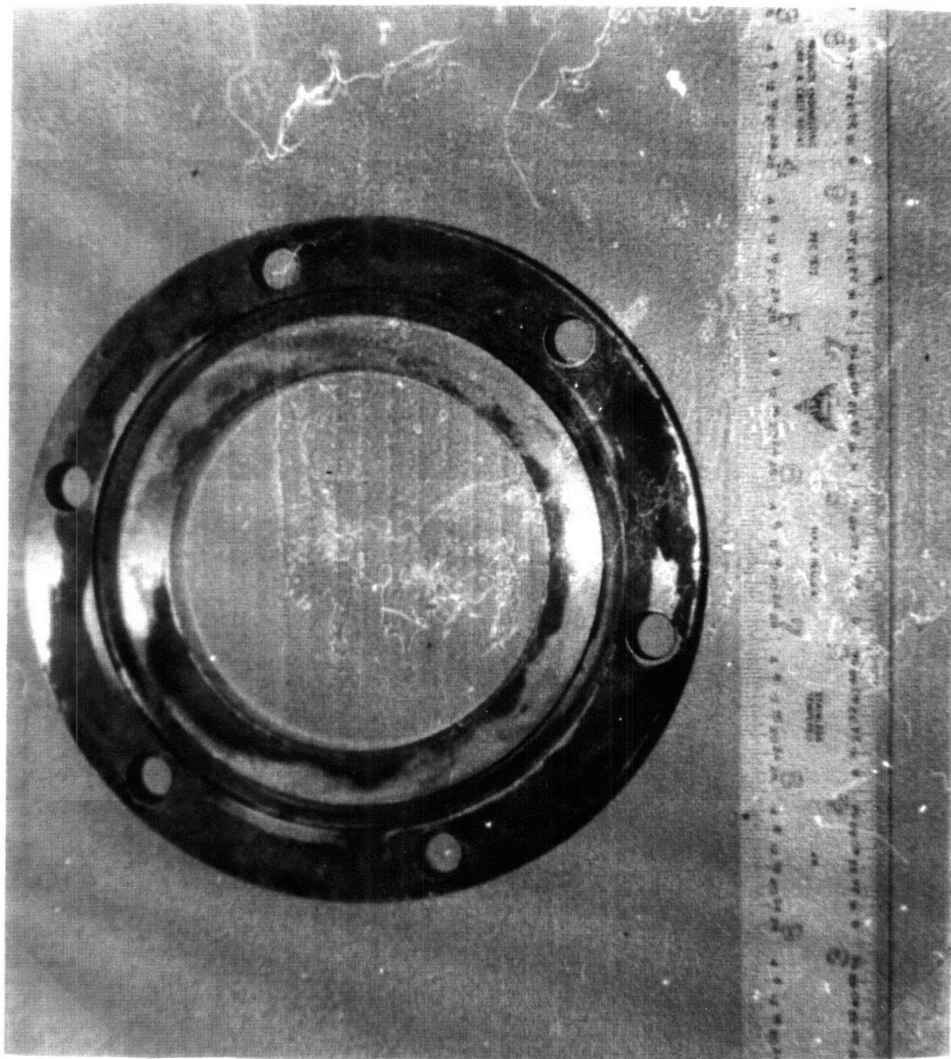
Figure 1-1: Corrosion-Damaged Specimen #1 (O-ring grooved side)

experiment which exhibited this rapid and severe crevice corrosion. These components were 316 Stainless Steel space rings which were used to join two pressure housings on a large fixed instrument. The components were produced on an end-mill in the machine shop at the Woods Hole Oceanographic Institution and given a smooth surface finish. Each has six holes through which fasteners passed and an O-ring groove milled into one side. Outer diameter is 4.5 inches, inner diameter is 3.5 inches, and thickness is 3/8 inches. Figures 1-1 and 1-2 are photographs of one of these corrosion-damaged components, while figure 1-3 is a line drawing of the vorticity instrument suspended within its tripodal frame for deployment on the sea bottom. The location of the two rings in the pressure housing is indicated by the arrow. The rings were separated from the rest of the instrument by spacers composed of Delren plastic.

The particular components which were analyzed by me were utilized in an instrument deployed on 11 July 1994 at 48° 23.55' N latitude 124° 31.91' W longitude in 130 meters of water off the coast of the state of Washington. Surface tidal currents were approximately 3 knots. A sacrificial zinc was attached in the immediate vicinity of the spacer rings. When the instrument was recovered on 28 May 1995, it was immediately noted that the zinc had been totally consumed. Upon disassembly, the severe corrosion (see figs. 1-1 and 1-2) of the rings was noted, as well as the fact that they were both heavily coated with a brown slime. At the time, it was assessed that if the corrosion had proceeded much further, the pressure boundary would have been breached, the experiment flooded out, and its data lost.

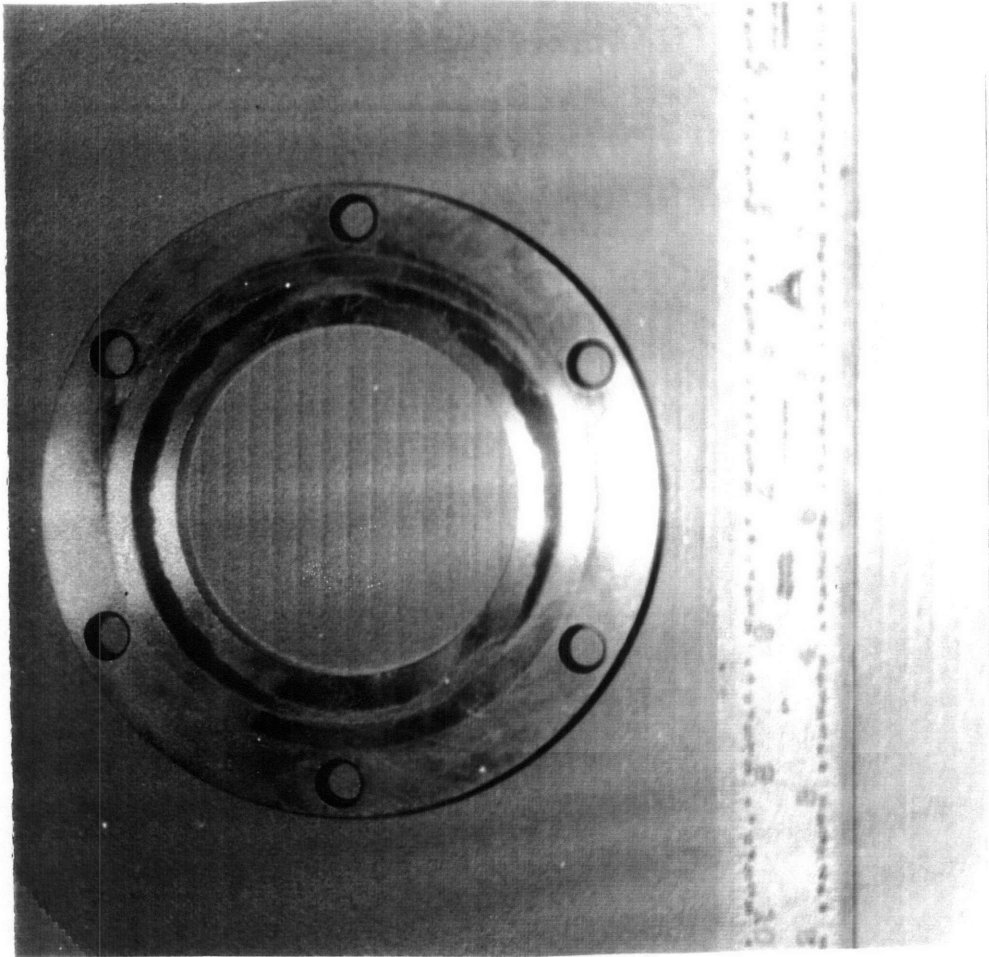
Figure 1-2: Corrosion-Damaged Specimen #1 (reverse side)

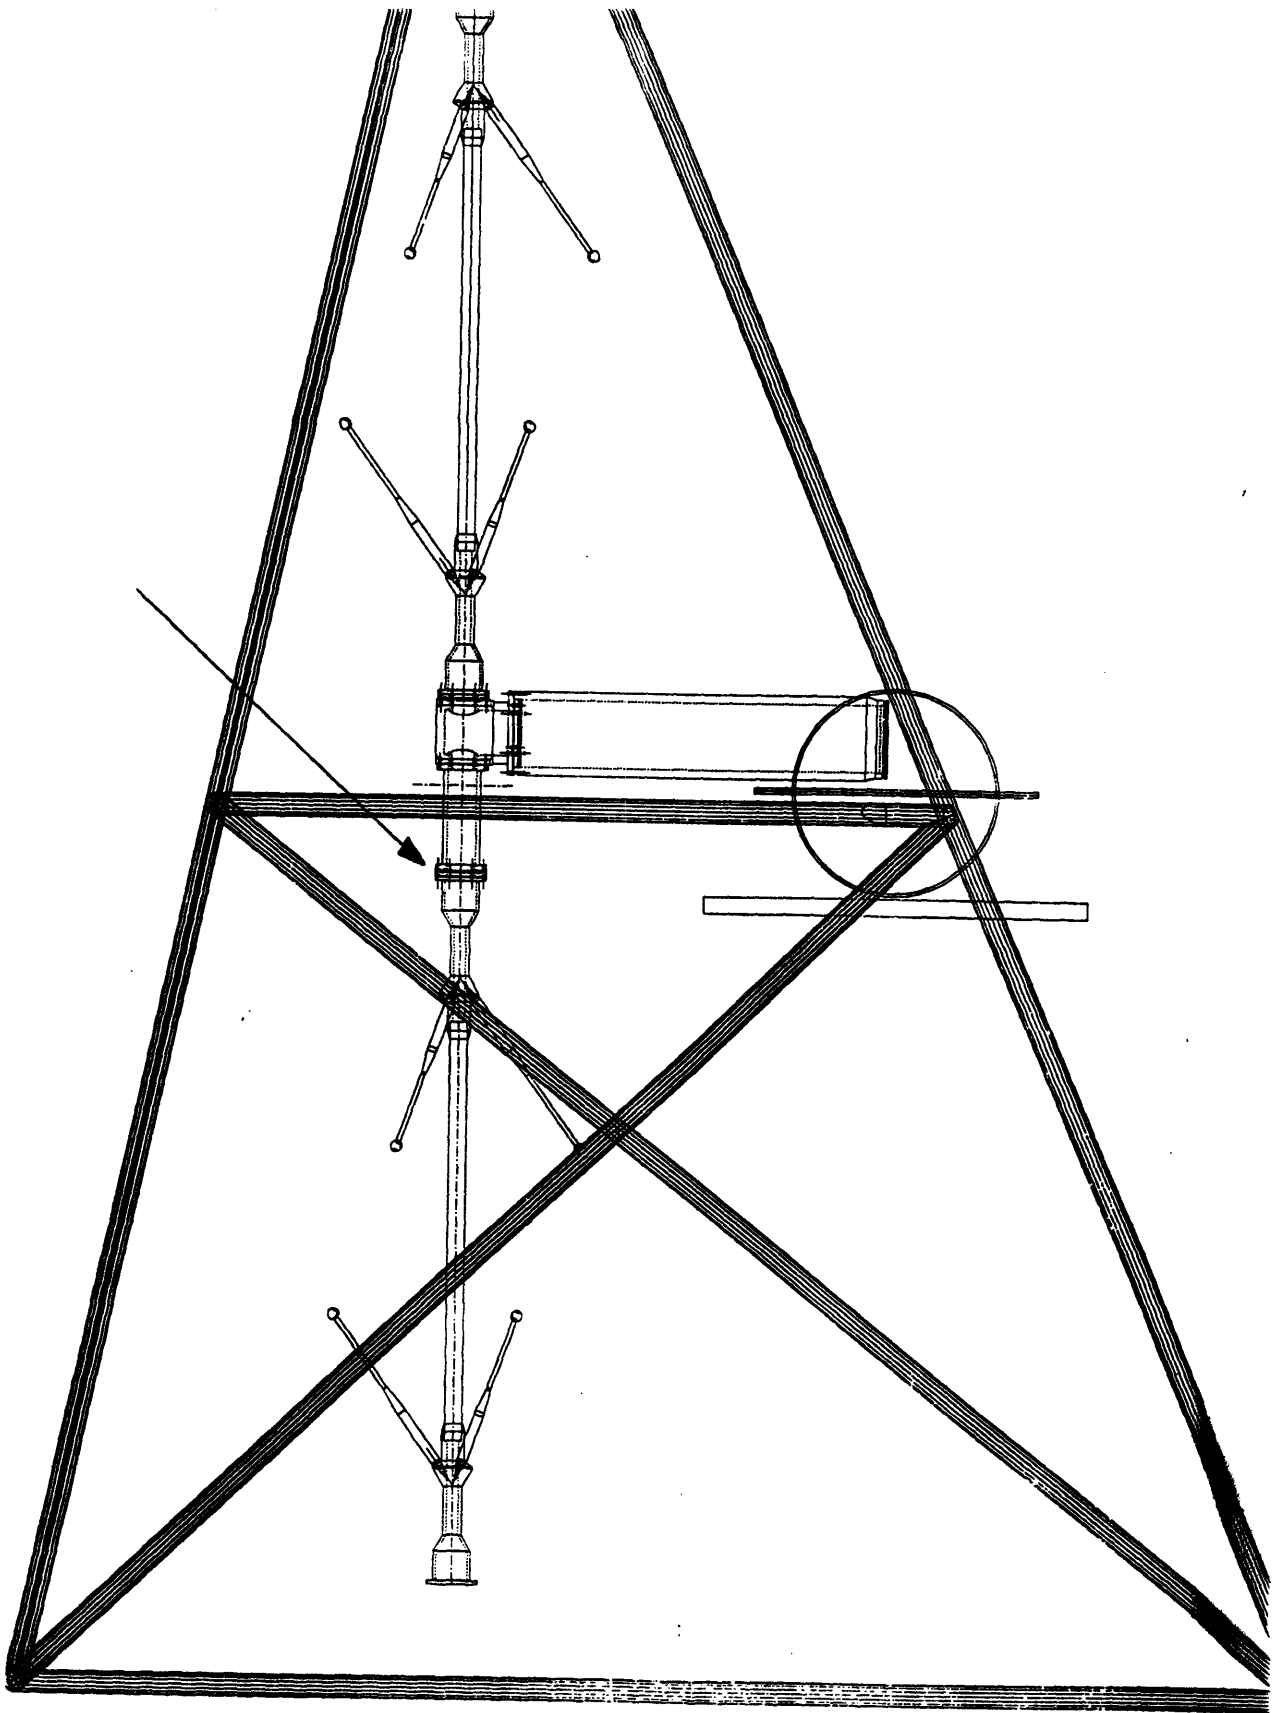
Figure 1-3: Line Drawing of Vorticity Instrument within Support Pyramid

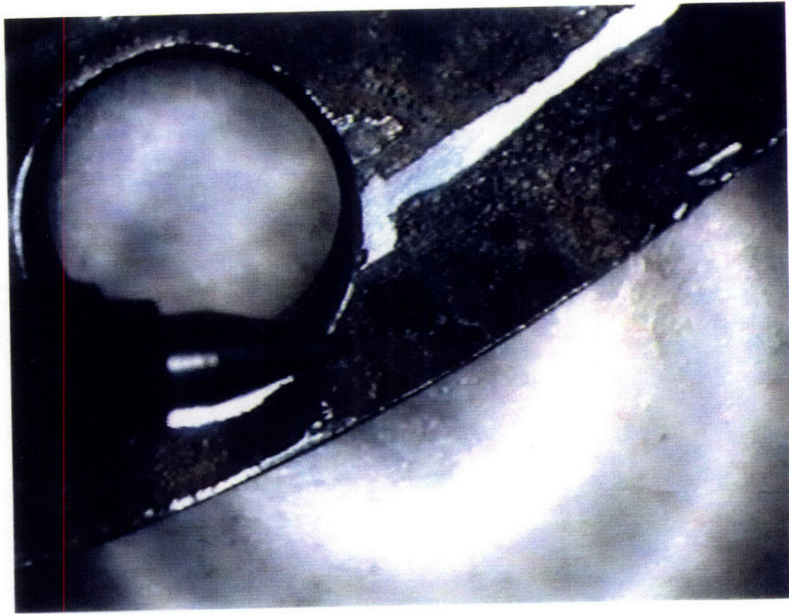
Figure 4-1: Specimen #1 Cavernous Pit (20X magnification)

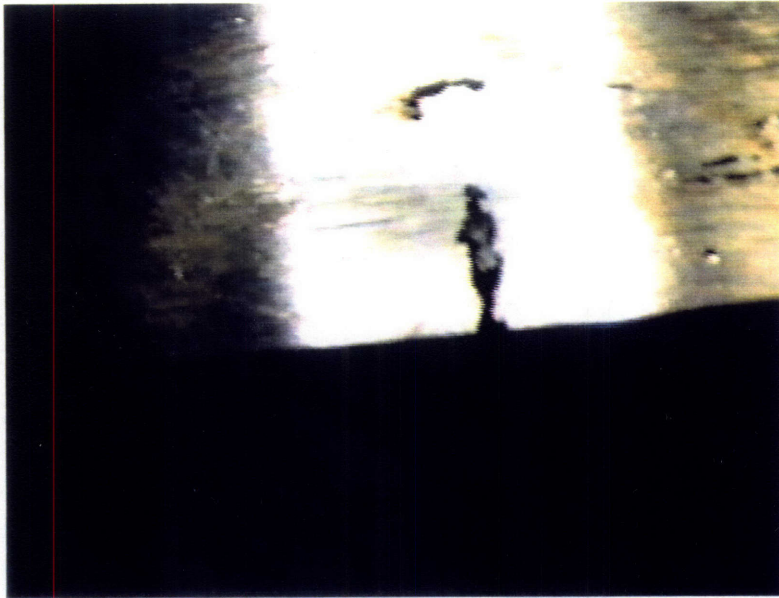
Figure 4-2: Specimen #1 Edge View of Deep Pit (20X magnification)

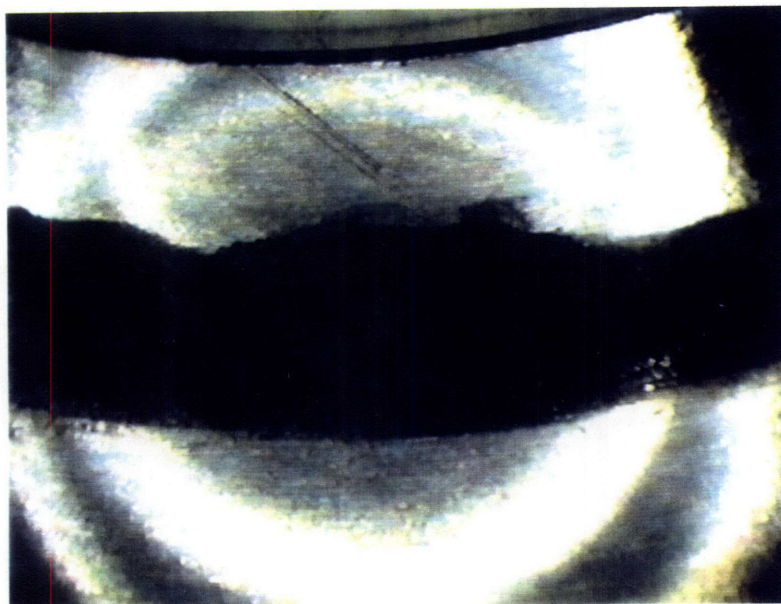
Figure 4-3: Specimen #1 Reverse Side (20X magnification)

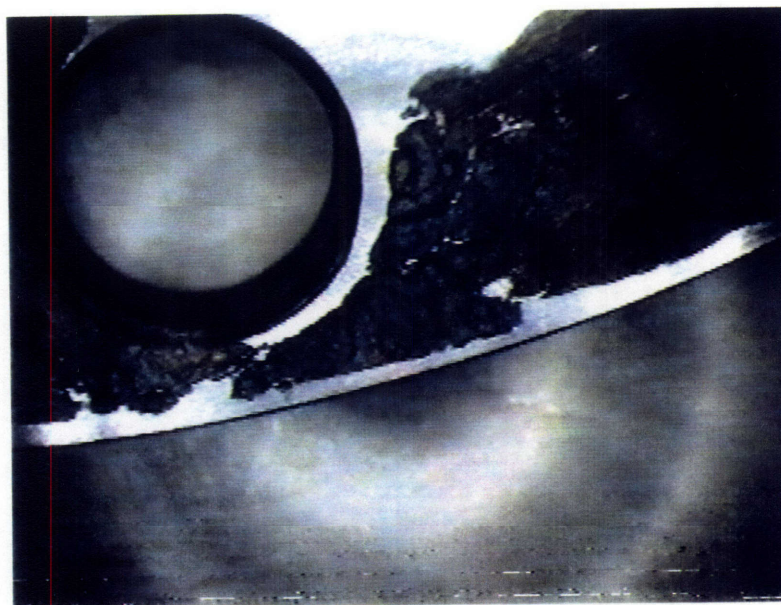
Figure 4-4: Specimen #2 Hemispherical Pits (20X magnification)

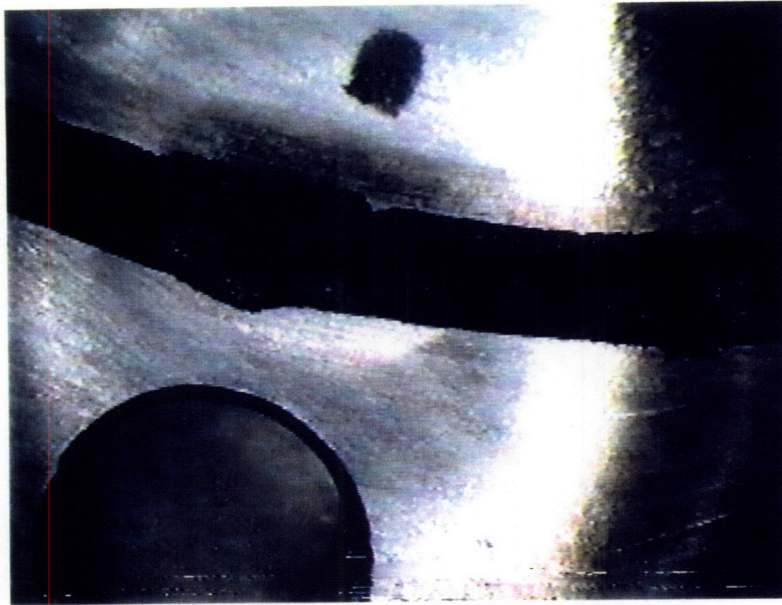
Figure 4-5: Specimen #2 Reverse Side (20X magnification)

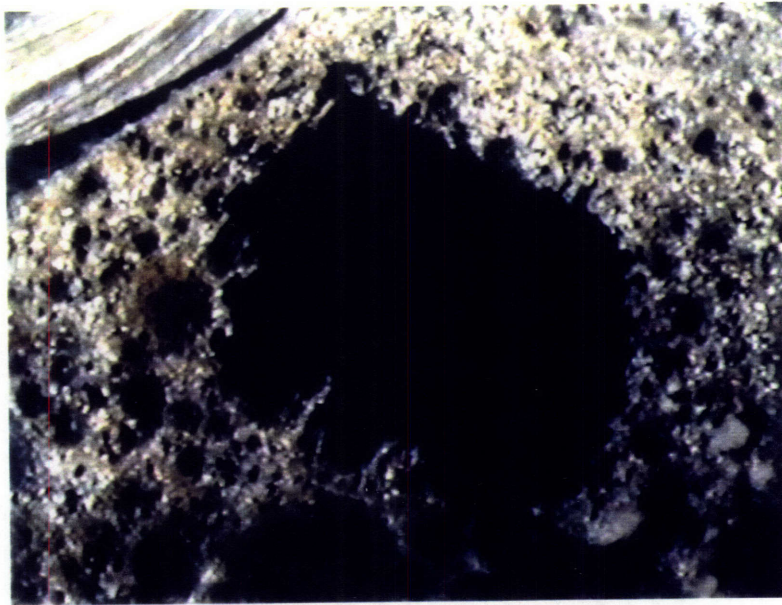
Figure 4-6: Specimen #1 Cavernous Pit (100X magnification)

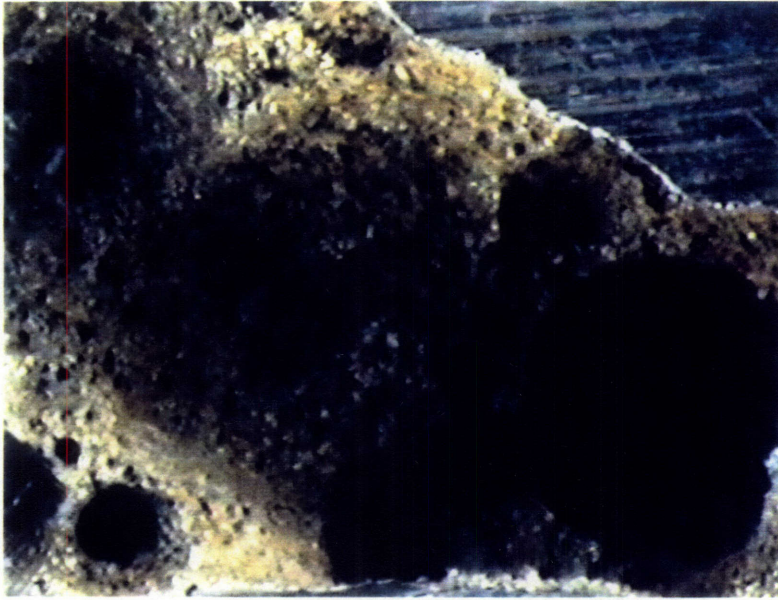
Figure 4-7: Specimen #1 Deep Pits (100X magnification)

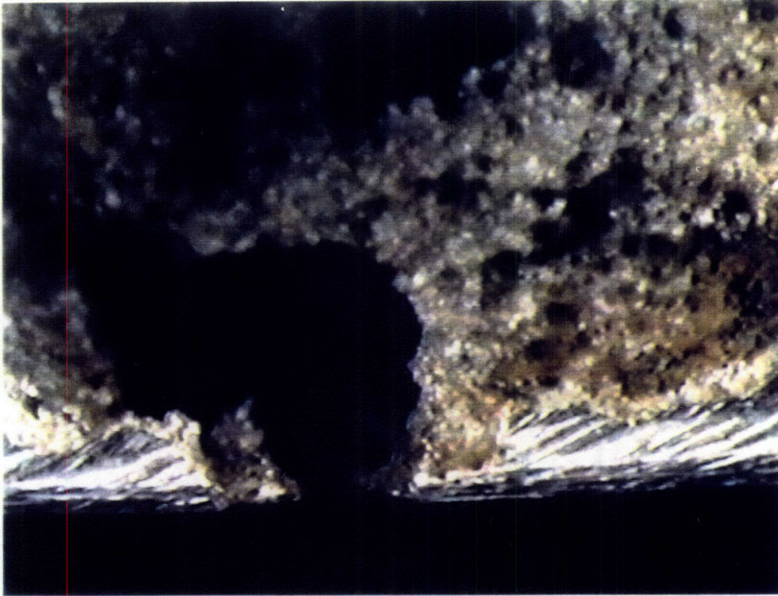
Figure 4-8: Specimen #1 Deep Edge Pit (100X magnification)

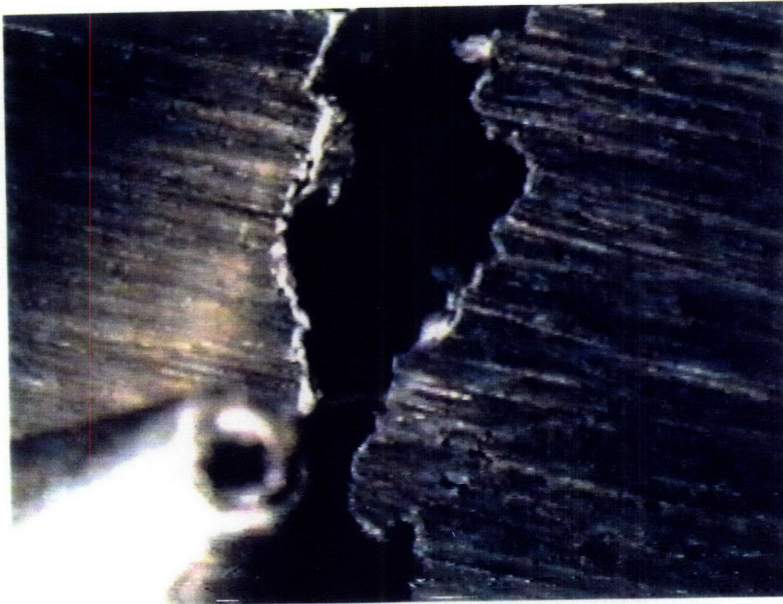
Figure 4-9: Specimen #1 Deep Edge Pits (100X magnification)

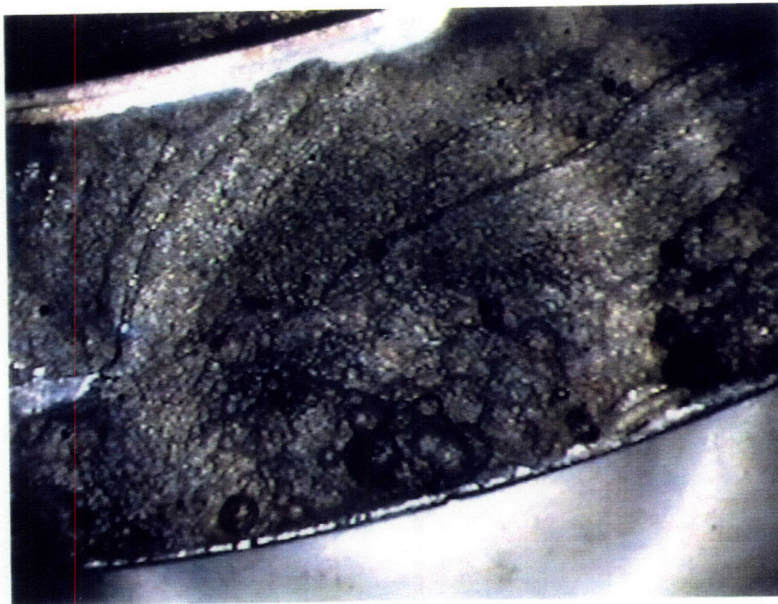
Figure 4-10: Specimen #2 Hemispherical Pits (20X magnification)

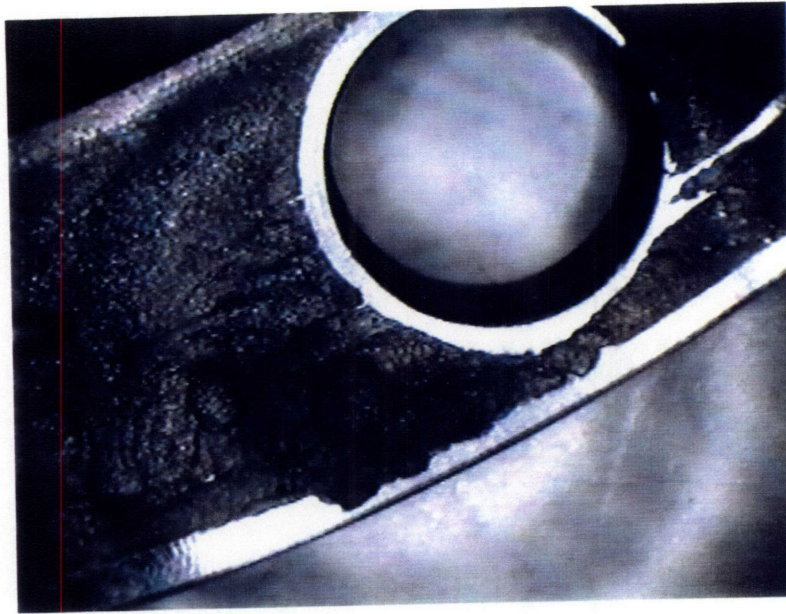
Figure 4-11: Specimen #2 Hemispherical Pits (20X magnification)

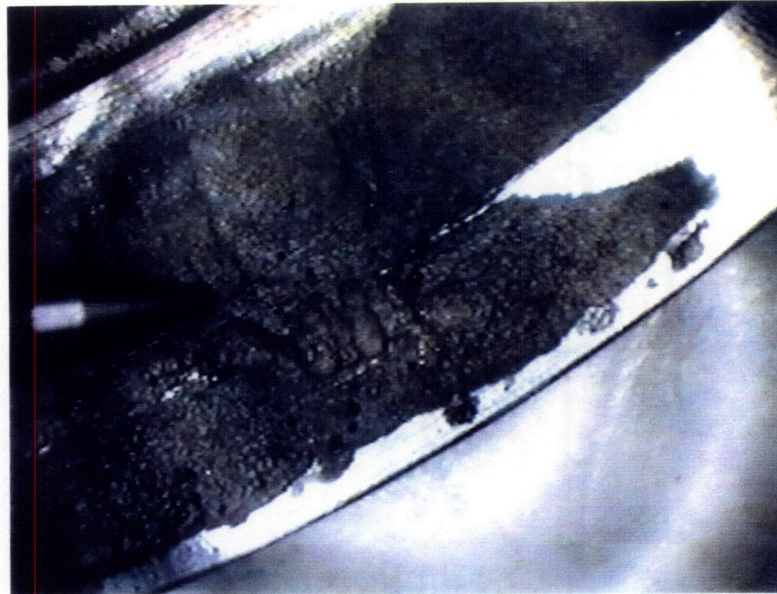
Figure 4-12: Specimen #1 Hemispherical Pits (20X magnification)

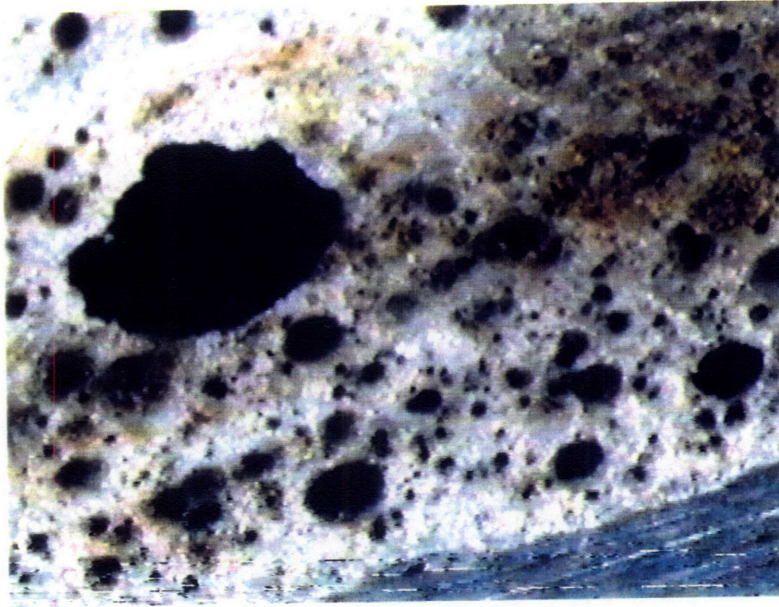
Figure 4-13: Specimen #2 Deep Pits (100X magnification)

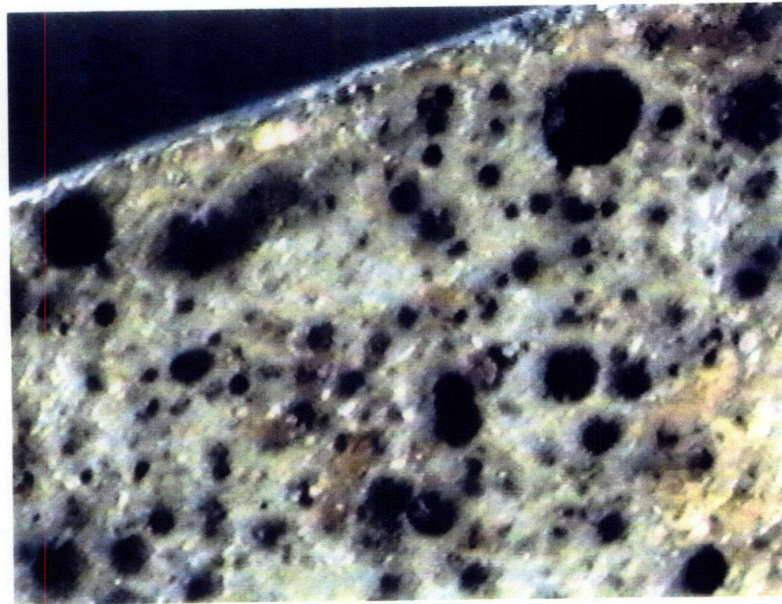
Figure 4-14: Specimen #2 Deep Pits (100X magnification)

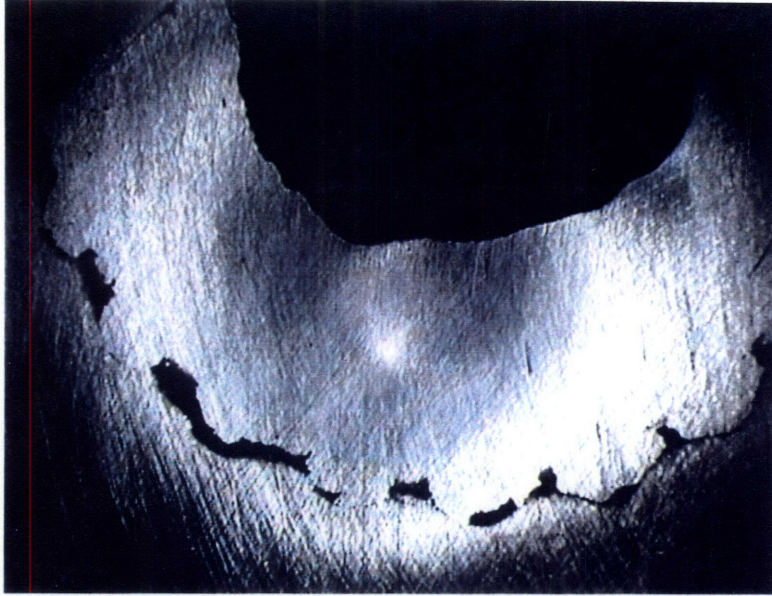
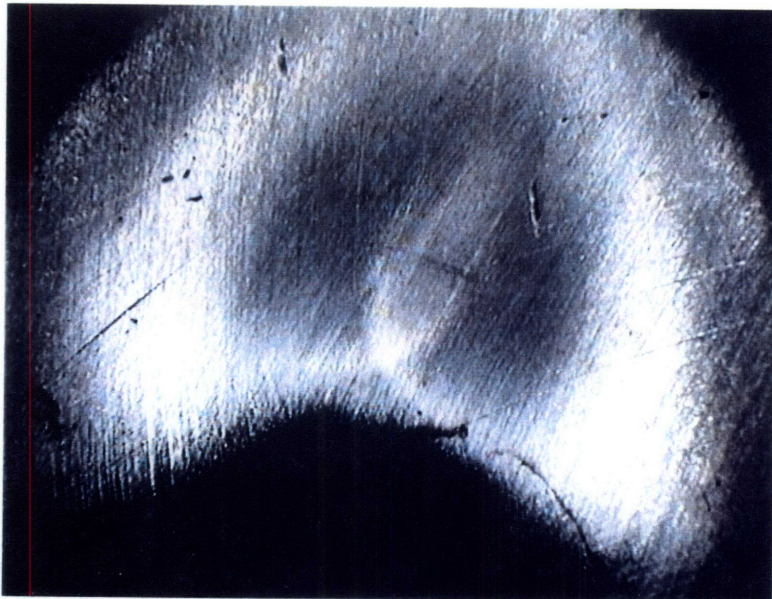
Figure 5-1: Sterile Seawater Specimen (20X magnification)

Figure 5-2: Sterile Seawater Specimen (20X magnification)

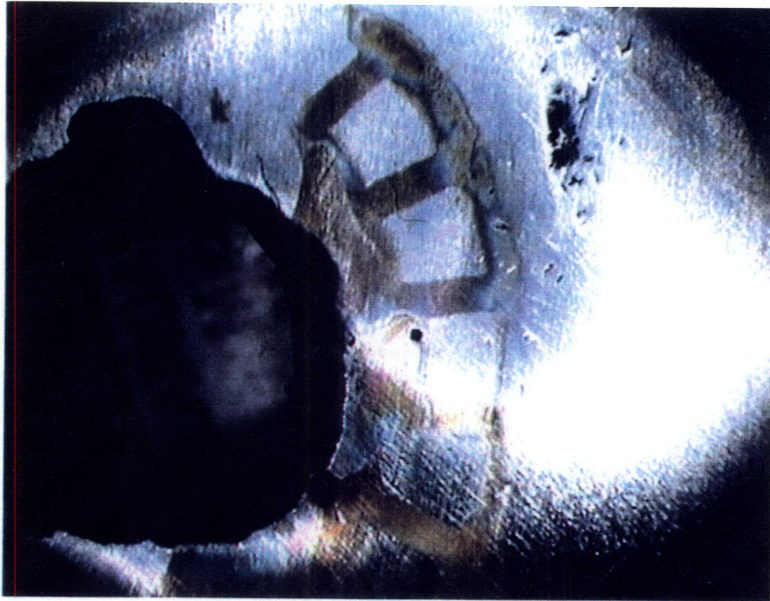
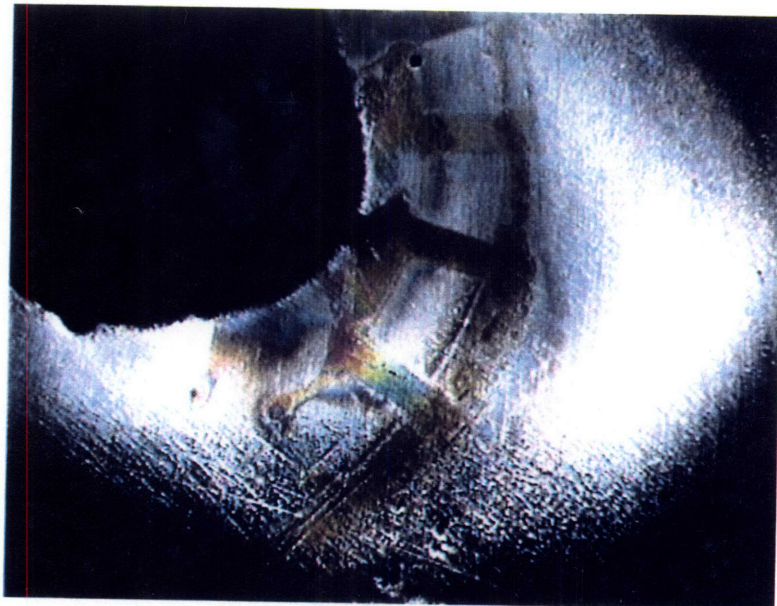
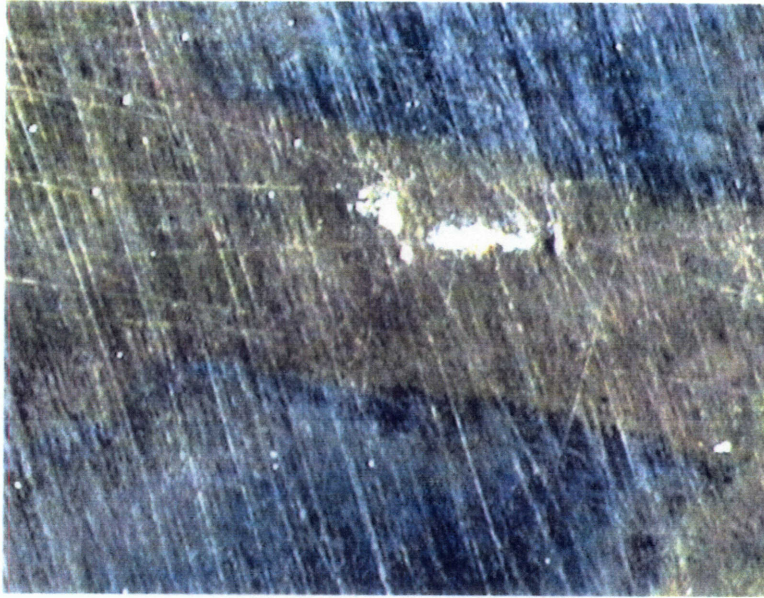
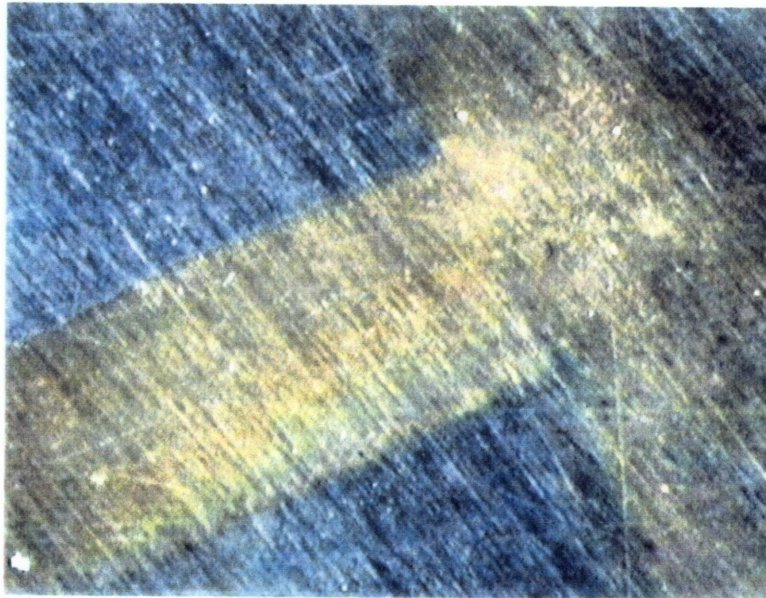
Figure 5-3: Active Seawater Specimen (20X magnification)

Figure 5-4: Active Seawater Specimen (20X magnification)

Figure 5-5: Active Seawater Specimen (100X magnification)

Figure 5-6: Active Seawater Specimen (100X magnification)

active specimen. It did display the formation of a single pit at the edge of the crevice region, suggesting that with additional time, more significant corrosion might have occurred.

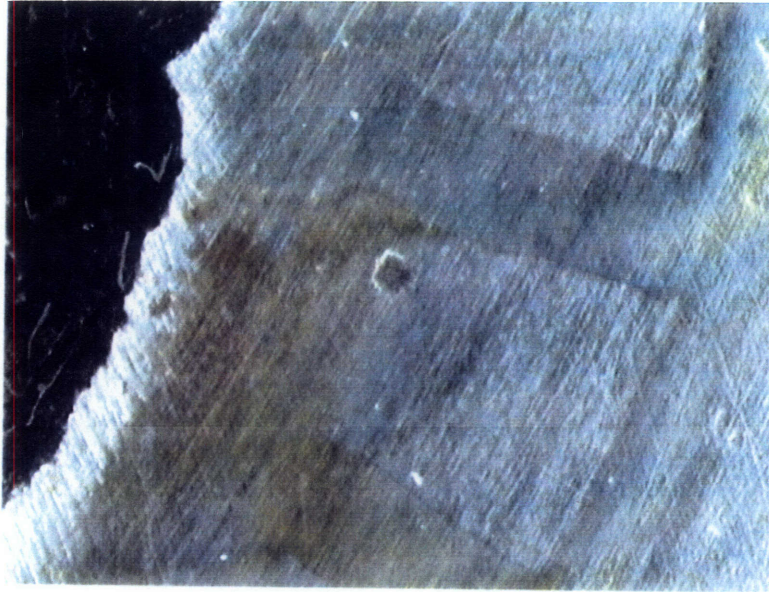
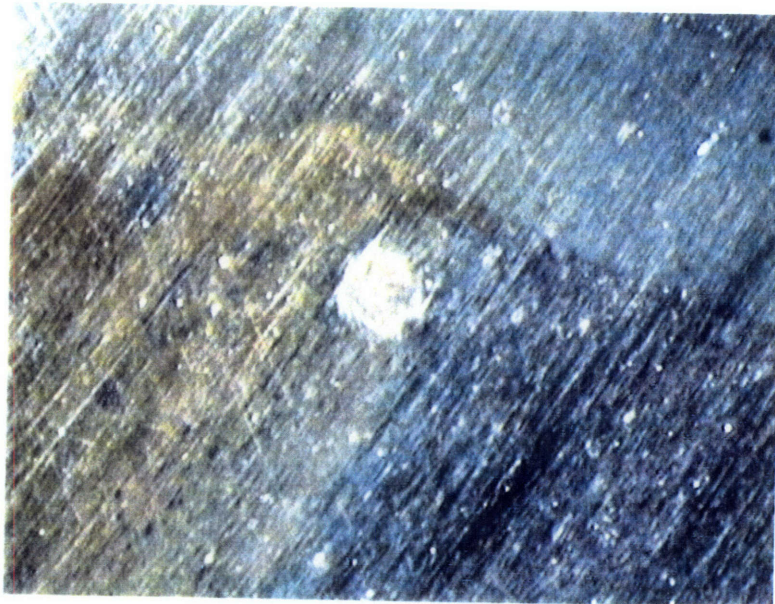
Figure 5-7: Active Seawater Pit (60X magnification)

Figure 5-8: Active Seawater Pit (100X magnification)

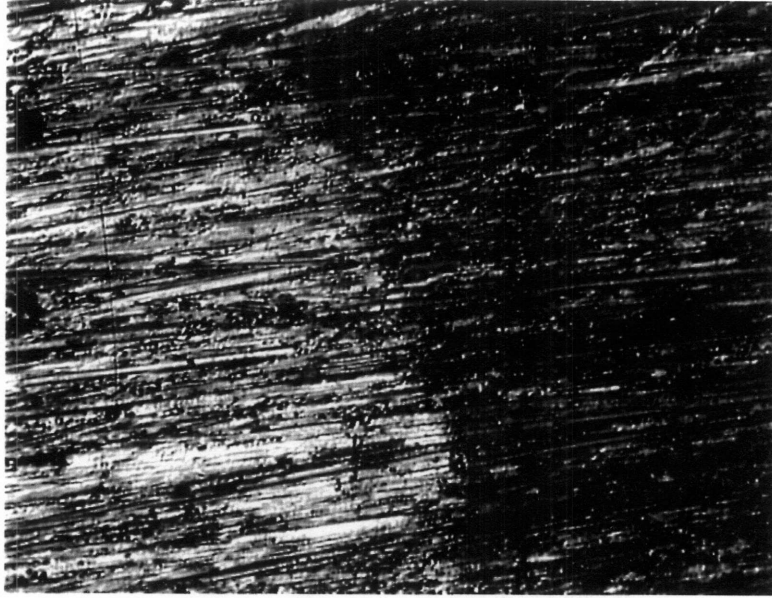
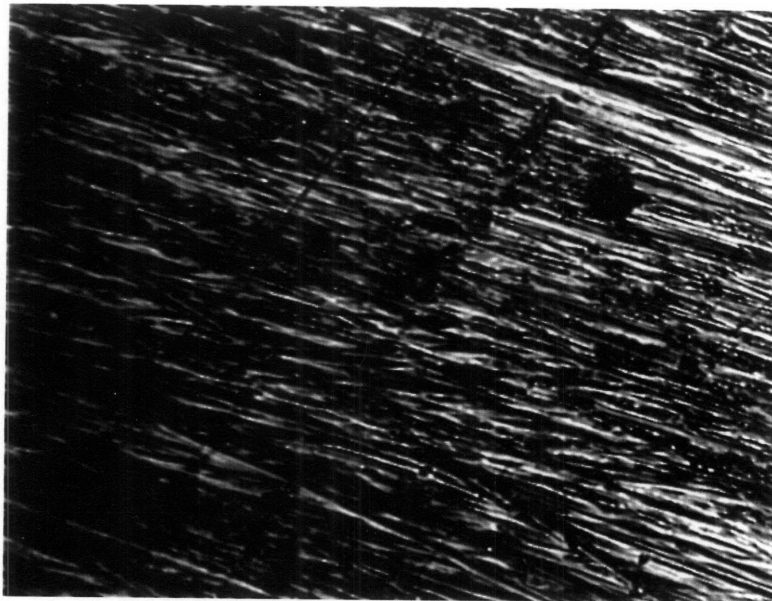
Figure 5-9: Active Seawater Specimen (600X laserscope magnification)

Figure 5-10: Active Seawater Specimen (600X laserscope magnification)

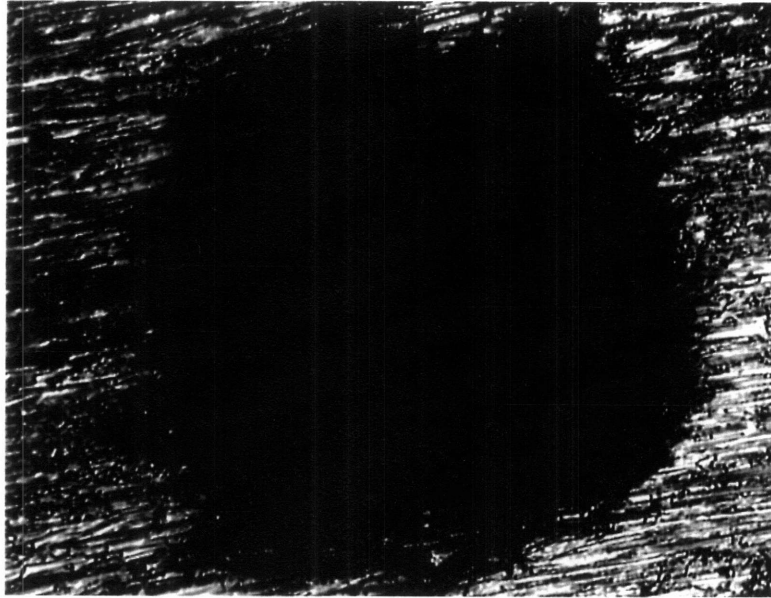
Figure 5-11: Active Seawater Pit (600X laserscope magnification)

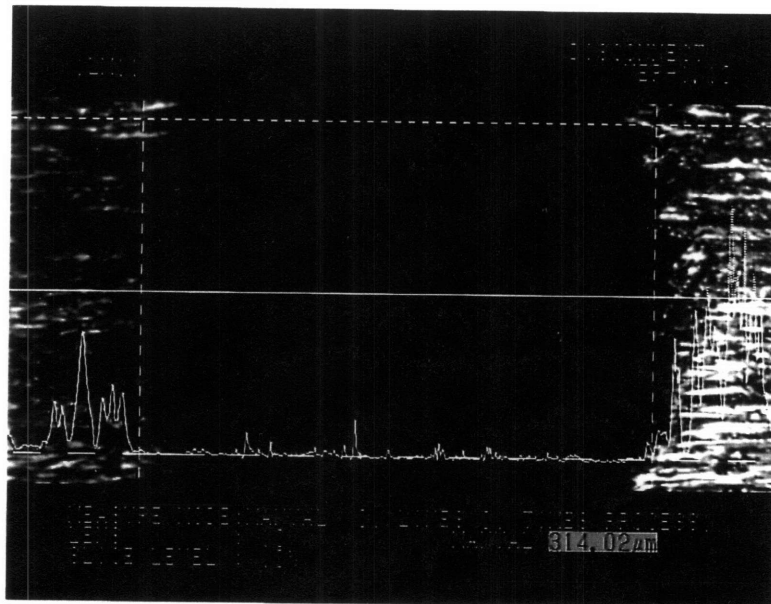
Figure 5-12: Active Seawater Pit (600X laserscope width/depth measurement)
