THE EFFECT OF IMPLANTS ON THE
STRUCTURAL INTEGRITY OF GRAPHITE/EPOXY
LAMINATES

Submitted to the Department of Aeronautics and Astronautics in
Partial Fulfillment of the Requirements for the Degree of

MASTER OF SCIENCE

MASSACHUSETTS INSTITUTE OF TECHNOLOGY

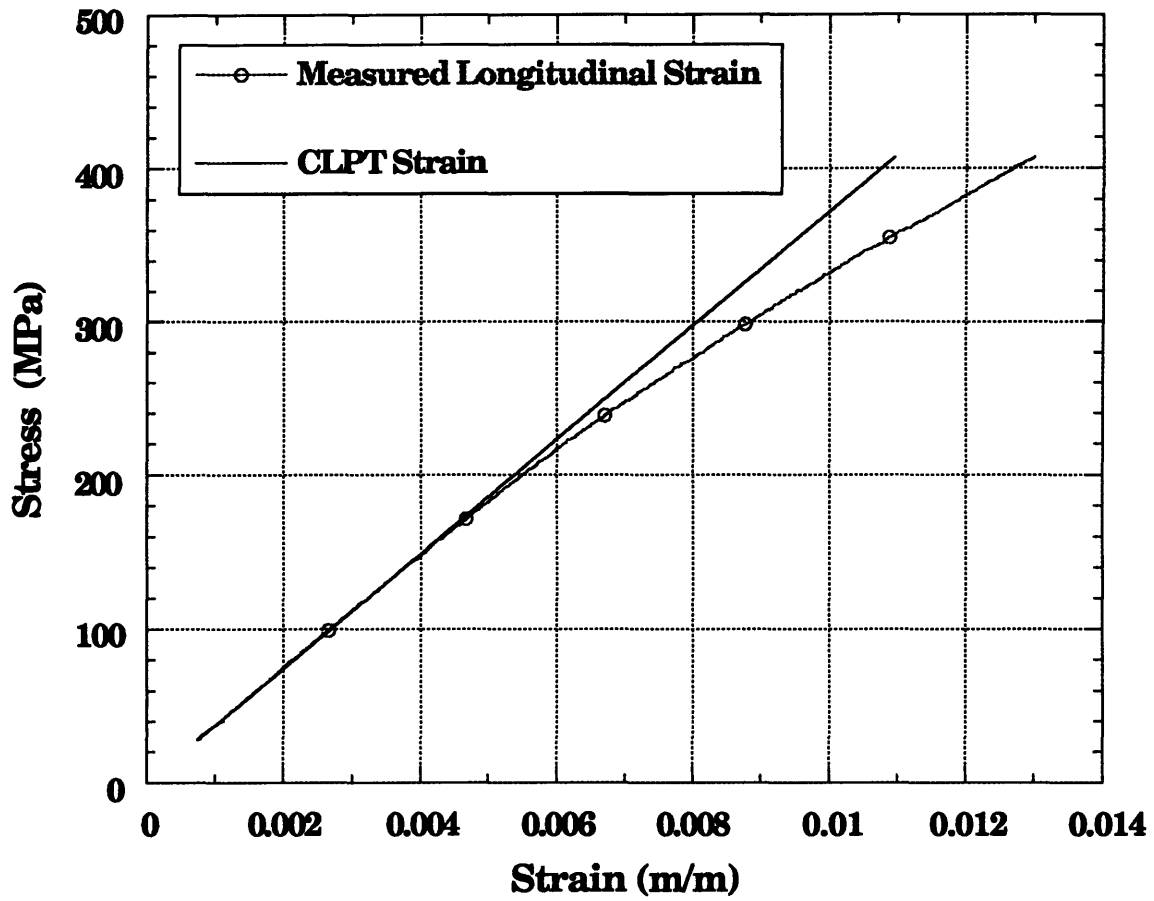
Figure 4.1 Stress-Strain Curves for Virgin Coupon 1V-E with a Layup 1, $[0/(\pm 45)_2/90/(\pm 45)_2]_s$, Configuration Tested to Failure

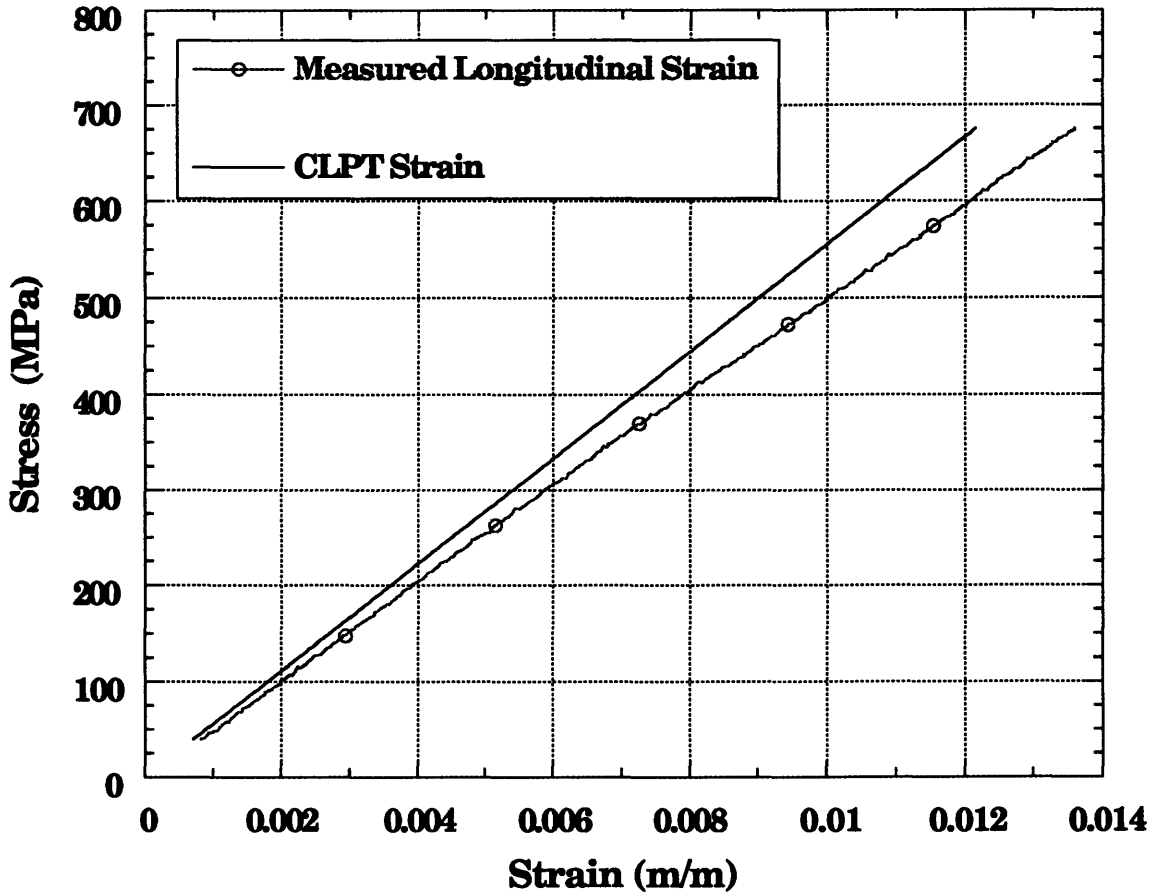
Figure 4.2 Stress-Strain Curves for Virgin Coupon 2V-A with a Layup 2, $[0/\pm 45/90]_{2S}$, Configuration Tested to Failure

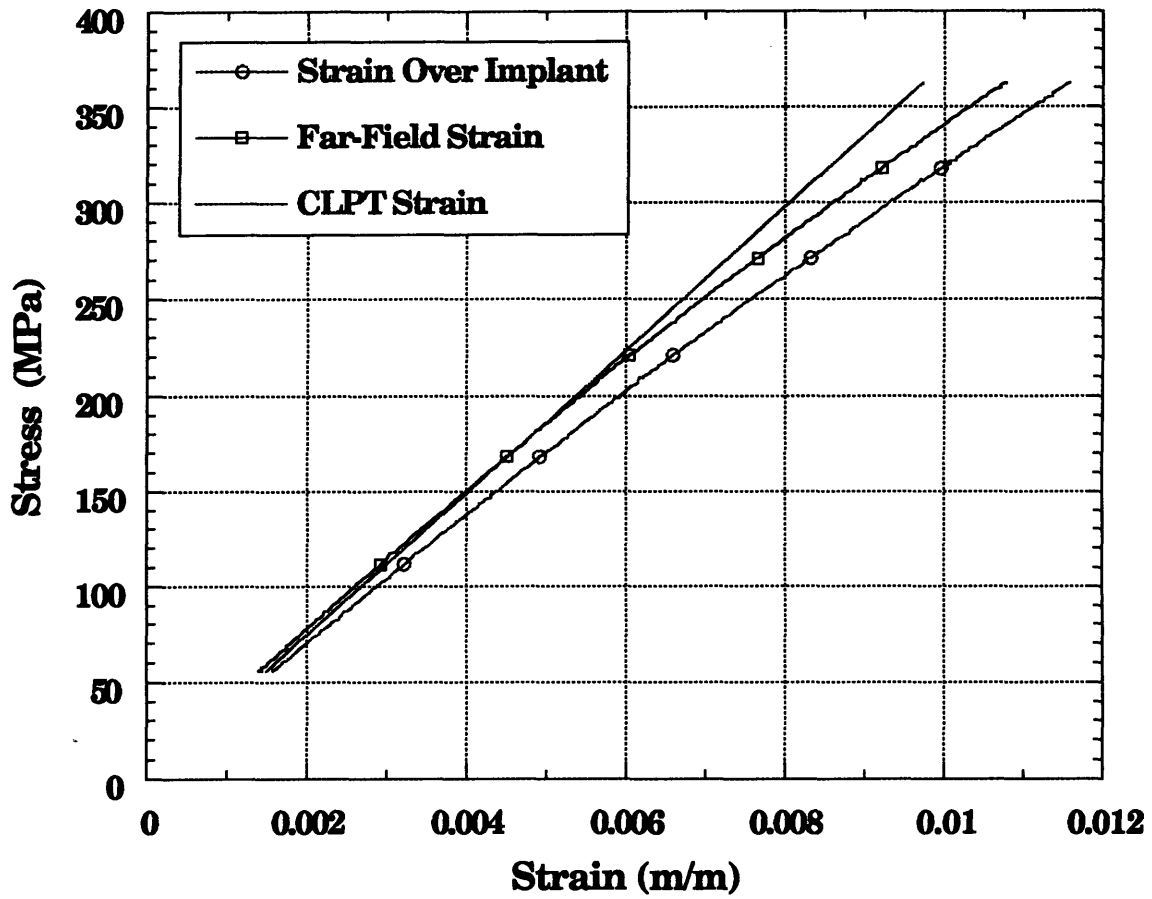
Figure 4.6 Stress-Strain Curves for Coupon 1CHIP-D with a Layup 1, $[0/(\pm 45)_2/90/(\pm 45)_2]_s$, Configuration Tested to Failure

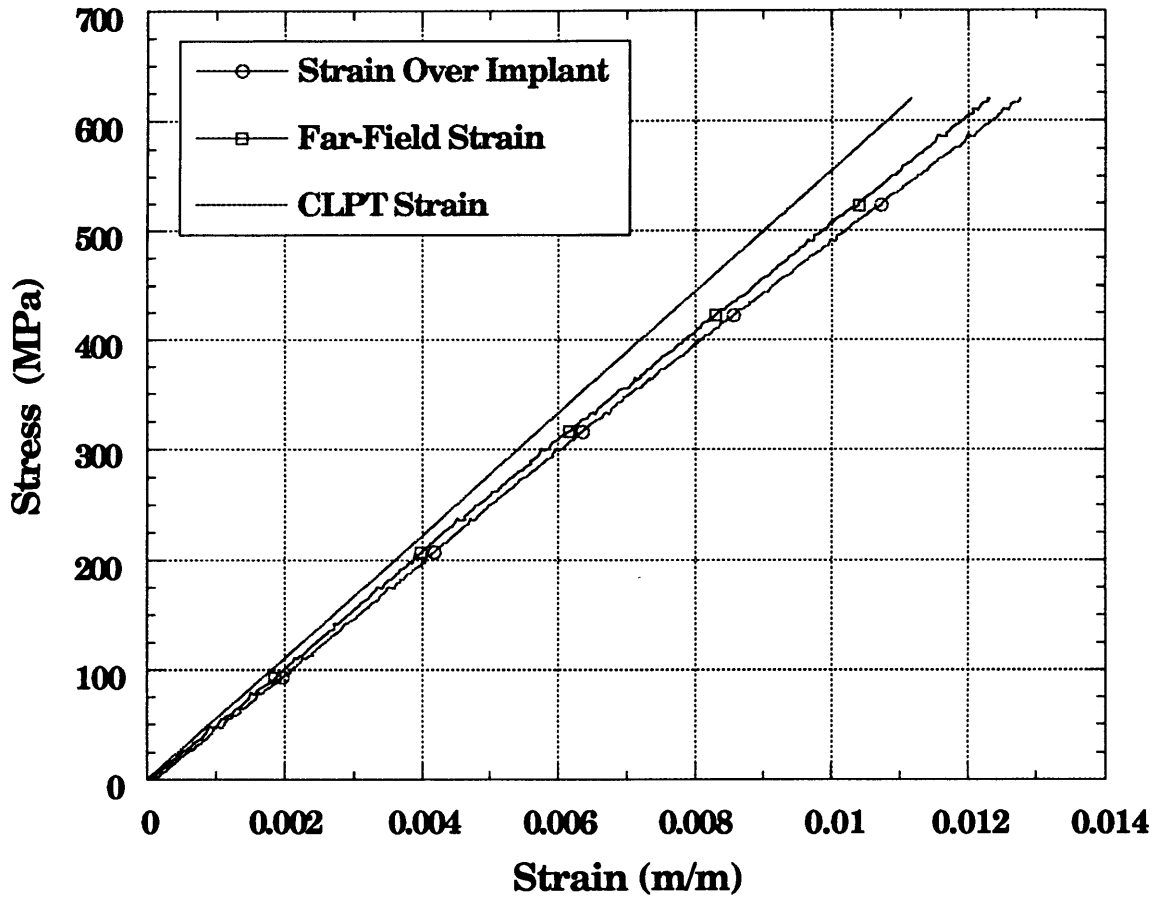
Figure 4.12 Stress-Strain Curves for Coupon 2TP-E with a Layup 2, $[0/\pm 45/90]_{2s}$, Configuration Tested to 95% of its Ultimate Stress

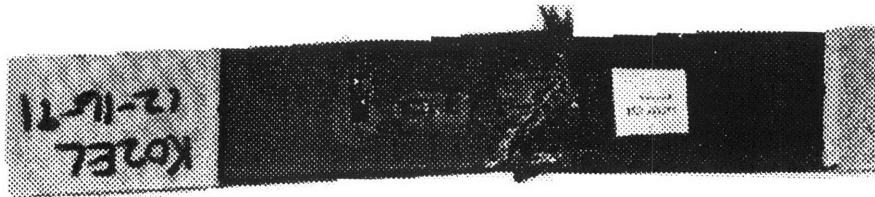
Center of Implant ^
 |
Photograph of Coupon 2PZA-B

Figure 4.27 Photographs of Coupons 2PZA-B and 2PZA-D with a Layup 2, $[0/\pm 45/90]_{2s}$, Configuration Tested to Failure

Both coupons with the PZA implant failed at the implant as shown by the photographs of specimens 2PZA-B and 2PZA-D in Figure 4.27. Coupon 2PZA-B broke at 90° 10 mm from the center of the implant across half the coupon width and then the break changed to a 45° orientation. This was unusual compared to the virgin specimens which only exhibited 90° breaks. The fibers of the coupon with the PZA implant broke very unevenly along the failure. Coupon 2PZA-D had three 90° breaks with one of the straight breaks extending along the lower edge of the implant where the lead wires extended out to the end of the coupon.

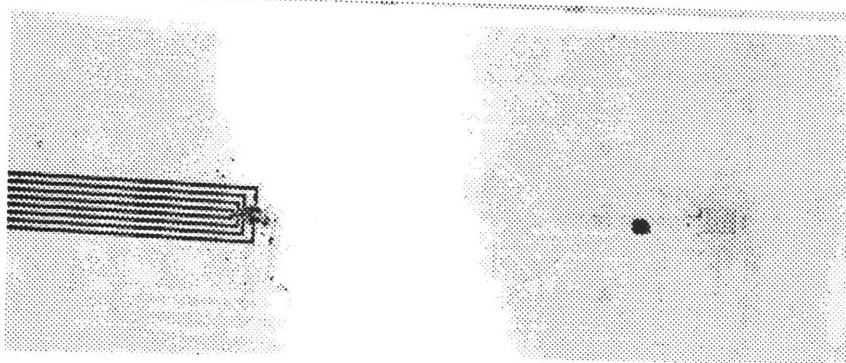
Figure 4.28 Photograph and X-Ray of Coupon 2CHIP-A Tested to Failure with the Chip Placed in a Cut Laminate with a Layup 2, $[0/\pm 45/90]_{2s}$, Configuration

One out of two failed specimens with the chip implant that was placed in a cut laminate, failed at the implant. Coupon 2CHIP-A failed with 90° damage propagation through the main sensor as shown by the photograph and X-ray in Figure 4.28. The other failed specimen,

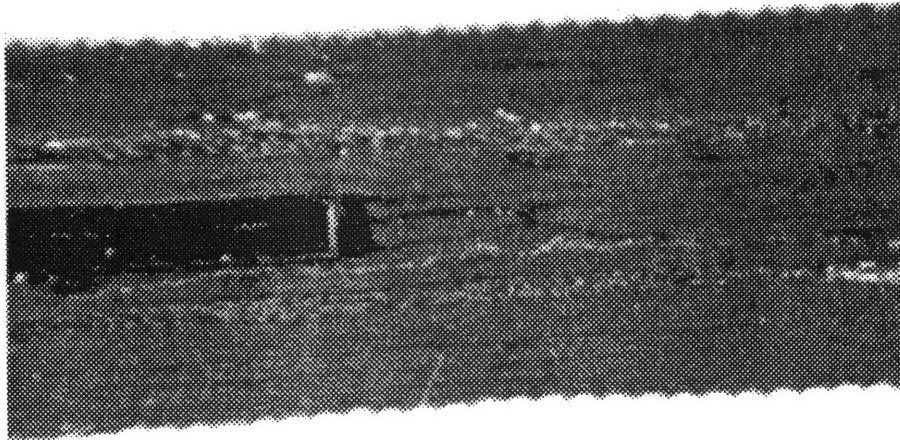
Dark area on left is part of the chip implant. The height is the full laminate thickness; however, only a local section of the specimen width is shown. Dark lines to right of implant are resin rich areas.

Figure 4.46 Photograph of Section of Coupon 1CHIP-B with a Layup 1, $[0/(\pm 45)_2/90/(\pm 45)_2]_s$, Configuration Showing Typical Adhesion to Composite

Resin rich areas occurred at the top edge of the chip implant. This can be seen in the photograph of the untested specimen 1CHIP-A shown in Figure 4.45. A typical cross-section of the implanted chip and leads is shown in the photograph of the failed coupon 1CHIP-B in Figure 4.46. Note that the resin pockets at the side of the implant should not be mistaken for cracks emanating from the upper and lower edges of the chip. Many specimens had misaligned fibers at the side of the implant as shown by a photograph of the untested coupon 1CHIP-A in Figure 4.47. No obvious delaminations at the implants were observed for any of the specimens with chip implants.

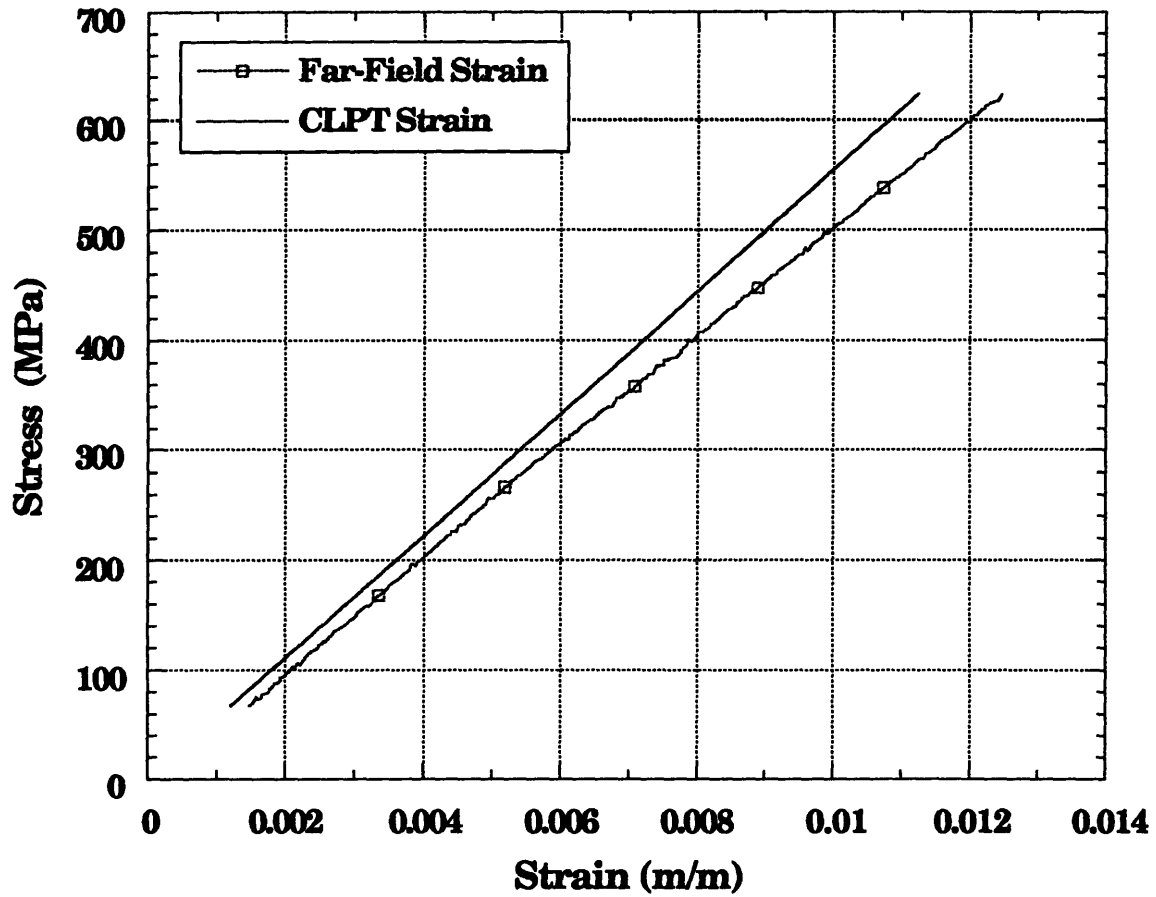
Figure E.10 Stress-Strain Curves for Coupon 2OF-D Tested to Failure with Optical Fiber Placed Directly in Laminate with a Layup 2, $[0/\pm 45/90]_{2S}$, Configuration
