# Analysis of Headless Shear Stud Connections

SUBMITTED TO THE DEPARTMENT OF CIVIL AND ENVIRONMENTAL ENGINEERING  
IN PARTIAL FULFILLMENT OF THE REQUIREMENTS FOR THE DEGREE OF

MASTER OF SCIENCE IN CIVIL AND ENVIRONMENTAL ENGINEERING  
AT THE  
MASSACHUSETTS INSTITUTE OF TECHNOLOGY

June 2012

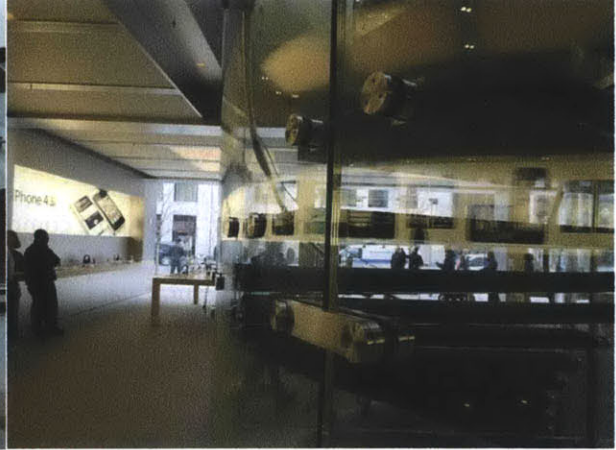
Picture 4: Interior Staircase Connection 2

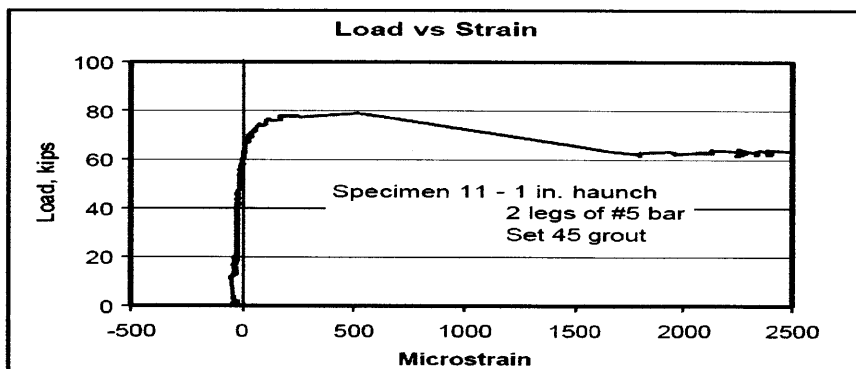
Menkulasi looked at the load-strain behavior of each of his specimens. The strain in the studs approached, but did not cross the yield strain of the material, before cracking appeared. After cracks in the surrounding grout appeared, he observed that the strain immediately became more than the material yield strain. See Figure 23 for a typical representation of his load-strain results.

Figure 23: Load vs. Strain Relationship for a Typical Experimental Run (Menkulasi, 2005)

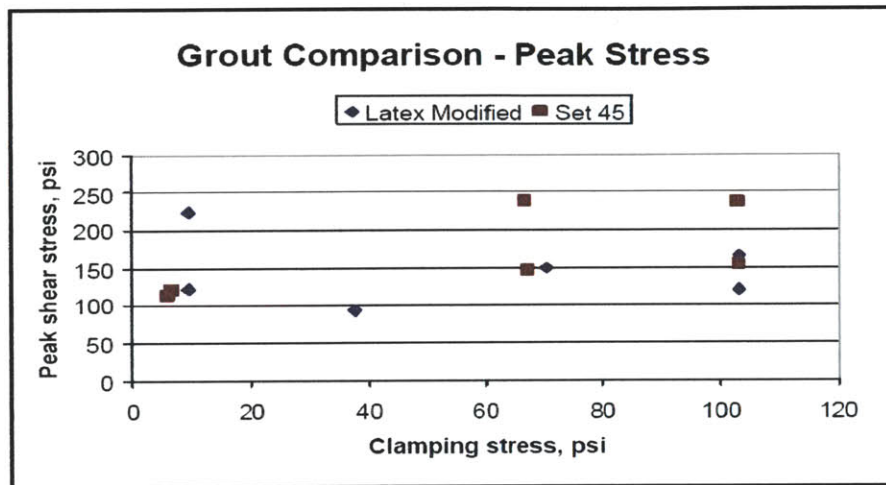
arrangements with the two grouts. The shear connector arrangements were the following: 1. No connectors 2. Two legs of No. 4 rebar 3. Two legs of No. 5 rebar. For his analysis the clamping stress was defined as  $v_{clamp} = (A_{vh}f_y + P_n)/(b_v s)$ . He defined the peak shear stress as:  $v_{peak} = V_{max}/(b_v s)$ . (Menkulasi, 2005) See Figure 24 for his results of different grout types.

Figure 24: Comparison of Different Grout Types vs. Peak Stress (Menkulasi, 2005)

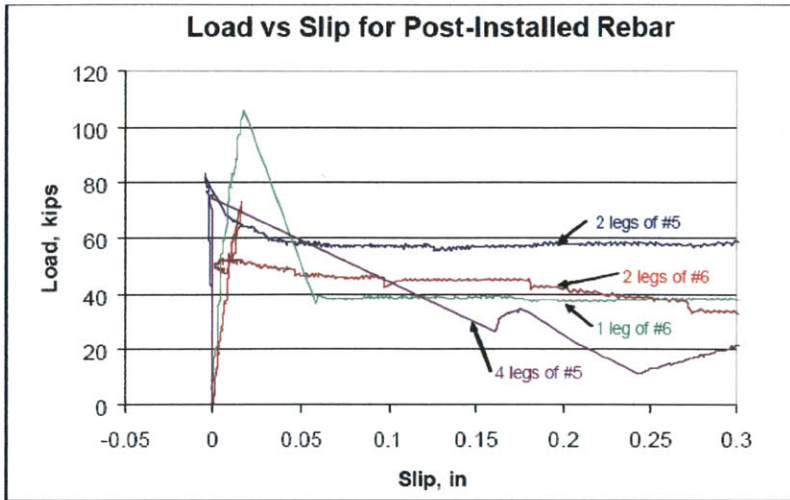
Figure 29: Post-Installed Rebar Load vs. Slip (Menkulasi 2005)

Menkulasi found that the post-installed reinforcing bars were very simple to install. After he poured the girder, he drilled a hole in the girder and installed the reinforcing bars with epoxy. For the Dayton-Richmond anchors, the installation was a two step process. First, he placed the looped portion prior to the pouring of the girder. After the girder was in place, he installed the ¾ inch coil bolt. He formed the shear keys into the girder during the pouring process. He found from the load vs. slip comparison of the three alternate shear connectors that all were a viable solution for transferring shear. The results of the tests from the hooked reinforcing bars, Dayton-Richmond anchors and the shear keys can be seen in Figures 29, 30, 31.

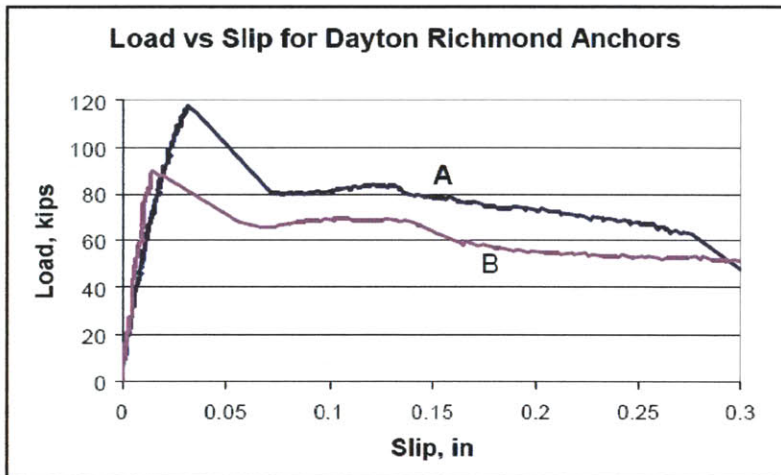
Figure 30: Dayton-Richmond Anchors Load vs. Slip (Menkulasi 2005)

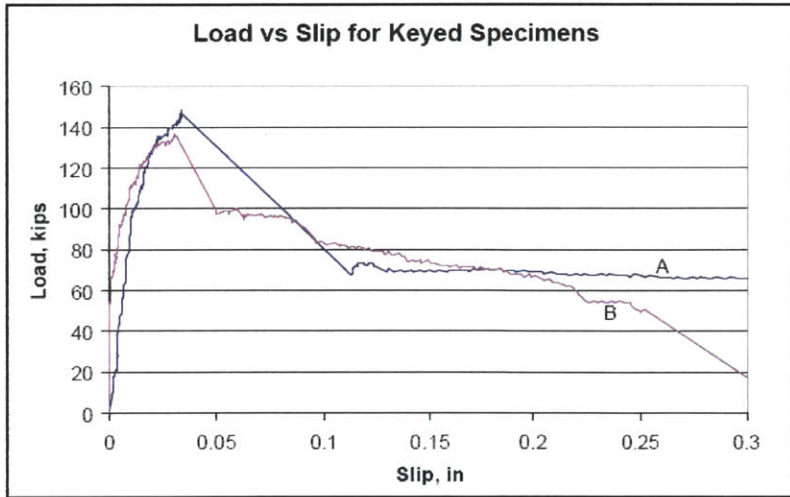
Figure 31: Keyed Specimen Load vs. Slip (Menkulasi 2005)

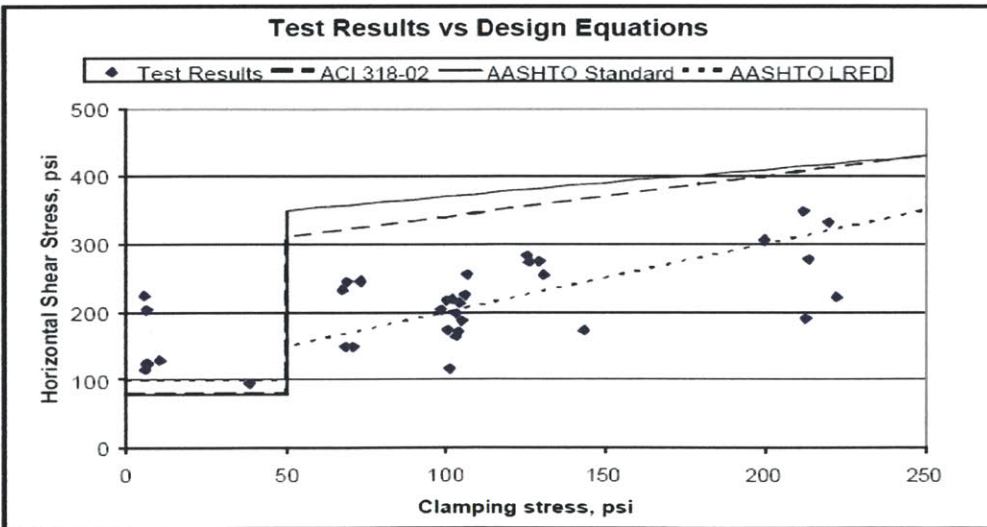
Menkulasi found, that of the ACI 318-02, AASHTO Standard Specifications for Highway Bridges and the AASHTO LRFD Design Specifications, the AASHTO LRFD Specifications most accurately predicted the loads that he found in his experimentation. He felt that the un-conservative values of the ACI 318-02 and AASHTO Standard Specifications compared to his research could be attributed to the fact that those codes were for new concrete cast against old concrete while his experiment included all precast concrete elements. See Figure 32.

Fig. 20. Peak stresses from push-off tests compared to design equations.

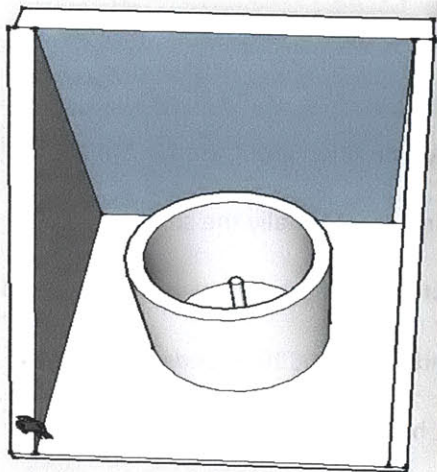
Welding the stud to a separate steel plate from the loading frame allowed for multiple iterations to be prepared and tested rapidly. The separate test specimens were attached to the loading frame so that the supporting steel plate bore on the back of the loading frame during load application. This arrangement ensured that the shear was fully transmitted through the cylinder to the stud. Since the steel plates, cylinder and loading frame were over designed, they simply supported and encased the grout and steel shear stud while not affecting the loading seen by the grout and stud.

Picture 5: Schematic of Experiment Showing Shear Stud

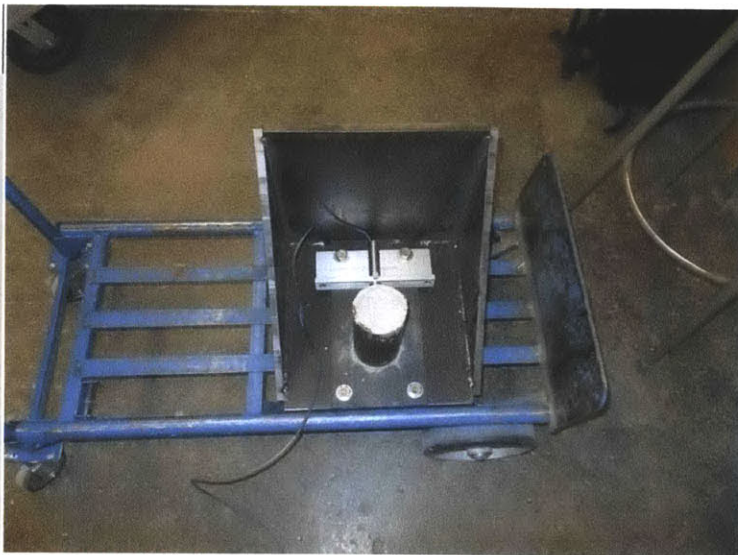
Picture 6: Experimental Setup

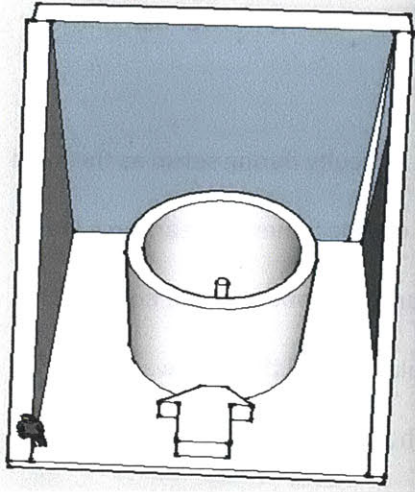
The cylinder was set horizontally in the loading machine for the load to be applied vertically to the base of the steel cylinder. (See Pictures 7 and 8) The loading machine was an MTS Hydraulic Press Machine and the load application was quasi-static. The load was applied with a displacement control of 0.05 inches per minute. The load was applied vertically to prevent the influence of the cylinder from increasing the interface shear. The self weight of the cylinder would cause the interface shear between the cylinder and the bearing plate to influence the recorded strength of the connection. By applying vertical loading, the interaction between the stud and the grout is further isolated. An LVDT was placed under the steel cylinder to measure the movement of the cylinder with load application. The voltage range of the LVDT was set to plus or minus 2.5 volts.

Picture 7: Schematic of Load Application

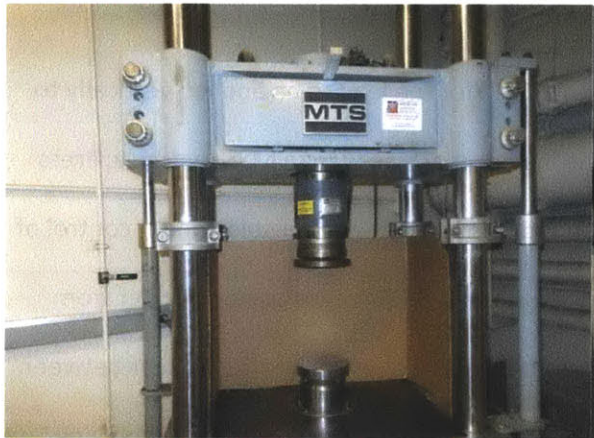
Picture 9: MTS Loading Machine

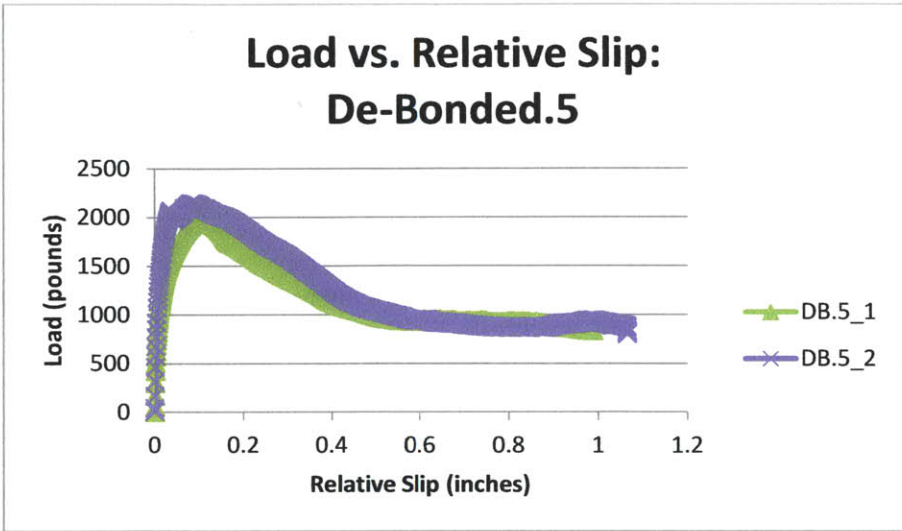
The first partially debonded iteration (DB.5\_1) had a peak load resistance of 2.003 kips and a minimum load resistance of 0.913 kips. The second partially debonded iteration (DB.5\_2) had a peak load resistance of 2.147 kips and a minimum load resistance of 0.865 kips. (See Graph 3)

Graph 3: Partially De-Bonded Iterations Load vs. Slip Comparison

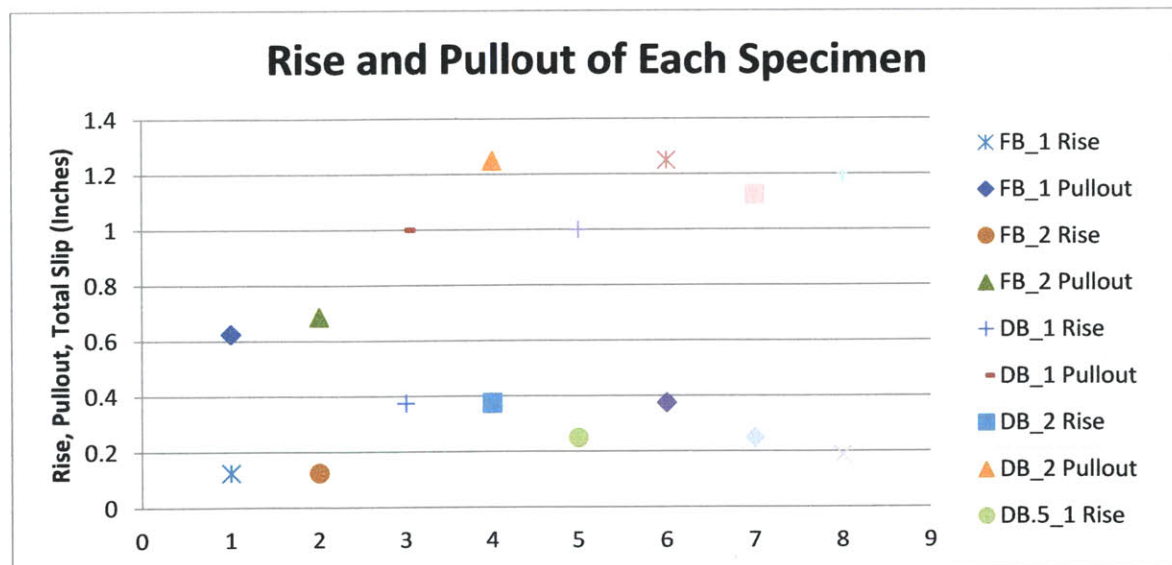
During the experiment, each specimen separated from the supporting metal plate during load application. While the separation was not instantaneous, it did occur during the first minutes of load application. Once each specimen separated from the supporting steel to a certain extent, which varied for each iteration, the separation remained constant throughout the duration of the experiment. The only specimens not measured were the fully bonded iterations. (See Graph 5) Due to safety concerns and for continuity between test iterations, an accurate measurement could not be taken before the specimen failed with the fracture of the steel shear stud.

Graph 5: Rise (lift-off), Pullout and Total Slip for all Specimens

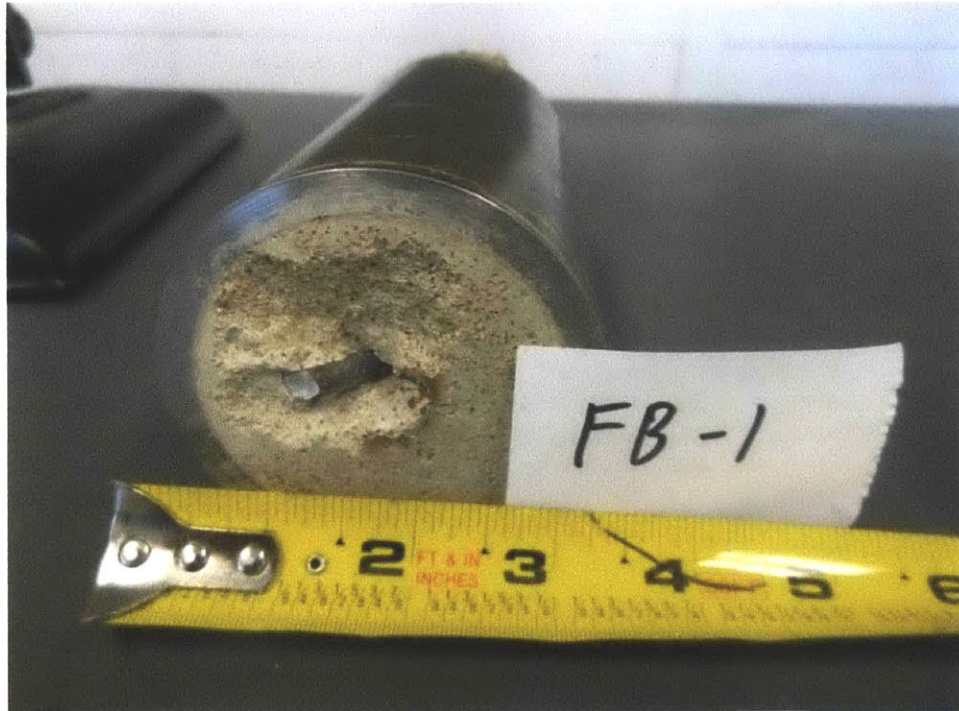
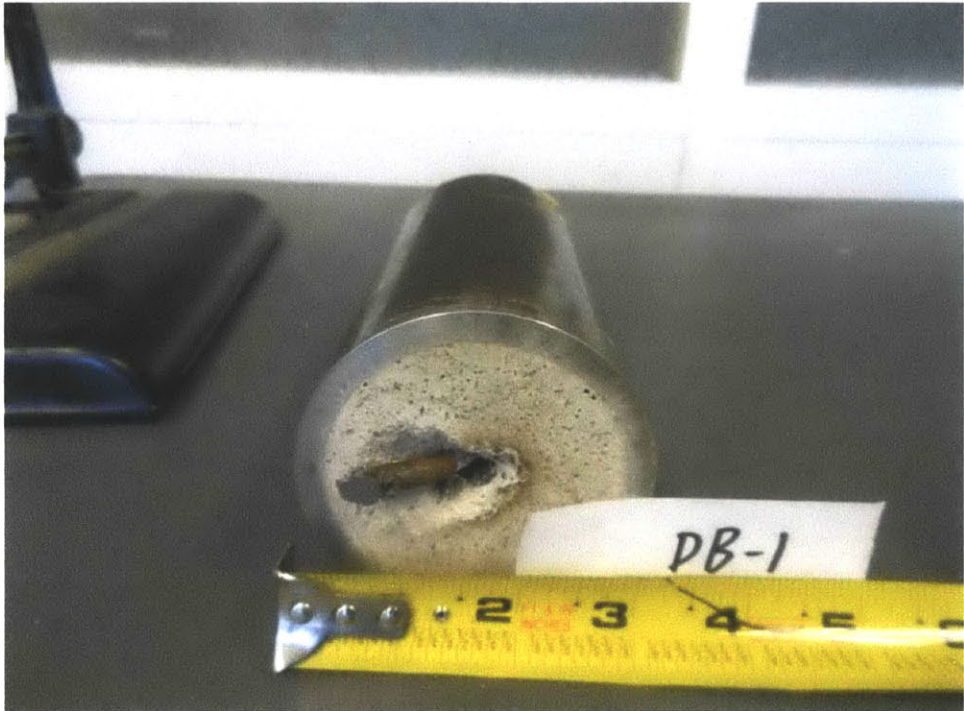
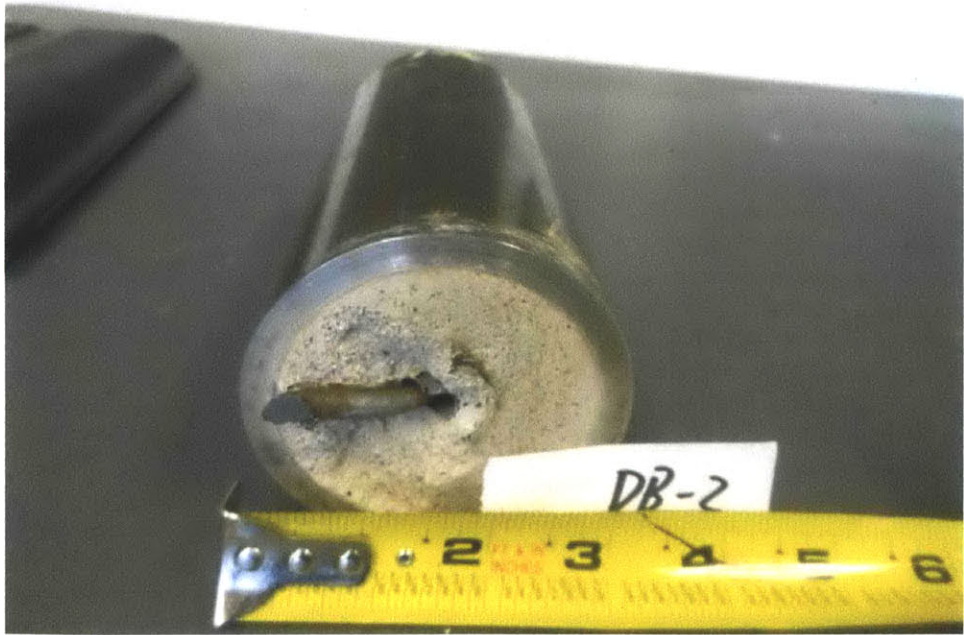
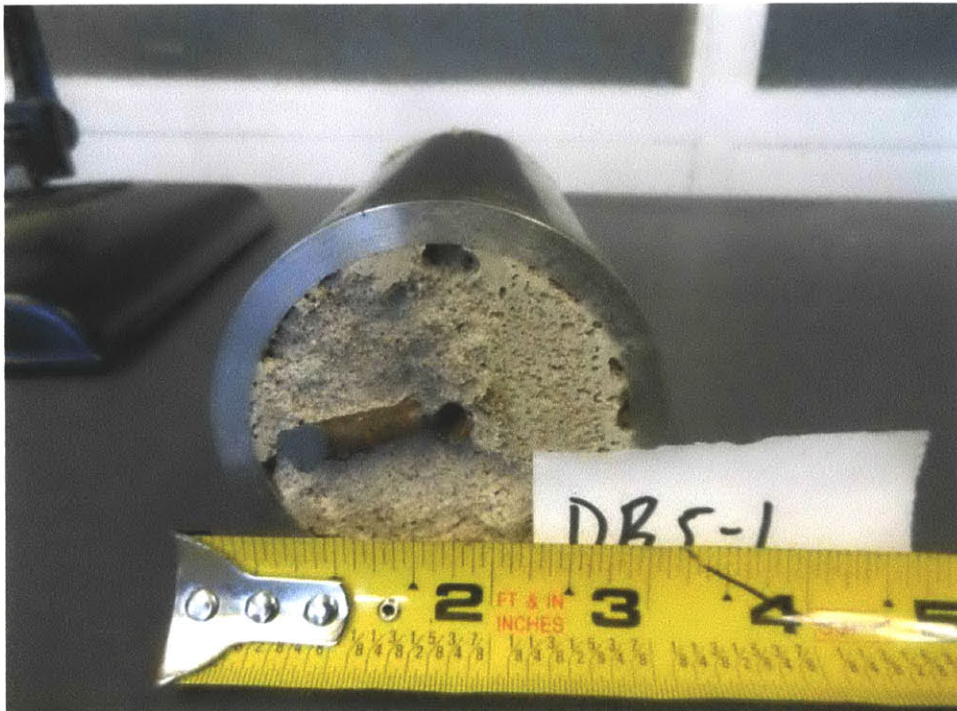
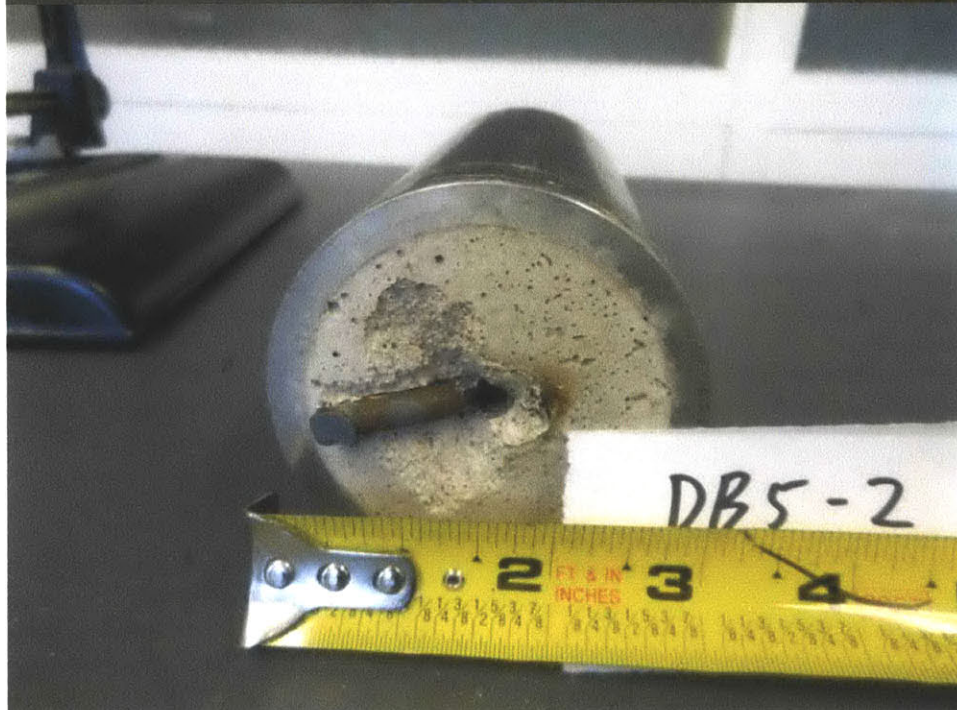
**Photos Showing Grout Damage for each Iteration**

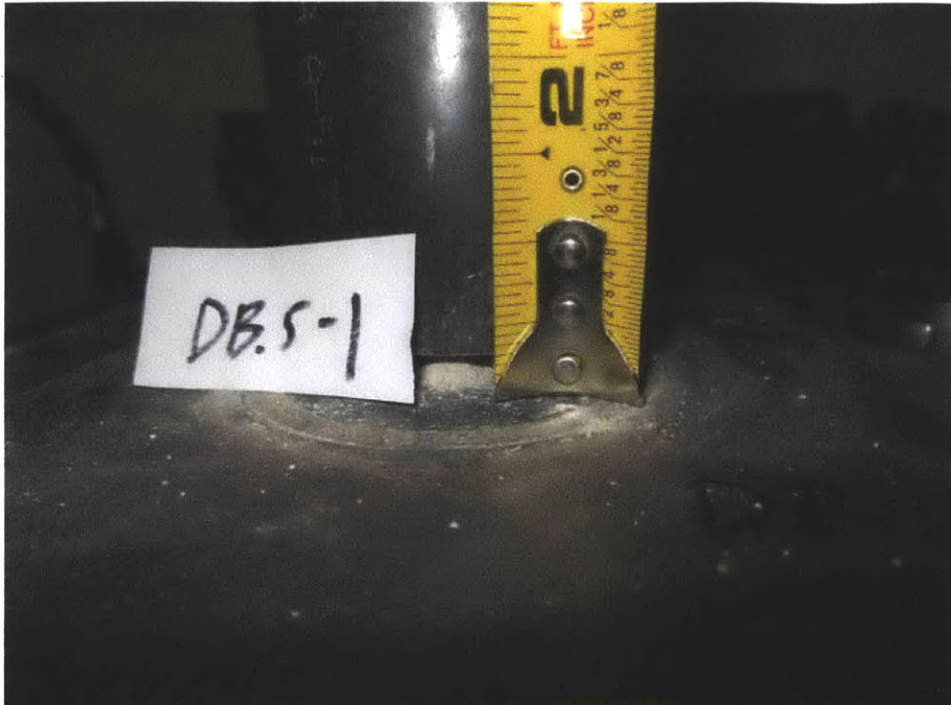
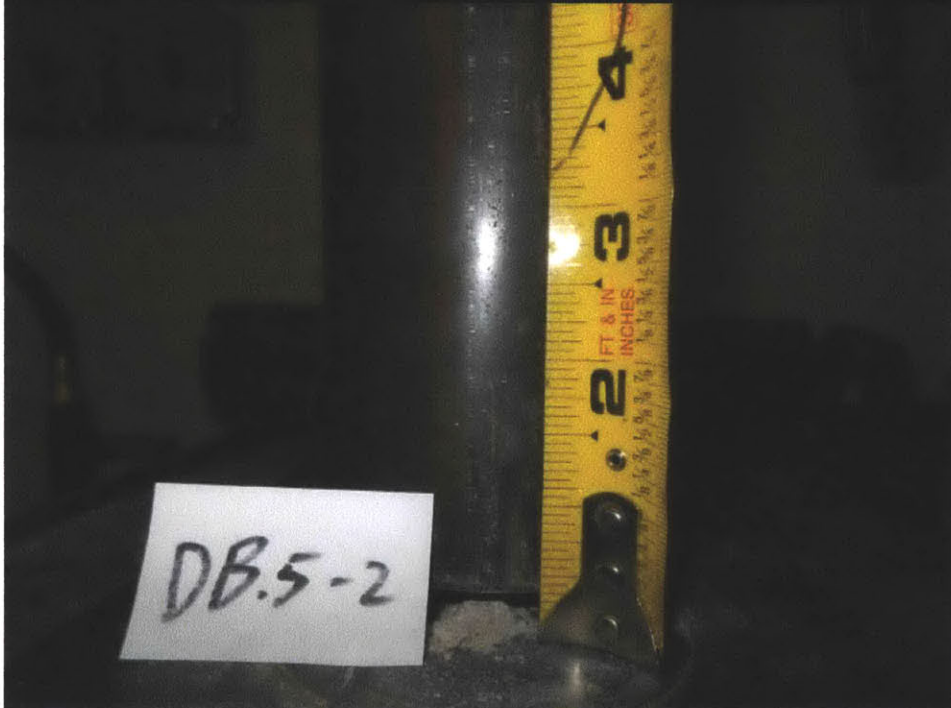
**Pull-off Photos of all specimens that did not fail in Shear**

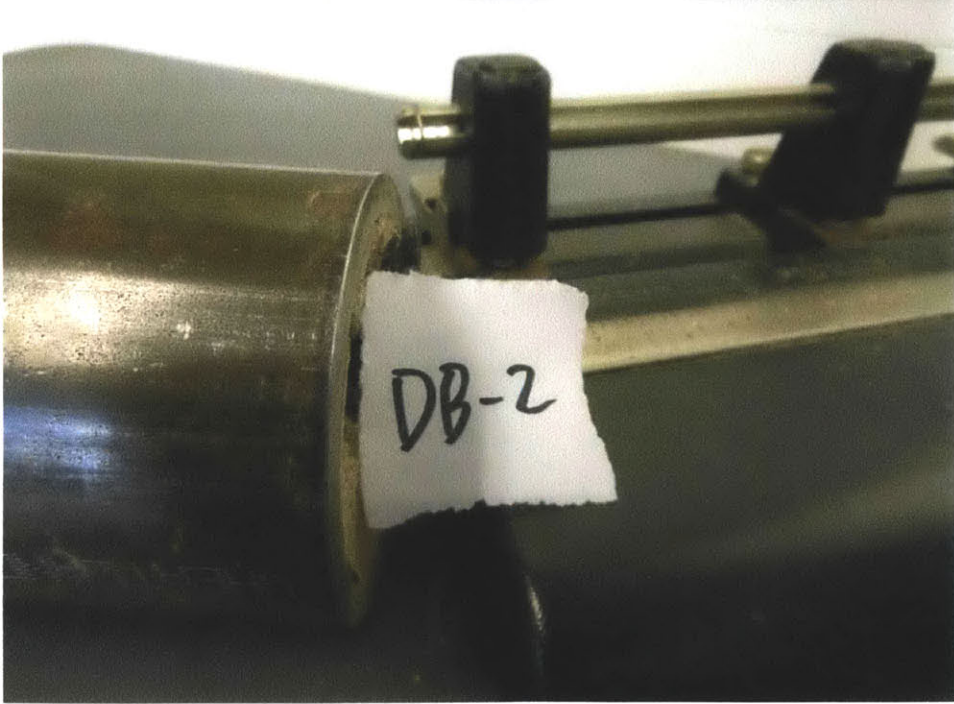
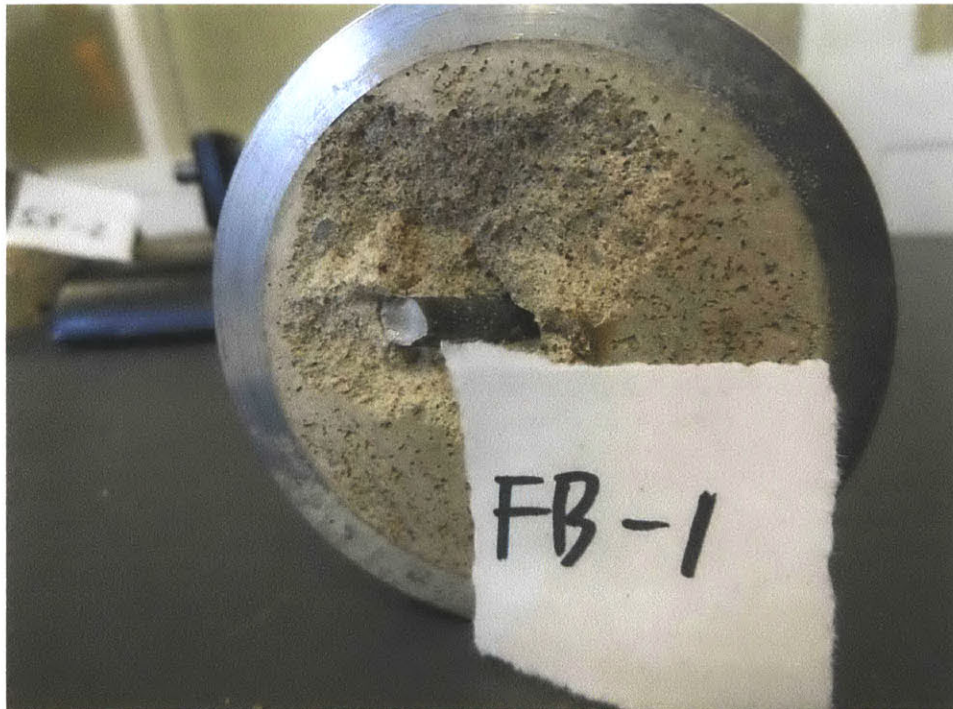
**Steel Stud Damage Photos for all Specimens that exhibited Steel Stud Damage**
