PSFC/JA-06-18

**Test Results for:
Pre-Operational Testing of
MERIT BNL – E951/(n-ToF-11), 15T Pulsed Magnet
for Mercury Target Development Neutrino Factory
and Muon Collider Collaboration**

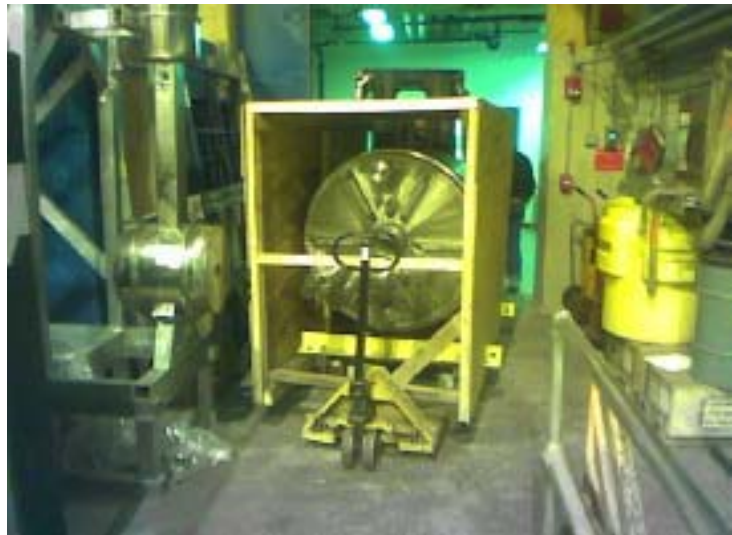
Assembled Magnet Entering The Test Cell at MIT, Tuesday Jan 10 2006

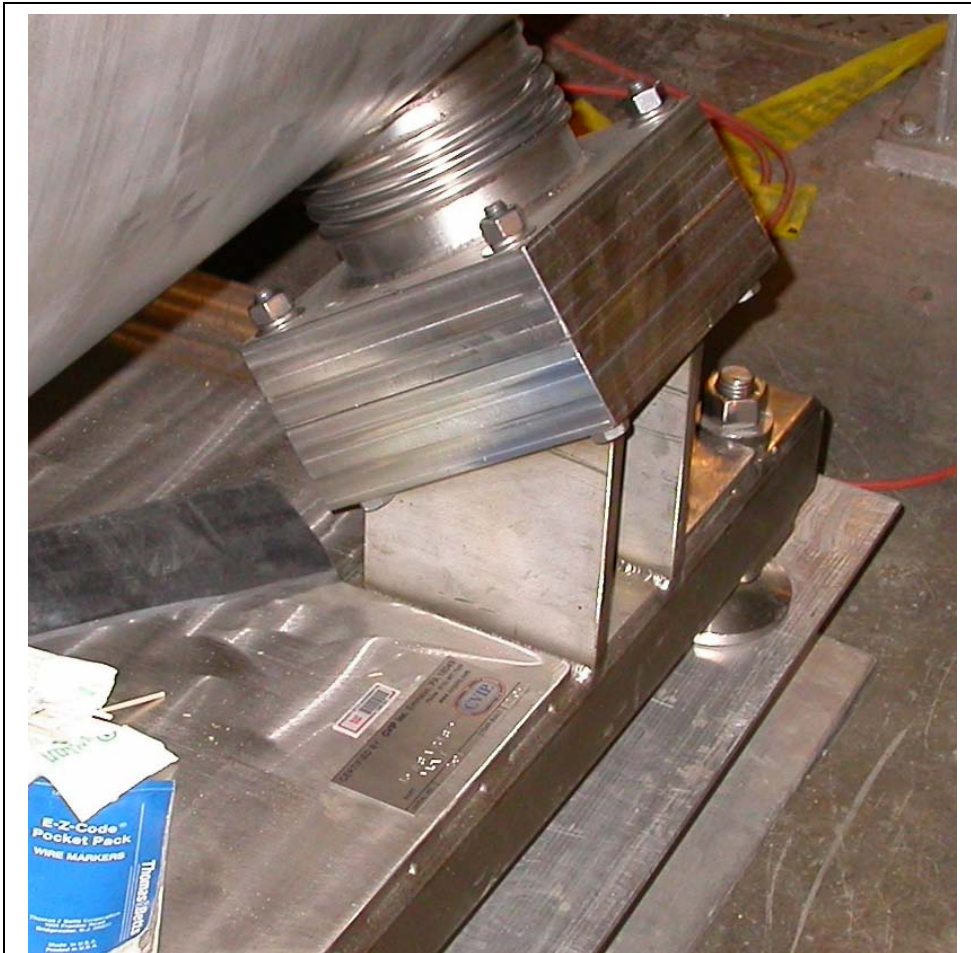
Labels Applied to the Base of the Magnet System, February 21, 2006

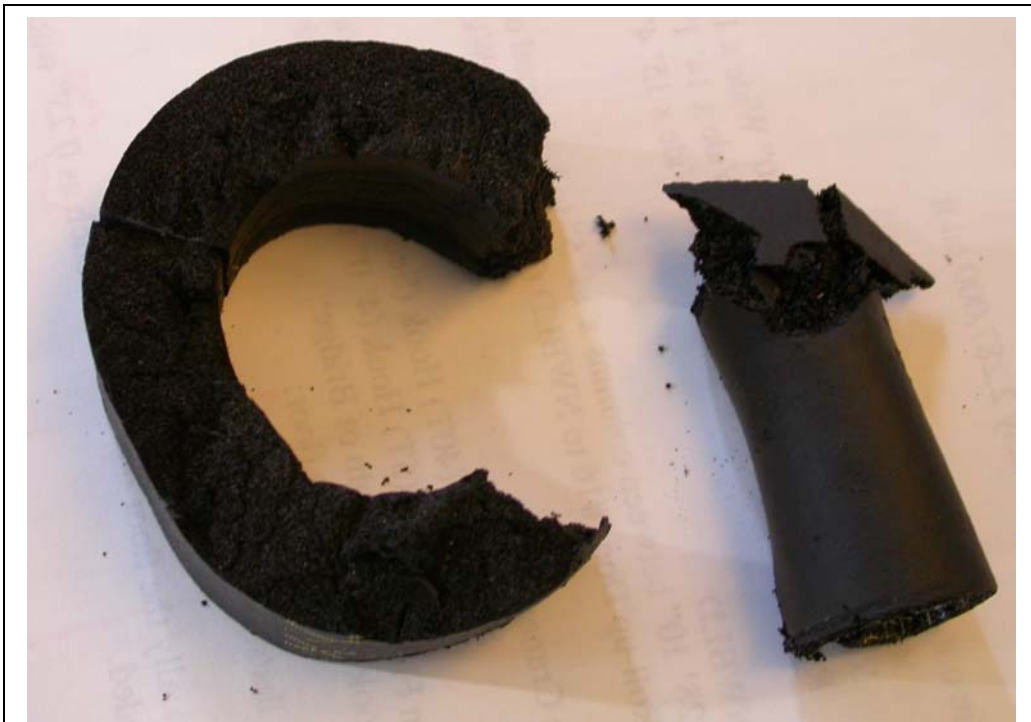
ARMACELL ARMAFLEX from Home Depot – but used extensively at the PSFC Feb 9 LN2 dunk test: The pipe covering (Left) survived well enough – was brittle at LN2 temp, but did not crumble. Properties were pretty much restored at RT. The adhesive tape (right) was not as good, but was acceptable.

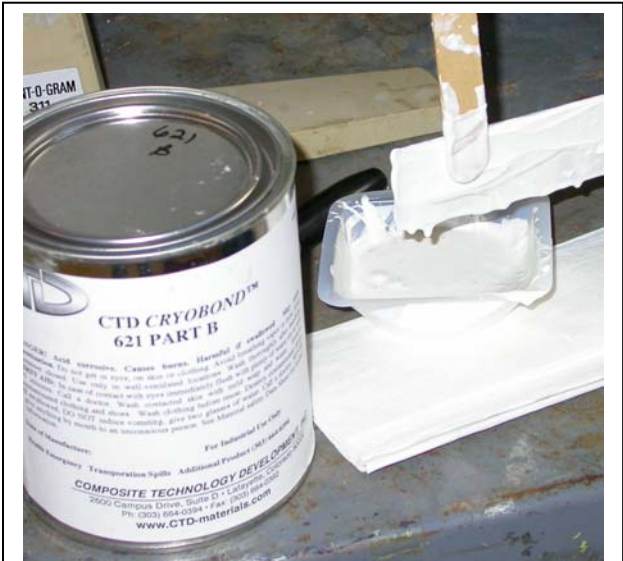
Initially, after mixing, this material was too runny to be applied vertically.

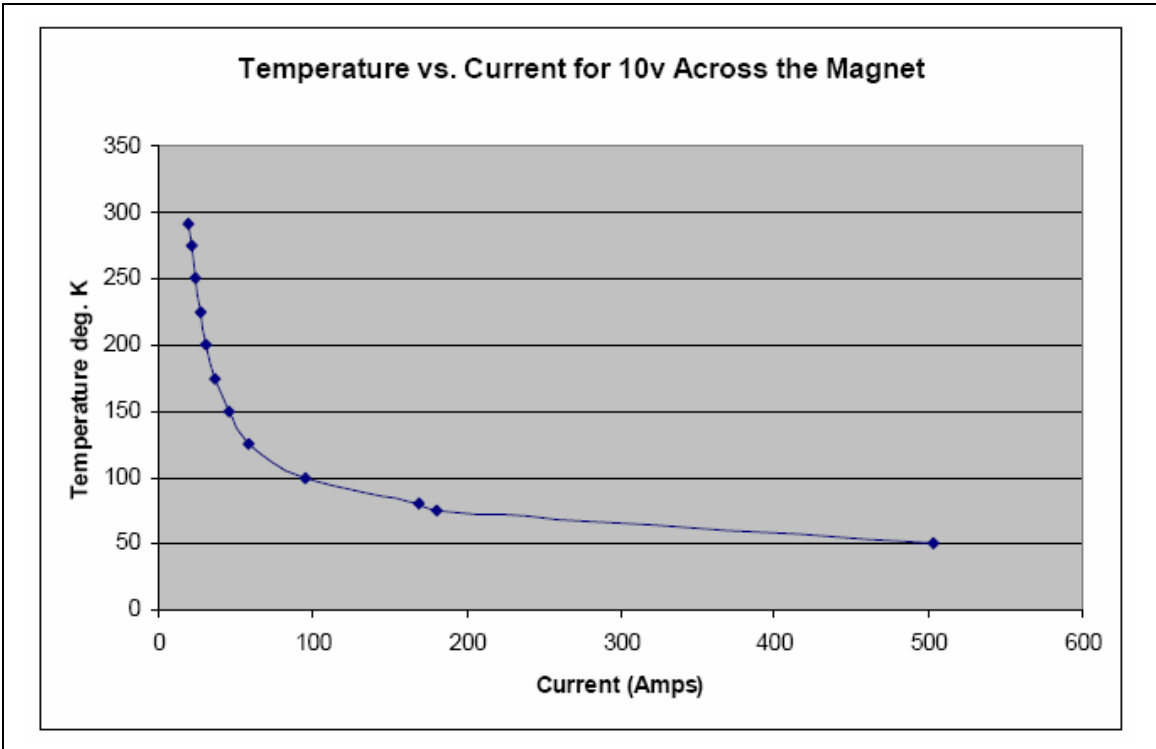
Boil-Off – Heat Leak Test – Weekend Warm Tests March 24 to March 27

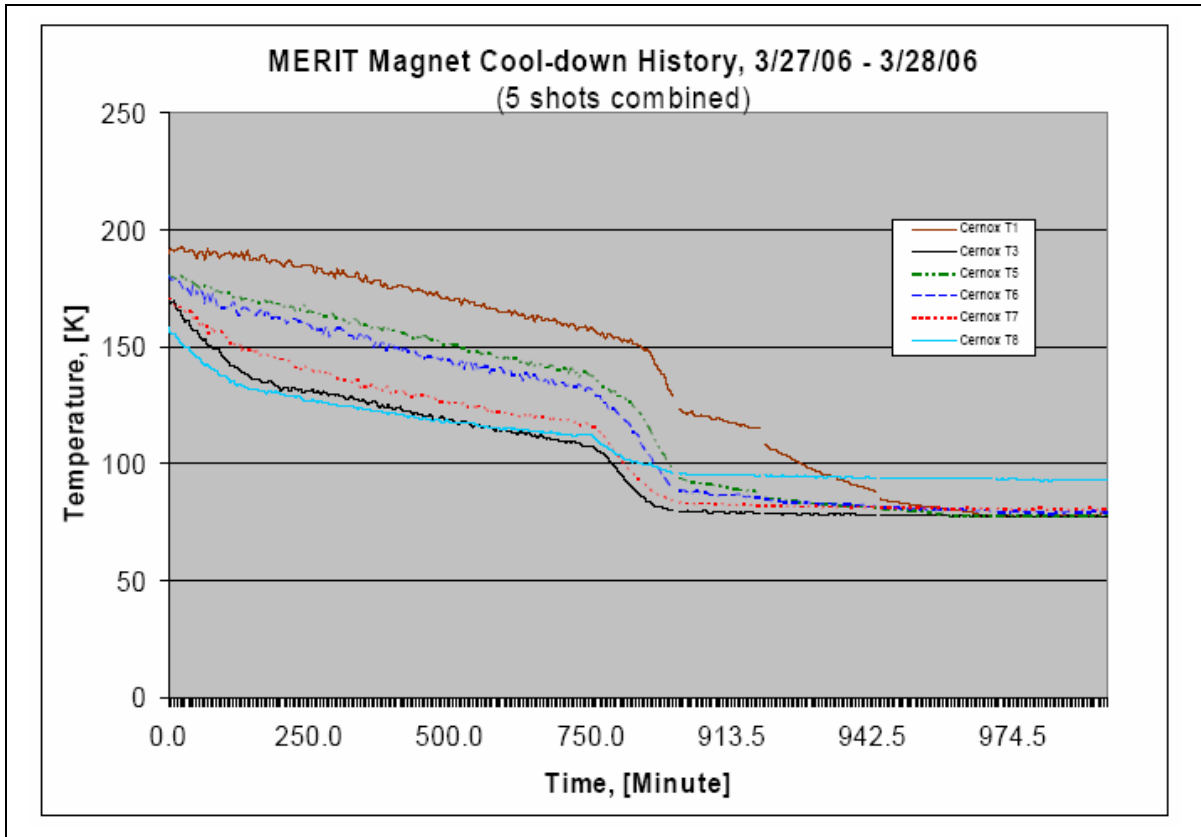
Second Cooldown, Tuesday March 28

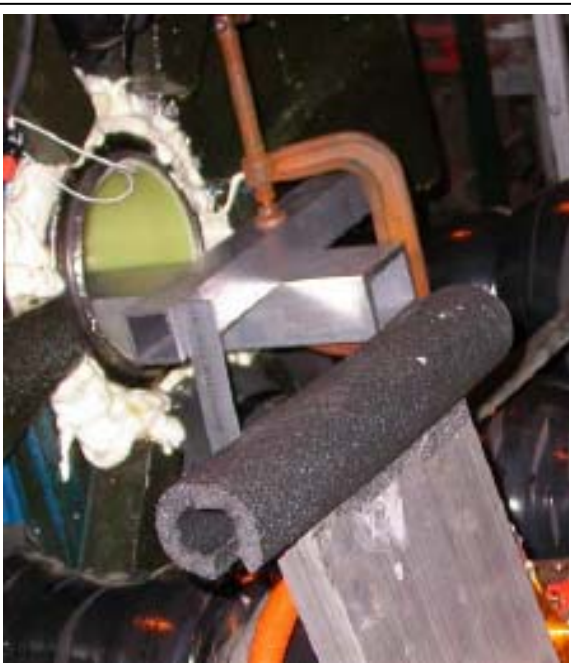
Cooldown displacement fixture.

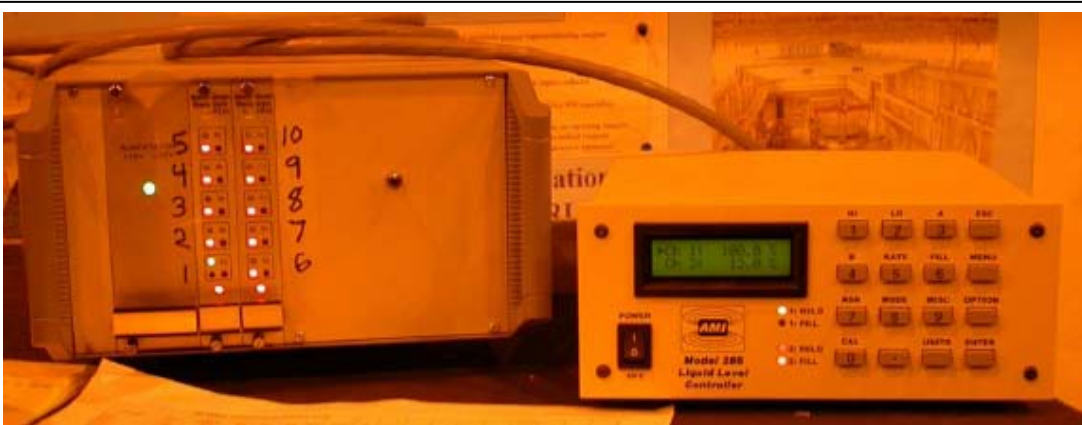
Discrete level sensor is not working. – Only one sensor goes green.-
 Capacitive sensors are fairly reliable qualitative indications of level. Not sure about absolute calibration yet.

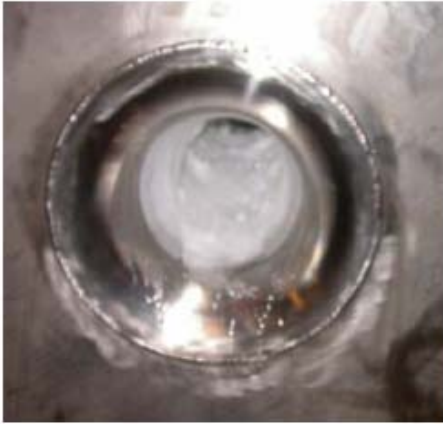
Condition of the Dished Head end Bore April 4 2006. There is a substantial ice build-up. This accumulated over the couple of weeks that the magnet was cold.
