**Framework to Assess a Facility's Ability to Accommodate  
Change: Application to Renovated Buildings**

**Master of Science in Civil and Environmental Engineering**

**MASSACHUSETTS INSTITUTE OF TECHNOLOGY**

February 1999

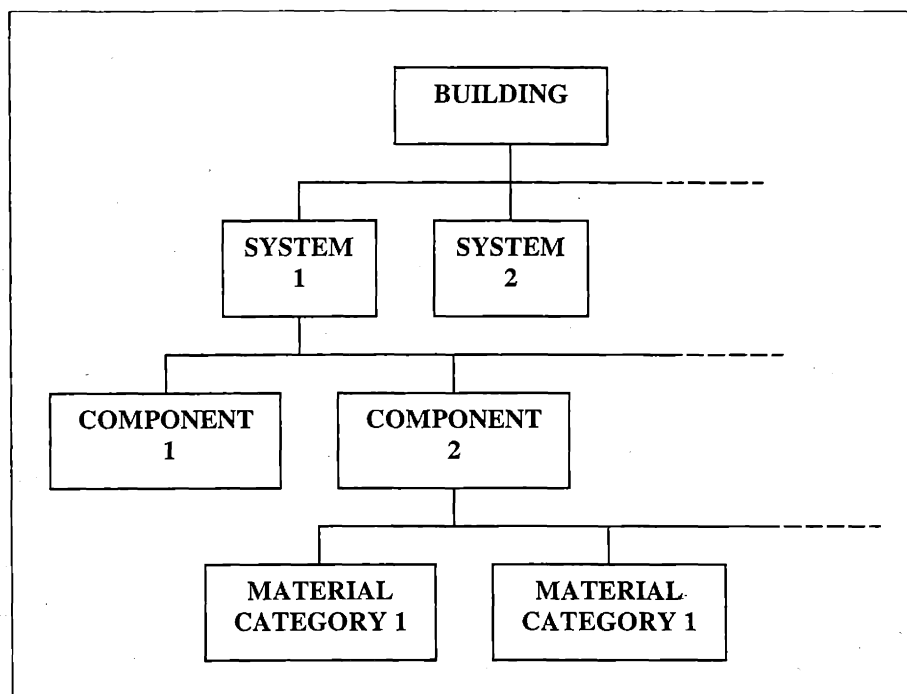
**Figure 2.1 – Building Hierarchy (Uzarski and Burley, 1997)**

In order to examine and determine the amount or levels of deterioration that a building may possess, most of the past research has divided a building into more defined components or building systems. The deterioration within these systems are then measured and used to determine the feasibility and potential for future reuse or renovation of the building or of particular parts or systems within the building.

1. Structural system – Foundation and the Structural framing
2. Enclosure System – exterior walls, exterior openings, exterior finishes, roofing and sheet metal, and weatherproofing and insulation
3. Interior Finish System – interior partitions, interior openings, interior finishes (often governed by the installation, etc. of services)
4. Services Systems – safety and security, comfort trades (heating, air conditioning, ventilation, plumbing, sprinklers, electric, vertical transportation).

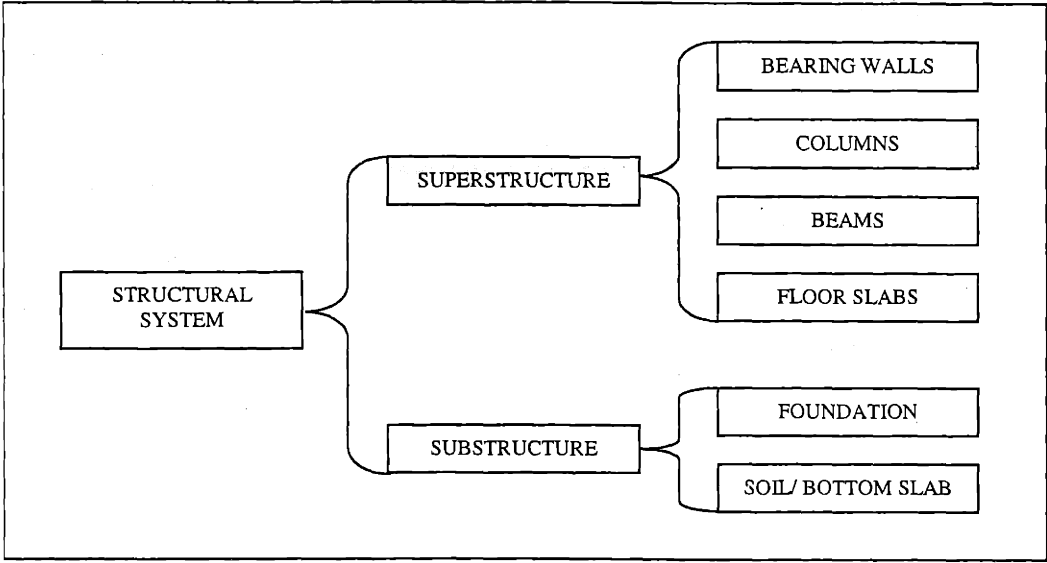
**Figure 3.1 – Structural System and Components**

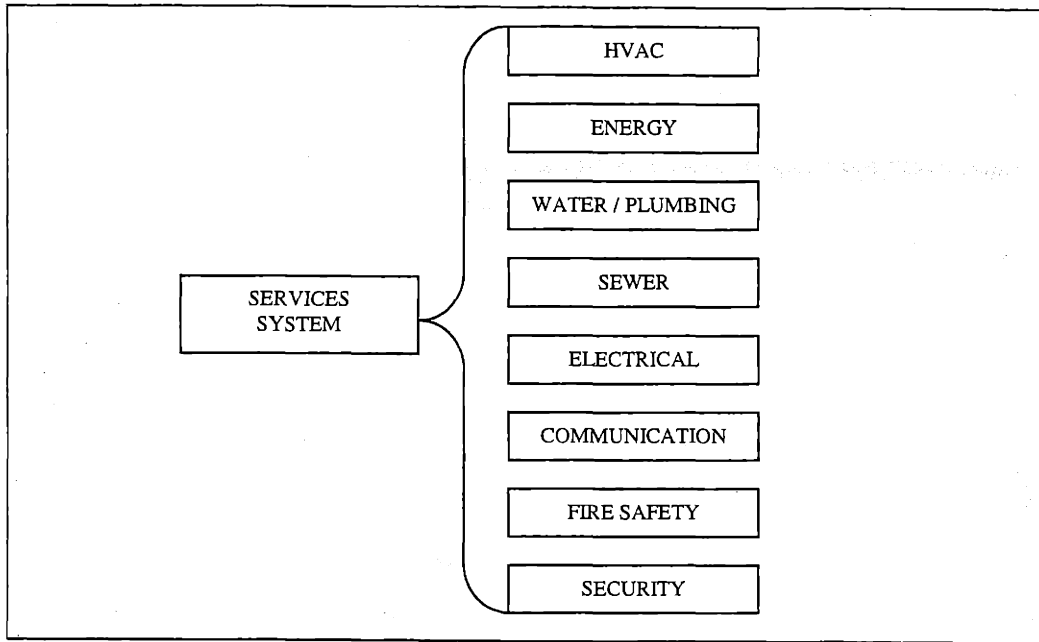
**Figure 3.3 – Service System and Components**

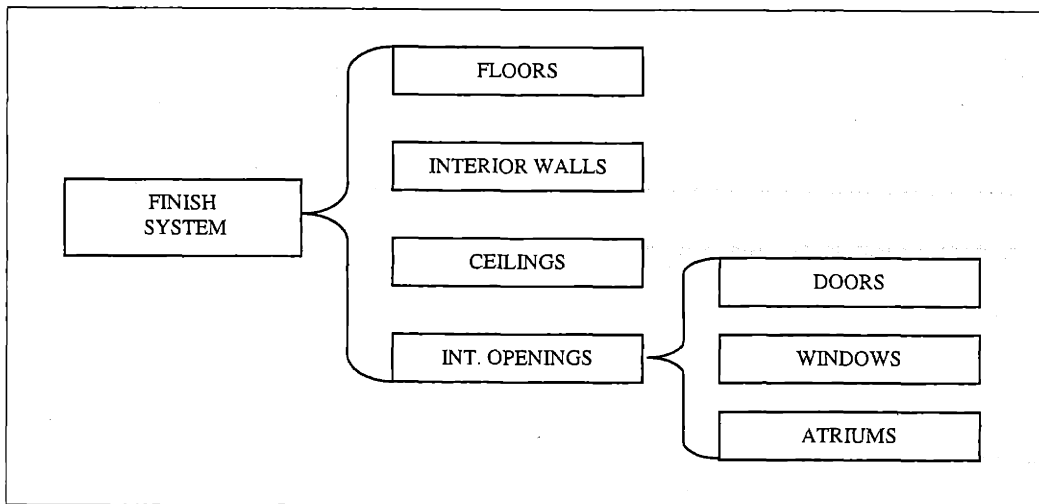
**Figure 3.4 – Interior Finish System and Components**

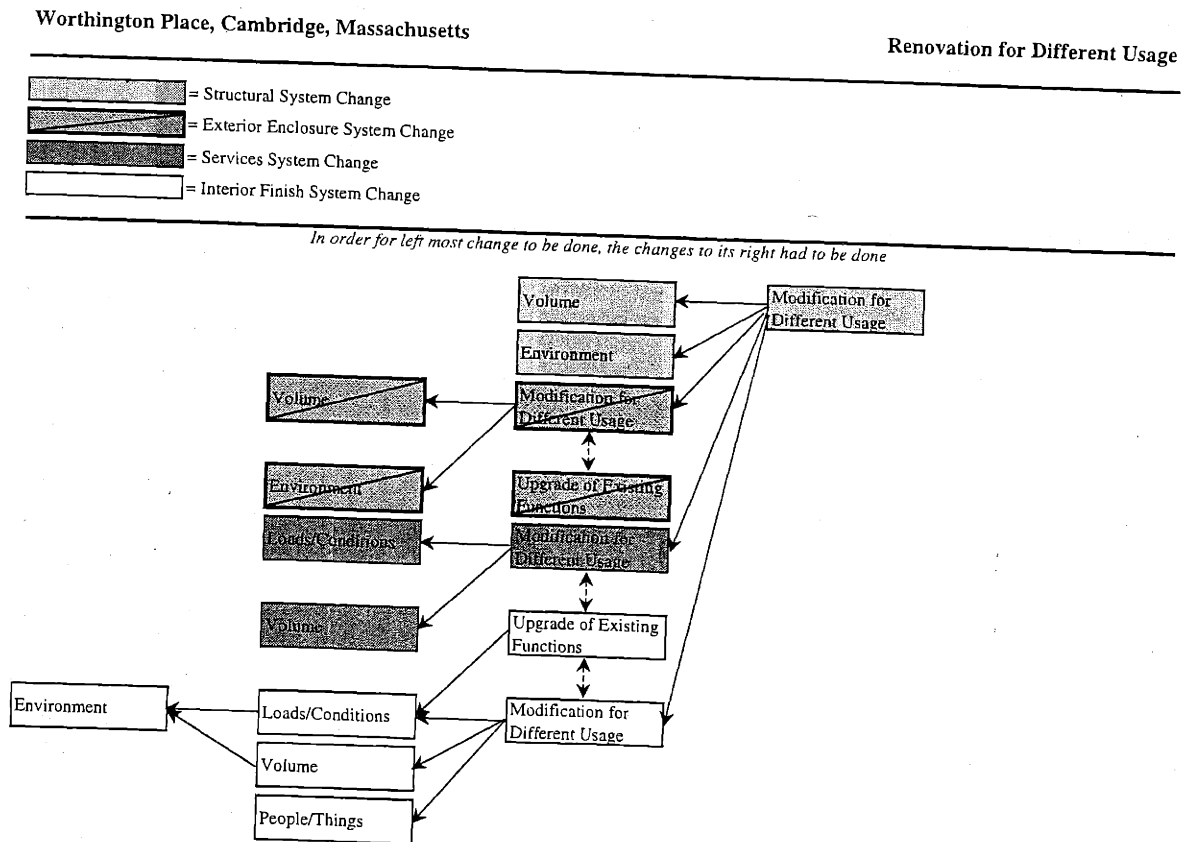
**Figure 5.10 – Example of Change Progression Chart: Worthington Place, Cambridge, Massachusetts**

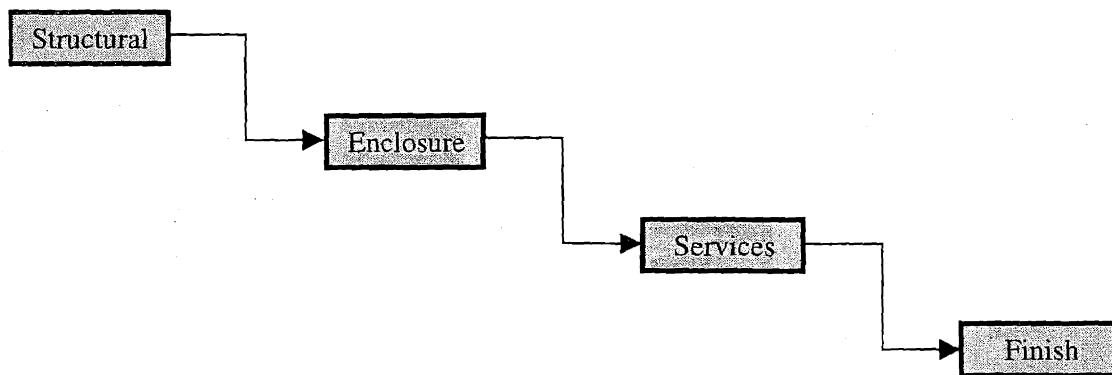
**Figure 5.11 – General Cascade of Changes within Building Systems**

In the past, common thought within the building construction industry presented a general cascade with which changes in building systems generally occur. Traditionally, it has been believed that changes to the structural system precede changes to the exterior enclosure system that in turn preceded changes to the services systems followed by changes to the interior finish system. This general cascade of changes within the building systems is represented by Figure 5.11. In a sense, these building systems and hence any changes within them have remained coupled in the past. For example, when changes are required in the service system, changes are usually also made within the interior finish system. In the past, it was thought that most building renovations follow the same general pattern. Depending on the scale of the renovation to be performed, work would generally follow this pattern, beginning with the upgrade or modification of the structural system, then proceeding to changes to the exterior enclosure system, followed by work on the service systems and finishing with changes to the interior finish systems.

While this pattern or cascade in building system changes is common, it does not always have to occur for building renovations to succeed. During the analyses performed on the case studies used in this research, each case was compared to this system cascade. The cases were examined according to the end product with which they were to be renovated for: renovation to meet the same usage, or renovation to meet a new and different usage.

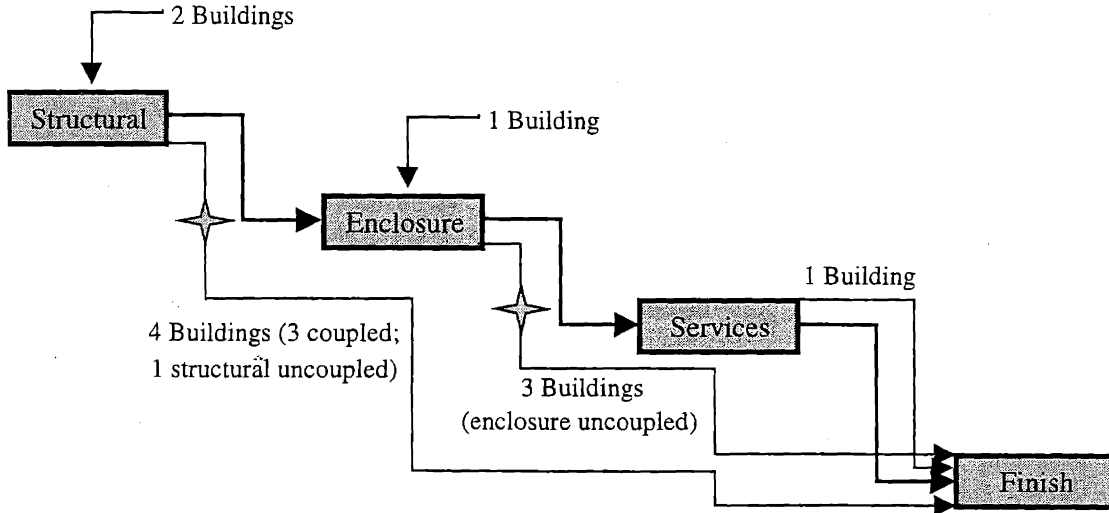
**Figure 5.12 – Links between Changes in Building Systems for Same Usage**

Although some of the cases renovated for the same usages appear to follow the traditional cascade, a large proportion of them does not. The eleven case studies that presented renovation for the same usage and the links between the changes in the building systems are represented by Figure 5.12 and summarized within Table 5.8 as shown below.

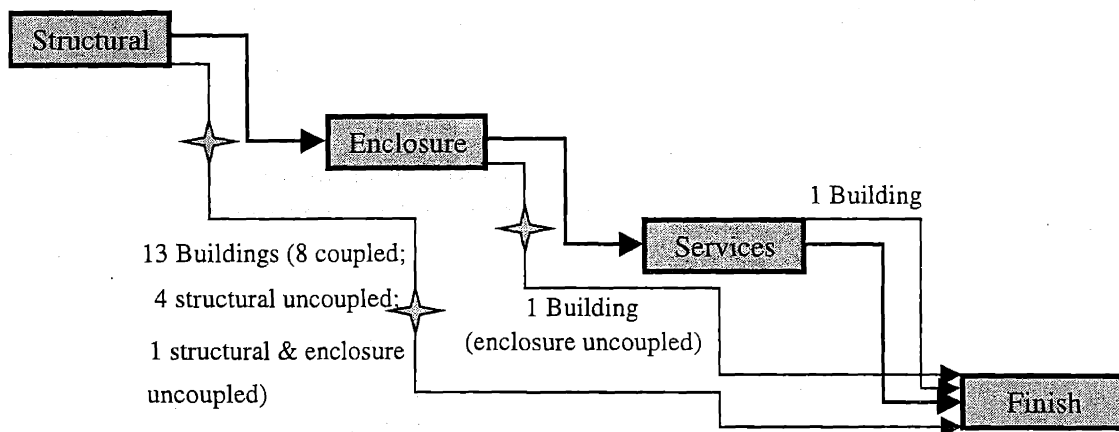
**Figure 5.13 – Links between Changes in Building Systems for Different Usage**

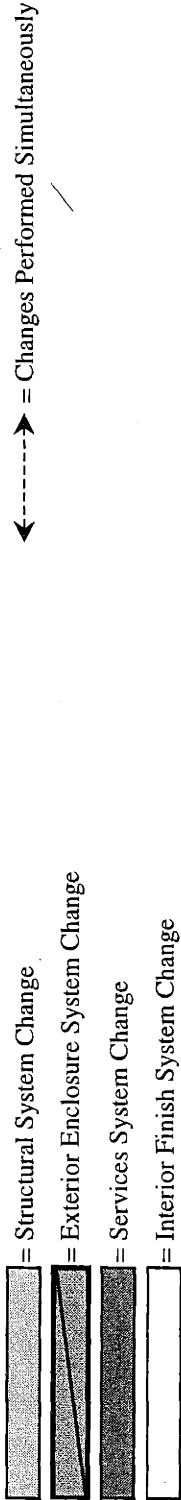
**Citicorp Building, Manhattan, New York**

*In order for left most change to be done, the changes to its right had to be done*

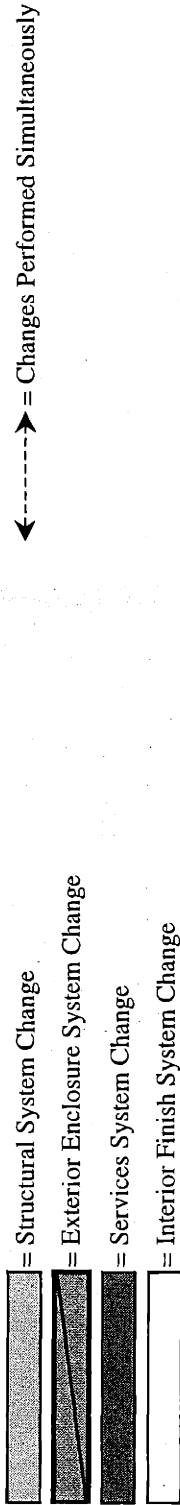
Iowa State University Office Building, Ames, Iowa

*In order for left most change to be done, the changes to its right had to be done*

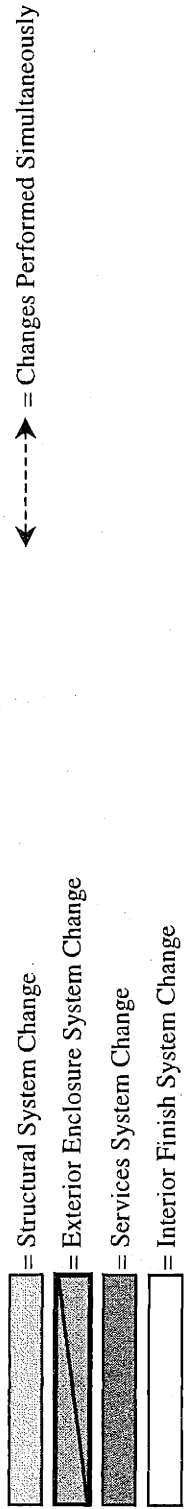
Philadelphia Naval Base Foundry, Philadelphia, Pennsylvania

*In order for left most change to be done, the changes to its right had to be done*

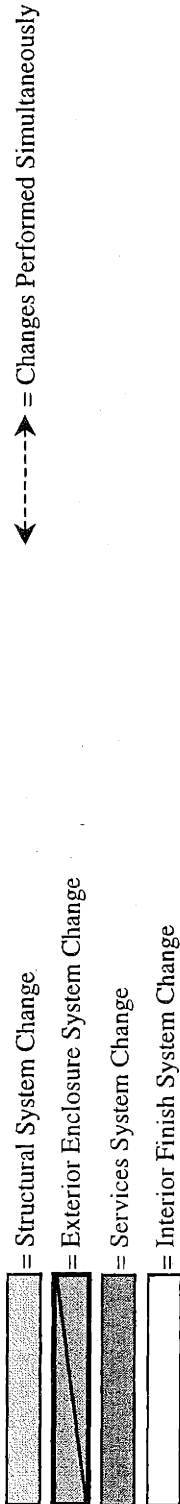
PROJECT: St. Luke's Medical Center

*In order for left most change to be done, the changes to its right had to be done*

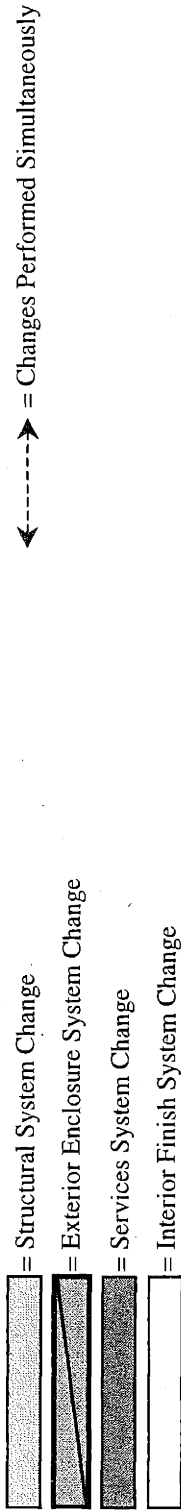
Standard Life Tower, Calgary, Alberta

*In order for left most change to be done, the changes to its right had to be done*
