Evaluation of Multilayer Silicon Carbide Composite Cladding Under Loss of Coolant Accident Conditions

MASTER OF SCIENCE IN NUCLEAR SCIENCE AND ENGINEERING
AT THE
MASSACHUSETTS INSTITUTE OF TECHNOLOGY

Abstract

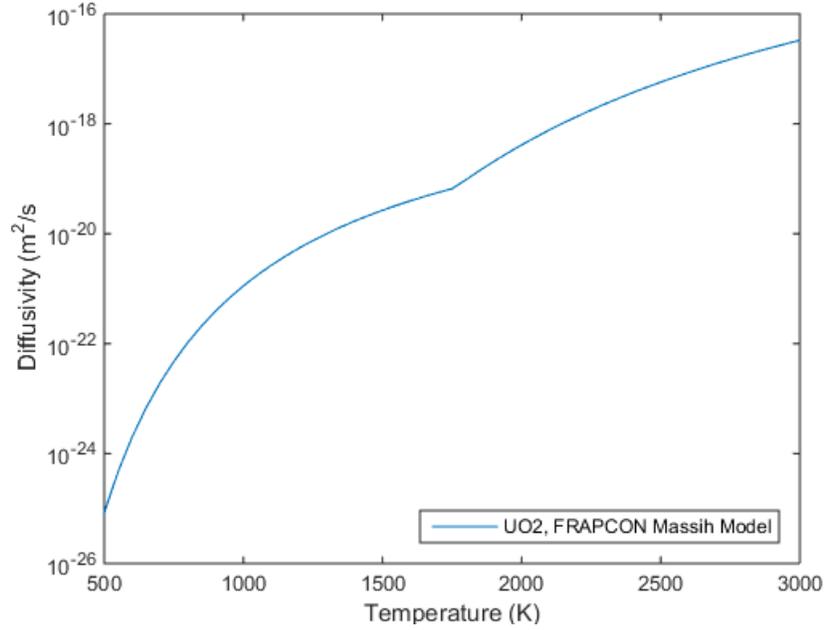
Thus, the diffusion coefficient relationship used by the FRAPCON Massih model is either the high-temperature or low-temperature diffusion coefficient relationship, depending on which is greater. The diffusion coefficient for UO_2 plotted as a function of temperature is shown in Figure 1. In the figure, it can be observed that the diffusivity model changes at a temperature of approximately 1750 K, corresponding to the point when the diffusivity model changes from the low-temperature to the high-temperature model.

Figure 1: Diffusivity for UO₂ implemented in FRAPCON Massih model

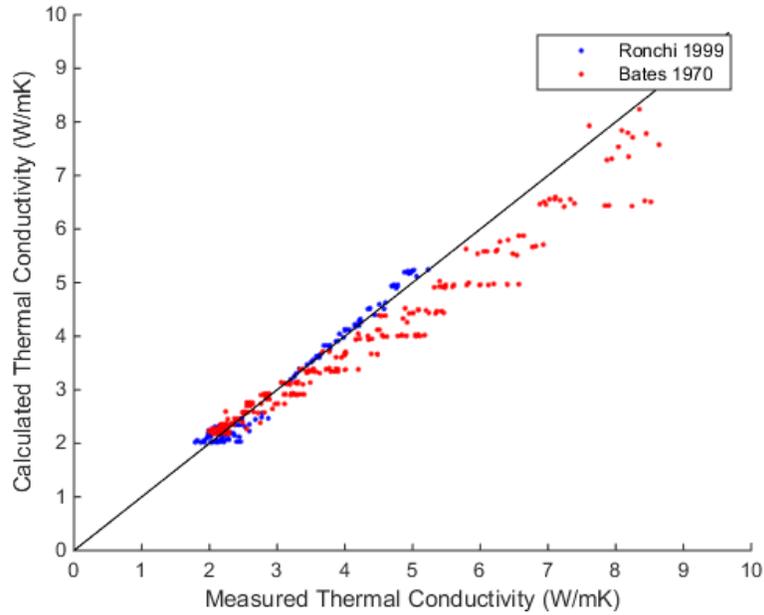
whereas FRAPCON-3.4-MIT appears to under predict the Bates results (6% mean error magnitude). Overall, the Ronchi results are likely more accurate than the Bates results owing to the comparatively small spread of the Ronchi results and the fact that, because of technological advances in the 30 years between the Bates and Ronchi studies, Ronchi was able to obtain the results via the simultaneous measurement of thermal diffusivity and heat capacity on the same sample. Because of the good correspondence between the FRAPCON-3.4-MIT urania thermal conductivity mode and the Ronchi results, the FRAPCON-MIT urania model is considered to be accurate at modeling the thermal conductivity of urania fuel.

Figure 2: Thermal conductivity comparison for urania

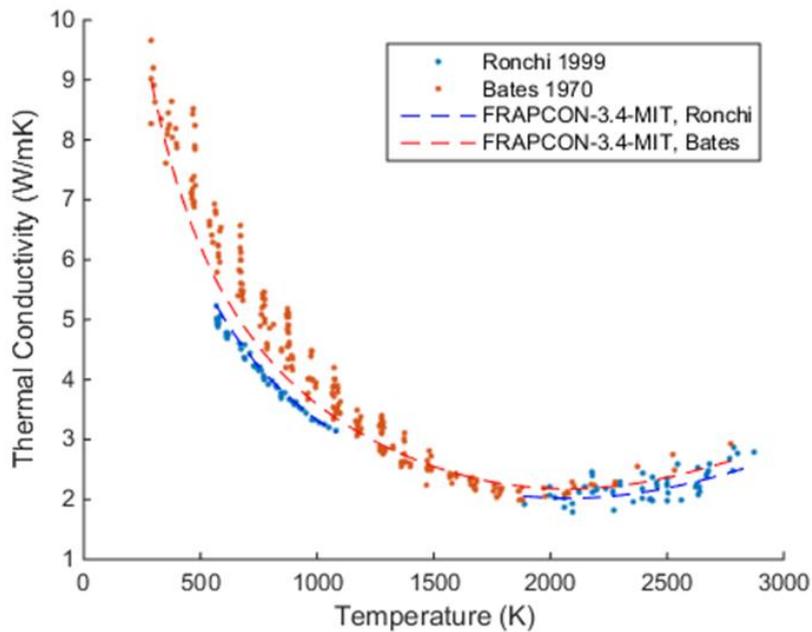
Figure 3: Urania thermal conductivity versus temperature comparison

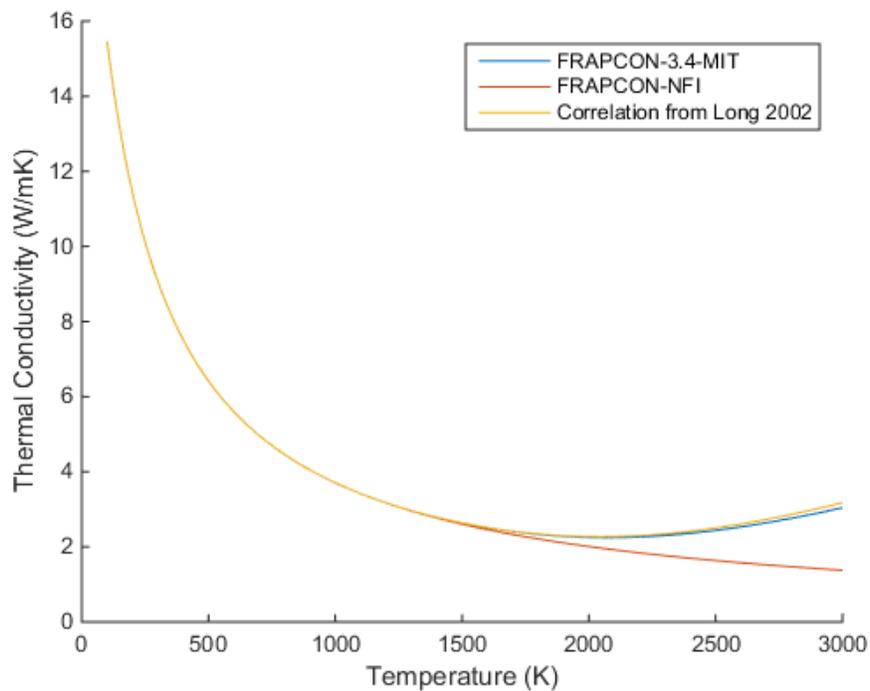
The UO_2 phonon transport model used in FRAPCON-3.4-MIT is based on the Nuclear Fuels Industries (NFI) model (Ohira & Itagaki, 1997), except that the FRAPCON-3.4-MIT model includes the influence of electron thermal transport. The effect of the electron transport model can be seen in Figure 4, where the FRAPCON-3.4-MIT model and the NFI model diverge at temperatures above 1500 K because of electron-transport's contribution to heat conduction. Long also implemented a high-temperature heat transfer addition to the NFI model in his work and argued that radiative heat transfer should cause an increase in thermal conductivity at high temperatures (Long, 2002). Figure 4 shows a comparison between Long's results and the FRAPCON-3.4-MIT model, where both models produce almost identical results for UO_2 . Although Long implemented a radiative heat transfer relationship instead of electron transport, he nevertheless identified the need for a high-temperature addition to the standard NFI model to more accurately model UO_2 's thermal conductivity at high temperatures, and his work supports the FRAPCON-3.4-MIT UO_2 thermal conductivity model.

Figure 4: Comparison of FRAPCON urania thermal conductivity models

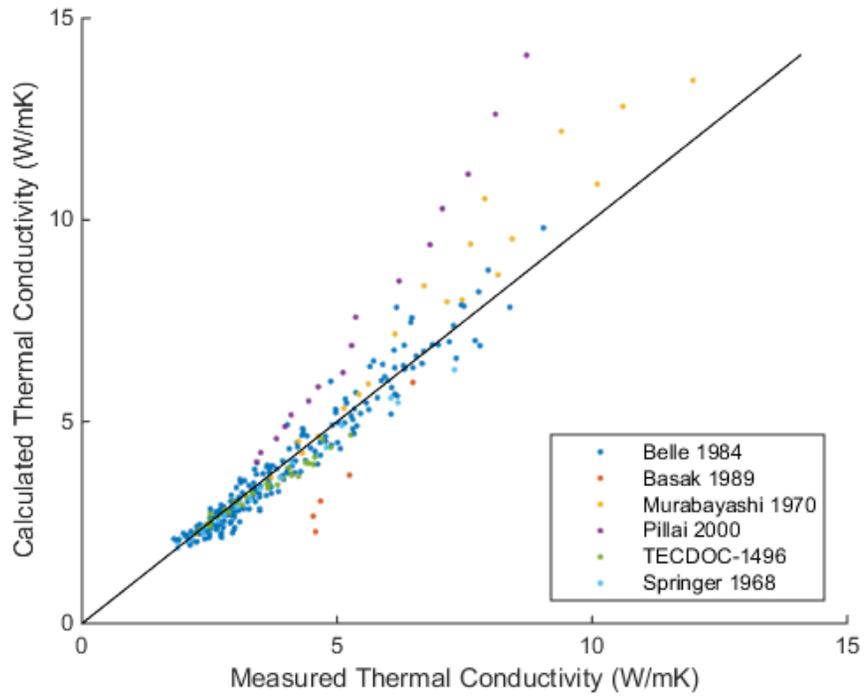
The FRAPCON-3.4-MIT thoria-urania thermal conductivity model was compared against the experimental results of Belle (Belle & Berman, 1984), Basak (Basak, Sengupta, & Ganguly, 1989), Murabayashi (Murabayashi, 1970), Pillai (Pillai & Raj, 2000), TECDOC-1496 (IAEA, 2006), and Springer (Springer, Eldridge, Goodyear, Wright, & Langedrost, 1968). The comparison between the experimental results and the FRAPCON-3.4-MIT results are presented in Figure 5 and Figure 6.

Figure 5: Thermal conductivity comparison for thoria-urania

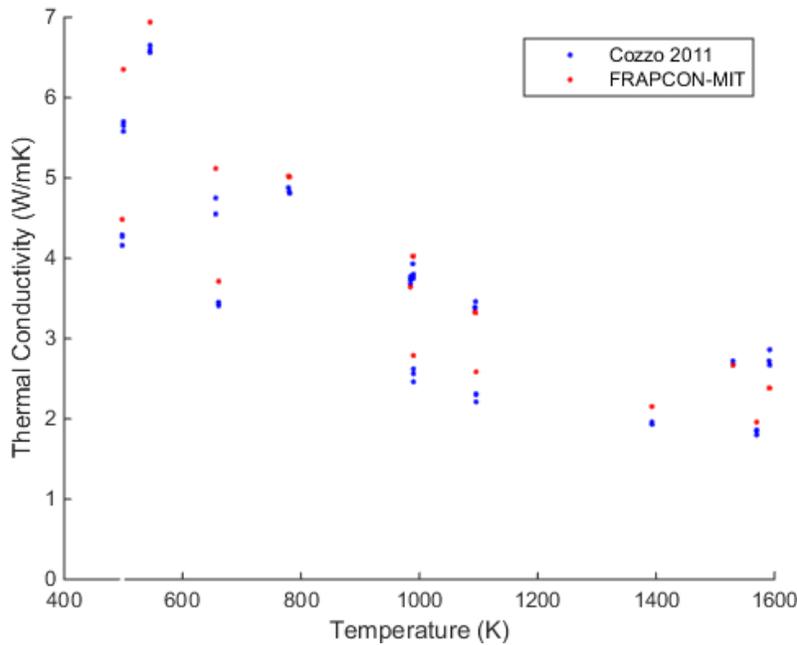
Figure 8: Thoria-plutonia thermal conductivity versus temperature comparison

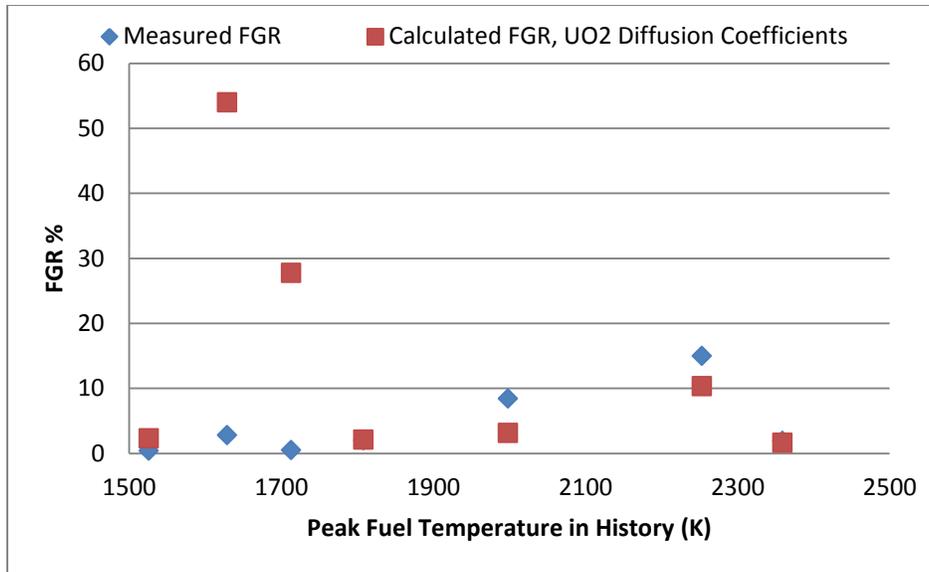
The LWBR test rods were simulated in FRAPCON-3.4-MIT, and the calculated FGR was compared to the experimentally reported FGR. It was observed that using the original UO_2 diffusion coefficients to simulate the thorium-uranium rods resulted in a general over prediction of FGR for the lower temperature rods and a general under prediction of FGR for the higher temperature rods. This result suggests that the low-temperature diffusion coefficient should be lowered, while the high-temperature diffusion coefficient should be increased, for the thorium-uranium system. Figure 10 presents the observed correlation between peak historic fuel temperature and FGR error.

Figure 10: FGR versus peak calculated historic thoria-urania fuel temperature

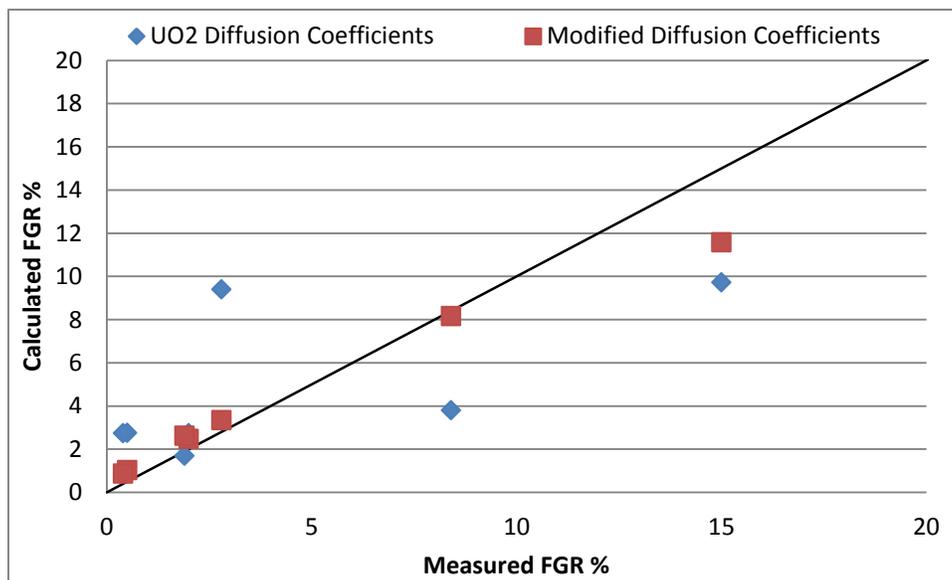
The resulting comparison between the UO₂ diffusion coefficients and the modified diffusion coefficients is presented in Figure 11. From the figure, it can be observed that the modified coefficients better predict the experimental results than the UO₂ coefficients.

Figure 11: Results of FGR modeling for thoria-urania rods

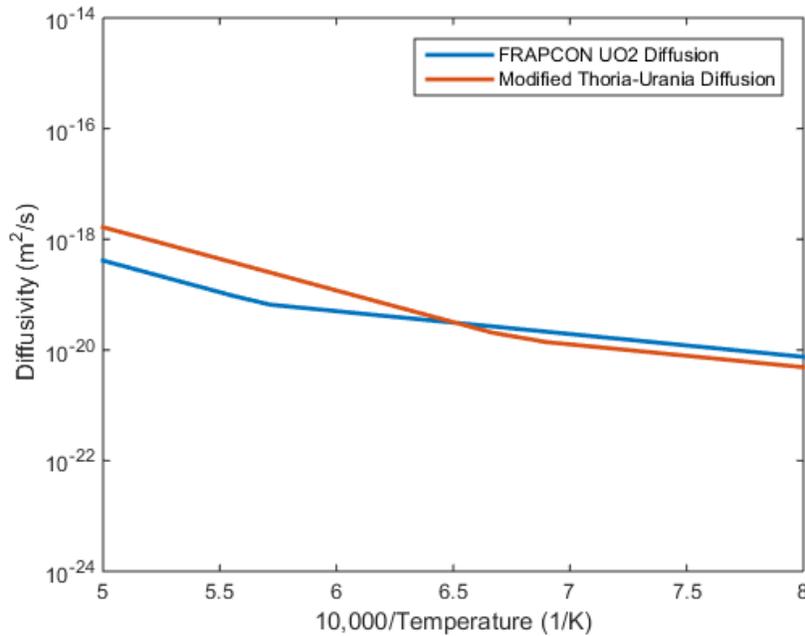
The comparison between the UO_2 diffusion coefficients and the modified diffusion coefficients are presented in Figure 12. From the figure it can be observed that the modified thorium-uranium diffusivity is slightly lower than the UO_2 diffusivity at low temperatures, and significantly higher than the UO_2 diffusivity at high temperatures. This implies that, unlike what is commonly found in the literature, thorium-uranium fuel at high temperature will have higher fission gas diffusion than uranium fuel.

Figure 12: Diffusivity for UO_2 and modified thorium-uranium model

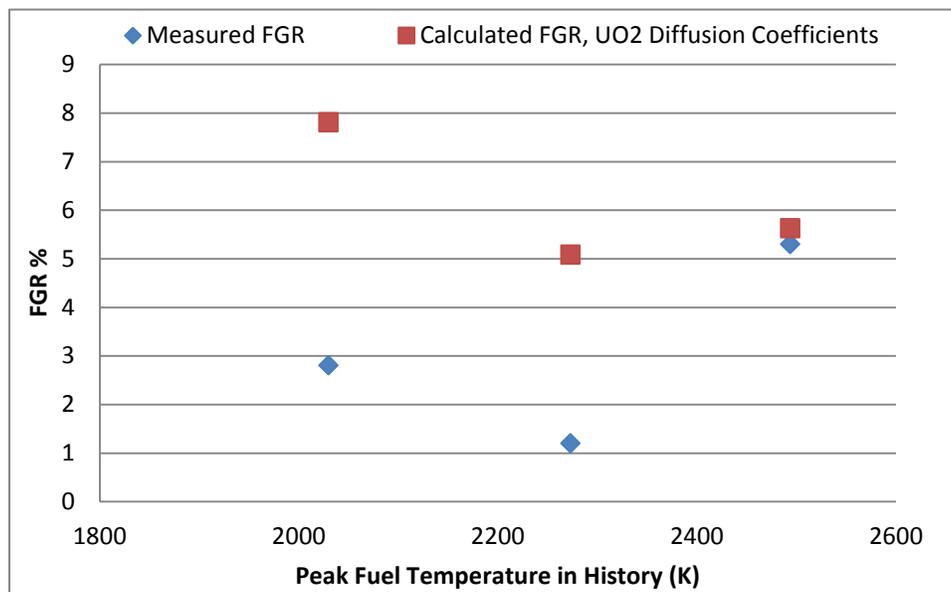
It was observed that using the original UO_2 diffusion coefficients to simulate the thoria-plutonia rods resulted in a large over prediction of FGR for the lower temperature #1 rods, while the UO_2 diffusion coefficients accurately predicted the FGR for the high temperature #1 rod. This result suggested that the low-temperature diffusion coefficient should be lowered substantially, and the high temperature coefficient should remain similar to the UO_2 coefficient. Figure 14 presents the observed correlation between peak historic fuel temperature and FGR error.

Figure 14: FGR versus calculated peak historic thoria-plutonia fuel temperature (#1 rods only)

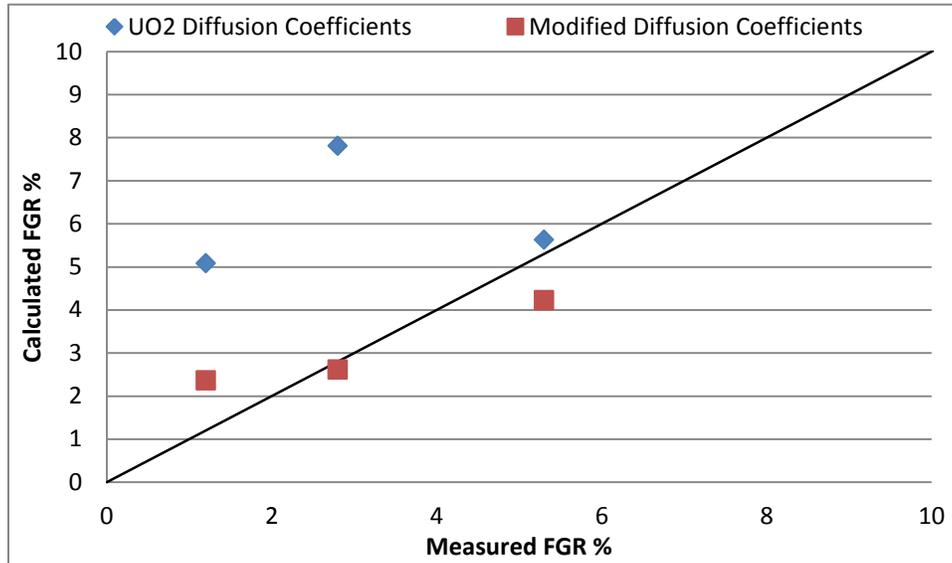
The resulting comparison between the UO_2 diffusion coefficients and the modified diffusion coefficients is presented in Figure 15. From the figure, it can be observed that the modified coefficients better predict the experimental results than the UO_2 coefficients. Furthermore, the figure illustrates how the #19 rods (clustered at low FGR) did not show any FGR sensitivity to the change in diffusion coefficients.

Figure 15: Results of FGR modeling for thoria-plutonia rods

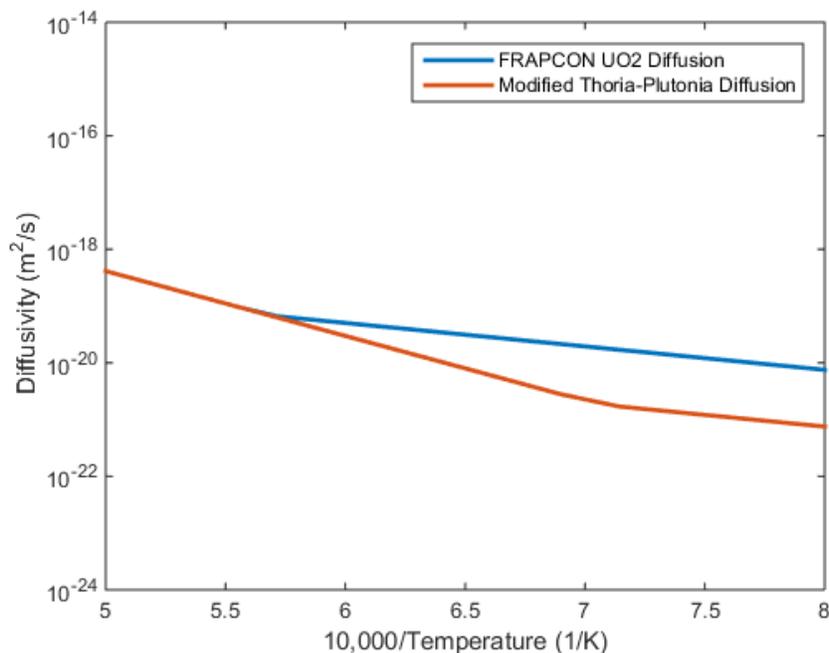
The comparison between the UO_2 diffusion coefficients and the modified thoria-plutonia diffusion coefficients is presented in Figure 16. From the figure, it can be observed that the high-temperature thoria-plutonia diffusivity is identical to that of UO_2 , but the low-temperature diffusivity is much lower for thoria-plutonia.

Figure 16: Diffusivity for UO_2 and modified thoria-plutonia model

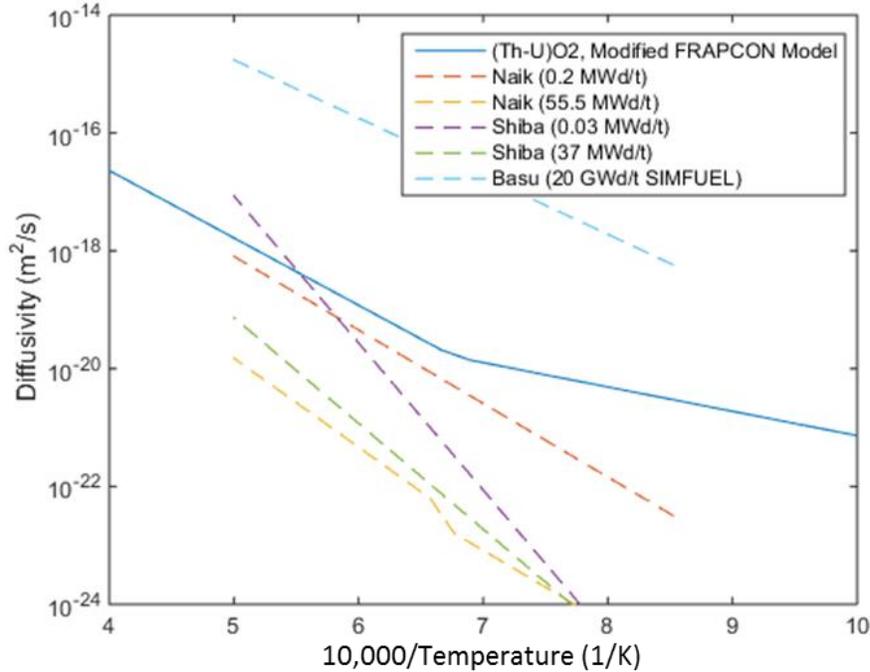
Where D is the diffusivity at the temperature of interest, D_0 is the frequency factor, Q_0 is the activation energy, R is the gas constant, and T is the temperature. Although previous studies concerning thoria-plutonia fuel are lacking, studies by Naik (Naik, 1992), Shiba (Shiba, 1992), and Basu (Basu, Mishra, Bharadwaj, & Das, 2010) have attempted to experimentally determine the diffusivity of thoria-urania fuel. The comparison between the experimentally-derived diffusivity and the diffusivity implemented in FRAPCON-3.4-MIT in this work is presented in Figure 17 and Table 5. It can be noted that the sudden change in slope of the FRAPCON model is attributable to the change from the low-temperature diffusivity to the high-temperature diffusivity model.

Figure 17: Comparison of modified FRAPCON thoria-urania diffusivity and published data (burnup indicated)

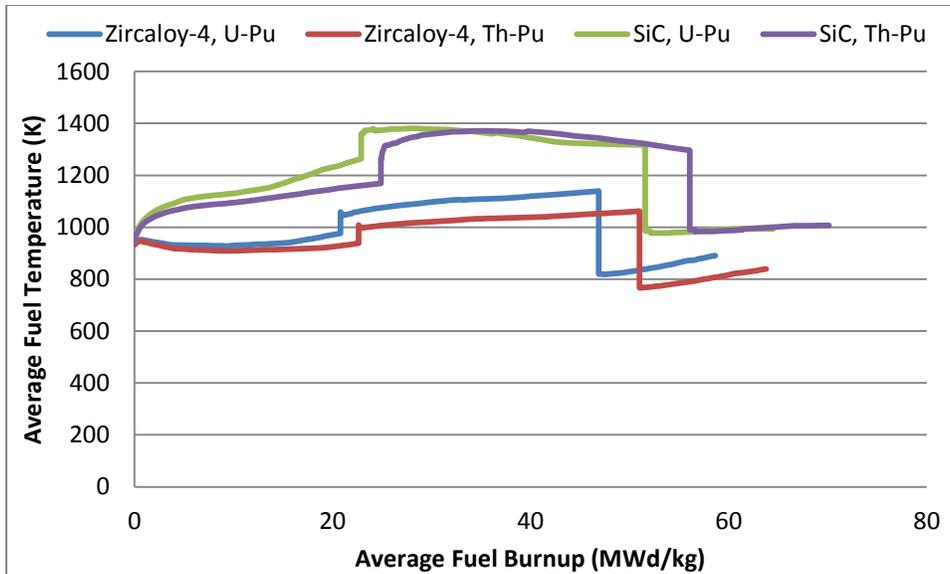
From this analysis, it was seen that using the thorium-plutonium fuel substantially reduced the temperature, FGR, and plenum pressure for the fuel clad in Zircaloy-4. However, the SiC-clad fuel was much less influenced by the use of thorium. Because of the lower thermal conductivity of irradiated SiC cladding and its open gap, the SiC-clad fuel temperature is higher than its Zircaloy-clad counterpart. Therefore, the SiC-clad fuel operates in the high-temperature region of the new diffusivity model which, as discussed in Section 2.4.2.3, is identical to the high-temperature diffusivity model of uranium. However, the higher thermal conductivity of thorium does reduce the fuel temperature slightly and results in slightly less FGR and plenum pressure for the thorium-plutonium rod than for the uranium-plutonium rod. Figure 23, Figure 24, and Figure 25 present comparisons of the fuel temperature, FGR, and plenum pressure for the Zircaloy- and SiC-clad rods.

Figure 23: Comparison of fuel temperature for simulated rods

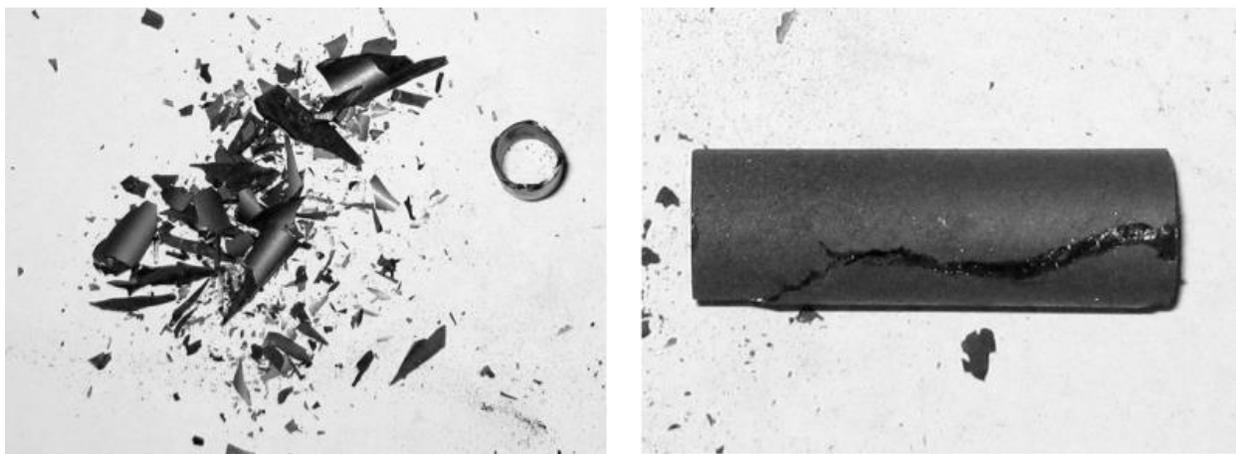
To prevent the brittle and catastrophic failure of the monolith cladding, multilayer composite cladding was developed. With multilayer cladding, the corrosion resistance of monolith SiC is combined with the improved mechanical behavior of the CMC to create a cladding that has good high-temperature corrosion performance while maintaining failure characteristics compatible with nuclear accident scenarios. The failure behavior of multilayer composite cladding can be observed in Figure 31. From the figure, it can be noted that, whereas the monolith tubing failure results in shattering of the cladding, the failure of the multilayer composite has much less fragmentation and remains relatively intact.

Figure 31: Comparison of failure behavior for monolith (left) and multilayer composite (right) tubing (Carpenter, 2010)

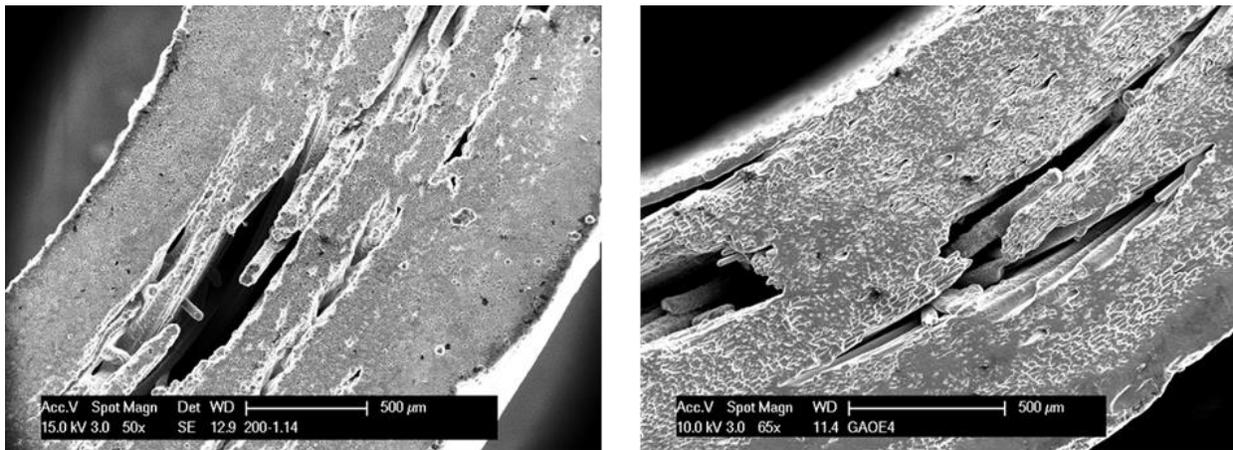
Two approaches have been taken to addressing the design concerns for multilayer cladding. The first approach is the three-layer design, which uses an inner mSiC layer for fission gas retention, a middle CMC layer for mechanical performance, and an outer mSiC EBC to protect the CMC from corrosion. The second approach is the two-layer design, which uses an inner or outer CMC layer for mechanical performance and an outer or inner mSiC layer to retain fission gases and prevent corrosion of the CMC. Cross-sectional SEM views of the two-layer and three-layer designs are shown in Figure 32. It should be noted that the large voids observed in the figure exist because of the inability of the manufacturing techniques to completely fill the matrix within the CMC. Such voids are currently unavoidable and will likely be present in reactor-grade cladding.

Figure 32: Cross-sectional SEM views of three-layer (left) and two-layer (right) samples

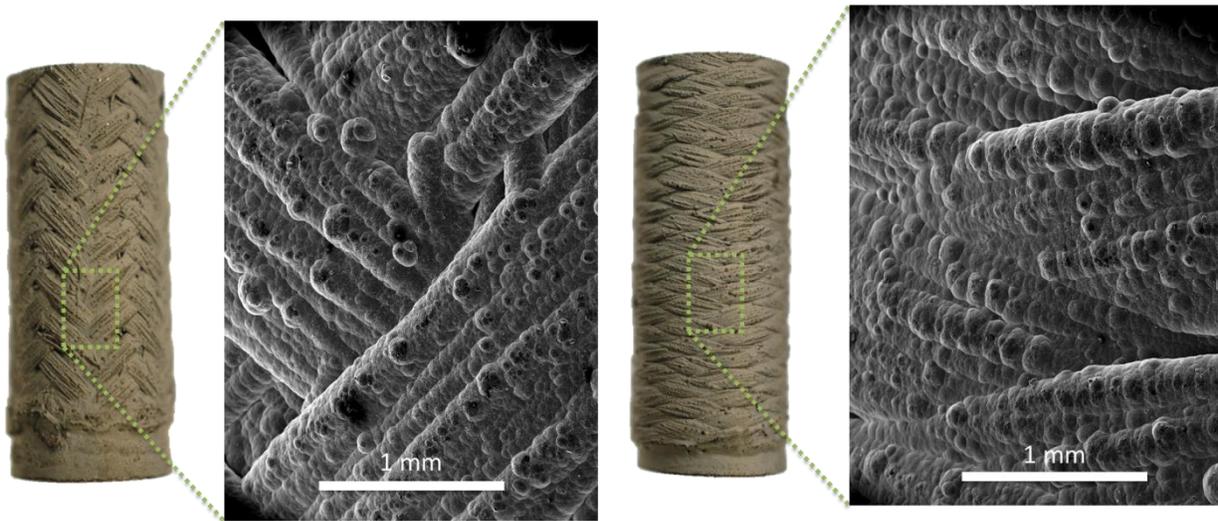
Figure 37: Typical GACE-A sample (left) and GACE-B sample (right) with SEM close-ups

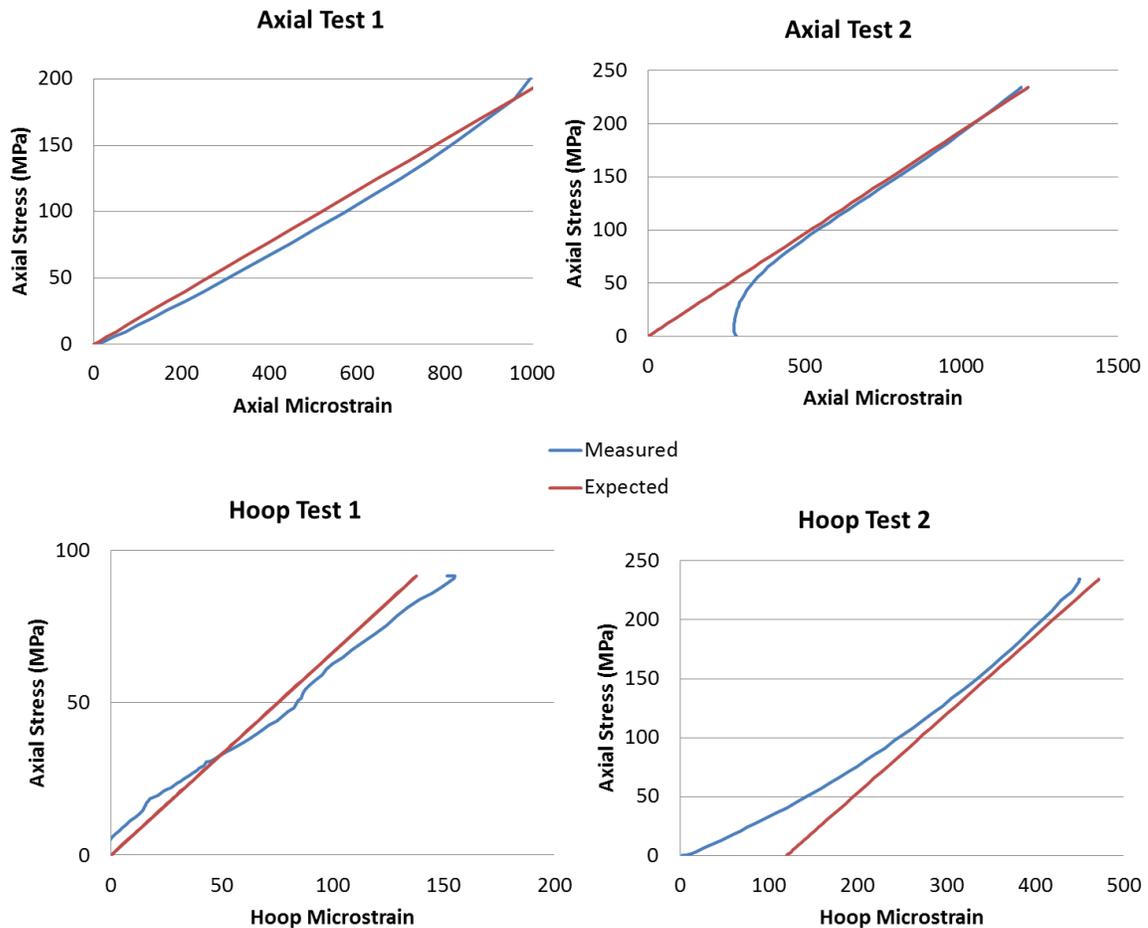
Test	Material	Expected Quantity	Measured Quantity
Axial 1	18-8 SS	E = 193-210 GPa	E = 197 GPa
Axial 2			E = 205 GPa
Hoop 1		v = 0.29	v = 0.28
Hoop 2			v ≈ 0.29

Figure 43: Strain gage validation data

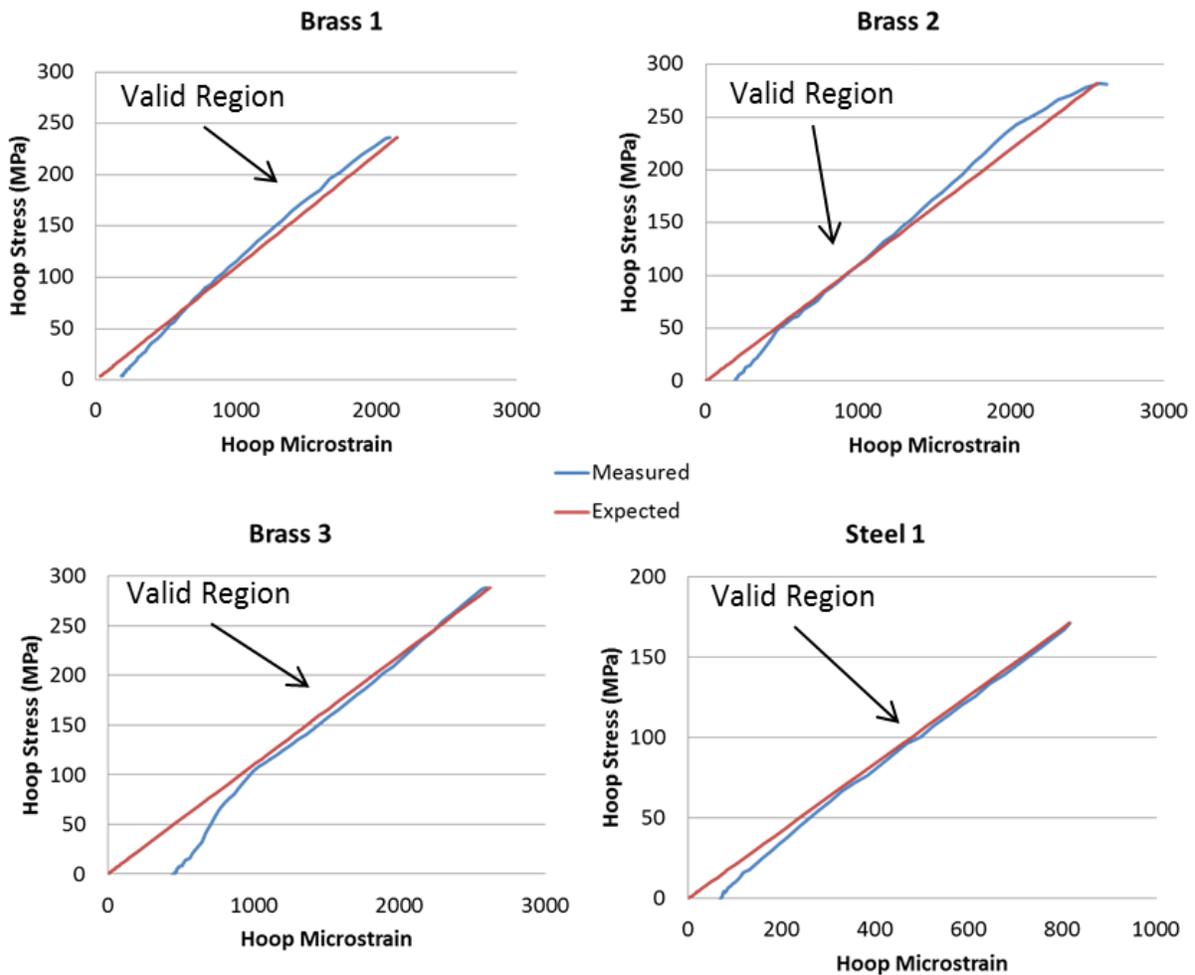
Test	Material	Expected Quantity	Measured Quantity
Brass 1	260 Brass	$E \approx 110 \text{ GPa}$	$E = 126 \text{ GPa}$
Brass 2			$E = 124 \text{ GPa}$
Brass 3			$E = 118 \text{ GPa}$
Steel 1	4130 Steel	$E = 190\text{--}210 \text{ GPa}$	$E = 214 \text{ GPa}$

Figure 44: Pressurization test validation data

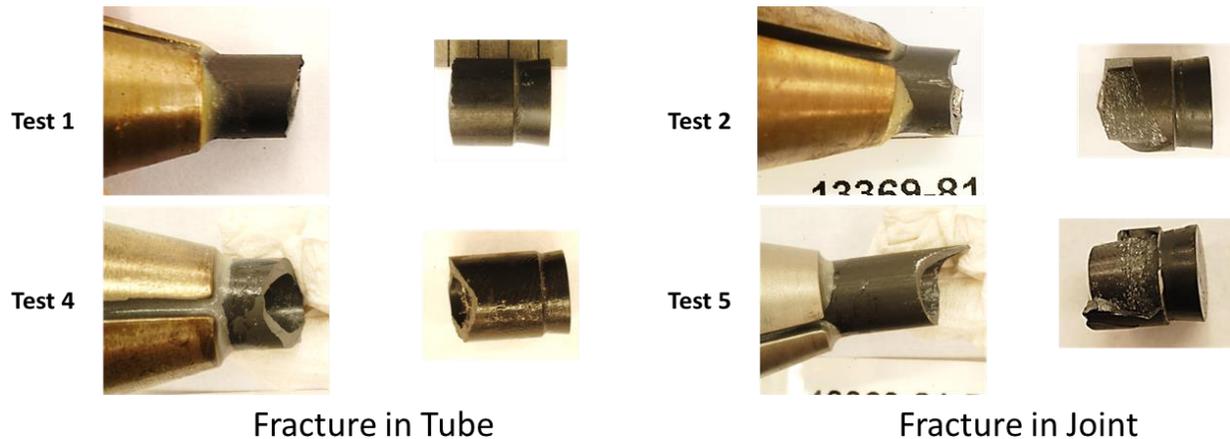
Figure 47 presents photographs showing the different failure characteristics of the valid dummy tests. Although variance was observed in the fracture location among the valid tests, all valid tests exhibited similar burst strengths which matched the burst strengths observed by GA during their validation testing. Therefore, the valid tests were all an indication of the true strength of the endplug joint for the dummy samples. Because four of the tests were valid, and because the invalid test was attributable to a manufacturing flaw, the endplug joint strength testing facility was considered validated.

Figure 47: Failure characteristics of valid dummy tests

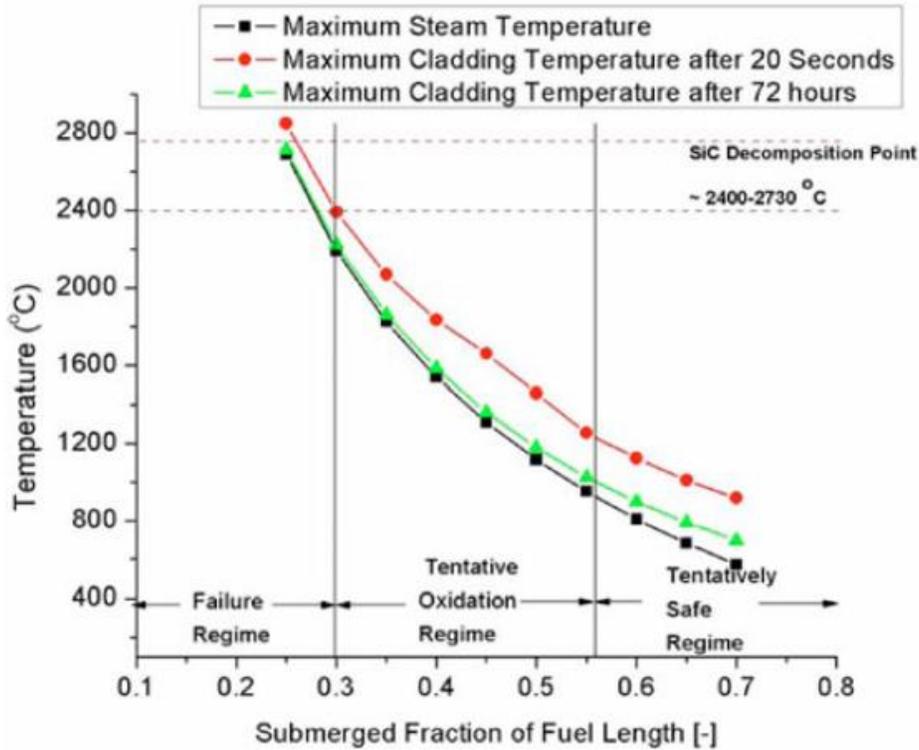
Oxidation conditions were intended to approximate the long-term accident conditions in a typical PWR, although the peak oxidation temperature was limited by the capabilities of the experimental facility. Following Lee's work (Lee Y. , McKrell, Yue, & Kazimi, 2013), the 1400°C oxidation temperature was based on the limits of the oxidation facility and the results of Figure 50. Furthermore, the steam flow rate and facility geometry were based on Lee's analysis of subchannel oxidation conditions in a typical PWR (Lee Y. , McKrell, Yue, & Kazimi, 2013).

Figure 50: Oxidation regime for SiC (Lee Y. , McKrell, Yue, & Kazimi, 2013)

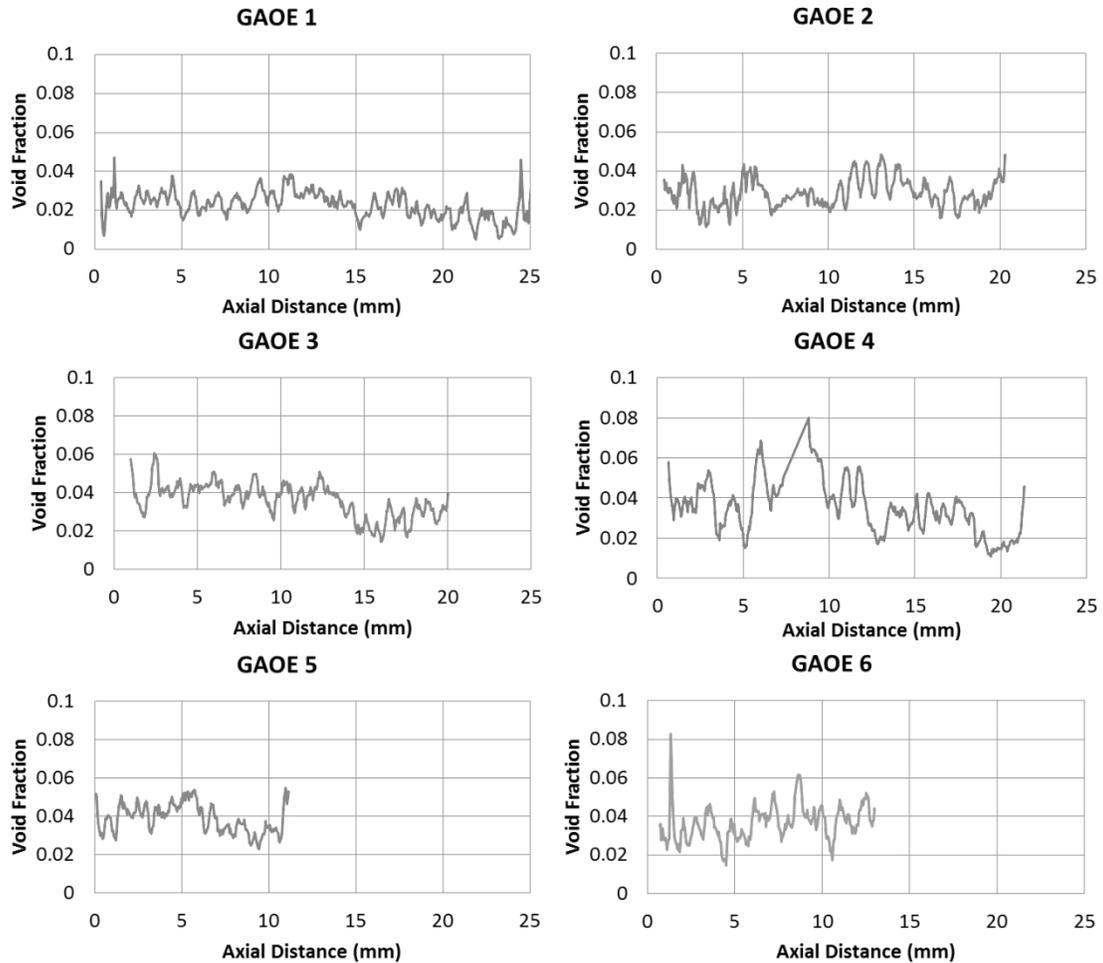
Void fraction analysis was performed on all samples, and from the analysis the axial variation in void fraction was obtained. However, because the GAOE samples had already been strength tested (except GAOE 1), the failed CMC regions were eliminated from the void fraction analysis and only the intact CMC regions were considered. The resulting axial variation of void fraction for each GAOE sample is presented in Figure 59. From the figure, it can be observed that all GAOE samples had similar void fractions, and the period of the axial fluctuations of void fraction roughly correspond to the 1.47 mm axial inter-tow distance of the GAOE series. The CMC void fractions varied from 2% to 10%, corresponding well with the 6-7% (Abdul-Aziz, Ghosn, Baaklini, & Bhatt, 2003) and 10% (Bloom, 1998) porosity values obtained in a previous studies but somewhat higher than the 0.03% void fraction determined by Puglia (Puglia, Sheikh, & Hayhurst, 2004).

Figure 59: Axial variation of void fraction for GAOE series

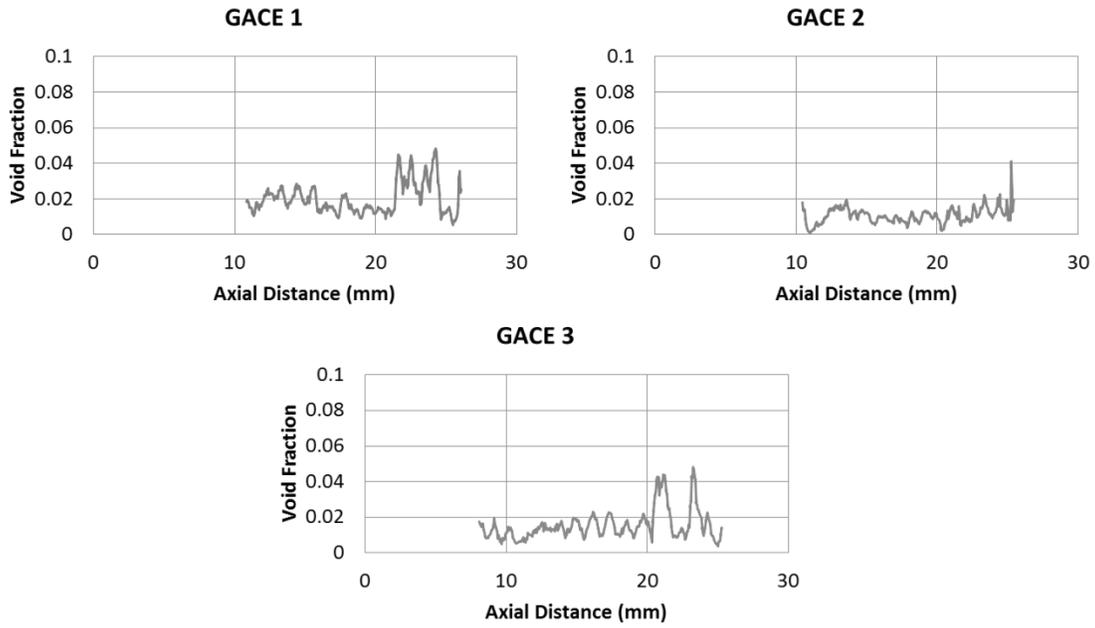
For the GACE samples, the endplug influences the void fraction in axial slices containing the endplug because it appears as a large non-void region. Therefore, the CMC void fraction of the GACE samples was calculated only above the endplug joint (which comprised approximately the first 10 mm). Figure 60 presents the axial variation of the void fraction for the GACE-A series, and Figure 61 presents the axial variation of the void fraction for the GACE-B series. From the figures, it can be noted that most of the samples within a series have similar void fractions, although the GACE-B series exhibited more spread in void fraction among its samples. Also, the period of the axial fluctuations of void fraction roughly correspond to the axial inter-tow distance of 1.8 mm and 1.2 mm for GACE-A and GACE-B respectively.

Figure 60: Axial variation of void fraction for GACE-A series

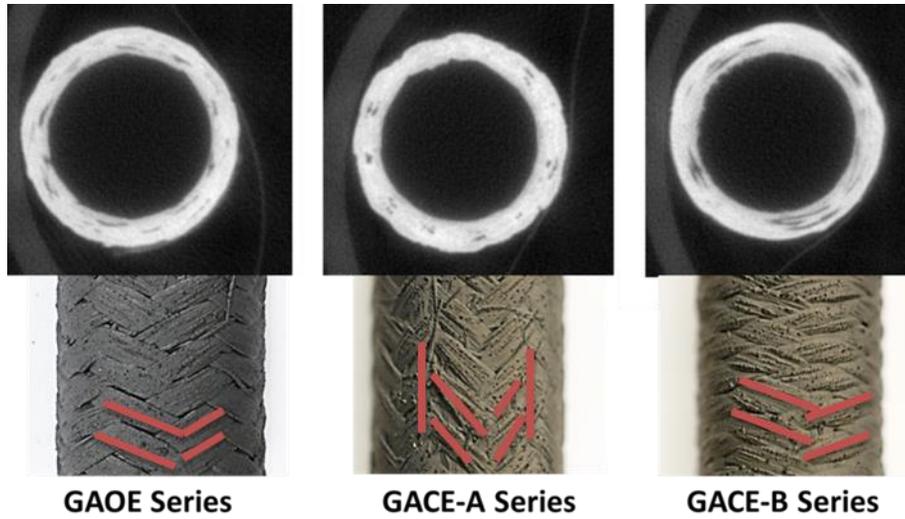
From the XCT scans, it was observed that the void morphology was dependent on the architecture of the samples. Figure 65 shows a comparison between the sample architecture and the void morphology for the different series. The interlace angle between tows strongly influenced void morphology: the higher interlace angle of the GACE-B series with respect to the GAOE series led to voids that visibly appeared more circumferentially-elongated and the GACE-B series had a higher void fraction. In contrast, the GACE-A series had the shallowest interlace angle, and the XCT scans revealed that the CMC voids were visibly smaller in the circumferential direction than those of the GAOE and GACE-B series. Furthermore, the GACE-A series exhibited the smallest CMC void fraction of all series. Figure 66 demonstrates the apparent dependence of CMC void fraction on tow interlace angle. The correspondence between void fraction and interlace angle that was observed during XCT analysis suggests that the high interlace angles interfere with the CVI process used to fill the inter-tow regions, thus resulting in numerous large voids.

Figure 65: Comparison of void morphology and sample architecture

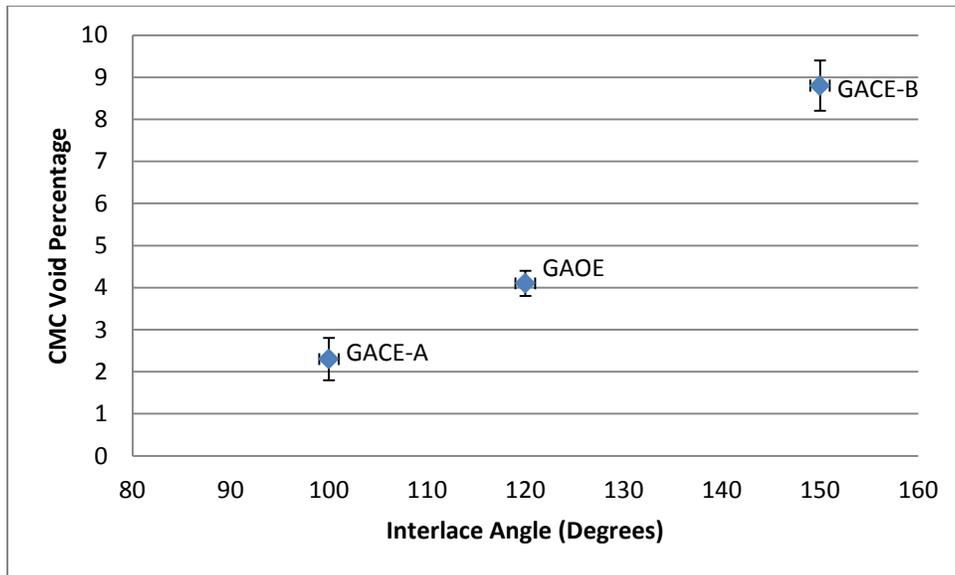
Figure 66: Observed dependence of CMC void fraction on interlace angle

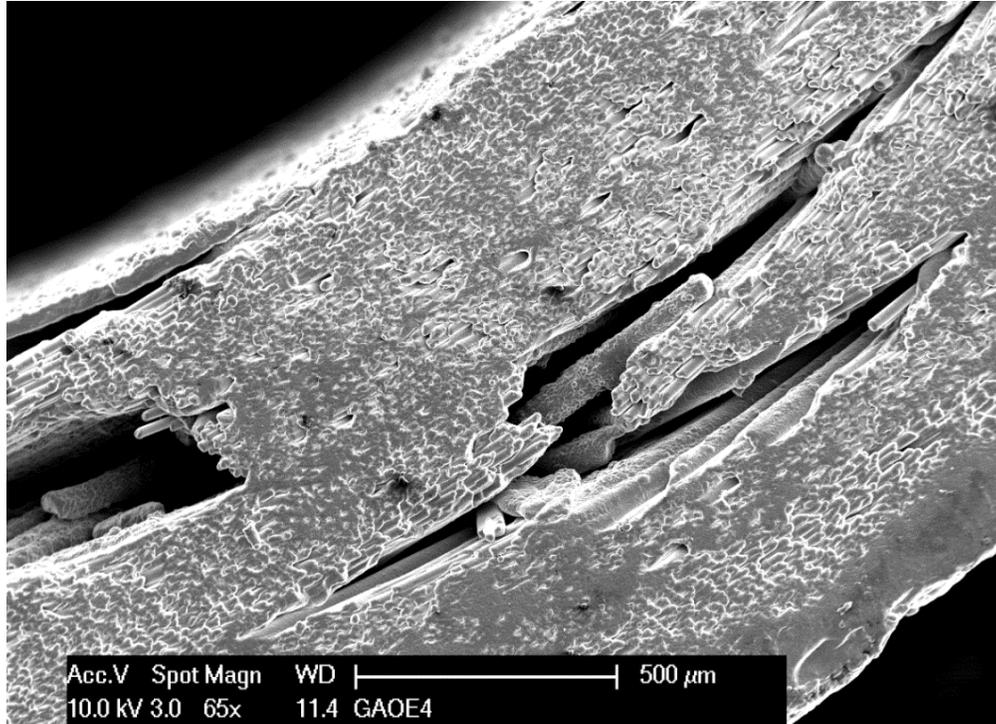
Figure 69: SEM cross-sectional view of GAOE 4 showing entrances to the CMC void network at the cut surfaces

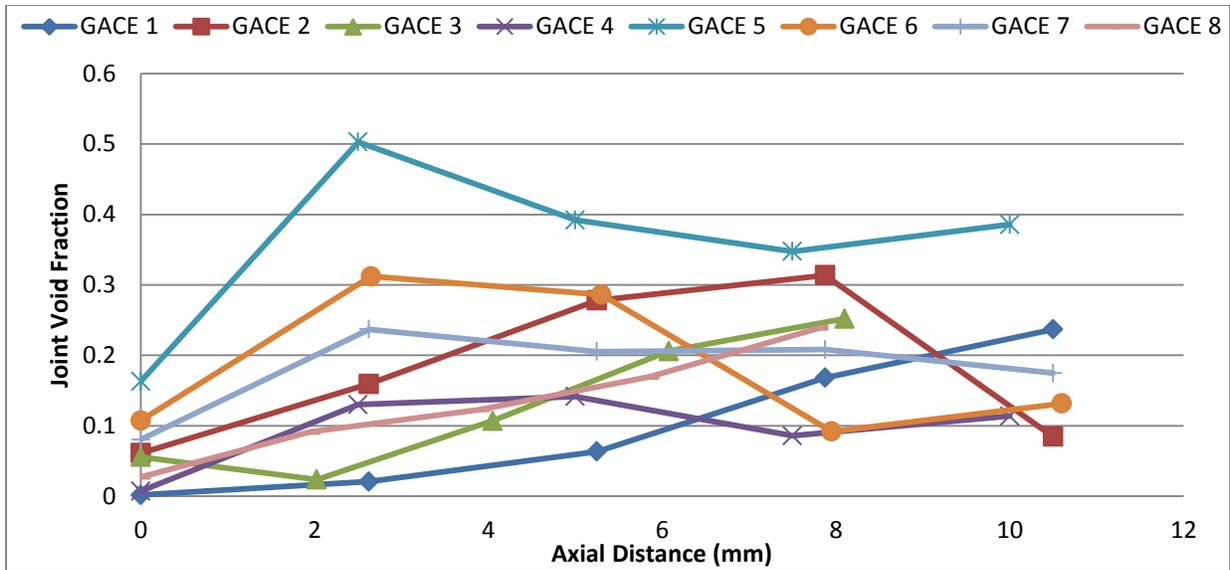
Figure 70: Axial distribution of joint void fraction for GACE samples

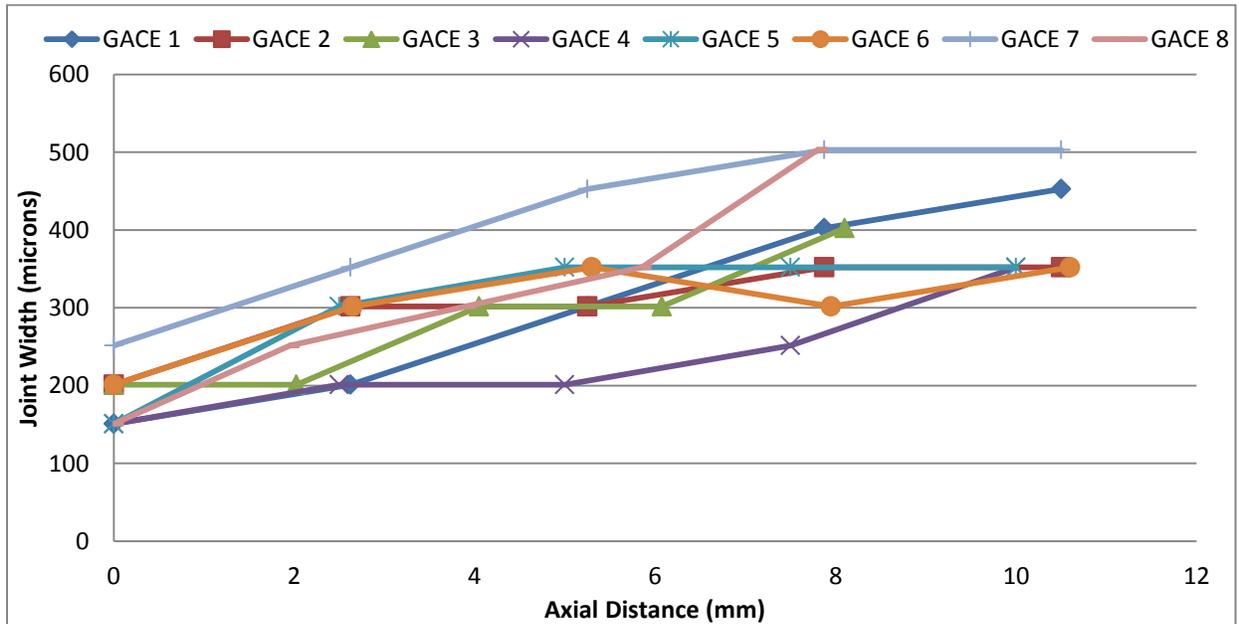
Figure 71: Axial distribution of joint thickness for GACE samples

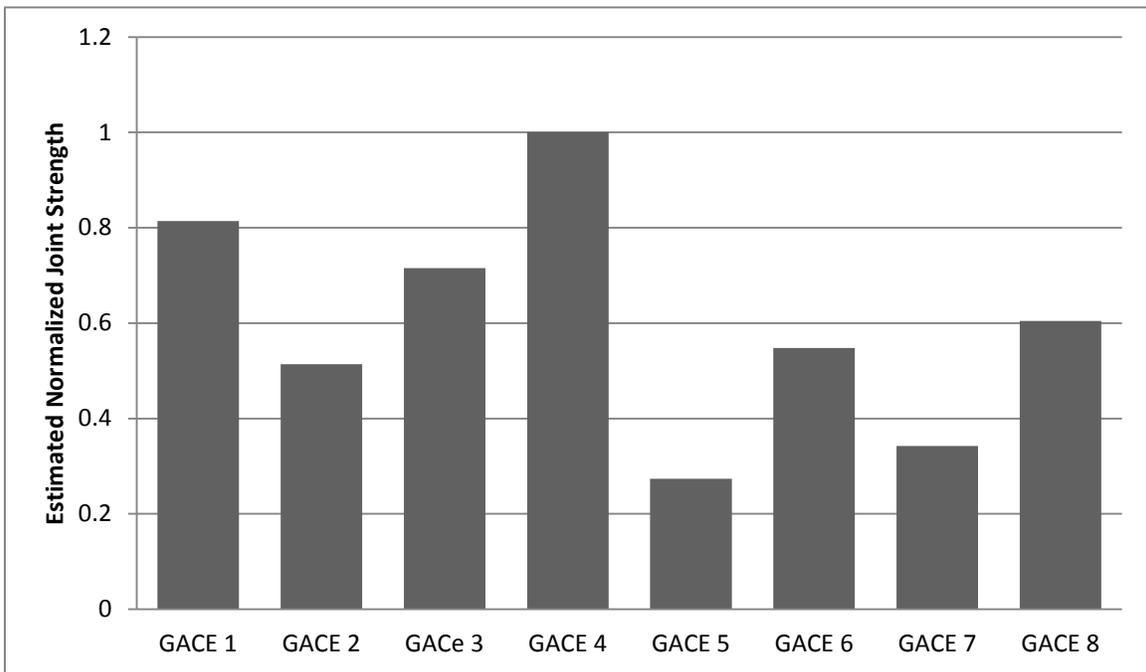
Figure 75: Approximated relative joint strengths of GACE samples from XCT analysis
