Evaluation of Multilayer Silicon Carbide Composite Cladding Under Loss of Coolant Accident Conditions

MASTER OF SCIENCE IN NUCLEAR SCIENCE AND ENGINEERING
AT THE
MASSACHUSETTS INSTITUTE OF TECHNOLOGY

Abstract

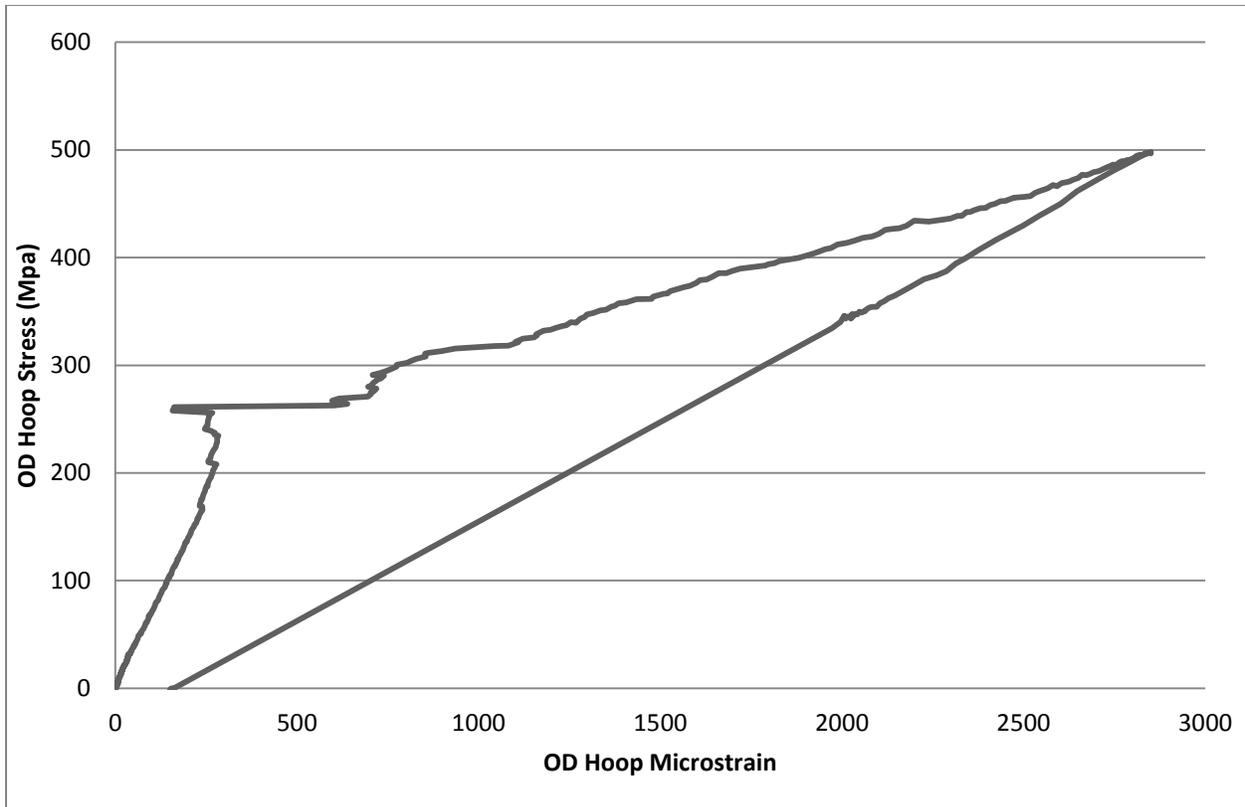
Figure 76: Stress-strain behavior for GAOE 2

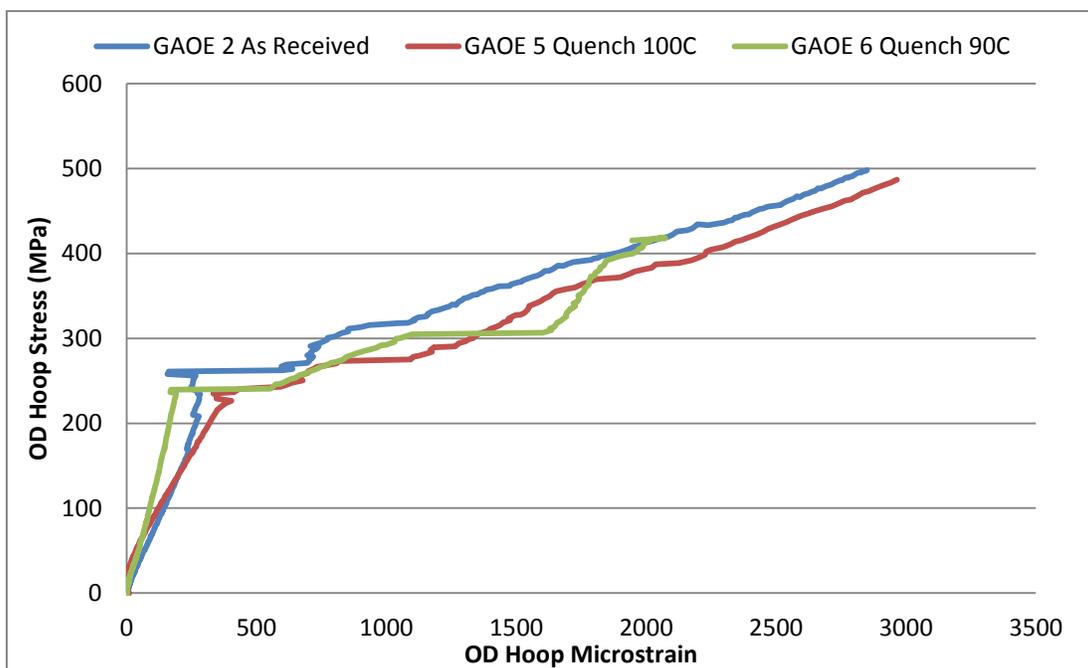
Figure 82: Stress-strain comparison between thermal-shock and as-received GAOE samples

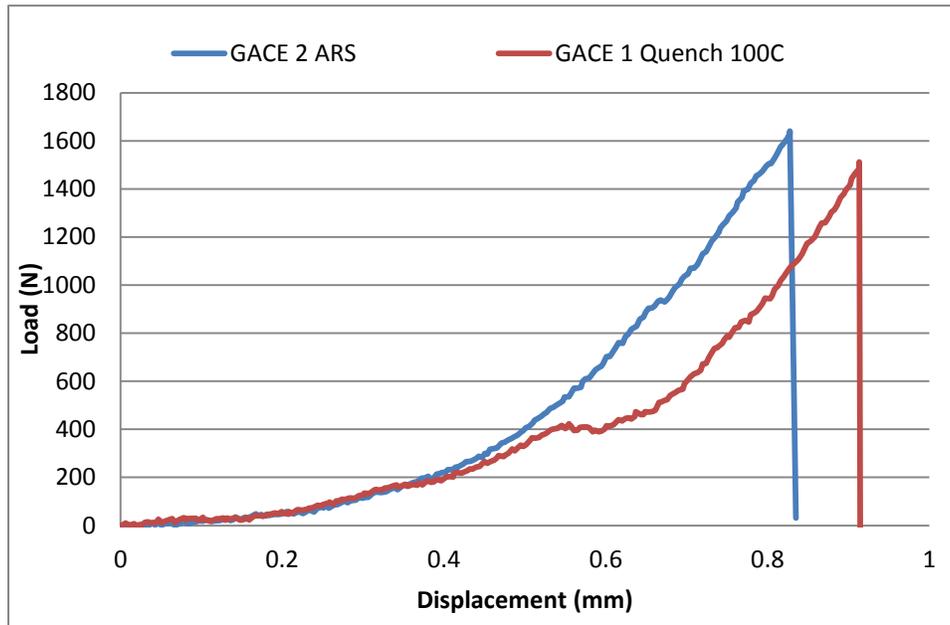
Figure 83: Pushrod load versus displacement comparison between thermal-shock and as-received GACE-A samples

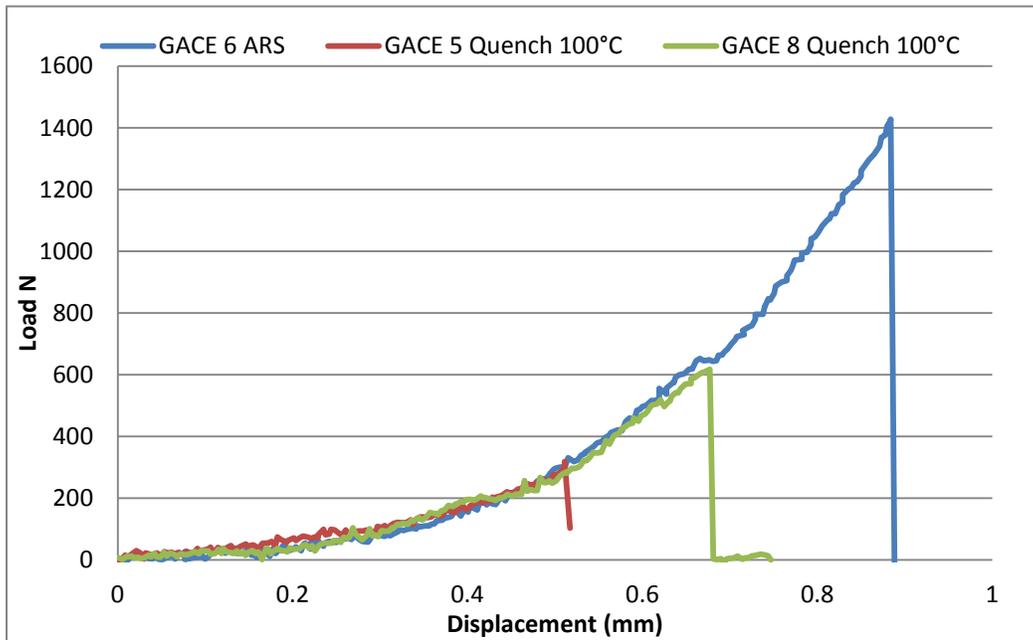
Figure 84: Pushrod load versus displacement comparison between thermal-shock and as-received GACE-B samples

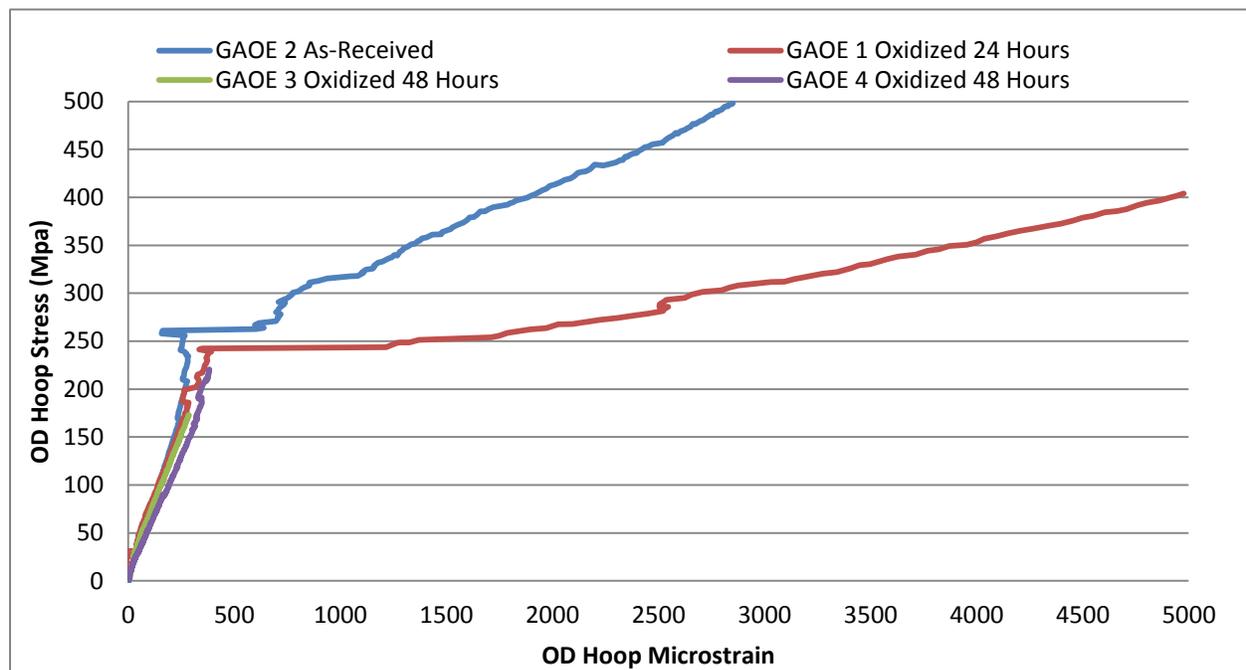
Figure 90: Stress-strain comparison between oxidized and as-received GAOE samples

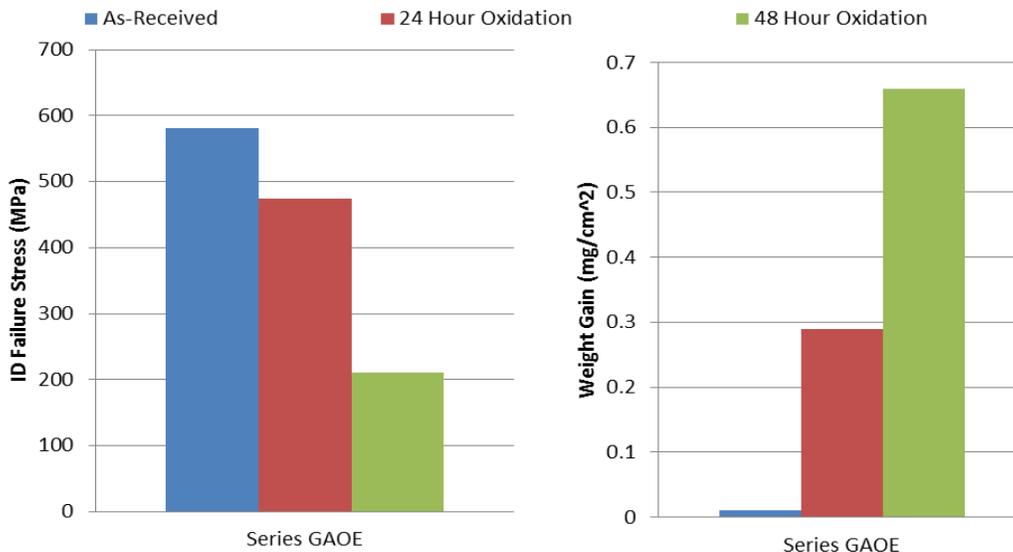
Figure 91: Comparison of weight change and failure stress for oxidized GAOE samples

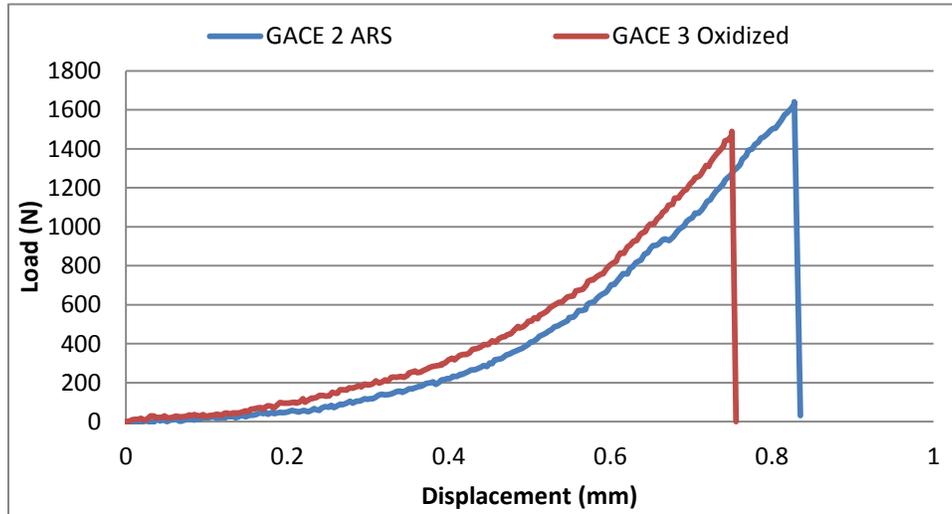
Figure 92: Pushrod load versus displacement comparison between oxidized and as-received GACE-A samples

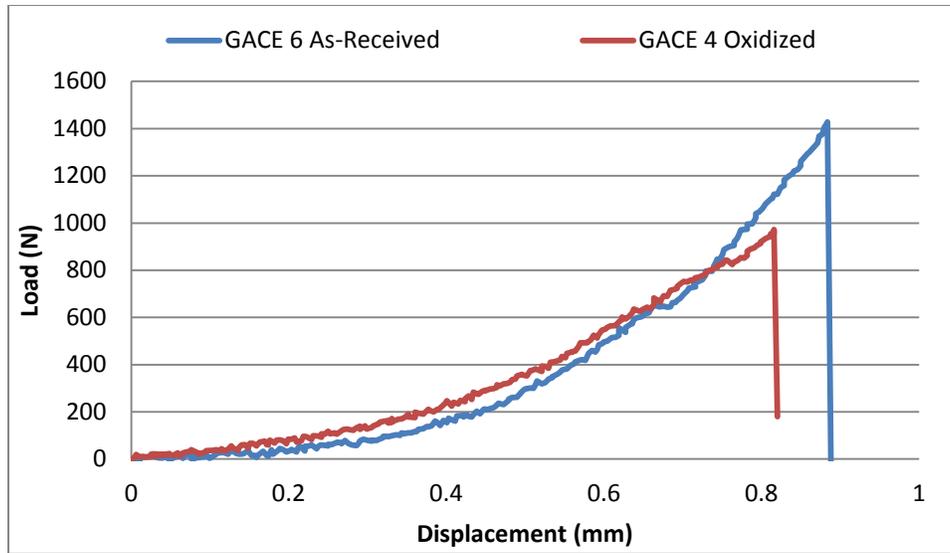
Figure 93: Pushrod load versus displacement comparison of oxidized and as-received GACE-B samples

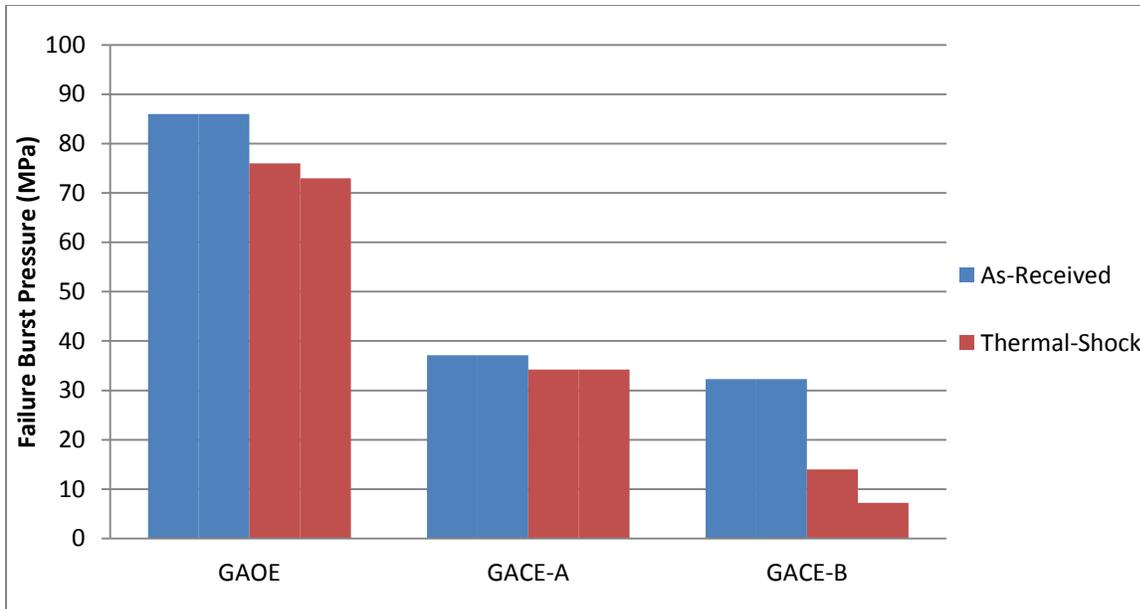
Figure 99: Comparison of as-received and thermal-shock results for all series

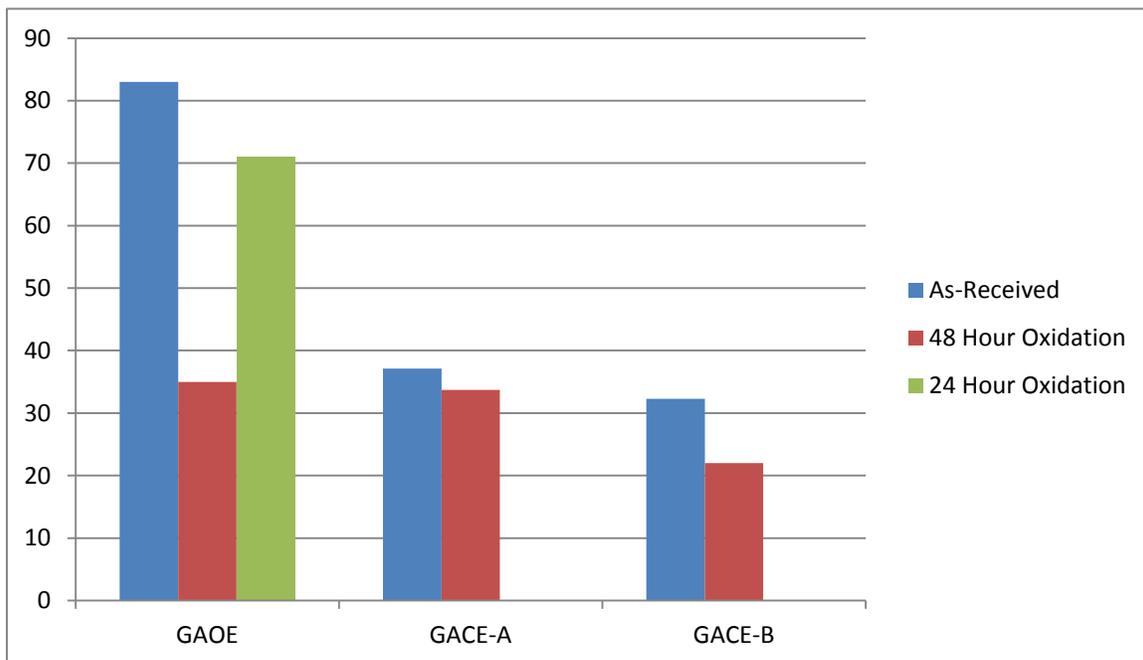
Figure 100: Comparison of as-received and oxidized results for all series

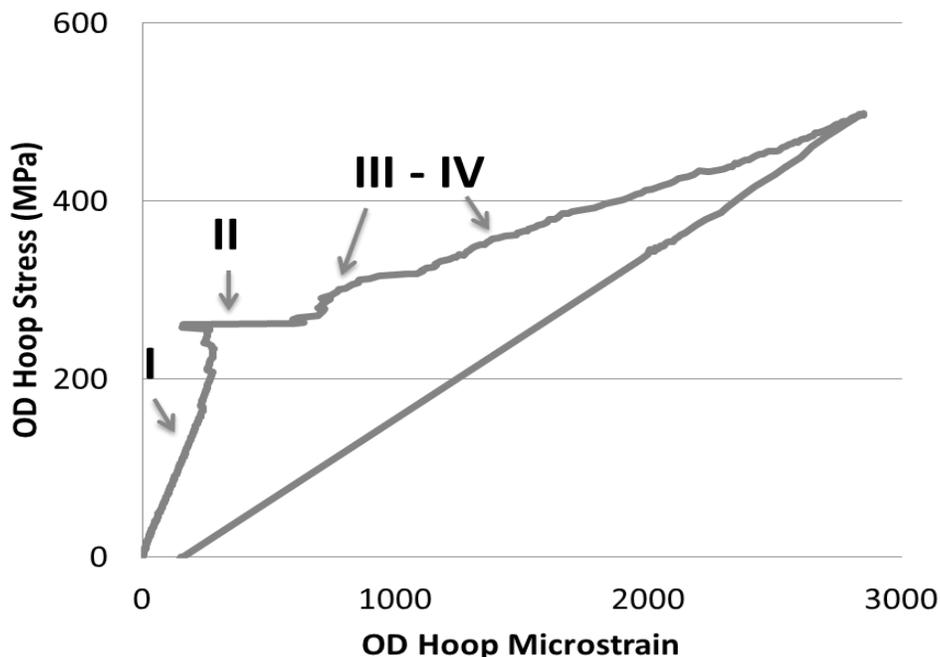
Figure 101: Unique regimes of stress-strain behavior for GAOE 2

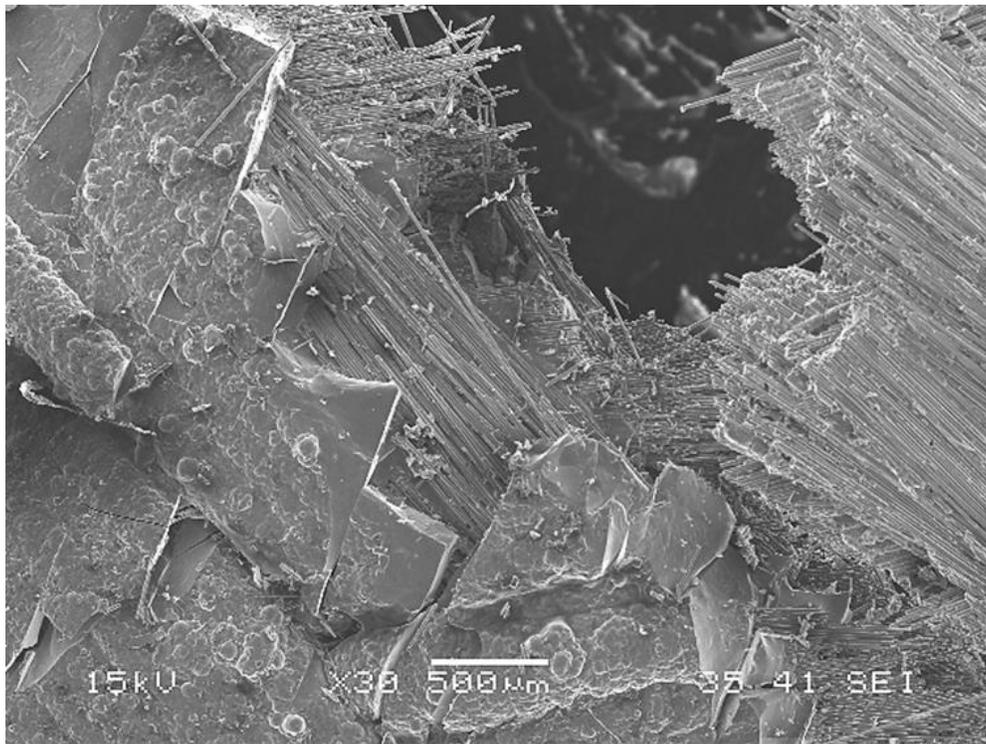
Figure 102: SEM view of failure location for GAOE 2 showing freed fibers

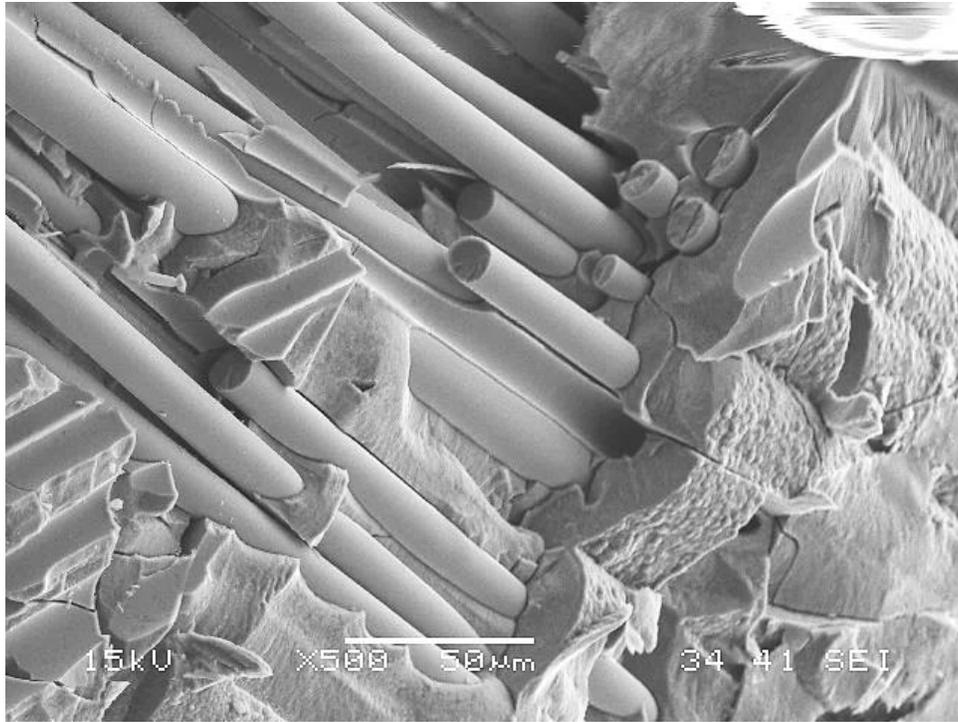
Figure 103: SEM view of fragmented intra-tow matrix for GAOE 2

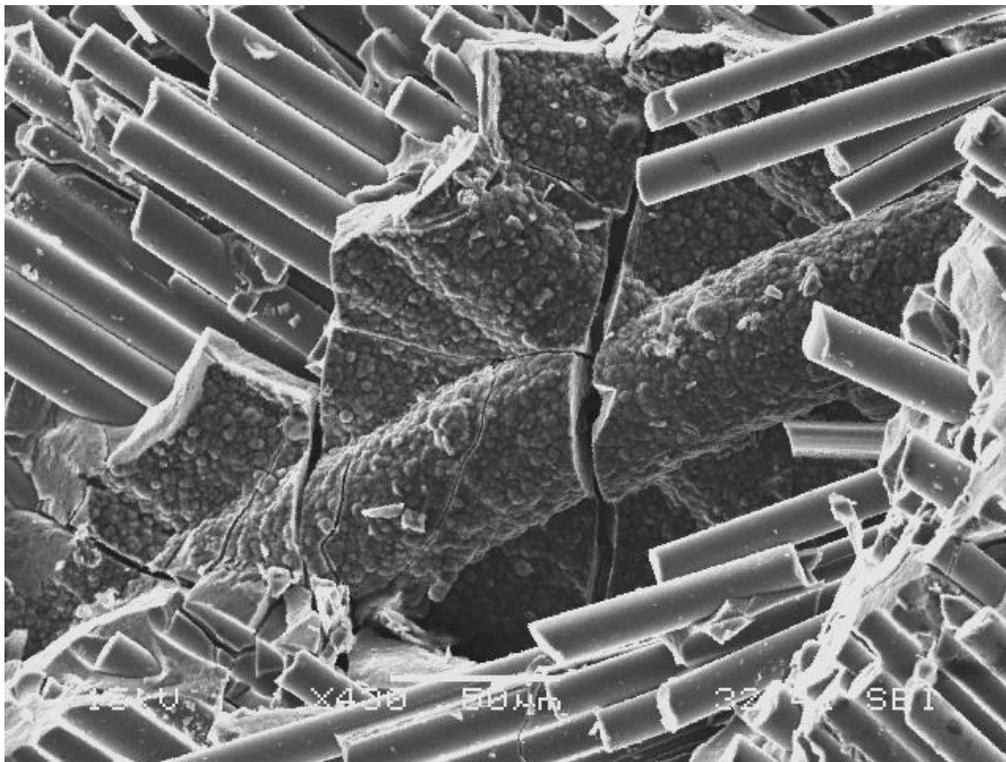
Figure 105: SEM view of CMC region of GAOE sample showing fragmented matrix among exposed fibers

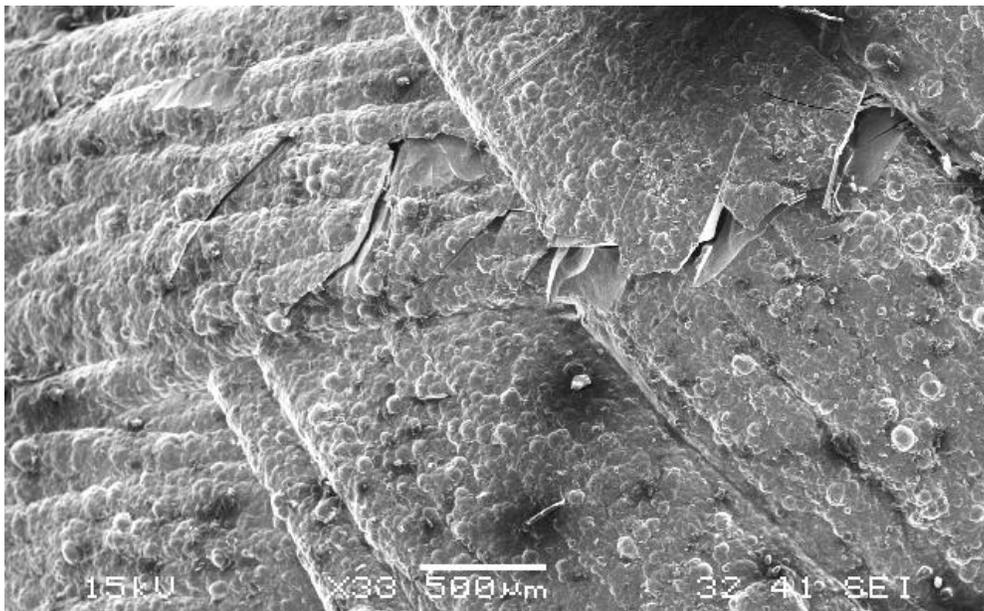
Figure 108: Lateral SEM image of GAOE 2 showing cracked EBC

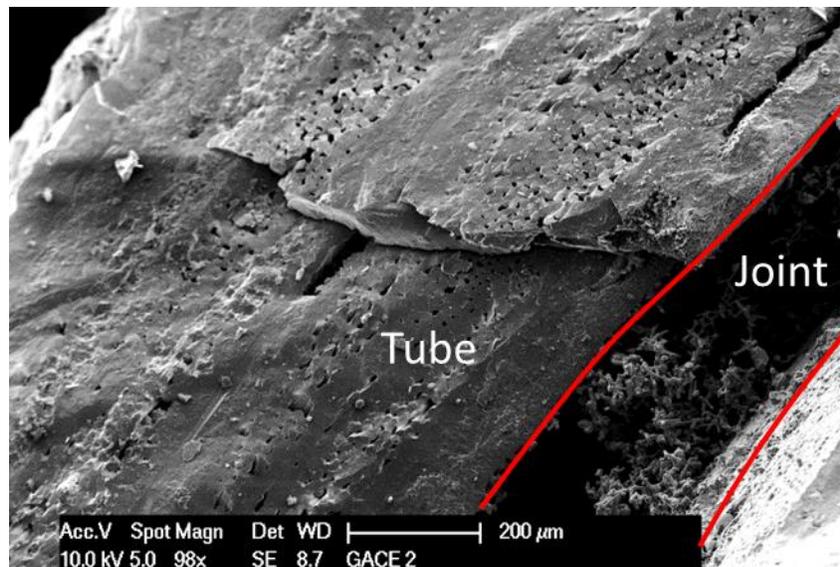
Figure 111: Cross-sectional SEM view of CMC region still attached to endplug

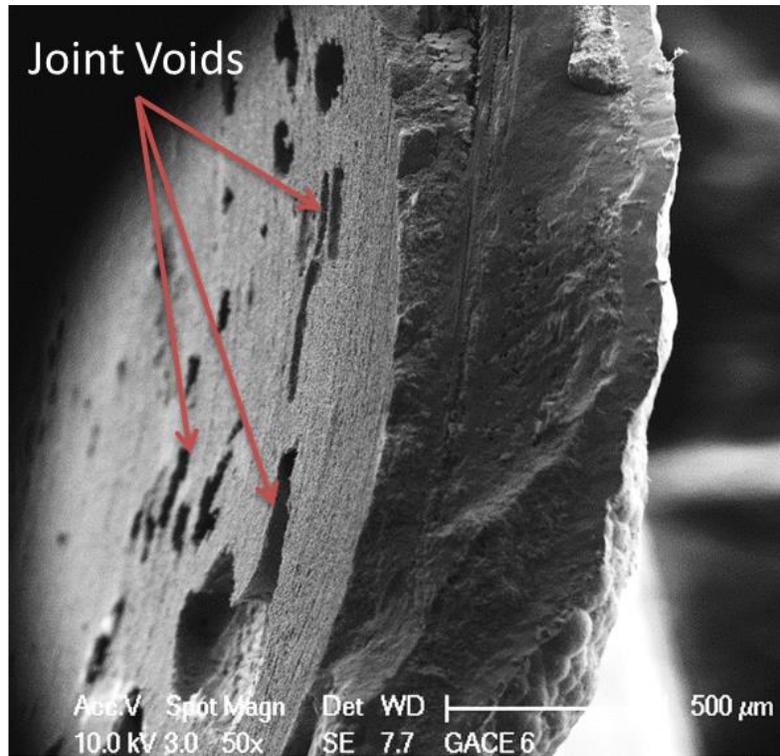
Figure 112: SEM view of joint inside tubing for GAOE 6 showing voids

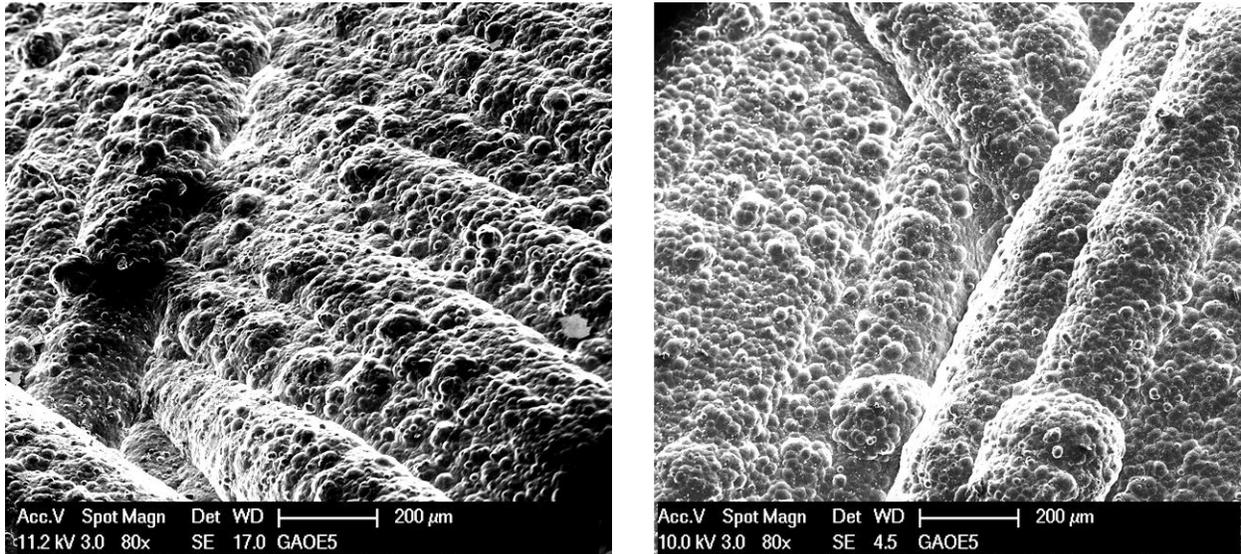
Figure 113: Lateral SEM view comparison of post-thermal-shock sample (left) with as-received sample (right)

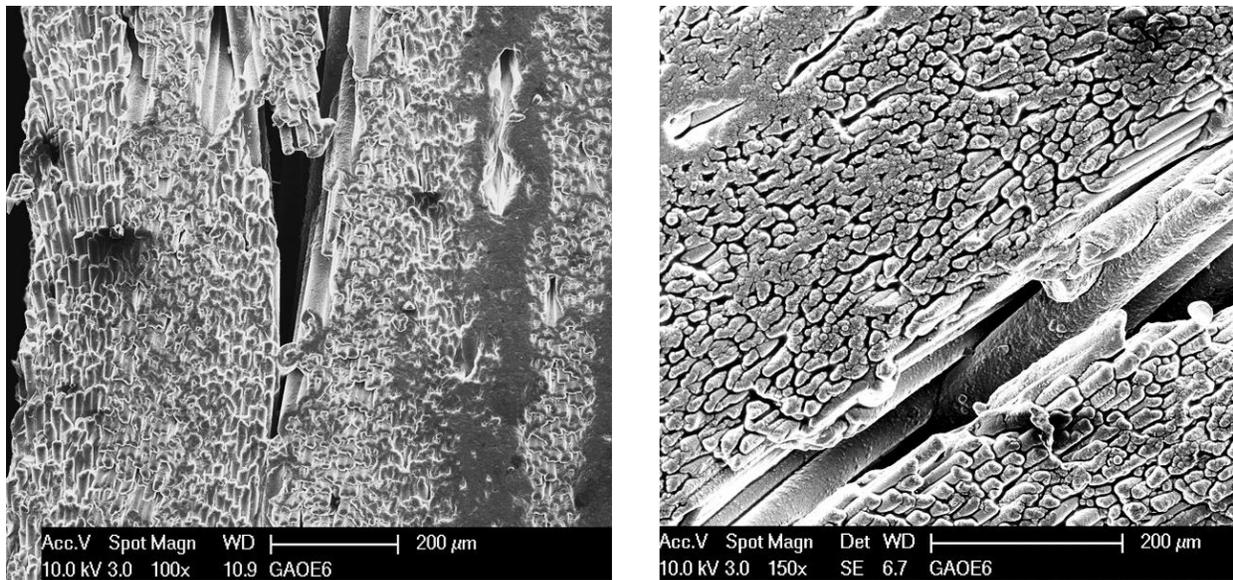
Figure 114: Cross-sectional SEM view comparison of post-thermal-shock sample (left) with as-received sample (right)

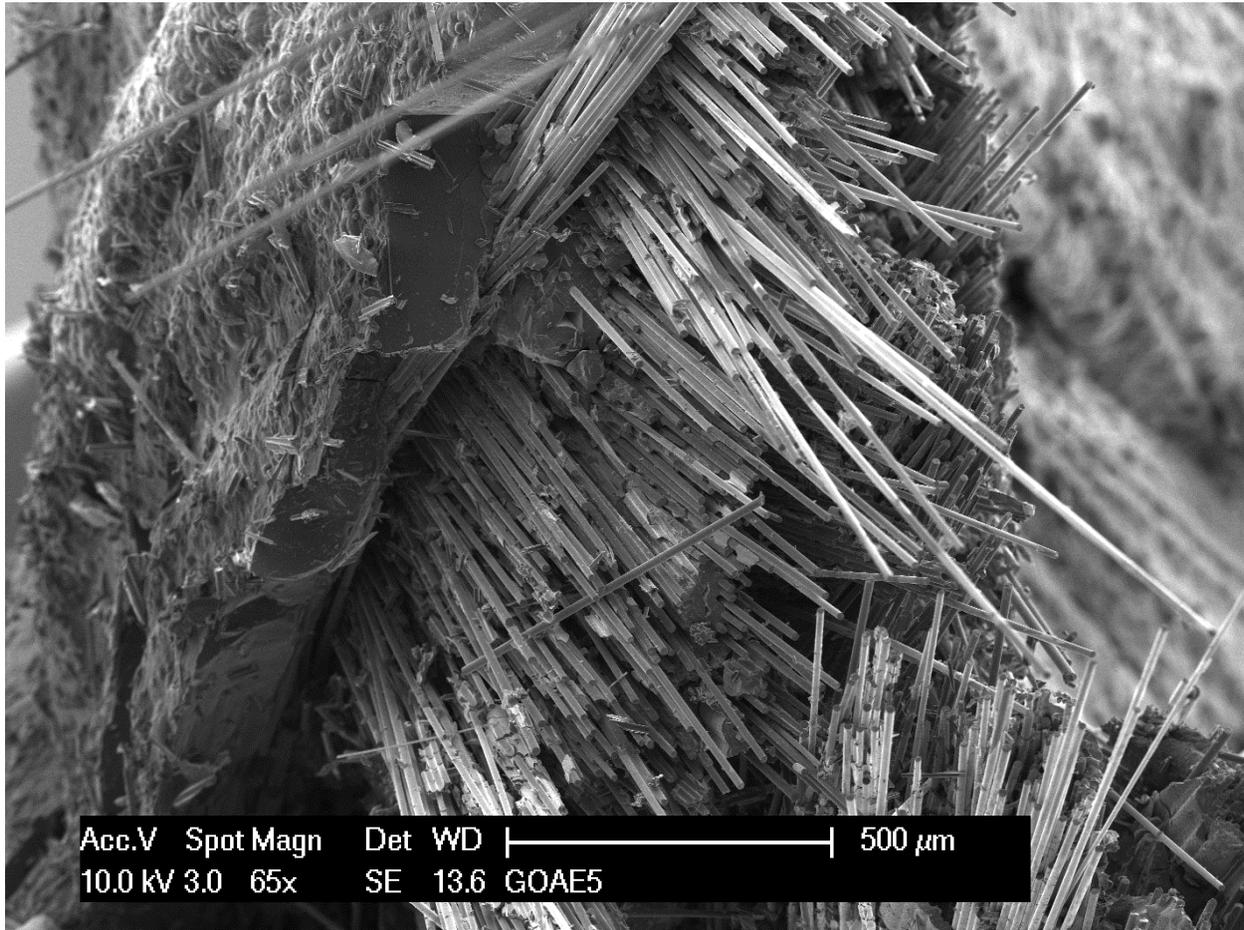
Figure 115: SEM view of failure location in thermal-shock sample showing fiber pullout

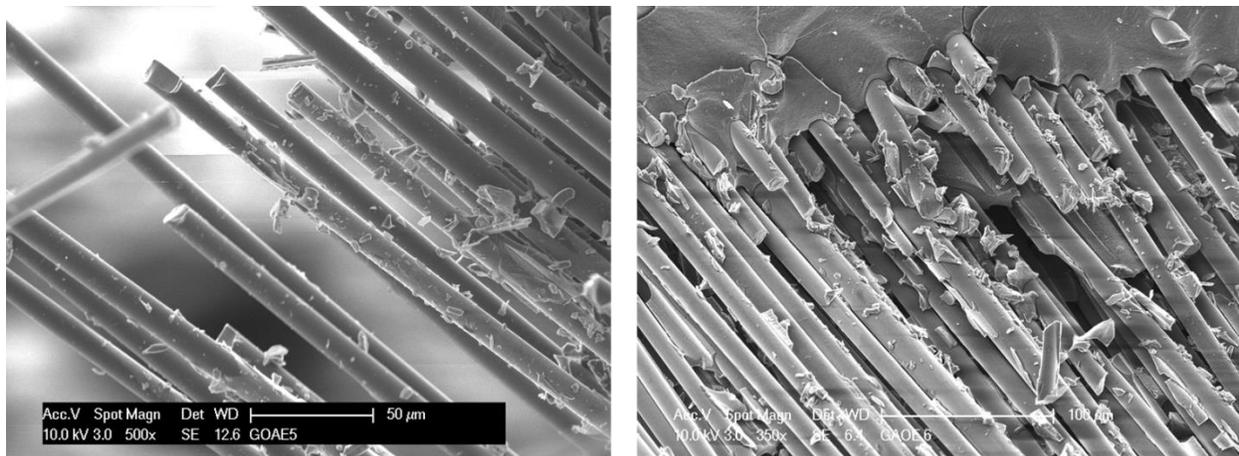
Figure 118: SEM views of failure location for GAOE 5 (left) and GAOE 6 (right) showing exposed fibers

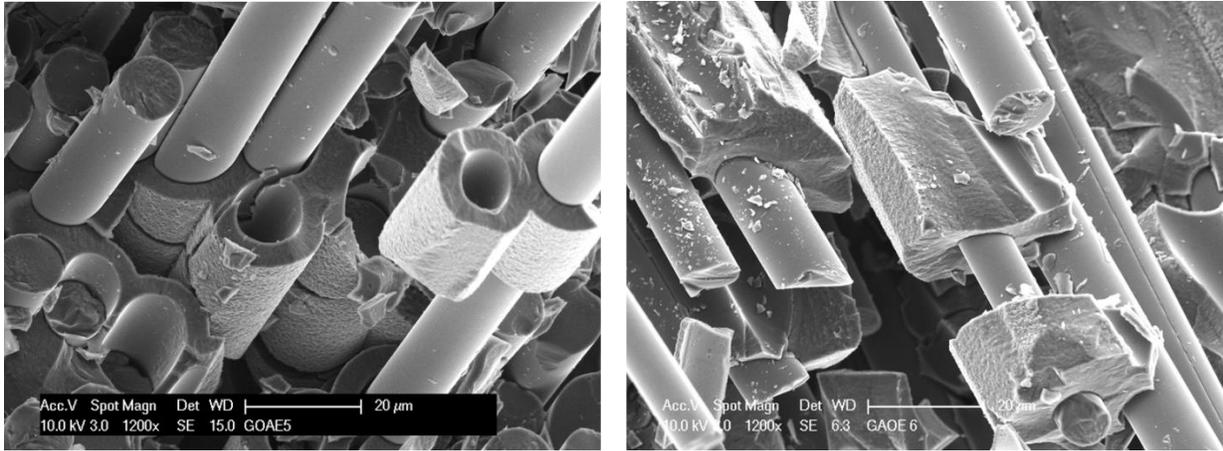
Figure 119: SEM views of failure location for GAOE 5 (left) and GAOE 6 (right) showing fragmented matrix

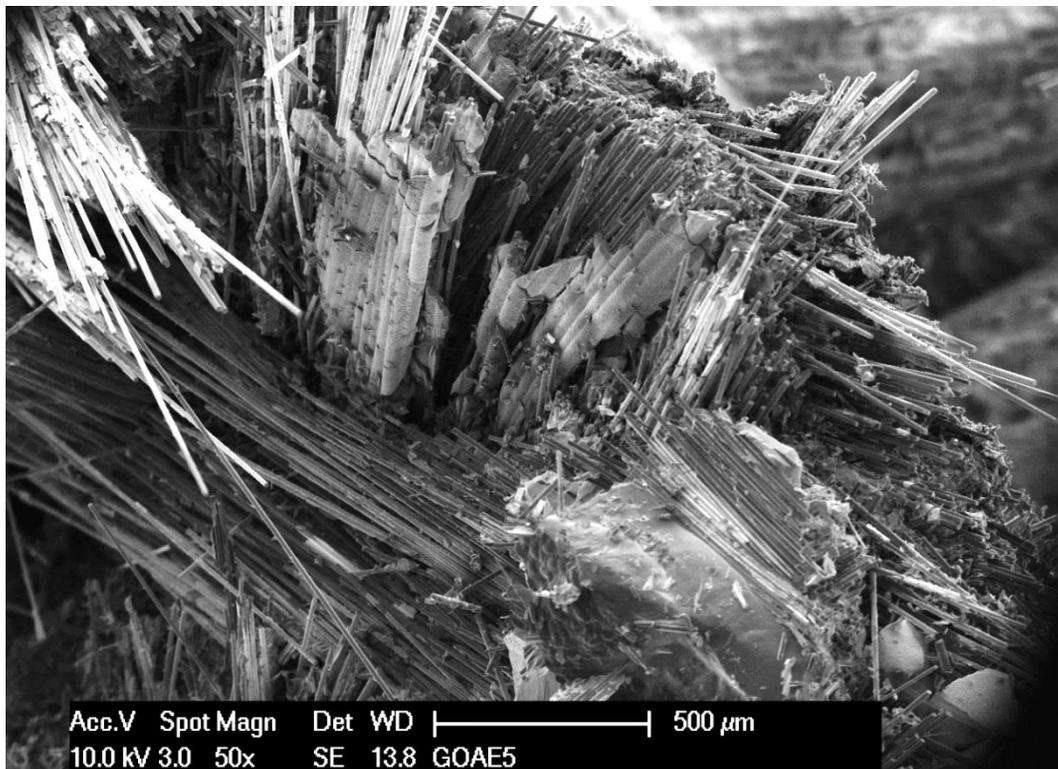
Figure 120: Lateral SEM view of failure location for GAOE 5

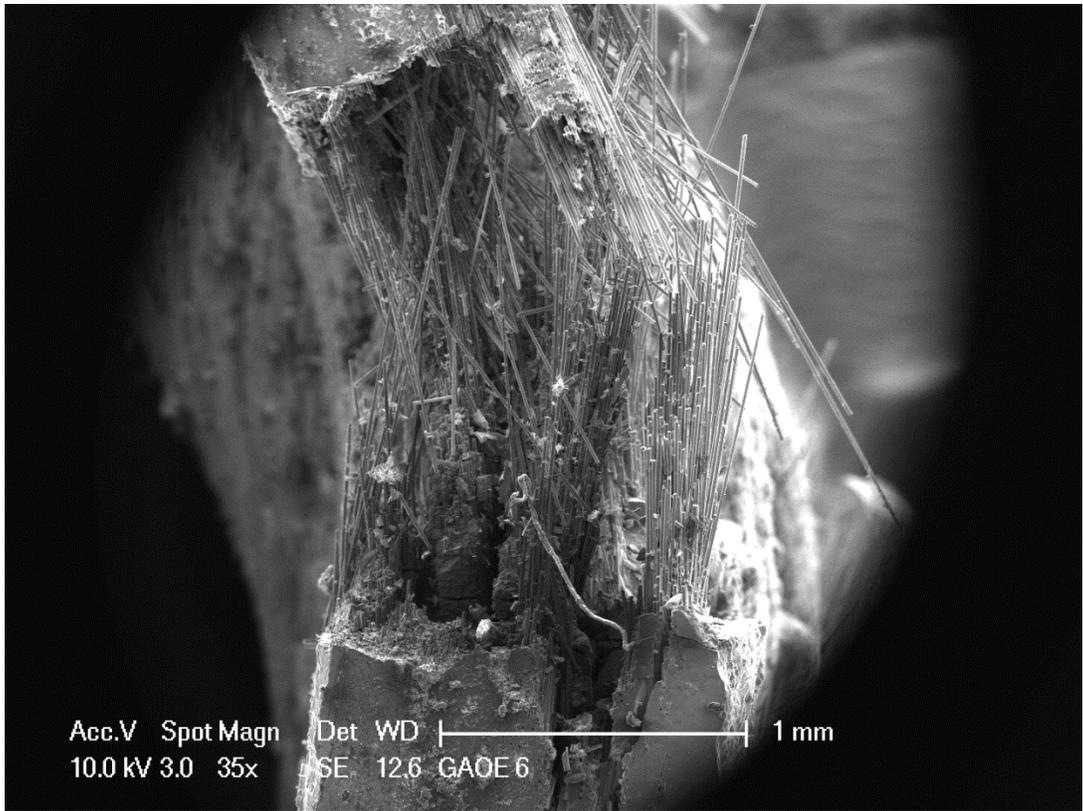
Figure 121: Cross-sectional SEM view of failure location for GAOE 6

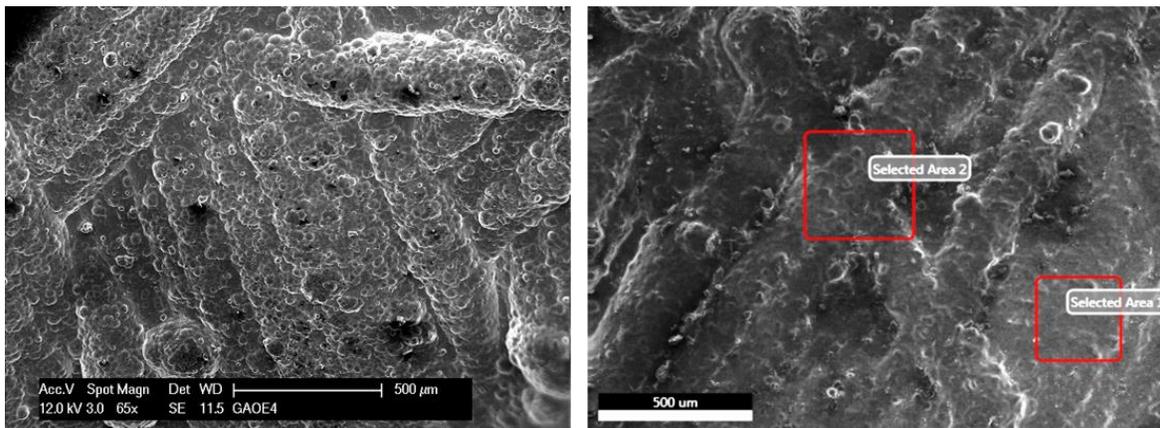
Figure 126: Lateral SEM view of GAOE 4 before (left) and after (right) oxidation

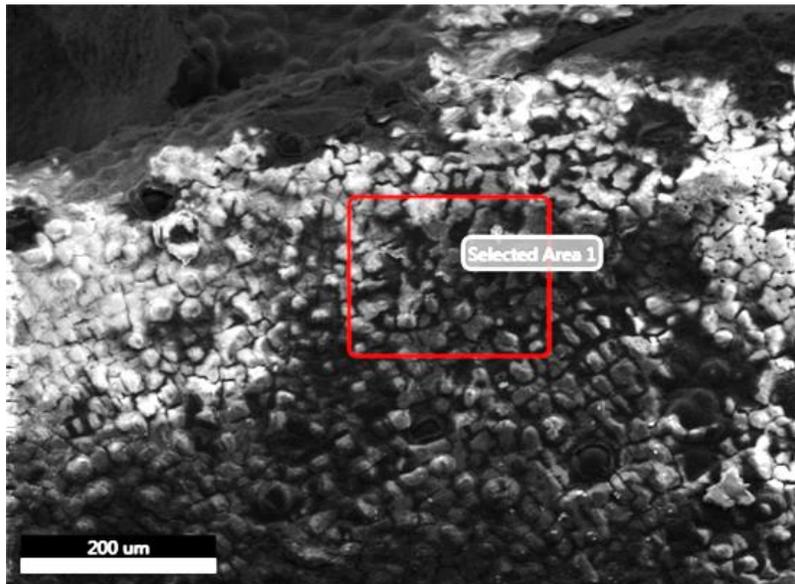
Figure 127: Cross-sectional SEM view of GACE 3 endplug showing faceted oxide morphology

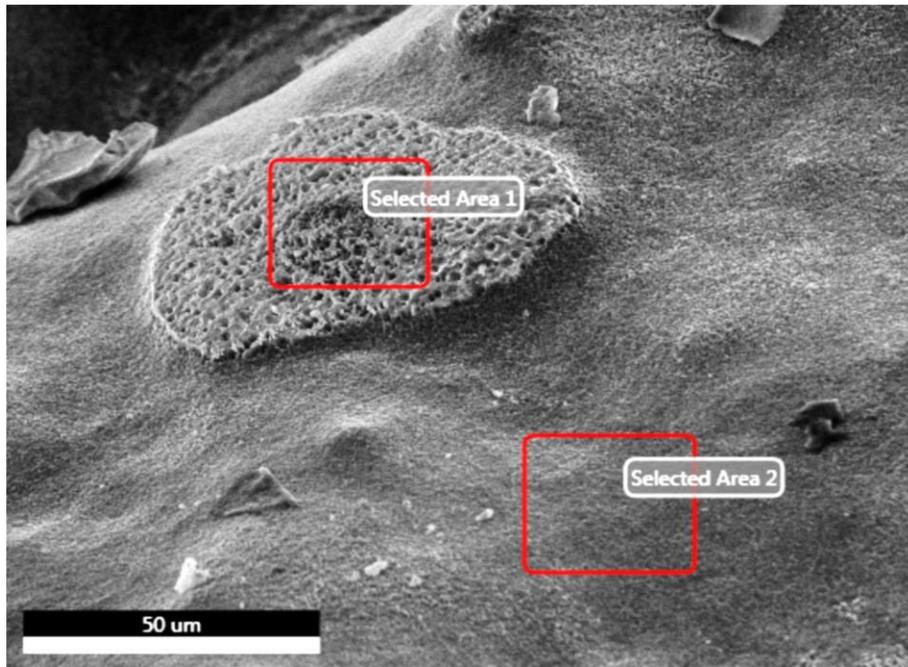
Figure 129: Lateral SEM view of GACE 4 endplug showing textured and smooth oxide

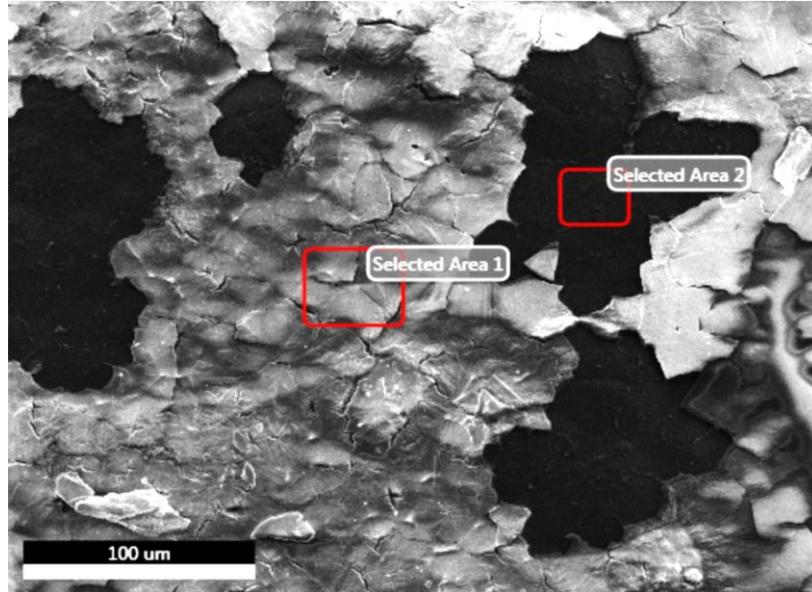
Figure 134: Lateral SEM view of GACE 4 endplug showing silica plate structure

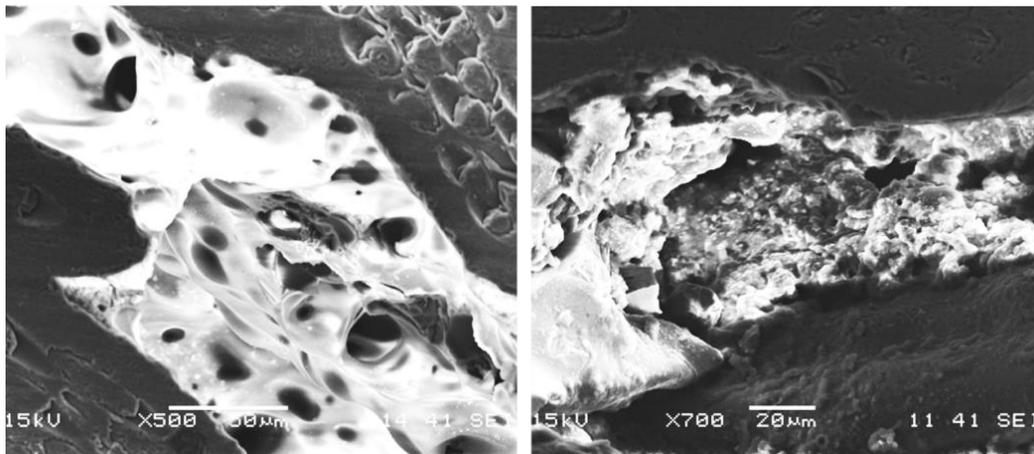
Figure 135: Cross-sectional SEM views of oxidized GAOE 3 (left) and GAOE 4 (right) showing oxide formation in CMC voids

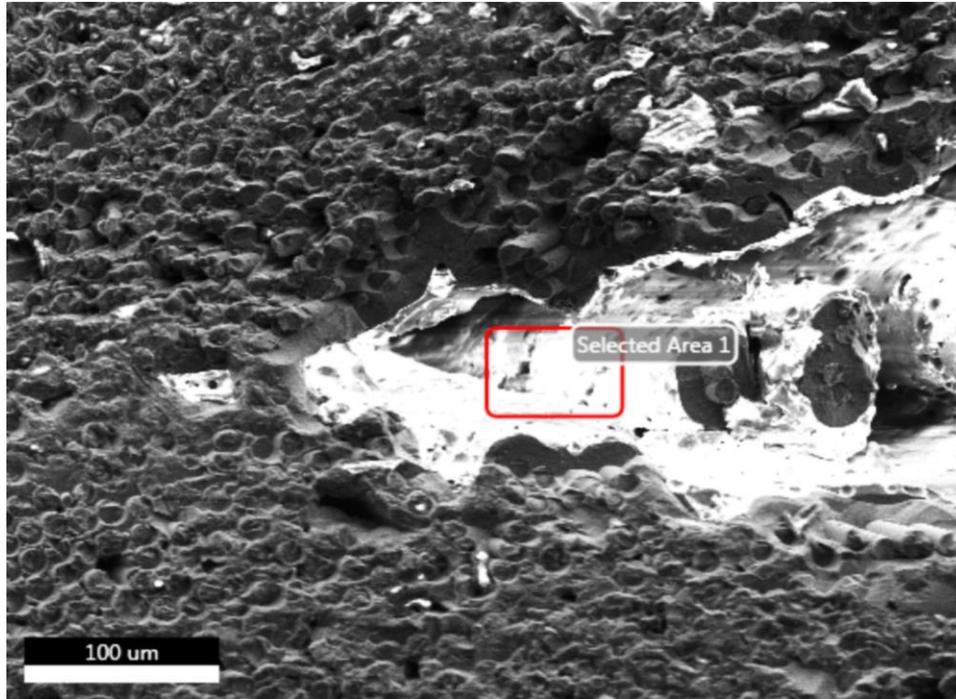
Figure 136: SEM view of silica formation filling GAOE 1 interior CMC void

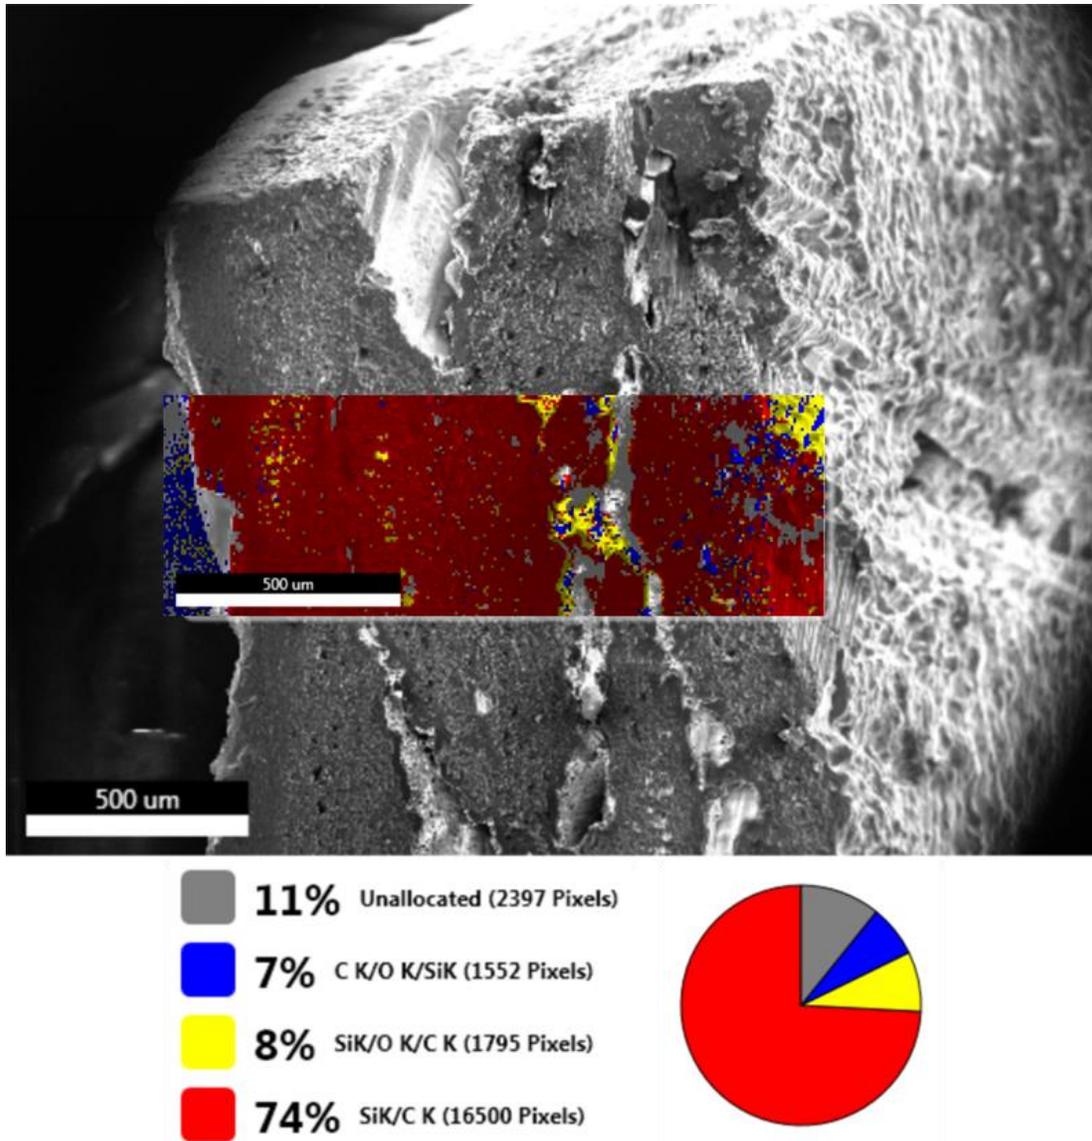
Figure 138: EDS analysis of GAOE 1 oxidation penetration from CMC voids into surrounding SiC

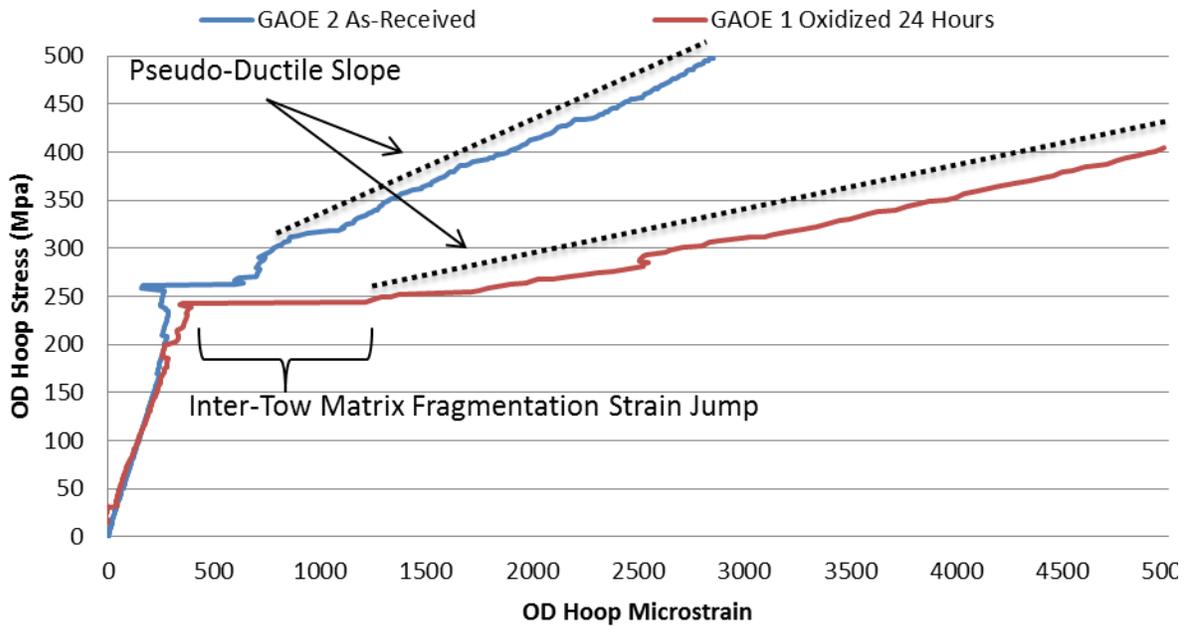
Figure 139: Illustration of stress-strain regimes important for oxidation behavior
