Evaluation of Multilayer Silicon Carbide Composite Cladding Under Loss of Coolant Accident Conditions

MASTER OF SCIENCE IN NUCLEAR SCIENCE AND ENGINEERING
AT THE
MASSACHUSETTS INSTITUTE OF TECHNOLOGY

Abstract

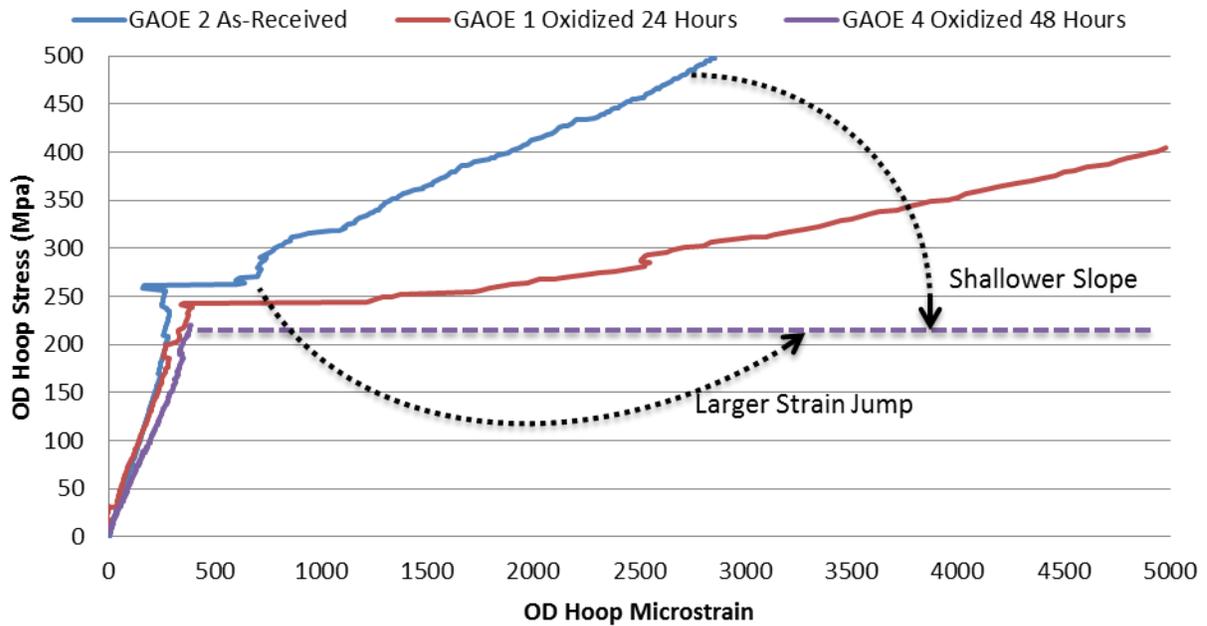
Figure 140: Illustration of evolution of brittle failure for oxidized samples

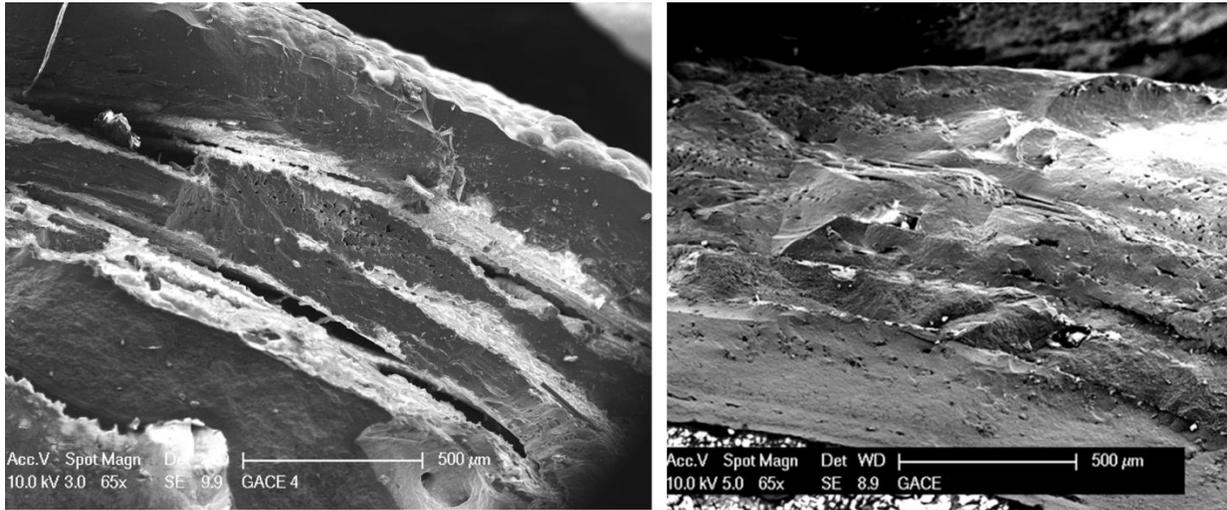
Figure 143: Cross-sectional post-pushout SEM views of GACE 4 (left) and GACE 3 (right)

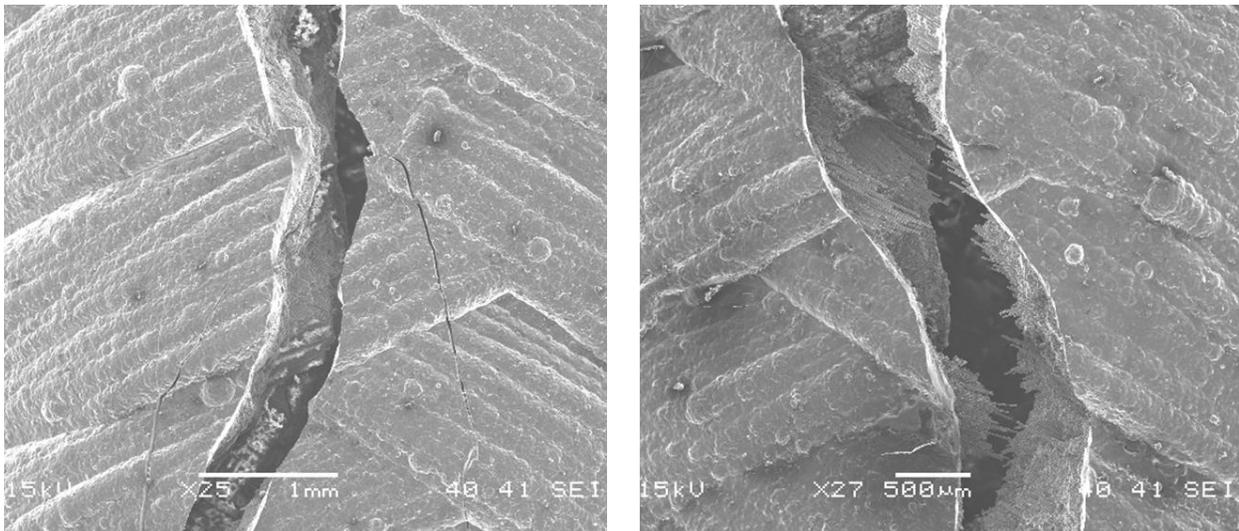
Figure 145: Lateral SEM view of failure location for GAOE 3 (left) and GAOE 4 (right)

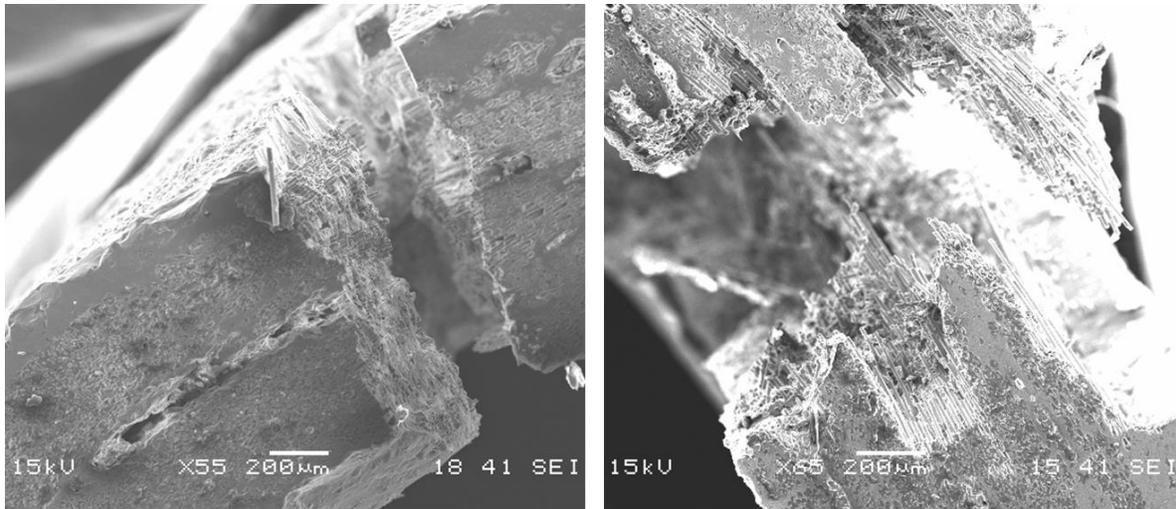
Figure 146: Cross-sectional SEM view of failure location for GAOE 3 (left) and GAOE 4 (right)

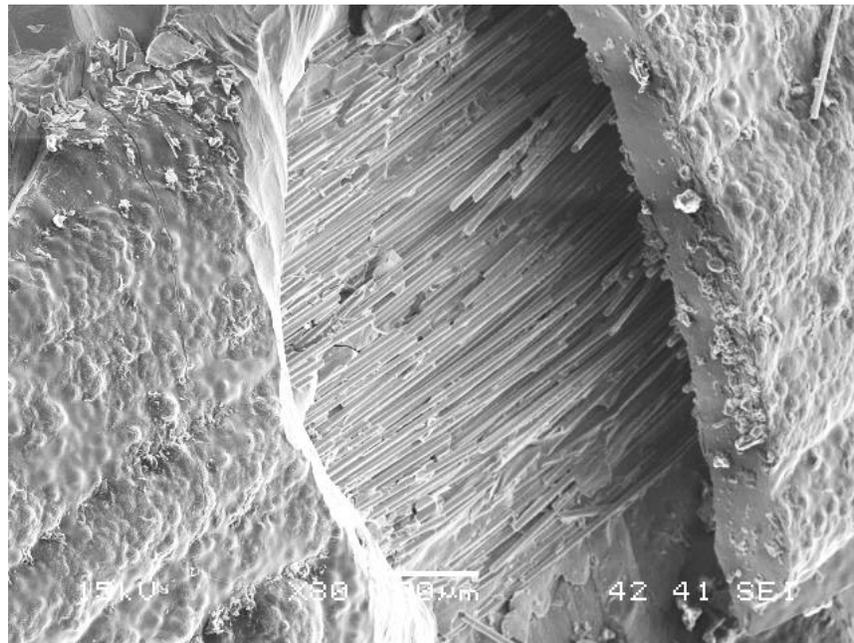
Figure 147: Lateral SEM view of fiber pullout observed in GAOE 4

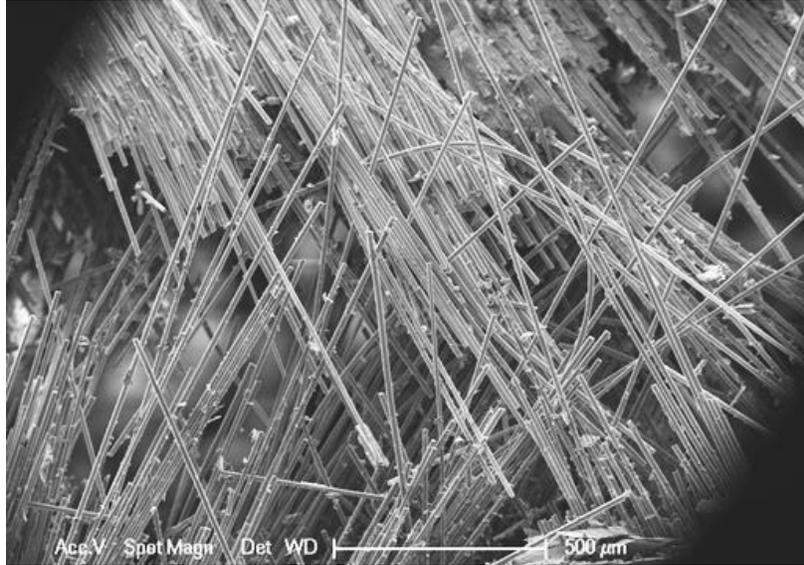
Figure 148: Lateral SEM view of failure location for GAOE 1

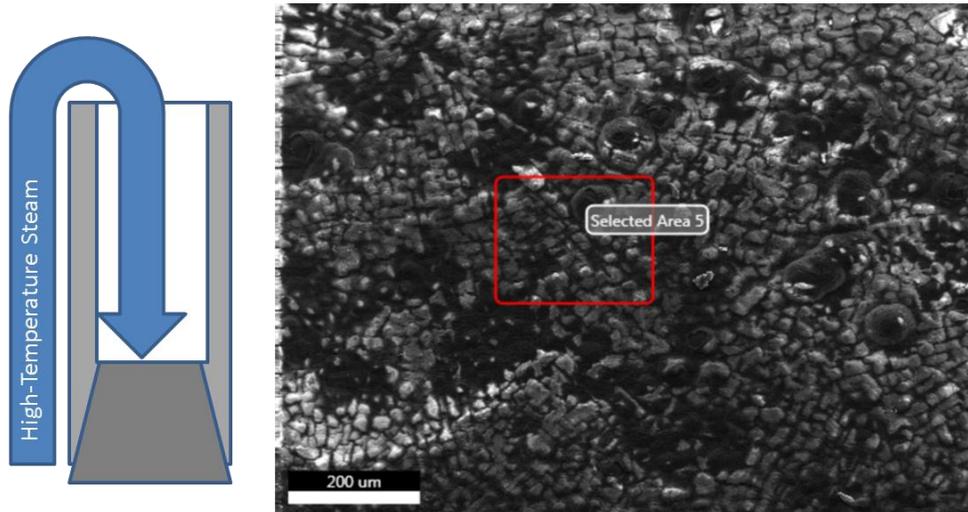
Figure 149: Steam flow path (left) and SEM view of top surface of GACE 3 endplug (right)

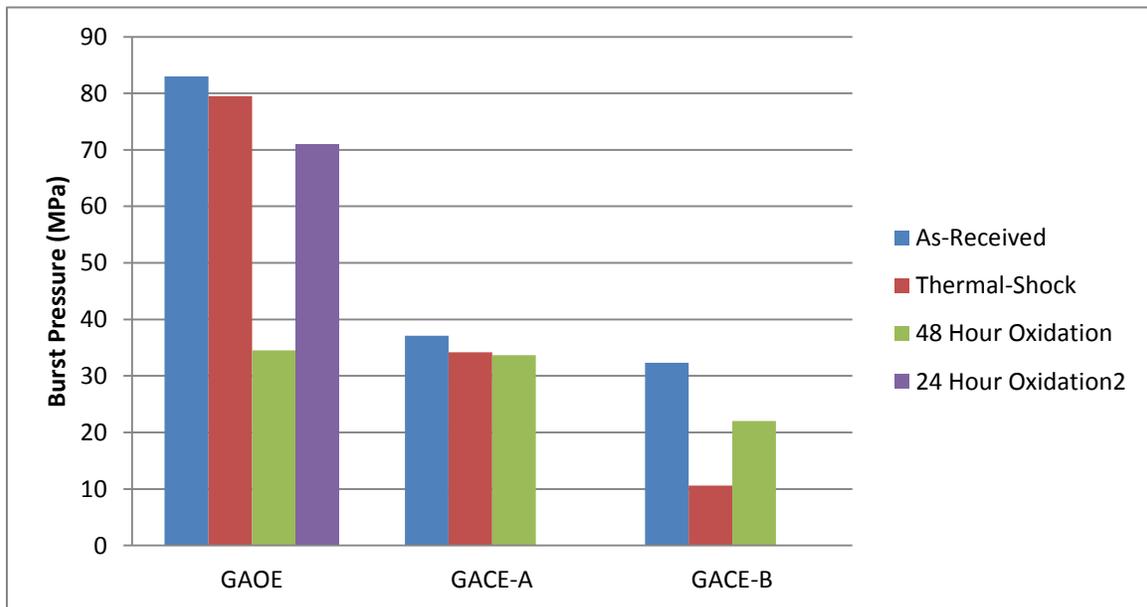
Figure 152: Comparison of results for all samples
