Corrosion Resistance of Concrete Reinforcement

SUBMITTED TO THE DEPARTMENT OF CIVIL AND ENVIRONMENTAL
ENGINEERING IN PARTIAL FULFILLMENT OF THE REQUIREMENTS FOR THE
DEGREE OF

MASTER OF ENGINEERING IN CIVIL AND ENVIRONMENTAL ENGINEERING
AT THE
MASSACHUSETTS INSTITUTE OF TECHNOLOGY

JUNE 2005

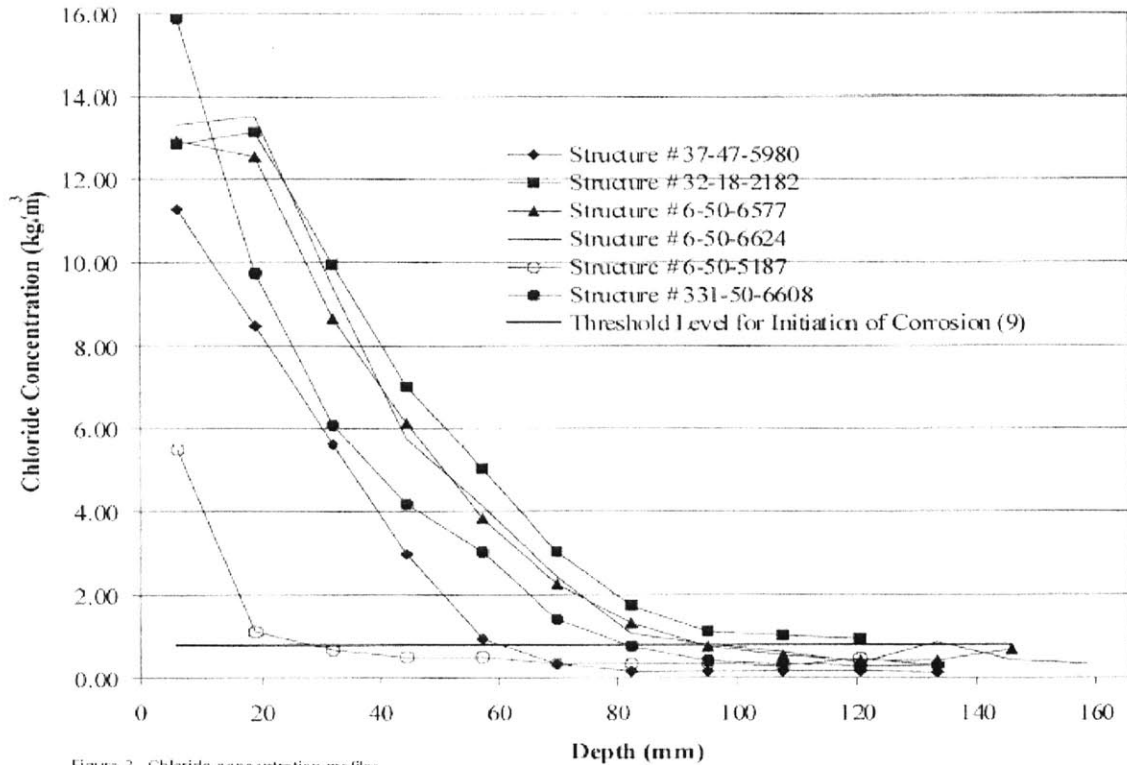
Figure 1: Chloride Concentration v Concrete Depth

Highway Agency (FHWA) specifies CCC as 0.4 – 1% by cement weight for typical carbon steels. A typical corrosion threshold used by state DOTs is 1.2 lb/yd³ (300 ppm), which corresponds to a CCC of 0.2% of cement weight of concrete. In the presence of higher alkalinity of the concrete and the water in the voids, the iron oxide film protecting the steel from the initiation of chloride corrosion will provide more protection to the steel and increase the corrosion threshold. Figure 1 illustrates the diffusion of chloride ions through the concrete as concentration of chloride versus the depth from the surface of the concrete. The solid line at the bottom of the plot shows the chloride threshold for initiation of corrosion (~50 mm = 2” or typical rebar depth).

Figure 3. Chloride concentration profiles

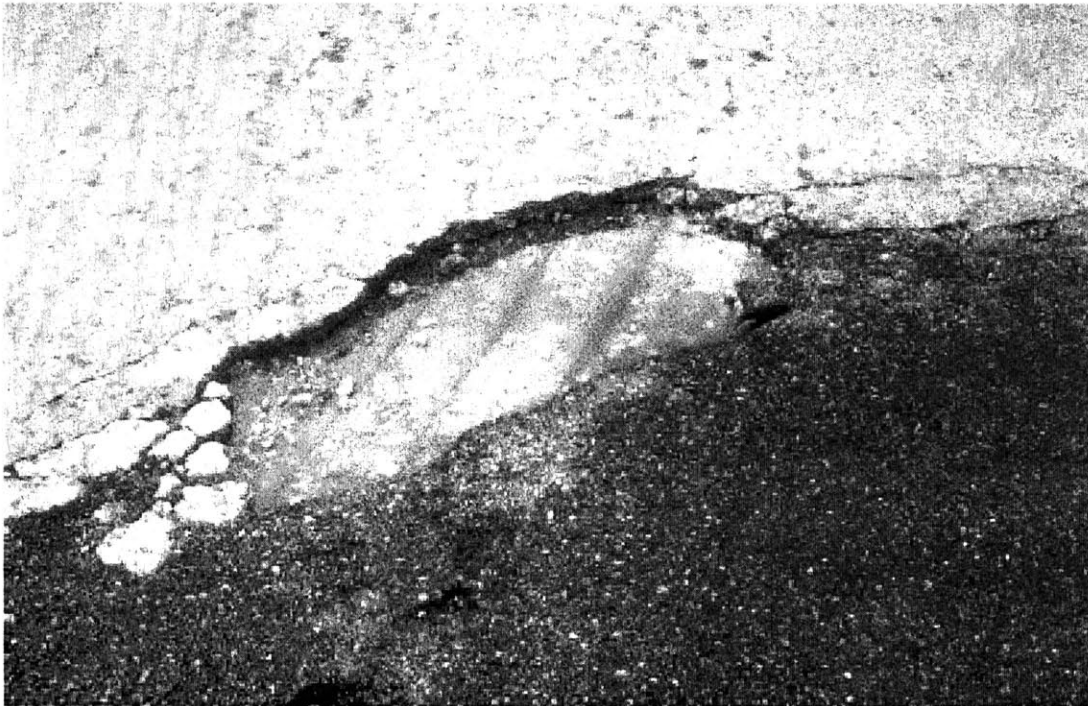
Figure 2: Concrete Spalling with Exposed Reinforcement

The products of corrosion can increase the volume of the bar by 3-6 times its original volume, applying significant pressure and stresses to the surrounding concrete and resulting in cracking, spalling (Figure 2), and delamination. This damage caused to the concrete provides new pathways for the corrosive agents to reach the steel.

Eventually the corrosion-induced damage in a concrete element becomes significant enough to require repair and maintenance. The point at which the concrete requires maintenance to remain in service is termed the end of functional service life of the element.

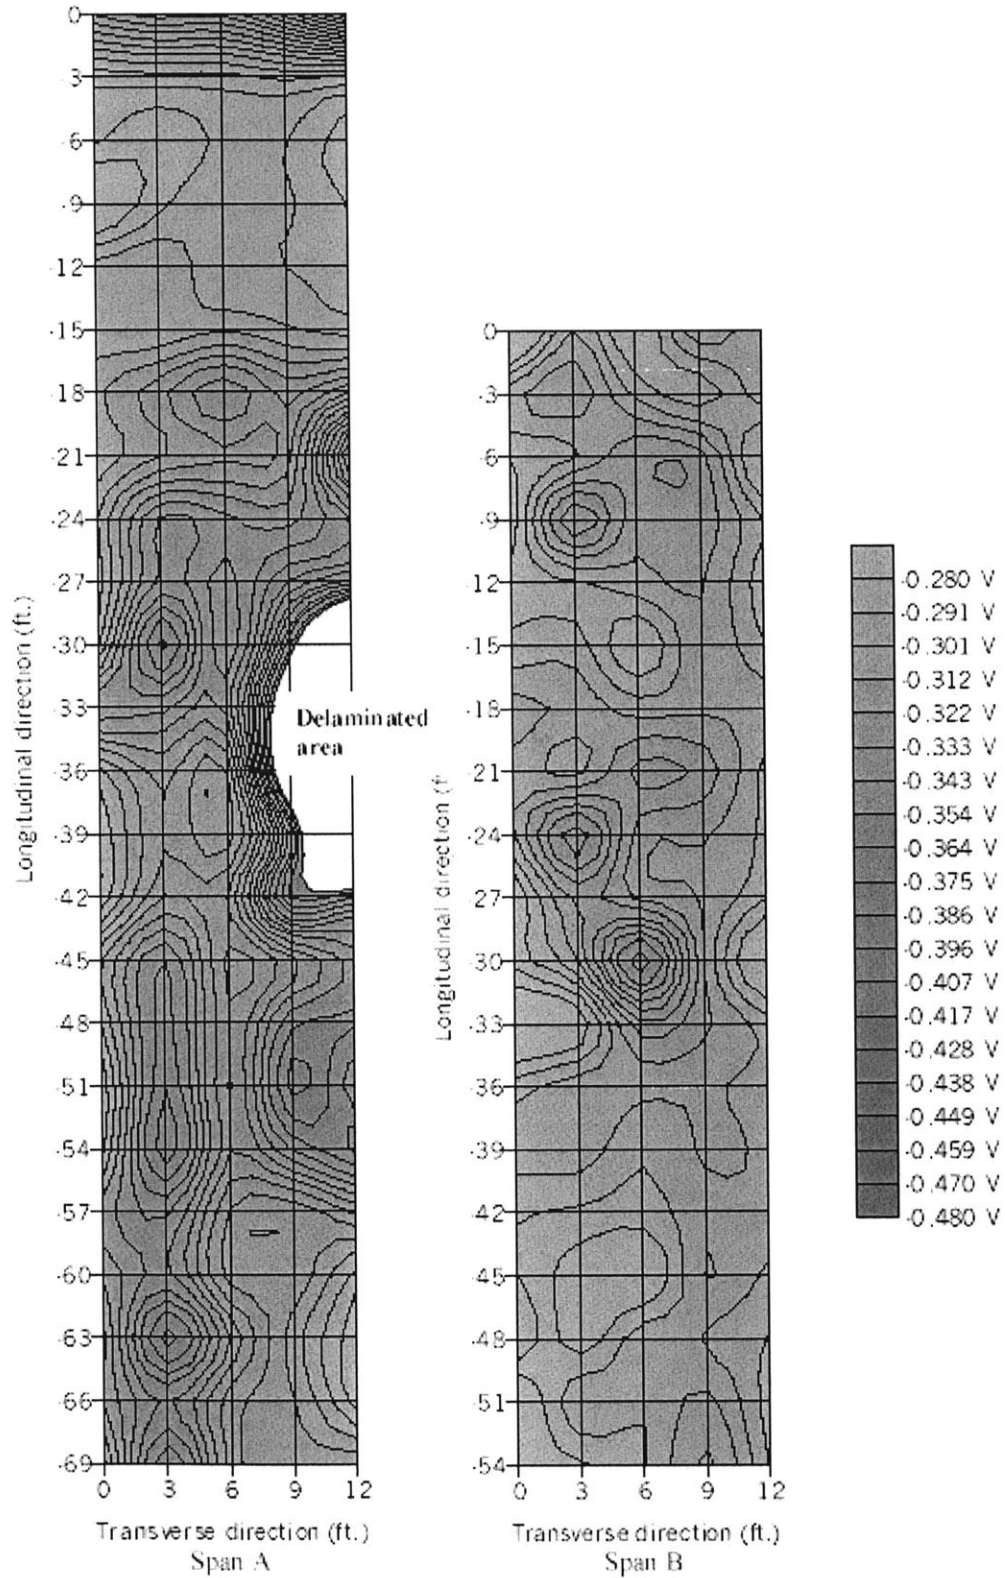
Figure 3: Electrical contour mapping

- Electrical continuity tests and corrosion potential mapping – Using a half-cell, electrical connections are made to the rebar and voltage readings are taken across the rebar. The voltages can be interpreted using the Numeric Magnitude Technique (ASTM C876) to the corrosion state of the rebar (the existence of corrosion is measured as a negative shift in the half-cell potential). If enough readings are taken over the whole deck surface the condition of the deck can be “mapped” as shown in Figure 3. (These methods are performed only on uncoated steel rebar.)

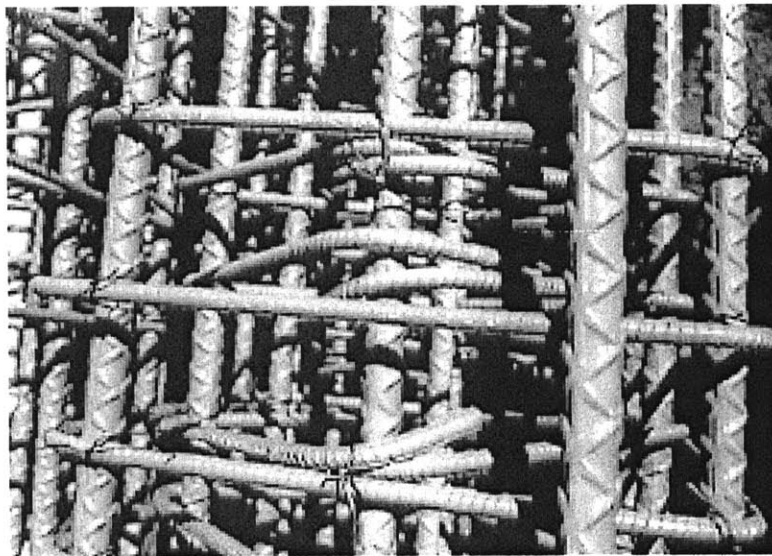
Figure 4: Epoxy Coated Rebar

Designed to provide a physical barrier between chlorides and oxygen absorbed in the concrete and the reinforcing steel, epoxy coating consists of organic epoxy resins combined with curing agents. Epoxy coating is a thermoset material; meaning that it is not subject to damage by high temperatures once it is cured. The coating starts out as a dry powder, and is heat-treated to melt the powder and catalyze the chemical reaction that

The surface of the steel must be cleaned and roughened with abrasive material in order to provide an uneven surface for the epoxy to bond to mechanically as well as chemically. The steel is then heated and passed through a sprayer which charges the epoxy powder and causes it to evenly coat the surface of the steel. The heated steel melts the powder on contact, initiating the chemical reaction that forms complex polymers in the epoxy and bonds the epoxy molecules to each other and the rough steel surface.

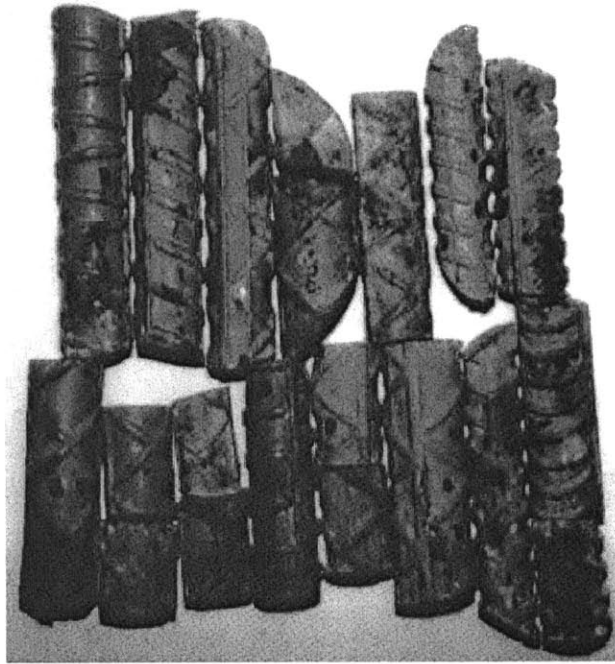
Figure 5: ECR Showing Significant Corrosion

A corrosion rating of 3 indicates noticeable corrosion (Figure 5), and ECR with ratings of 3 were extracted from concrete with chloride concentrations around 7.5 lb/yd³. This signifies an approximate corrosion threshold for ECR around 7.5 lb/yd³ and a conservative estimate approximately half of this value or 3.6 lb/yd³. The end of functional service life for R/C elements reinforced with ECR is associated with a corrosion rating of 1, plus 5-8 years for the corrosion product to build up and create spalls and delaminations in the concrete. Using this method of prediction for the end of

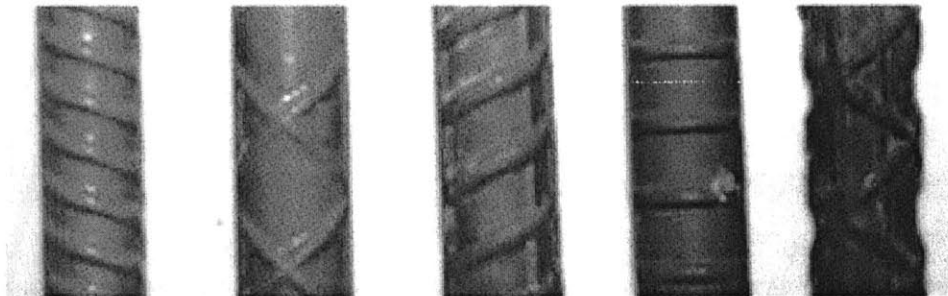
Figure 6: ECR Showing Discoloration

EC also becomes discolored (Figure 6) after prolonged exposure to chloride contamination. A closer look at a severely discolored ECR with a scanning electron microscope (Figure 7) revealed a network of micro-cracks that had developed on the coating surface. At this time little is understood about the impact of these cracks, and for now they are assumed to be superficial and negligible.

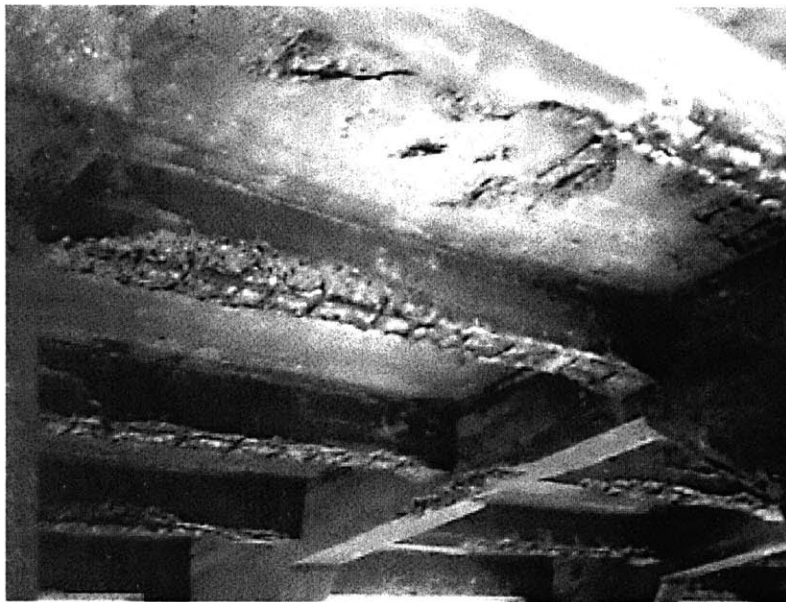
Figure 8: Extensive Black Steel Rebar Corrosion on Parking Garage Ceiling

The City of Minneapolis specifies a high water/cement ratio (.38 - .45) and corrosion inhibitors in the concrete mix to be used in conjunction with ECR for parking garage construction. Parking garages built around 1980 with black uncoated rebar

exhibited significant corrosion (Figure 8) and required extensive maintenance within a few years of construction. Minneapolis' Government Center parking garage required \$3 million to repair and replace more than 30% of the concrete after only 12 years of service. The repair cost eventually exceeded the cost of construction. Part of the problem at Government Center was that 1.5" of concrete cover for the rebar had been specified and poor construction resulted in an average of only 1" of cover. Quality of construction is often an unreliable variable and provisions should always allow a factor of safety to account for possible shoddy work.

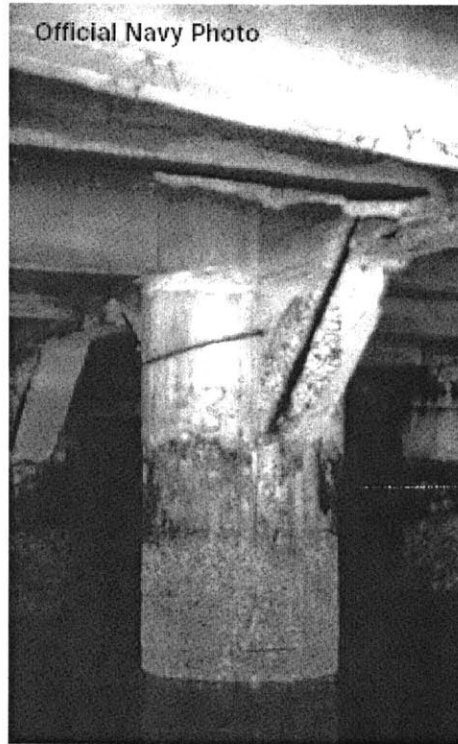
Figure 9: Navy Marine Structure with Extensive Corrosion Damage

The US Navy owns thousands of marine structures in which the major mechanism of deterioration is corrosion of the reinforcement (Figure 9). In addition to ACI standards, the Navy requires a water/cement ratio of 0.4 and 3" of concrete cover for reinforcement used in R/C structures with "splash zone exposure." These marine structures are often subject to more severe conditions than the typical bridge deck would due to tidal wetting with salt water and drying and higher temperatures in subtropical

locations that speed the rate of corrosion. As in the Minneapolis garages, inspection of the Navy structures has shown that the specified level of quality was not always maintained, and as little as ½” of concrete cover was discovered in several cases. Chloride content where only ½” of cover existed was measured at levels reaching 10 kg/m³, with only 1 kg/m³ required to initiate corrosion in steel.

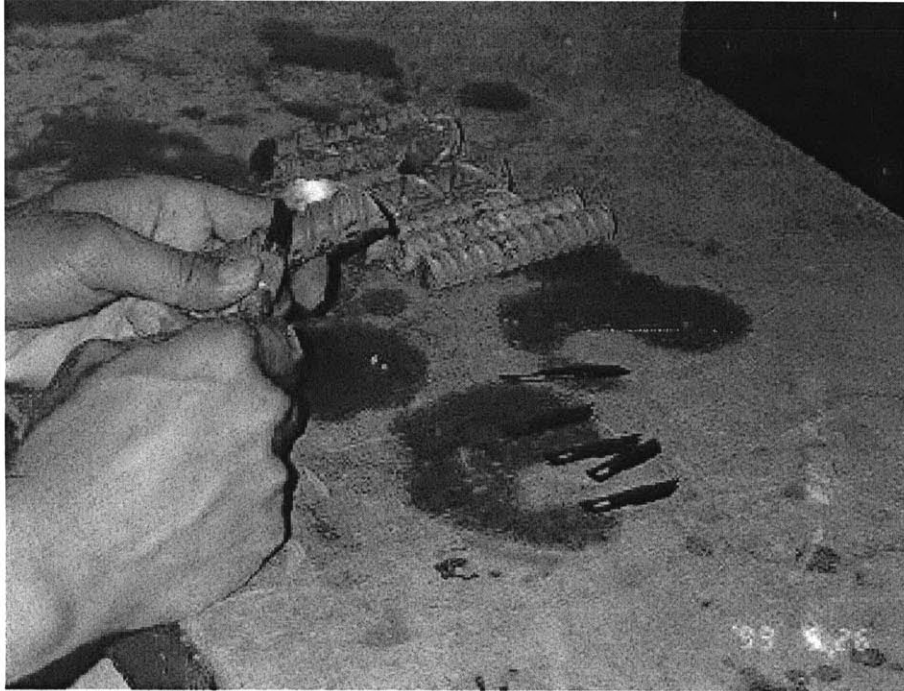
Figure 10: Dry Knife Adhesion Test

A study conducted at Iowa State University for the Iowa DOT attempted to describe the relationship between deterioration of ECR in cracked and uncracked concrete, as well as the improvement provided by placing ECR in both the top and bottom mats of bridge decks as opposed to strictly the top mat.

Rating	Description
3	Well adhered coating that cannot be peeled or lifted from the substrate steel
2	Coating that can be pried from the substrate steel in small pieces but cannot be peeled off easily
1	Coating that can be peeled from the substrate steel easily, without residue

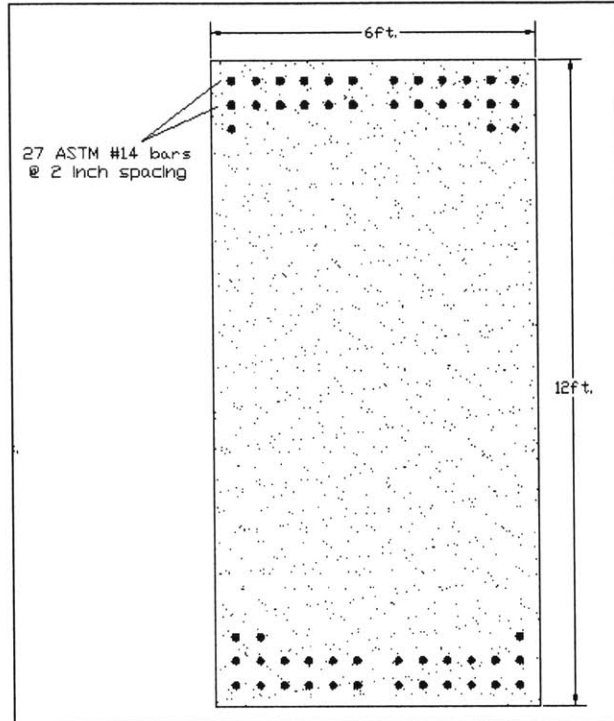
Figure 12: Bridge Pier Cross Section

1. Using a previous design (Figure 12) for the reinforcement of a bridge pier using ASTM standard black steel rebar, estimate the service life of the pier. The pier cross section measures 6' wide by 12' deep, and is reinforced with 27 ASTM No. 14 bars at each end. Two inches of concrete cover as well as two inches of spacing is provided between all rebar and the exterior of the concrete section.
