Heavy Ion radiation assessment of a 100G/200G commercial optical coherent DSP ASIC

Raichelle J. Aniceto, Randall Milanowski, Steve McClure, Alexa Aguilar, Slaven Moro, Eric D. Miller, Kerri Cahoy, Neal Nicholson, Daniel Greene, "Heavy Ion radiation assessment of a 100G/200G commercial optical coherent DSP ASIC," Proc. SPIE 10910, Free-Space Laser Communications XXXI, 1091011 (4 March 2019); doi: 10.1117/12.2513244

Event: SPIE LASE, 2019, San Francisco, California, United States

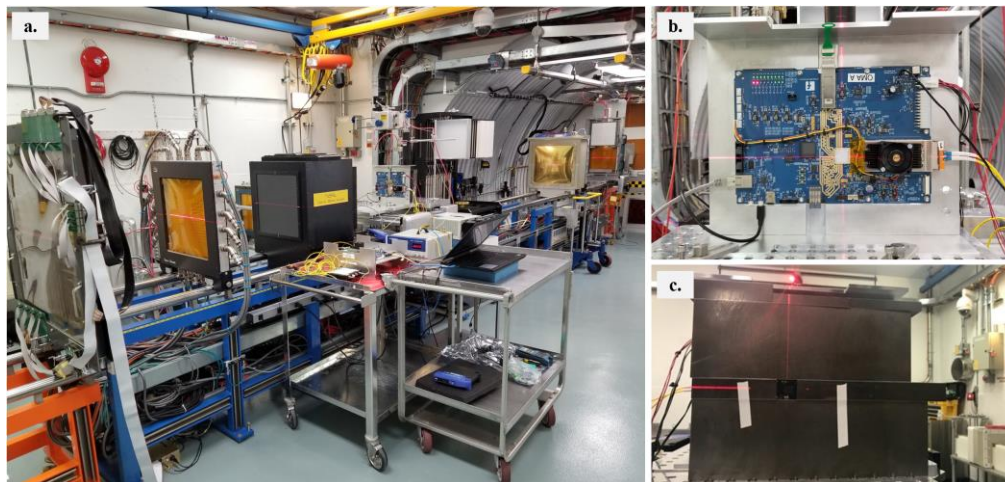
Figure 4. Heavy ion radiation test setup at NSRL. (a) The OMA fixed to a test stand in line of heavy ion beam and (b) the DUT aligned to center of the heavy ion beam path using lasers. (c). Lead blocks used to shield the rest of the OMA from heavy ion radiation.

Heavy ion radiation testing was conducted at NASA Space Radiation Laboratory (NSRL) at Brookhaven National Laboratory (BNL) in Long Island, NY. The OMA was fixed to a test stand in-line of heavy ion beam penetration, and a laser was used to align the DUT to the center of the heavy ion beam. Lead blocks were placed in front of the OMA with a small square hole above the DUT area to block the peripheral OMA components from heavy ion radiation and to ensure heavy ion radiation was isolated to the DUT. The test setup equipment for optical noise-loading, GOMA, laptops, and power supplies were set-up on a cart next to the OMA and out of the direct path of the heavy ion beam. Figure 4 shows the heavy ion radiation test setup at NSRL. Figure 4(b) shows the OMA with laser alignment of DUT in the center of the heavy ion beam path and Figure 4(c) shows the lead blocks used to shield the rest of the OMA from heavy ion radiation.
