# Fatigue Crack Initiation in Weldments

Takatoshi Nakamura

Submitted to the Department of Ocean Engineering on September 27, 1993  
in partial fulfillment of the requirements for the Degree of  
Ocean Engineer and  
Master of Science in Mechanical Engineering.

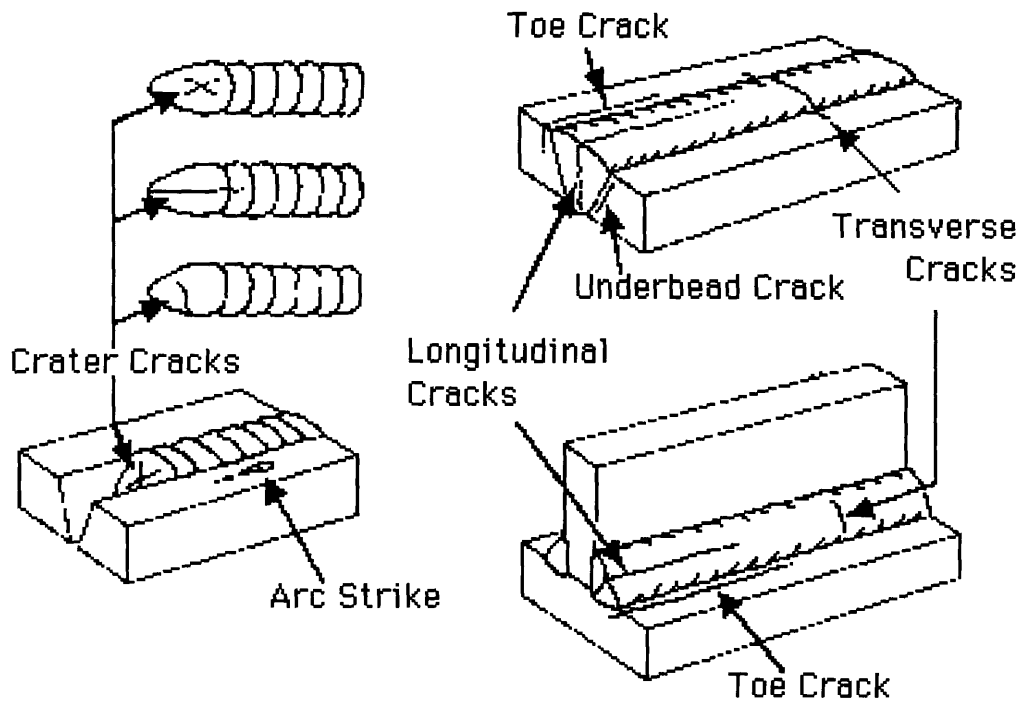
Figure 3.2.1. Cracks in welded joints [Ref. 1]

Whenever the welding operation is interrupted, there is a tendency for the formation of cracks in the crater. These cracks are usually star-shaped and proceed only to the edge of the crater.

Figure 3.1.1 shows the three categories.

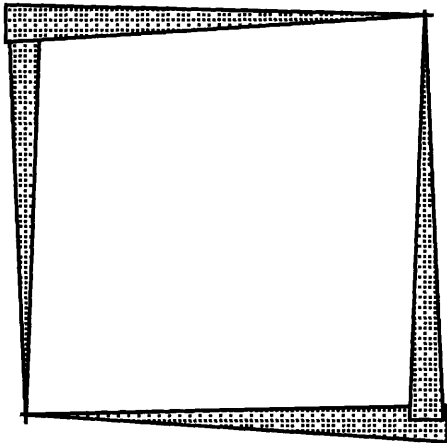
Figure 3.2.2. Types of horizontal discontinuity

Although this classification was sufficient to visible cracks, a new classification standard is necessary to make classification of micro surface discontinuities of the weld surface. The new standard refers to shape, direction, and depth or height. First, two major categories, horizontal discontinuities and vertical discontinuities are suggested. Horizontal discontinuities are the horizontal openings, which are usually deep and called cracks. They are classified into three subcategories by their appearance and direction. Figure 3.2.2 shows those three types. They are as follows:

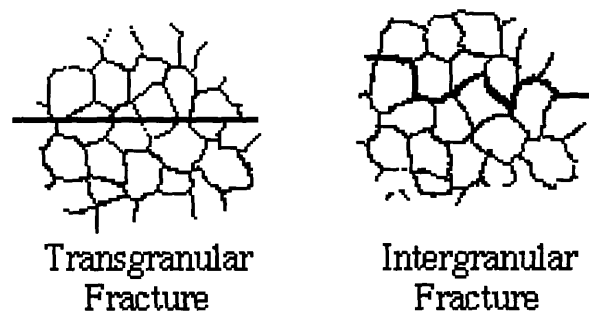
Figure 3.4.1. Transgranular and intergranular fractures

Fracture means the separation of body into several parts. It is affected by several factors such as material, applied stress, and temperature. Weld fractures are often initiated at weld defects, such as surface discontinuities, sharp notches, or cracks. In terms of its way of propagation, fracture is classified into two types, transgranular and intergranular fractures as shown in Figure 3.4.1.

Transgranular fracture has a cleavage mode and a shear mode depending on the crystal structures of materials.

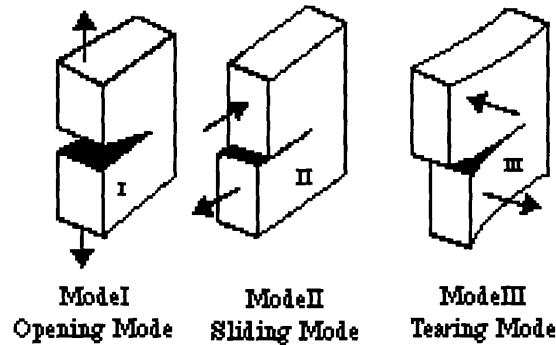
Figure 3.4.2. Modes of cracking

There are three modes of cracking as shown in Figure 3.4.2. Normal stresses cause the opening mode (Mode I), in-plane shear stresses give the sliding mode (Mode II) and out-of-plane shear stresses make tearing mode (Mode III). Although the superposition of all three modes describes the general case of loading, Mode I is the most important for fracture mechanics theory.

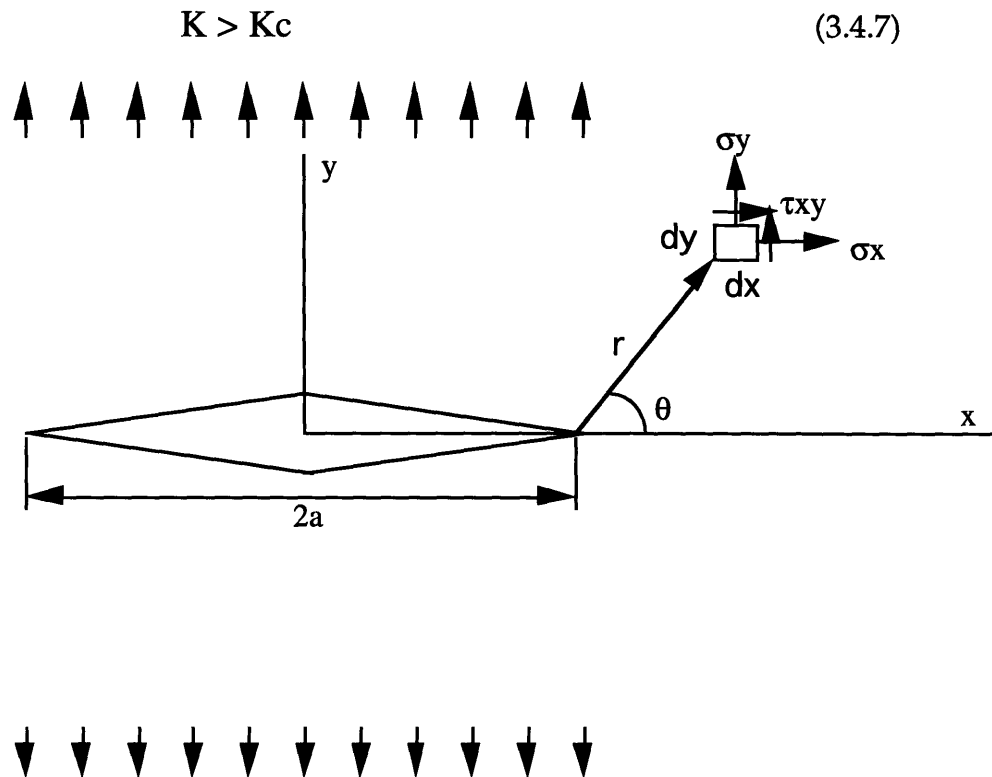
Figure 3.4.3. Crack in an infinite plate [Ref. 11]

Consider a simple case which is a through-the thickness Mode I crack of arbitrary size,  $2a$ , in an infinite plate as shown in Figure 3.4.3. The crack tip stresses can be written as

If the stress intensity factor,  $K$  exceeds the critical stress intensity factor,  $K_c$ , the crack extends fracture.

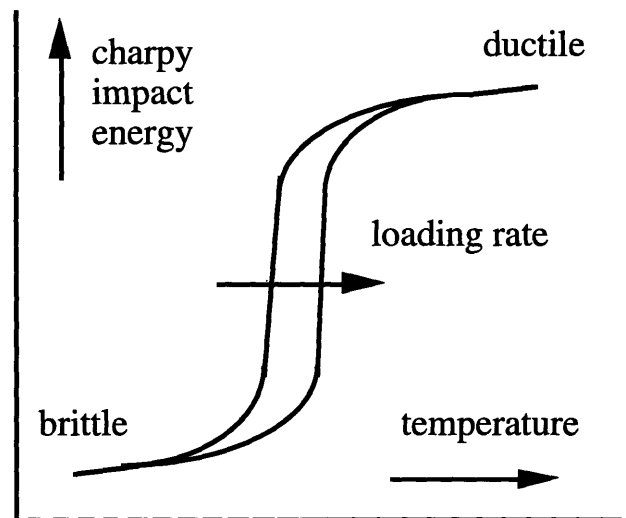
Figure 3.4.4. Brittle-Ductile transition

The quality of metallic materials transmits from ductile to brittle as the temperature decreases, as shown in Figure 3.4.4. The fracture which occurs at the temperature in the region where the material is brittle is called a brittle fracture. Brittle fractures are usually initiated at sharp notches or cracks. On the other hand, the fracture in the region of ductile material ductile is a ductile fracture. The most familiar type of ductile fracture is by overload in tension, which produces the classic cup and cone fractures.

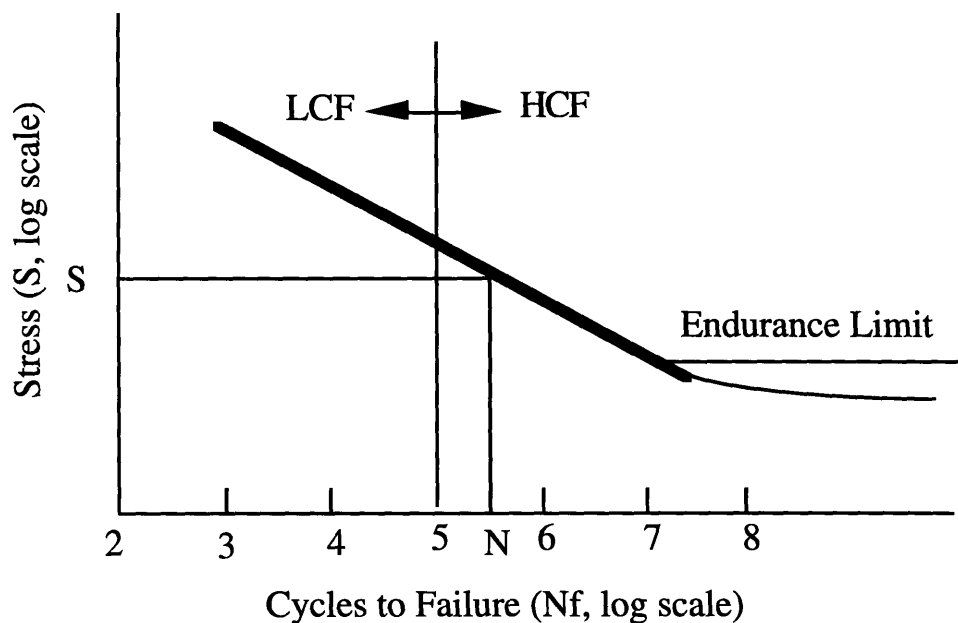
Figure 3.4.5. S-N diagram

In order to investigate failure life of a material, the S-N diagram, as shown in Figures 3.4.5 is used. It is necessary to test several similar specimens to determine the fatigue strength of a particular material under a given condition. Some materials such as steels have endurance limit . Below this stress level fatigue fracture never occurs. But most materials do not have endurance limit.

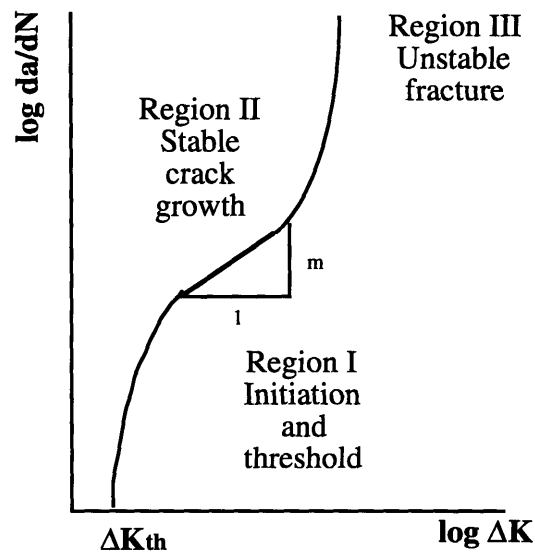
Figure 3.4.6. Relation between  $da/dN$  and  $\Delta K$  [Ref. 13]

where  $C$  and  $m$  are material constants. A double-logarithmic plot of  $da/dN$  versus  $\Delta K$  would then be a straight line. However, equation 3.4.8 does not represent reality. Actual experimental data fall on an S-shaped curve as shown in Figure 3.4.6. This fact infers the existence of the threshold value of  $\Delta K$  below which there is no crack growth at all. It is often difficult to verify the existence of this value,  $\Delta K_{th}$ .

This figure infers the possibility of existence of the threshold value  $\Delta K_{th}$  at which fatigue fracture occurs when  $\Delta K$  reaches. However, more data is necessary to study Region I.

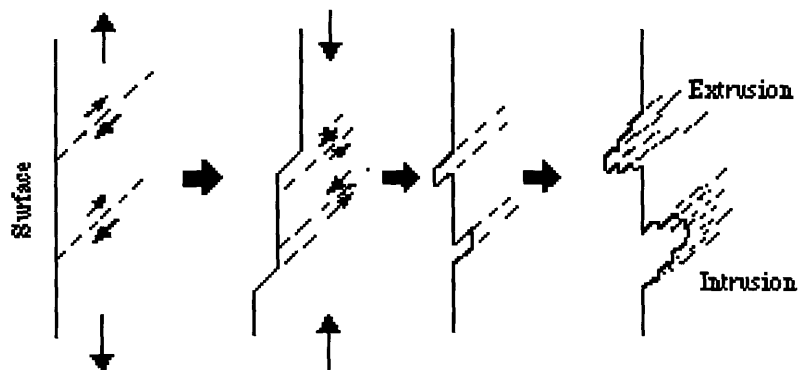
Figure 3.4.7. Wood's model for fatigue crack initiation

Wood [Ref. 8] suggested one of the models, as shown in Figure 3.4.7 to explain the mechanisms of fatigue crack initiation by local plastic deformation. The cyclic slips caused by cyclic loading create the extrusions and the intrusions on the surface of materials. The picture of an example of fatigue crack initiation is shown in Figure 3.4.8.

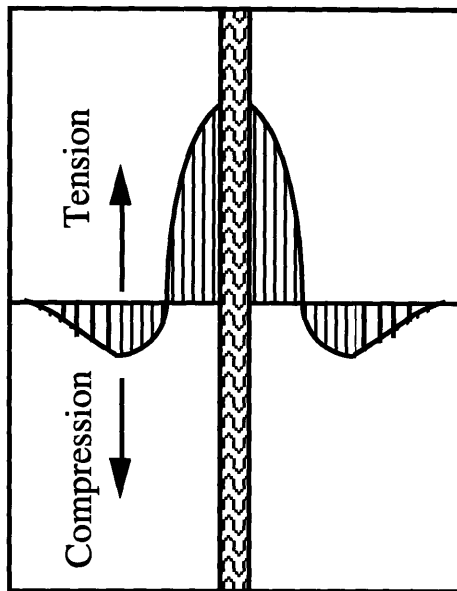
Figure 3.5.1. Residual stresses due to welding [Ref. 1]

Figure 3.5.1 shows the residual stresses due to welding. The pattern of residual stresses by welding is greatly influenced by the geometry of the joint, the number of weld passes, the type of welding processes, interpass temperatures, the materials used, and other factors.

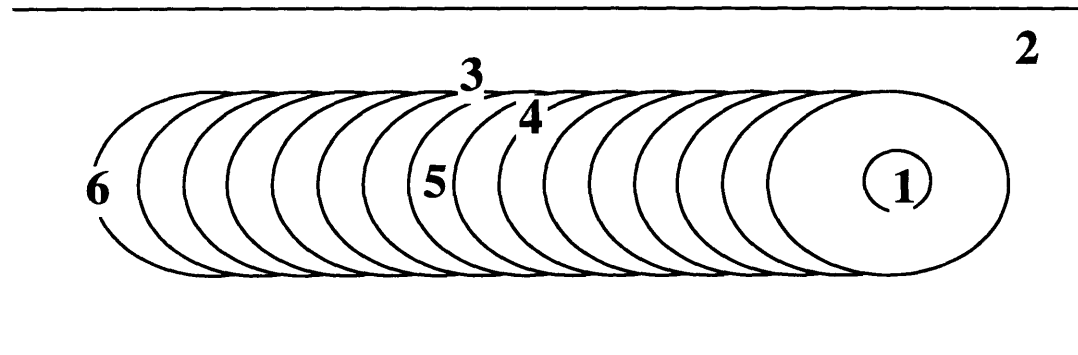
Figure 4.3.1. Location of welded specimen

**1: Weld Crater, 2: Base Metal, 3: HAZ, 4: Edge of Weld, 5: Center of Weld, 6: Start-up Toe**

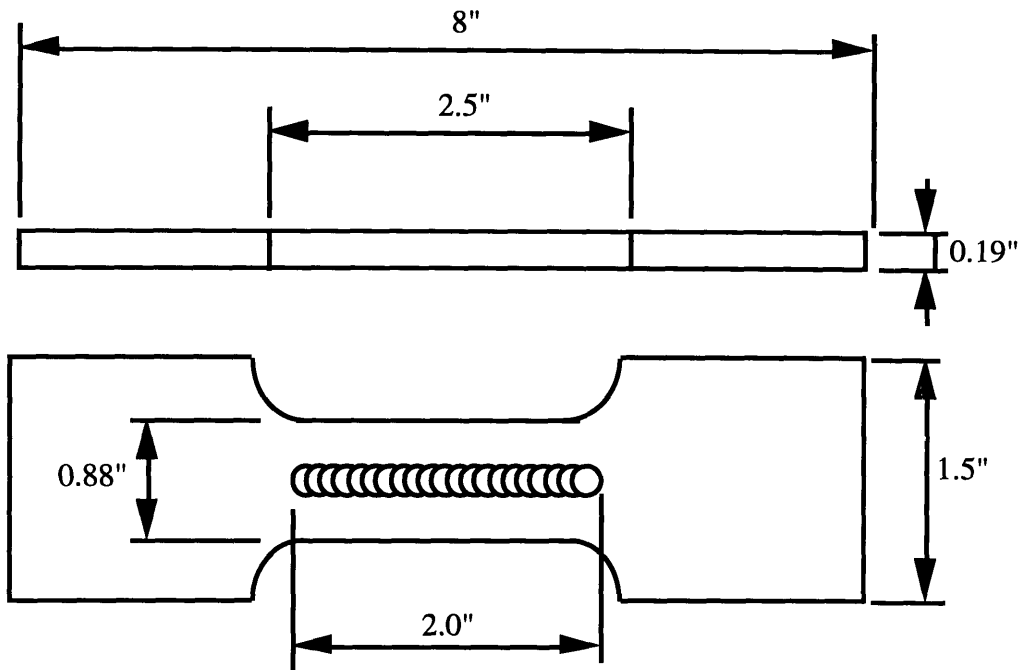
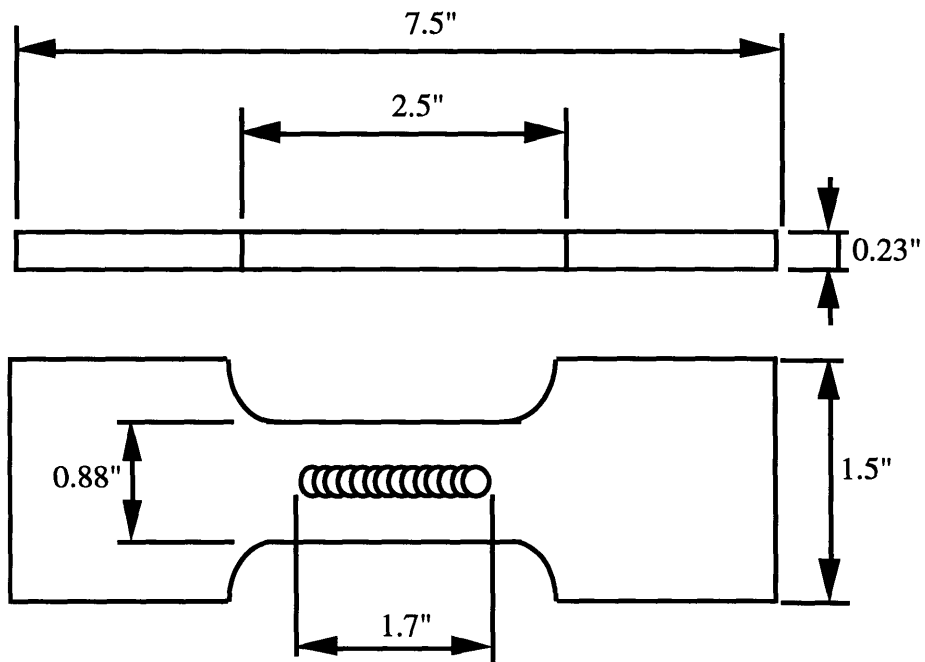
Figure 6.2.1. Specimen for Fatigue Test I

(Ultimate Tensile Strength: 82ksi, Cross Sectional Area: 0.167 in<sup>2</sup>, Polished Surface, FT-1, 2, 3, 4, 5)

(Ultimate Tensile Strength: 69ksi, Cross Sectional Area: 0.167 in<sup>2</sup>, Polished Surface, M-1, 2)

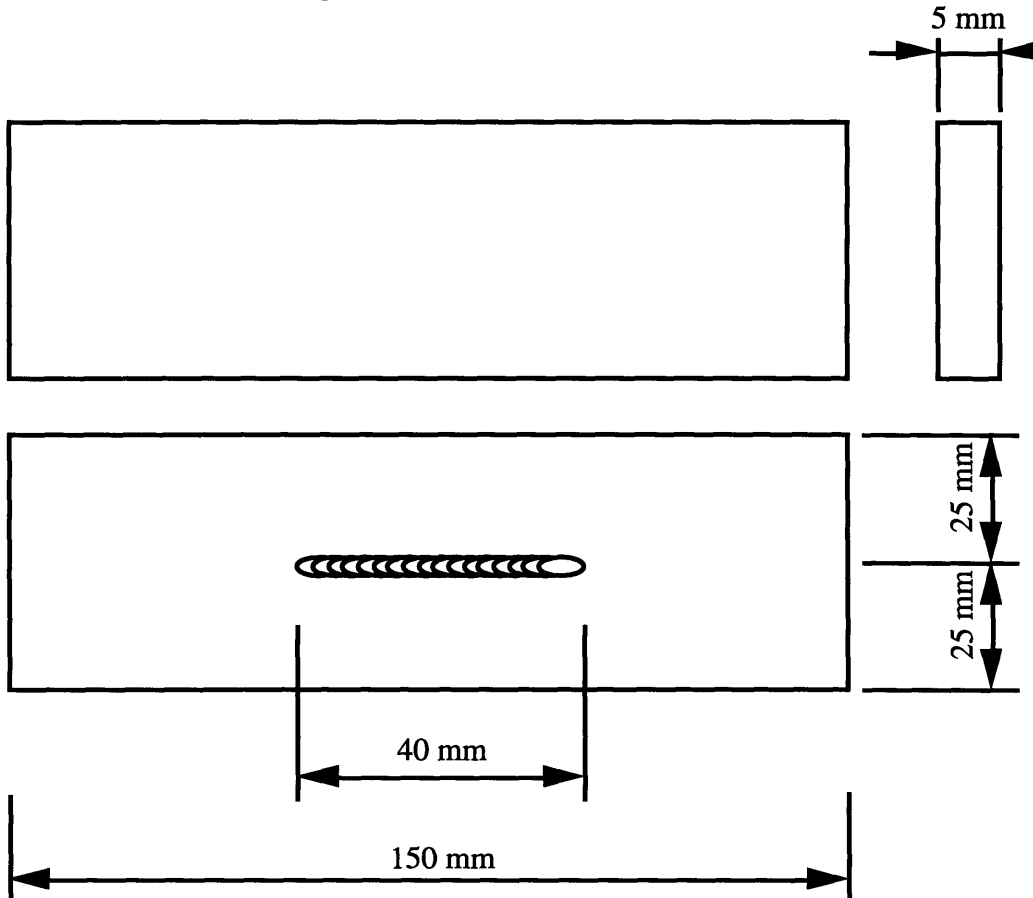
Figure 6.2.2. Specimen for Fatigue Test II

(Cross Sectional Area: 0.389 in<sup>2</sup>, Normal Surface, MT-1, ST-3, AT-2, 3, TT-2)

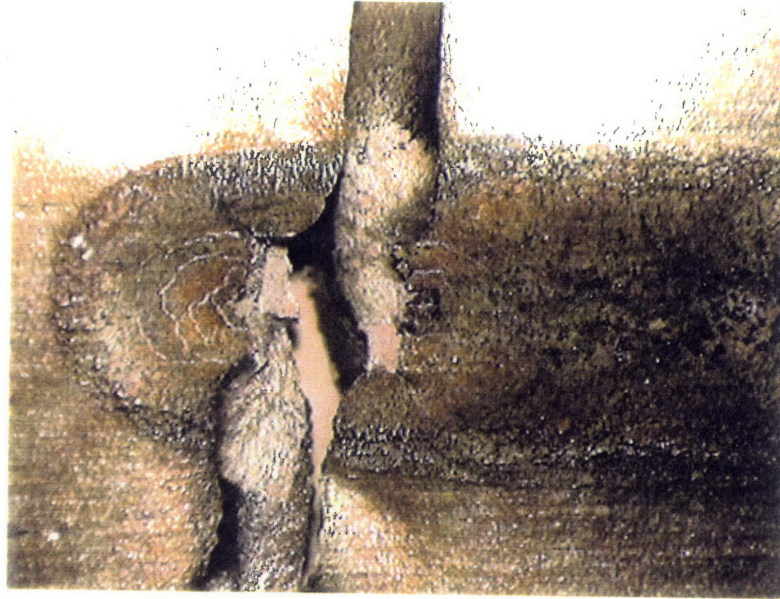
Figure 7.2.11. Fatigue fracture of AT-2

AT-2  
(3,450 cycles)  
6.5X

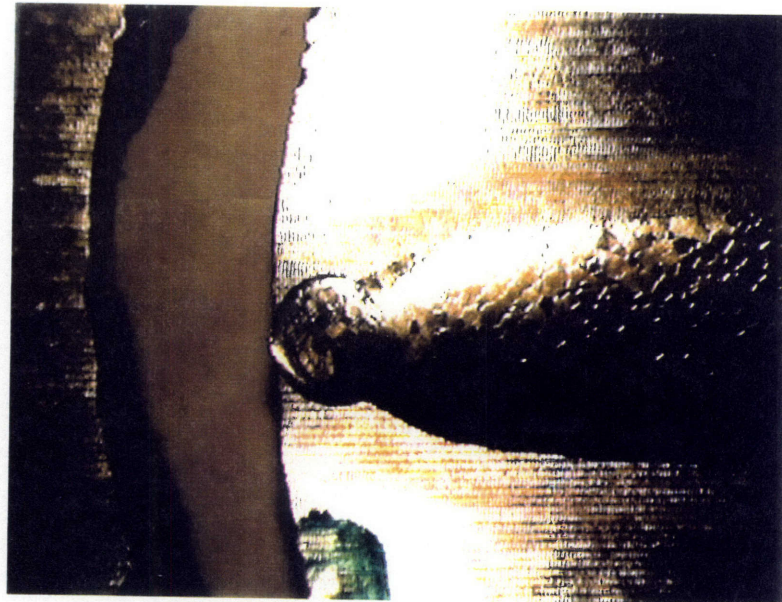
Figure 7.2.16. Fatigue fracture of TT-2

Table 7.1 1 summarizes the experimental results of the Fatigue Test II. MT-3 and ST-3 did not show fatigue crack initiations, and no micro surface features showed any indication of fatigue crack. AT-2 and AT-3 broke around 3,450 and 470 cycles at weld craters due to low-cycle, high-stress fatigue. The surface of aluminum alloys were covered by thick oxide layers as discussed in Chapter 5. These layers prevented us from observing the specimens' surface of aluminum alloys. TT-2 had a fatigue fracture at 17,930 cycles in HAZ on the start-up toe .

TT-2  
(17,930 cycles)  
6.5X
