MEASURED PERFORMANCE OF SLURRY WALLS **ENG^f**

Submitted to the Department of Civil and Environmental Engineering
on May 19, 2000 in partial fulfillment of the requirements for the
Degree of Master of Science in Geotechnical Engineering

Abstract

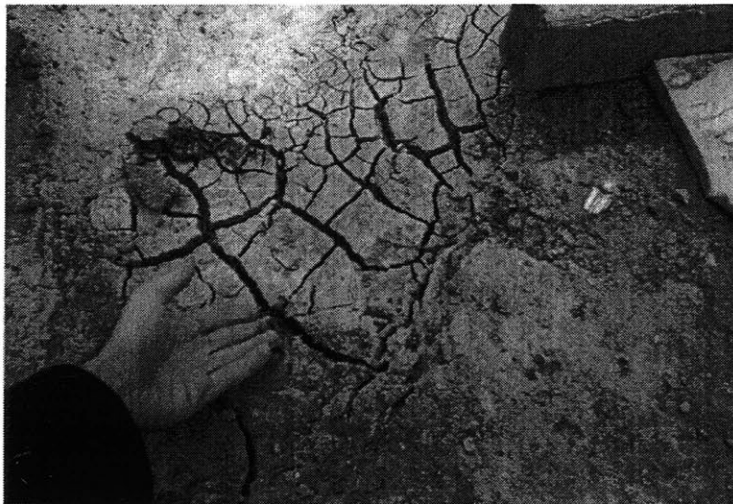
Figure 2.16: Top concrete layer, slurry contaminated concrete easily crumbles with finger pressure (author's hand), note fissures at the concrete

When concrete is tremied overpouring is required in order to push out the slurry contaminated concrete in the upper few feet of the wall. Despite the overpouring, the upper foot of the slurry wall concrete is still contaminated by slurry and thus it is chipped off. Slurry contaminated concrete can easily break with finger pressure (Fig. 2.16).

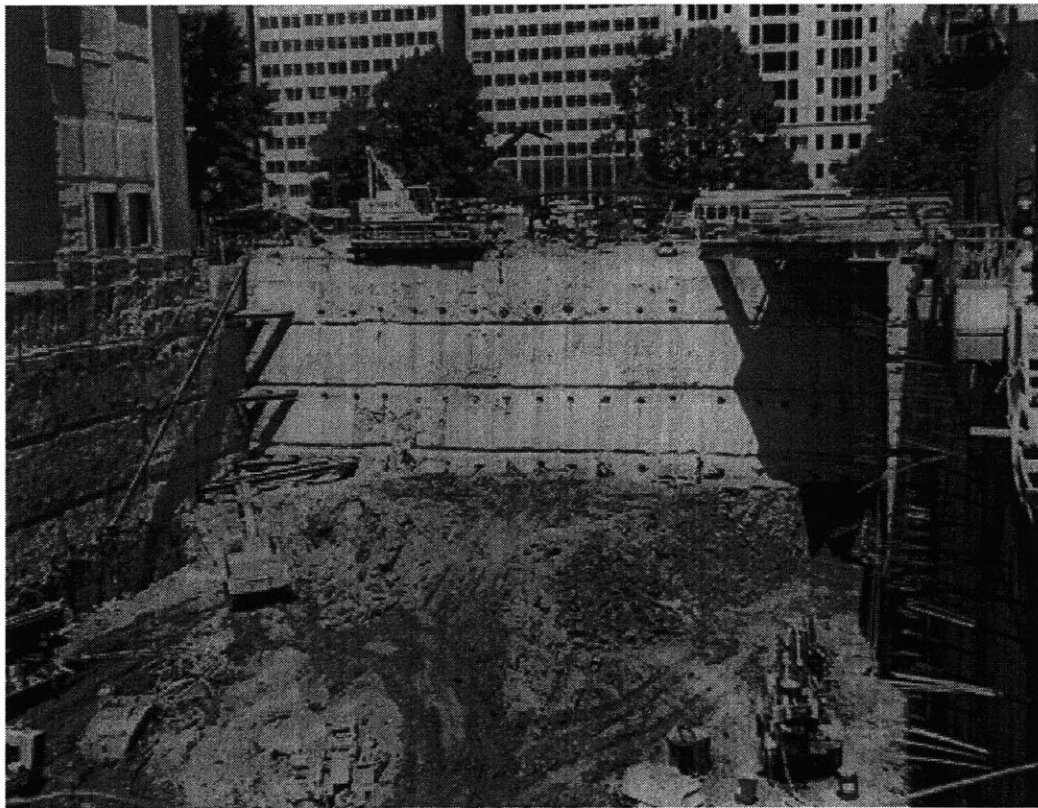
Figure 2.24: Picture from a tieback slurry wall excavation (World Bank Project Washington, Case Study W-1)

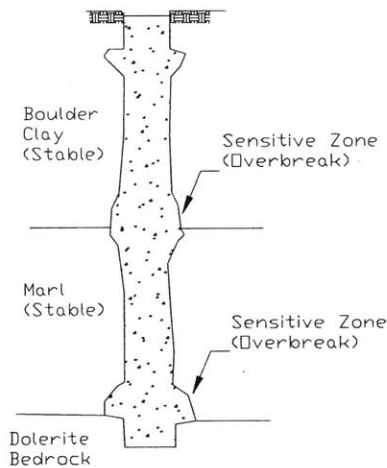
Figure 2.37: Concrete overbreaks due to strata change (after ICE, 1976)

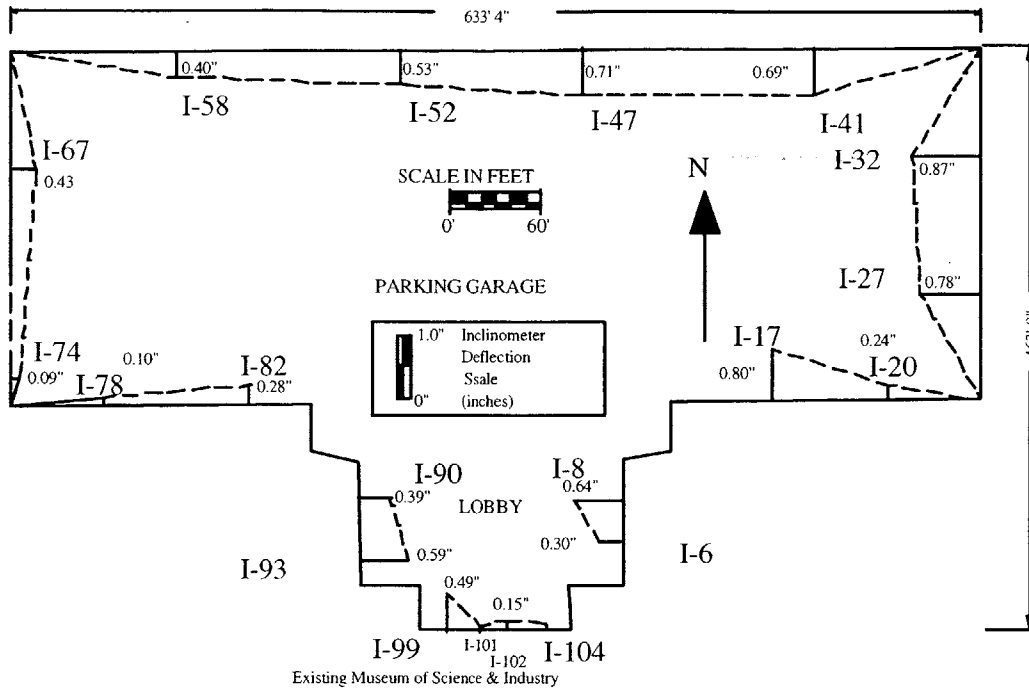
Figure 5.26: MSI (C10) site and maximum final inclinometer deflections.
