Flexible Water Hose Failures: A Case Study and General Design Considerations

Citation: Taylor, Richard, and Thomas Eagar. "Flexible Water Hose Failures: A Case Study and General Design Considerations." *Journal of Failure Analysis and Prevention* 16, no. 3 (March 16, 2016): 333–336.

Richard Taylor and Thomas Eagar

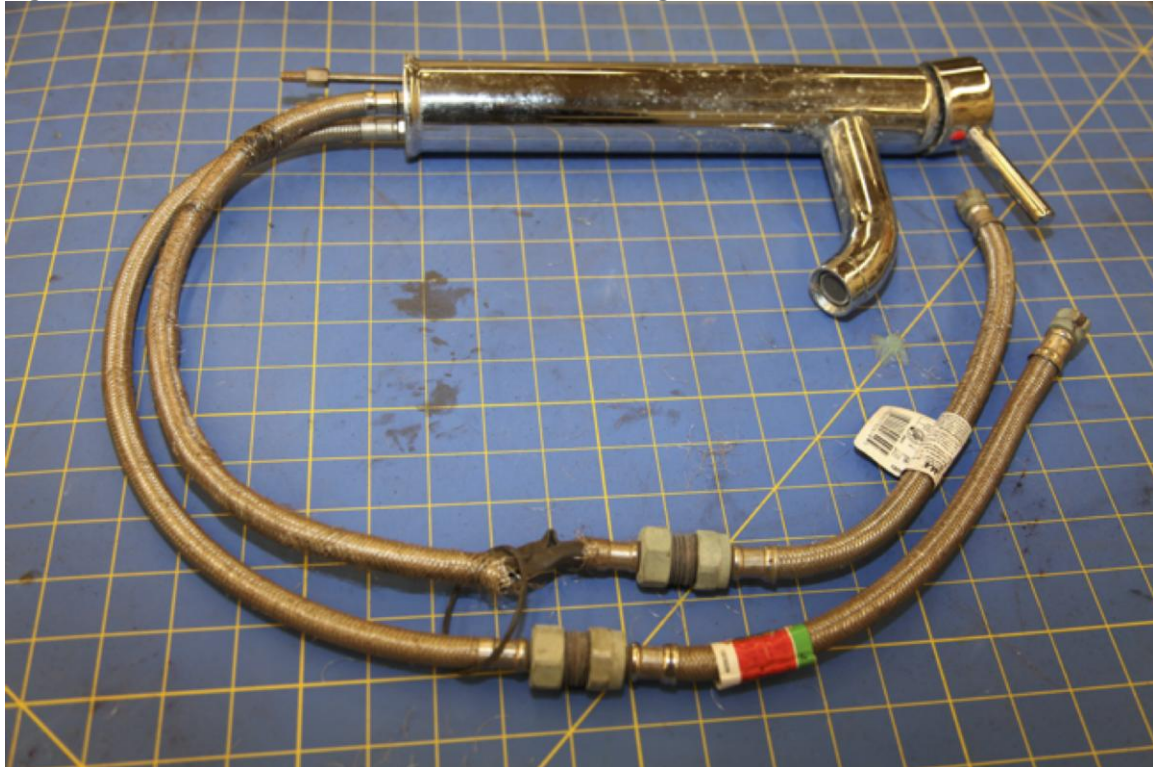
A recent case demonstrates many of the key design considerations. The incident in question involved a flexible water hose connected to a faucet (Figure 1). The metal braiding on the hot water side was compromised and a rupture occurred in the elastomeric tube, which caused flooding and considerable property damage.

Fig 1: Flexible water hose failure. The hoses supplied water from the household plumbing to a faucet. The background grid shows one-inch squares.

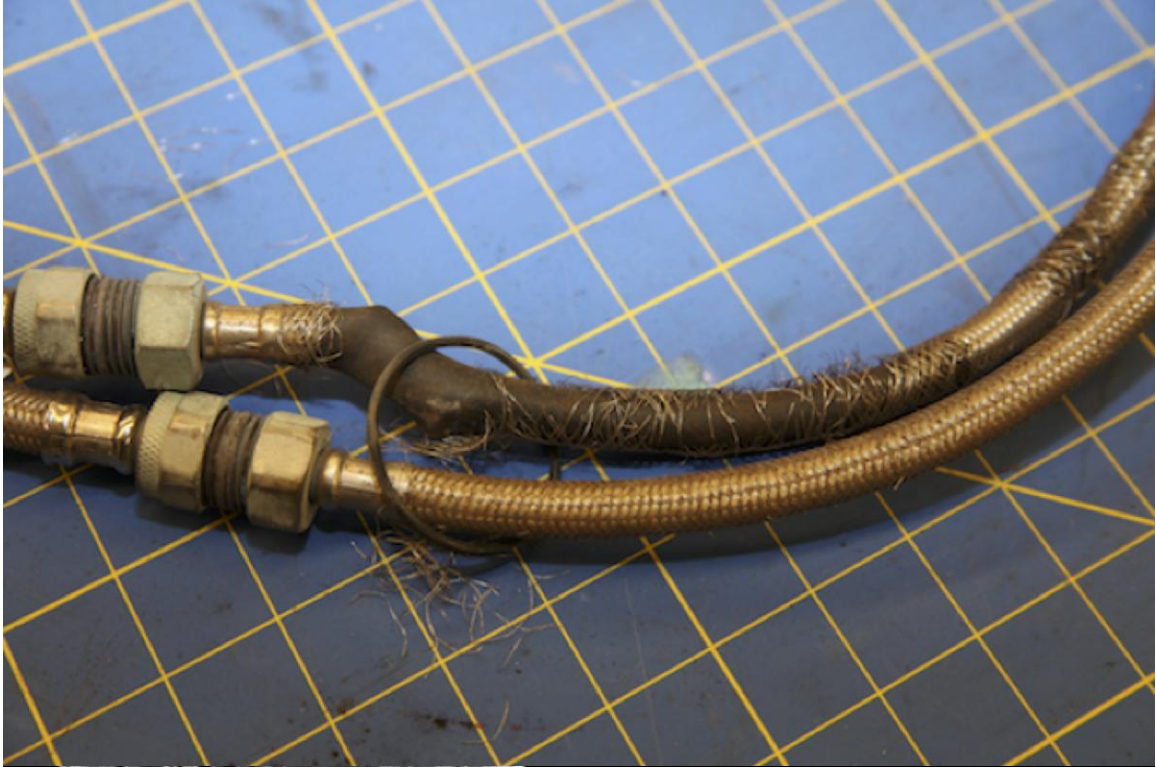
Upon examination of the hose it was found that the tube braiding was heavily frayed with large portions missing, displaced or loose (Figure 2). The rupture in the rubber hose was consistent with a failure from hoop stresses on the tube, having formed longitudinally along the length of the tube.

Fig 2: Hose with fraying, missing, or loose braiding. The background grid shows one-inch squares.

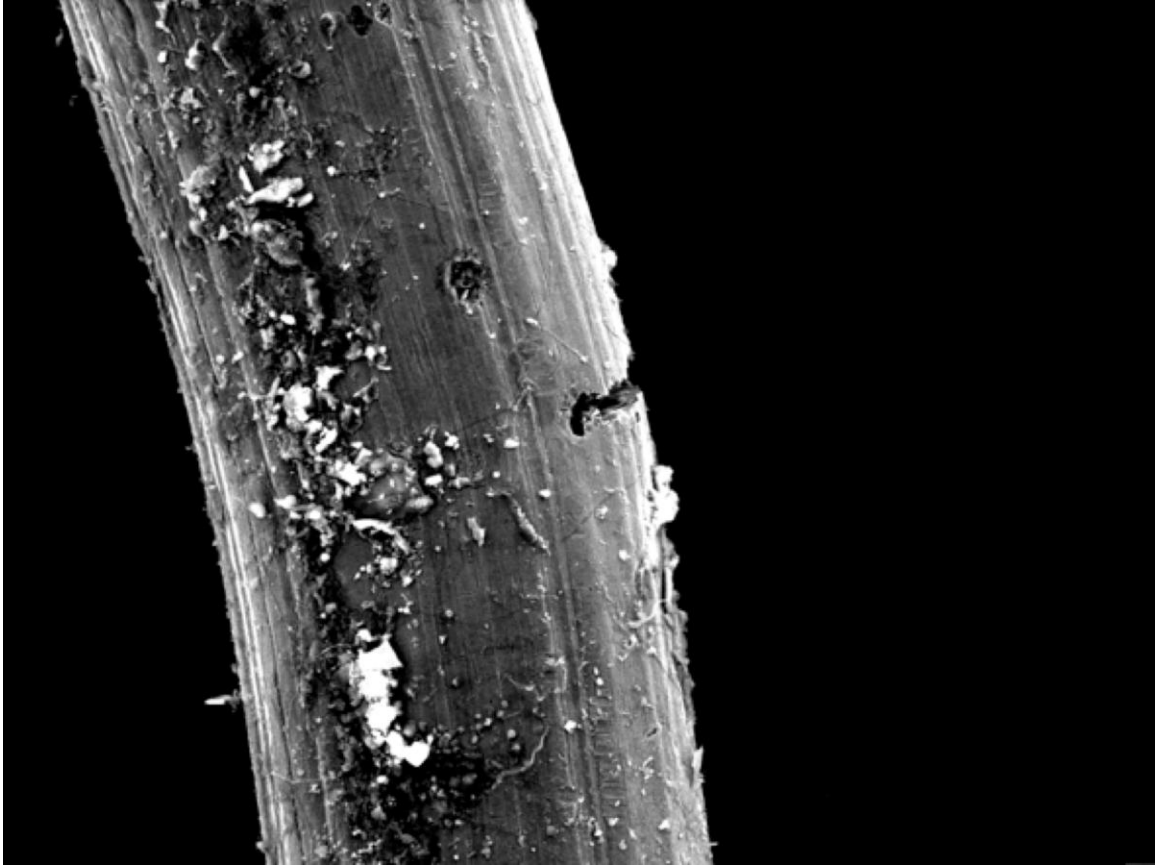
To understand the cause of the braiding failure, the hose was examined with a digital scanning microscope (DSM) and a scanning electron microscope (SEM). Intergranular and pitting corrosion damage was observed on the individual braid wires (Figure 3). The composition of the braid wires was analyzed using EDS indicating manganese in the base metal of a percentage approximately equal to the percentage of nickel. The compositional analysis of the braids revealed a chromium-manganese (CrMn) steel with a chromium content of approximately 16% and nickel and manganese of approximately 6% (Table 1).

Fig 3: SEM image of individual braid wire. A fracture in progress is visible. Pitting and corrosion deposits are also seen on the surface of the wire.

As a result of the expected environment of flexible water hoses it is important that the metal braid be fabricated from a grade of stainless steel that is sufficiently resistant to chlorides and other forms of household chemicals. Inexpensive hoses with steel braids manufactured in China and India should be avoided (or cautiously considered), as the use of CrMn steels (200 series and related) has increased due to lower material cost. The fact that distributors and retailers seldom report the grade of the stainless steel is problematic, but barring any other information cost may be a reasonable indicator of quality. Alternatives to stainless steel braids (e.g., polymer coated fibers) should also be considered.

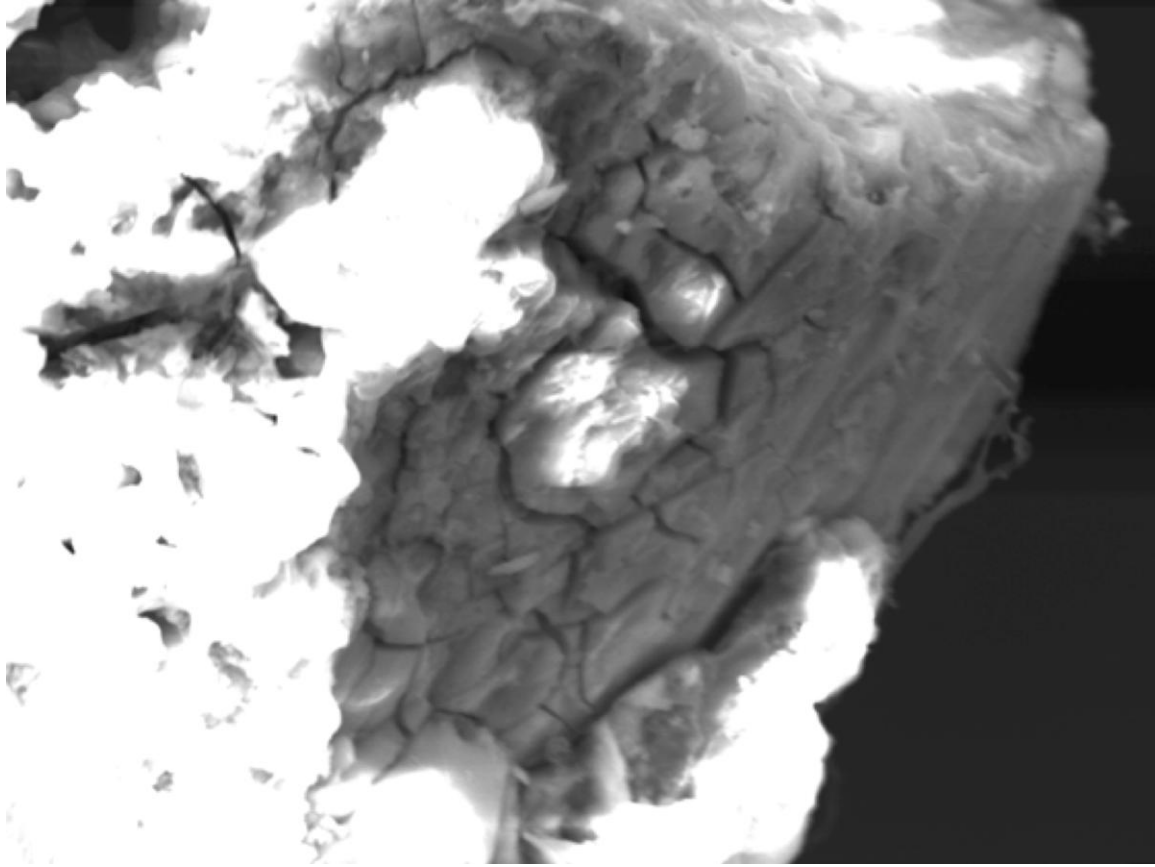
The low percentage of chromium and nickel in many CrMn steels as compared to the 300 series stainless grades increases their susceptibility to corrosion¹. The reduction in chromium (in part to facilitate the austenite phase) and nickel of the CrMn steels leads to problems with chloride stress corrosion cracking and pitting. Corrosion product on the incident braid wires, analyzed using EDS, contained chlorides at a concentration of approximately 1% (10,000 PPM). The susceptibility to failure by chloride attack was worsened by an inappropriate choice of braid metal material.

Fig 4: Fractured individual braid wire with intergranular attack.
