MEASURED PERFORMANCE OF A LARGE EXCAVATION ON
THE MIT CAMPUS

Matthew Blake Olsen

MASTER OF SCIENCE IN CIVIL AND ENVIRONMENTAL ENGINEERING

This thesis evaluates the measured performance of a large excavation on the MIT Campus. The new Ray and Maria Stata Center, currently under construction, was designed with a 42ft deep basement carpark. The excavation plan area is approximately rectangular and measures 386 ft by 316 ft. Lateral earth support during excavation was provided by a 30 in thick, 70ft deep concrete diaphragm wall, that forms part of the permanent structure. The toe of the wall floats within a deep layer of Boston Blue Clay that underlies the site and ranges in thickness from 60 to 90 ft within the footprint of the new building. The wall was supported by a combination of a) three levels of prestressed tieback anchors on three sides, b) two levels of prestressed rakers braced against the foundation slab on the fourth side, and c) two levels of corner bracing in each of the four corners of the site. Control of ground movements was a critical aspect of the subsurface design, due to the close proximity of the excavation to the Alumni swimming pool (Building #57).

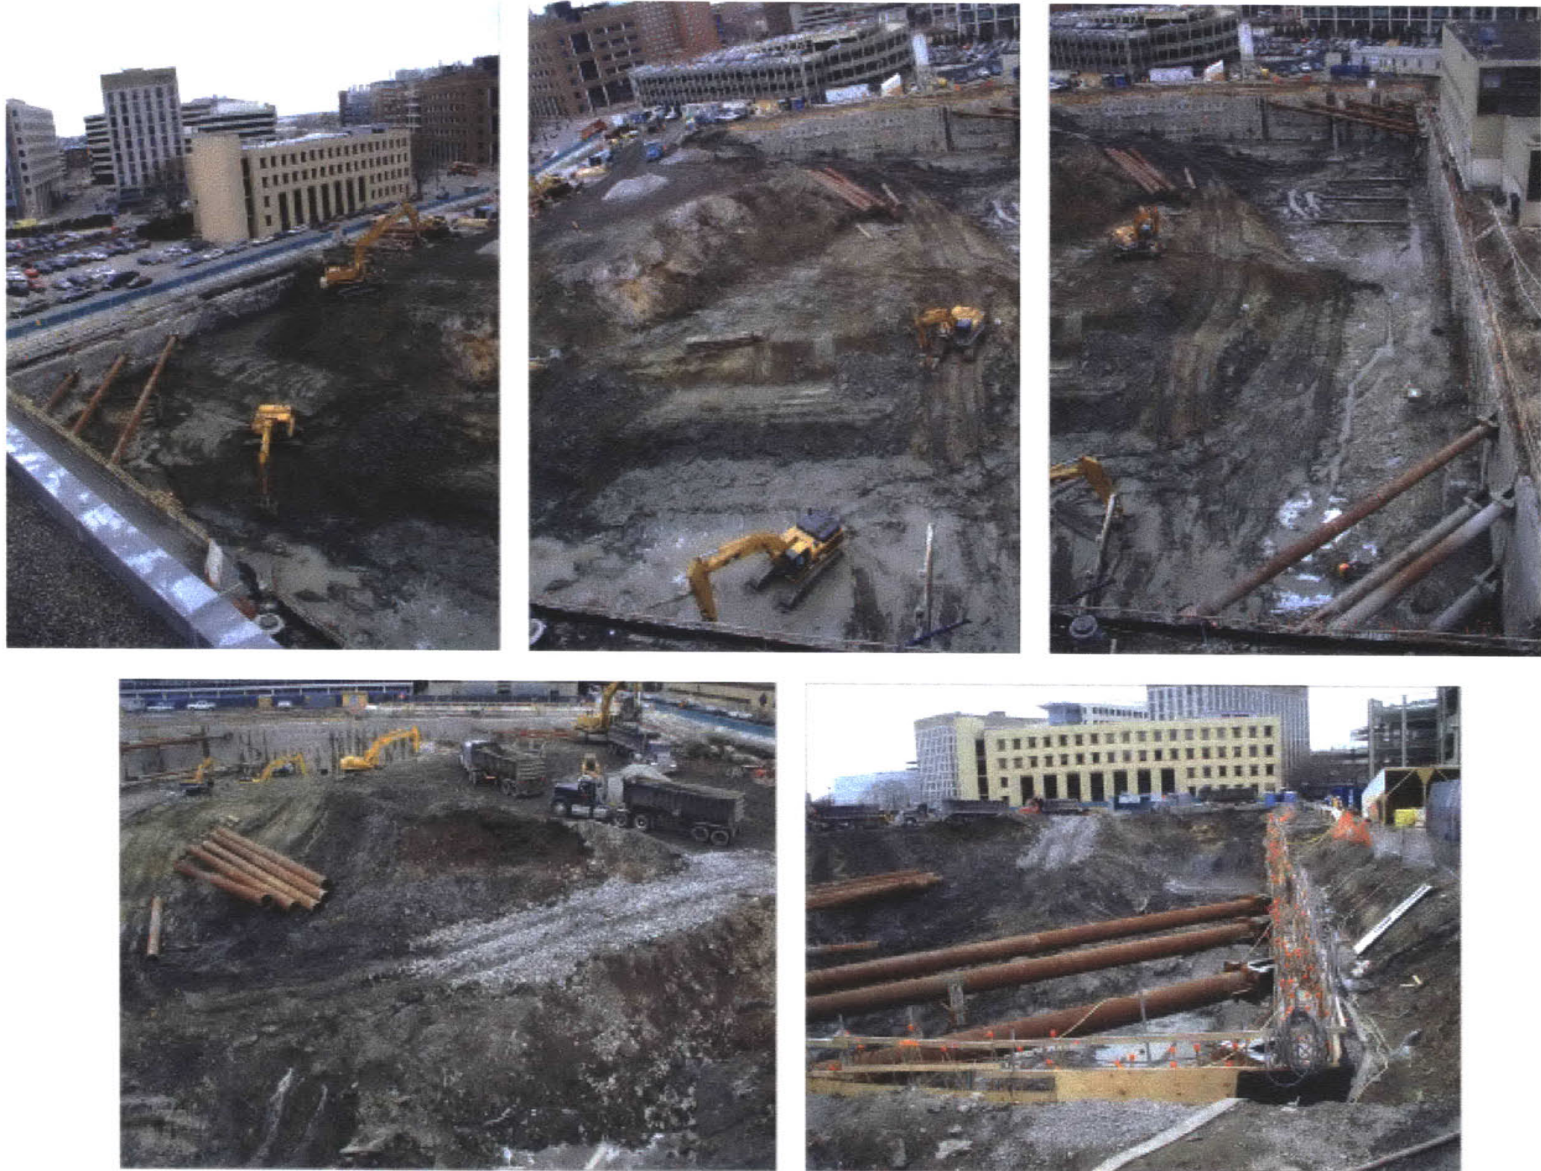
FIGURE C-5: Excavation on 2/5/01.
