Foundation Settlements of English Cathedrals

Masters of Engineering in Civil Engineering

MASSACHUSETTS INSTITUTE OF TECHNOLOGY

June 2017

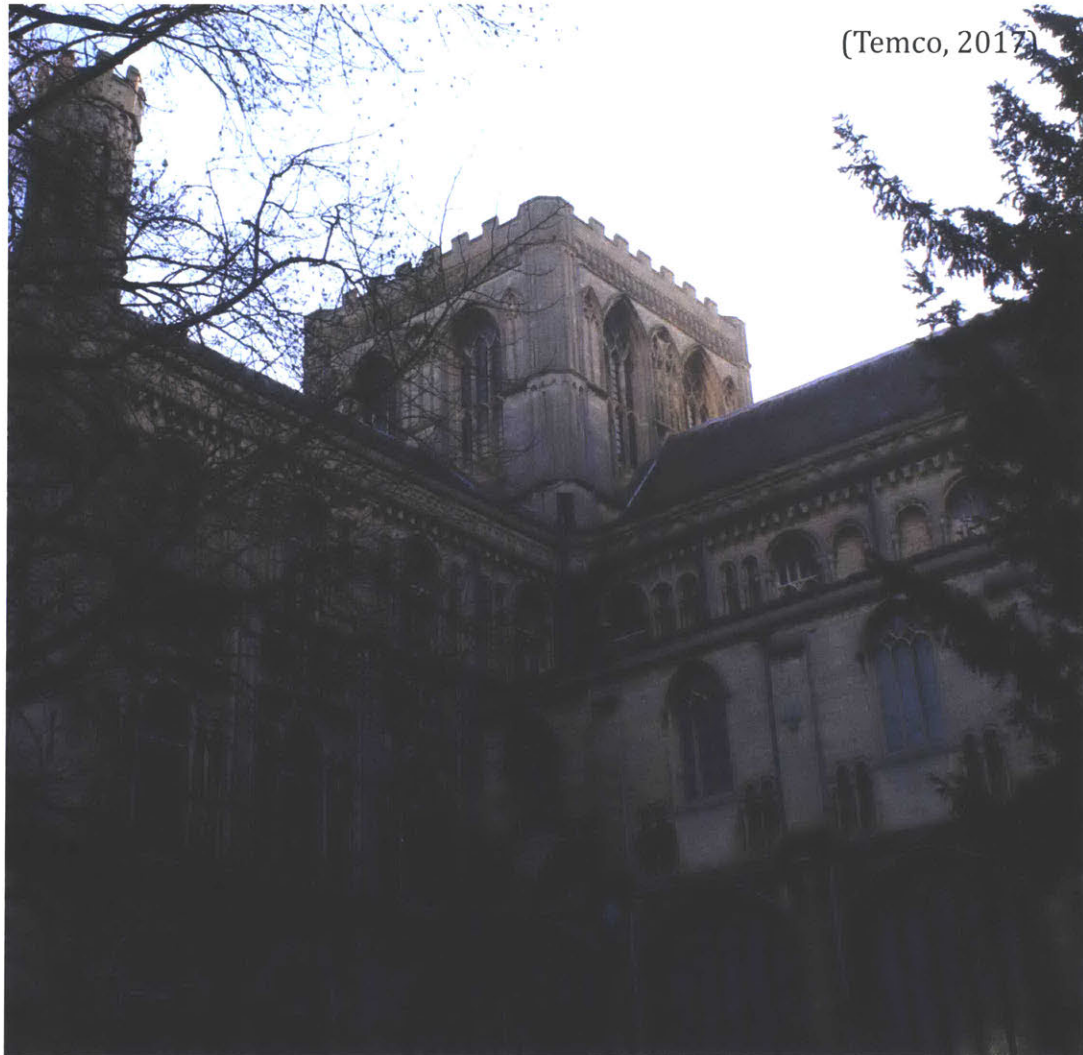
Figure 2: Peterborough Cathedral, which has a typical central tower

period as well. Norman artwork also left a legacy in the stained glass still remaining in most cathedrals. Figure 2 shows Peterborough Cathedral, which has a typical central tower. Central towers like this one are the focus of this thesis.

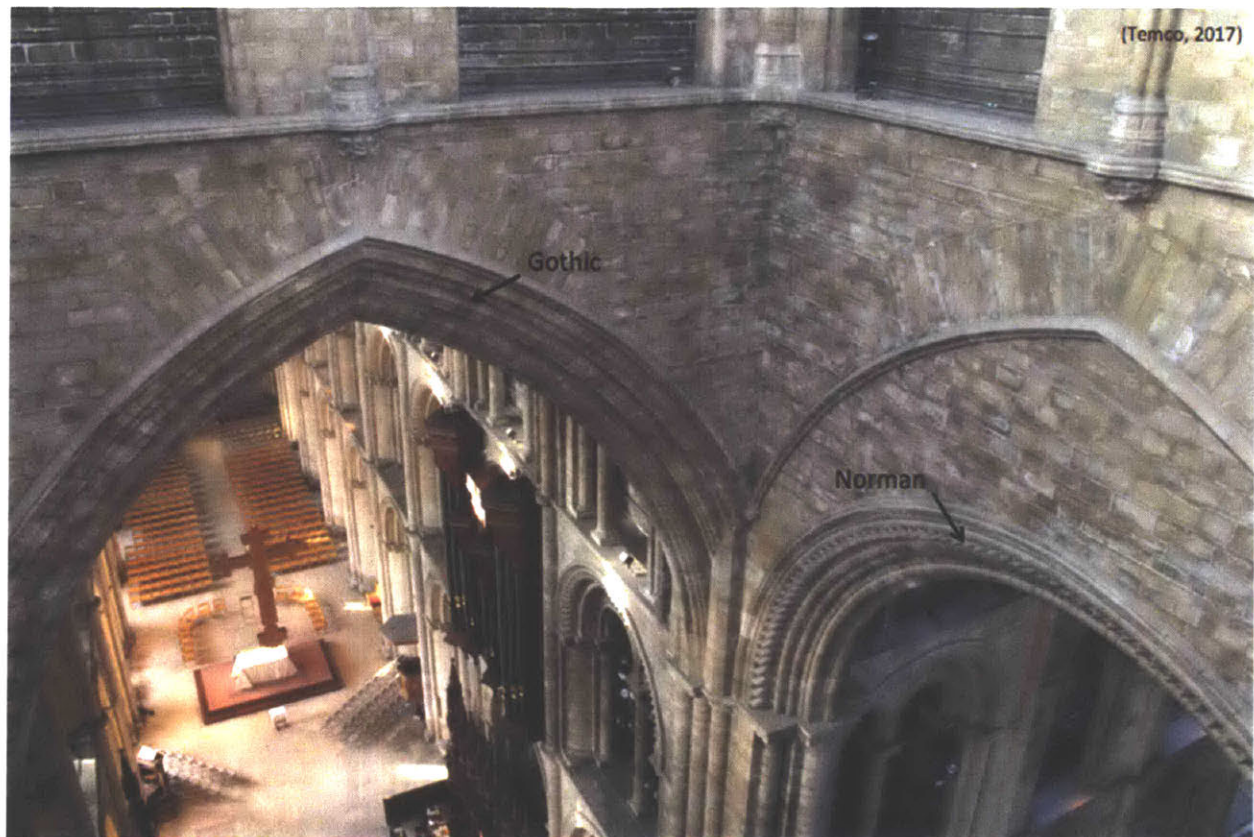
Figure 4: The difference in styles in Peterborough's tower

Figure 4 shows the two types of arches at Peterborough Cathedral.

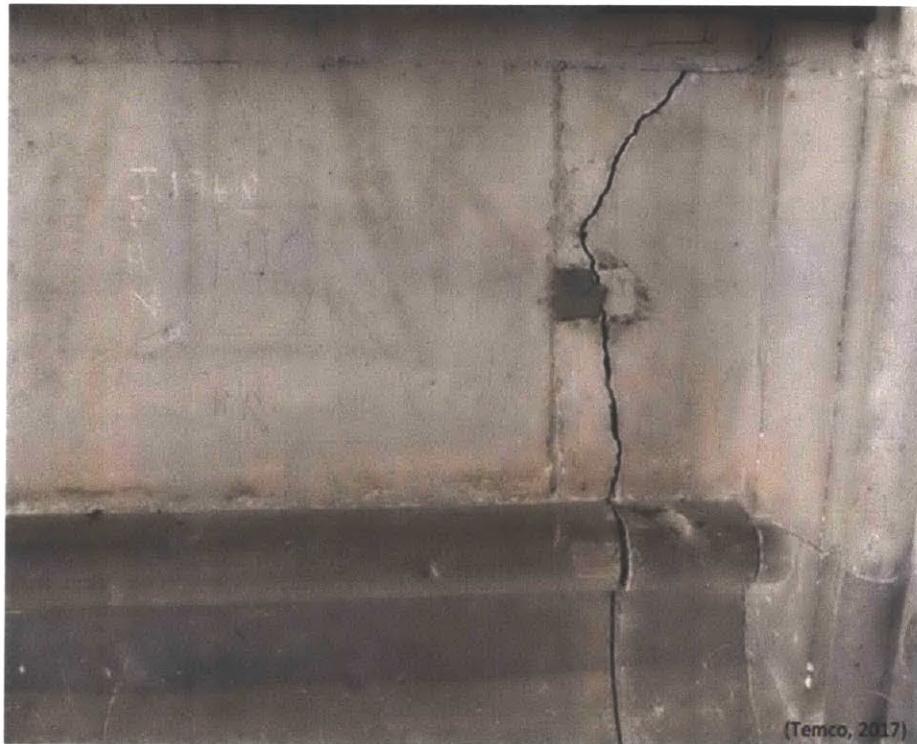
Figure 7: Cracked stone at Winchester Cathedral

One reason for structural distress is a weakness between masonry layers. This can be caused by inadequate mortar or gaps between stones. Cracks can propagate between limestone blocks through the mortar as shown in Figure 6. It is less common for the limestone itself to crack, however, this has occurred at Winchester Cathedral, as shown in Figure 7.

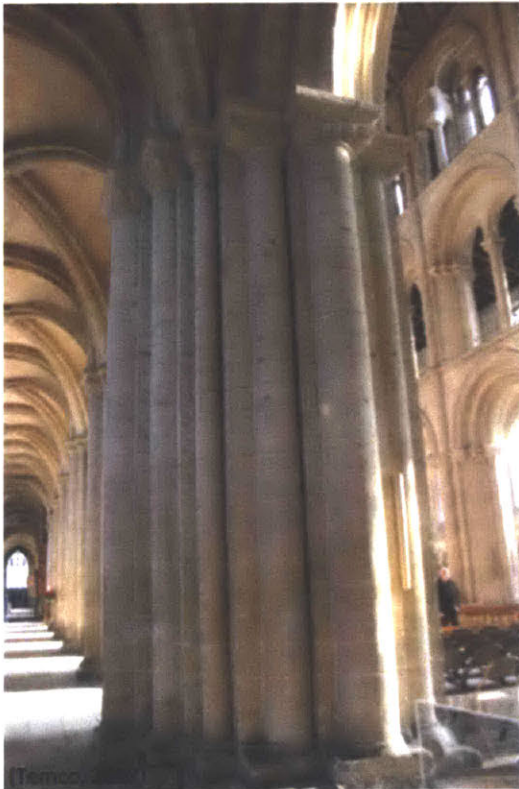
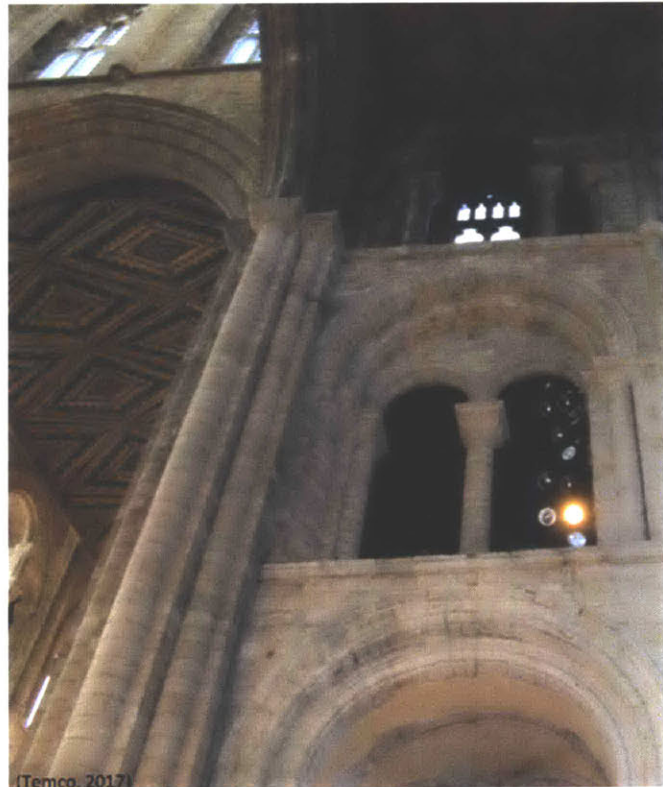
(a) Nave Pier

(b) Tower Pier

Figure 11: Peterborough Piers (a) Nave and (b) Tower

Many simplifying assumptions were made when finding the volume and weight of each cathedral's central tower. The dimensions for each cathedral can be found in Appendix A. Some general assumptions were made for each cathedral. Gothic arches were approximated as triangles and Norman arches were treated as ellipses to simplify the calculation of the volume of the structures as shown in Figure 9. A constant tower wall thickness of 1.52m was assumed for each cathedral and a thickness of 0.61m was assumed for each nave arch. Tower piers were considered as rectangular to simplify calculations. Figure 10 shows a plan view of the assumed tower and nave dimensions. Figure 11 shows the difference in size of Peterborough Cathedral's nave and tower piers.

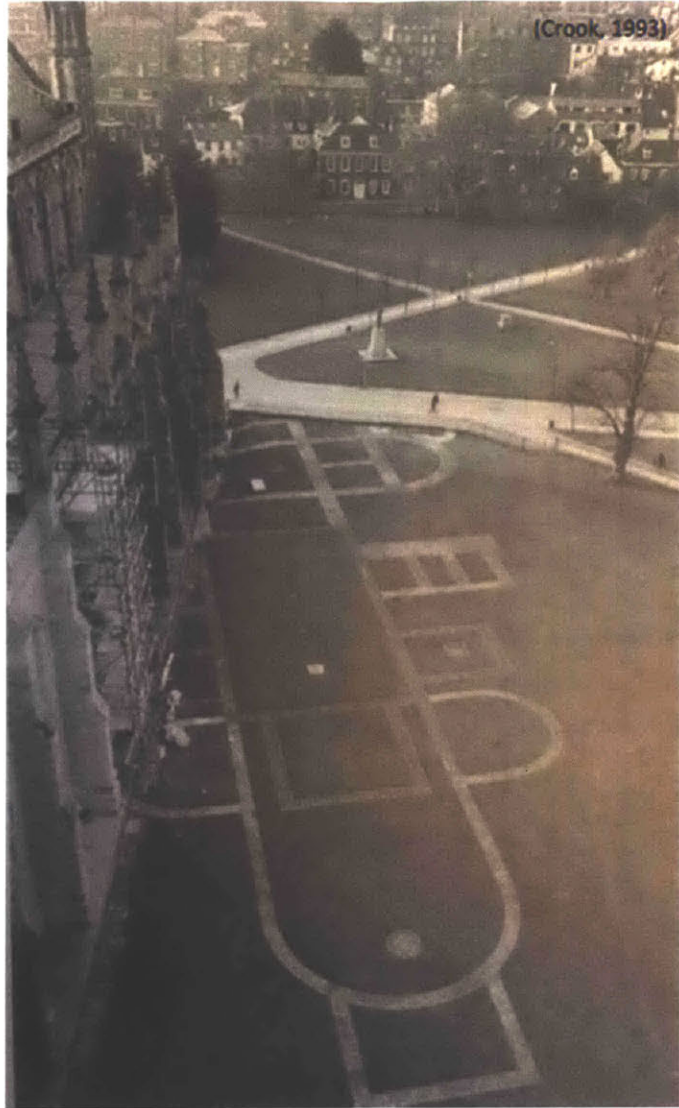
Figure 30: Orientation of the old minster along the current cathedral

Winchester Cathedral is located in Hampshire County. It is about 60 miles south west of London. Winchester was first settled during the Iron Age, and then during the Roman period. It was constantly inhabited during the Dark Ages, during which the Old Minster was built. In 871 Alfred the Great declared Winchester as his capital (“Winchester, Ancient Capital of England”). The Normans began a cathedral on the site of the old minster in 1079. Figure 30 shows the orientation of the old minster and the north west side of the current cathedral.

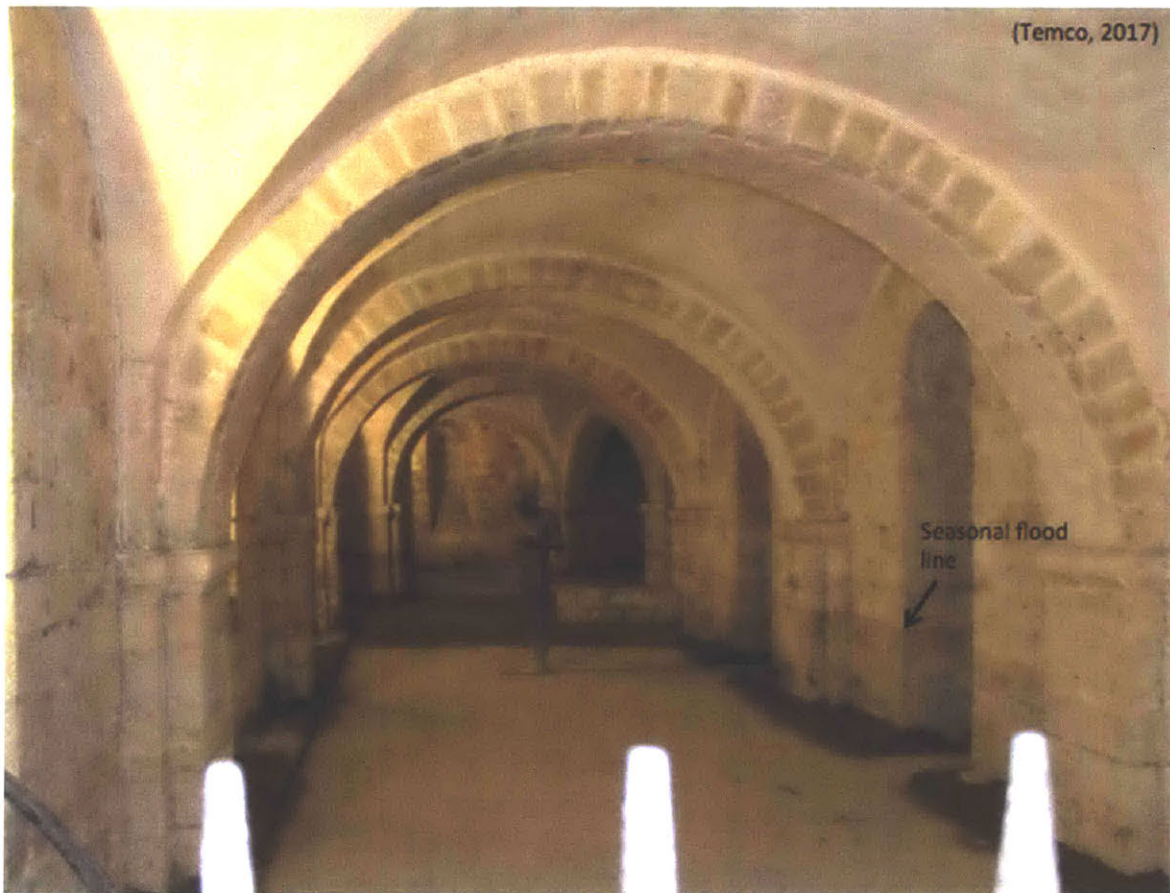
Figure 31: Winchester Cathedral Crypt

The groundwater and soil conditions of Winchester Cathedral contribute to the unique state of the crypt and the repairs done on the choir foundations in the early 20th century. When the crypt was first built the floor was at a depth greater than it is now. It flooded regularly as the ground water table rose each winter. The water level in the crypt is shown in Figure 31. As John Crook remarks in his book with Ian Henderson, *The Winchester Diver*, because of the yearly flood, “the floor level of the Crypt was artificially raised, at some date before the fifteenth century, by

half-filling it with earth: this was cleared again in the late nineteenth century... the level of the Crypt floor would seem to indicate a rise in the winter water-table since the end of the eleventh century.... The water table seems to be higher now than when the cathedral was first built” (Crook and Henderson, 1984).

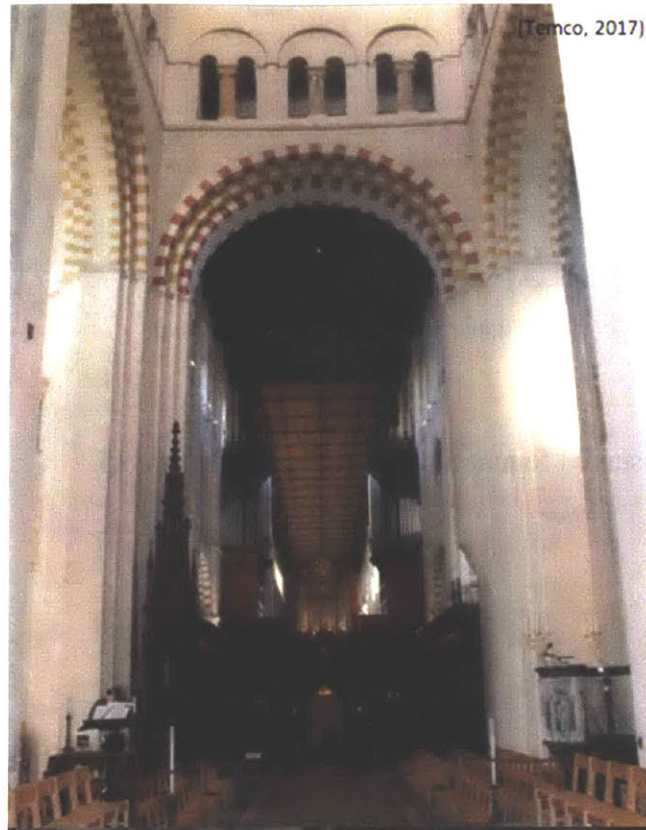
Figure 36: St Albans Central Tower Piers

no pier, no shaft becomes a being with an individual life” (Pevsner and Metcalf, 1985b). The tower piers are shown in Figure 36.

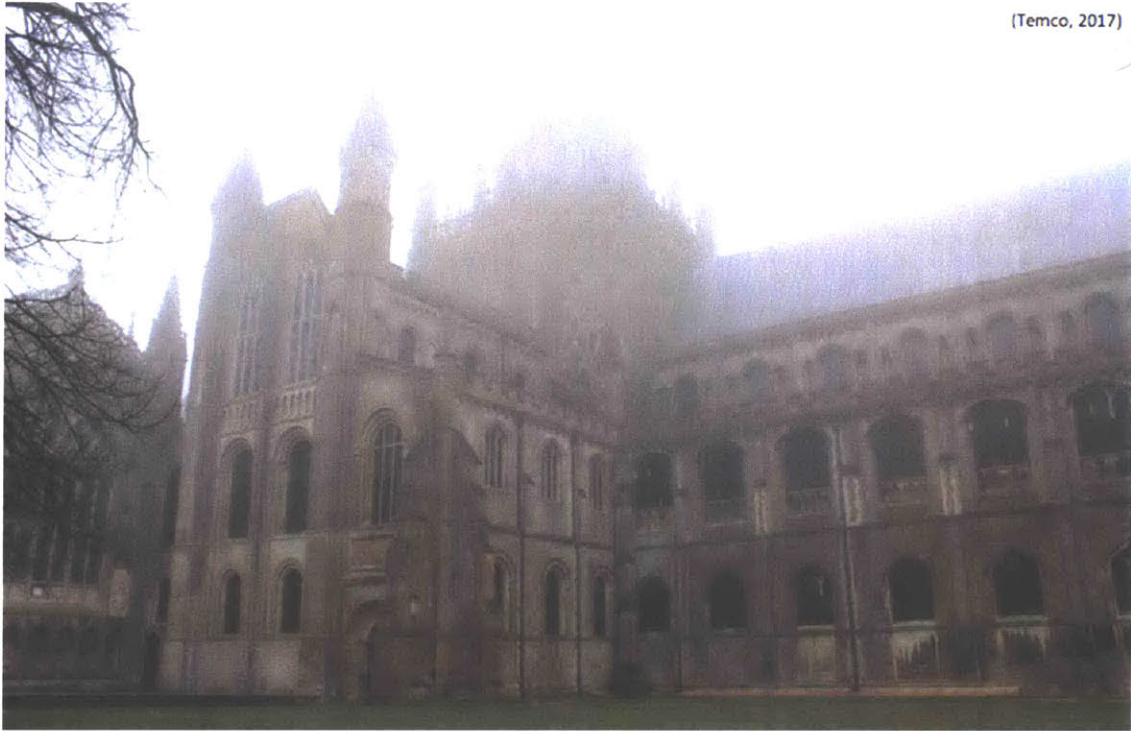
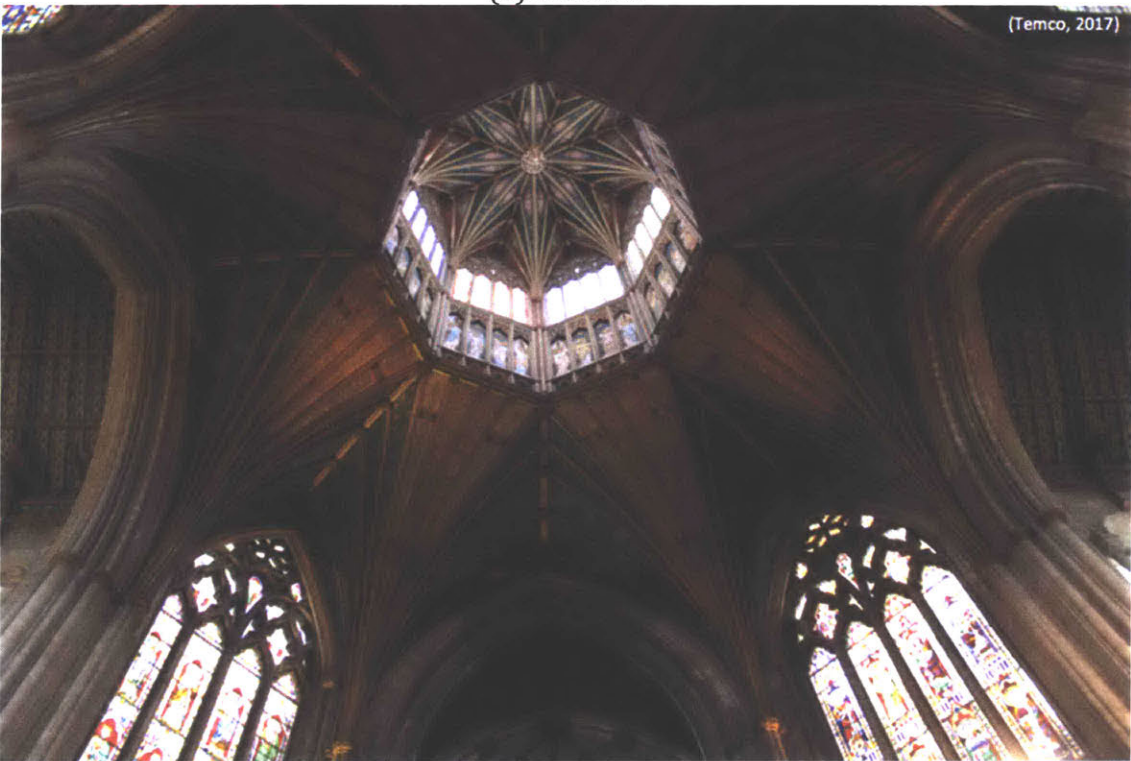
(a) Exterior

(b) Interior

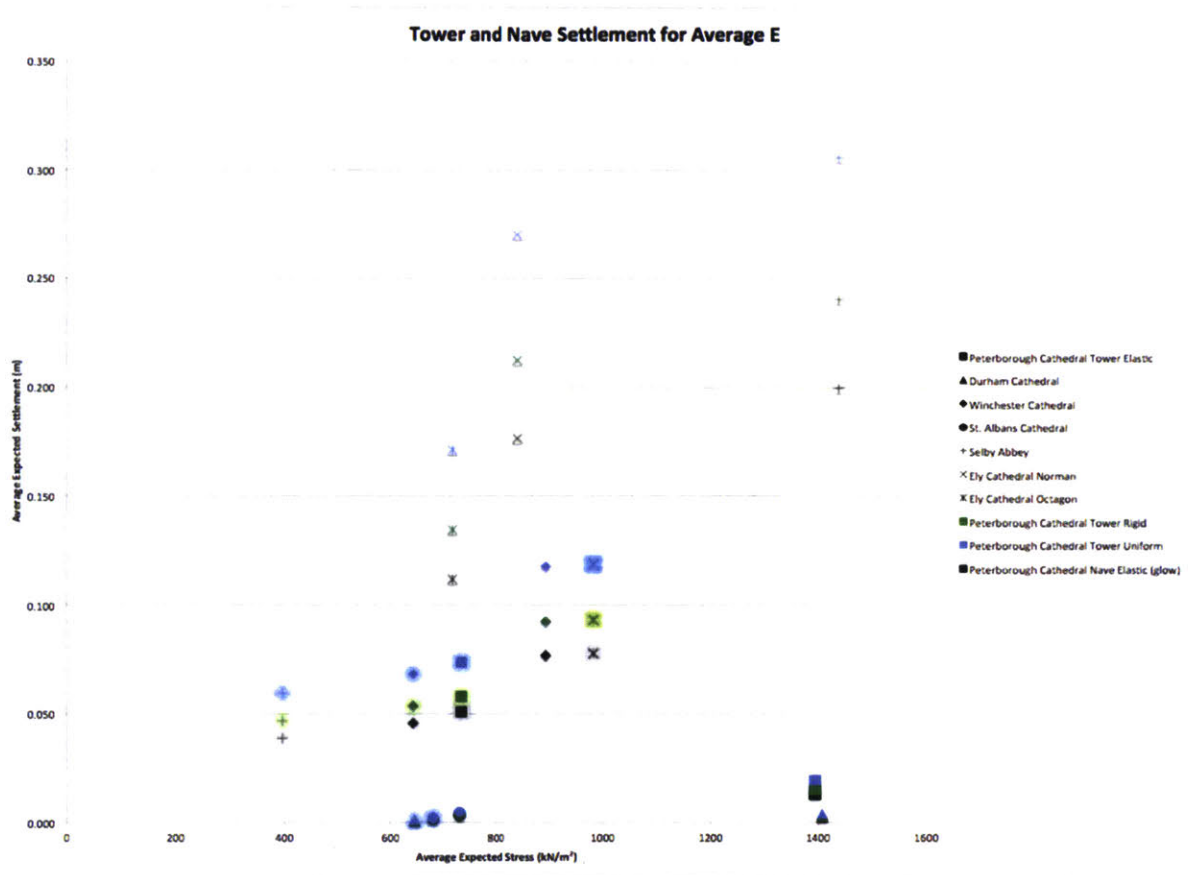
Figure 56: Tower and Nave (glowing) Average Expected Settlement for E_{avg}

The differential settlement between the nave and the tower piers is important to understand because it can lead to cracking, which can later lead to structural instability. Figure 56 shows the difference between the settlement that can be expected by a nave pier versus the settlement to be expected by a tower pier. The nave pier data points are glowing, while the tower pier data points are represented as before.

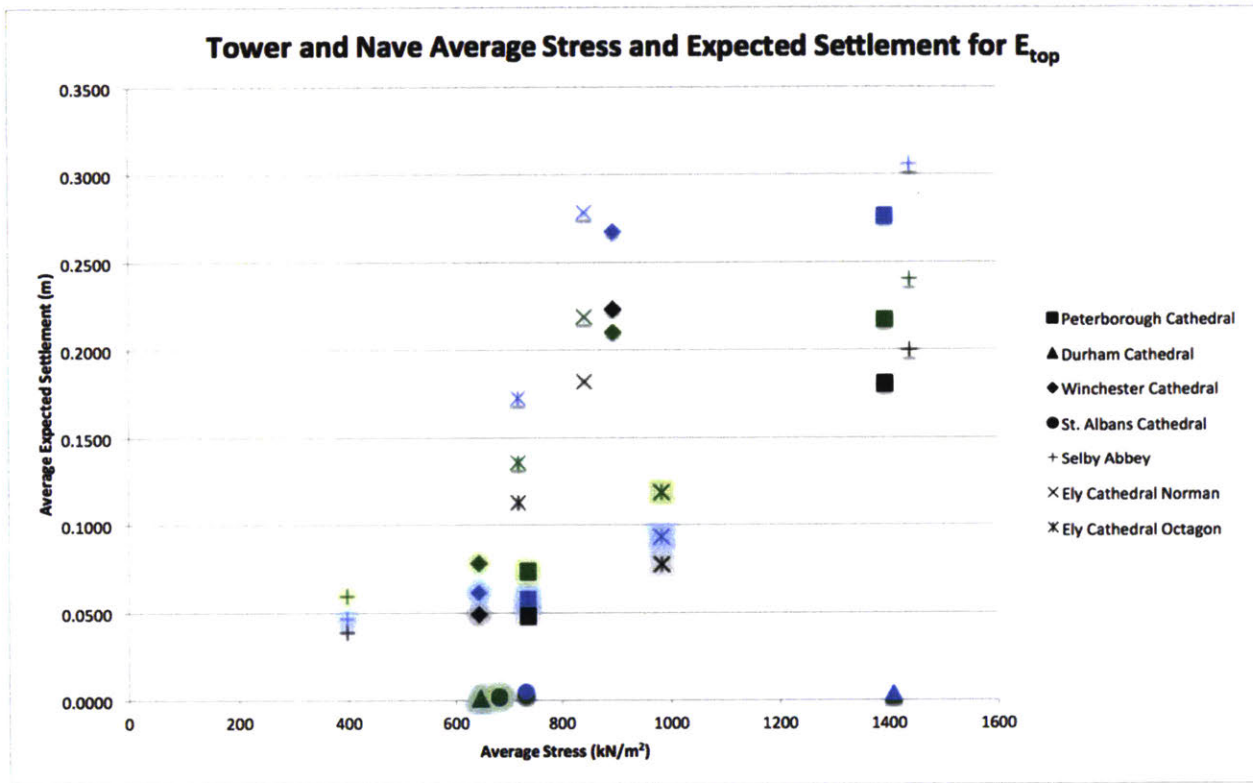
Figure 57: Tower and Nave (glowing) Average Expected Settlements for E_{top}

Selby's Tower and Nave, as previously shown in Figure 42. Figure 57 shows the data for E_{top} . As demonstrated previously, the tower settles much more than the nave.
