Damage Tolerance of Pressurized Graphite/Epoxy Tape Cylinders Under Uniaxial and Biaxial Loading

Submitted to the Department of Aeronautics and Astronautics
in Partial Fulfillment of the Requirements for the Degree of

Master of Science

Aeronautics and Astronautics

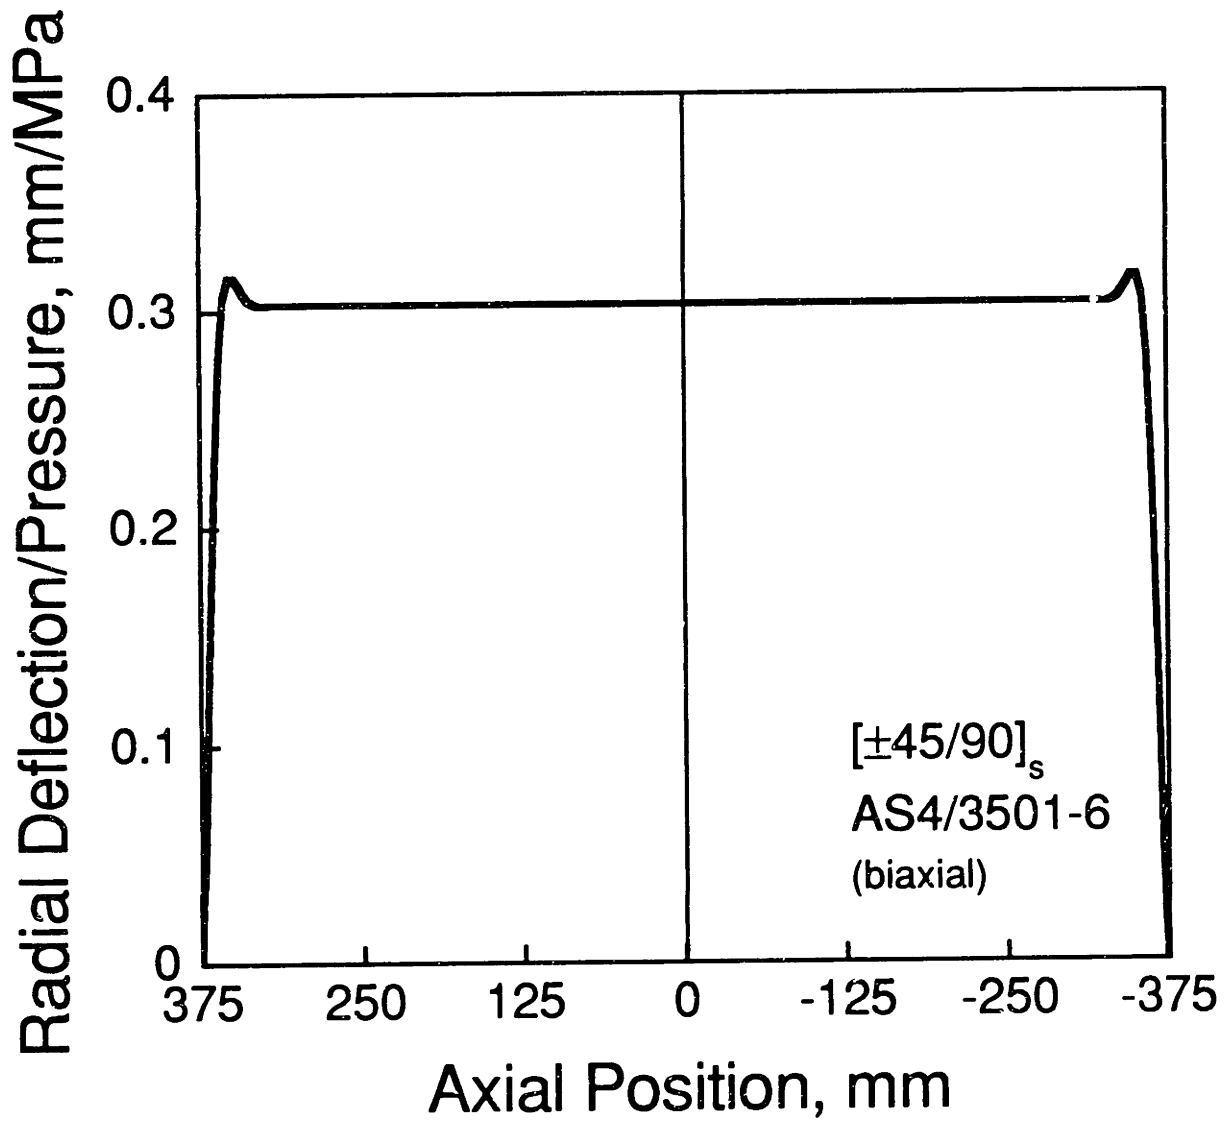
Figure 3.3 Plot of radial deflection versus axial position for unnotched, biaxially loaded $[\pm 45/90]_s$ tape cylinder with bonded endcaps.

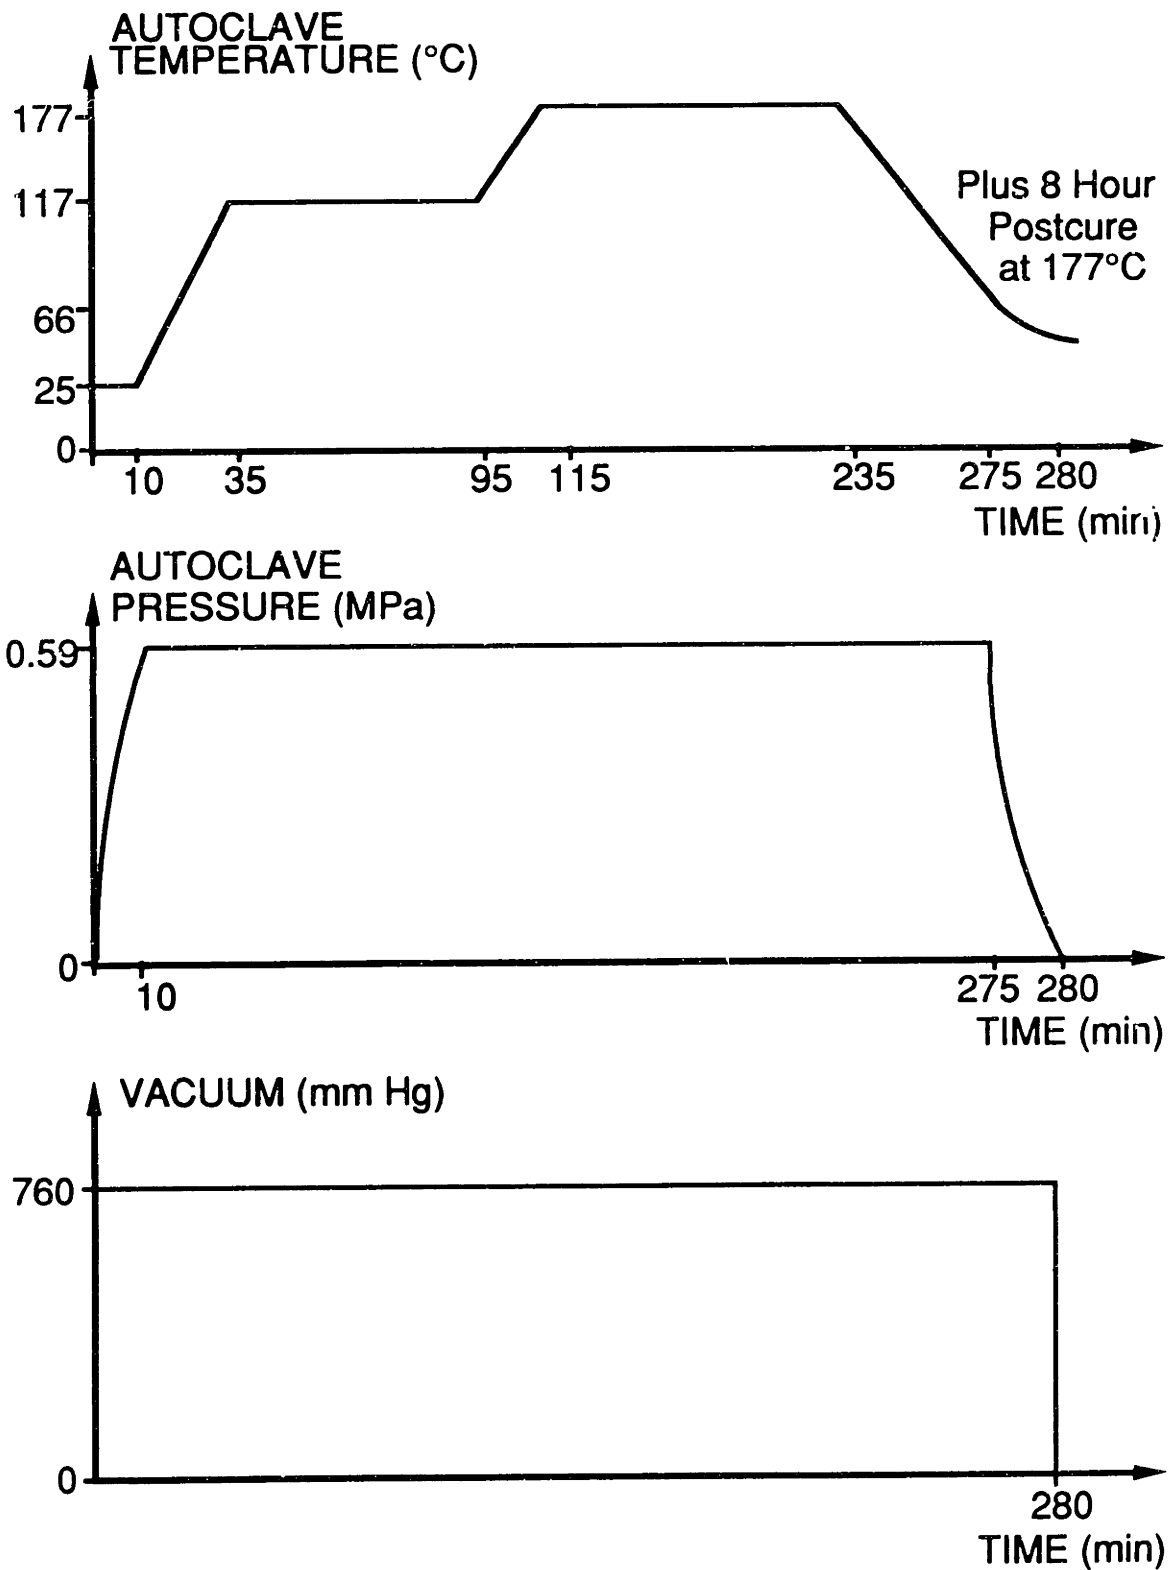
Figure 4.3 Standard cure cycle for AS4/3501-6 graphite/epoxy laminates.

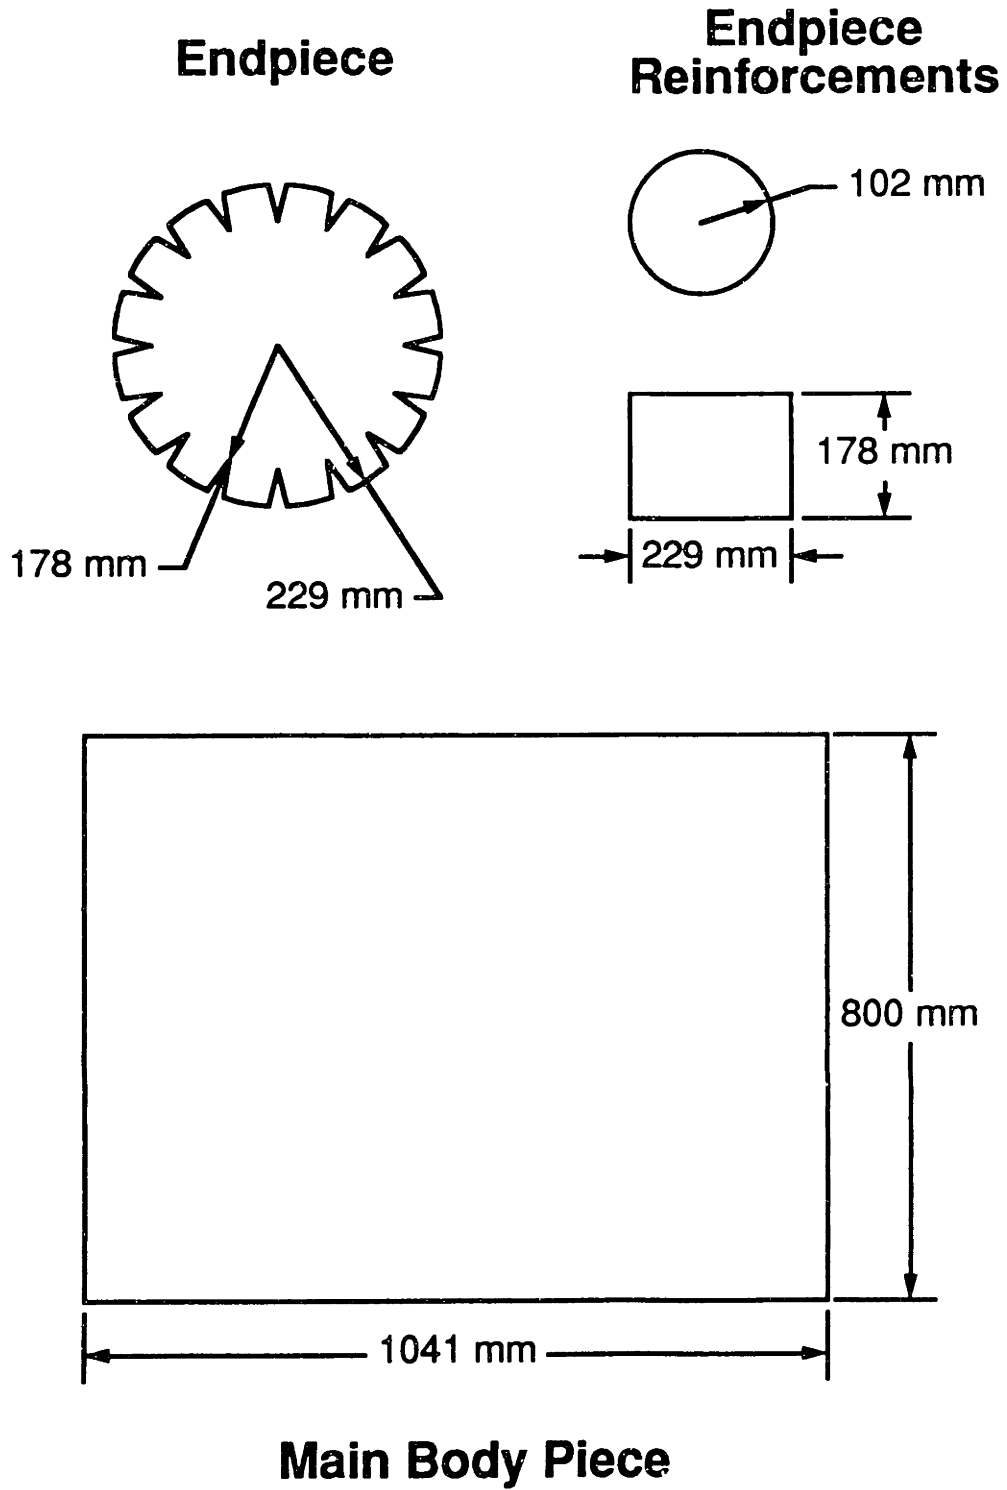
Rubber bladders were constructed to line the cylinders so that the nitrogen gas does not leak while the cylinders are pressurized. The standard TELAC bladder manufacturing process used is described in more detail in an internal TELAC document [34]. Each bladder is made from four pieces of 1/32" (0.8 mm) thick pure gum rubber which are cut from a 915 mm wide roll. These pieces are held together by vacuum tape and rubber adhesive. The main body of each bladder is formed from a rectangular piece 1041 mm by 800 mm. Two strips of 13 mm wide vacuum tape, #213-3 made by General Sealants, are placed side-by-side along one of the two shorter edges. The other short edge is lapped over the tape by 25.4 mm to form a 1016 mm circumference rubber tube. Two more strips of vacuum tape are placed side-by-side around the circumference of the main bladder piece at each end. These strips of tape are used to connect the toothed circular endpieces that are shown along with the other bladder pieces in Figure 4.20. Each circular endpiece is 458 mm in diameter and has triangles with a base of approximately 25 mm and a height of 51 mm cut from it to form 16 teeth. Teeth are connected one at a time in an alternating fashion to the main bladder piece. One of the endpieces has a 25 mm diameter hole cut into the

Figure 4.20 Rubber pieces for cylinder bladders.

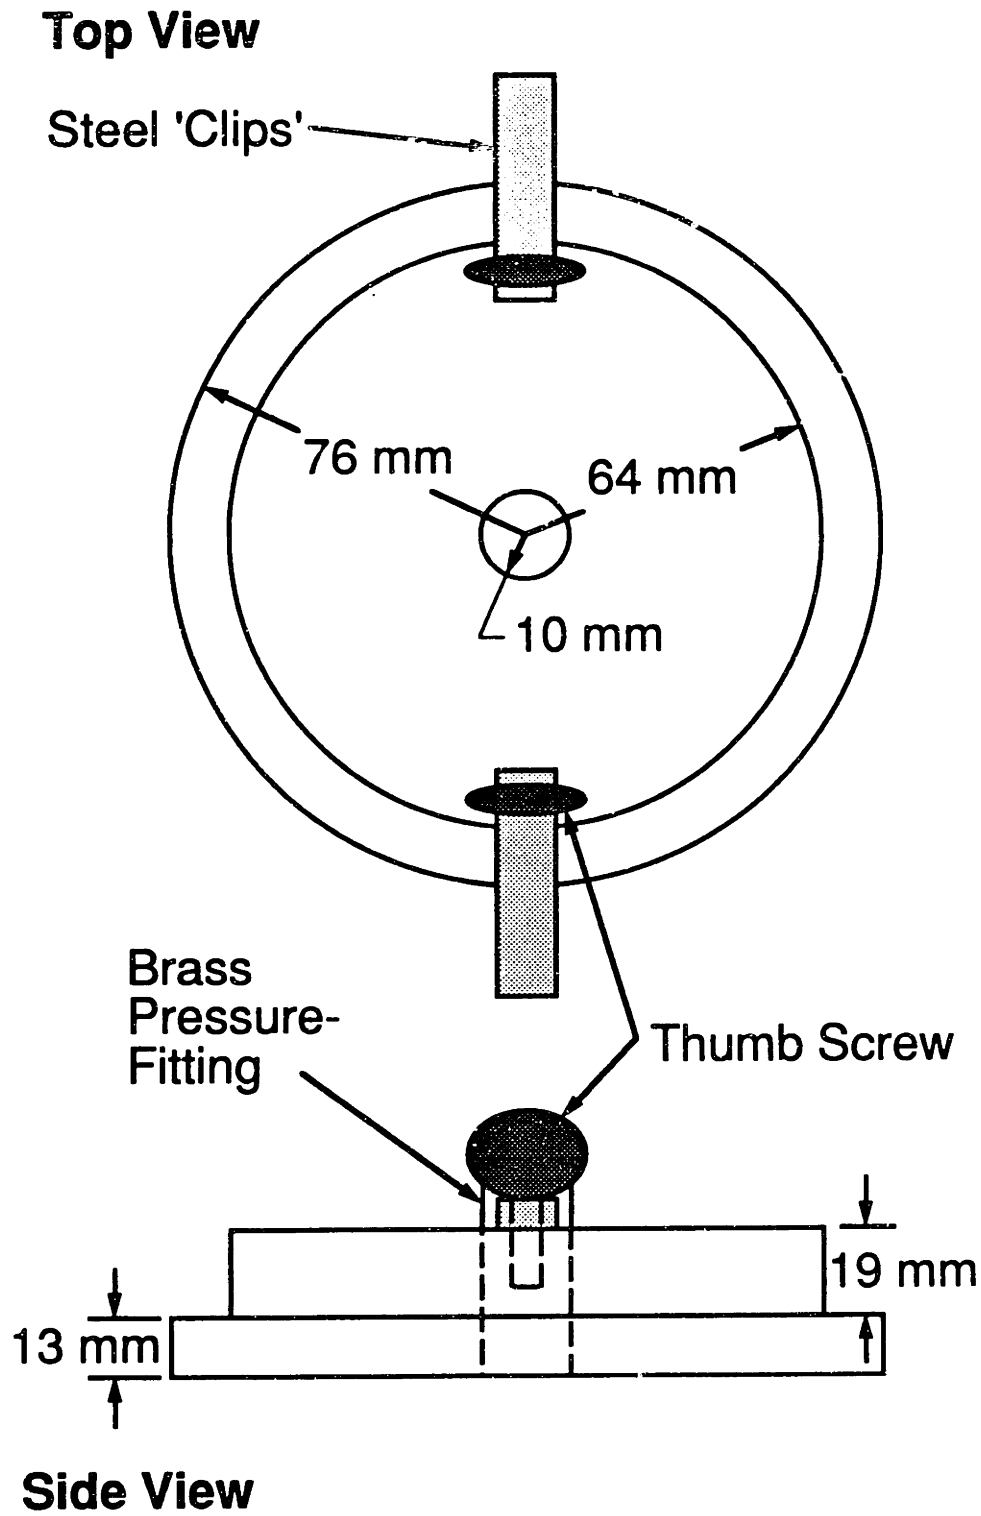
Figure 5.3 Illustration of uniaxial test apparatus pressure-fitting plate.

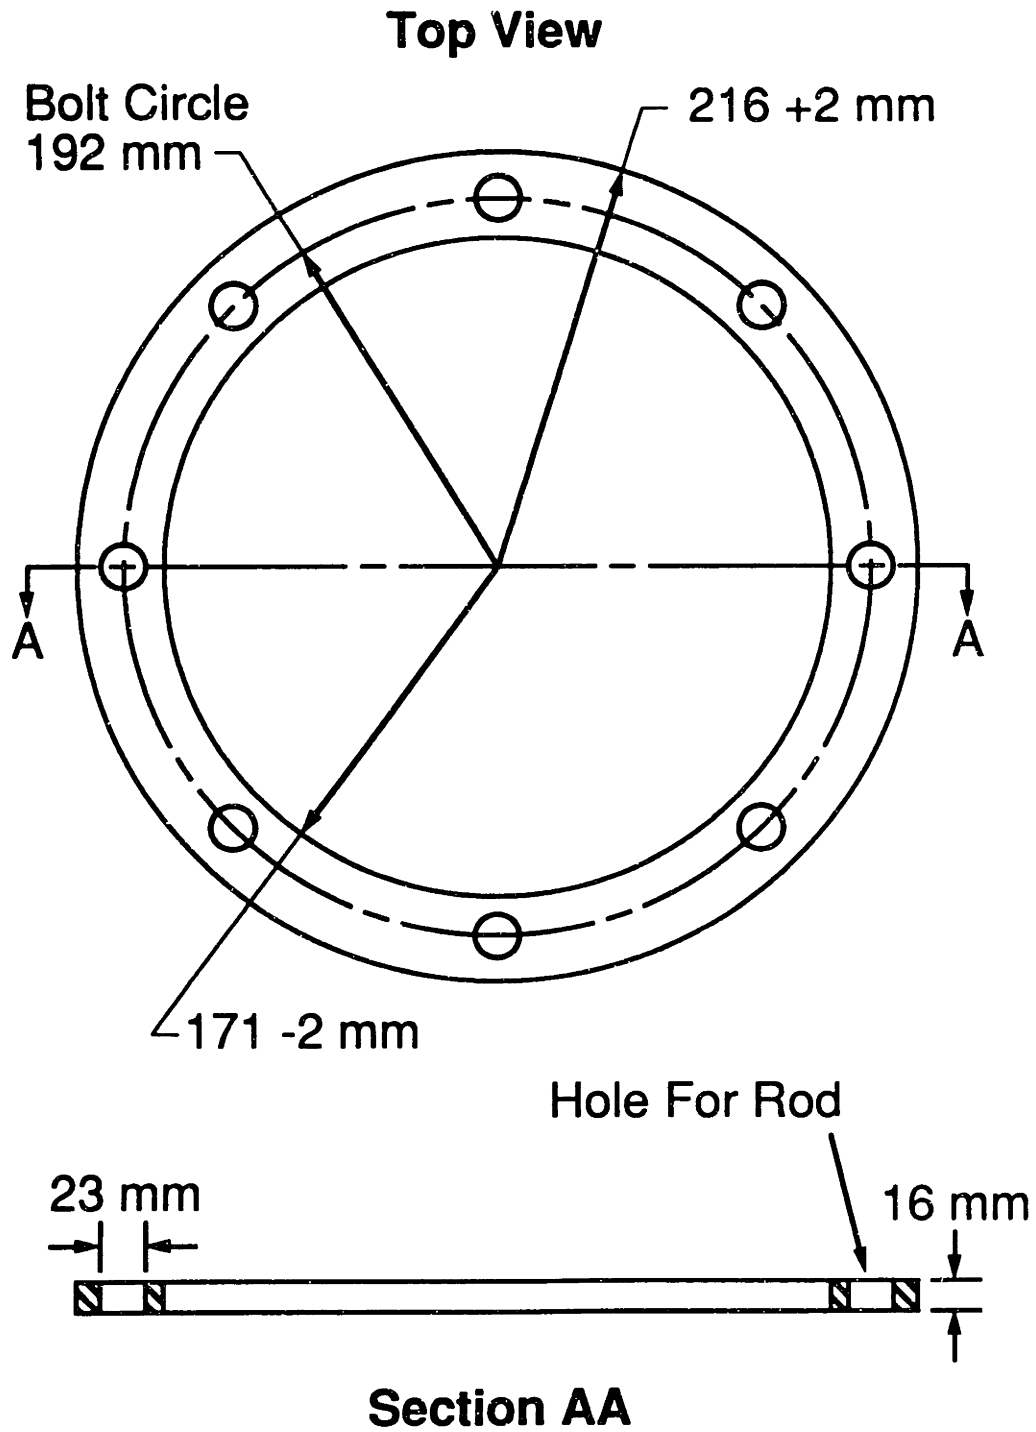
The rod support plates, shown in Figure 5.5, were added to the AALD design after the design verification tests since some of the rods were damaged during the first test of a cylinder to failure using the original design. The rod damage is described in more detail in Section 5.5.2. The purpose of the plates is to prevent excessive deflection and, thus, permanent deformation of the rods due to buckling or bending induced by the cylinder explosion. The three plates were purchased as steel rings with an inner diameter of $13.5 - \frac{1}{8}$ " (343 -3 mm), an outer diameter of $17 + \frac{1}{8}$ " (432 +3 mm), a thickness of $\frac{5}{8}$ " (16 mm), and a mass of 6 kg. Each of the eight holes for the continuously threaded rods was drilled through all three plates at the same time using a

Figure 5.5 Illustration of uniaxial test apparatus rod support plate.

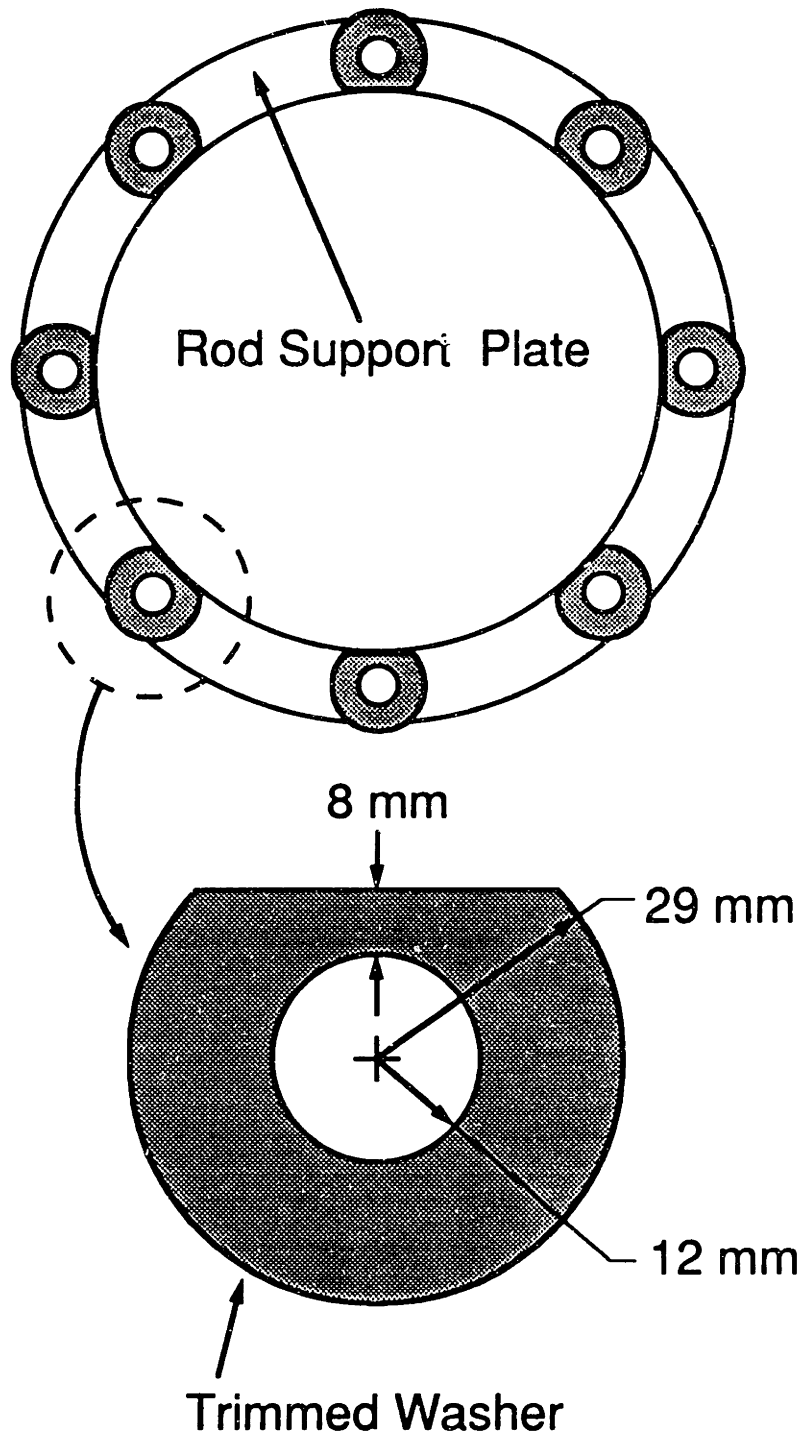
Figure 5.6 Schematic of trimmed washer.

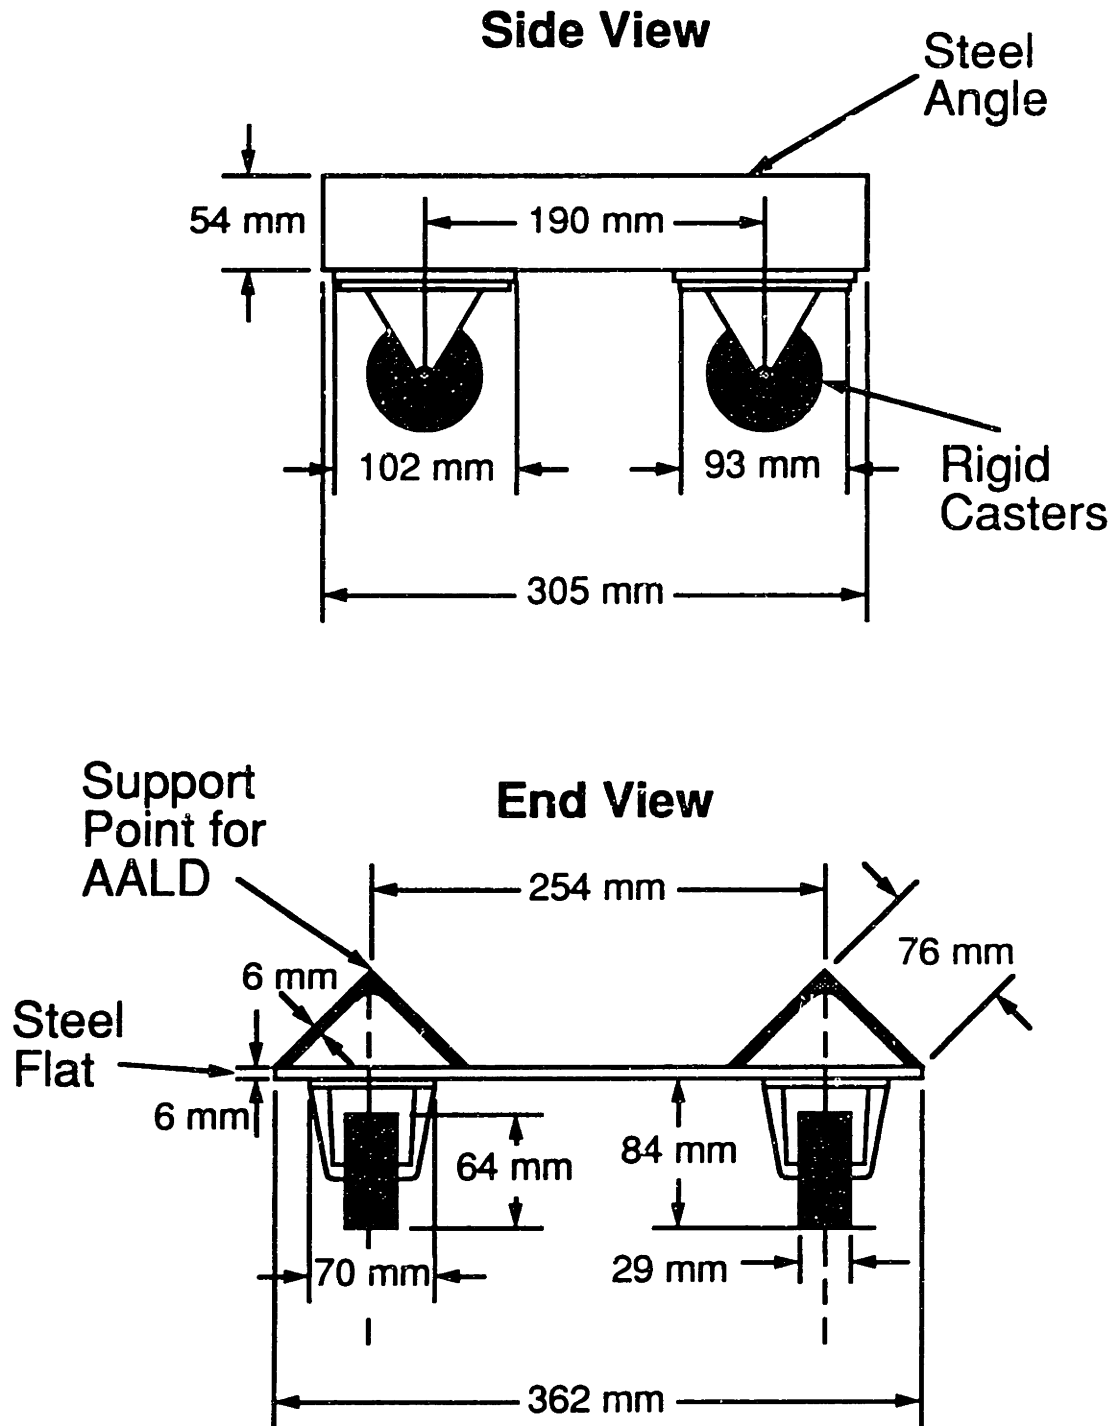
The main frame of each support and the legs on the fixed support were manufactured from 4" (102 mm) wide by 1/4" (6 mm) thick steel flats and 3" by 3" by 1/4" thick (76 x 76 x 6 mm) steel angles. Individual steel pieces were cut from stock lengths and trimmed to the proper dimensions on a milling machine. The pieces were tackwelded together to form the frames prior to the attachment of the casters or the machine-leveling mounts.

Figure 5.7 Illustration of rolling AALD support.

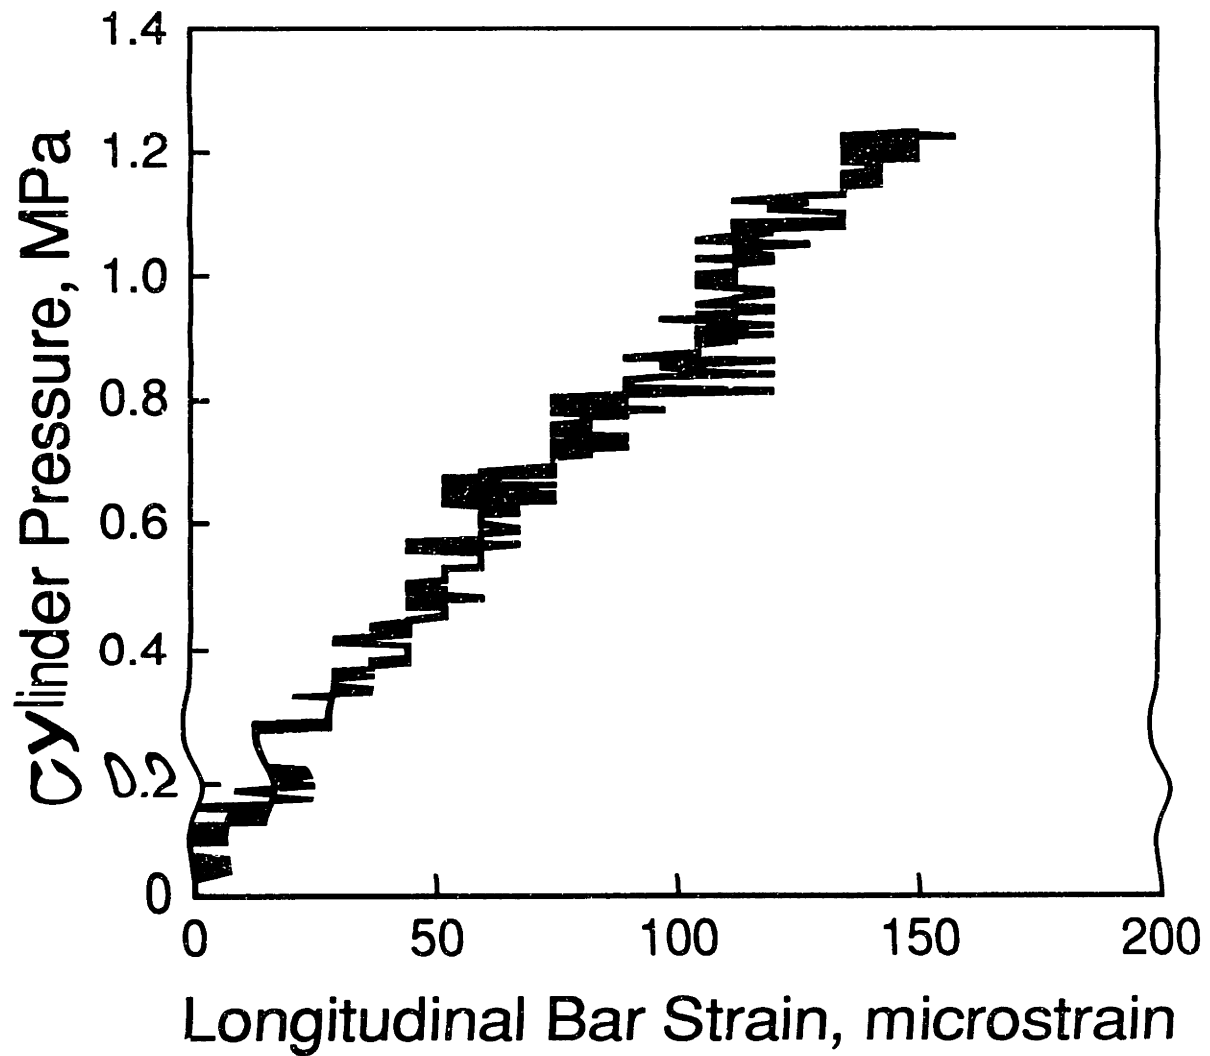
Strain readings obtained in Test 4 from the longitudinal gage on rod 'A' are provided in Figure 5.16. As can be seen in this figure, the general trend

Figure 5.16 Rod 'A' longitudinal strains from AALD Verification Test 4 of unnotched $[90/0/\pm 45]_8$ cylinder.

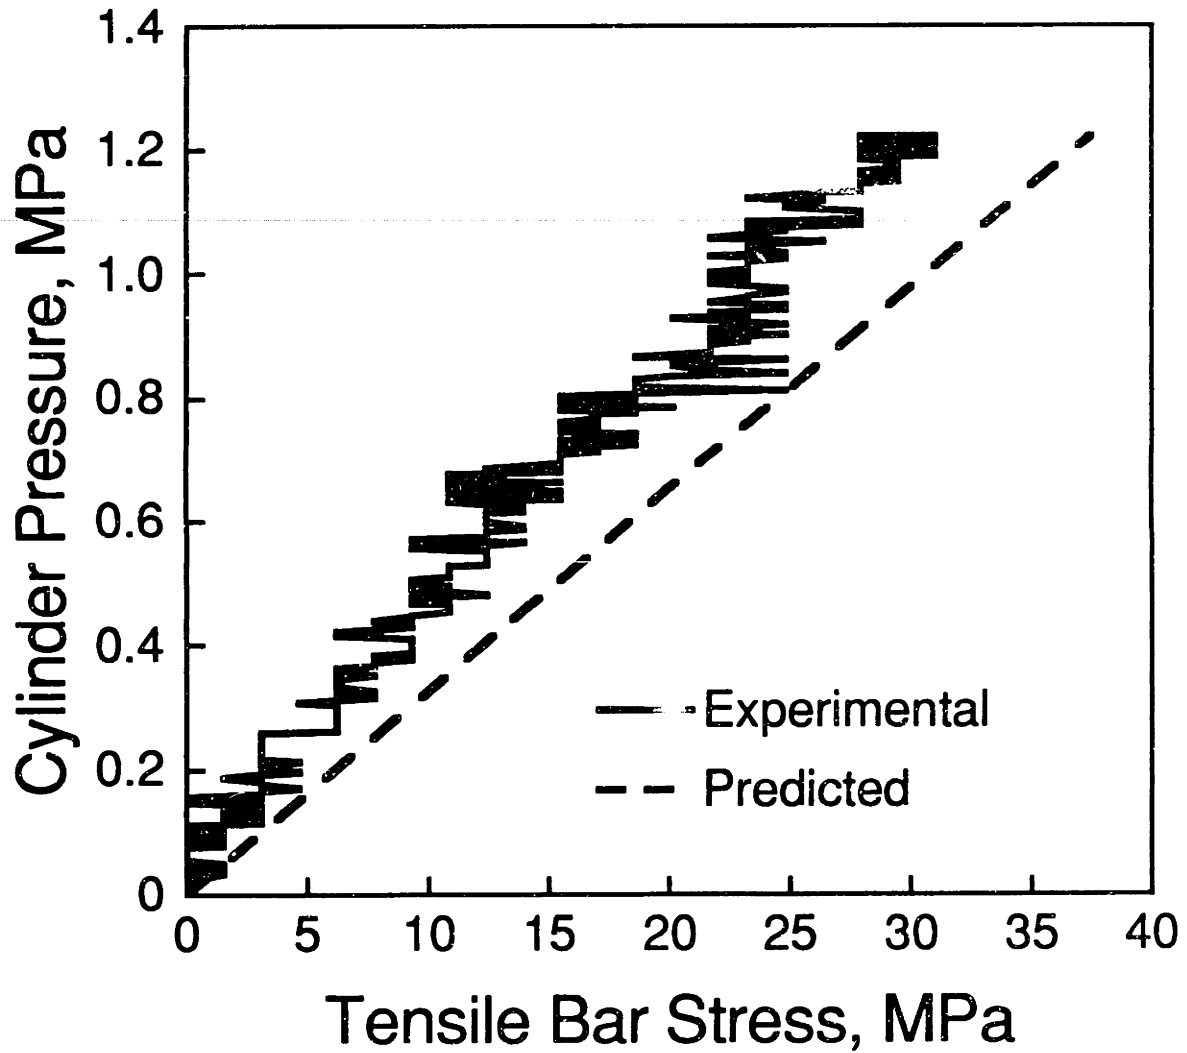
Figure 5.17 Experimental and predicted Rod 'A' longitudinal stresses from AALD Verification Test 4 of unnotched $[90/0/\pm 45]_s$ cylinder.

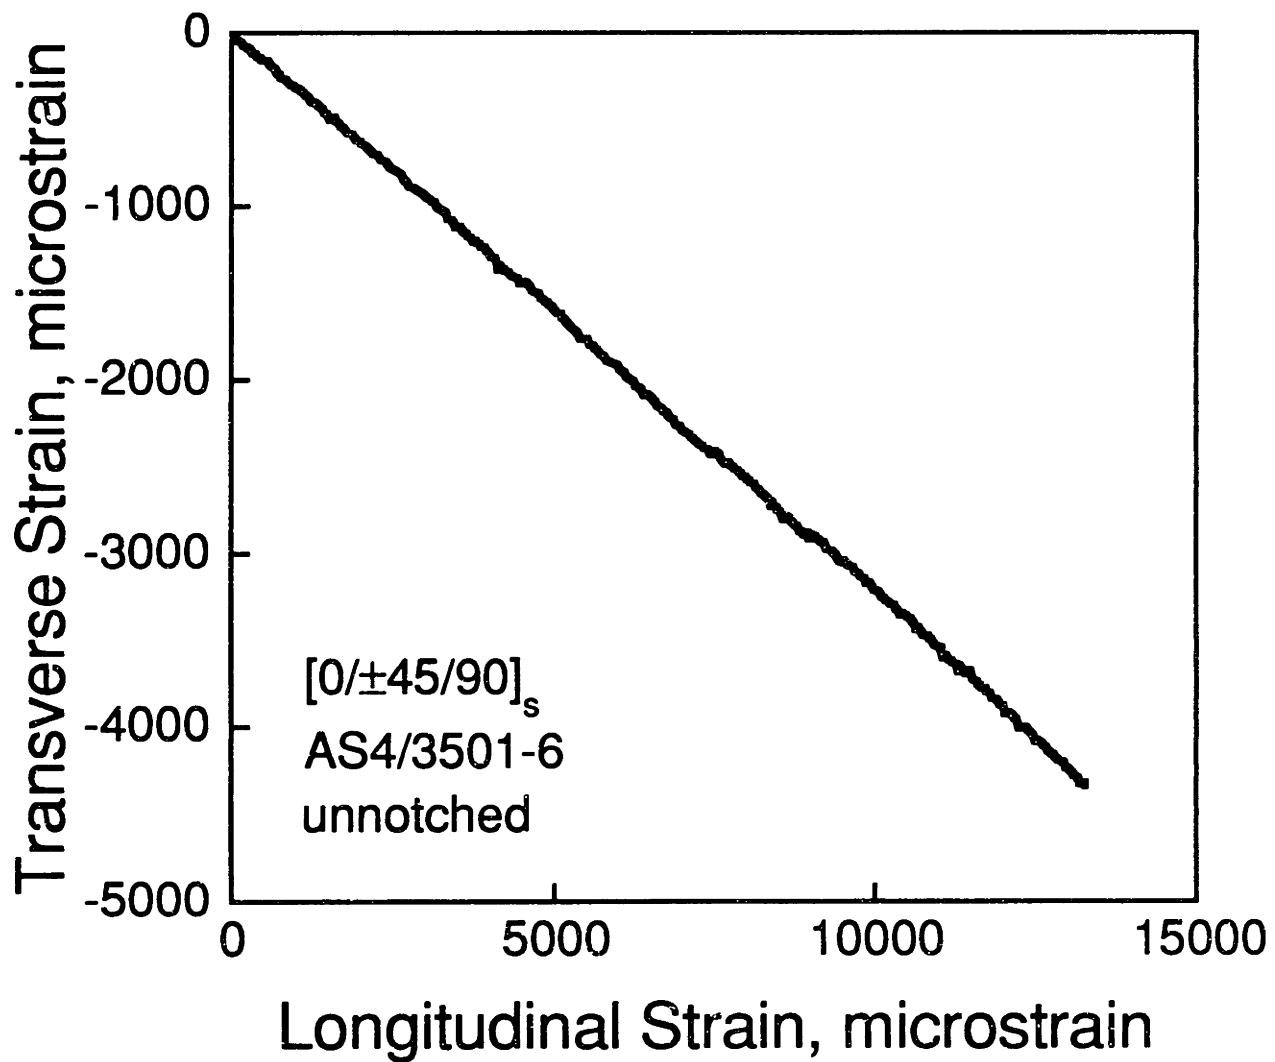
Figure 6.2 Transverse strain versus longitudinal strain for typical $[0/\pm 45/90]_s$ coupon.

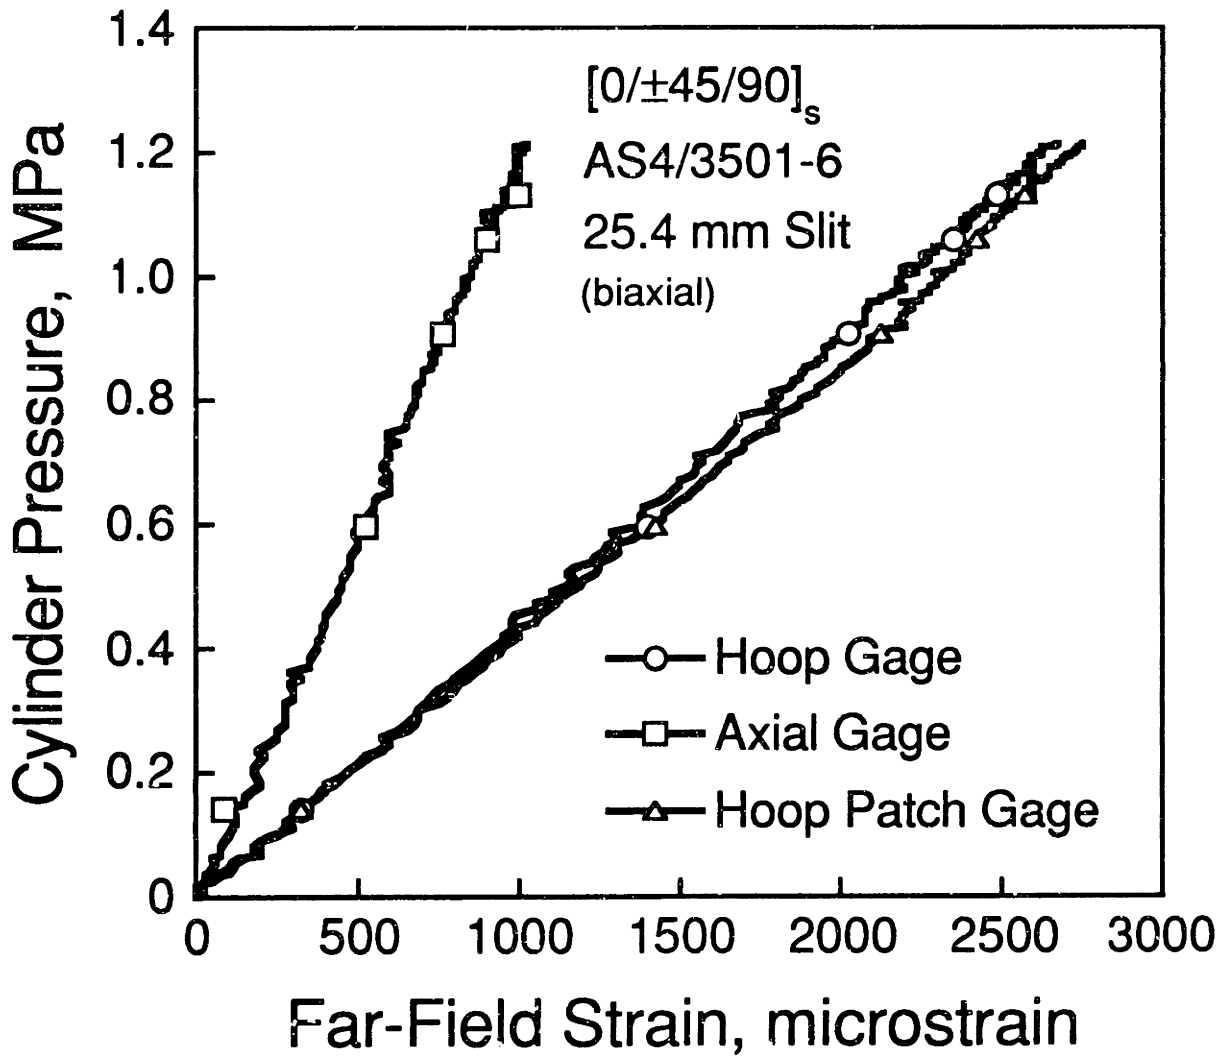
Figure 6.5 Cylinder pressure versus far-field and circumferential patch gage strains from failure test of biaxially loaded $[0/\pm 45/90]_s$ cylinder with 25.4 mm slit.

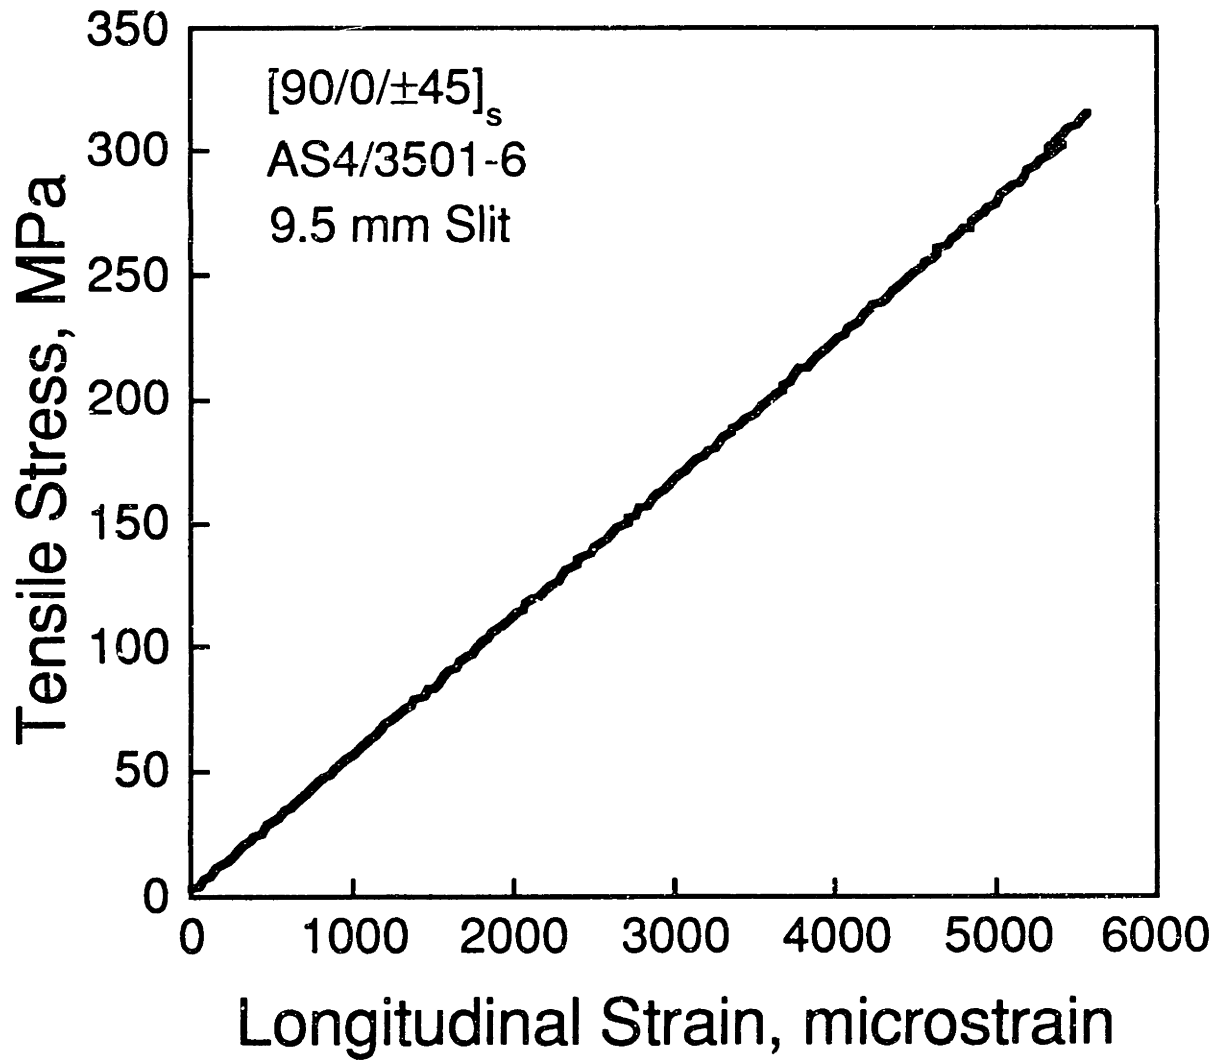
Figure 6.13 Tensile stress versus longitudinal strain for typical notched $[90/0/\pm 45]_s$ coupon.

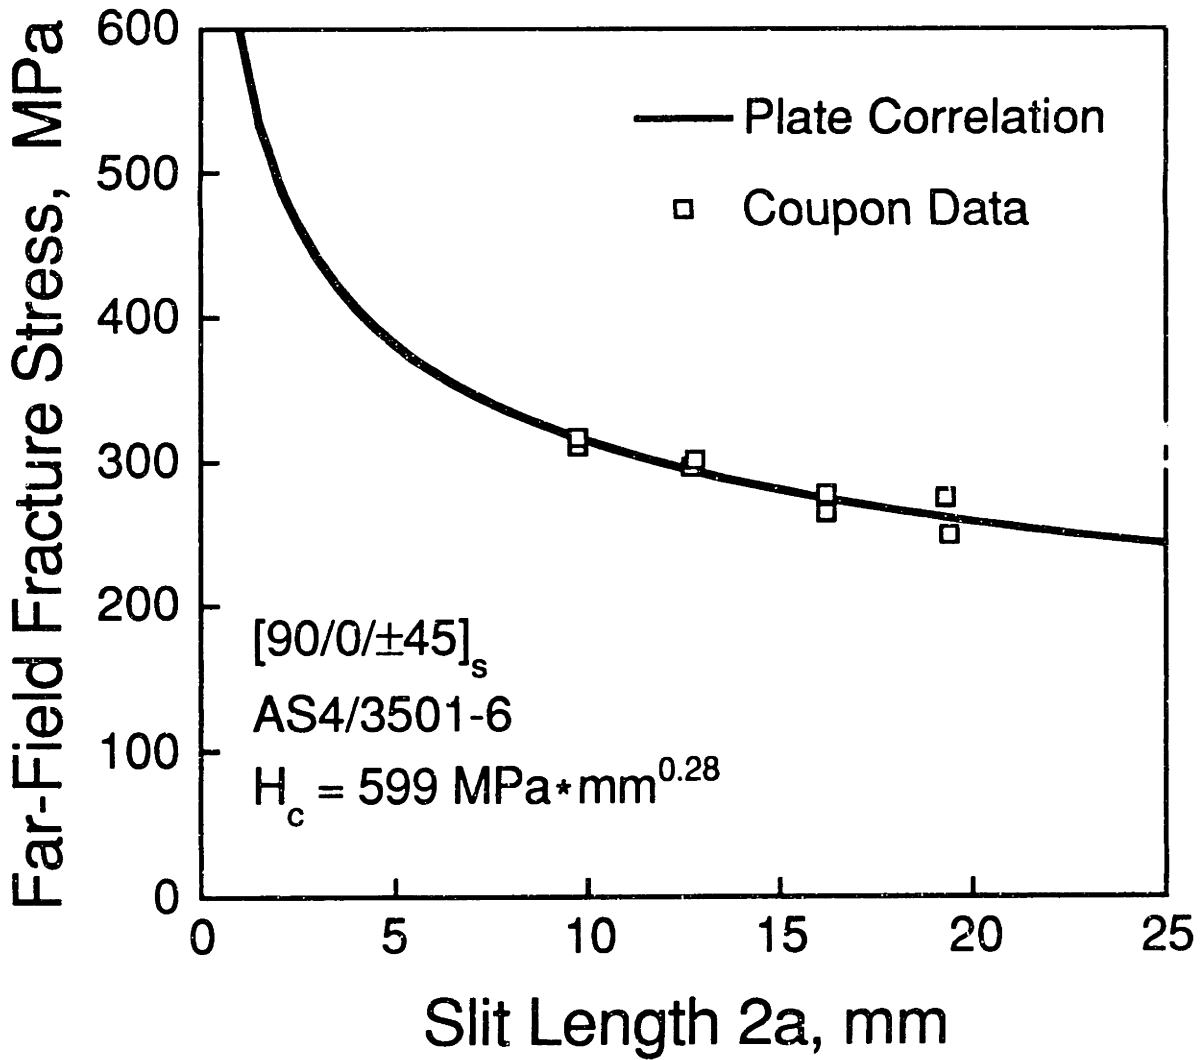
Figure 6.14 Individual failure stresses and failure stress correlation curve for notched $[90/0/\pm 45]_s$ coupons.

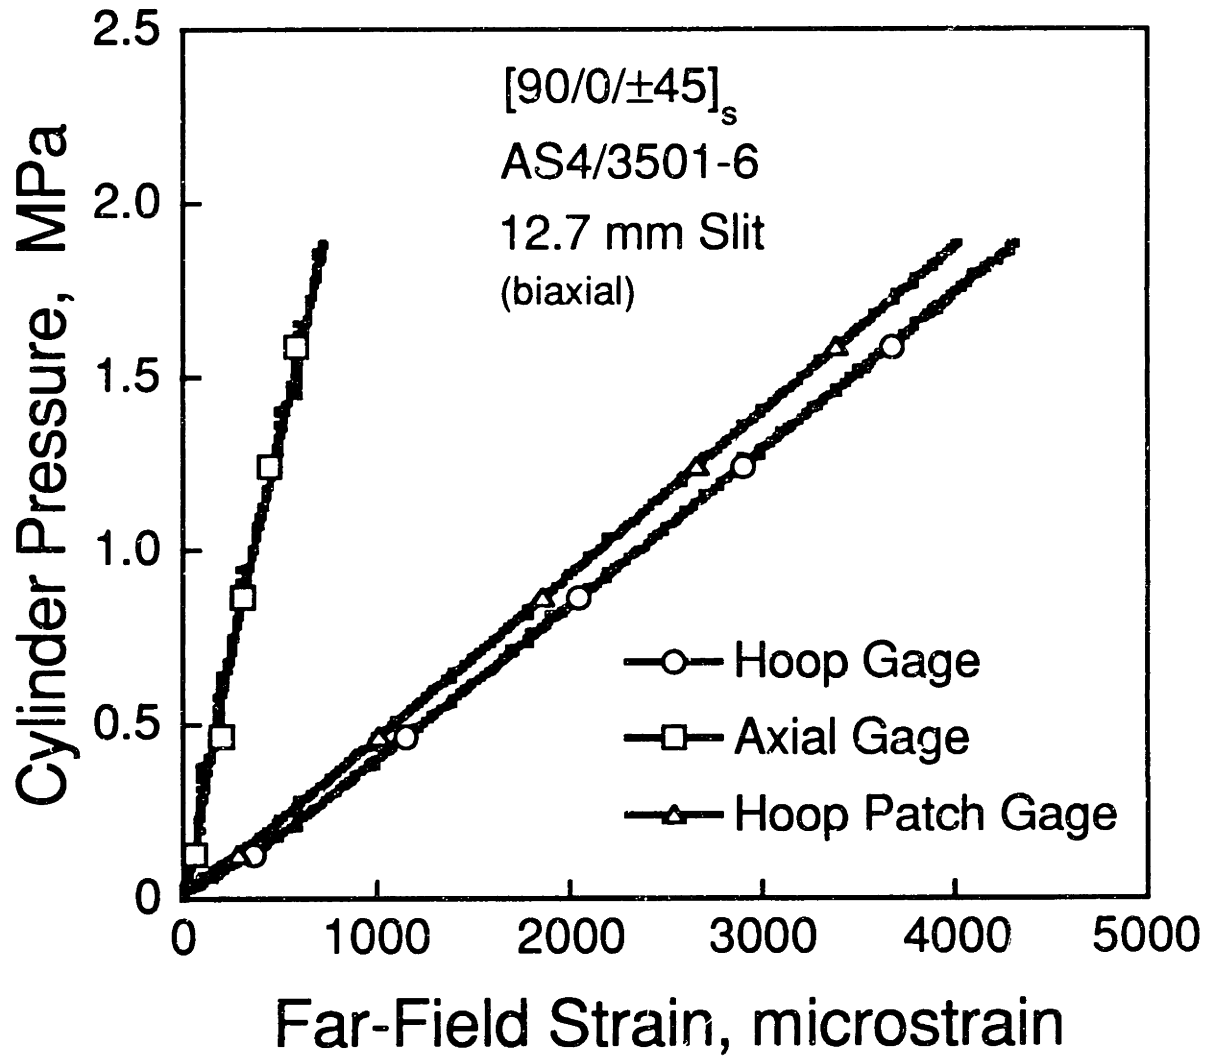
Figure 6.16 Cylinder pressure versus far-field and circumferential patch gage strains from failure test of second biaxially loaded [90/0/±45]_s cylinder with 12.7 mm slit.

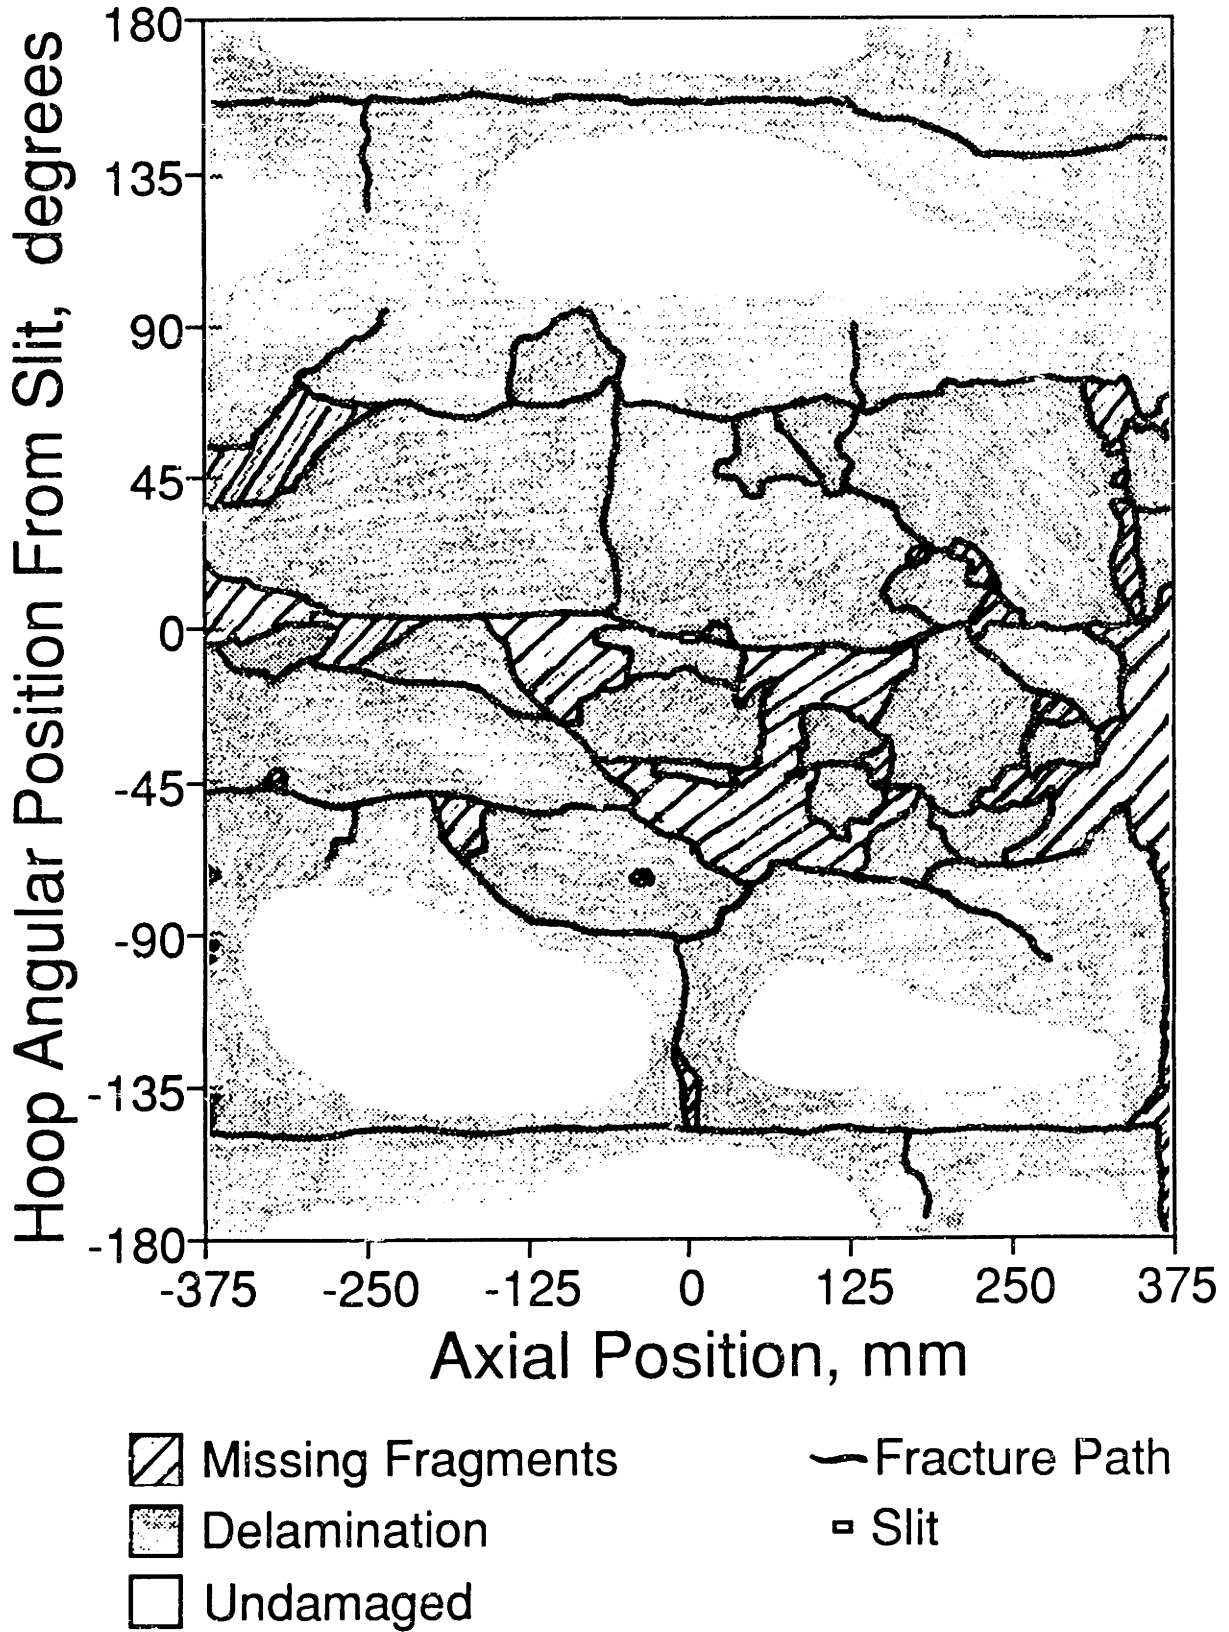
Figure 6.20 Schematic of damage in first biaxially loaded $[90/0/\pm 45]_s$ cylinder with 12.7 mm slit.
