Damage Tolerance of Pressurized Graphite/Epoxy Tape Cylinders Under Uniaxial and Biaxial Loading

Submitted to the Department of Aeronautics and Astronautics
in Partial Fulfillment of the Requirements for the Degree of

Master of Science

Aeronautics and Astronautics

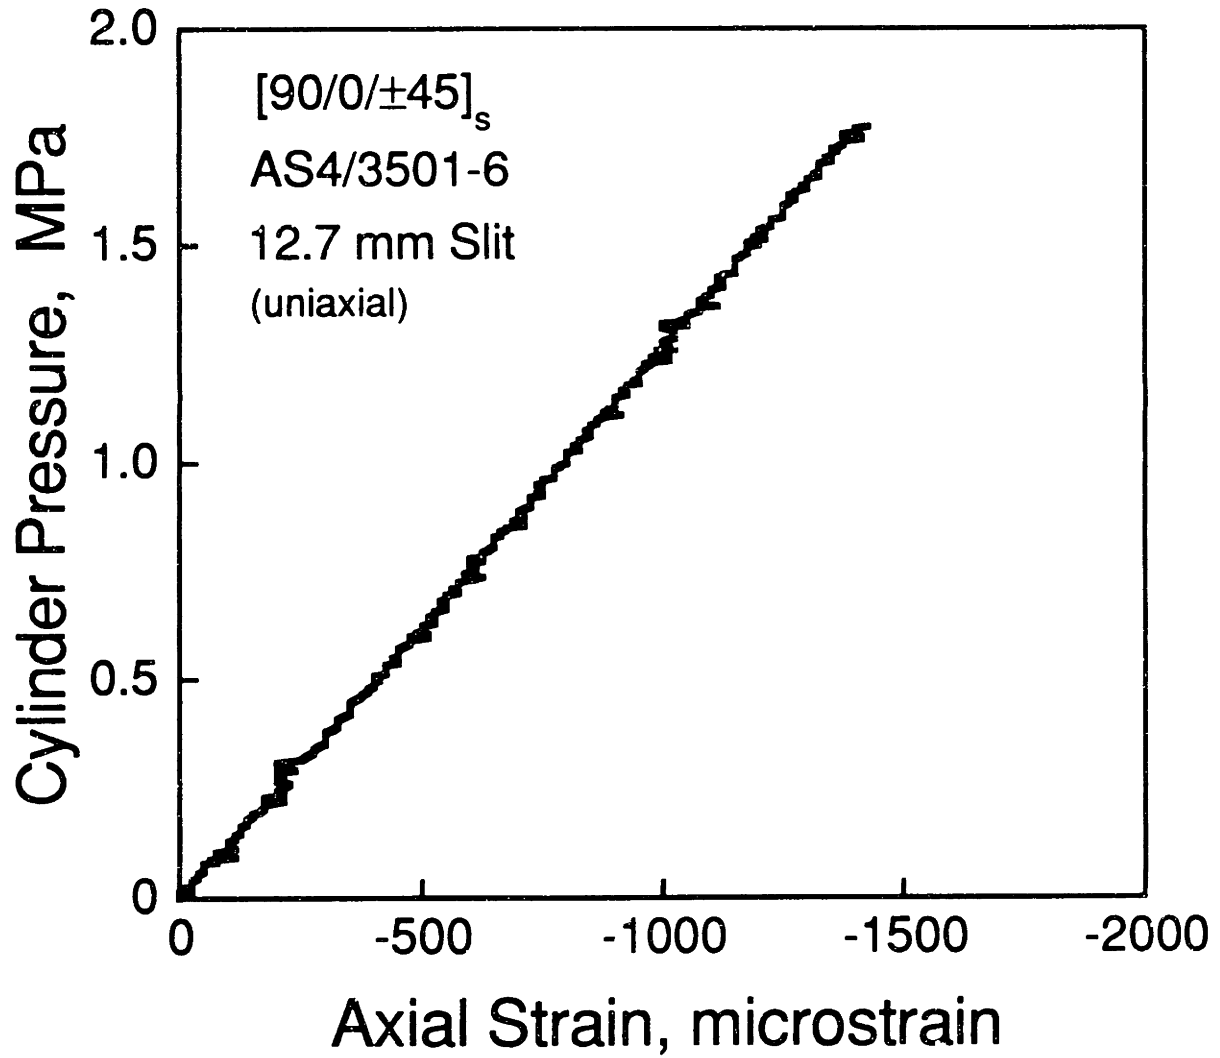
Figure 6.24 Cylinder pressure versus far-field longitudinal strain from failure test of uniaxially loaded $[90/0/\pm 45]_s$ cylinder with 12.7 mm slit.

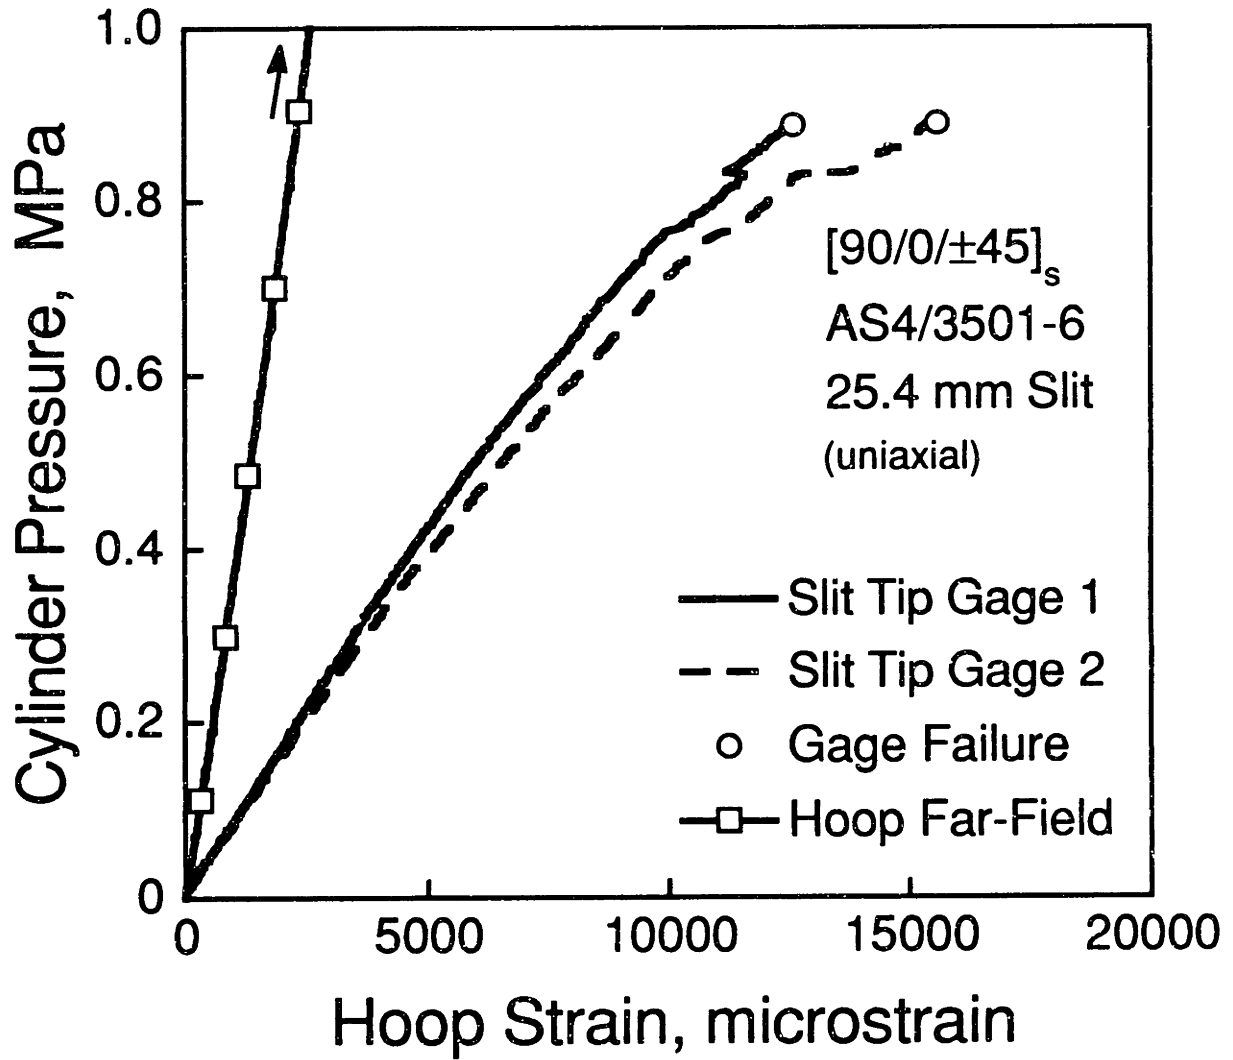
Figure 6.26 Cylinder pressure versus slit tip gage and far-field circumferential strains from failure test of uniaxially loaded $[90/0/\pm 45]_s$ cylinder with 25.4 mm slit.

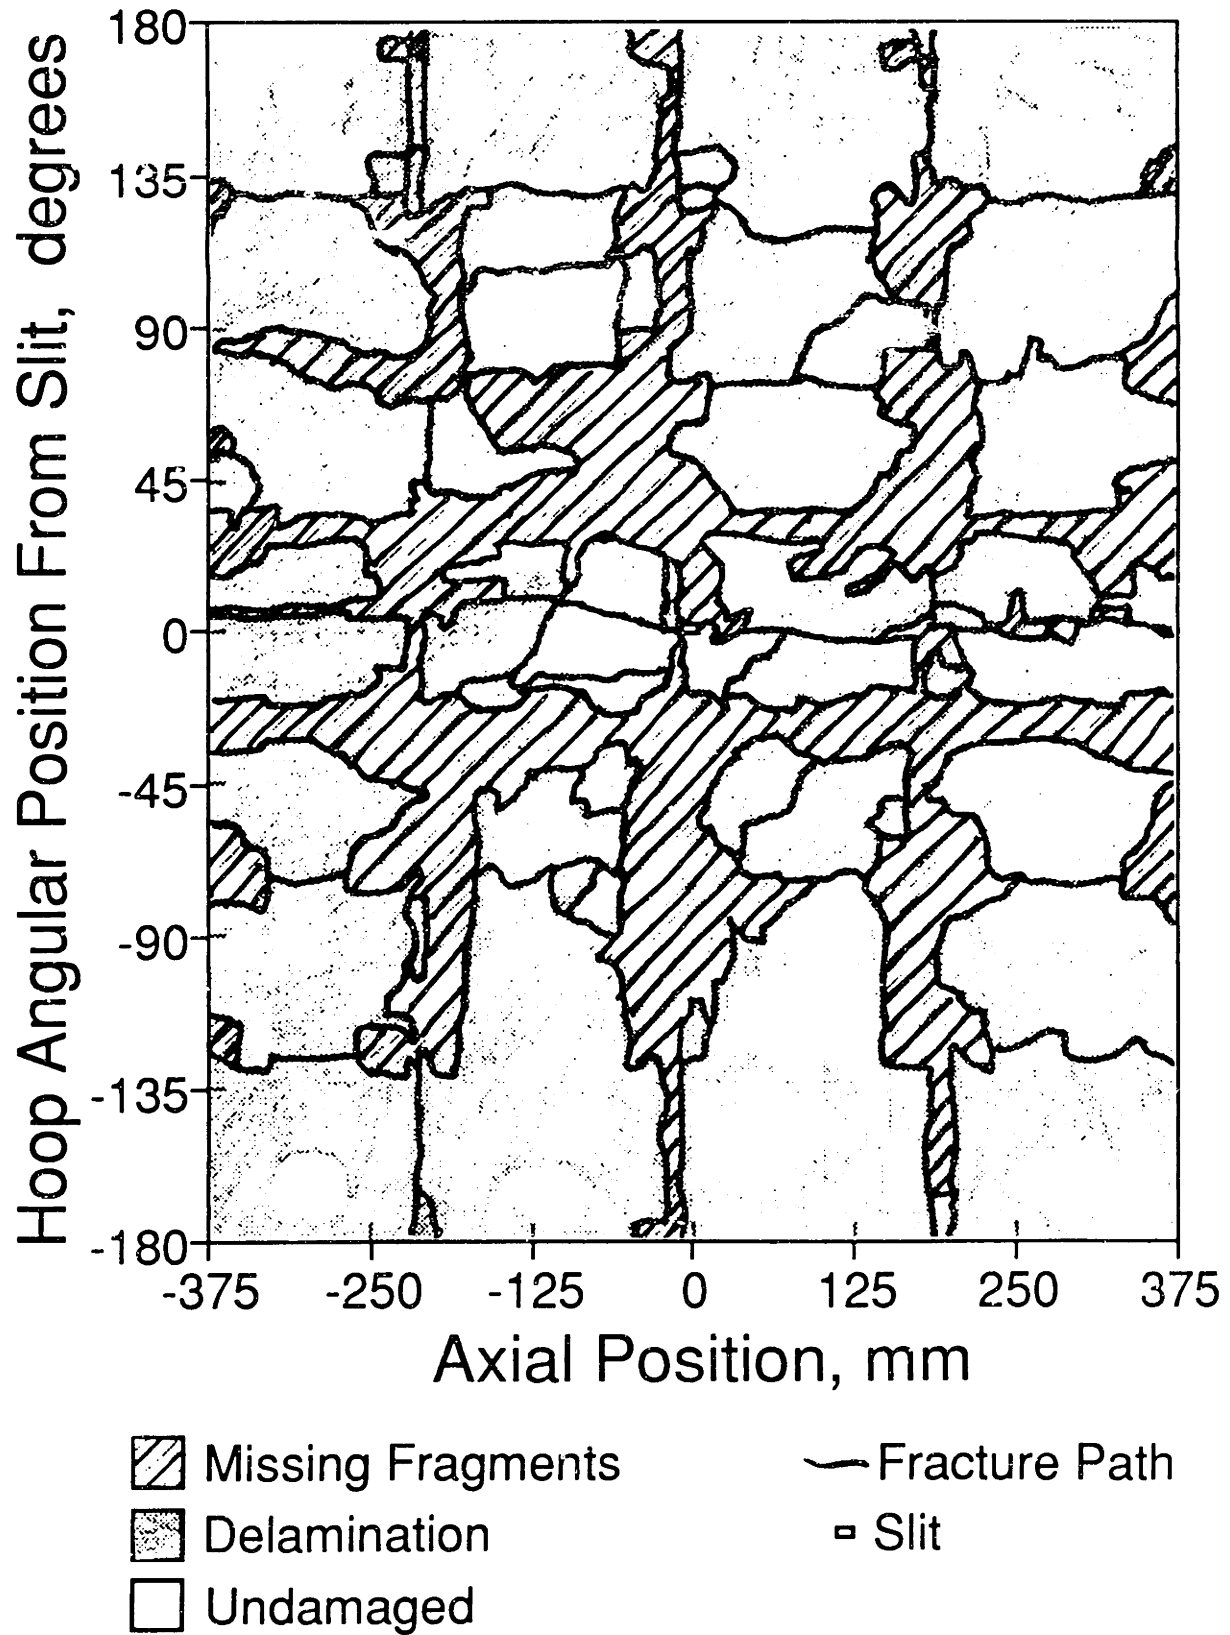
Figure 6.29 Schematic of damage in uniaxially loaded $[90/0/\pm 45]_s$ cylinder with 12.7 mm slit.

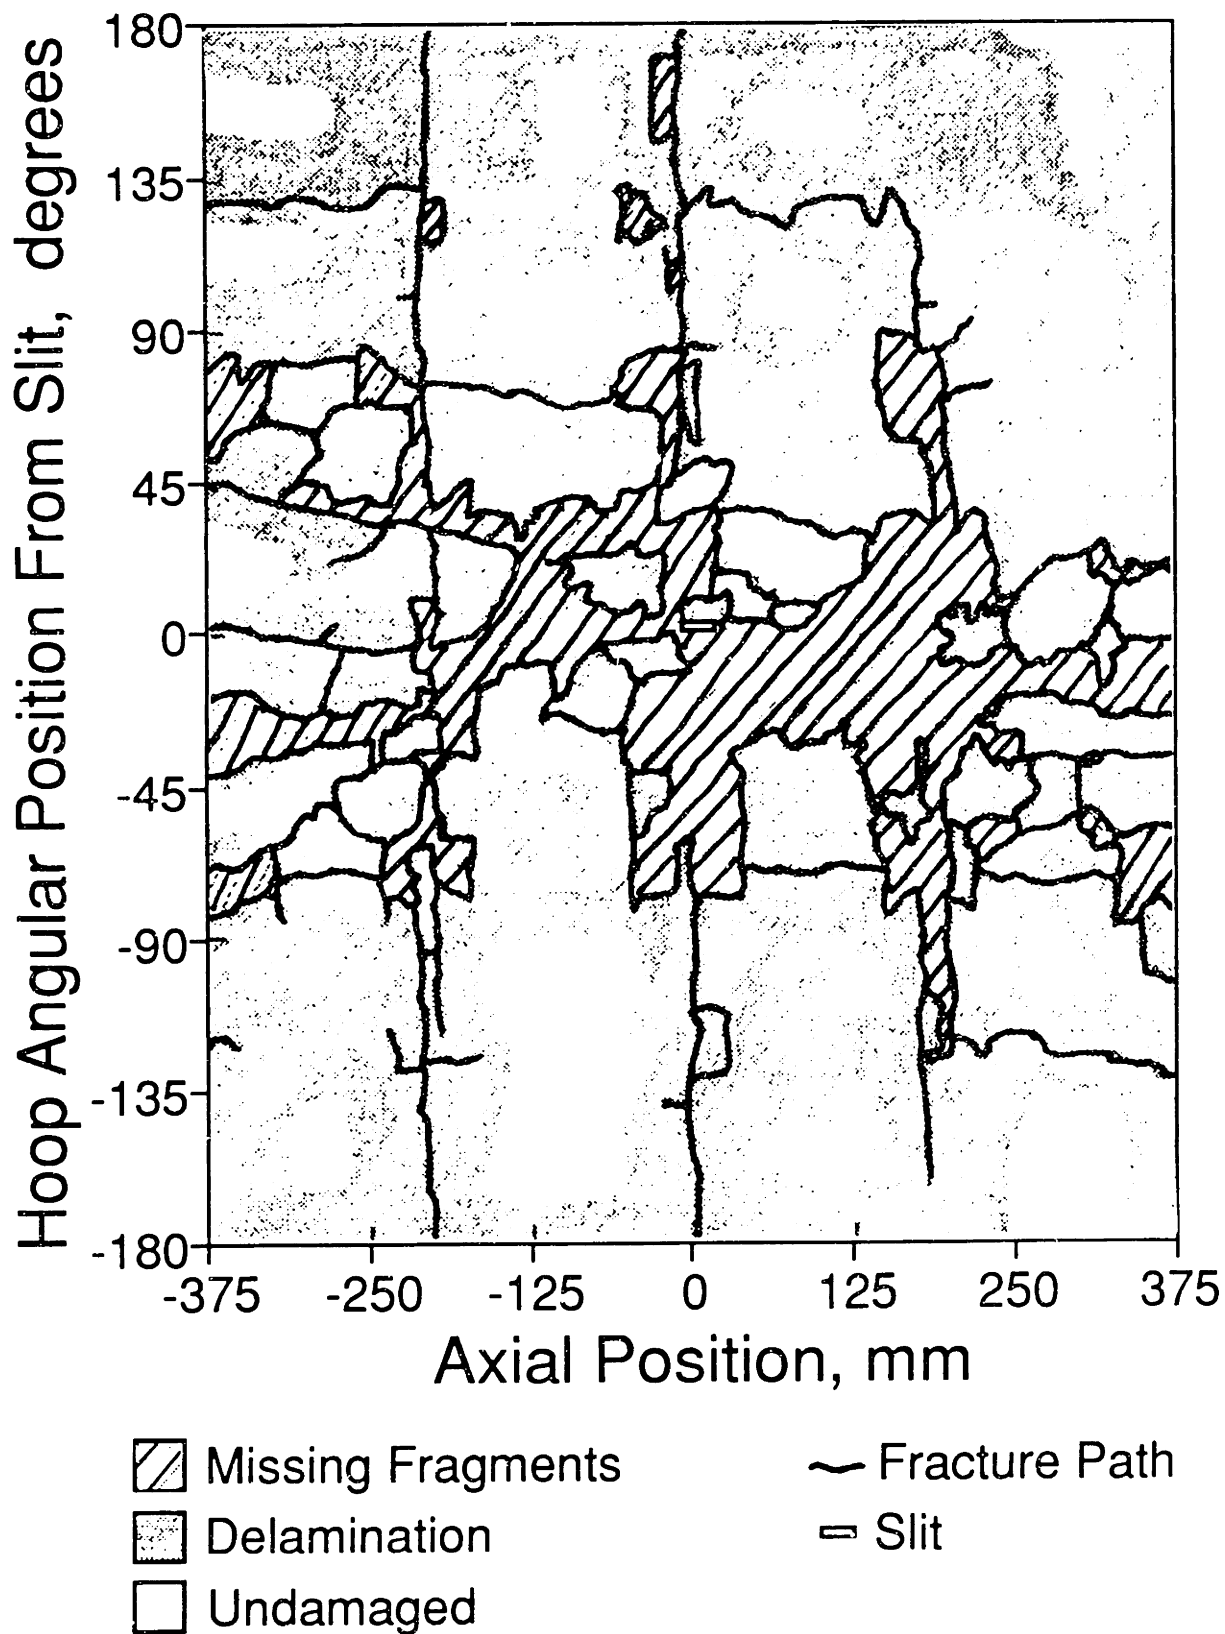
Figure 6.31 Schematic of damage in uniaxially loaded $[90/0/\pm 45]_s$ cylinder with 25.4 mm slit.

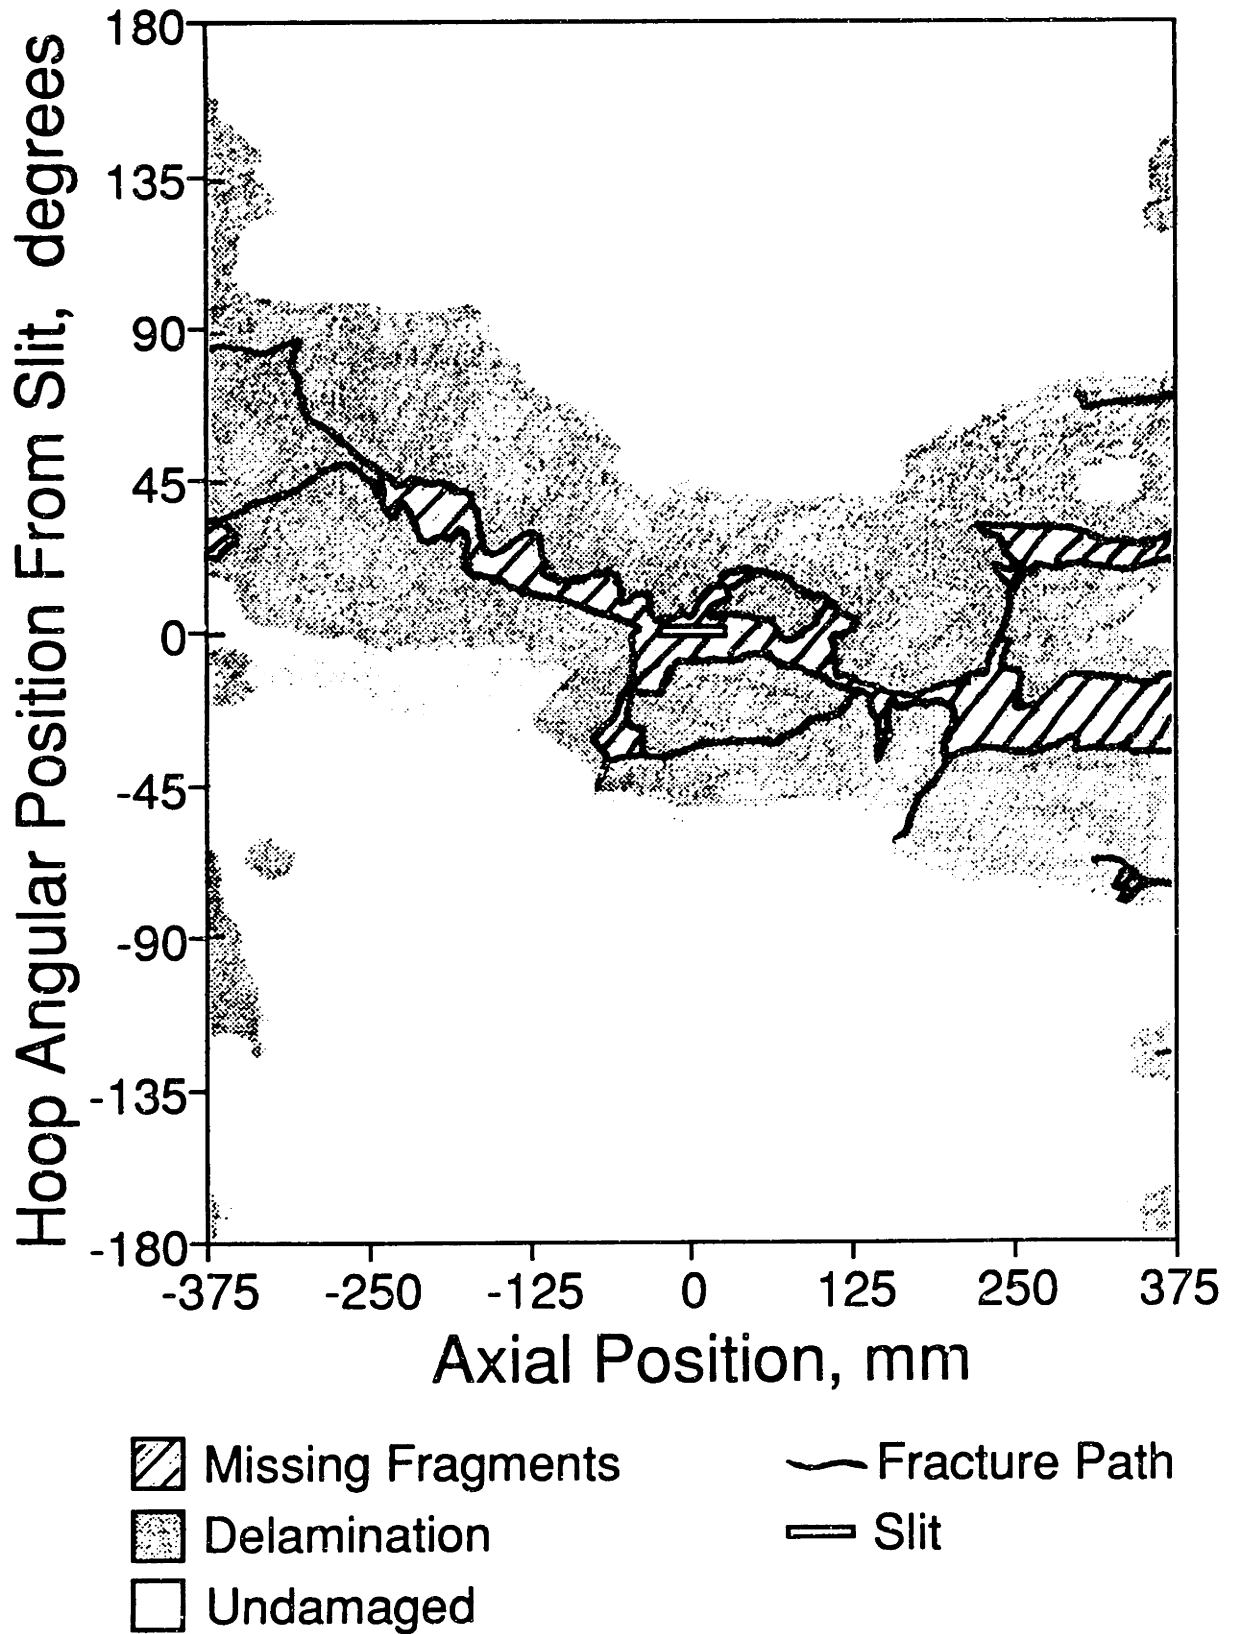
Figure 6.33 Schematic of damage in uniaxially loaded $[90/0/\pm 45]_8$ cylinder with 50.8 mm slit.

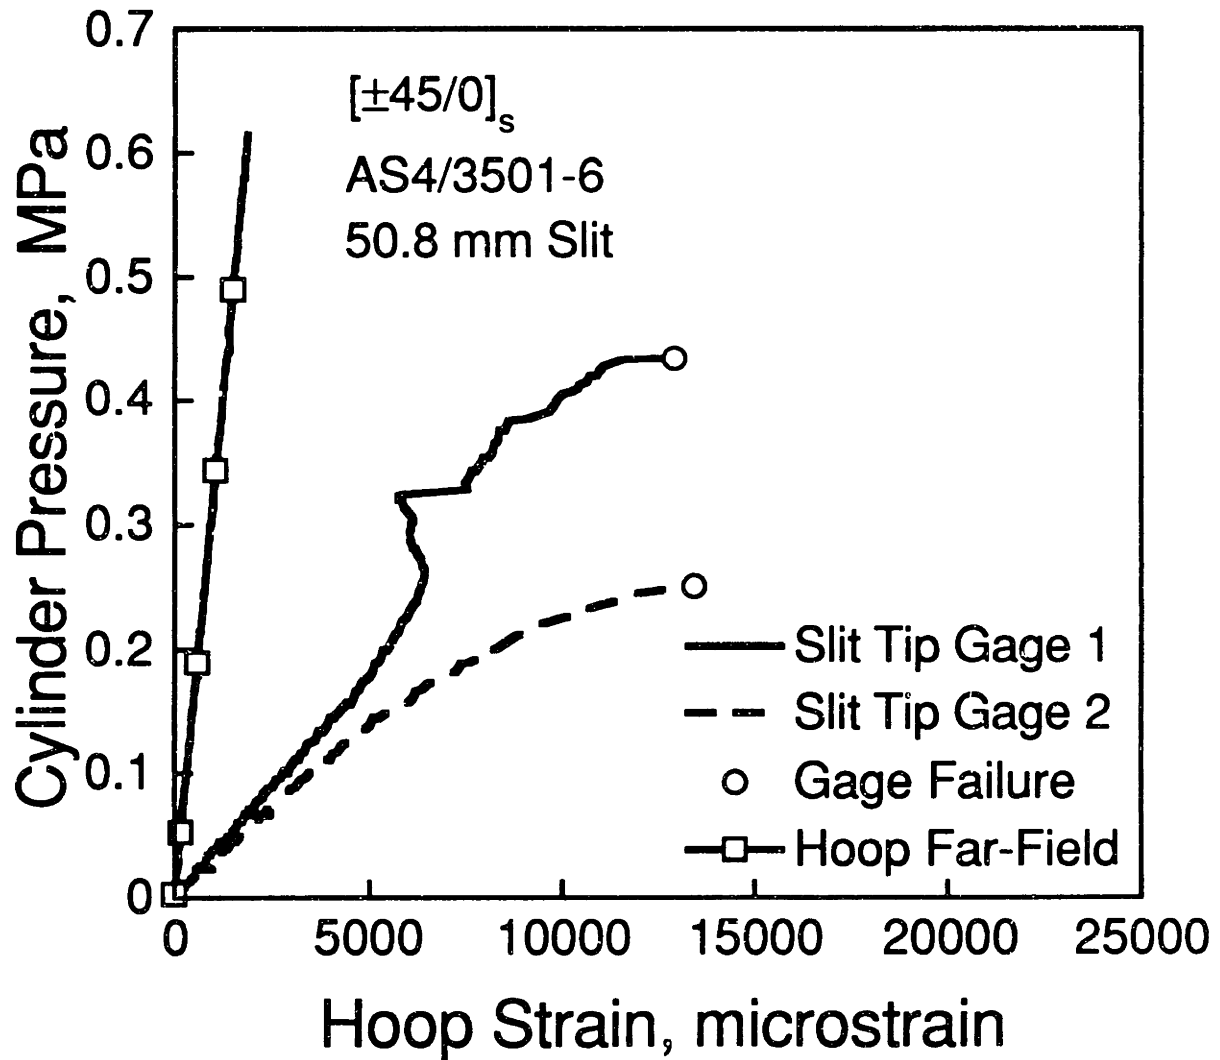
Figure 6.39 Cylinder pressure versus slit tip gage and far-field circumferential strains from failure test of uniaxially loaded $[\pm 45/0]_s$ cylinder with 50.8 mm slit.

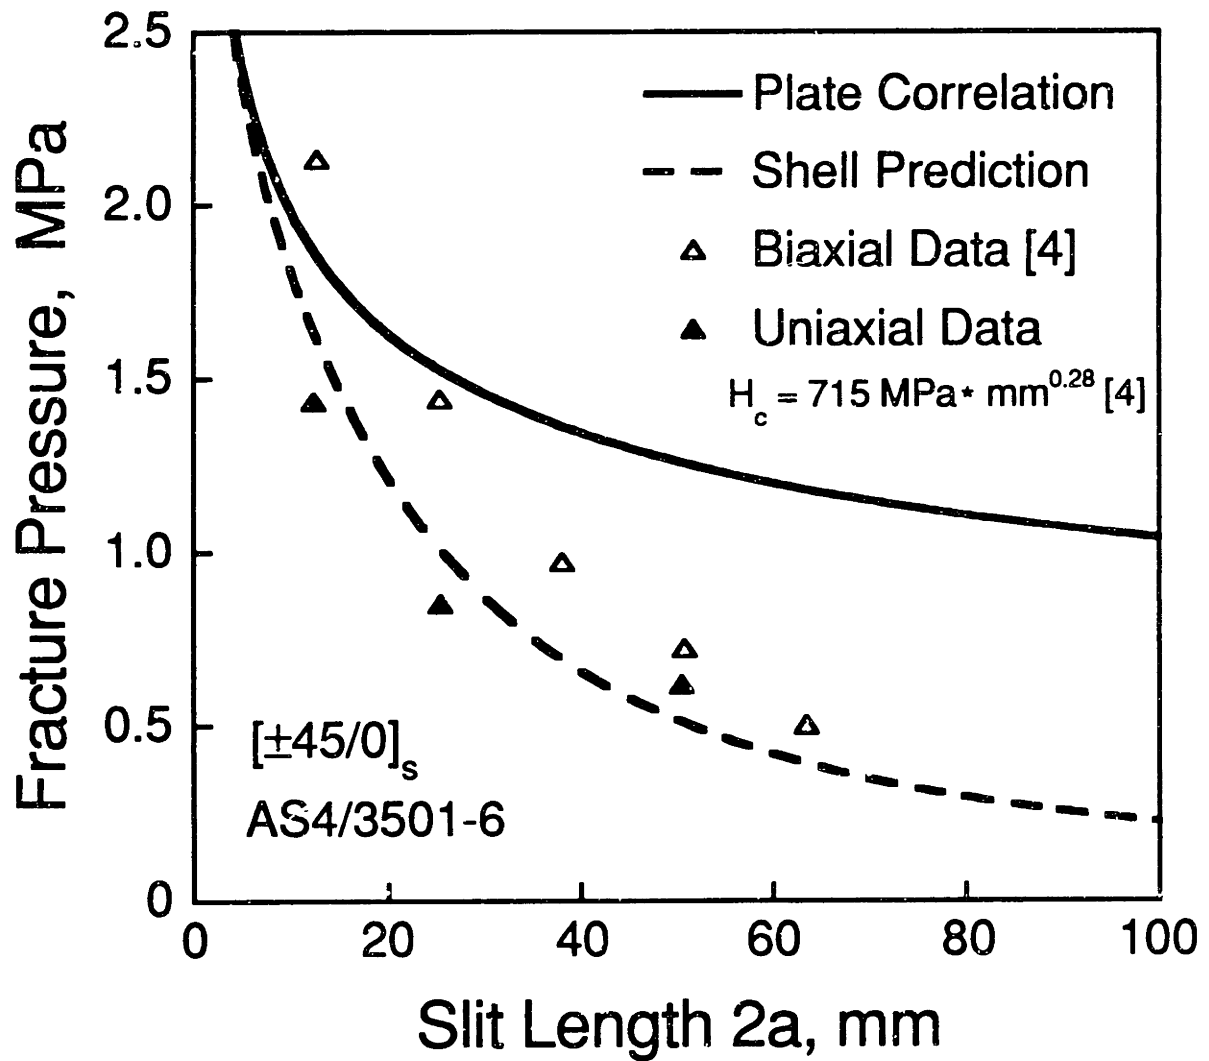
Figure 6.40 Experimental and predicted failure pressures for uniaxially loaded $[\pm 45/0]_s$ tape cylinders.

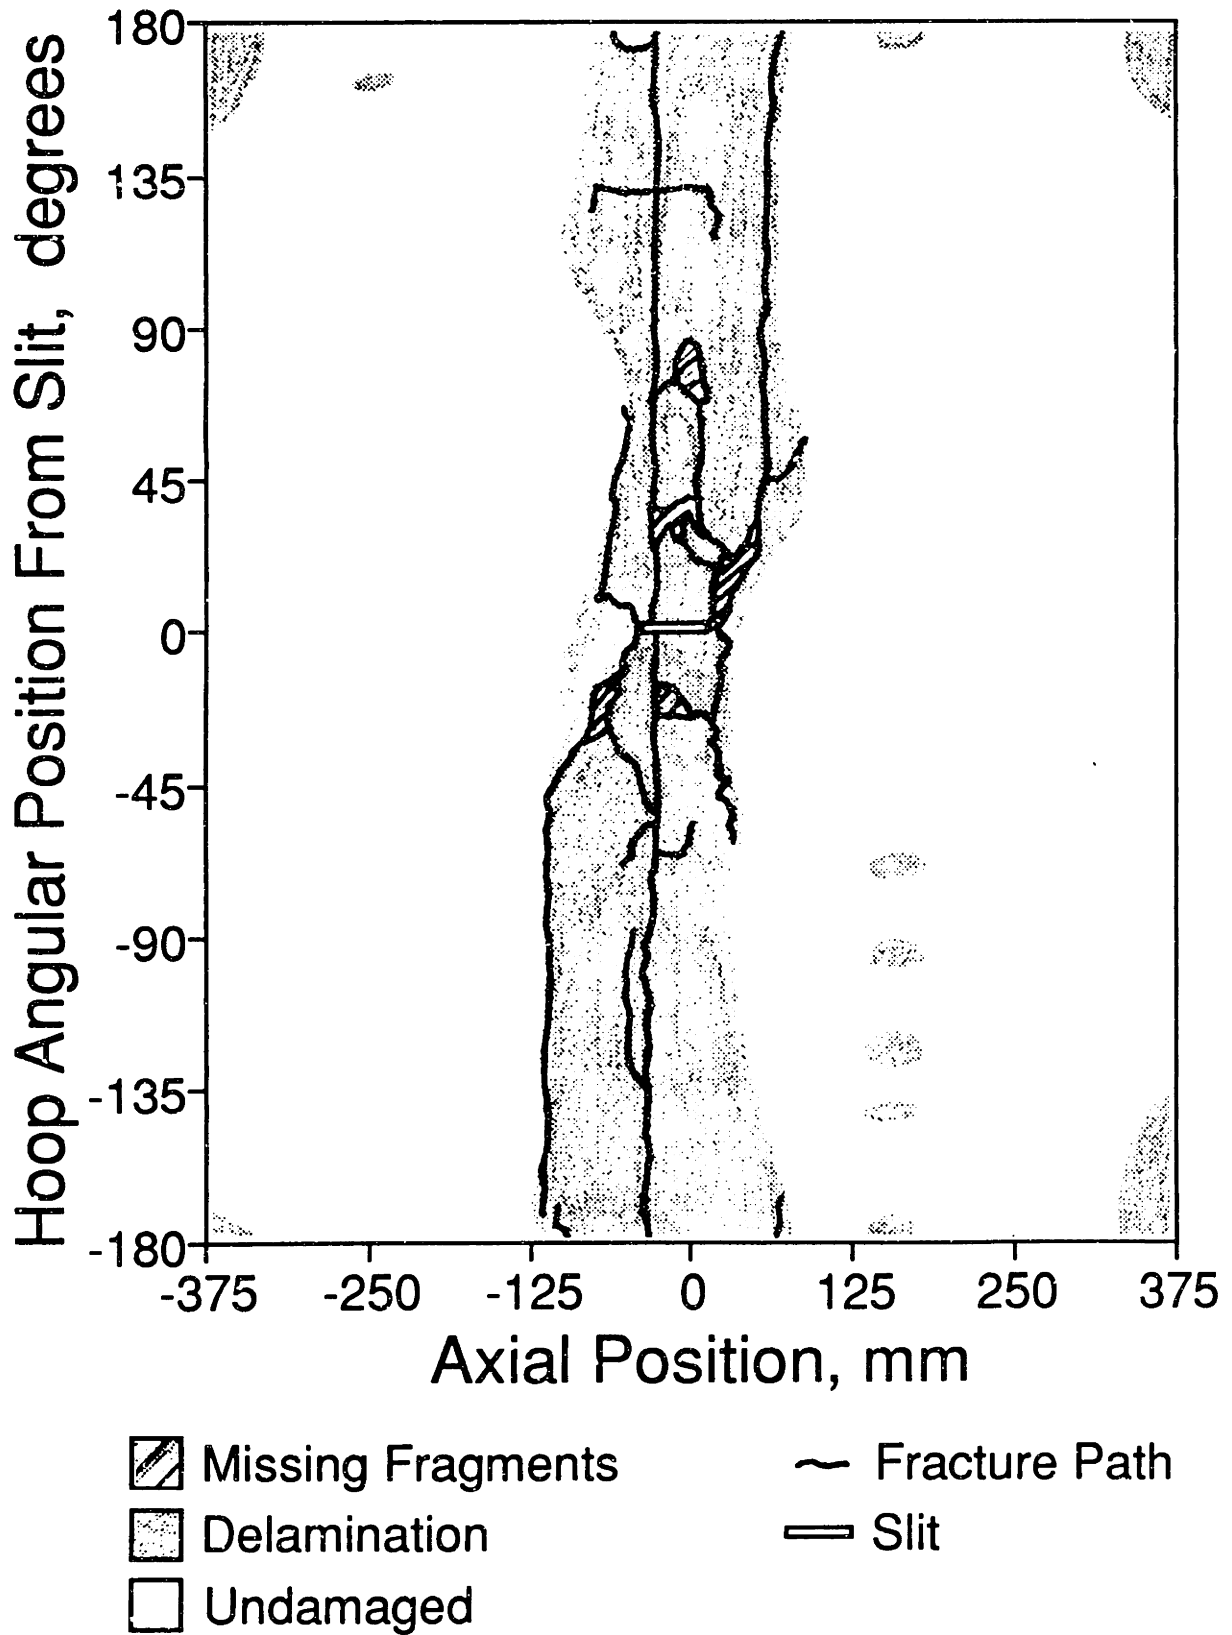
Figure 6.46 Schematic of damage in uniaxially loaded $[\pm 45/0]_8$ cylinder with 50.8 mm slit.

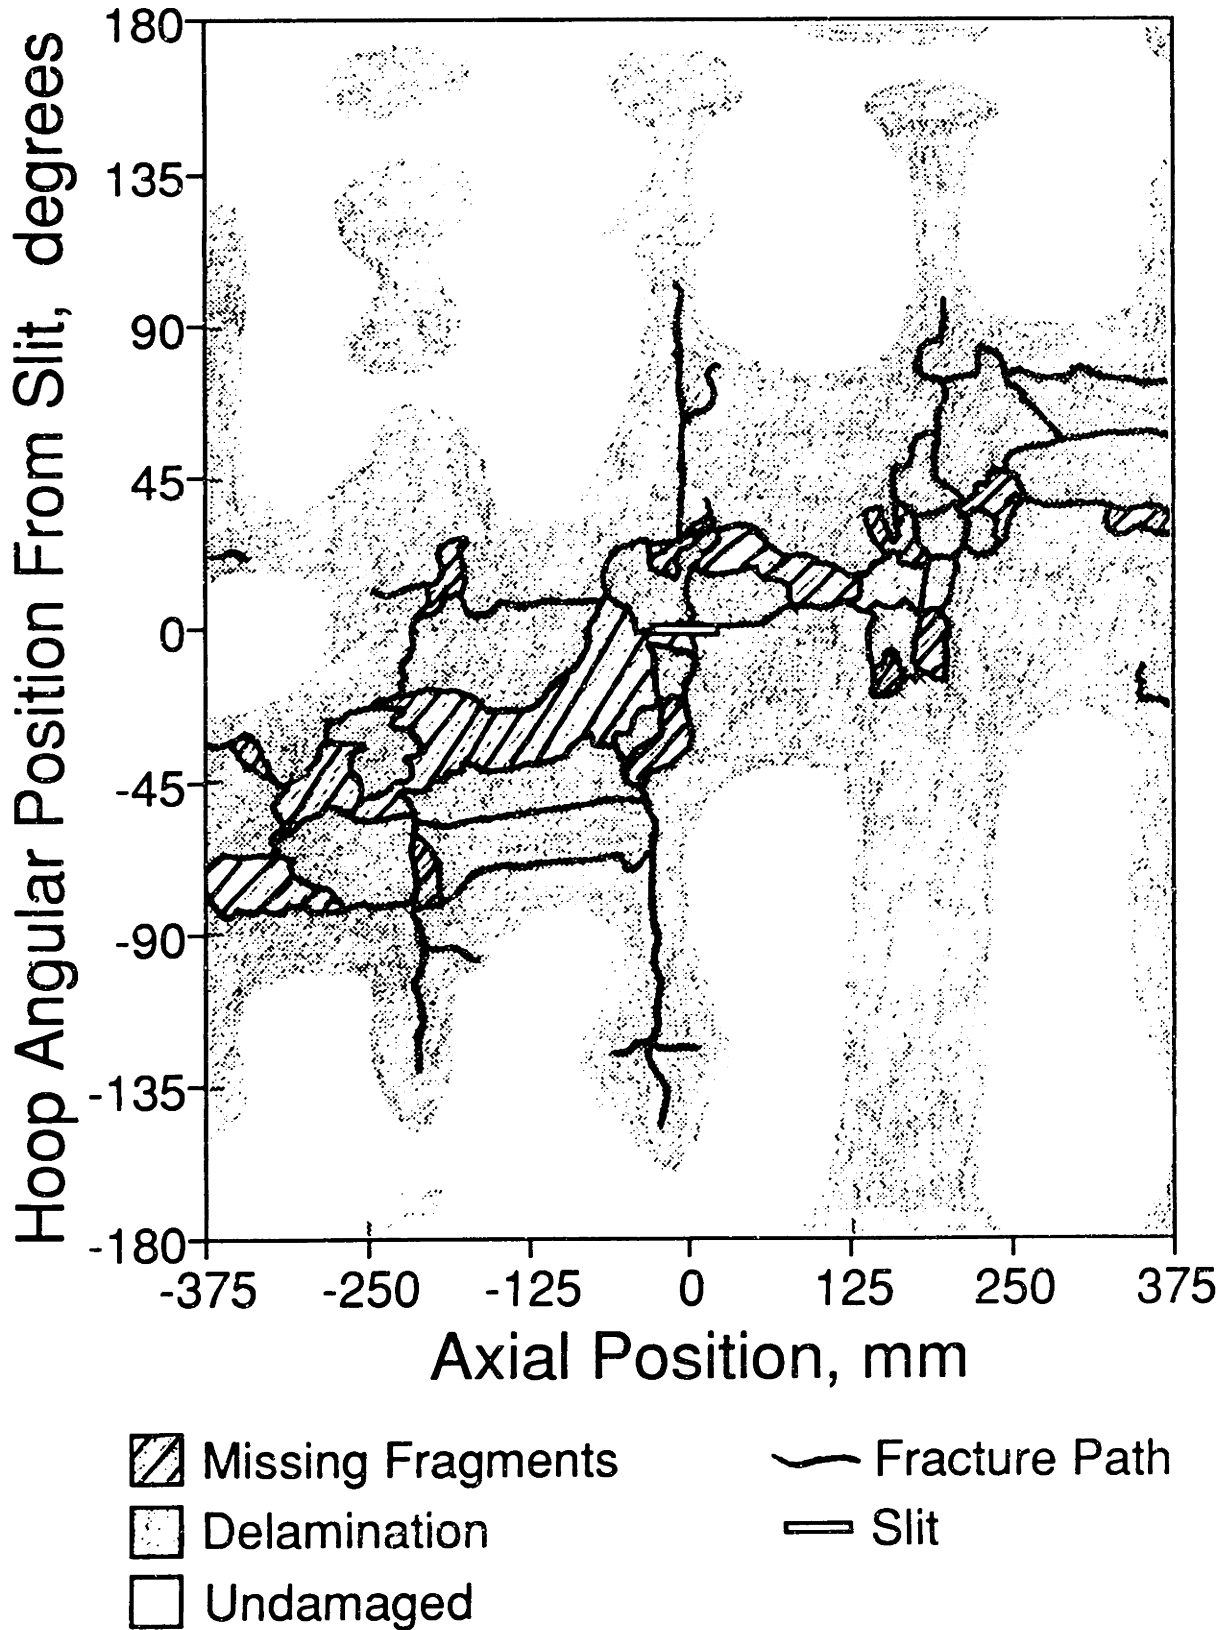
Figure 6.58 Schematic of damage in uniaxially loaded $[\pm 45/90]_8$ cylinder with 50.8 mm slit.
