# Distributed Sensors, Data Analysis, and Non-Intrusive Load Monitoring: Foundations for Reliability-Centered Maintenance on Ships

MASTER OF SCIENCE IN NAVAL ARCHITECTURE AND MARINE ENGINEERING

MASSACHUSETTS INSTITUTE OF TECHNOLOGY

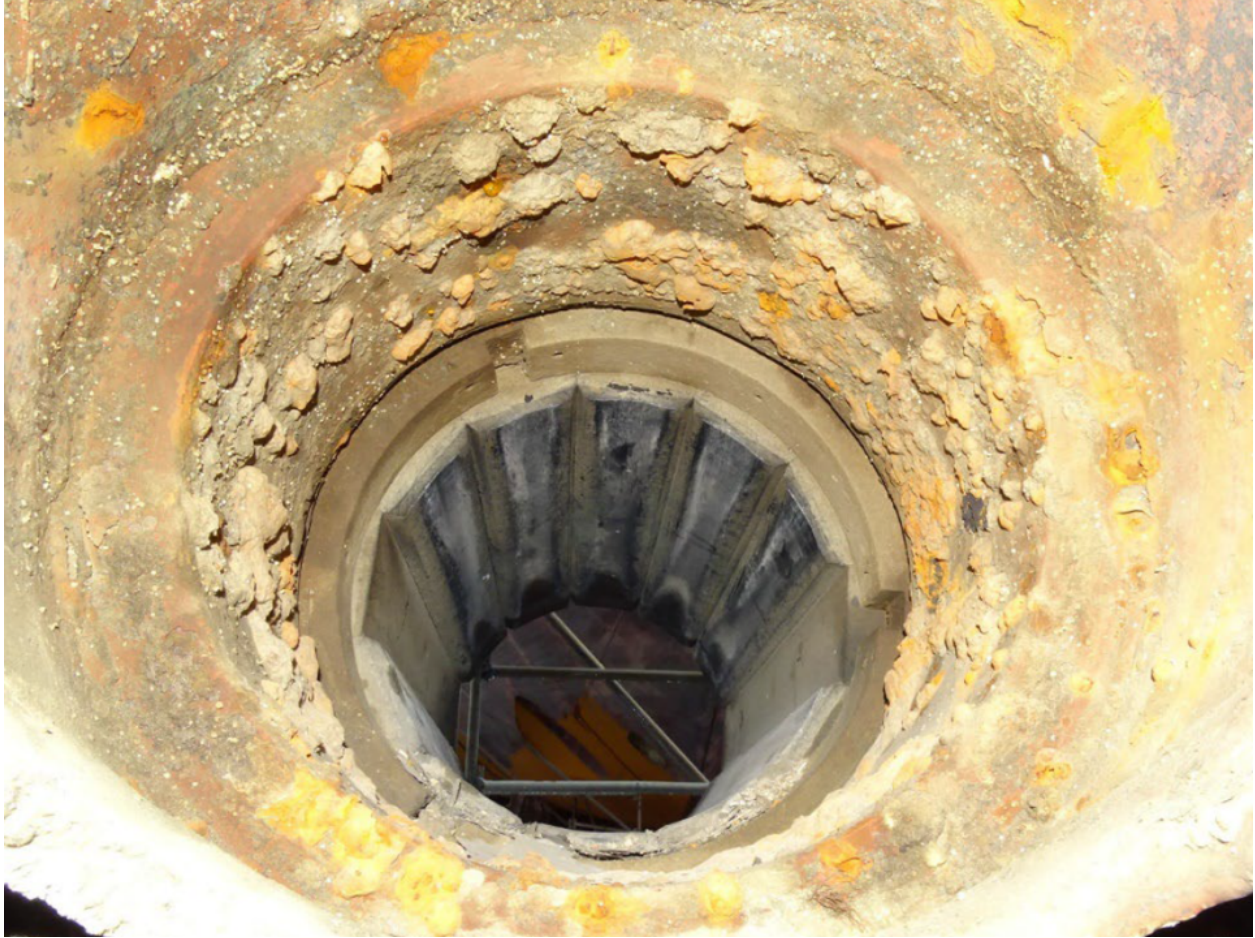
Figure 2.2: Corrosion damage in the stern tube of *USCGC Richard Dixon* as discovered in dry dock.

FRCs have often showed varying degrees of stern tube corrosion damage, but one particularly bad example came from Puerto Rico. On April 19, 2022, *USCGC Richard Dixon* (WPC 1113) entered dry dock at the Coast Guard Yard in Baltimore, MD. Commissioned on June 20, 2015, *Dixon* was the first cutter based in San Juan to undergo shaft removal and stern tube maintenance. After yard workers removed the shafts, they discovered that the inside of the stern tubes showed widespread coating failure and heavy rust all over. Blasting the tubes back to bare metal revealed deep pits throughout but concentrated closer to the bearing housings. The deepest pits were about 3/8 inches deep, representing almost 50% wastage in

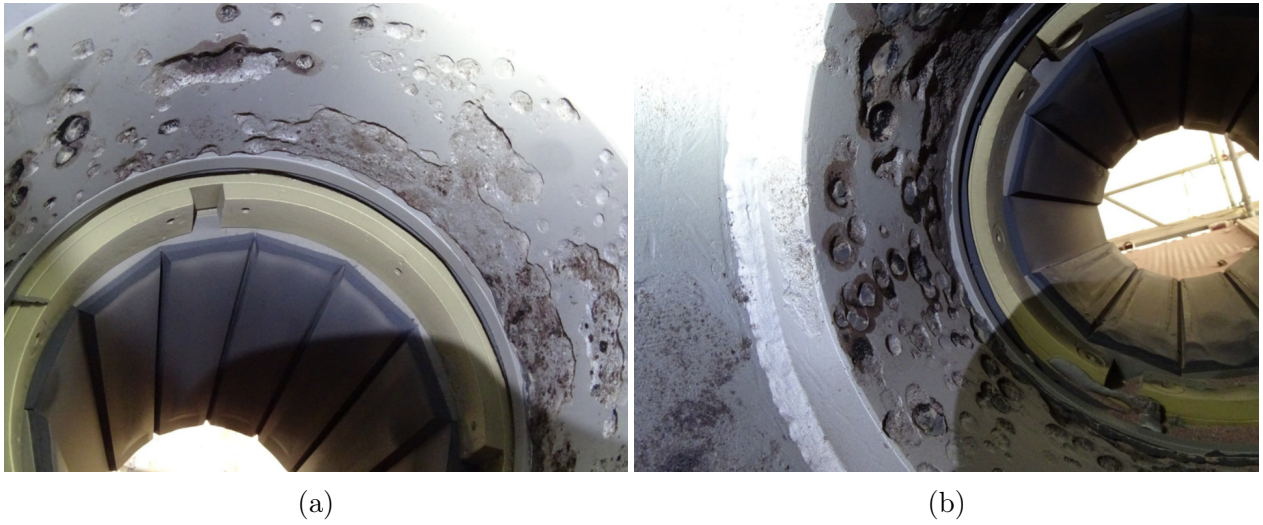
Figure 2.3: Stern tube of *USCGC Richard Dixon* after sandblasting[23].

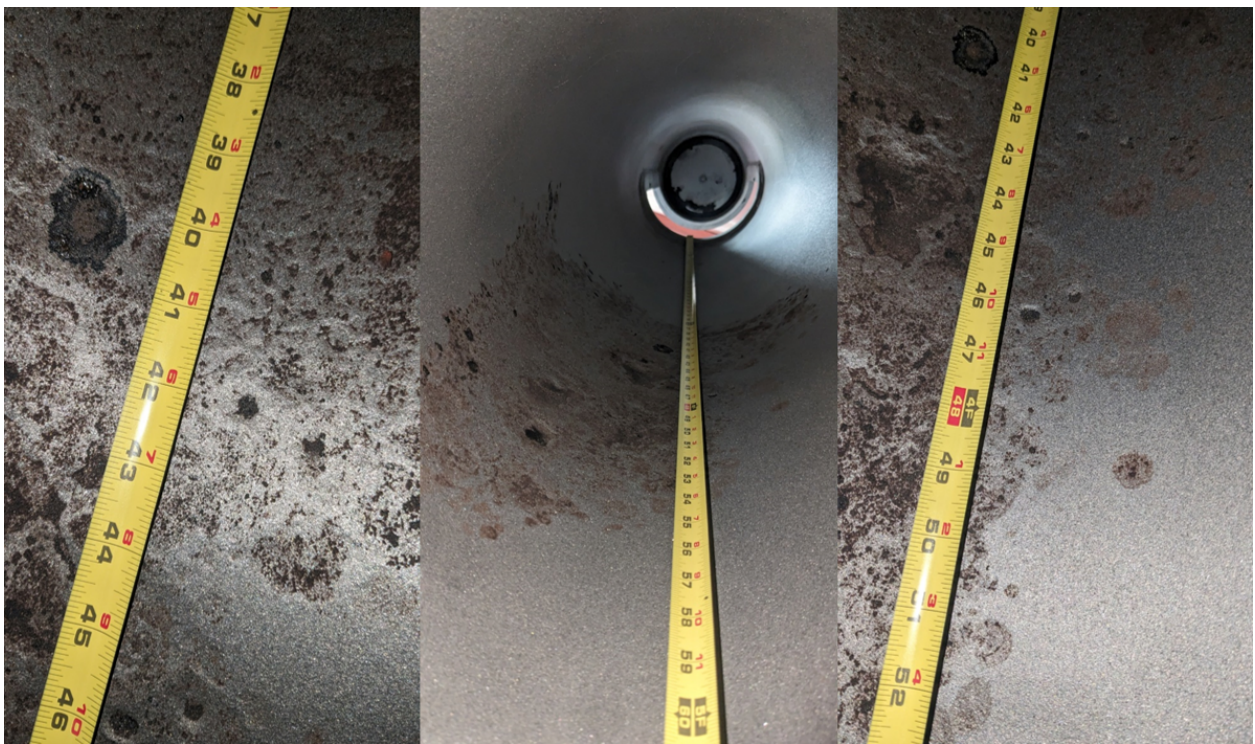
Figure 2.4: Damage to the stern tube of *USCGC Charles Moulthroppe* after sandblasting[24].

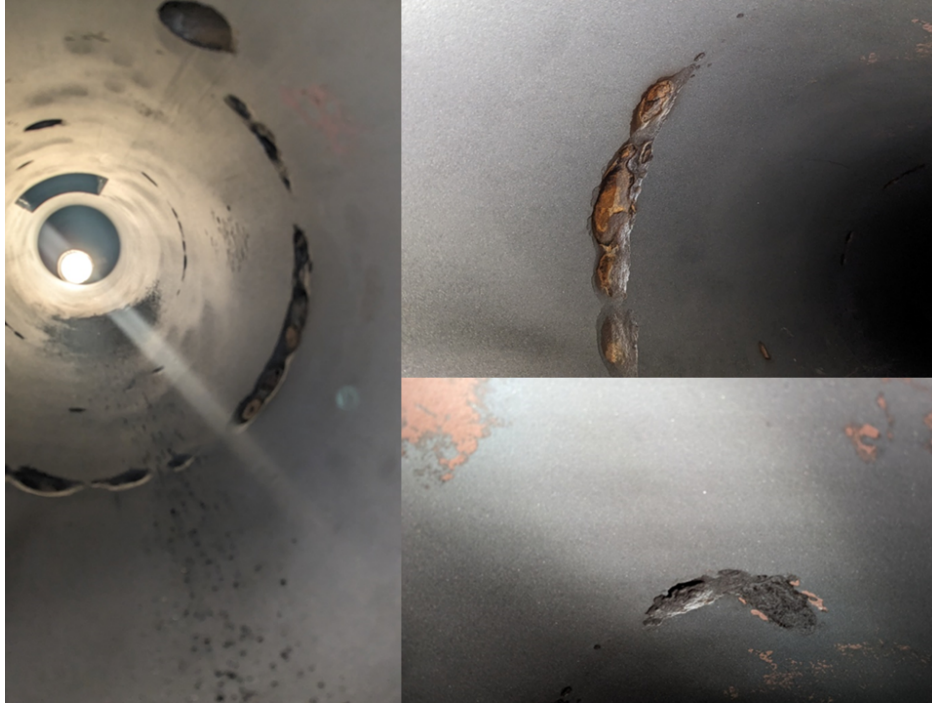
Figure 2.5: Deep pitting in the stern tube of *USCGC Charles Moulthrop*[24].

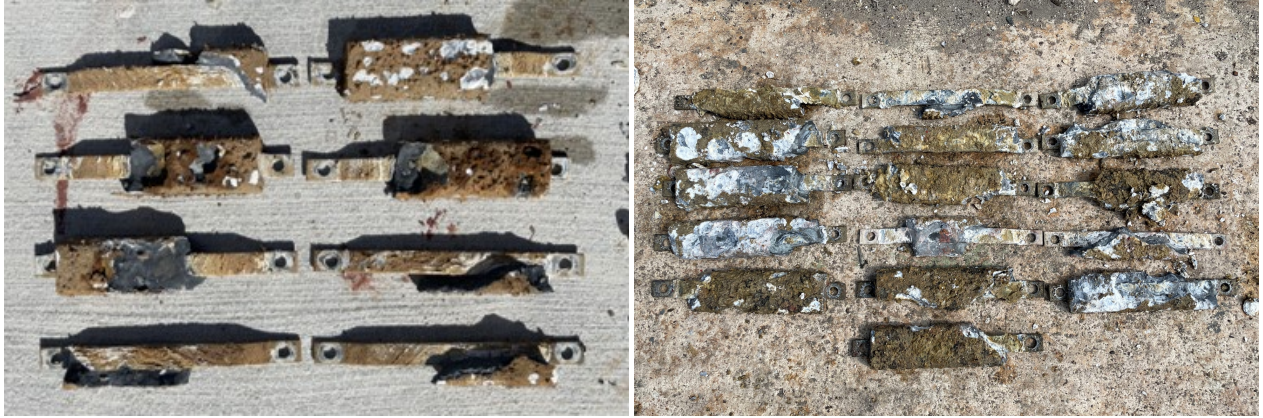
(a) *William Chadwick*, 18 mo. -850 mV, Boston    (b) *Margaret Norvell*, 12 mo. -850 mV, Miami

Figure 2.8: Stern tube zincs at the time of replacement on two cutters.

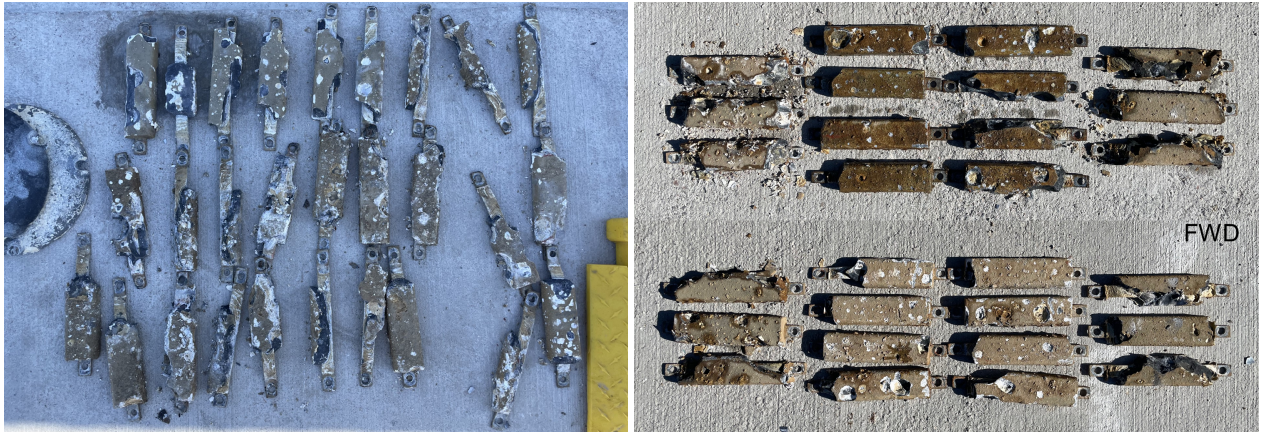
(a) *Warren Deyampert*, 14 mo. -850 mV, Boston    (b) *William Sparling*, 9 mo. -1050 mV, Boston

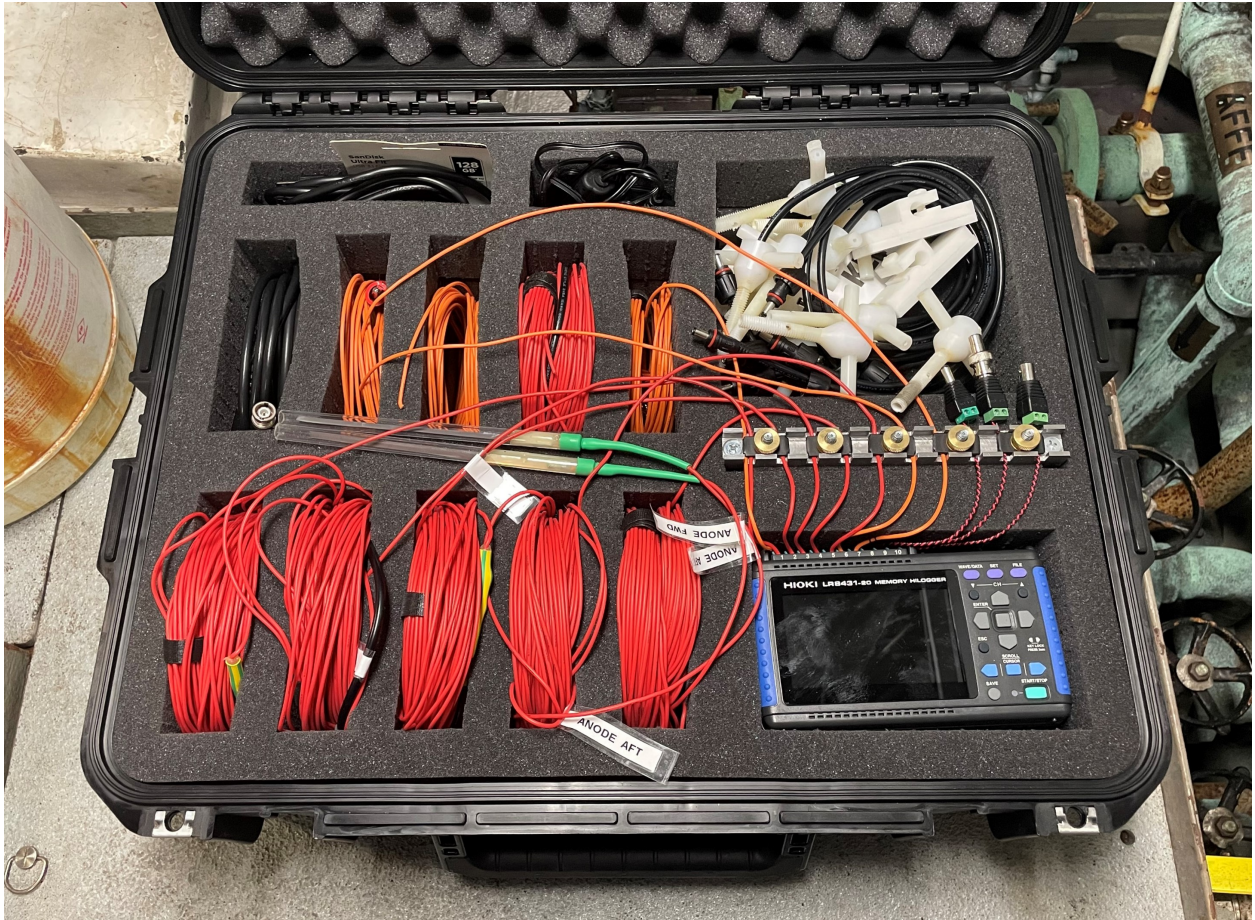
Figure 2.15: The data acquisition kit used in the *Margaret Norvell* experiment.

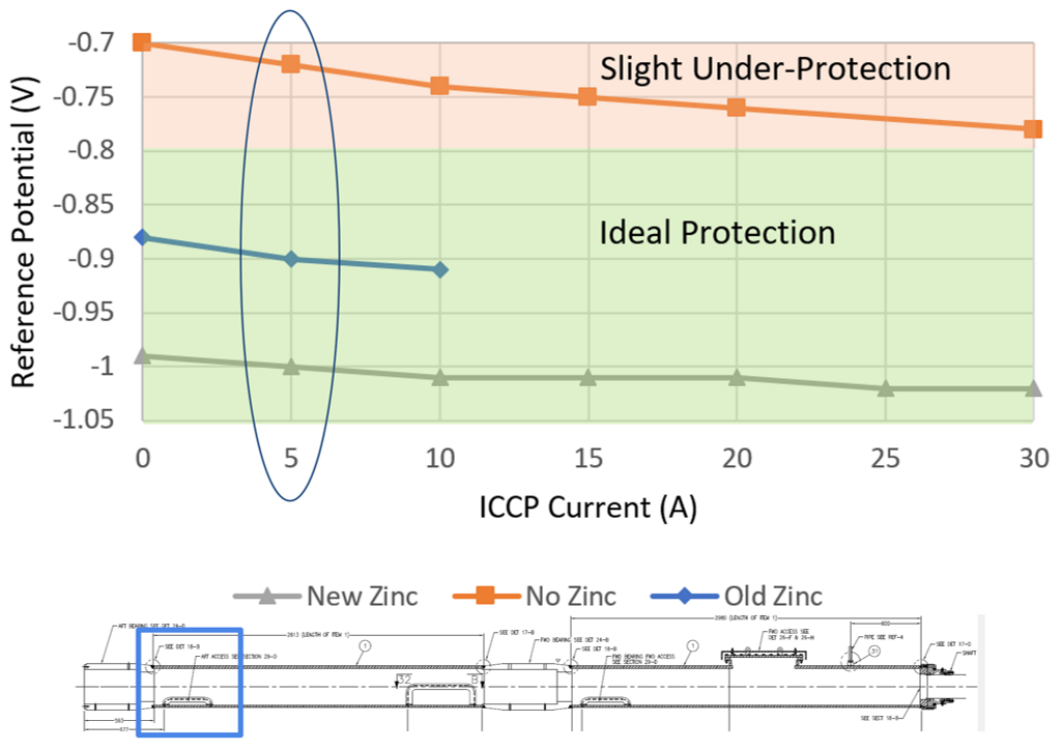
Figure 2.20: Potential in the stern tube as a function of ICCP output current, aft stern tube cover.

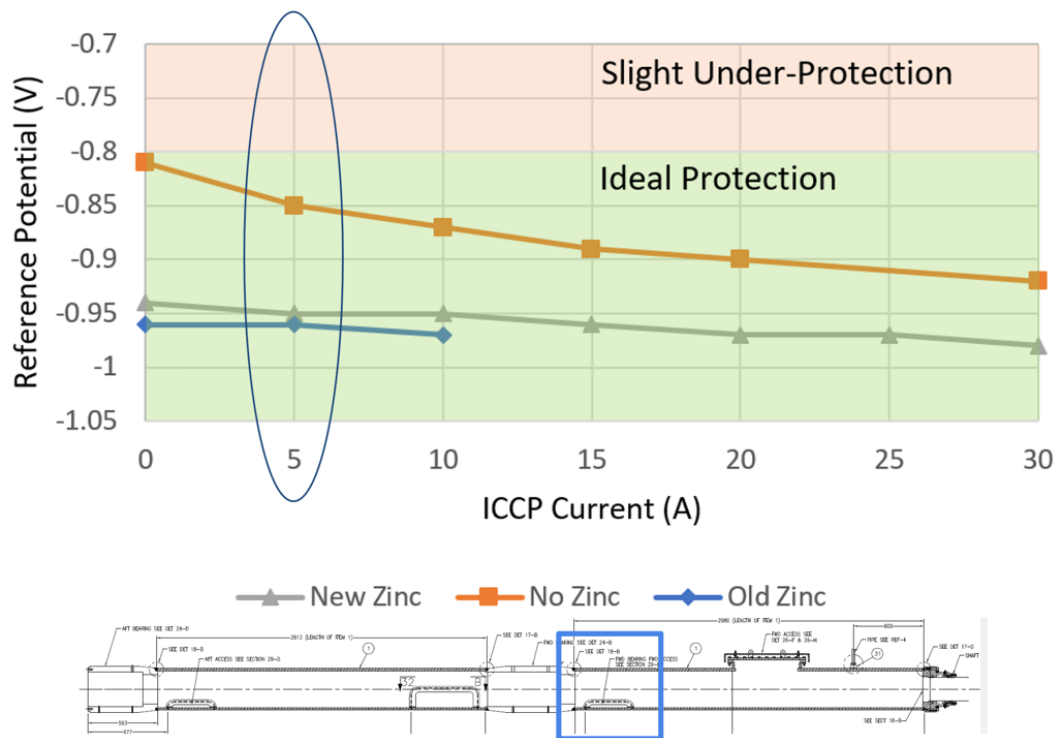
Figure 2.22: Potential in the stern tube as a function of ICCP output current, forward stern tube cover.

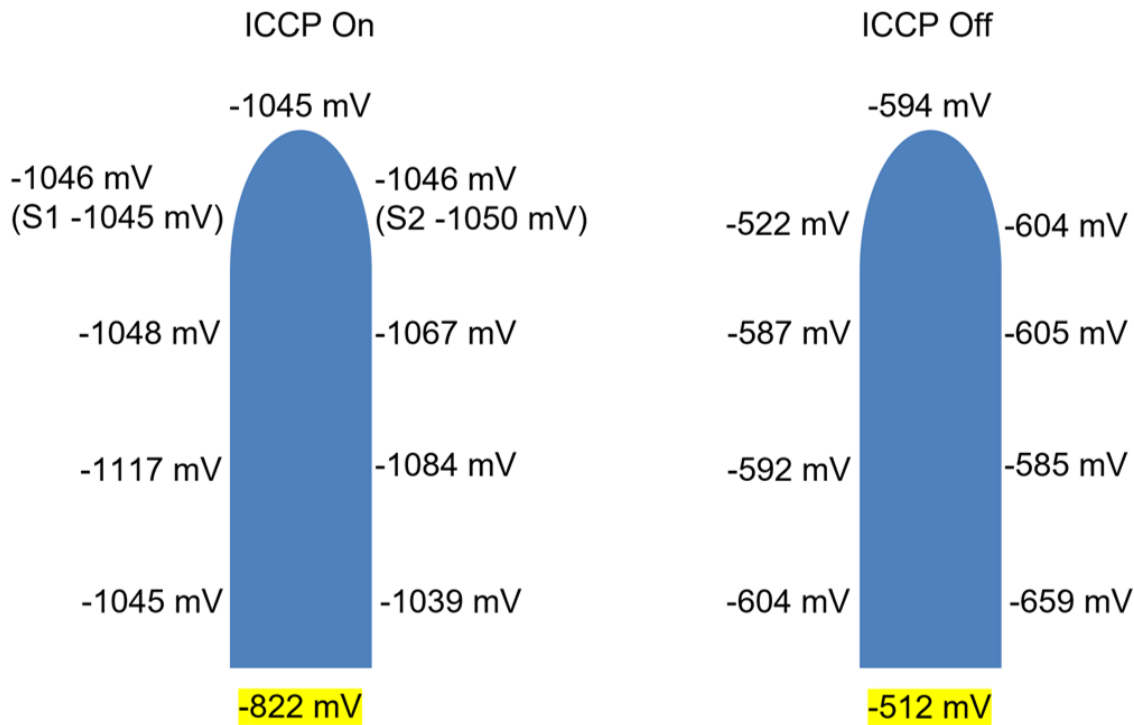
Figure 3.11: Hull potential survey for *USCGC John McCormick* (WPC 1121).

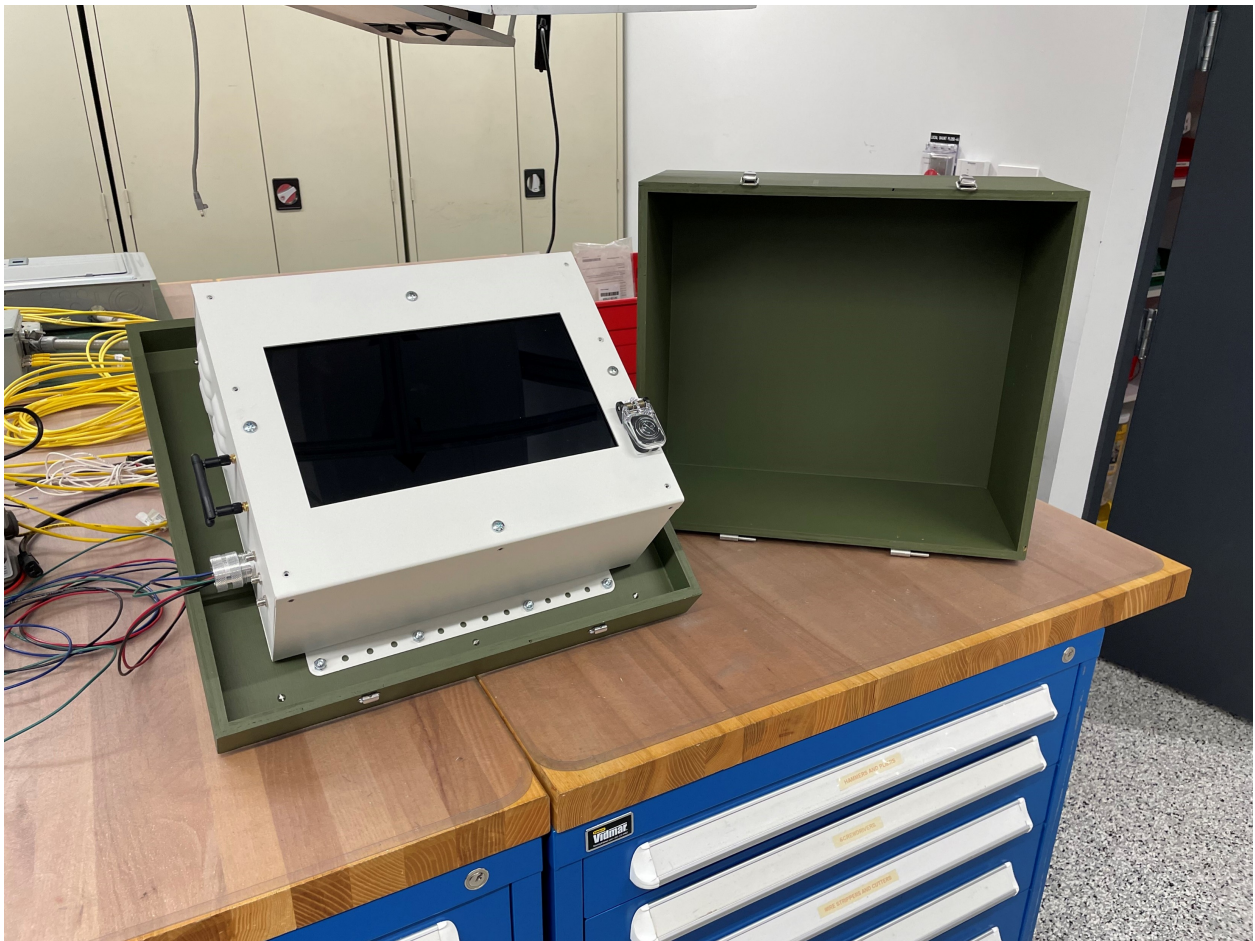
Figure 4.4: Porta-NILM

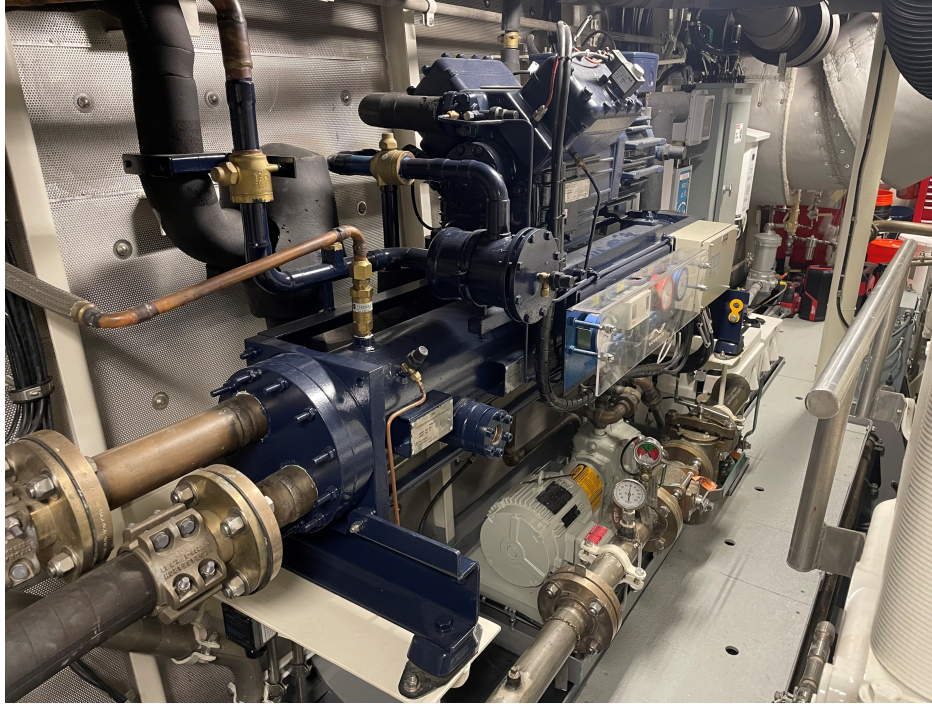
Figure 4.5: Air conditioning compressor C1

This breaker serves the C1 air conditioning compressor shown in Figure 4.5, model HGX5/1240-4 S made by GEA in Frickenhausen, Germany. Like most shipboard air conditioning units,

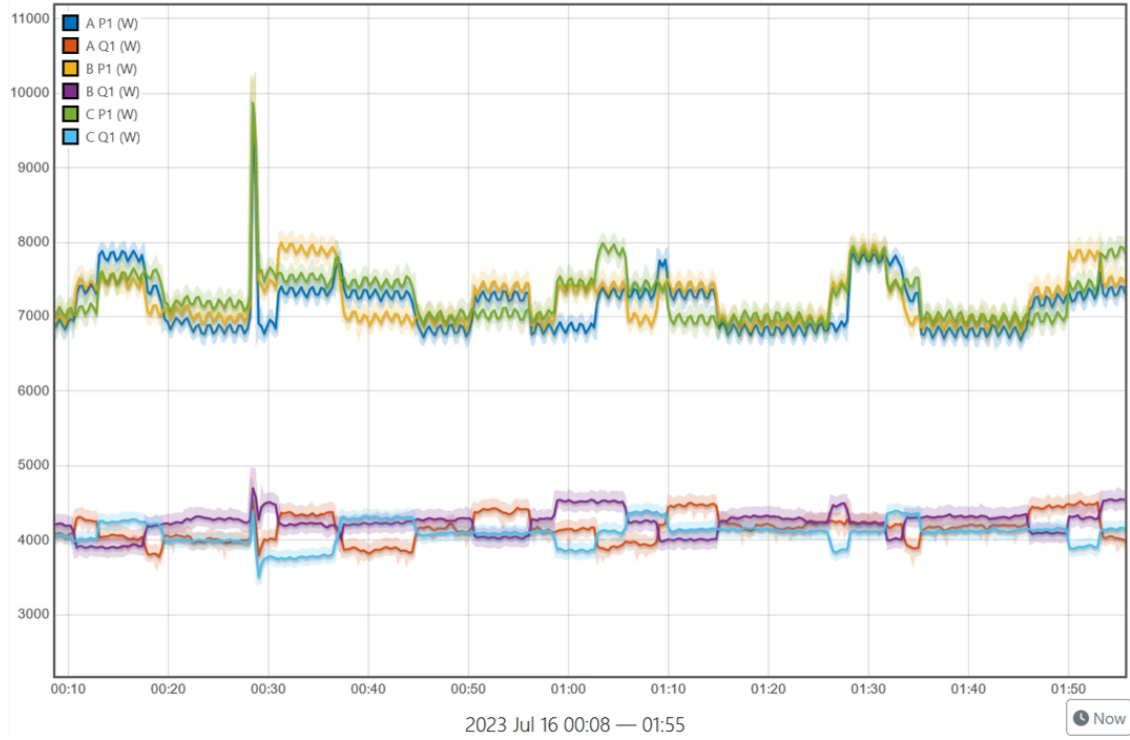
Figure 4.7: Signature from the HVAC main control panel, showing miscellaneous equipment and harmonic distortion from the HVAC control systems.

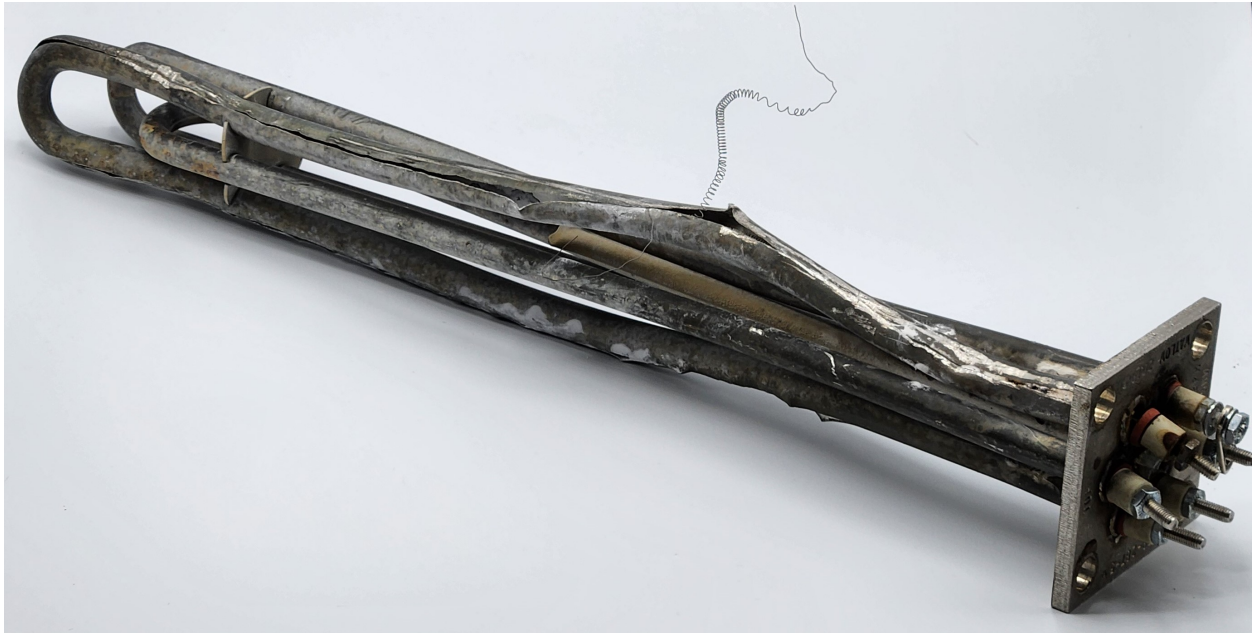
Figure 4.18: Boost heater from the dishwasher. Note the filament wires sticking out. Corrosion did the damage to the heater – according to the technicians, removal did virtually no damage to it.

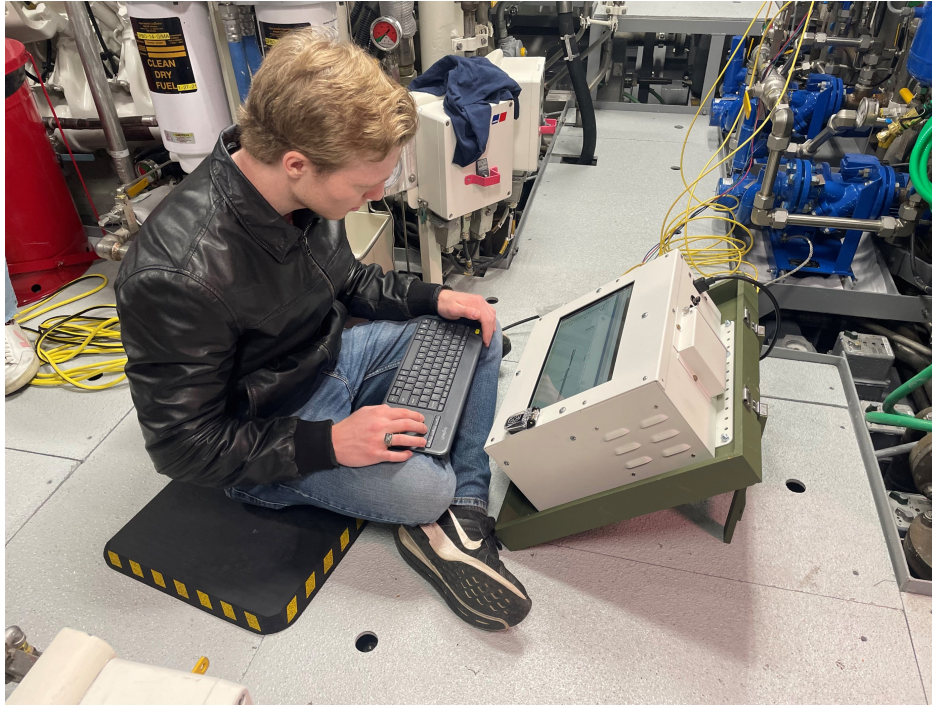
Figure 4.21: Porta-NILM being used to assess the ICCP system.

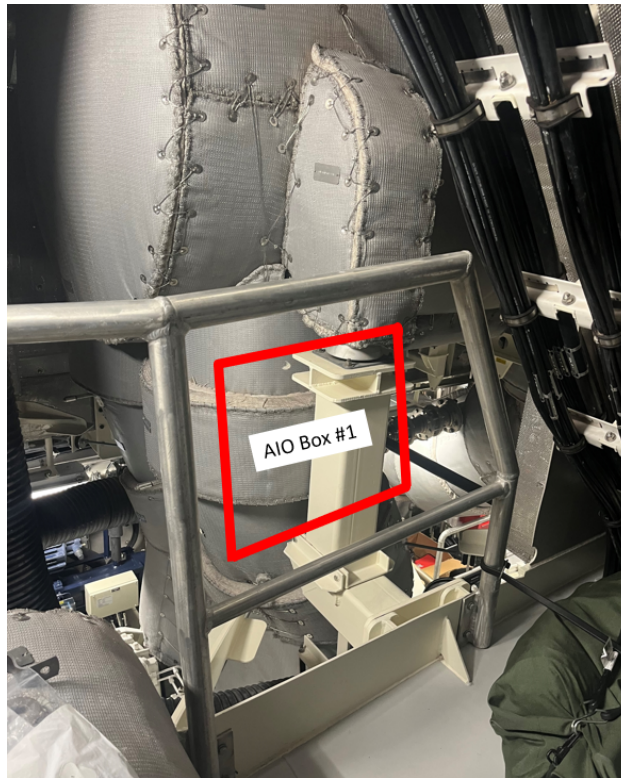
Figure B.2: Location to mount the STBD side AIO Box

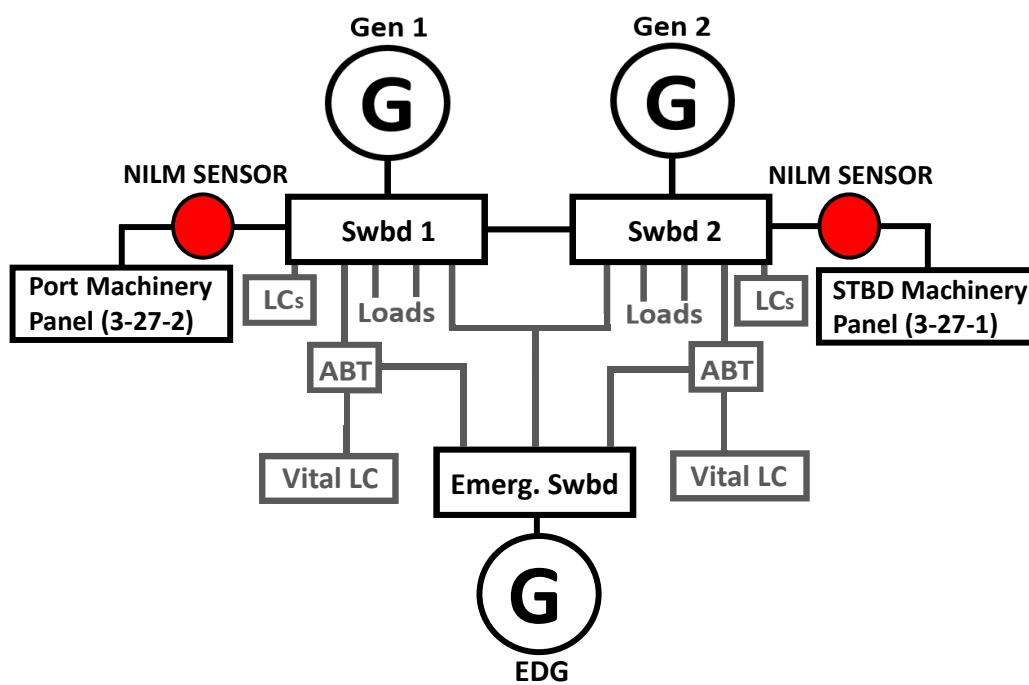
Figure B.20: USCGC WILLIAM CHADWICK (WPB 1150) electrical diagram with NILM sensor installation points identified (red circles).
