NONDESTRUCTIVE EVALUATION OF HISTORIC STRUCTURES

MASTER OF ENGINEERING
In Civil and Environmental Engineering
AT THE
MASSACHUSETTS INSTITUTE OF TECHNOLOGY

JUNE 2003

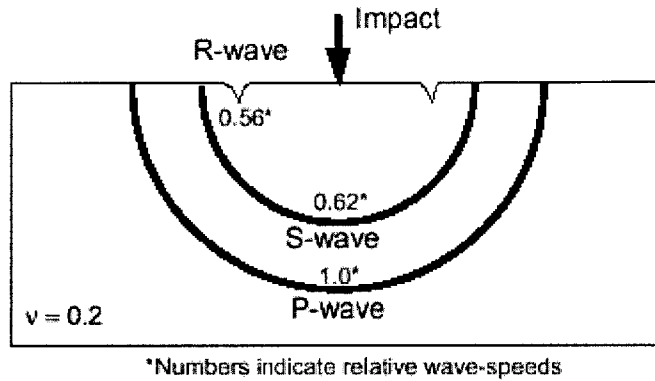
Figure 1. Impact-Echo testing produces longitudinal, shear, and surface waves. Source: Carino 2001.

Engineers have had great success applying the Impact-Echo technique to heterogeneous materials, such as concrete and masonry. An Impact-Echo test is “based on monitoring the surface motion resulting from a short-duration mechanical impact” (Carino 2001). An engineer uses a testing device to apply a mechanical impact and then measure displacements close to the impact point. The impact generates shear waves (S-waves), surface or Raleigh waves (R-waves), and longitudinal waves (P-waves) (Figure 1). The longitudinal waves that travel into the specimen are reflected at discontinuities, defects, and at the back-face of the specimen. From the resulting waveforms, one can determine the depth (d) of these anomalies using Equation 1.

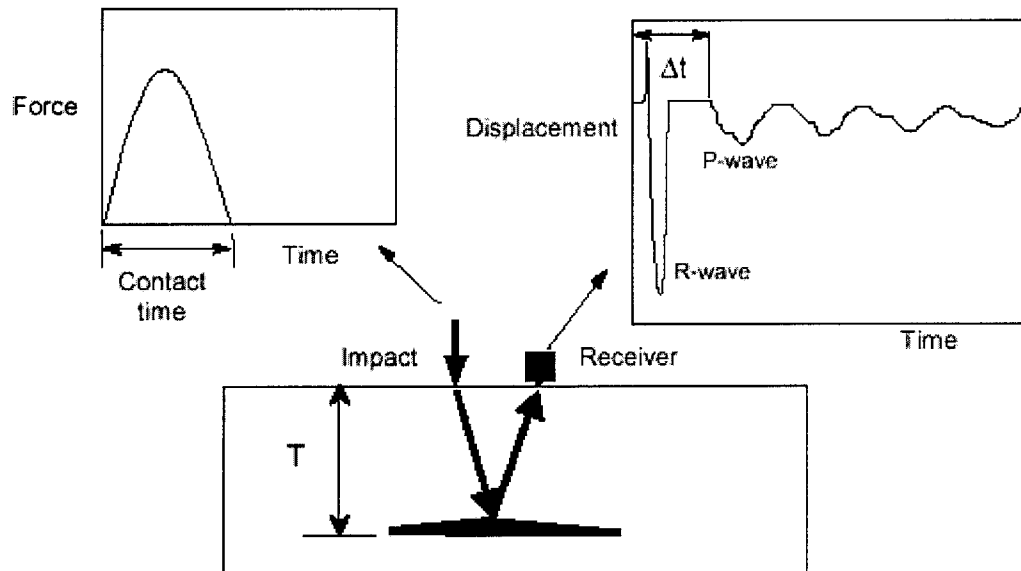
Figure 2. Impact-Echo technique. Source: Carino 2001.

Here, C_l is equal to the longitudinal wave speed of the specimen, and Δt is equal to the time between successive P-wave arrivals (Sadri 2003). Figure 2 shows a typical Impact-Echo test setup and results. Figure 3 shows an Impact-Echo test being performed on an actual specimen.

Typical components of an Impact-Echo test include the following three items: (1) an impact source, (2) a receiver, and (3) a waveform analyzer. Engineers use the waveform analyzer to collect data, store waveforms, and perform the signal analysis.

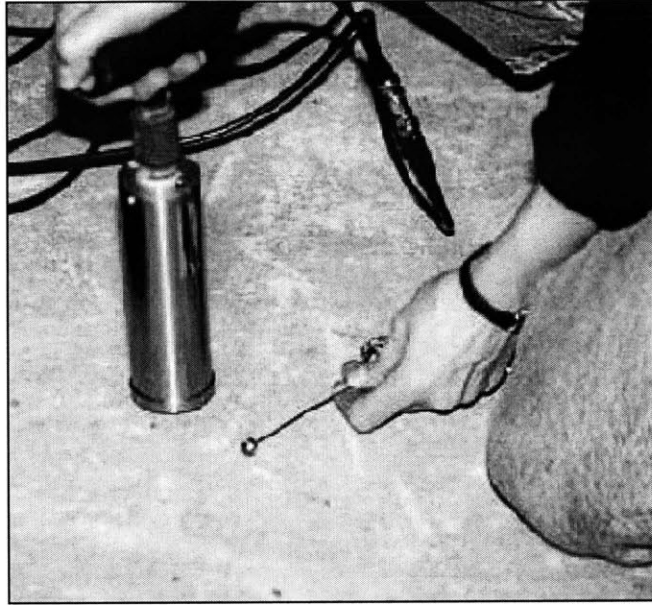
Figure 3. Inspector performing Impact-Echo test. Source: Carino 2001.

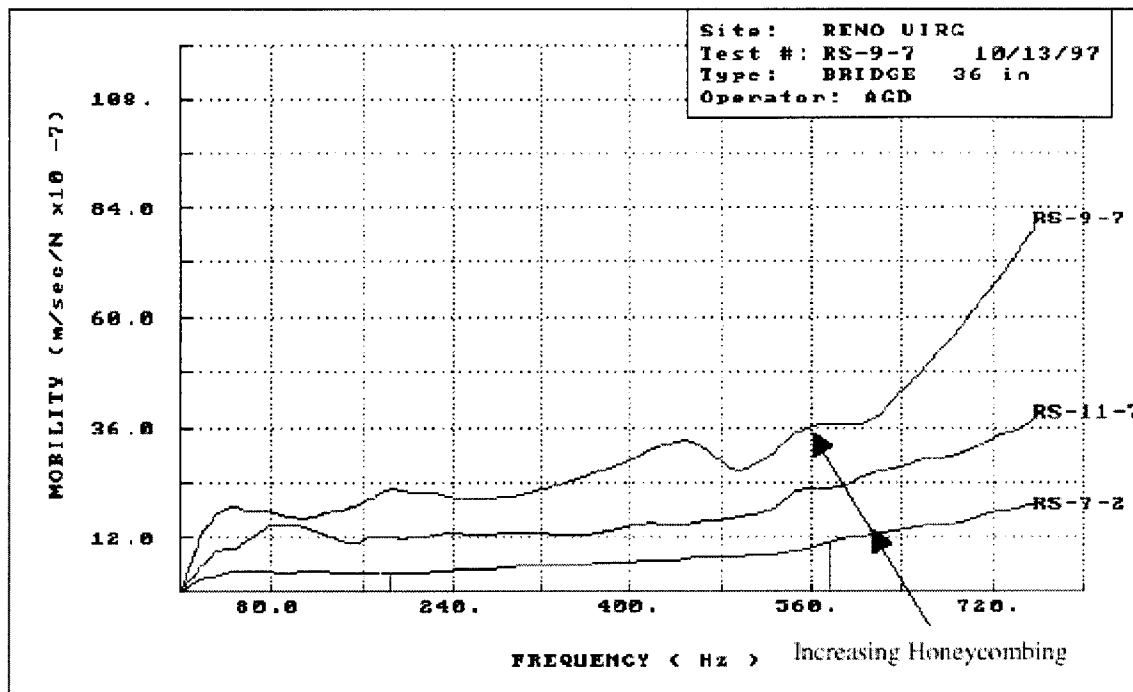
Figure 4. Typical results of Impulse Response testing. Source: Davis et. al. 2001.

Impulse Response is one of the lesser-known NDT techniques. It is a stress wave test that is typically used on metallic elements in the aircraft industry. This method is related to the much better-known Impulse-Echo test, and uses “a low strain impact to send a stress wave through the tested element” (Davis et. al. 2001). Investigators typically use a 1-kg hammer that has a load cell built into the hammerhead. Investigators can then measure the response using a velocity transducer, or geophone. The stress levels created by the hammer vary by material, with levels of about 5 MPa for rubber tips to 50 MPa for aluminum tips. The compressive stress that develops at the impact location in the concrete can be related to the properties of the hammerhead material. Then hammerhead and the geophone can be connected to a portable computer in order to collect and store data (Davis et. al. 2001).

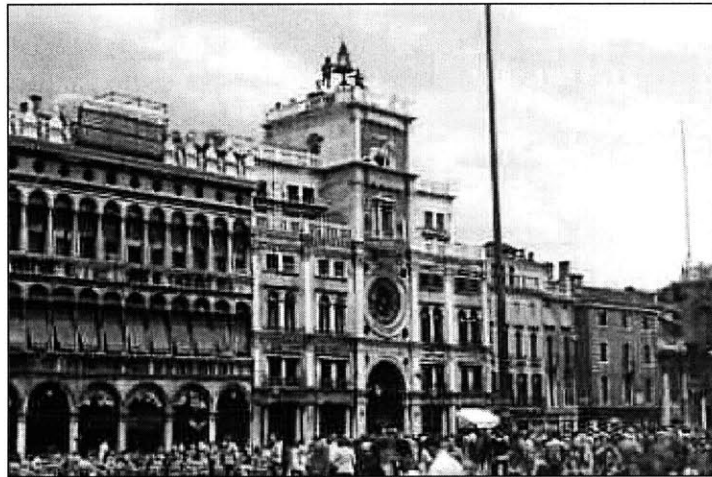
Figure 5. Tower of the Orologio. Source: Almesberger et. al. 2000.

The Torre dell' Orologio, or clock tower, is located in San Marco, Venice (Figure 5). The clock for the tower was complete in 1495, and the tower was completed approximately 2 years later. In 1500 the Senate decided to add buildings to either side of the tower, which were completed in 1506. In 1755, 8 columns were added to "reinforce the pillars at the ground level and support the two lateral bodies" (Almesberger et. al. 2000). The building helps to link the piazza to the rest of Venice and is a subsequently a major civil and religious symbol in Italy.

From a visual inspection, it is clear the building is in need of restoration. One can see that there is a major crack along the keystone of the arcade, there are cracks on the arch imposts, and there are cracks on the limestone slabs. There are cracks on the ground floor pillars, which are coupled with signs of crushing. Investigators were also concerned about possible deformations in the vault where the clock is because of thermal effects from a nearby glassworks oven. Inspectors used a combination of magnetromic, endoscopic, sonic, and ultrasonic techniques to nondestructively evaluate this structure.

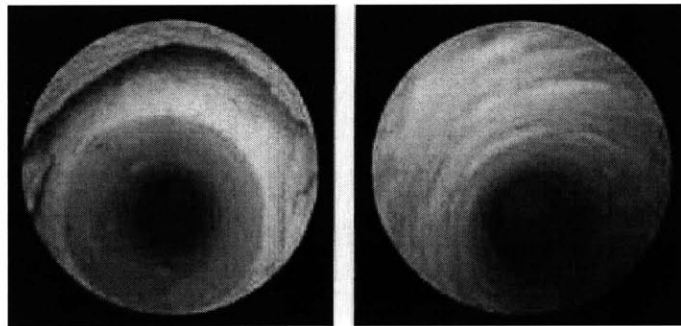
Figure 6. Photos from the endoscopic investigation of the Tower of the Orologio. Source: Almesberger et. al. 2000.

The investigators found that the endoscopic investigation was one of the most useful for obtaining information about walls, including thicknesses, cavities, and binders. Endoscopic investigation involves real-time imaging of the inside of structure with the aid of a miniature camera (Figure 6). However, this method does require the presence of a bore hole. On the Tower of the Orologio, whenever possible, investigators took advantage of boreholes that were present from previous explorations. The camera was inserted into the 14 mm boreholes to a depth of 500 mm. From the endoscopic investigation, inspectors realized that mortar was degrading in some areas.

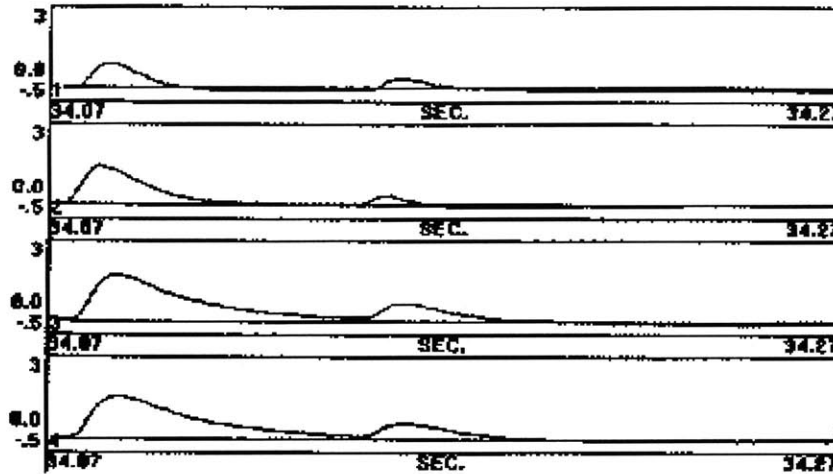
Figure 7. Results of sonic investigation. Source: Almesberger et. al. 2000.

From the sonic investigation, NDE technicians were able to locate some detachments of facing stone slabs from the brick masonry. High velocities obtained from the ultrasonic tests on the ground floor pillars revealed that the stone was overloaded. Sample results from the sonic and ultrasonic investigations are shown in Figures 7 and 8, respectively.

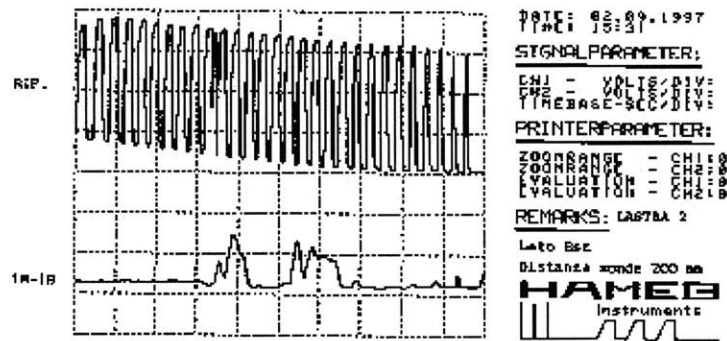
Figure 8. Results of ultrasonic investigation. Source: Almesberger et. al. 2000.

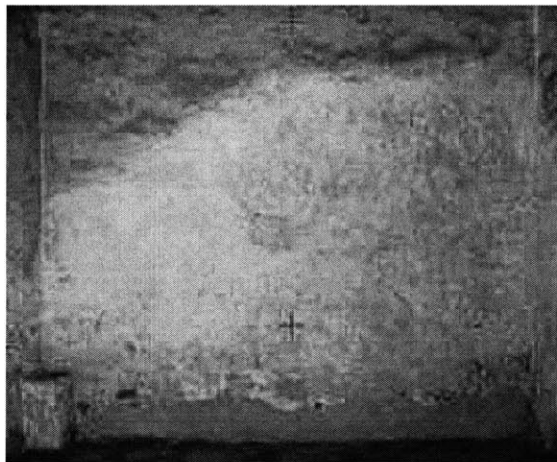
Figure 10. Wall in the castle. Source: Rosina et. al. 2000.

NDE investigators used infrared thermography to monitor moisture in the walls and to locate delaminations of plaster and masonry bonds, and to locate infilled openings. Through thermography, they were able to locate areas of damage and areas that posed risks for future damage. Figure 10 shows a castle wall, and Figure 11 shows a thermographic imaging of that wall.

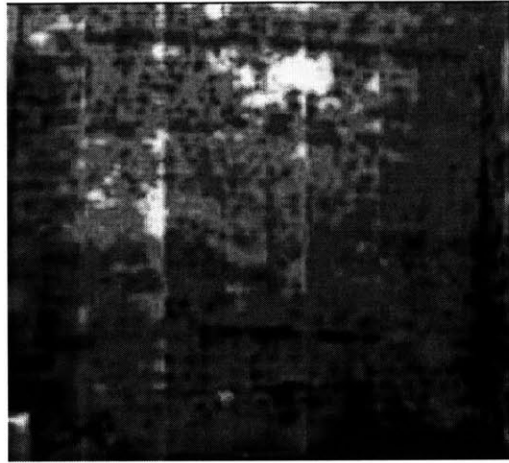
Figure 11. Thermography results of wall inspection. Source: Rosina et. al. 2000.

Investigators also installed sensors to monitor temperature and humidity in the castle daily. The masonry in the castle is quite thick, ranging from 60 to 80 cm in depth. Investigators determined that in many rooms, a combination of poor ventilation and cool temperatures was causing condensation on the walls.

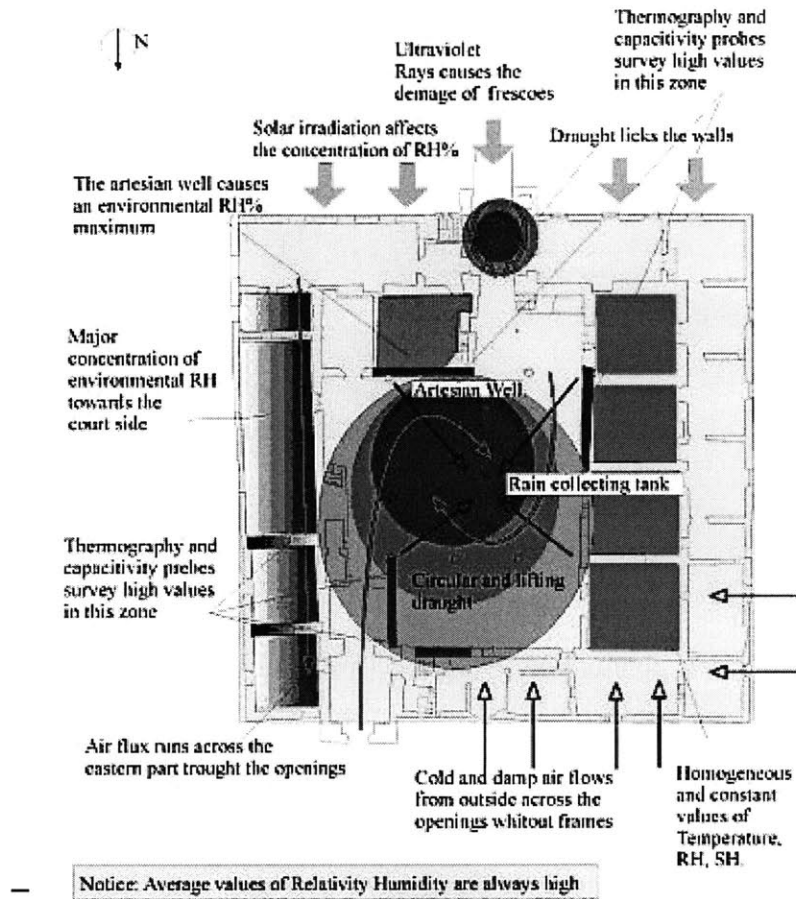
Figure 12. Malpage Castle, design solutions. Source:

From their careful studies, the investigators on this project were able to determine the causes and extent of water infiltration in the castle, and to subsequently remedy these issues (Figure 12). They were also able to design a renovation plan that would not harm the masonry walls or frescoes, including choosing locations for various types of spaces, such as meeting rooms, hallways, and cafeterias, and to design the HVAC system.

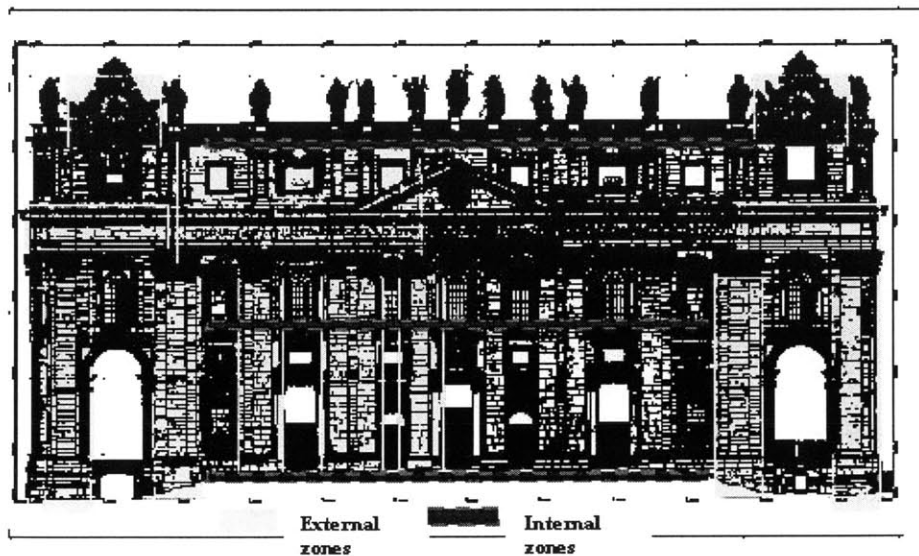
Figure 14. Map of façade from photogrammatry data imported into CAD. Source: Giunta et. al. 2000.

The NDE inspectors predominantly used a combination of photogrammetry and ground penetrating radar. By integrating photogrammetric data with GPR survey results, they were able to map approximately 4000 sq. m. of the 7000 -sq.-m. façade (Figure 14). Investigators were also able to use special software to import their GPR and photogrammetric data into an AutoCAD program, creating 3D models of their results.

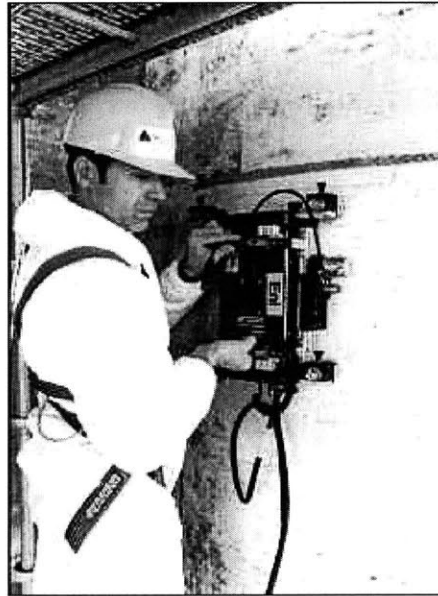
Figure 15. Inspector performing NDT tests. Source: Giunta et. al. 2000.

By using GPR analysis, the investigators of St. Peter's were able to determine information about the internal structure of the façade, including detailed information on the “travertine stone facing, masonry structure, plugs, cramp irons, cavities, [and] detachments” (Giunta et. al. 2000). This information would have otherwise had to have been obtained through a destructive analysis. Figure 15 shows an investigator performing GPR tests.

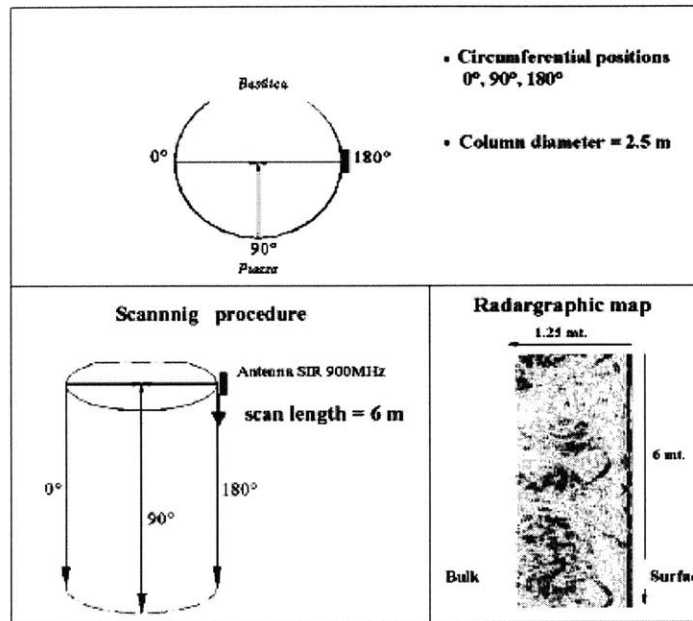
Figure 16. Scanning procedure for columns. Source: Giunta et. al. 2000.

Investigators operated the GPR survey at several different frequencies in order to study different depths, which varied from 50 cm to 3 m. For the majority of the study, they ran the tests at 900 MHz. However, they also performed tests at 1.5 GHz to obtain a 70 cm penetration on the clocks, and at 200 MHz to study 10–12 m depths at the portico. The inspectors typically ran their tests at a rate of 1 m per minute.

scanned at 900 MHz for a depth of 1.3 m. They were able to survey 18 m of the 22-m-tall columns. Figure 17 shows some results from the column investigation.

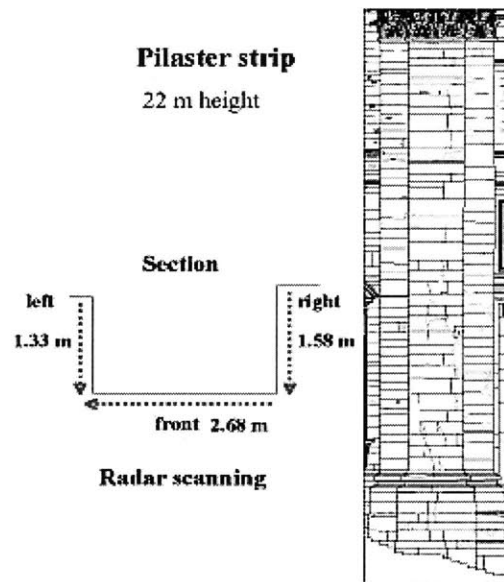
Figure 18. Scanning procedure for pilasters. Source: Giunta et. al. 2000.

There are also 4 pilasters located on the façade. Inspectors moved the antenna horizontally around the 3 sides of the pilasters, and then vertically in steps of 20 cm (Figure 18). With this method, they completed approximately 130 sections for each pilaster.

For the pilasters and columns, inspectors were able to use GPR to obtain accurate geometry and material composition. They found some detachment of the stone and masonry, and were able to locate metal cramps, which indicated where blocks had been fixed.

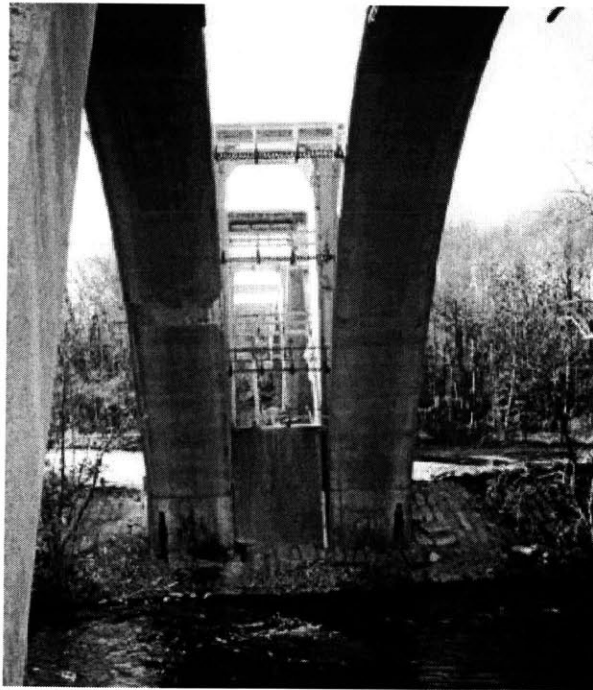
Figure 19. Cumberland, Rhode Island bridge with deck removed. Source: Davis et. al. 2001.

From a visual inspection, engineers were able to determine that the bridge deck was too deteriorated to salvage (Figure 22). They also noted low quality concrete on the center span arches. Throughout the restoration process, the engineers found unexpected areas of additional damage. They found that some parts of the bridge had been removed for patching, however, some areas had been filled in while others had not. Investigators used NDE to locate and determine the extent of cracking, delaminations, F/T deterioration, and areas of poor consolidation.

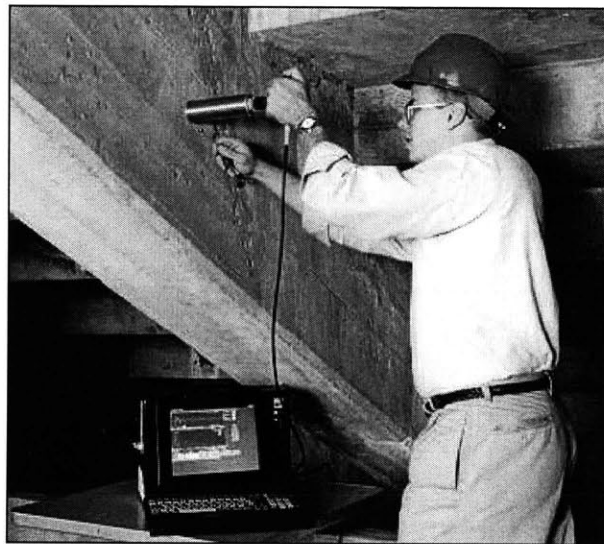
Figure 20. Worker performing Impact-Echo test. Source: Carino 2001.

The investigators used a 1 m² grid, resulting in 53 North-South test columns and 4 East-West test rows. For Impulse Response, average mobility values for sound concrete are typically less than 3, so engineers used Impact-Echo on any area that had an Impulse Response value greater than 3. Figure 23 shows an inspector performing an Impact-Echo test.

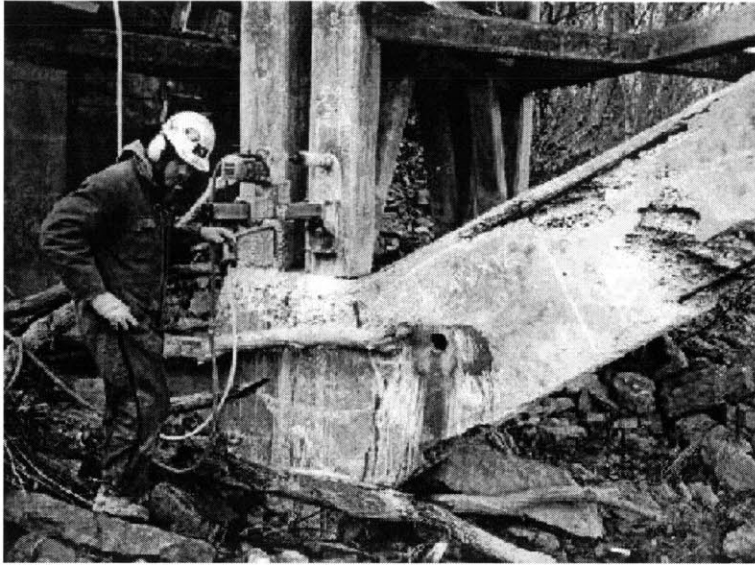
Figure 22. Coring at Putnam County Bridge. Source: Davis et. al. 2001.

The Impulse Response results showed some areas of high average mobility, so the engineers chose to take core samples at these sites. From the core samples, the concrete appeared to be sound on the surface, but was poorly consolidated underneath, verifying the Impulse Response results. Figure 25 shows a worker taking a core sample from the bridge. Some concrete deterioration is also visible in this image. Figure 26 shows a core sample with poor concrete consolidation inside.

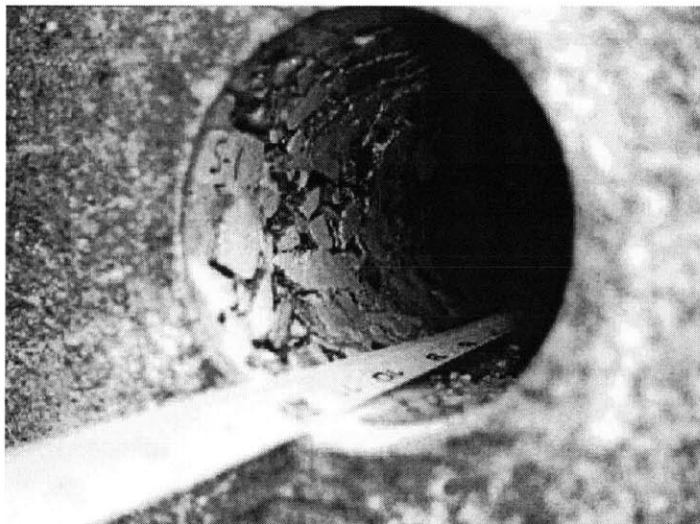
Figure 23. Core hole Source: Davis et. al. 2001.

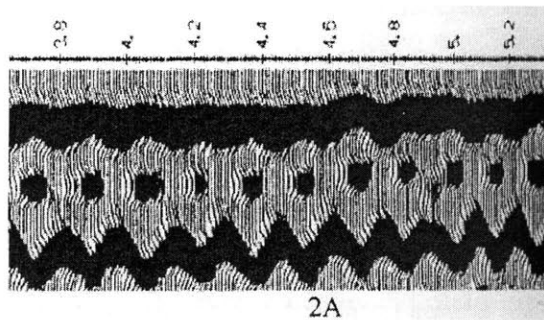
Figure 25. GPR imaging of concrete rebar. (Source: Xie et. al. 2002)

From the examination, the investigators were able to determine that the cross-section of the orthogonal ceiling has a steel reinforcement grid. The steel is arranged at 15-cm intervals in the x-direction and 30-cm intervals in the y-direction. They determined the wall thickness (20 cm), and that there is an 8 cm protective layer of concrete.

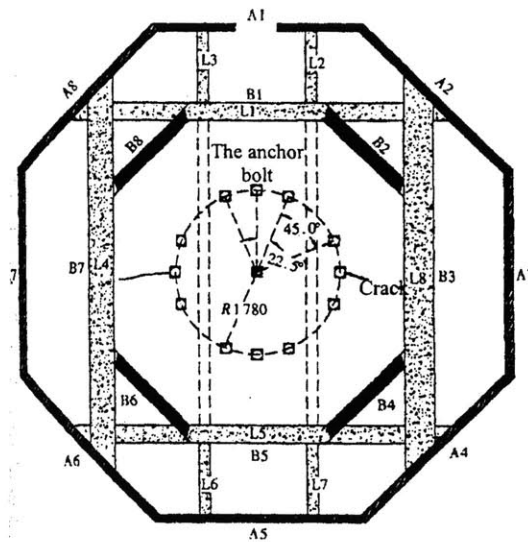
Figure 26. Plan view of octagonal ceiling showing anchor bolt locations. (Source: Xie et. al. 2002)

transfer mechanisms for the interaction force. From this data, they were able to generate a cross section of the results. Figures 29 and 30 show the locations of the anchor bolts.

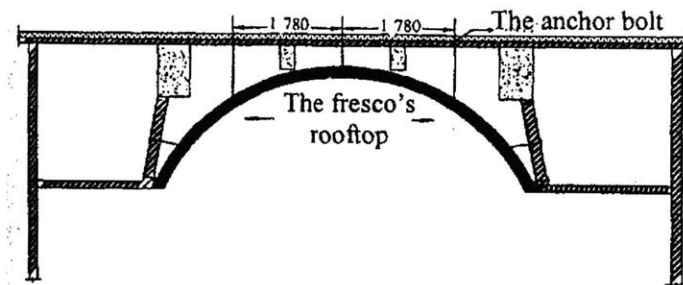
Figure 27. Cross-section of octagonal rooftop showing anchor bolt connections. (Source: Xie et. al. 2002)
