Ecological Assessment of Salt Ponds on St. John, USVI

**SUBMITTED TO THE DEPARTMENT OF CIVIL AND ENVIRONMENTAL ENGINEERING IN
PARTIAL FULFILLMENT OF THE REQUIREMENTS FOR THE DEGREE OF**

**MASTER OF ENGINEERING IN CIVIL AND ENVIRONMENTAL ENGINEERING
AT THE
MASSACHUSETTS INSTITUTE OF TECHNOLOGY**

JUNE 2003

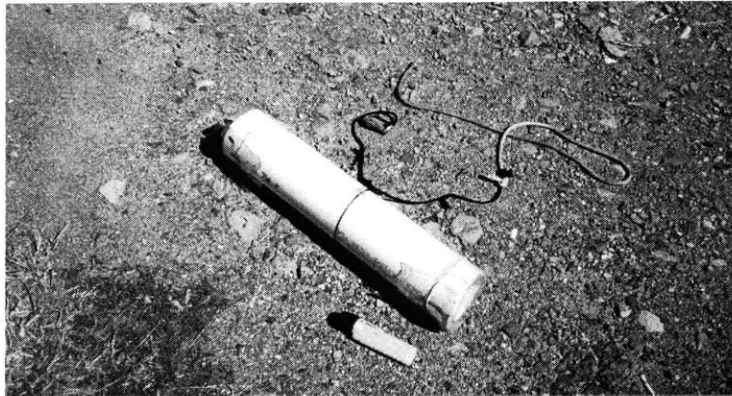
The light trap was constructed using an 18-inch-long piece of 3-inch-diameter polyvinyl chloride pipe and two plastic bottles. The necks of the bottles were placed inside the pipe pointing inward and the bottles were cut radially, and folded and secured with rubber bands around the outside. A dive light was placed inside the pipe so that macroinvertebrates that were attracted to the light would swim into the trap and be unlikely to escape (Figure 2.1).

Figure 2.1 Light Trap Used for Macroinvertebrate Sampling

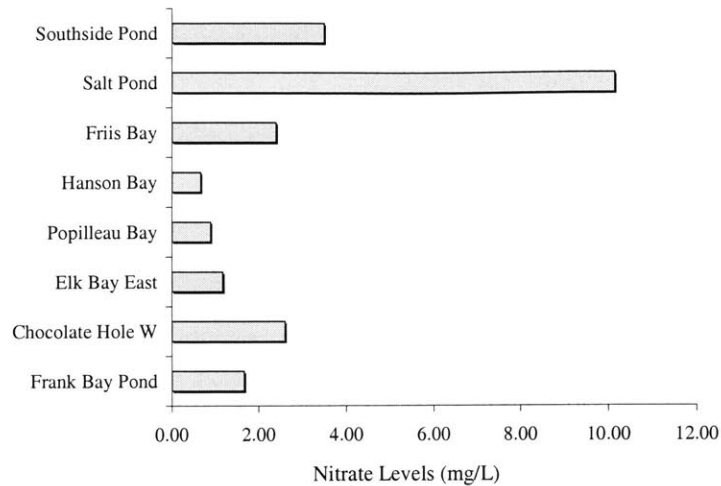
Measured nitrate levels generally indicate the amounts and types of runoff that end up in the ponds (Coulston, 1987). High levels of nitrates can adversely affect ecosystem populations within the ponds and may have implications for marine water quality around the island. Although ponds filter sediments and runoff before these materials flow into the ocean, elevated nitrates may make it into the surrounding marine environments because they are highly soluble, persistent, and mobile. Measured nitrate levels are listed by pond in Figure 3.3.

Figure 3.3 Measured Salt Pond Nitrate Levels

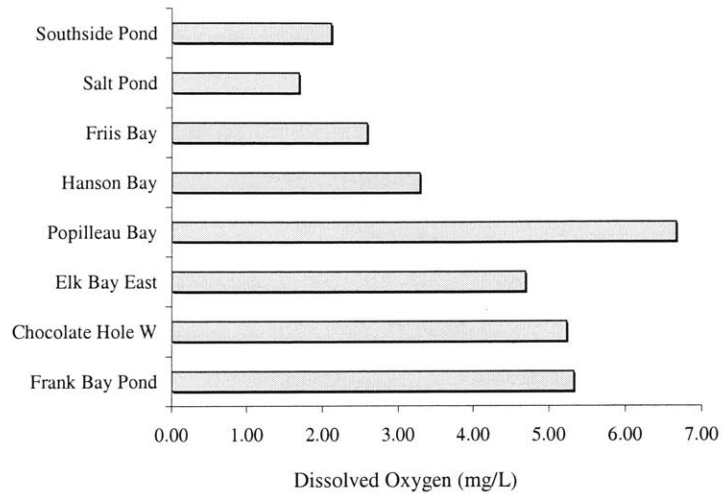
The average level of dissolved oxygen measured in the ponds is 3.95 mg/L. The levels of oxygen dissolved in the ponds (Figure 3.4) provide a reference set of data for the ecosystems currently in the salt ponds. Managing the ponds long-term will require dissolved oxygen monitoring to make sure that levels continue to be adequate to support the community living in and depending on the ponds.

Figure 3.4 Measured Dissolved Oxygen Levels

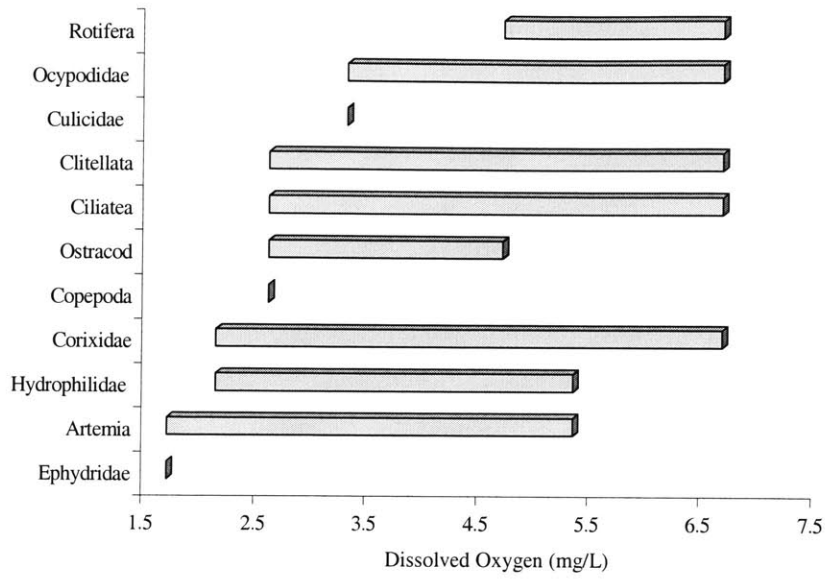
Figure 3.8 Invertebrates Present by Dissolved Oxygen

Figure 3.7 shows the ranges of chlorophyll a levels in which each type of macroinvertebrate was observed. Despite the wide range of chlorophyll a levels measured in the ponds, we can see that there are six types of macroinvertebrates living in the ponds with the highest levels of chlorophyll density. Macroinvertebrates present by range of dissolved oxygen and nitrate levels are illustrated in Figures 3.8 and 3.9, respectively.

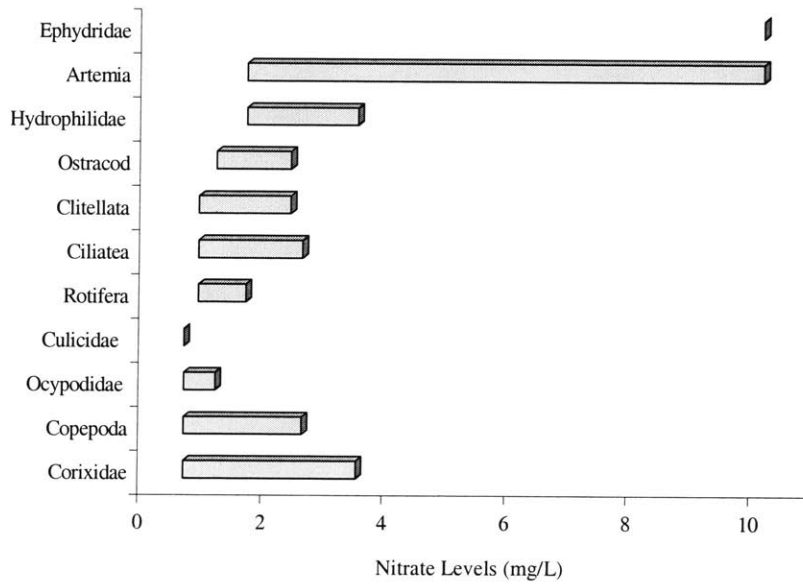
Figure 3.9 Invertebrates Present by Nitrate Levels

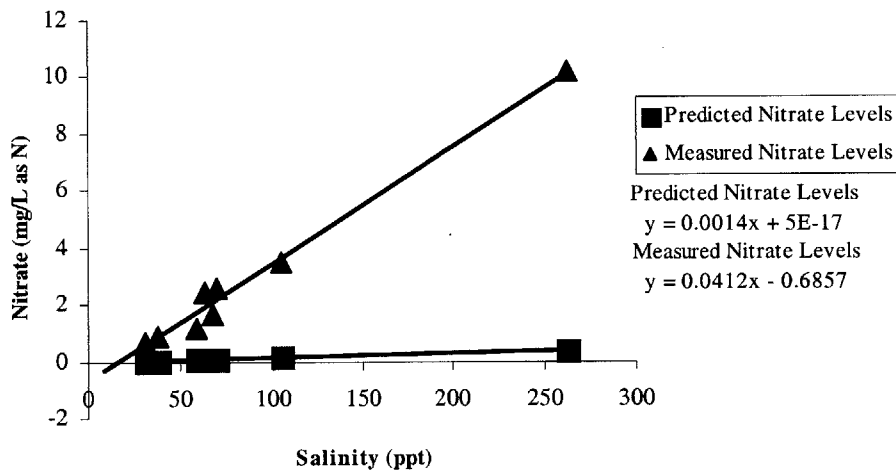
Data from latitude 18.5 and longitude 64.5 provided seawater data on nitrate (0.214 mg/L) and salinity (36.5 ppt) in the ocean near St. John (NOAA, 2001); a line was constructed through this point and the origin. If nitrate and salinity were concentrated in a common proportion, this line would predict nitrate levels based on the measured salinity of the pond. These predicted nitrate levels may be seen in Figure 3.12. Comparing predicted nitrate levels to measured nitrate levels (also in Figure 3.12) for each pond shows that the measured nitrate level is greater than the predicted nitrate level based on seawater data. Therefore, there appears to be one or more additional nitrate sources in the ponds. Further research on this topic is recommended.

Figure 3.12 Nitrate (as N) - Salinity Correlation: Predicted vs. Observed

From the measured and predicted nitrate levels in Figure 3.12, a “delta” value was calculated to measure nitrate above values predicted by seawater. This “delta” value measures the difference between measured and predicted nitrate levels. Delta was then compared via regression analysis to species richness and to housing density. Delta was significantly and negatively correlated with species richness ($R^2=0.54$) as illustrated in Figure 3.13. Removal of the one extreme outlier point reduces the R^2 value to 0.4293. However, the delta value was not correlated with housing density; housing density as calculated in this study may not be an appropriate indicator value for a measure of human impact.

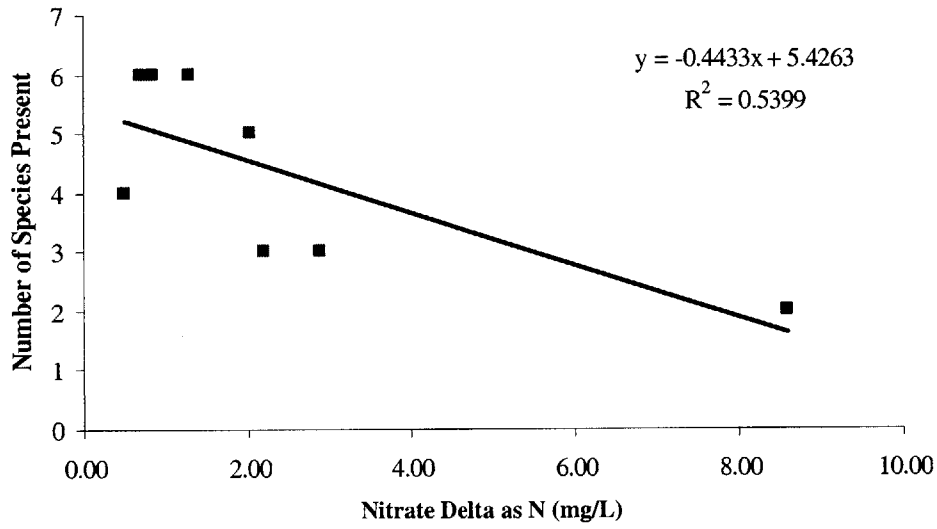
Figure 3.13 Species Richness vs. Nitrate (as N) Delta Regression Curve

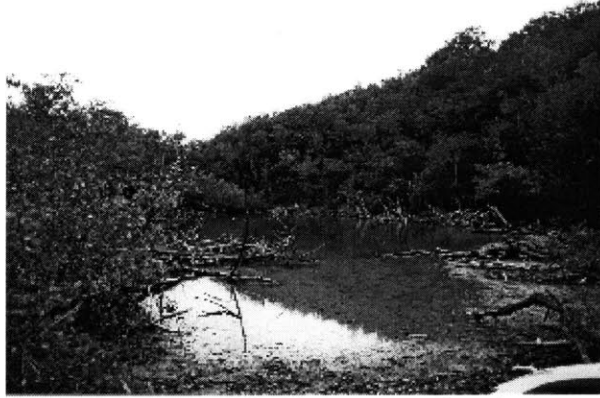
Figure C.6 Elk Bay East Pond

Elk Bay East is the only pond found in this study where all four types of mangroves coexist. Red mangroves formed a thick barrier between the pond and the ocean on the berm, and were also found along the ocean shore in Elk Bay. About 30% of the pond's bank was unvegetated; of the vegetated area, all of the plants were mangroves. Red mangroves comprised about 50% of the cover around the pond; black, white, and gray mangroves comprised 5%, 30%, and 15%, respectively. Red mangroves formed a thick barrier between the pond and the ocean on the berm, and were also found along the ocean shore in Elk Bay. The berm is composed of sand, silt, and soil, and is about 1m high. The pond's boundary is greater than 10 m, and no erosion seems to be affecting the pond.

The pond's sediment medium is a bacterial mat, mustard-green in color, over a more solid underlayer. Many twigs, leaves, and mangrove seeds were embedded in the pond sediment. *Corixidae*, *copepoda*, *rotifera*, *ciliatea*, *ostracoda*, and *ocypodidae* were found in this pond; fish were not present.

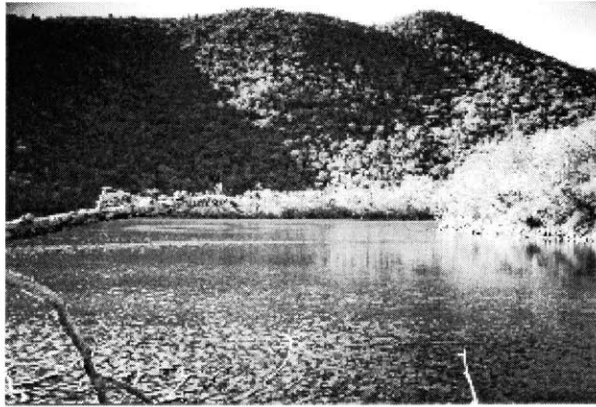
Figure C.8 Europa Bay Pond

The bacterial mat is orange around the edges of the pond and gray in the middle. *Corixidae*, *ciliatea*, *hydrophilidae*, *artemiidae*, *ephydriidae*, and *ceratopogonidae* were the macroinvertebrates observed in this pond.

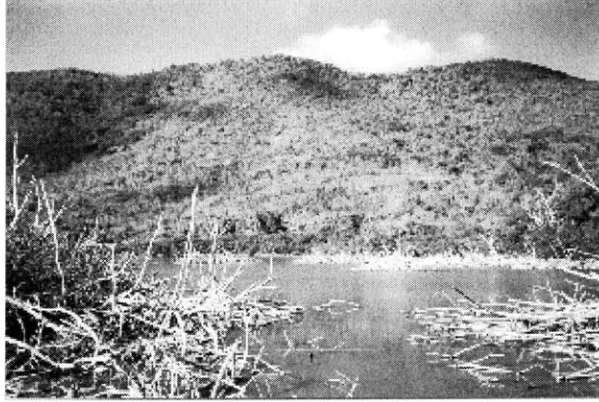
Figure C.11 Francis Bay Pond

There is a wide berm, about 1-2 m high, composed of soil and silt on which the walking path is located. The pond sediment is yellowish-green and very mucky – some sinking occurs although the pond is navigable by foot, and other footprints were also found in the pond, although the source of the prints was unclear. There were no fish observed in the pond; however, there were *corixidae*, *copepoda*, *ocypodidae*, *artemiidae*, *oligochaeta*, and *ephydriidae*.

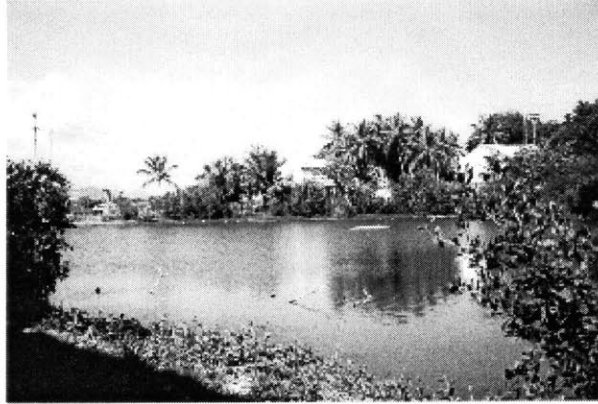
Figure C.13 Frank Bay Pond

About 75% of the pond bank is covered with vegetation; of the mangroves found on the banks, about 85% were white mangroves and 15% were gray. The boundary width is greater than 10m, and only about 5% of the bank is estimated to be affected by erosion. Fish were absent in this pond, but present were *corixidae*, *copepoda*, *rotifera*, *ciliatea*, and *hydrophilidae* larvae. The vast majority of macroinvertebrates were found near the sandy fill by the desalination plant.

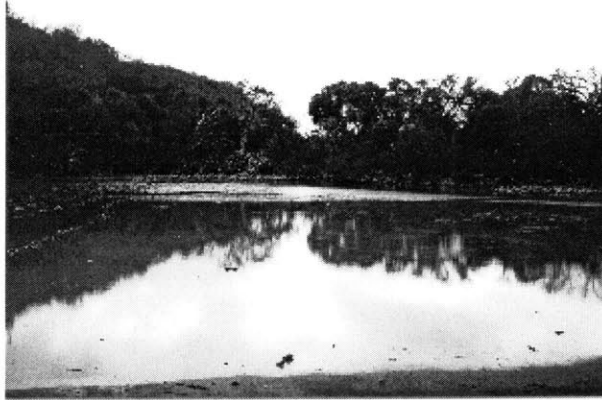
Figure C.22 Kiddel Bay Pond

The berm is about 3-4 m high, and is composed of rubble and coral. There is a visible seep from the ocean through a small section of the berm with no vegetation. The bacterial mat had a brownish layer on top of black thick mud with cohesive chunks of organic clay throughout. The sediment was firm enough to be navigable by foot on the far side, but did yield several feet to body weight near the berm. *Corixidae*, *artemiidae*, *copepoda*, *ocypodidae*, *ephydriidae*, and *hydrobiidae* were the macroinvertebrates observed in this pond.

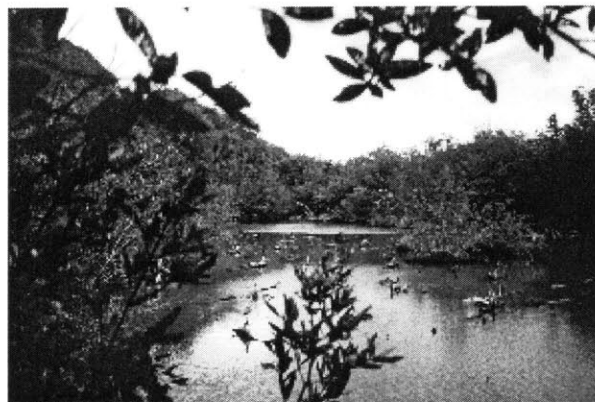
Figure C.25 Lagoon Point Pond

The sediment in the pond is very soft, making access to the far side of the pond impossible. Many *hydrobiidae* were found in the mucky black sediment, as were *ocypodidae* and *oligochaeta*. *Copepoda* and *corixidae* were also collected from pond samples at Lagoon Point.

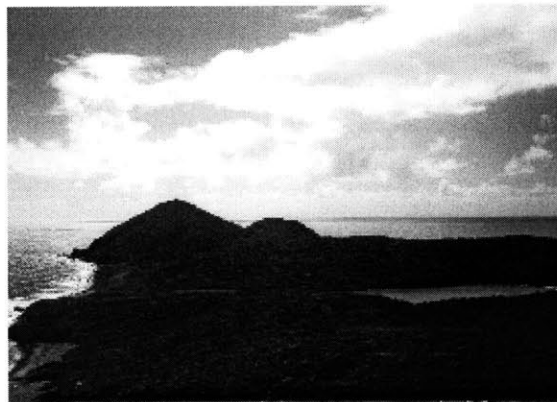
Figure C.32 Salt Pond

This pond has the highest measured salinity of the fifteen ponds studied. The pond water is clear to the bottom, and there are some rocks present on the bottom of the pond as well as around the edges. The edges of the pond were sandy and there was foam around the edges of the pond; the bottom of the pond had a hard crystallized layer over extremely soft mud. This hard crust on the pond sediment provides an ideal environment for *ephydriidae* larvae to which to attach. *Artemiidae* and *ephydriidae* were the only macroinvertebrates observed in this pond.

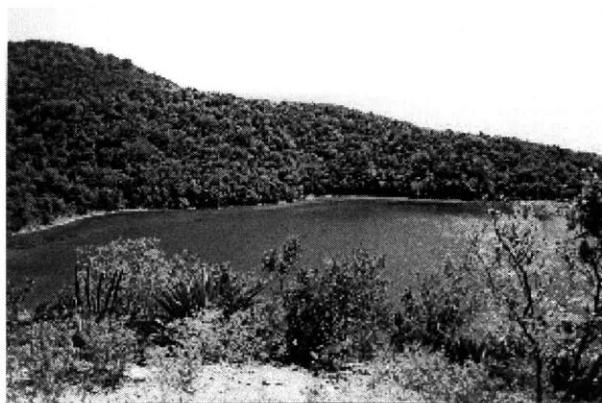
Figure C.35 Southside Pond

This pond has a very thick orange jellylike microbial mat that extends around the edges of the pond nearest the trail access point and covers the shallower half of the bottom of the pond. Some foam around the edges of the pond was observed. Goats and wild boar were also observed near this pond. *Corixidae*, *hydrophilidae*, and *artemiidae* were found in this pond.

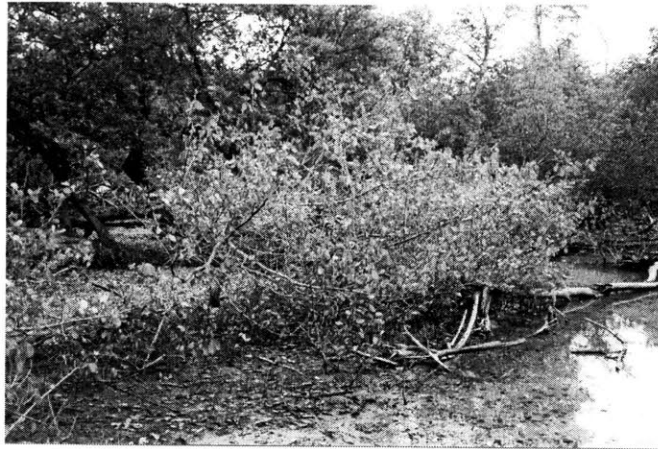
*Figure D.15 Avicennia Germinans
Black Mangrove Pneumatophores, Elk Bay, St. John*

Black mangroves have adaptive root mechanisms called pneumatophores that allow them to survive in the marshy areas around salt ponds. Pneumatophores are thin, spongy projections that grow up about six inches from the ground in the soil around the black mangrove and contain lenticels for oxygen absorption (Nellis, 1994). Both the rough black bark, the light-colored underside of the leaves, and the pneumatophores make for easy identification of these trees in the pond environment. Black mangroves can survive in salinities up to 100 ppt. Unlike red mangroves, black mangroves are able to metabolize the salt that is absorbed with the water by secreting it back into the environment. “The black mangrove secretes excess salt through specialized glands on the surface of leaves in addition to carrying out root ultrafiltration...Salt glands are microscopic and occur in epidermal depressions on the upper leaf surface. Each gland has 8-12 outer secretory cells, a lower stalk cell, and two to four other subtending, or basal cells, enclosed in a cuticle” (Schongalla, 2001). Secretions contain excess salt which dries on the undersides of the black mangrove leaves and then dissipates.

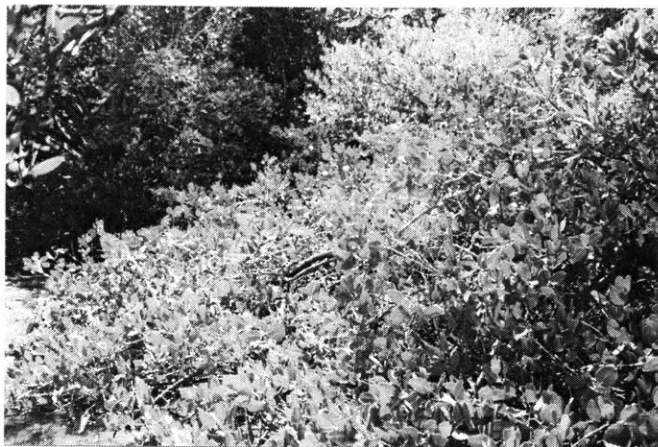
*Figure D.17 Laguncularia Racemosa
White Mangroves, Drunk Bay, St. John*

White mangroves are most easily recognized by the salt glands found on their leaves (Jarecki, personal communication). These glands show up as a border of dark spots around the edges of the leaves when they are held to the light. The white mangrove also has two raised salt glands at the base of every leaf. White mangroves can grow either a prop root system or pneumatophores in wetter soils. “The white mangrove prefers moist silty soil. It can grow in seawater-saturated soil if the site is shallow and protected from strong wave action” (Nellis, 1994). White mangroves are the most sensitive to cold and can be prone to uprooting from weather forces due to their shallow root systems.

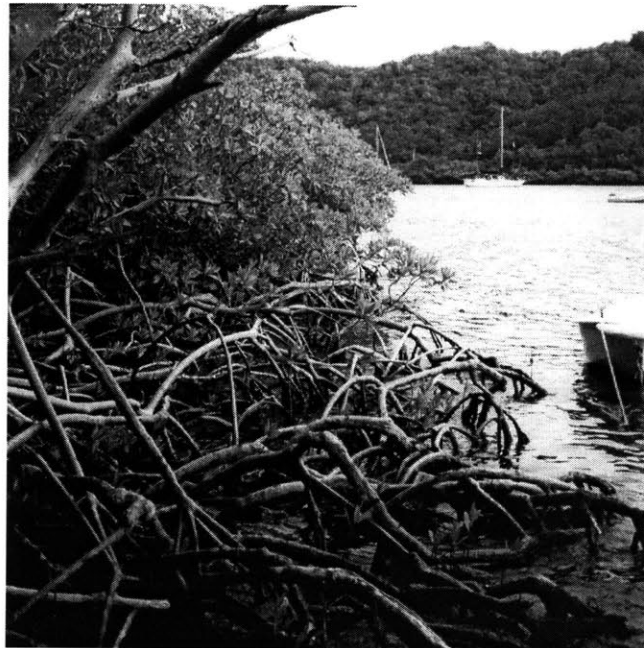
*Figure D.18 Rhizophora Mangle
Red Mangrove Prop Root System, Elk Bay, St. John*

Red mangroves are most easily identifiable by their root networks characterized by prop roots, also sometimes called “walking roots.” This highly branching root system helps keep the red mangrove anchored in place in waterlogged soils (EPA, 1998) and also allows them to survive in saline environments. These roots may branch out from the tree’s trunk or from its higher branches, and “contain numerous above-ground lenticels which provide oxygen for the roots immersed in anoxic mud. The roots are able to reject the excess salt from the environment, leaving the sap with a salinity typical of other plants” (Nellis, 1994). Unlike other mangroves, which have the ability to metabolize salt from the water, the red mangrove has a physical mechanism for blocking salt entry via the roots. “Rhizophora mangle is considered a non-secreting salt excluder because it excludes salt from entering the roots and lacks glandular secretory structures” (Schongalla, 2001). Red mangroves typically live nearer to the water than other mangroves, and are able to live in depths as great as 1 m, but they are the least tolerant of very high salinity, as observed on St. John. David Nellis states “Red mangroves can tolerate salinities from freshwater to 44 parts per thousand. The maximum height of the trees in a mature stand is inversely proportional to the soil salinity in the range of 17 to 72 ppt. Trees begin to die when soil salinities exceed 65 ppt. and all are dead if the salinity reaches 90 ppt.” Red mangroves were observed at three ponds on St. John: Hanson Bay, with measured salinity of 31 ppt; Friis Bay, salinity 63 ppt; and, Elk Bay, salinity 59 ppt.
