INVESTIGATION OF THE STRESS CORROSION CRACKING  
SUSCEPTIBILITY OF ANNEALED AND HEAT TREATED ALLOY 625  
CASTINGS AND FORGINGS IN SEA WATER

NAVAL ENGINEER  
and  
MASTER OF SCIENCE IN MATERIALS ENGINEERING

at the  
MASSACHUSETTS INSTITUTE OF TECHNOLOGY  
June, 1987

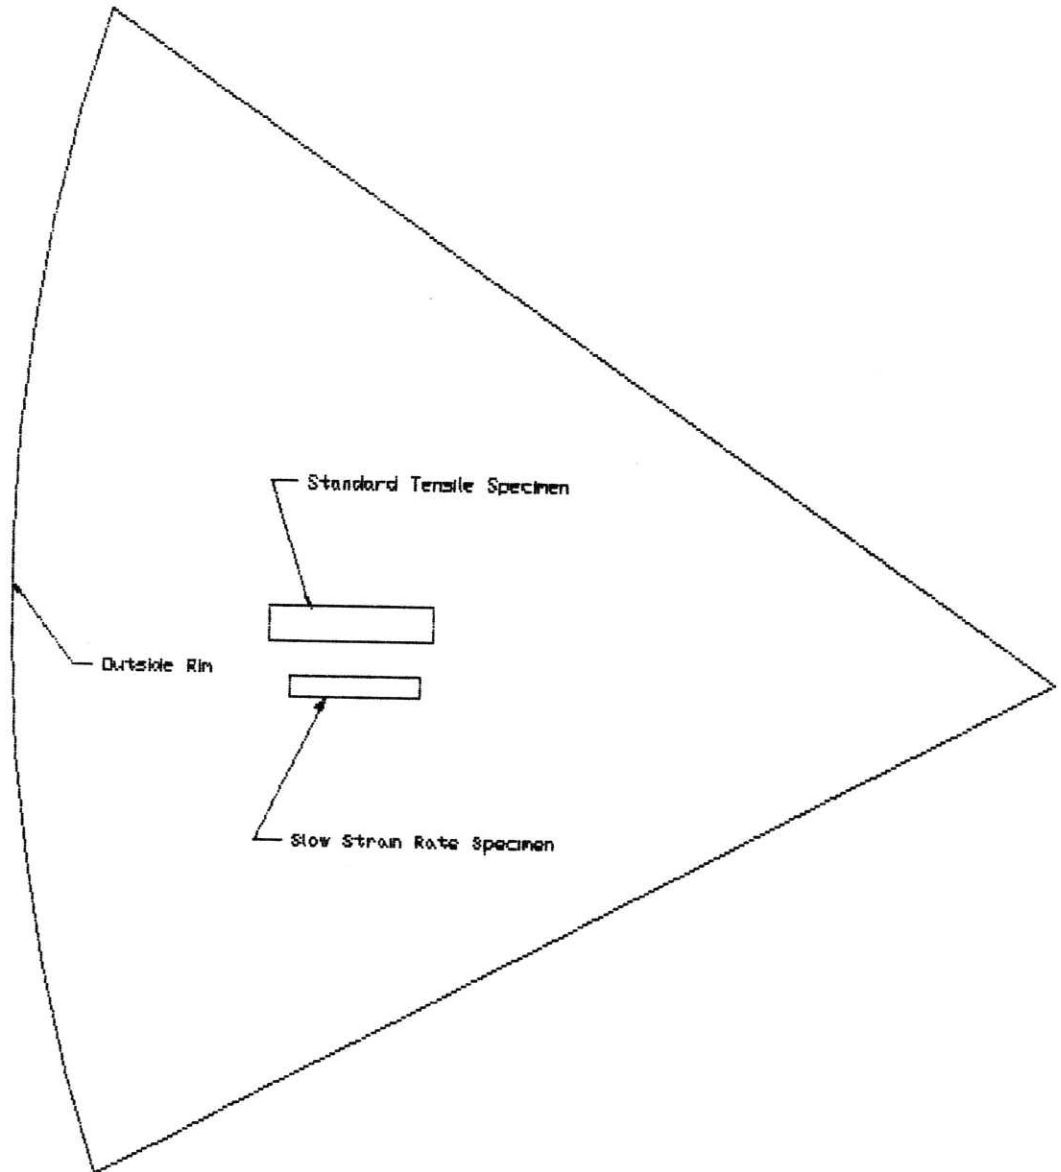
Figure 2 | Typical Test Specimen Location

Section of Alloy 625 Billet/Ingot

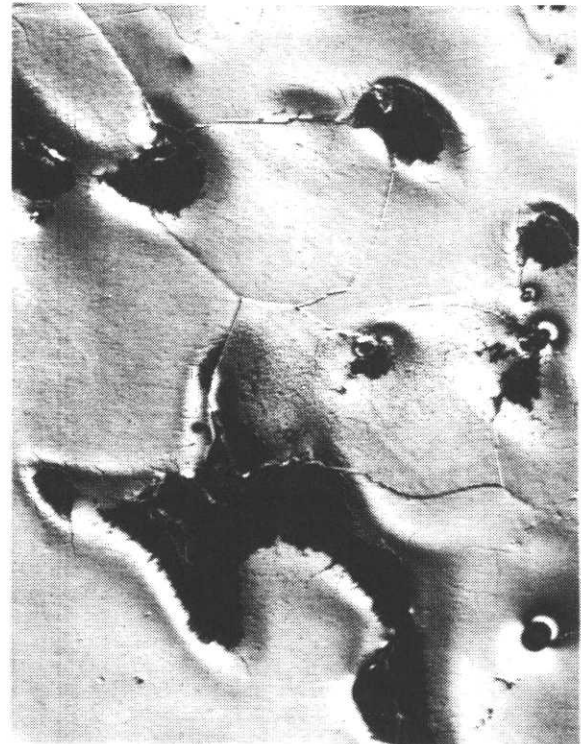
Top Left: 100X  
Bottom Left: 50X

Top Right: 1000X  
Bottom Right: 200X

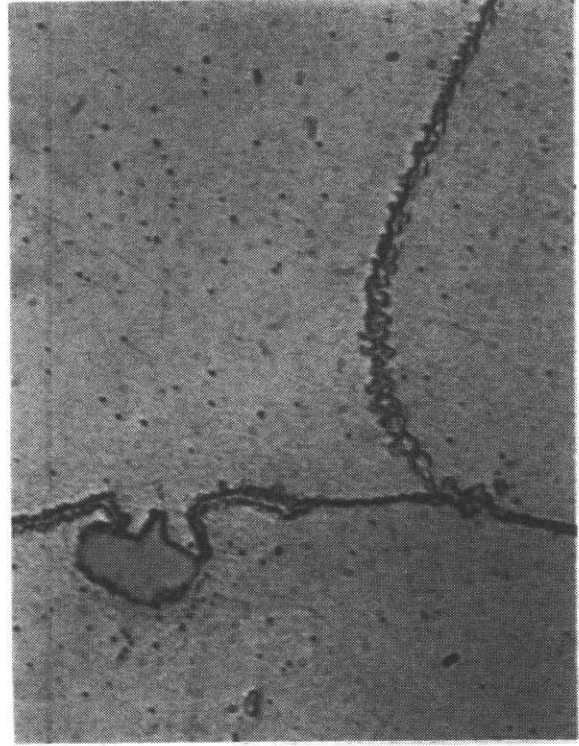
**Figure 7** Photomicrographs of "Cast/Heat Treated" Alloy 625

Top Left: 100X  
Bottom Left: 50X

Top Right: 1000X  
Bottom Right: 1000X

Heat treating the cast material in Figure 7 caused what appears to be globular or blocky  $M_{23}C_6$  carbides on the grain boundaries. The bottom photomicrographs show dislocation slip bands throughout the matrix and heavy growth along the grain boundaries.

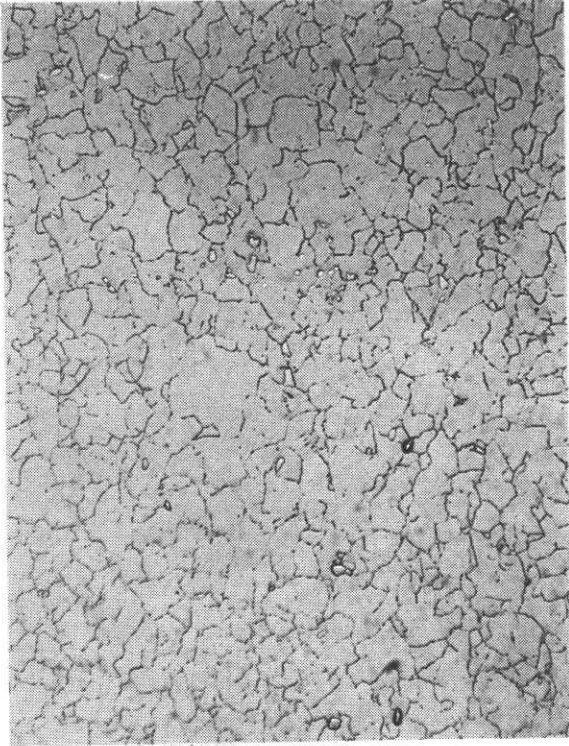
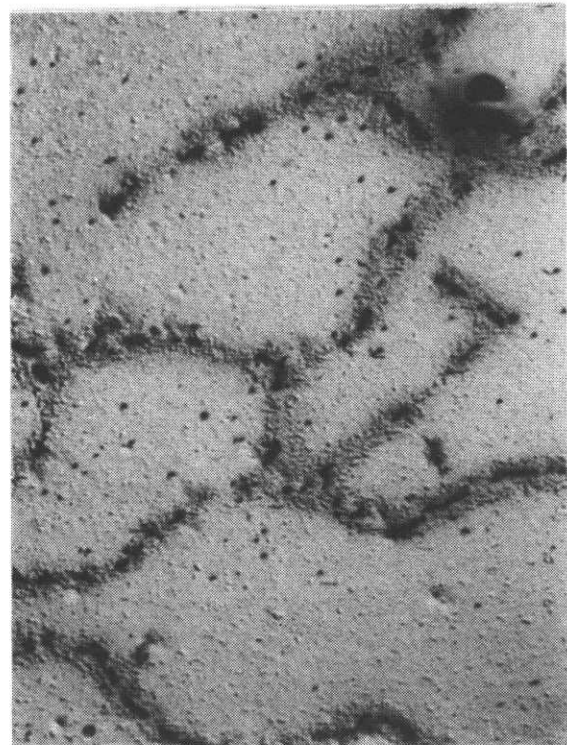
**Figure 8** Photomicrographs of "Forged/Annealed" Alloy 625

Top Left: 100X  
Bottom Left: 50X

Top Right: 1000X  
Bottom Right: 1000X

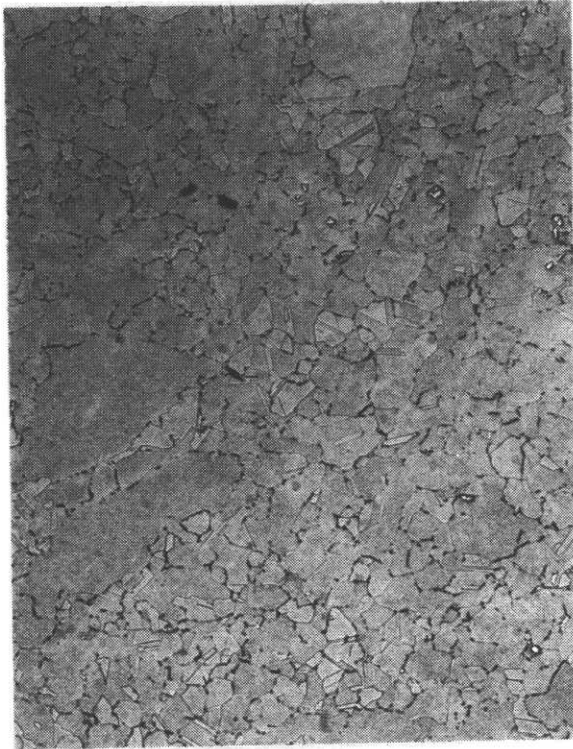
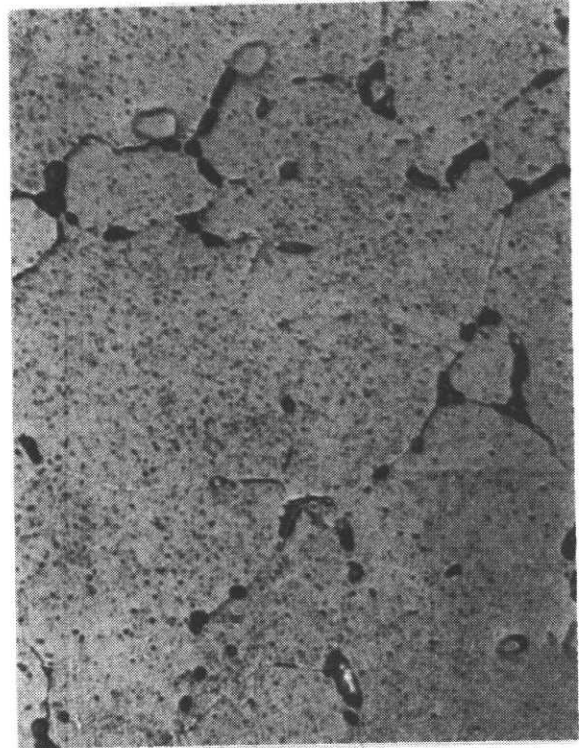
**Figure 9** Photomicrographs of "Forged/Heat Treated"  
Alloy 625

Top Left: 100X  
Bottom Left: 50X

Top Right: 1000X  
Bottom Right: 1000X

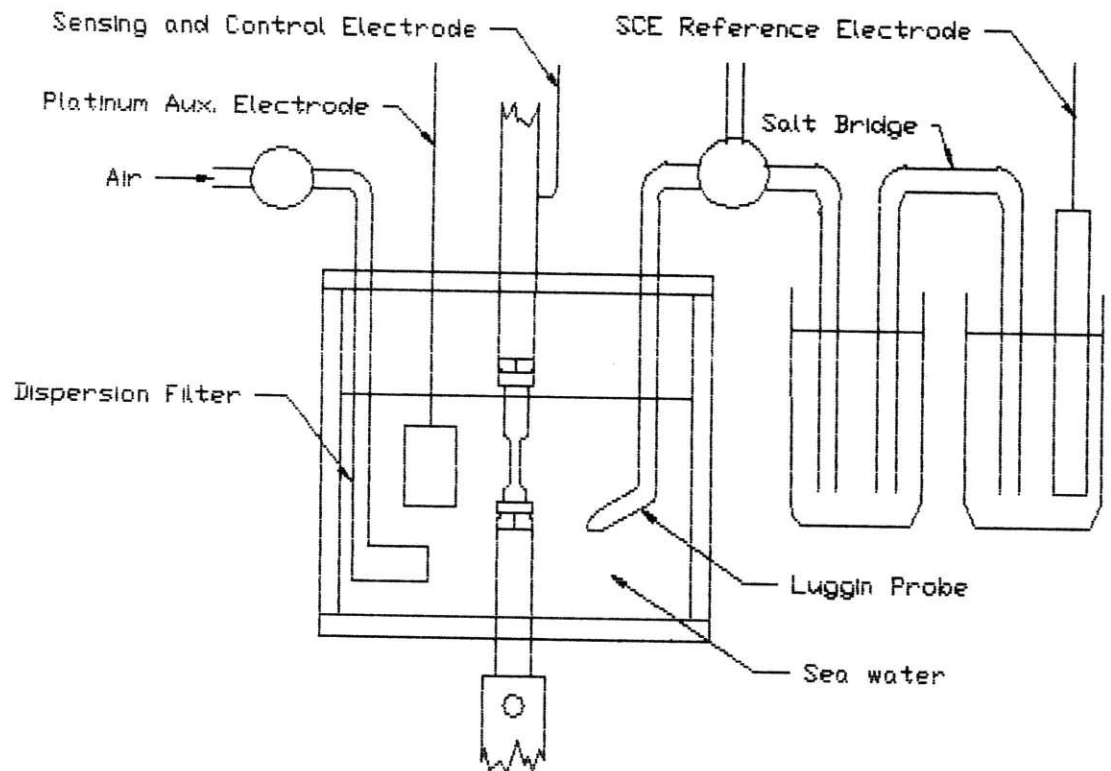
Figure 11 Test apparatus Used for Slow Strain Rate Testing

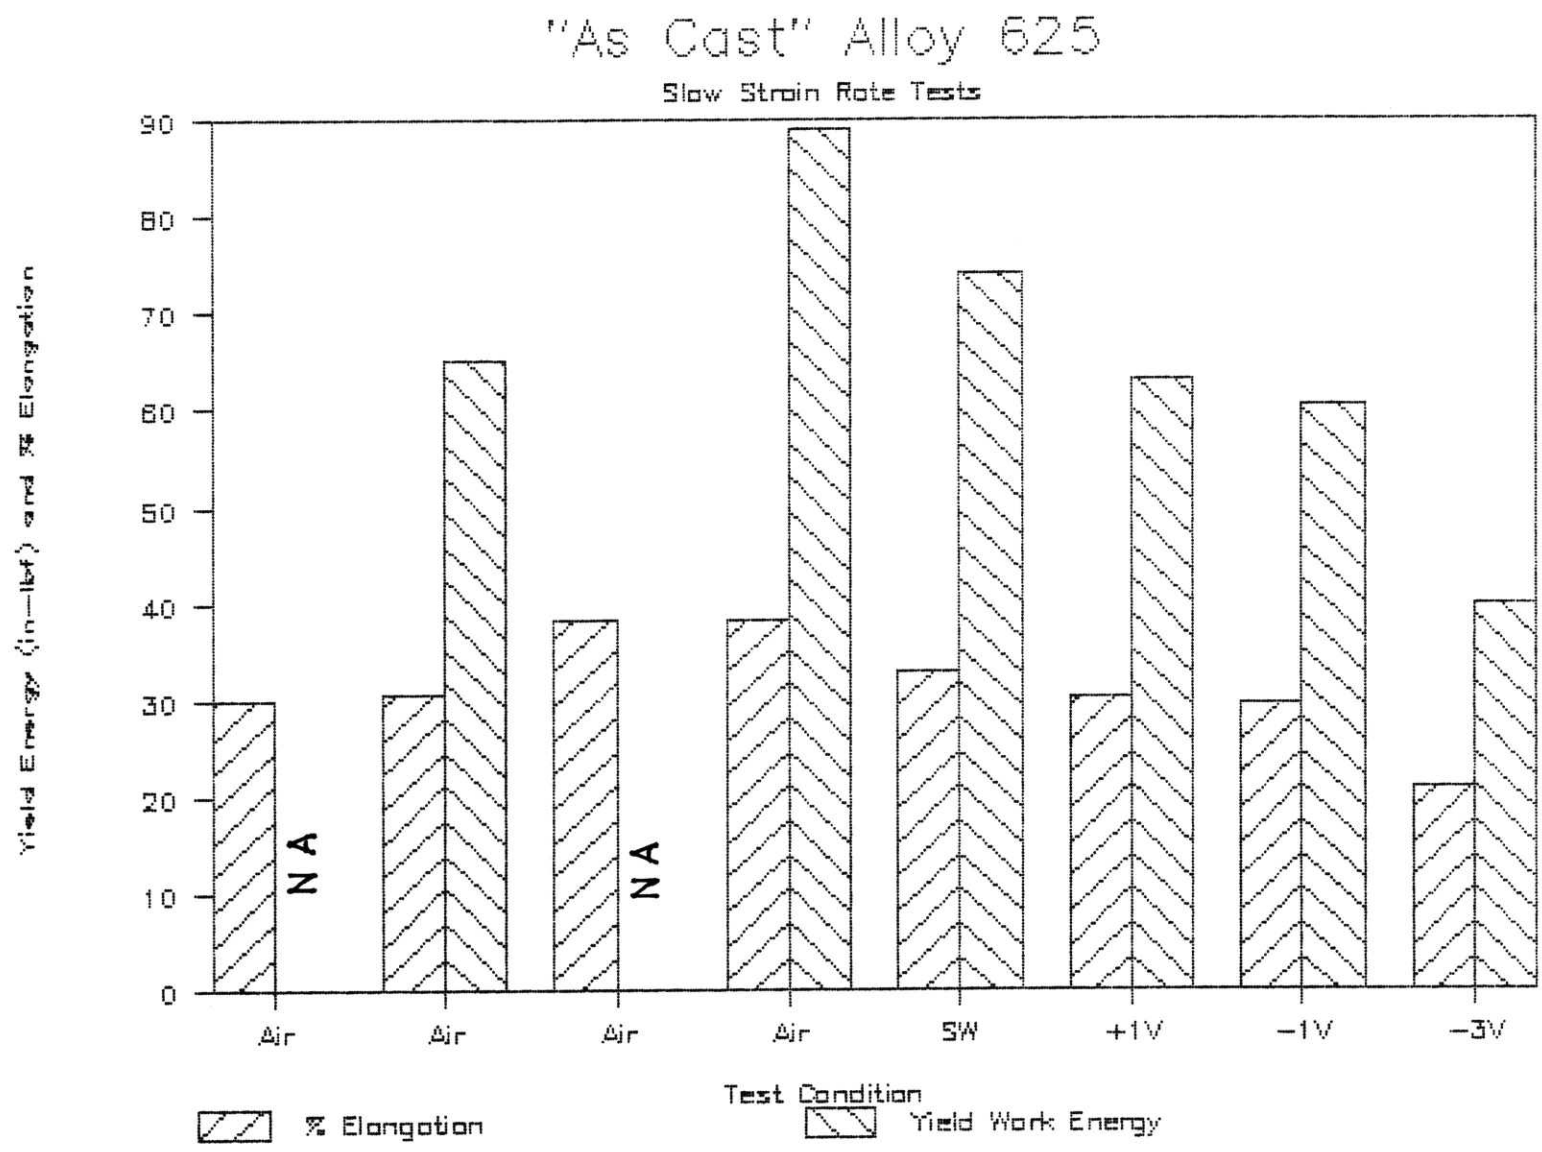
**Figure 14** Graph of Slow Strain Rate Test Results for "As Cast" Alloy 625 - Test Condition versus Percent Elongation and Yield Work Energy

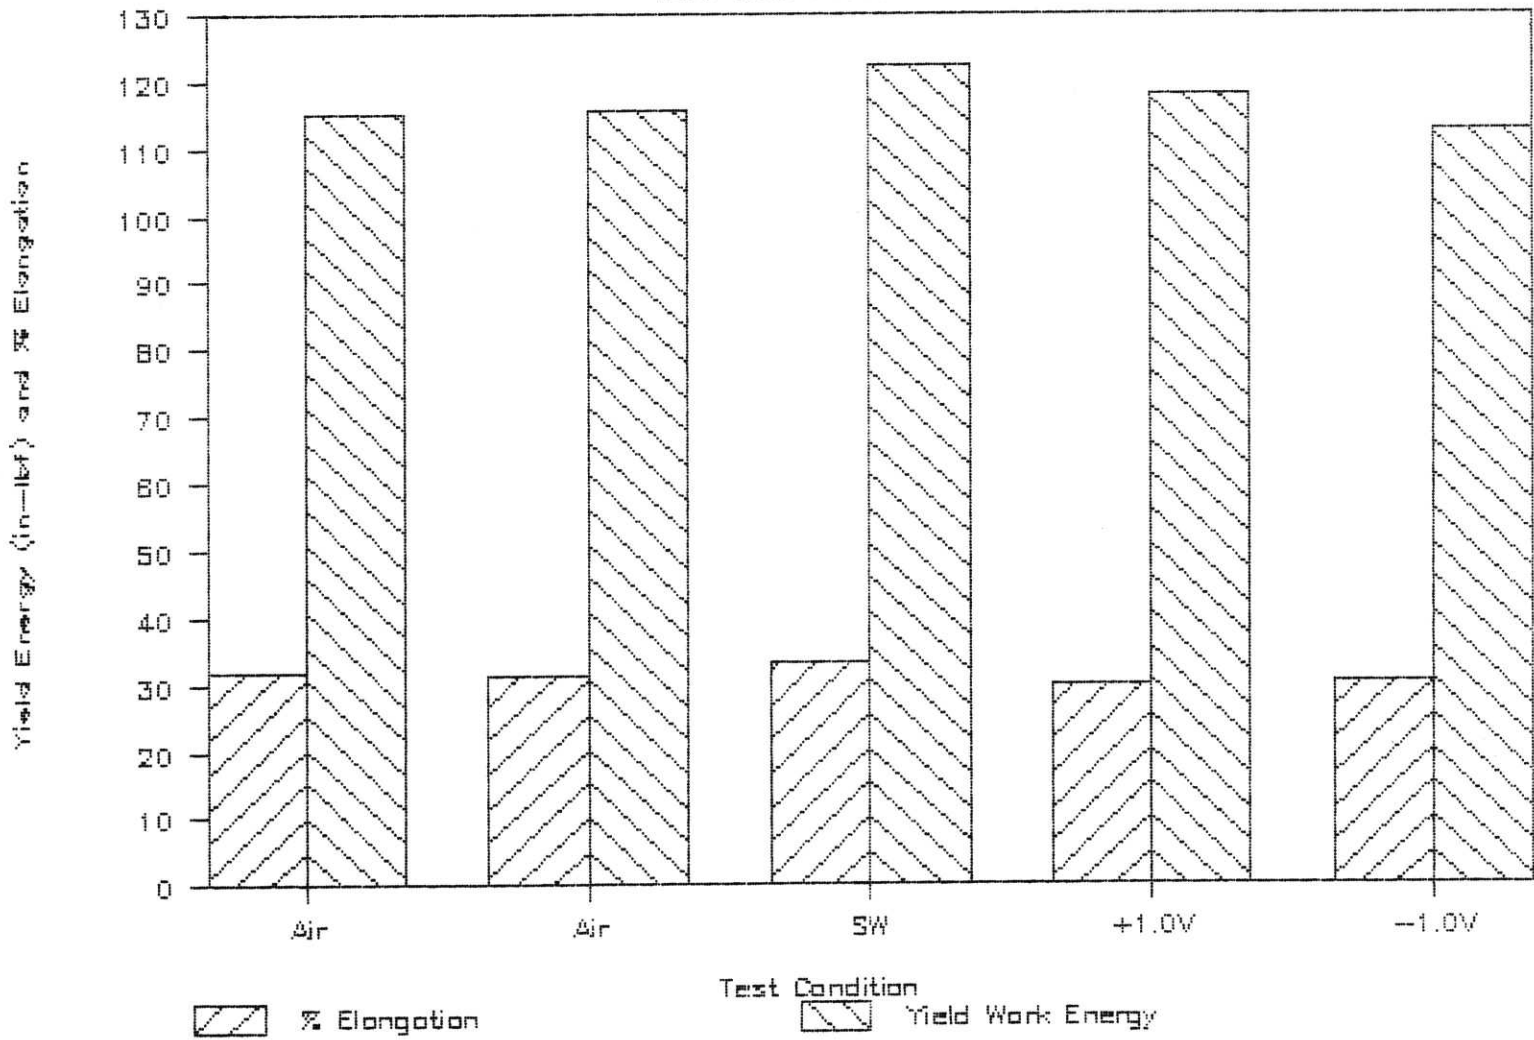
**Figure 20** Graph of Slow Strain Rate Test Results for "Forged/Heat Treated" Alloy 625 - Test Condition versus Percent Elongation and Yield Work Energy
