Erosion of Metals by Solid Particle Impingement

Richard Arnold Jarrett

Submitted in Partial Fulfillment

May, 1971

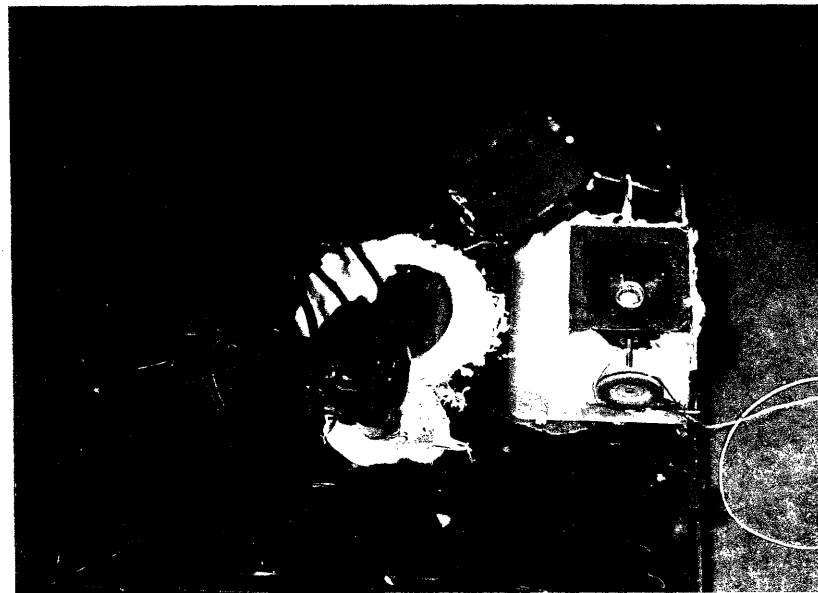
Fig. 8 Chamber Cover and Particle Dropper

A rotating arm erosion tester had been designed and built in the Materials Processing Laboratory. This apparatus consisted of a twelve inch arm which rotated in a vacuum chamber, an air turbine to drive the arm, and a photo transistor coupled with an electronic counter to measure the speed of the arm. In order to obtain a low vacuum for accurate determination of impingement speeds, silicon rubber gaskets and neoprene "O" rings were used on shafts and demountable surfaces. A mercury manometer was used to measure the vacuum. An arm was designed and built to undergo constant stress throughout its length and to withstand the bending moment created by the specimens. The apparatus is shown in Figures 3 through 9.

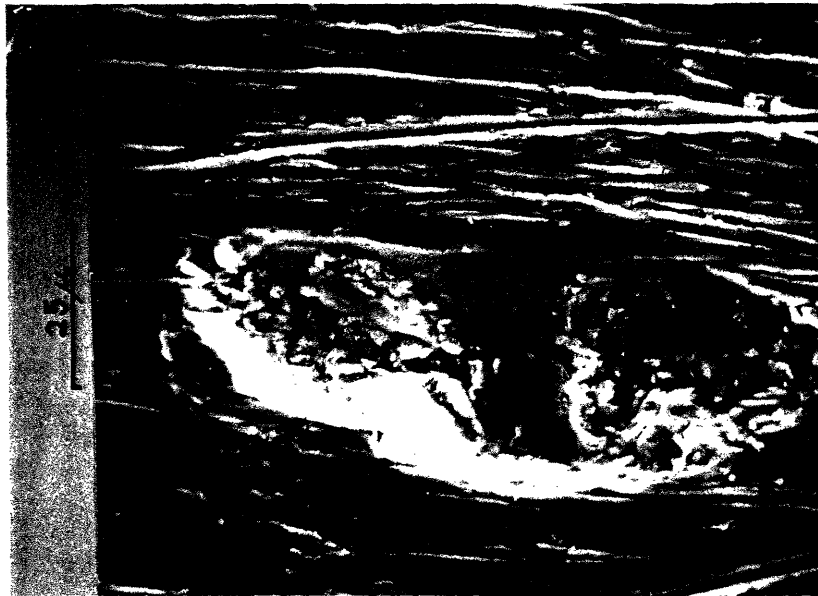
Fig. 10 CR 1020 Steel, 100 feet/sec.

in increased crater depth. Figures 10,11,12,and 15 all show shallow craters which were formed by particles traveling at 100 ft/sec. Slightly deeper craters were formed at 300 ft/sec. as shown in Figures 17 and 18, still deeper craters at 500 ft/sec. as shown in Figures 20, 22, and 25, and the deepest craters at 800 and 1000 ft/sec. as shown in Figures 27,28,35,38, and 39. This result is fairly conclusive as the 1020 steel acted in the same manner as the questionable materials in which voids were numerous.

The most prevalent form of damage, however, appears to be the pure shearing of the sides of the craters. Although the best examples of this are in Figures 38, 28, 20, and 10, shearing can also be seen in Figures 12, 15, 18, 19, 22, 25, 26, 27, 35, 36, and 39. In Figure 12 it can be seen how cleanly the shearing took place. In the lower left corner, the voids were undisturbed during the shearing process.

Another very interesting occurrence is the appearance of fibrous material in the bottom of the craters. This looks very similar to the exposed surface of a ductile material after a tensile fracture. Figures 38, 22, 20, and 10 show this effect in decreasing clarity as do many of the other pictures listed above that show erosion in the shear mode.

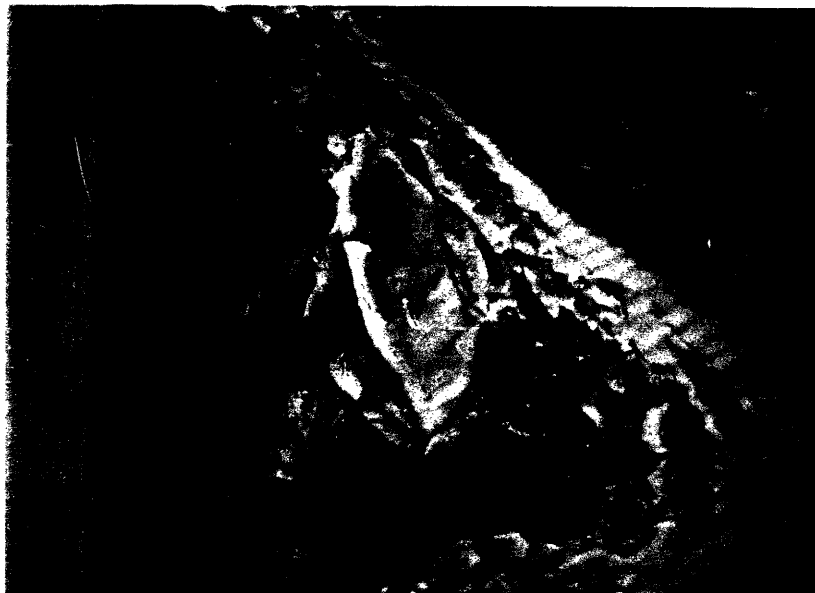
Fig. 19 Annealed Titanium Alloy, 300 feet/sec.

Our results with the small grained specimens are difficult to evaluate due to numerous voids throughout the specimens. These voids are clearly shown in Figures 13,15,17,18,19,25,26, 32, and 34. Material properties such as the compressive strength of the material may be drastically affected by such voids. The examination of the right side of Figure 26 with stereo viewers shows that apparently a section of the surface is depressed without showing any displaced metal elsewhere. This may be an indication that some of the voids were eliminated during the process.

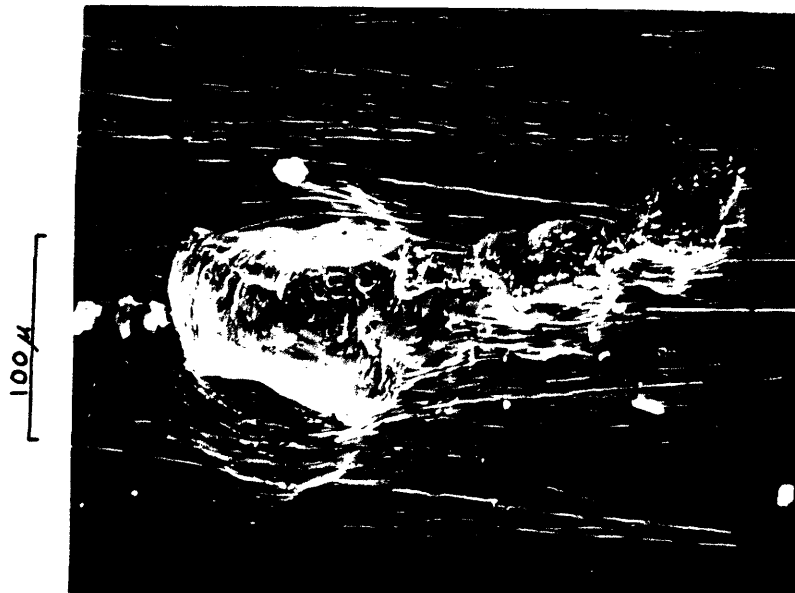
Fig. 20 CR 1020 Steel, 500 feet/sec.

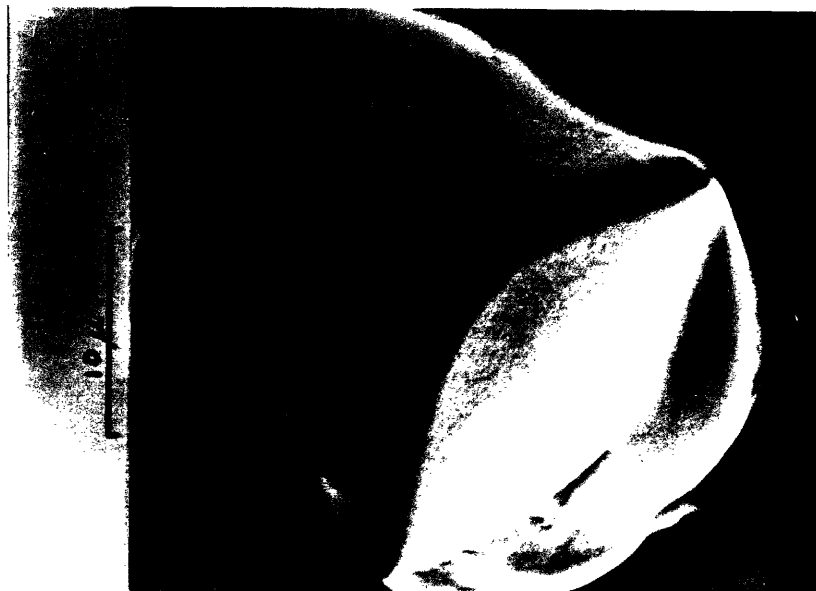
Fig. 21 Annealed 1020 Steel, 500 feet/sec.

So far, observations on the mechanisms of erosion have not been discussed in this paper. Finnie's model of micro-machining as mentioned in the introduction is possibly supported in four cases. It should be noted that his model was based on smaller impingement angles than 90° . However, due to the uncertainty in our testing, it is possible that this damage occurred from particles moving in unknown directions. Figure 34 shows a fragment of metal or silicon carbide which skimmed along the surface machining a groove until it lodged in the specimen. Figures 21 and 39 show a similar occurrence.

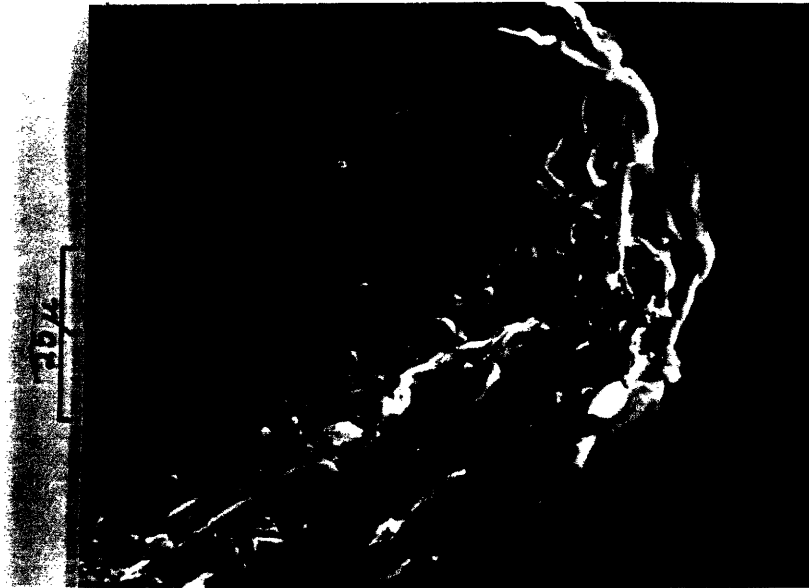
Fig. 23 A.R. Modified 1010 Steel, 500 feet/sec.

Fig. 24 A.R. Modified 1010 Steel, 500 feet/sec.

The foreign particle in Figure 39 was assumed to have been lodged after the erosion took place. In Figure 22, a larger particle could have skimmed from the lower left of the picture, machined a groove, and as it left, formed the large ridge. Figures 23 and 24 are enlargements of this damage.

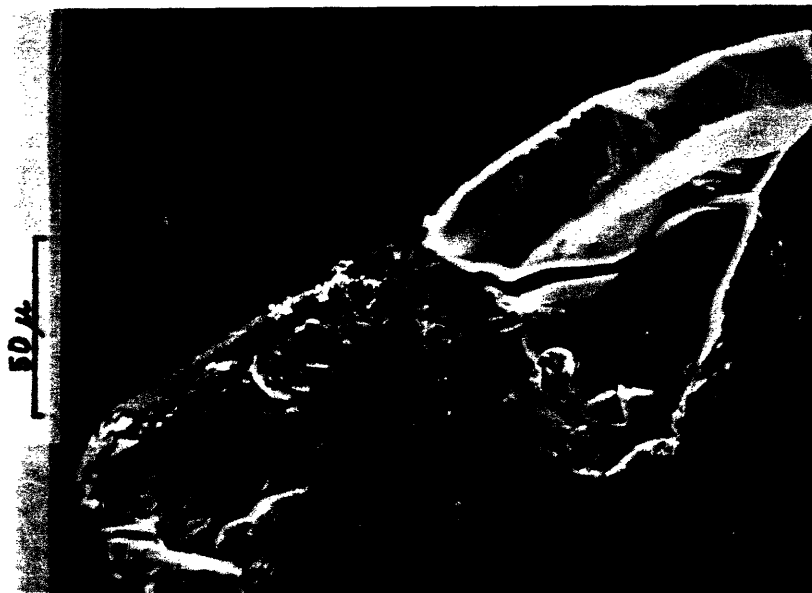
Fig. 26 A.R. Titanium Alloy, 500 feet/sec.

At higher velocities, however, the damage caused by such chips may be quite severe as shown in Figures 26,29,32,and 34.

Since the particles lack the voids that are prevalent in the surface of the specimens, it is doubtful that they are of the same material. Furthermore, with the possible exception of Figure 26, the particles do not appear to be silicon carbide, a non-conductor which would appear white under the microscope. Most likely, the particles are chips from either the rotating arm or the sides of the test chamber. Figure 33 shows a large chip which imbedded in the surface. A similar chip hit the surface in Figure 32 but upon impact shattered into many smaller pieces. Figure 29 shows a dramatic example of fragmentation. Figures 30 and 31, which are both enlargements of Figure 29, show respectively 50-micron fragments and sub-micron fragments. Logically, all of the fragments in these pictures did not remain lodged and some would be free to strike the surface again causing more damage. It is unlikely that either the chips or the fragments of the chips would be stationary inside the test chamber; instead, they would be traveling at some unknown velocity. Since the specimen is moving at a known velocity, the impact speed would be the vector sum of the unknown velocity and the known velocity. Therefore our results are obscured by not knowing the true impact conditions.

The secondary damage which was mentioned before (damage by fragmented particles and material) also tends to increase with increasing test velocity. Only a general statement can be made since the true impinging velocity is not known. Figures 29,30, and 31 show an excellent example of secondary damage. Other examples are shown in Figures 26, 33, and 40.

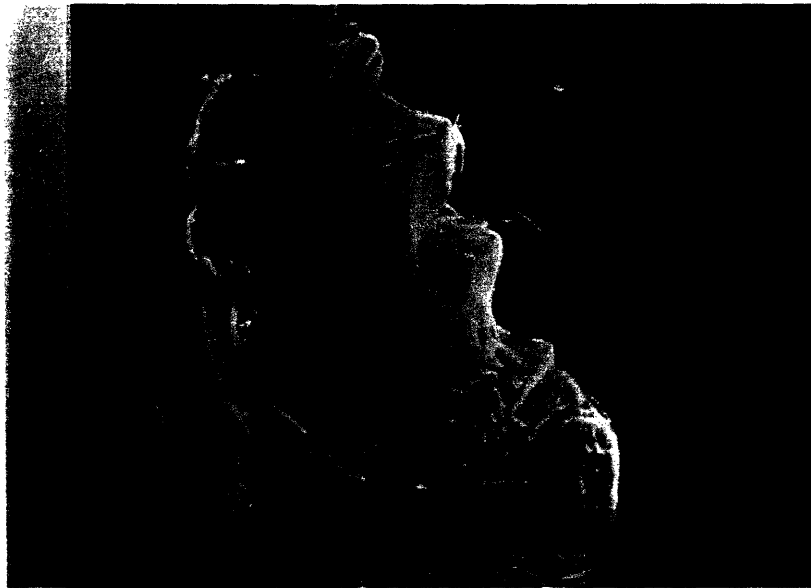
Fig. 28 Annealed 1020 Steel, 600 feet/sec.

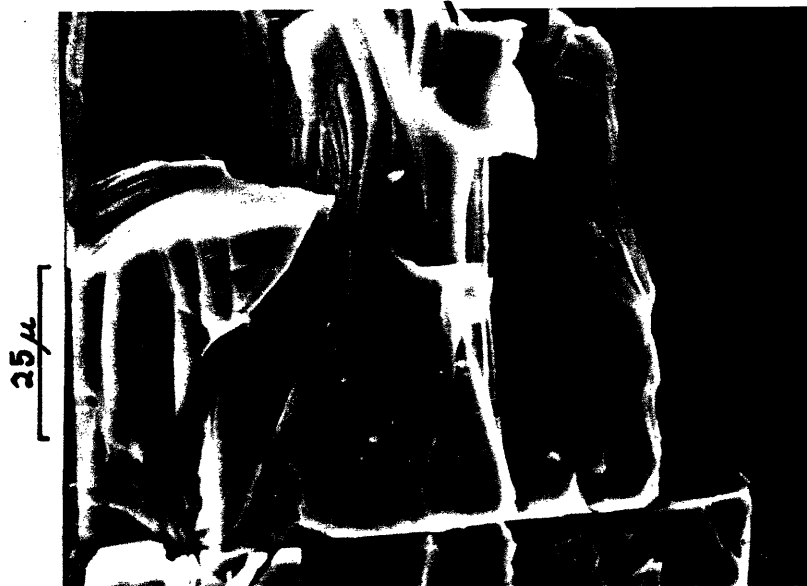
Fig. 30 A.R. Modified 1310 Steel, 800 feet/sec.

Fig. 31 A.R. Modified 1310 Steel, 800 feet/sec.

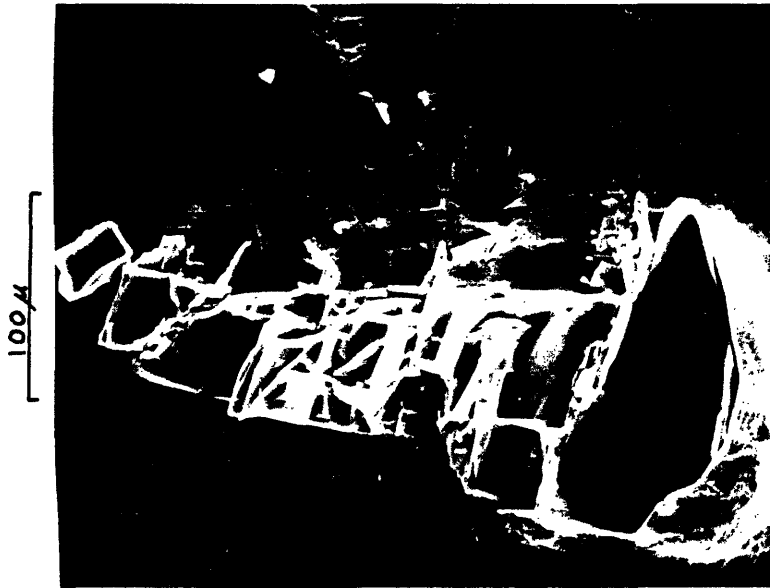
Fig. 32 Annealed Modified 1010 Steel, 800 feet/sec.

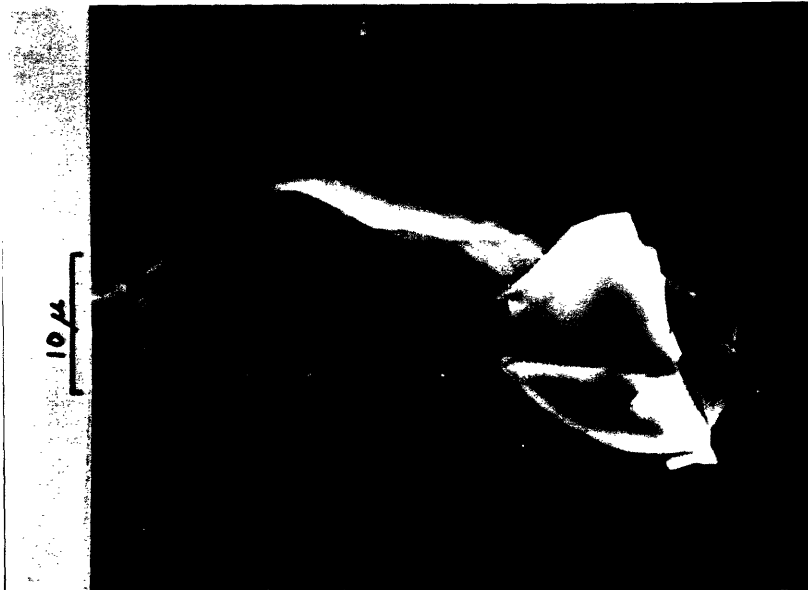
Fig. 34 Annealed Titanium Alloy, 600 feet/sec.

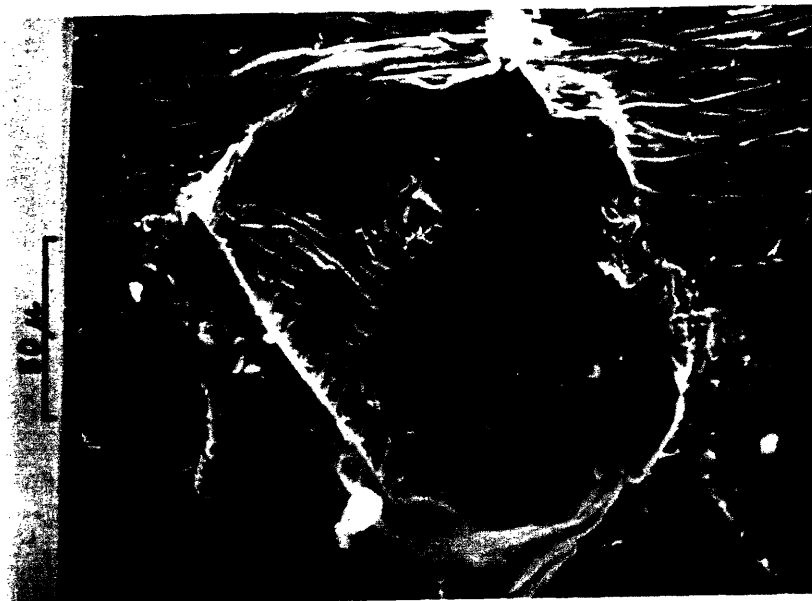
Fig. 35 CR 1020 Steel, 1000 feet/sec.

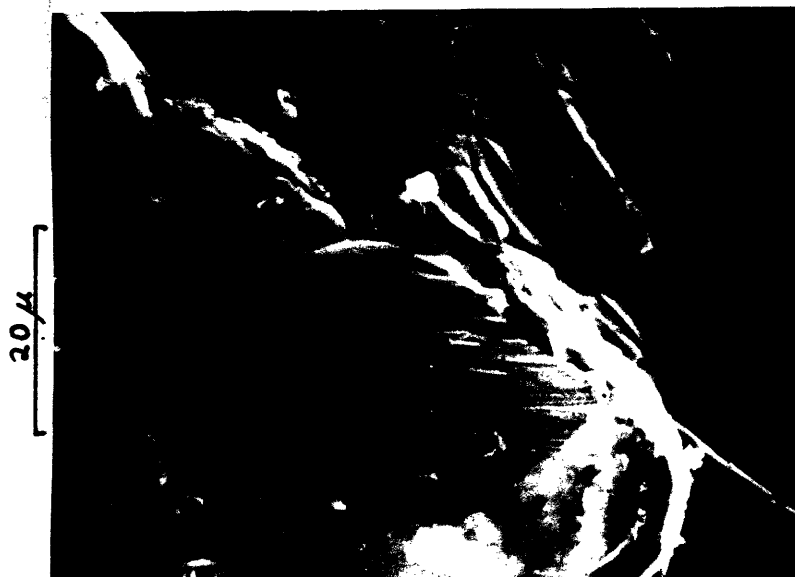
Fig. 37 CR 1020 Steel, 1000 feet/sec.

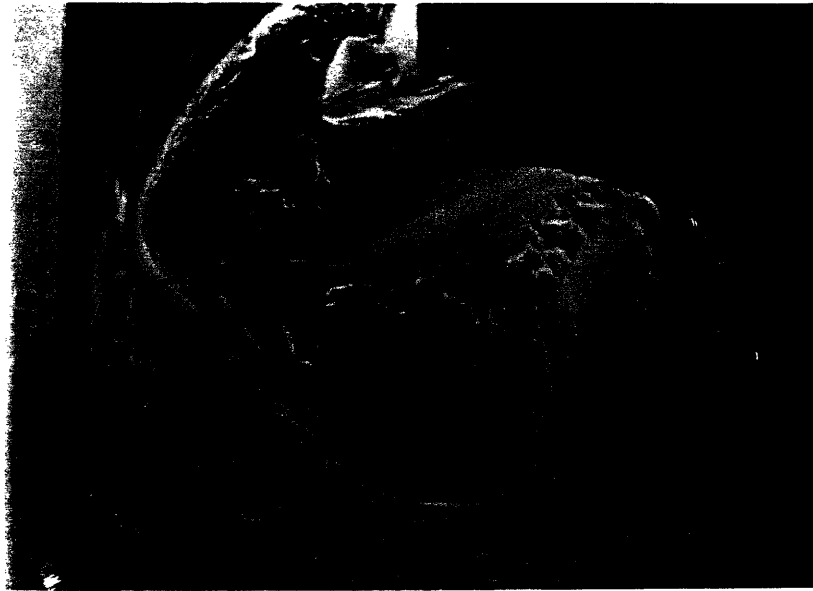
Fig. 38 A.R. Modified 1010 Steel, 1000 feet/sec.

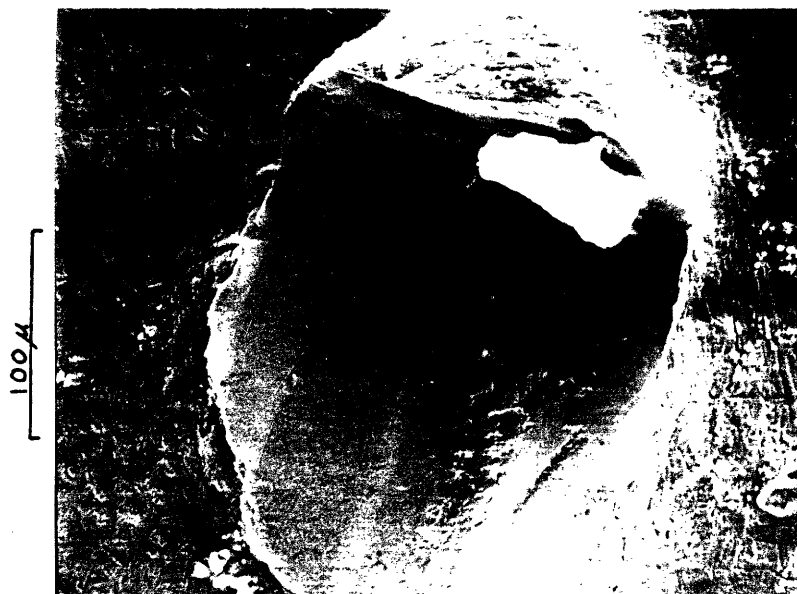
Fig. 39 Annealed Modified 1010 Steel, 1000 feet/sec.
