Norwegian Wood:
A Case Study of Stave Churches

Submitted in Partial Fulfillment
of the Requirements for the
Degree of
Master of Architecture
at the
Massachusetts Institute of Technology
February 1982

This thesis addresses the question: How did the medieval Norwegians meet the challenges entailed in designing a small wooden building (e.g., resisting snow and wind loads, detailing wood connections), and create an architectural masterpiece?

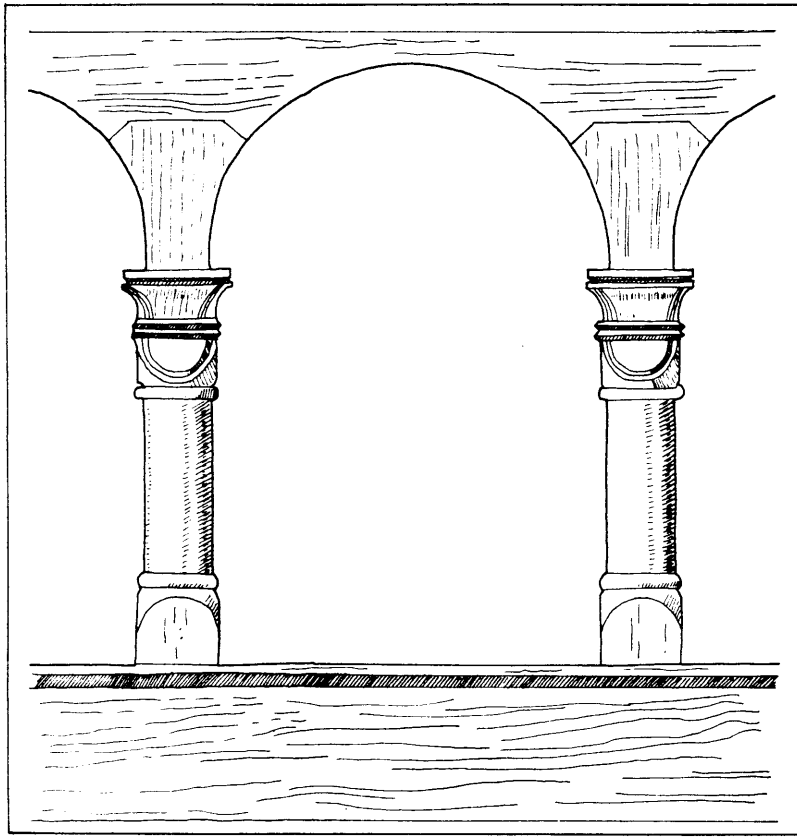
This drawing is of the arcade that surrounds the Gol Stave Church near Oslo. The scale is one-eighth actual size. The cube capitals and bases of the wooden columns bear a strong resemblance to Norman stone architecture built in England and France during the Middle Ages.

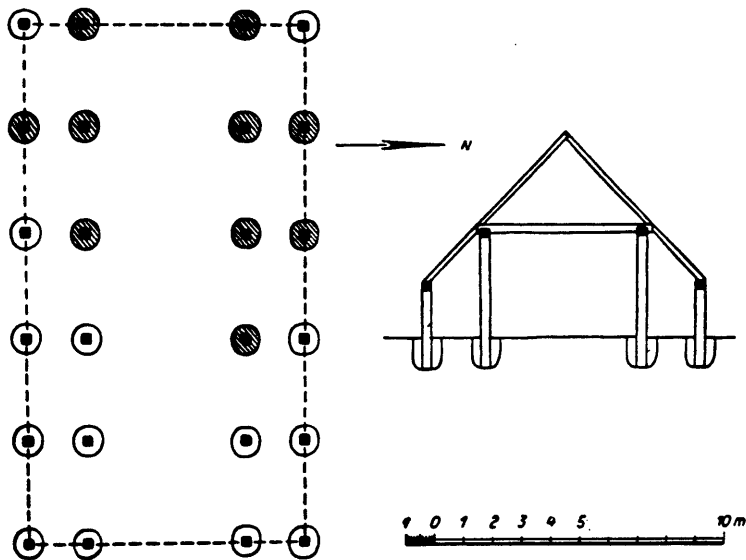
A Carolingian timber church unearthed at Breberen (near Aachen) Germany can be attributed to the eighth or ninth century by pottery shards and other accessories.

architecture. What was unearthed at the excavation in Breberen, Germany, was a Carolingian timber church. Judging from the post holes that remain, it is clear that the church had a central nave and side aisles. Pottery shards and other accessories discovered at the site led archeologists to believe that the church was from the eighth or ninth century. With this new evidence Hauglid's argument began to weaken, since the bay and aisle plan common to both the stave and Romanesque churches was observed in a timber church that predates both traditions.

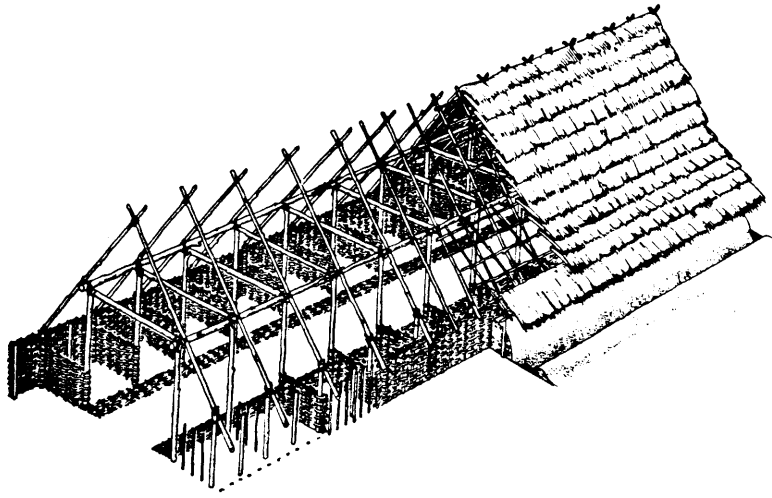
This cattle barn from Ezinge, Holland was built in the 3rd century B.C. and is a forerunner of the stave church.

At another site, this one in Ezinge, Holland, evidence was excavated that suggested that the bay and aisle system went back even further in history. At Ezinge a cattle barn from the third century B.C. was discovered. The excavation of the long barn revealed that it was constructed from a series of paired columns that divided a central "nave" from compartmental bays on the side. The system of wood

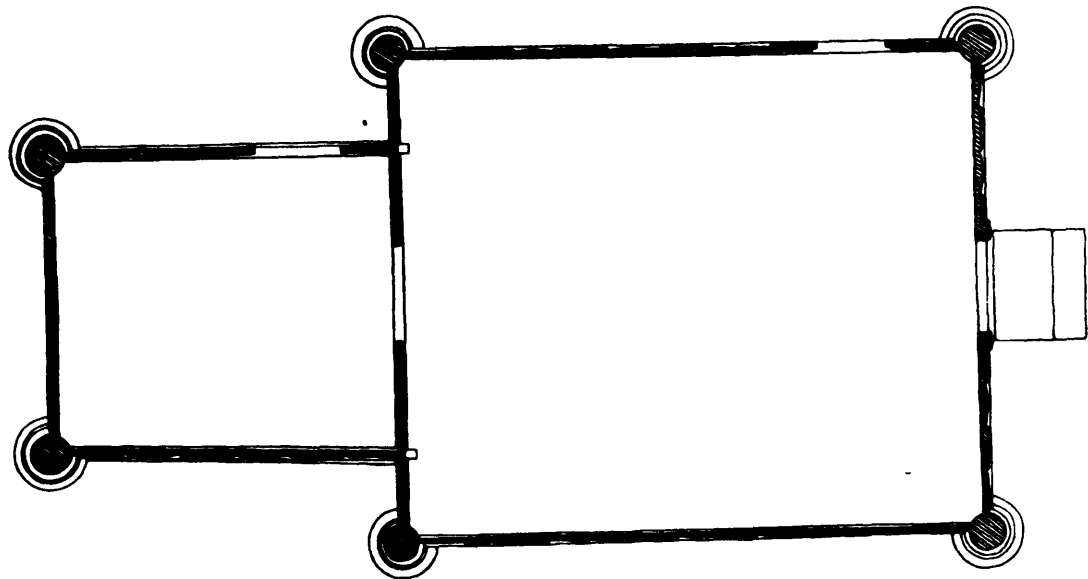
The Holtdalen Stave Church
(Longitudinal Section Looking
South)

The stave church at Holtdalen is one of the oldest and simplest of all the stave churches. No one knows its exact age, but many experts believe it was built in about the year 1100. The larger room, the nave, measures fifteen feet by nineteen feet. The smaller room, the chancel, is nine feet by eleven feet. The main entrance is on the west wall (on the right hand side of the page). There are two other entrances, both on the south side of the building (on the top of the page). A distinguishing feature of this building is the round wooden globe at the base of each of the corner columns.

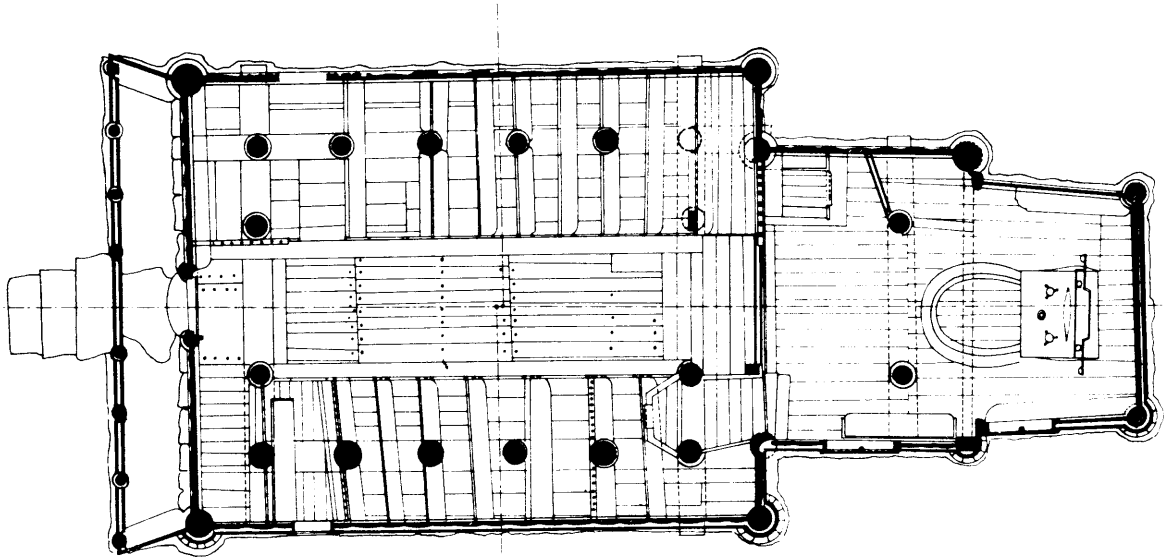
The Urnes Stave Church
(Longitudinal Section
Looking North)

As a point of departure from the simple chancel and nave of the Holtdalen Church, the Urnes Church represents a later stage in the development of stave architecture. Probably the single most important change is the introduction of the rectangular field of columns in the nave, which both support the clerestory and an elevated ceiling, and which separate the nave from the aisles that enclose the nave on four sides. Corresponding to the free-standing columns is a new sill system designed for their support. The west entrance (on the left hand side of the page) has an arcaded porch or ambulatory, and according to some accounts men were supposed to leave their weapons in the ambulatory before entering the nave. Overall, the building is taller, longer and wider than the earlier Holtdalen type.

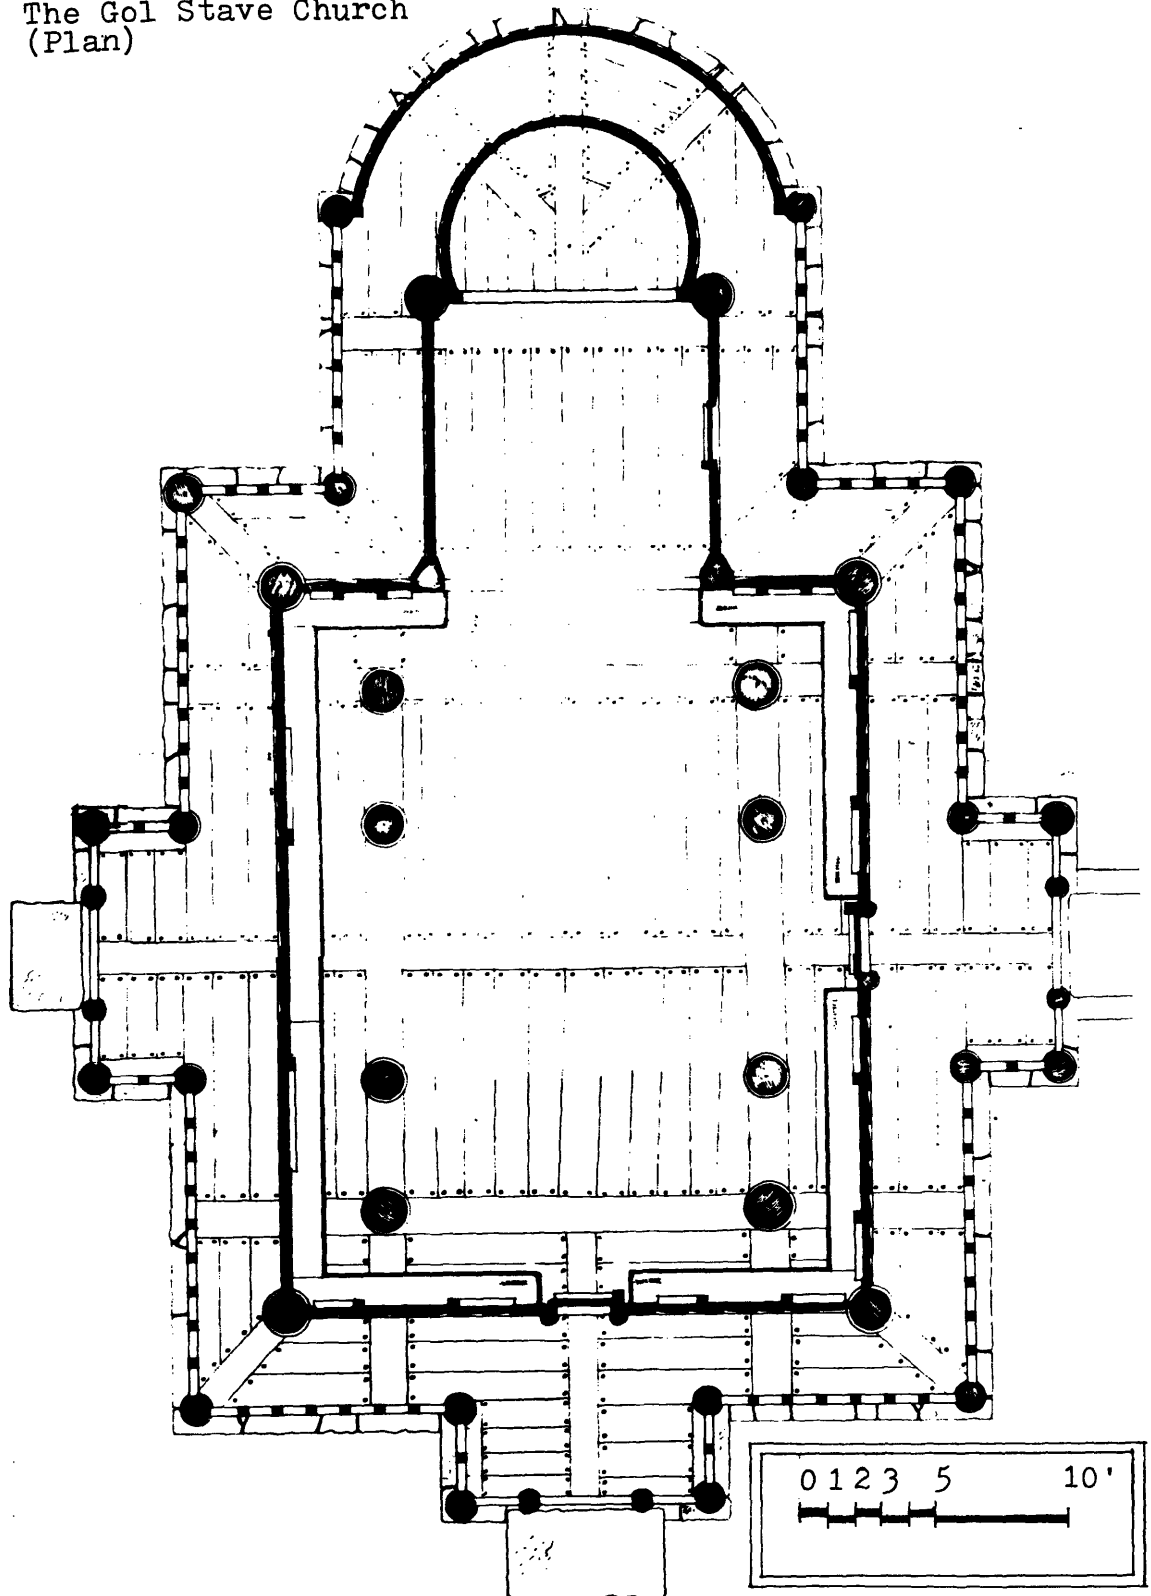
With its free-standing columns, a complete ambulatory and a semi-circular apse, the Gol Church represents one of the final stages of stave development.

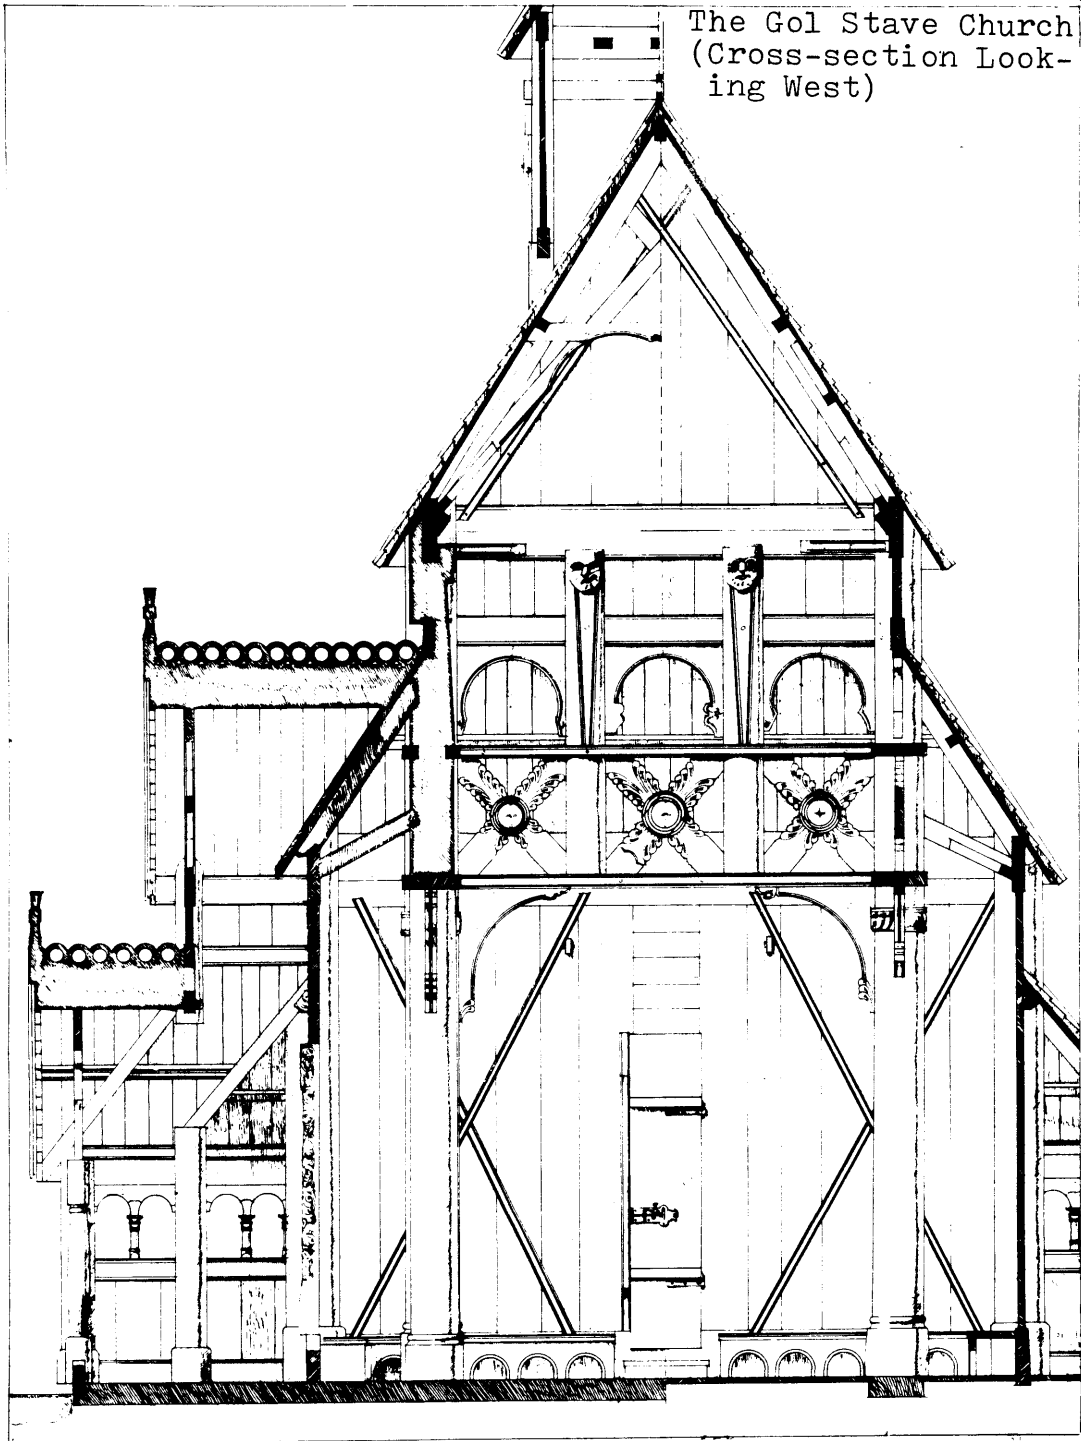
The Gol Stave Church (Longitudinal Section Looking North of the Western Portion of the Church)

The stave designers had come a long way from Holtdalen by the time they designed the Gol Stave Church, and they exhibited a marked talent for engineering in wood. By developing a very elaborate bracing system that transferred loads to the corner columns, the designers were able to terminate the middle columns before they reached the floor, thereby freeing-up extra space for the nave.

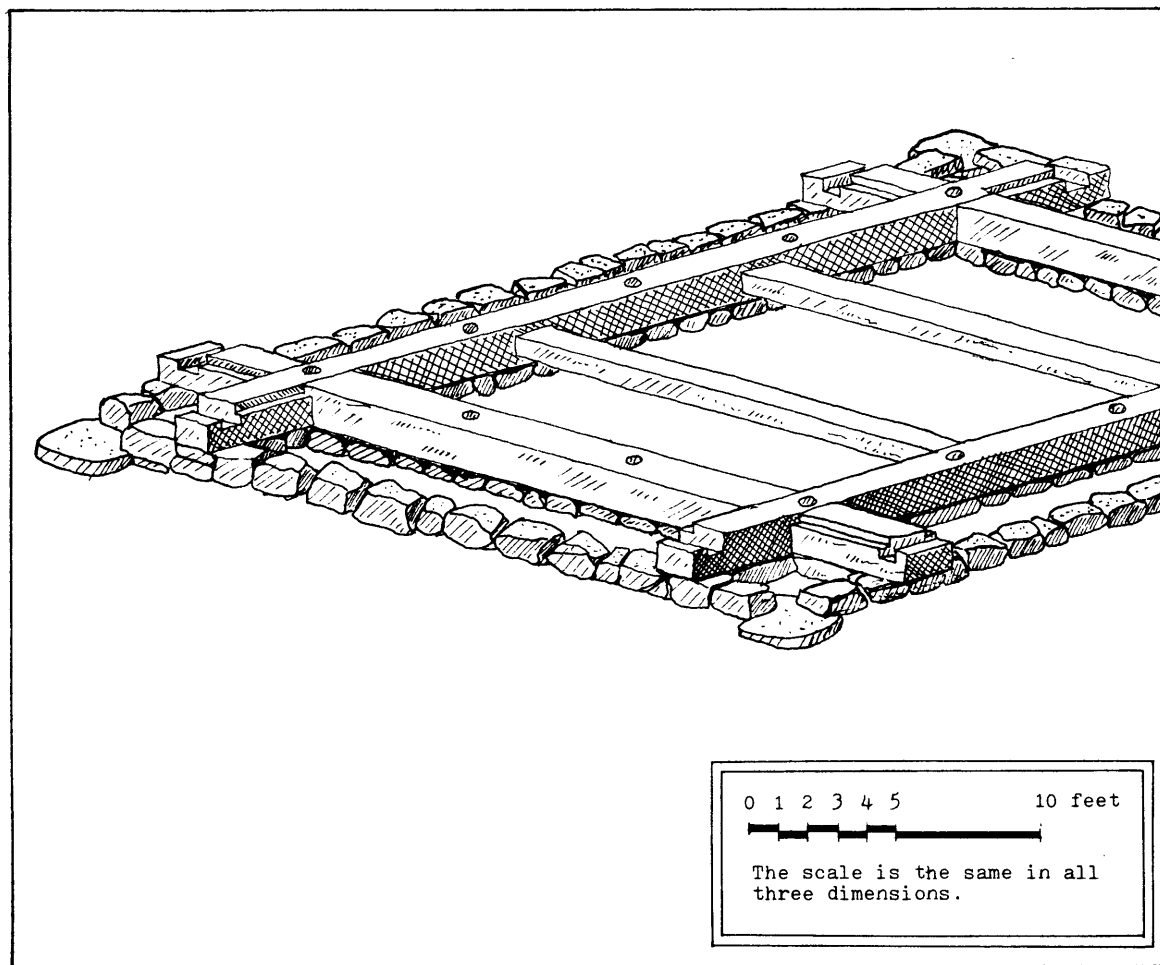
THE STONE FOUNDATION AND THE PRIMARY SILL

Connected in the form of a tic-tac-toe grid, the four primary sills are raised above the ground and protected against the detrimental effects of the soil's humidity.

Aligned along an east/west axis, the foundation resembles a tic-tac-toe grid inside a larger rectangle. This shape corresponds directly to the wooden structure it supports. The foundation not only provides a continuous support for the sills (which eases the transfer of the building's weight into the earth), but it also raises the wooden members above the ground, thereby avoiding the harmful effects of the soil's humidity.

We know from archeological excavations that the earliest stave churches did not use a sill or foundation. Instead, wooden members were set in post holes. The disadvantage of sinking the wood directly in the ground was that moisture in the soil slowly disintegrated the posts. As a consequence buildings which employed this method of construction collapsed after about one-hundred years. The sill and the stone foundation represent a major improvement over the earlier designs, and this design change is one of the reasons that a handful of the stave churches have survived to this day.

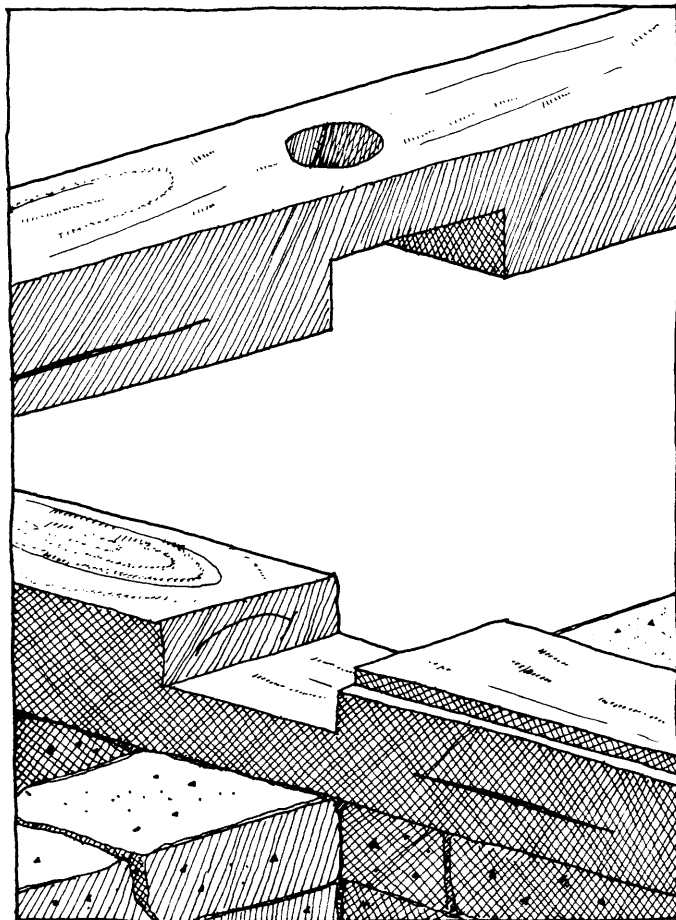
JOINTS OF THE PRIMARY SILL

The primary sills are attached together with a half-lap joint that prevents either member from slipping out of position. The round hole cut into the top of the sill is designed to hold one of the free standing columns, which is inserted later.

The primary sills serve four functions: First, they receive the weight of the roof via the columns and pass it along to the foundation. Second, they support the secondary sills which carry the outside walls. Third, the sills support the floor; and fourth, they serve as part of the finished floor. Each of these functions has an influence on the form of the sill.

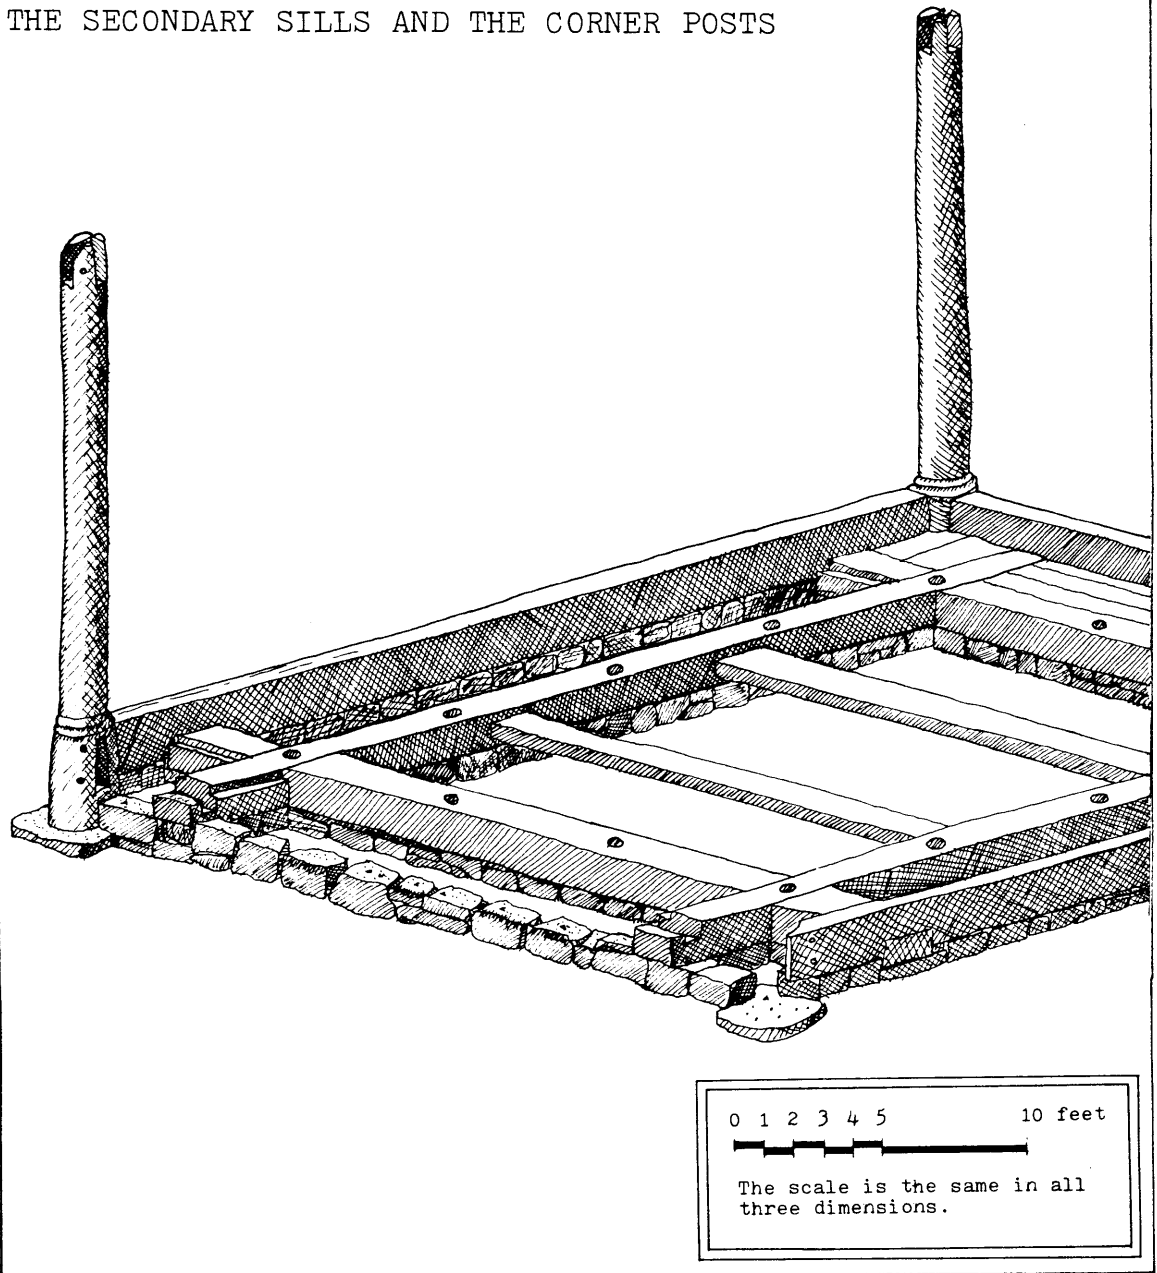
The large (one foot by two feet) horizontal members, which line the lower edge of the building, are the secondary sills. Their main function is to support the stave walls that will come later. The secondary sill rests on its own stone foundation and is connected to both the primary sill and the corner posts. The interlocking connection of the primary and secondary sill prevents either member from slipping out of position.

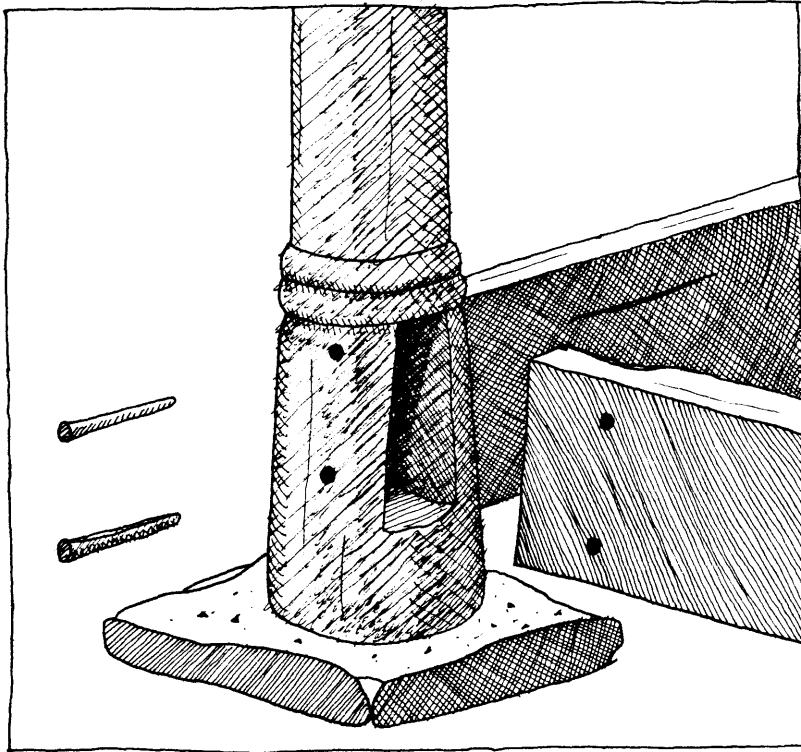
The ends of the secondary sill are attached to the base of the wooden columns. Two wooden pegs lock the members together.

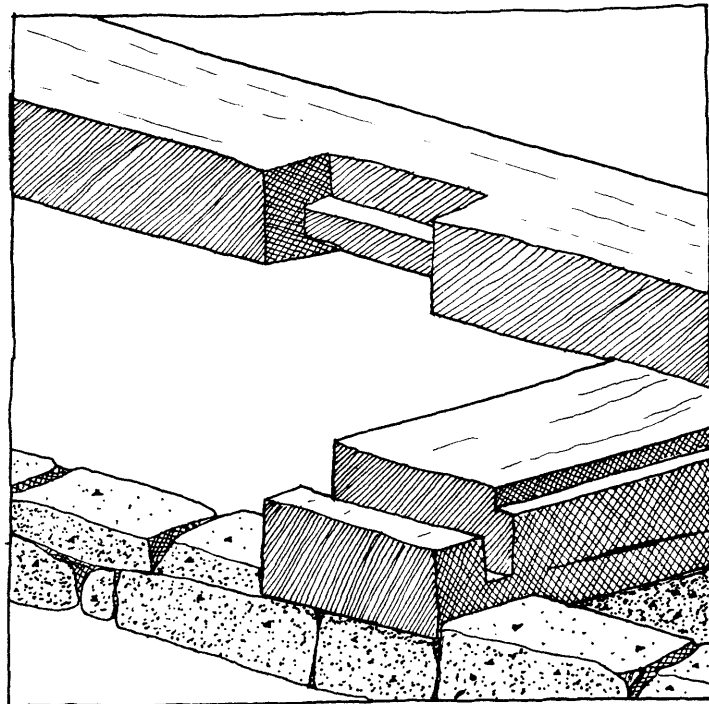
The secondary sill connects to the primary sill. The secondary sill has been raised and rotated to reveal the detail of the wood joint.

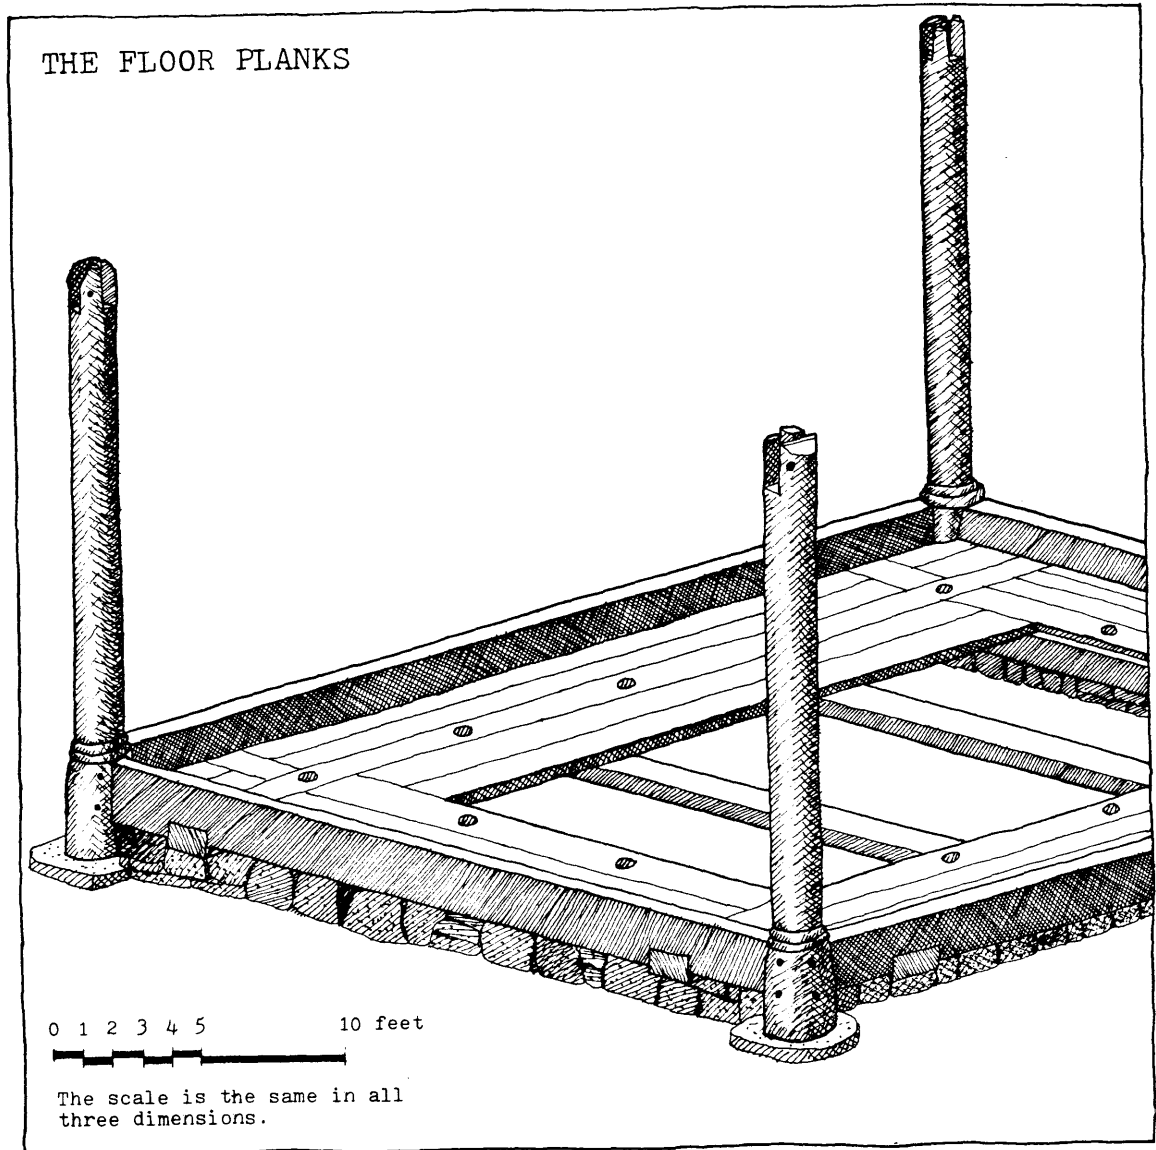
Once the sills and the four corner posts were in place, the carpenters began building the floor. Planks twenty-four inches wide were cut to the exact length needed to span between primary sills, and they were then placed in position on top of the floor joists. Ledges in the primary sill received the ends of the planks, and this joint created a flush fit across the top of the plank and the primary sill. This joint both enabled the sills to serve as part of the finished floor, and allowed the planks to transfer part of their load directly into the sills.

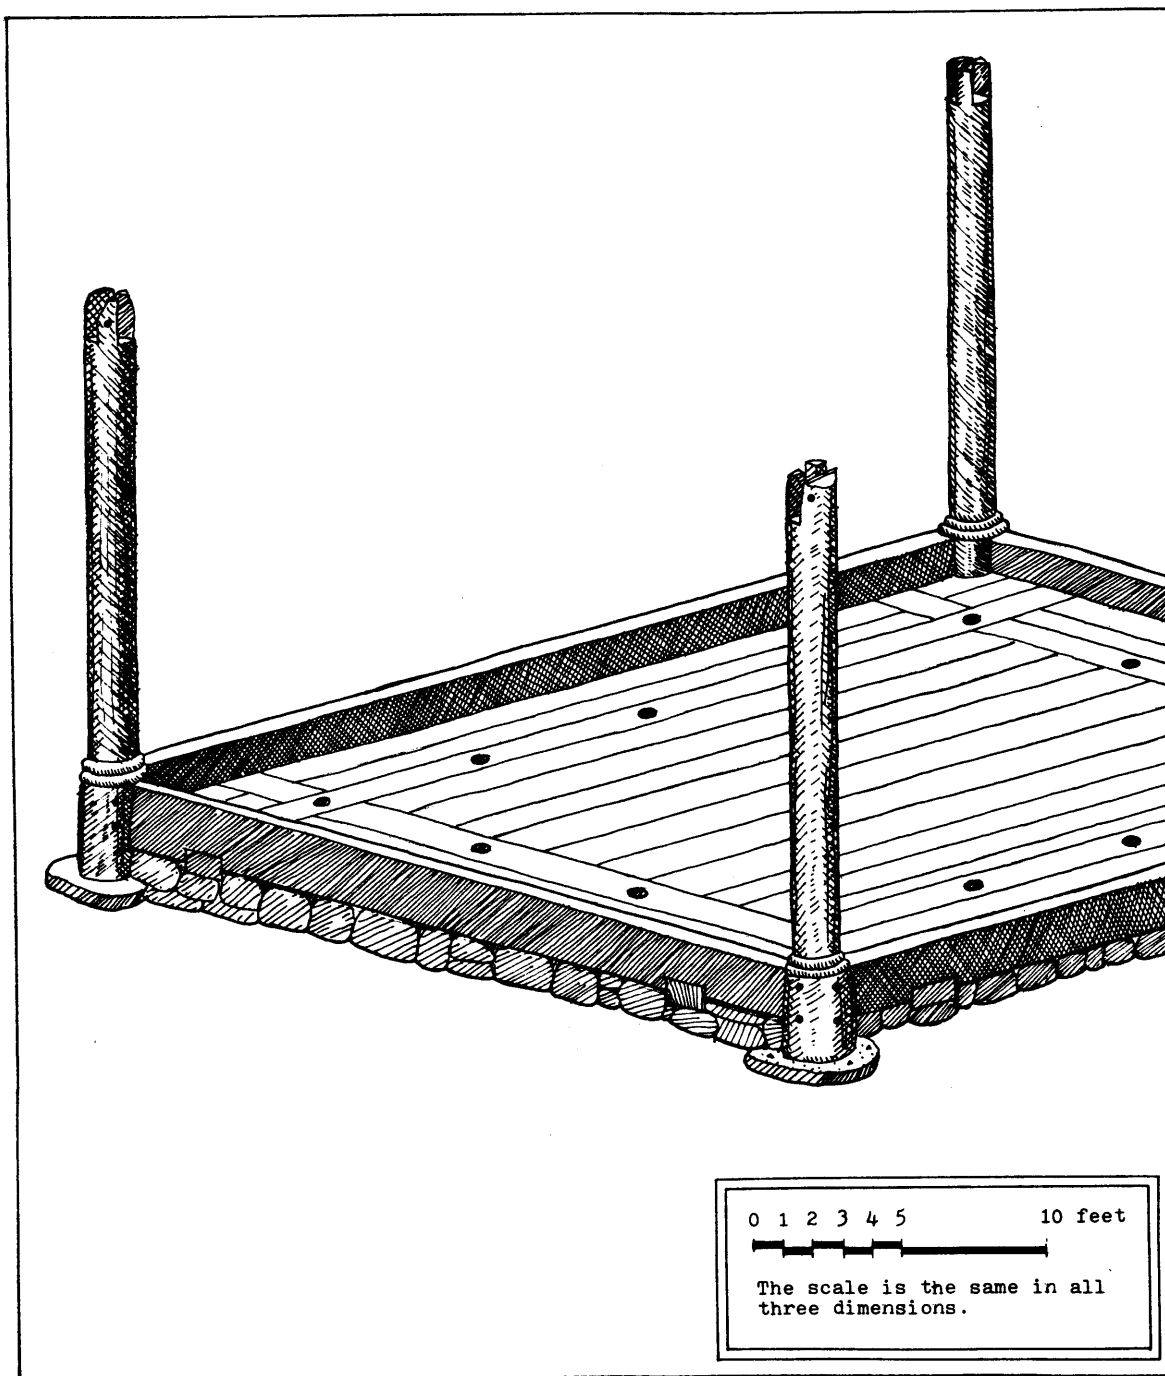
THE FLOOR

The floor of the Torpo Stave Church measures twenty-five feet by thirty feet, and stands two feet above the level of the ground. The round holes in the floor mark the spots where free-standing columns will be inserted.

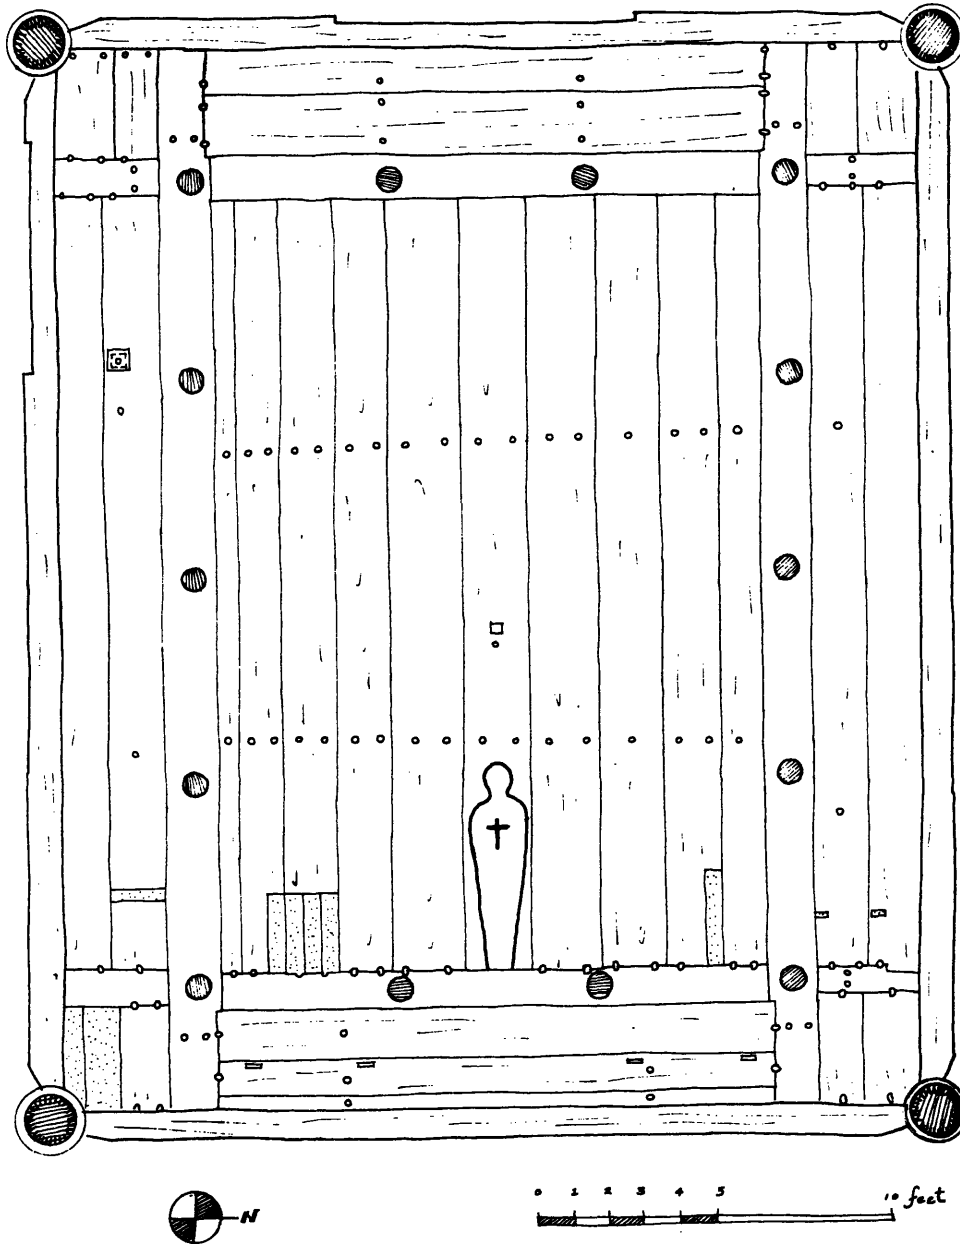
One advantage of pegging the floor planks was that it allowed for the possibility of removing them at a later date. Sometimes the ground below the floor was used for burying the dead. The figure outlined in the central floor plank of the nave marks the burial site of an important religious dignitary. The dotted portions of the floor indicate members that have been used to repair or replace the original flooring.

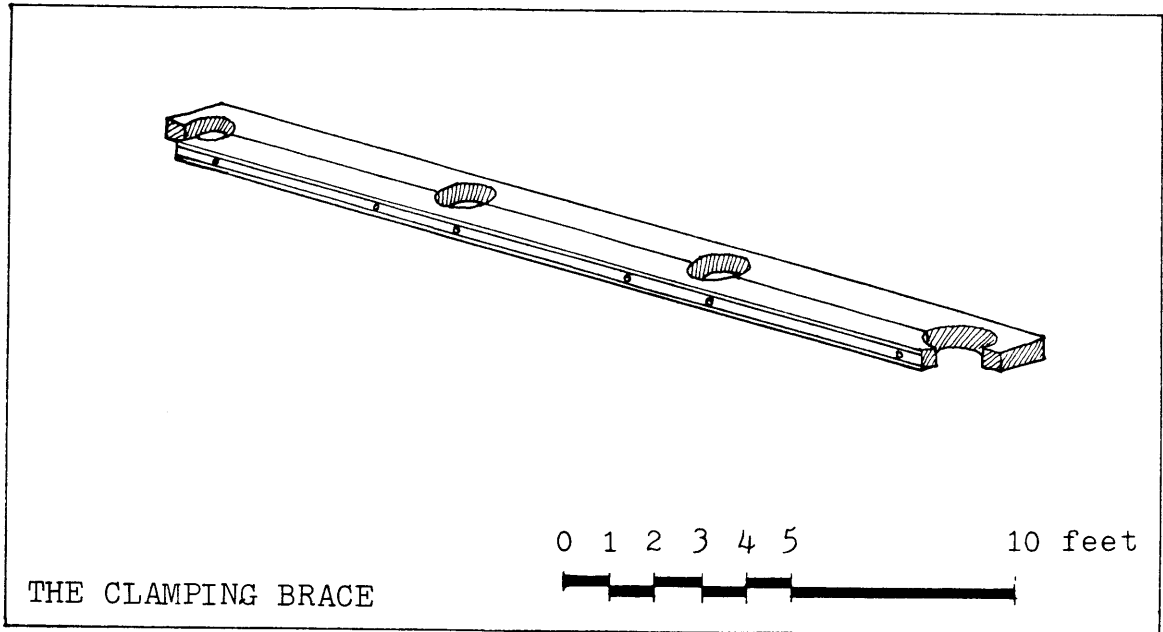
At the critical moment during construction when the row of columns is being raised like a wall into its final standing position, the clamping beam is called into action. The clamping beam helps hold the columns together, allowing them to be raised in a single motion. (This is desirable because it enables the wall to be assembled on the ground rather than in the air.) The role of the clamping beam does not end once the column wall is in position. Not only does the clamping beam continue to keep the columns in line, and prevent the braces from slipping out of position, but it also works in conjunction with the other bracing to resist wind loads.

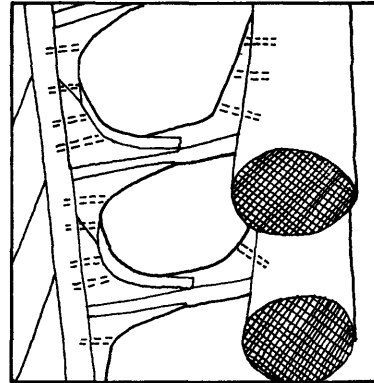
THE KNEE BRACE

Even though the St. Andrew cross is an efficient structural form for handling lateral loads, the knee brace is in fact more effective. This is because for a given lateral load, the knee brace causes a smaller bending moment in the column than the St. Andrew cross. The reason for this is simply that the knee brace is closer to the base of the column than the St. Andrew cross. Though these two braces perform the major roles in resisting lateral forces, the upper arch, the clamping brace, and the clerestory wall assist them to a lesser extent.

Eric Lundberg, the noted Swedish architectural historian, postulates that in "primitive" stave churches, the knee braces were attached to each other to form a three dimensional brace. Located above the aisle, a series of these three dimensional braces connected the top of the aisle wall to the free-standing column. The dashes indicate the location of the dowels; the cross-hatching indicates where the columns are severed (for the illustration).

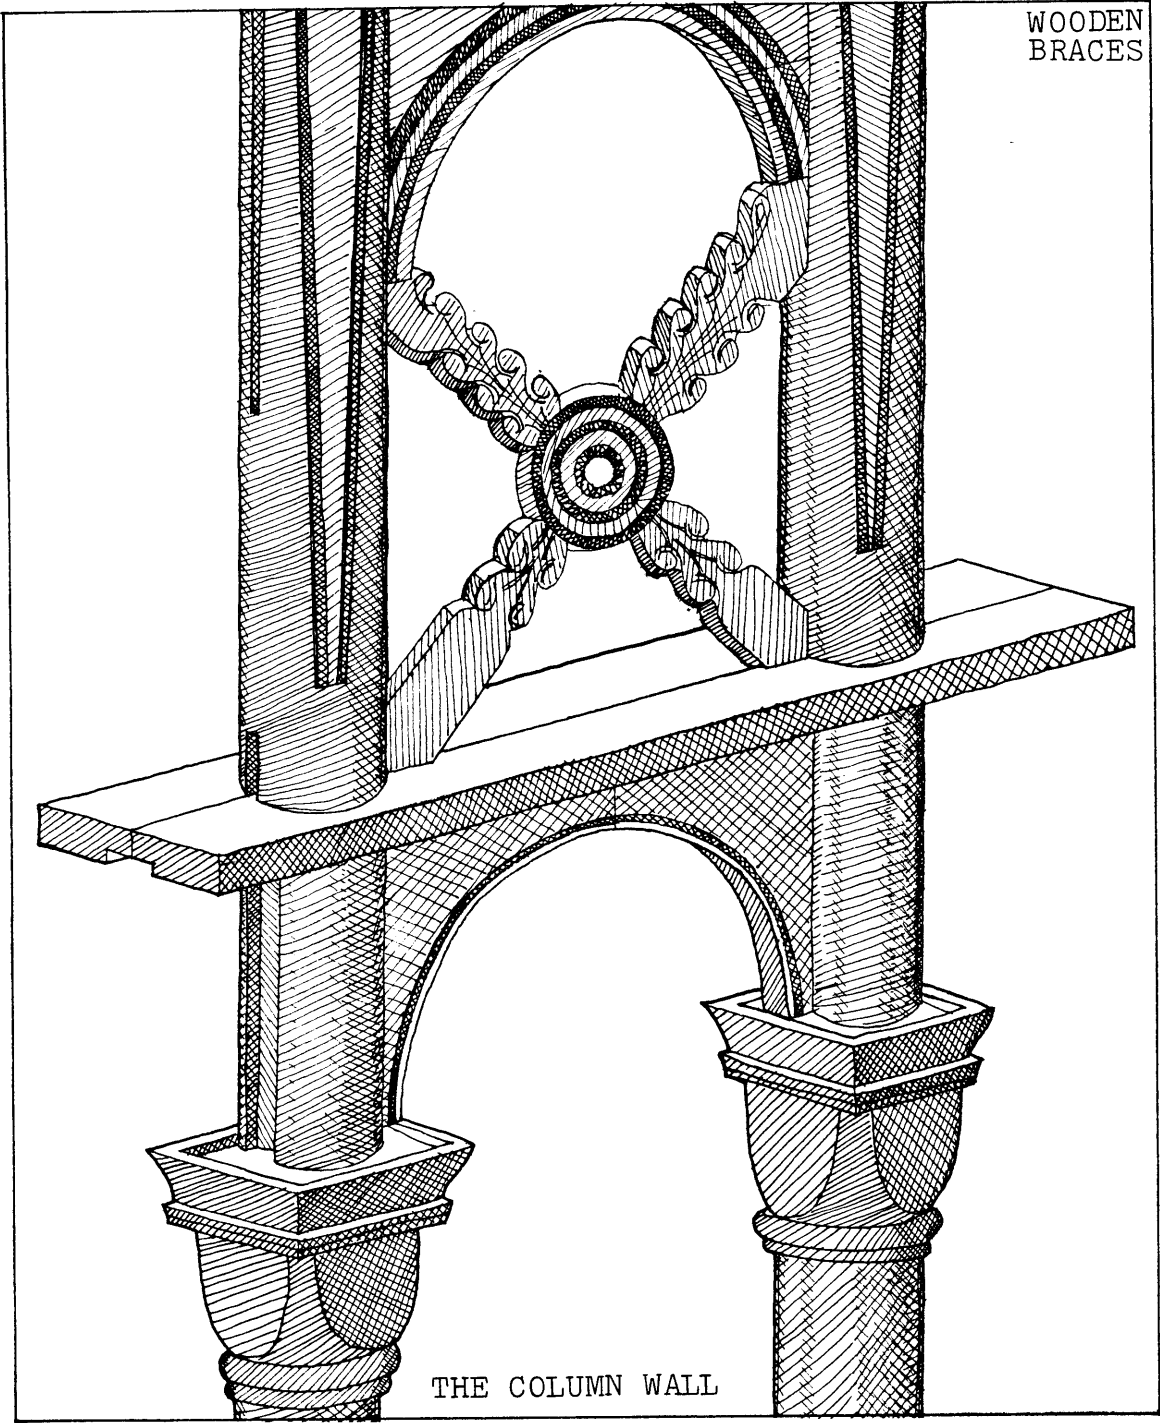
The braces are engineered to hold each other in place and to assist each other in the bearing of loads. Both of these functions are made possible by the tight joinery and the direct bearing of the braces against each other. But perhaps the most significant achievement of the column wall was its sculptural approach to structural engineering.

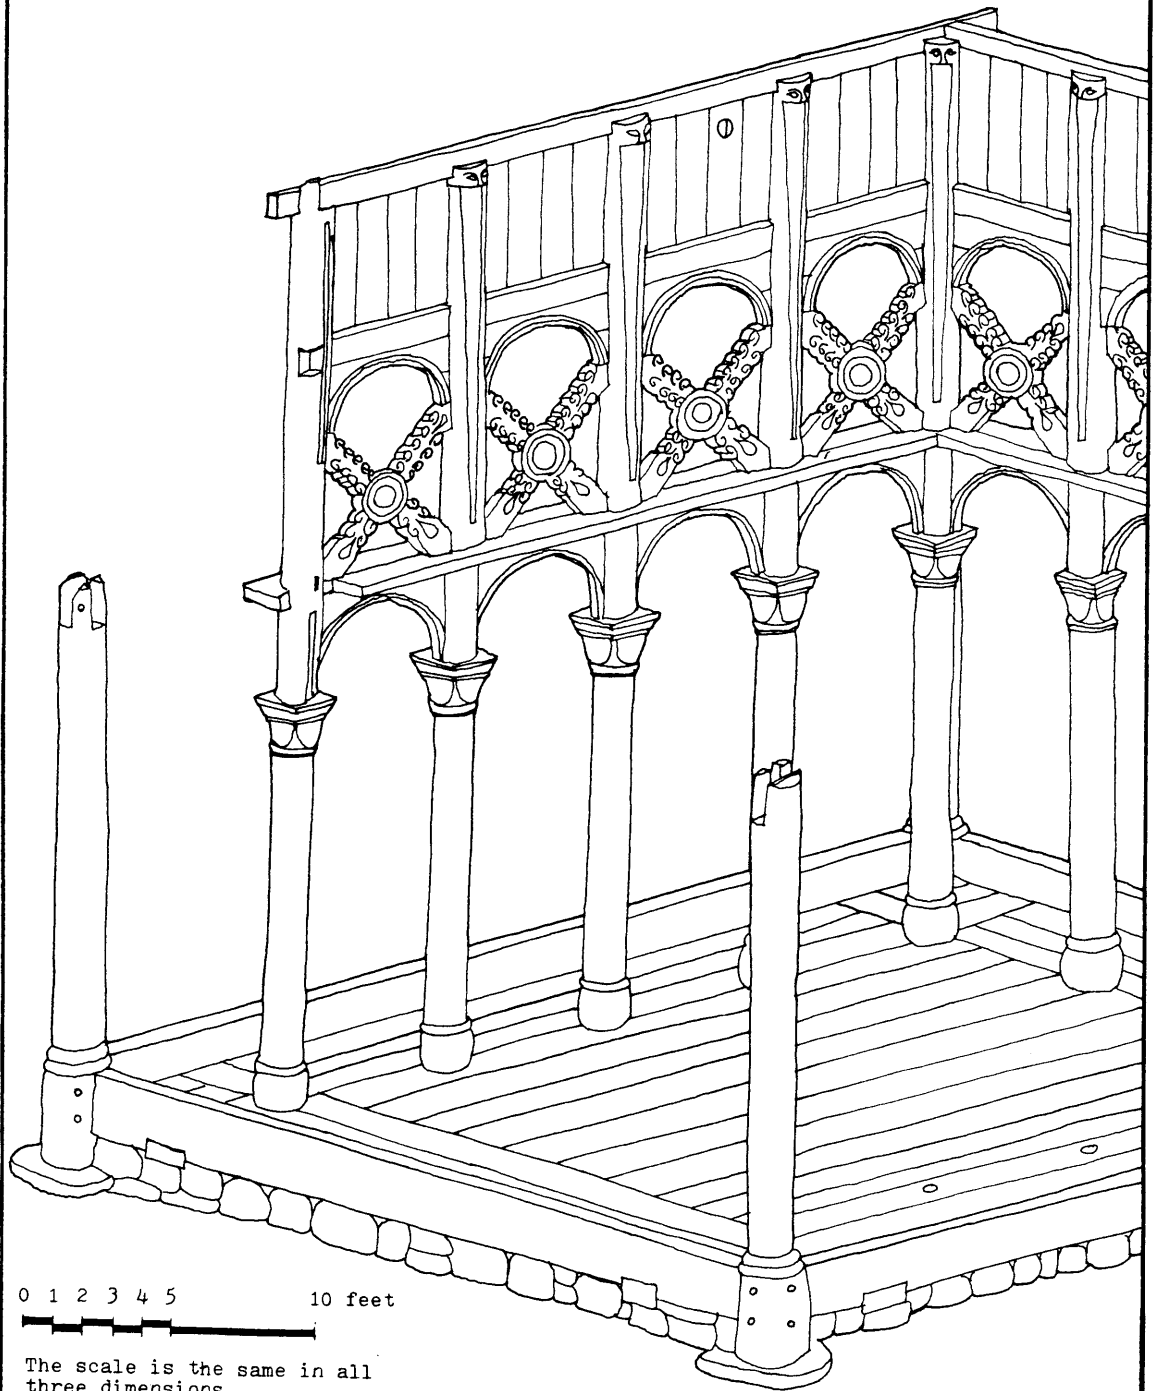
A second column wall is assembled on the ground, raised into position, and attached to the first column wall. The attaching of the column walls is performed in the air and entails connecting the wooden braces of the second column wall into the corner post of the first column wall.

The procedure of assembling the column walls on the ground and lifting them up and into position is continued until all four walls are fastened together. These four walls are the building's main structural support and form a kind of three-dimensional chassis. Other structural elements such as the aisle roof and the trusses are attached to the chassis. Structurally the chassis is analogous to a card table in that both are braced at the top and not the bottom. Such a bracing system works satisfactorily in resisting lateral forces as long as three conditions are met: (a) the columns must be large enough in diameter to resist the wind loads in bending, (b) the base of the columns must be prevented from sliding by at least a pin connection, (c) the building must be heavy enough to prevent it from overturning in a wind. The fact that the building is still standing after so many centuries is proof that the designers met the specific conditions imposed by elevated bracing.
