Norwegian Wood:
A Case Study of Stave Churches

Submitted in Partial Fulfillment
of the Requirements for the
Degree of
Master of Architecture
at the
Massachusetts Institute of Technology
February 1982

This thesis addresses the question: How did the medieval Norwegians meet the challenges entailed in designing a small wooden building (e.g., resisting snow and wind loads, detailing wood connections), and create an architectural masterpiece?

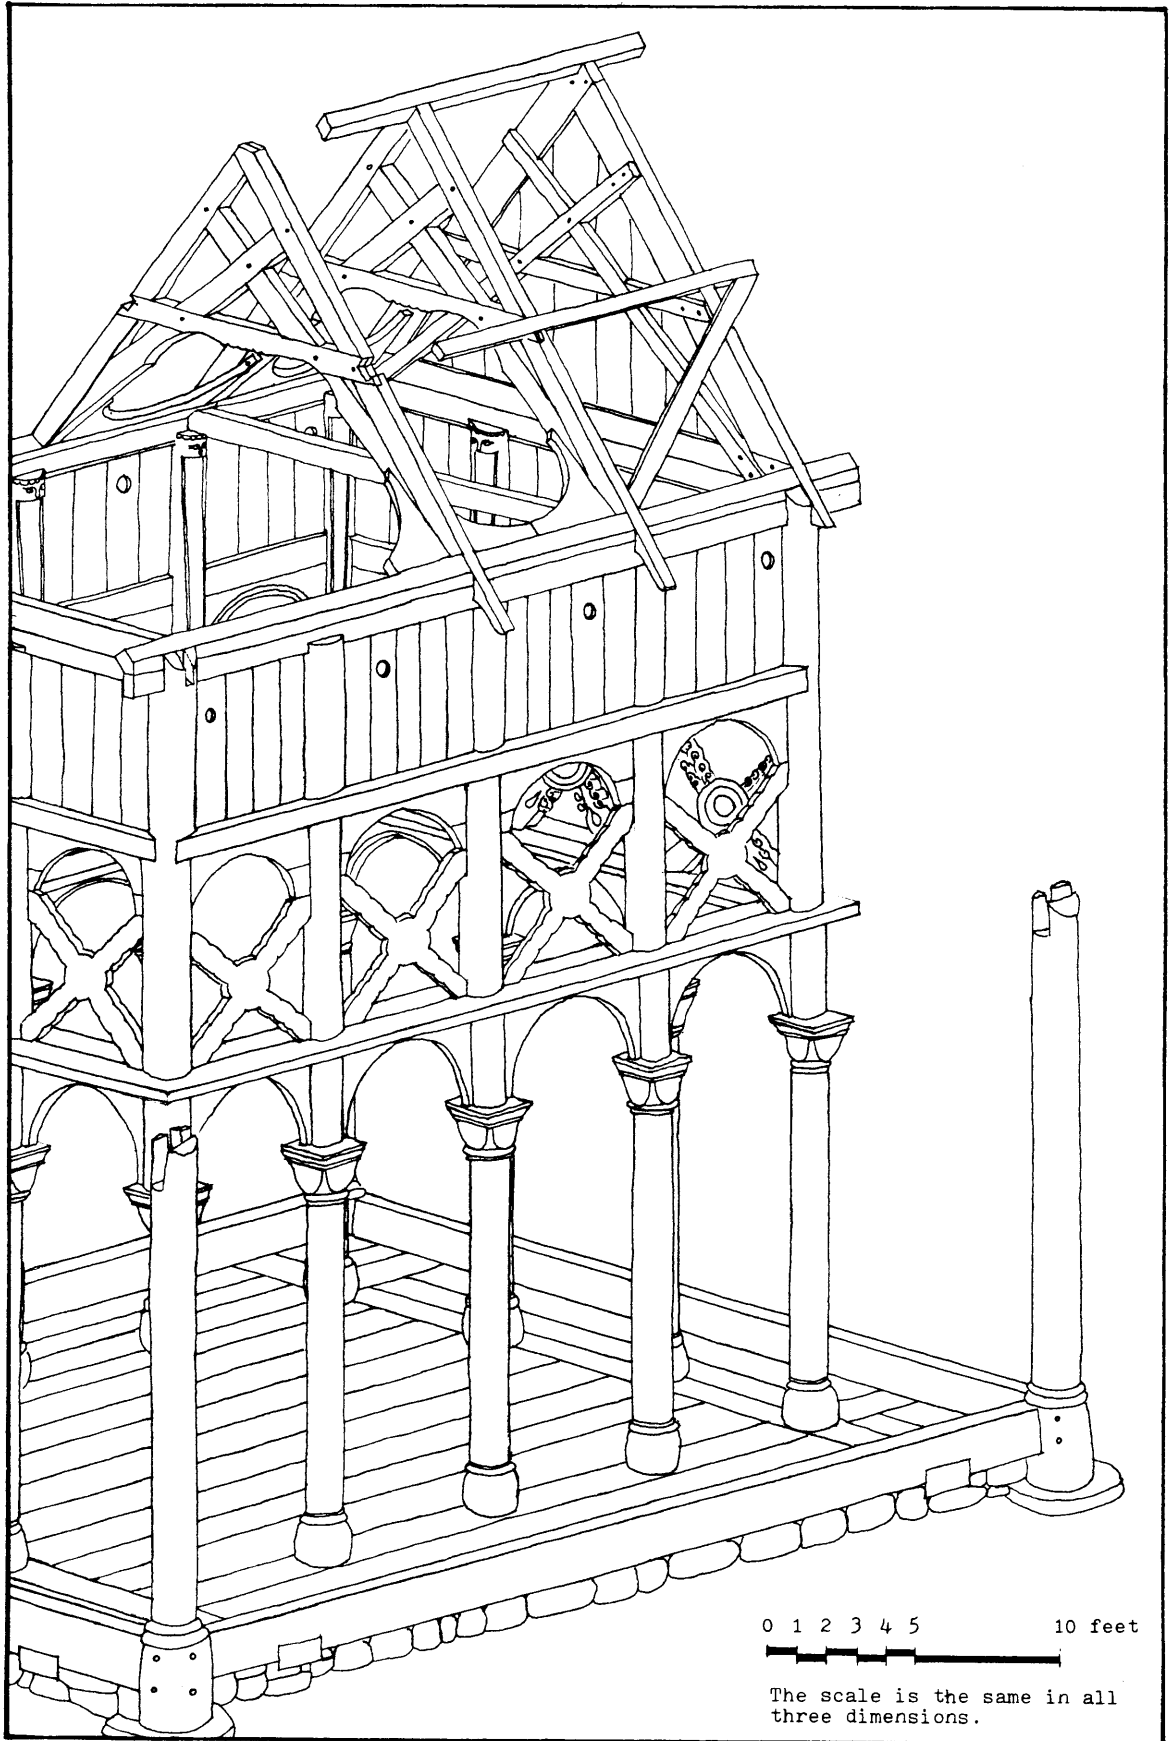
The trussed rafters of the Norwegian stave church are a forerunner of the modern scissor truss. The lateral beam of the truss contributes greatly to the strength and stiffness of the truss.

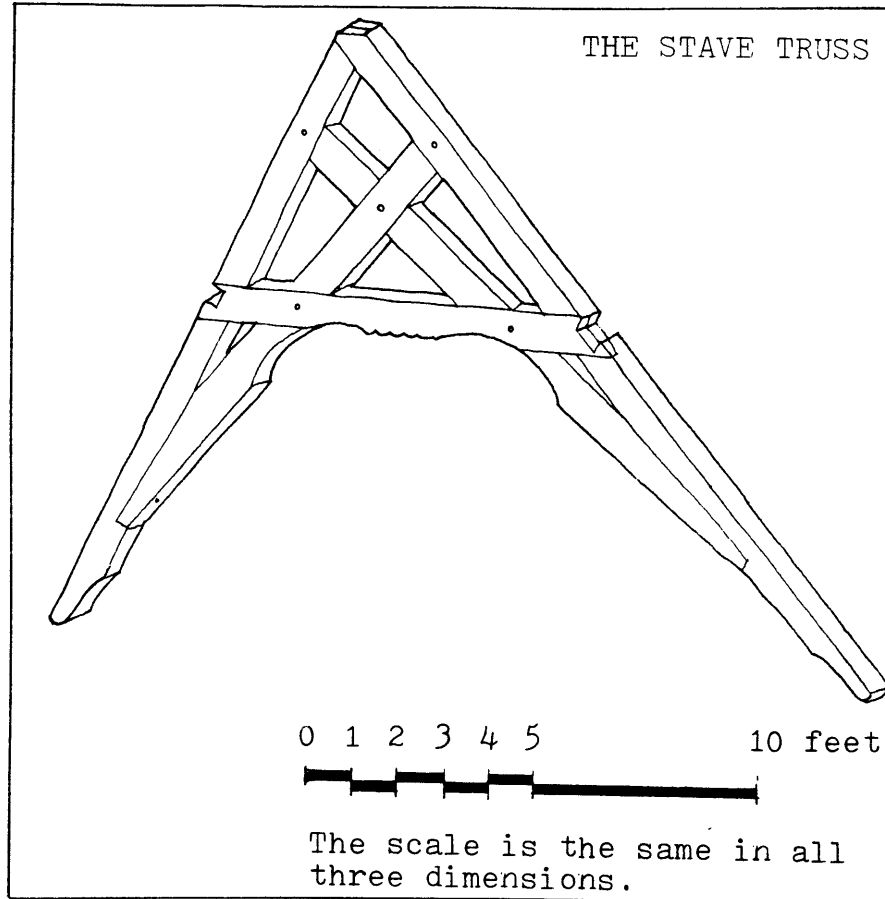
Perhaps partly because it allowed an open view of the ceiling, and partly because it gave an impression of a vault, the scissor truss gained wide acceptance in stave architecture. Employed in almost all of the remaining stave churches, the trussed rafter undergoes only slight variations from church to church, and even these changes are mostly stylistic. From a practical standpoint the steep pitch of the truss has been helpful in preventing large build-ups of snow which the comparatively weak scissor truss may not be capable withstanding. Roar Hauglid, the noted Norwegian historian of stave churches, believes that the truss was imported from abroad, probably France or England.

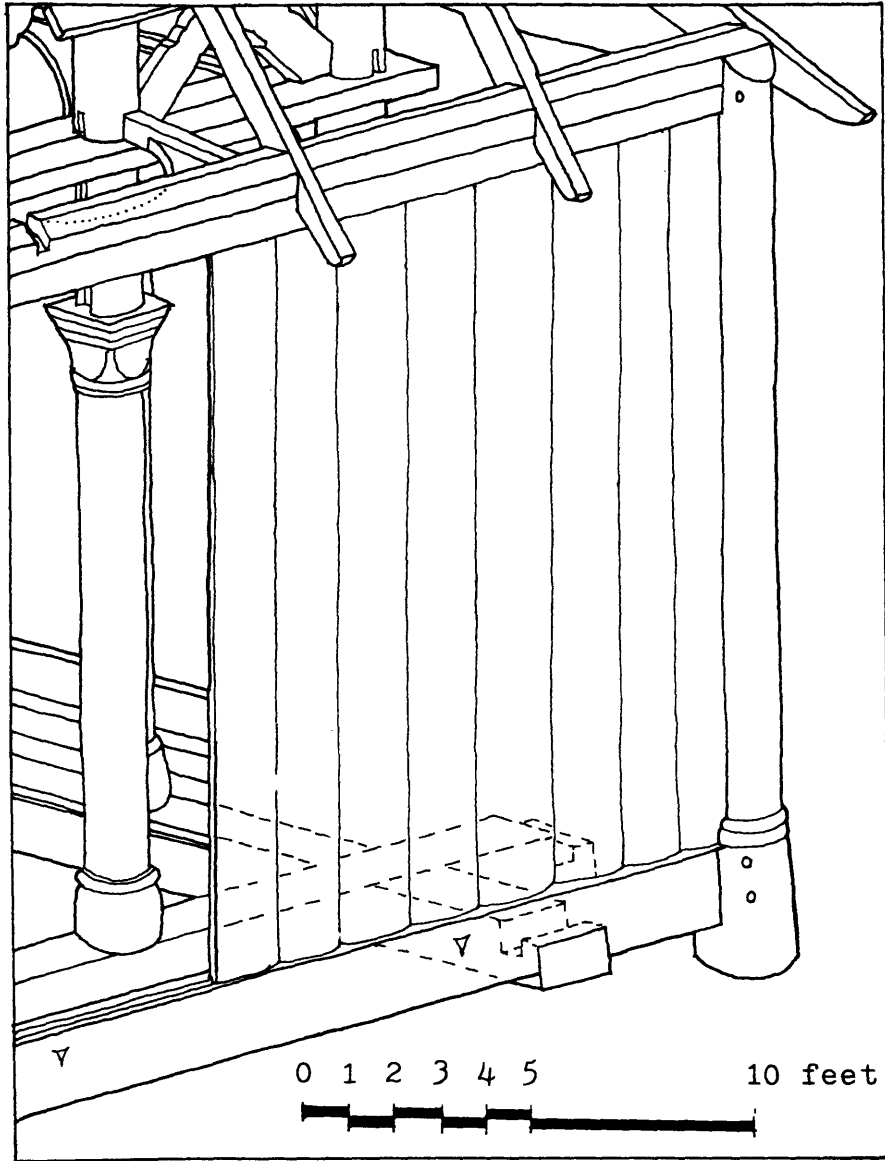
The technique employed in the building of the exterior wall accounts for the name "stave" construction. The stave wall can be understood as a wooden framework filled in by vertical planks, called staves. In this illustration of the Torpo Stave Church, the framework is composed of a sill, two corner posts (only one is shown) and a top plate. The staves have tenons carved on both ends and these fit into grooves cut into the top of the sill and the bottom of the wall plate. The staves connect to each other and to the corner posts with a tongue and groove joint. The expertise with which the joinery is executed enables the wall to act structurally, carrying a limited amount of the wind load into the foundation. The tight joinery also keeps out the cold winter weather.

A small but significant example of how the Norwegian designers sought to perfect and preserve their work can be seen in their solution to a problem that arose at the base of the outside walls. The groove in the top of the sill caused a problem in wet weather because it collected the rain water that ran down the walls. With the groove acting like a water trough, both the sills and the bottom ends of the wall planks remained wet for long periods of time, leaving them susceptible to rot. If left unattended the rotting would collapse the walls, and this in turn would leave the interior unprotected.

Rather than abandon the vertical method of construction that seemed to be causing the problem, they opted to modify the existing design. They carved a series of small holes in the sill from the outside slightly below the bottom of the groove. The "V" shaped holes penetrated into the groove and served as miniature drains which prevented the rain water from collecting in the sill. The holes also allow air to circulate in the joint thereby evaporating any excess moisture that might have built up during a rain. As witnessed by the absence of rot in these joints today, a potentially serious problem was resolved in a simple yet effective way.

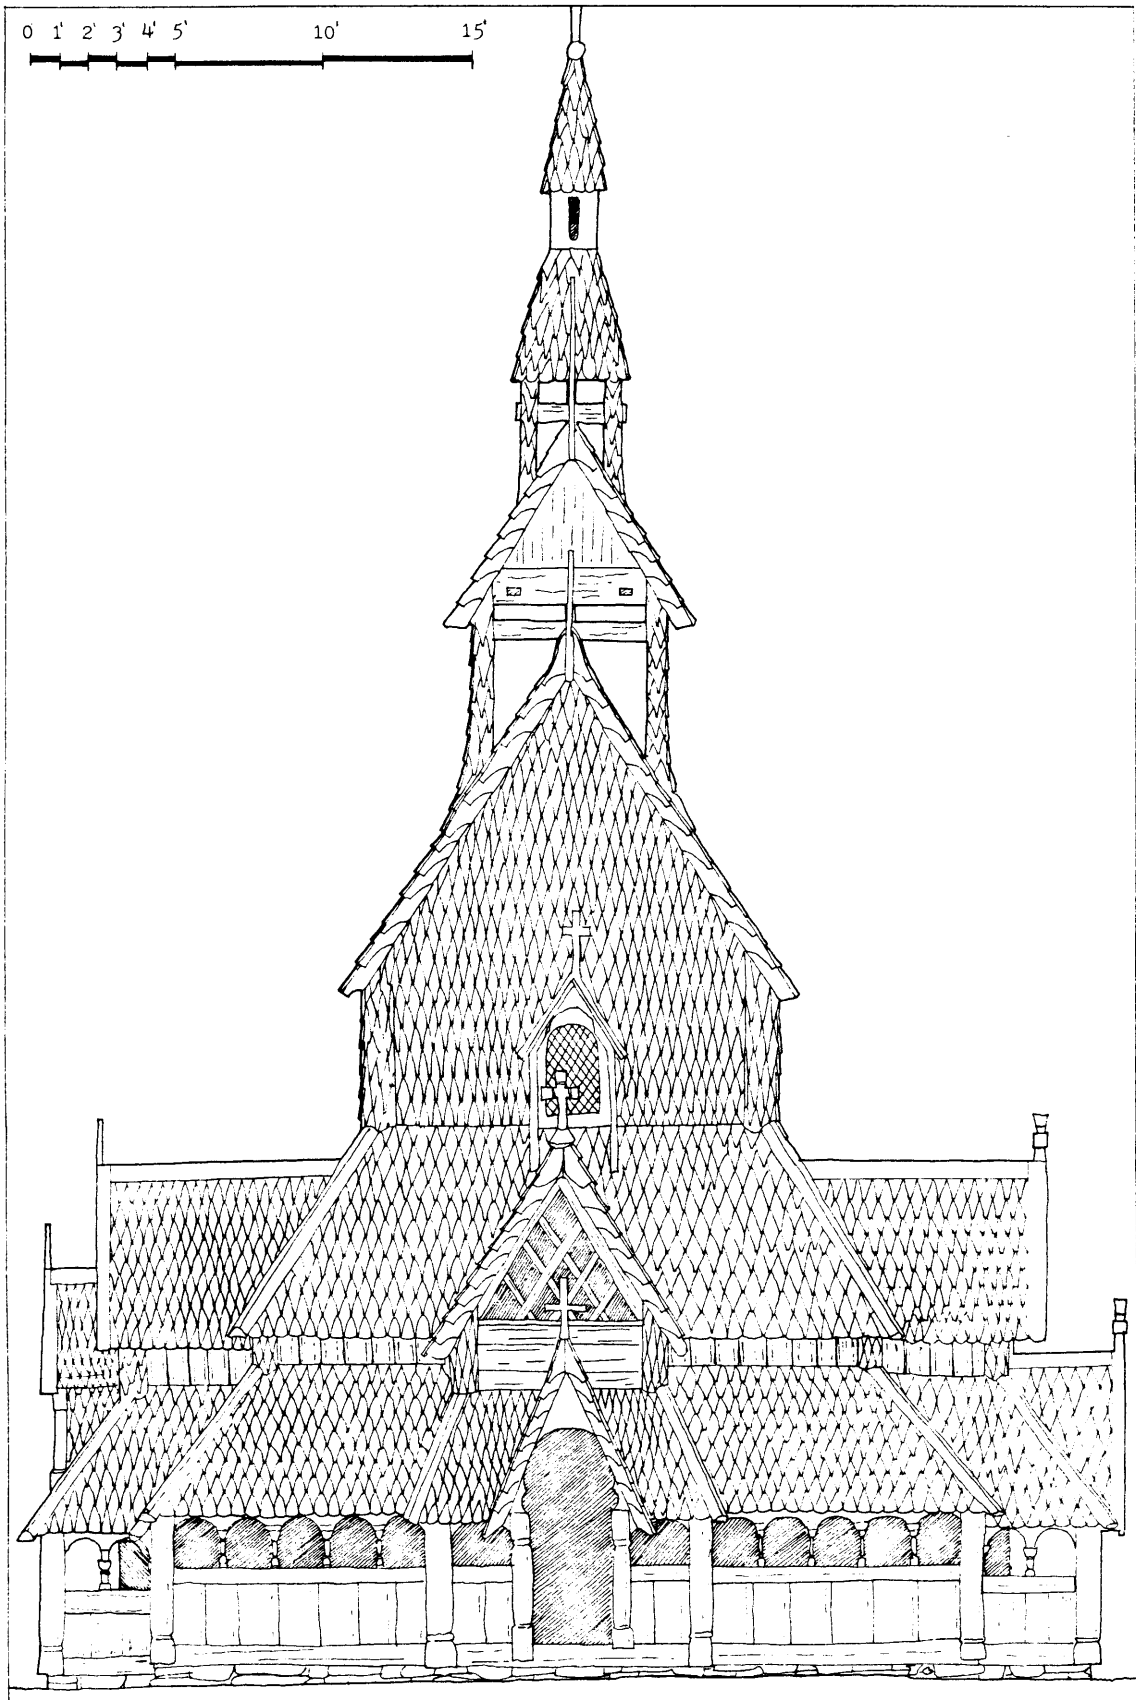
THE EXTERIOR

During the warm summer months when the sun beats down on the coated shingles, the black tar heats up and softens. Over a period of years some of the tar coating enters the pores of the wood making the surface of the wood virtually waterproof. As the tar wears off, it leaves the wood with a range of pleasing brown and red hues. This color change is most apparent on the south side of the building where the sunlight is the strongest. Conversely, the north side of the building tends to remain the cold black color of the tar compound. The striking difference in color from side to side is a reliable clue for fixing the orientation of the building.

In order to maintain the moisture barrier a new coating of tar is applied to the exterior about every four years. This process, which is still carried out to this day, has been kept up since the Middle Ages. Incidentally, the Vikings used a similar tar compound to waterproof their wooden ships. One important difference was that the Vikings added horse hair to their tar mixture.

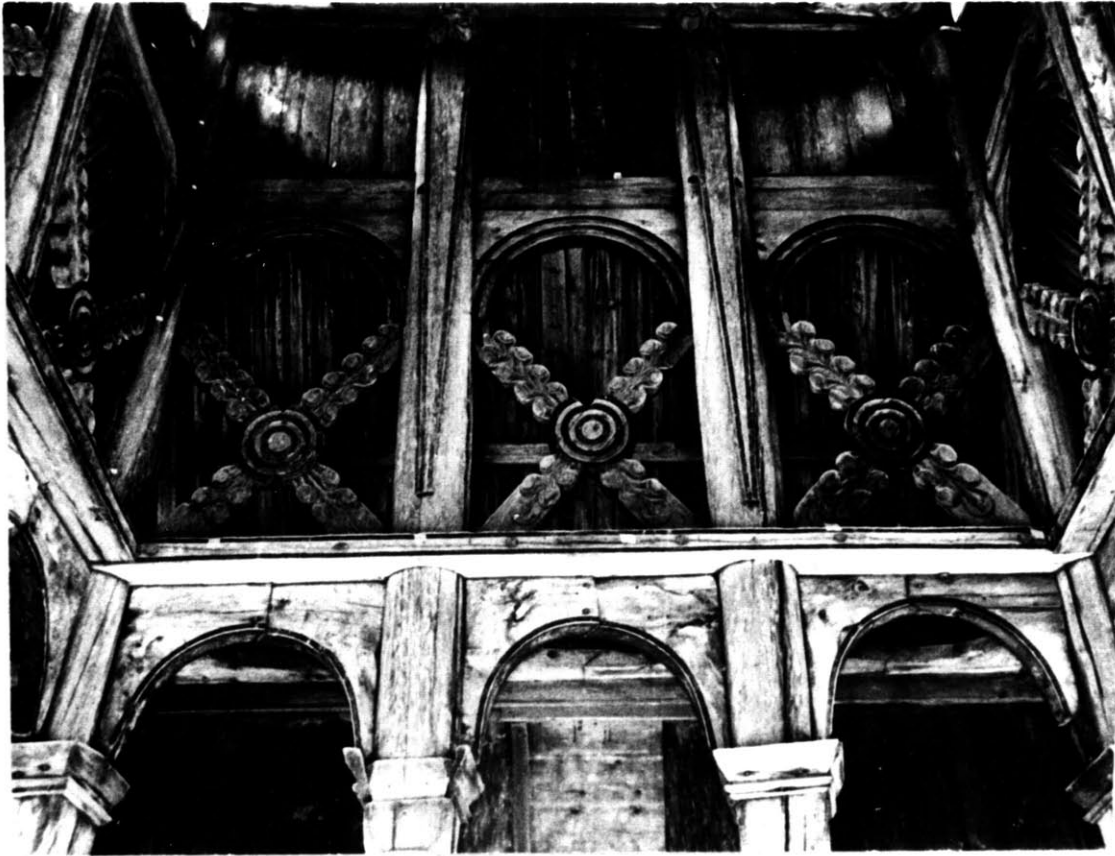
Columns and braces of the Torpo Church

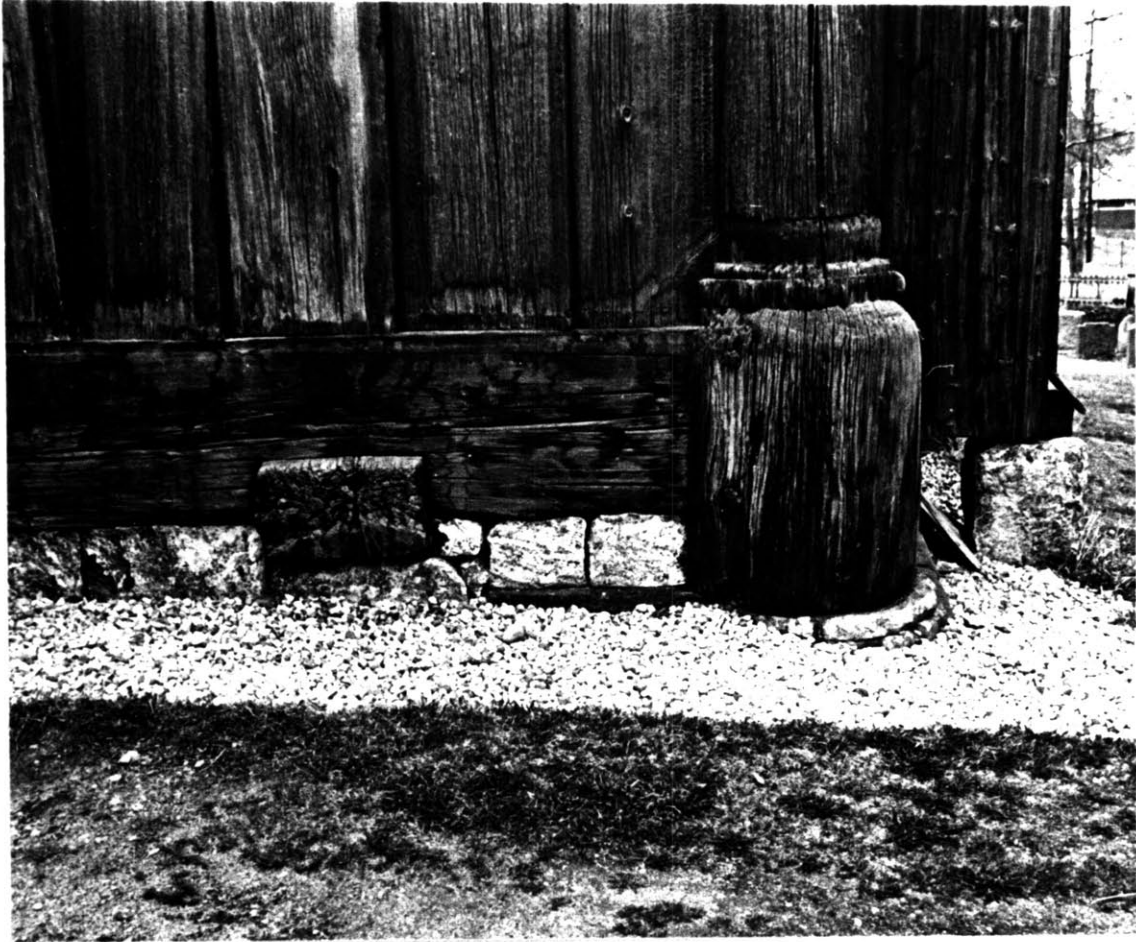
Stone foundation, sills, corner post, and staves of the
Torpo Stave Church
