WATER INTRUSION IN UNDERGROUND STRUCTURES

**MASTER OF ENGINEERING
IN CIVIL AND ENVIRONMENTAL ENGINEERING**

MASSACHUSETTS INSTITUTE OF TECHNOLOGY

June 2008

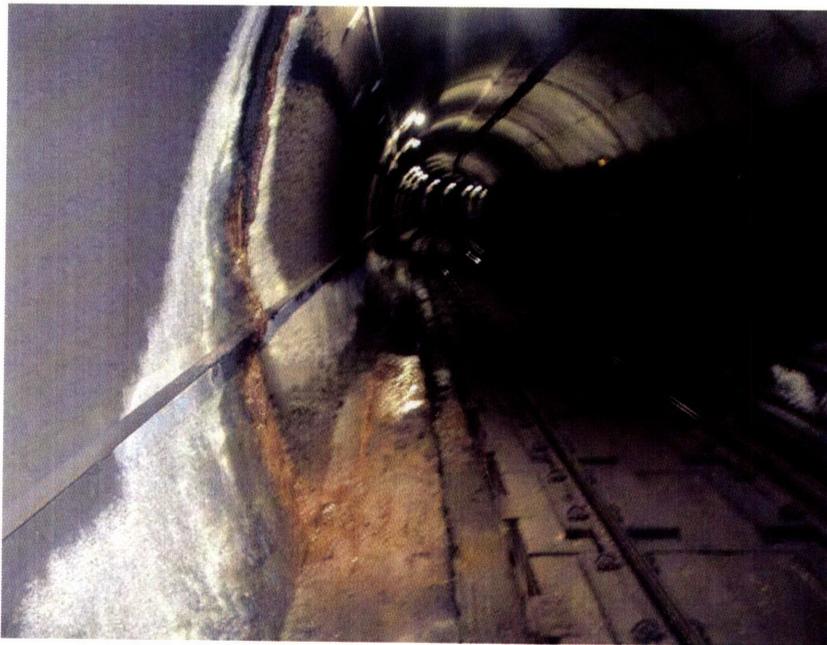
Figure 4-1, Red-line, between Porter Square and Harvard Square, Cambridge, MBTA, (Russell 2007)

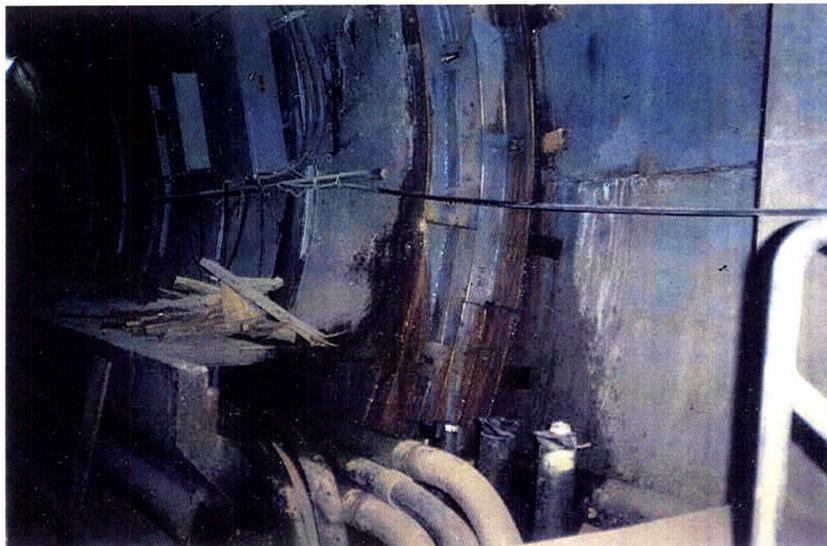
Figure 4-2, Seismic Joint, 7th Street and Flower Street, Los Angeles, MTA, (Russell)

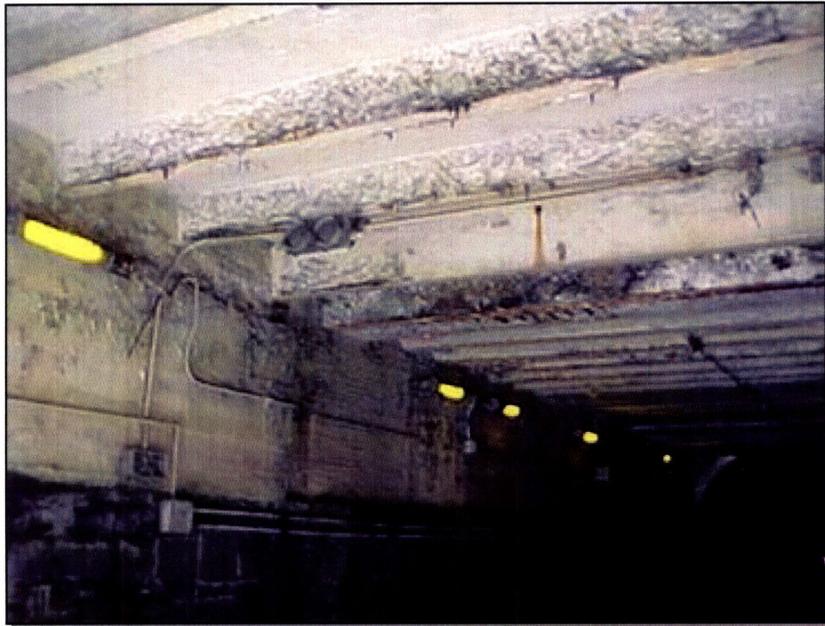
Figure 4-3, Roof of Park Avenue Tunnel, New York City, (Russell)

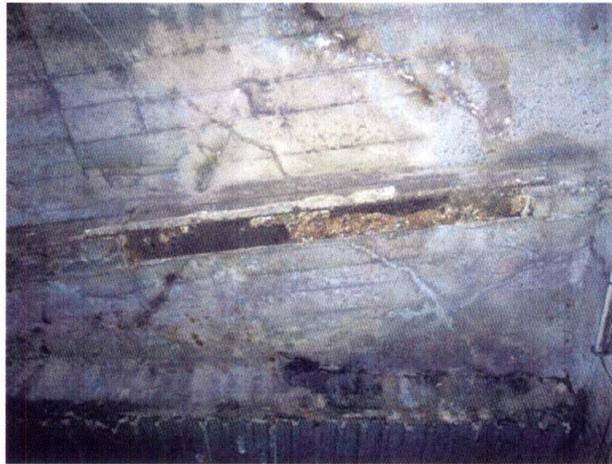
Figure 4-9, Ashmont Station, Red-line, Boston, MBTA (Russell 2007)

Groundwater infiltration can affect the structural adequacy of the tunnel. AITES-ITA (2001) concluded, from 157 cases, that water leakage is the principal cause of damage to and degradation of tunnel linings. An example roof slab spalling, caused by groundwater inflows is shown in Figure 4-9.

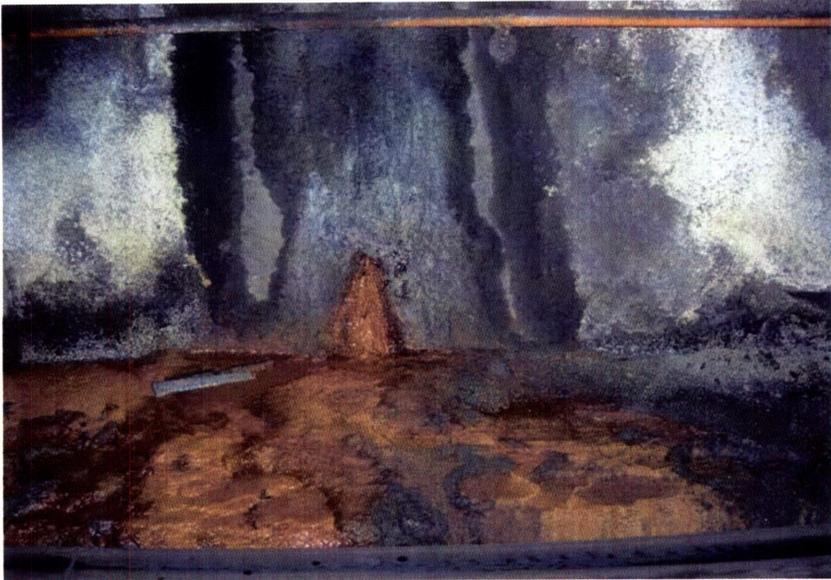
Figure 4-10, Red-line between Alewife and Davis Square, Cambridge, MBTA (Russell 2007)

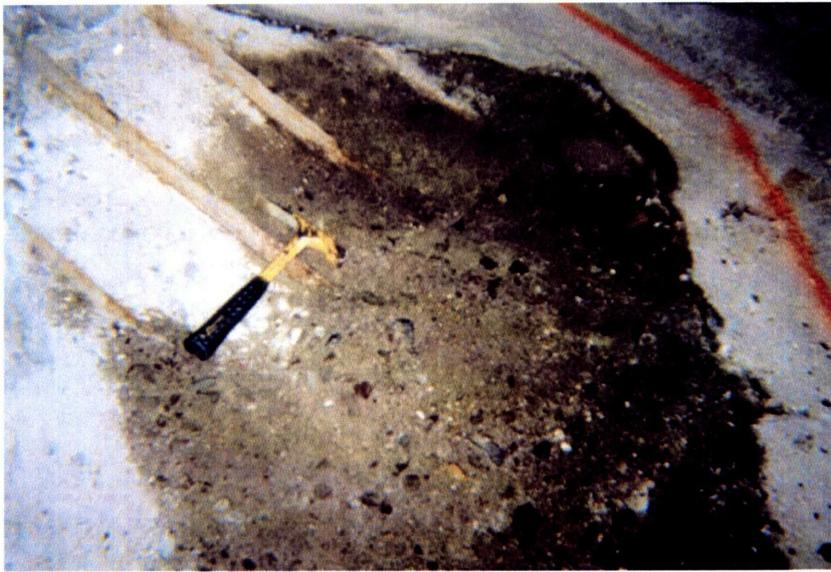
Figure 4-11, Total Slab Degradation, Sumner Tunnel, Boston (Russell 1989)

concrete linings. Chlorides in road salt cause corrosion of reinforcing steel (Russell 2000). Degradation, as a result of rebar corrosion and was recorded at the Sumner Tunnel in Boston (Figure 4-11).

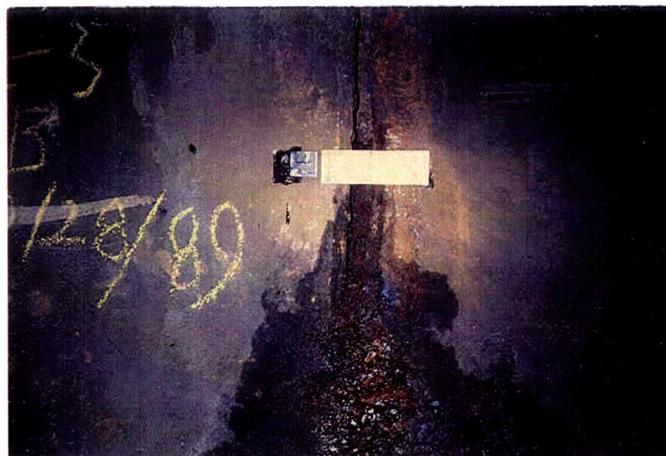
Figure 4-13, Crack Monitoring Gage, Chicago (Russell 1989)

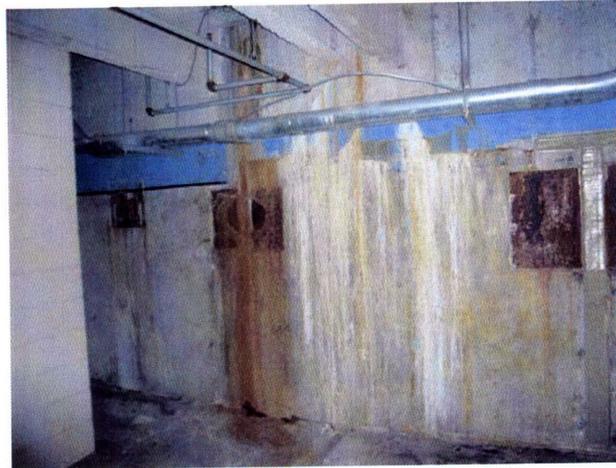
Figure 4-17, Waterfront Underground Parking Garage, Boston, MA, (Russell 2007)

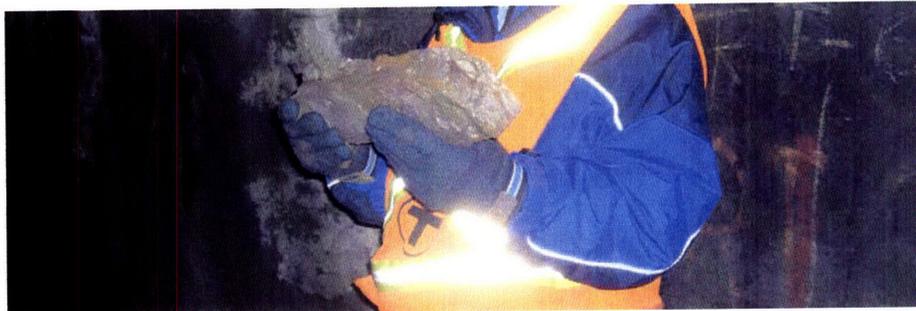
Figure 4-18, Concrete Spall Fell on the Track at Ashmont Station, Red-line, Boston MBTA, (Russell 2007)

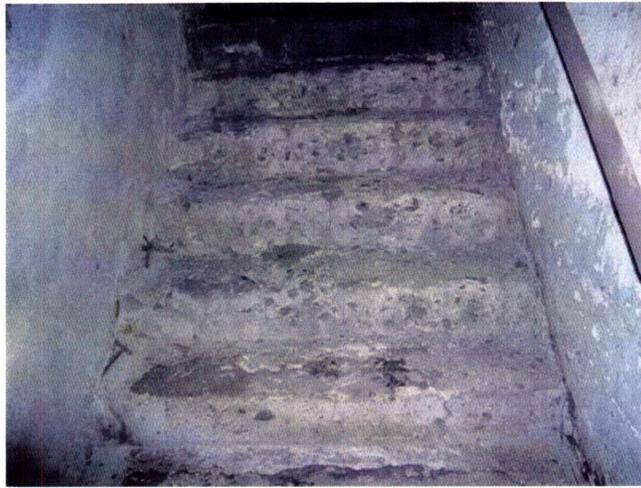
Figure 4-20, Emergency Exit Stairwell, Andrew Square, Red-line, Boston, MBTA, (Russell 2006)

Spalling occurs due to corrosion when a concrete or steel discards particles of corrosion products as part of the corrosion reaction progresses. A large volume change occurs during the reaction process. Rebar can expand drastically contributing to spalling of the concrete cover layers (in reinforced concrete liners). Figure 4-21 shows an example of spalling due to rebar corrosion in a Boston subway tunnel.

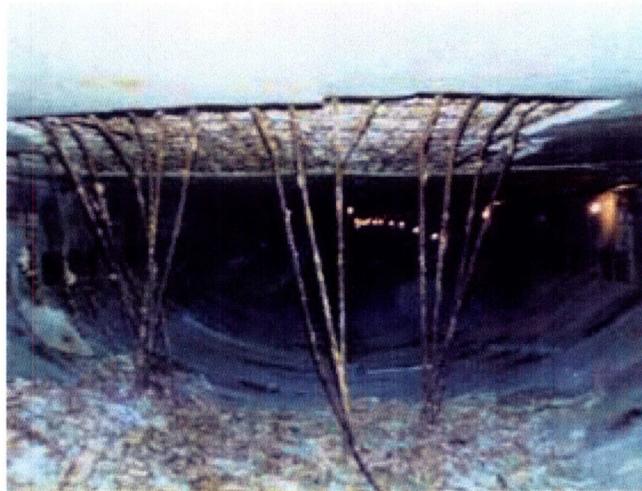
Figure 4-22, Sumner Tunnel, Boston, (Russell 1989)

Incidents of ground collapse in the upper parts of tunnel have taken place in Japan (e.g. Oyamano Tunnel). In 1999, spalling incidents occurred in Fukoka Tunnel and Kita-Kyusyu Tunnel along Shinkansen Line, and Rebunhama Tunnel – Muroran Line. In all the spalling accidents the cracks progressed gradually over several years, where cracks originally formed and then dropped. A schematic of the spalling mechanism in the Rebunhama Tunnel is presented in Figure 4-19 while a local example in Boston, Sumner Tunnel collapse is shown in Figure 4-22.
