Detecting Sources of Heat Loss in Residential Buildings from Infrared Imaging

SUBMITTED TO THE DEPARTMENT OF MECHANICAL ENGINEERING
IN PARTIAL FULFILLMENT OF THE REQUIREMENTS FOR THE DEGREE OF
BACHELOR OF SCIENCE IN MECHANICAL ENGINEERING
at the
MASSACHUSETTS INSTITUTE OF TECHNOLOGY
June 2011

Infrared image analysis was conducted to determine the most common sources of heat loss during the winter in residential buildings. 135 houses in the greater Boston and Cambridge area were photographed, stitched, and tallied to characterize nine major causes of heat loss: window frames, window surfaces, window cracks, basements, door cracks, corners, chimneys, roof ridges, and soffits. The nine causes of heat loss were mapped to the three modes of heat transfer: conduction, convection, and radiation.

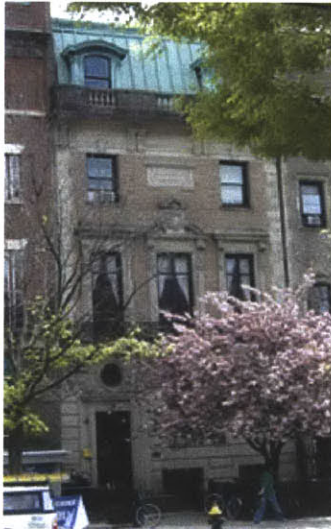
Figure 2: Front view of the 100-year-old house located at 478 Commonwealth Avenue

The houses in the study are in the greater Boston and Cambridge area, which means that the buildings tend to be older. Therefore, a case study was conducted on a 100-year-old brick house located at 478 Commonwealth Ave in the Back Bay area of Boston.

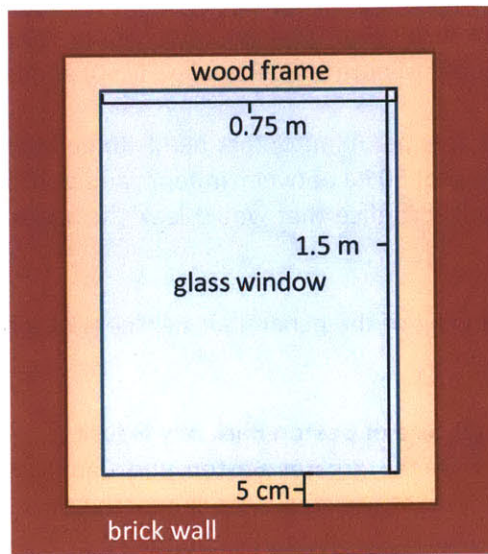
It was assumed that the temperature difference between the warm indoors and cooler outdoors was 30 degrees Celsius, or 30 Kelvin. The brick house has about 20 windows and 3 wood doors. The windows were modeled as plate glass with a wood frame, surrounded by brick. The wood and brick were assumed to be joined together with caulk and the cracks were formed at the window and wood interfaces. A schematic is shown below.

Figure 3: Schematic of an average window in 478 Commonwealth

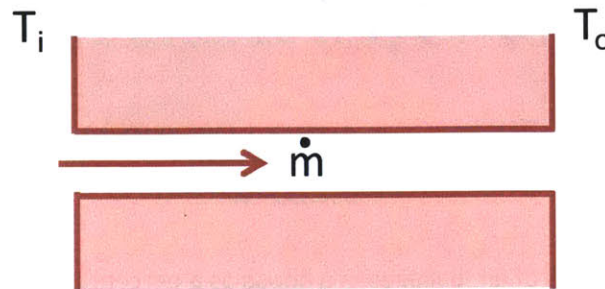
Equipped with a sense of the size of the cracks in a house, the next step is to determine the mass air flow through these cracks. Figure 5 shows how air mass flow through cracks of a building can result in heat transfer. When there is a temperature difference at the two ends of the mass air flow, such as in a building when it is warmer indoors in the winter compared to the outdoors, heat transfer is dependent on both the amount of mass flow as well as the difference in temperature, as highlighted in equation 2.

Figure 5: Mass flow through a crack results in heat transfer

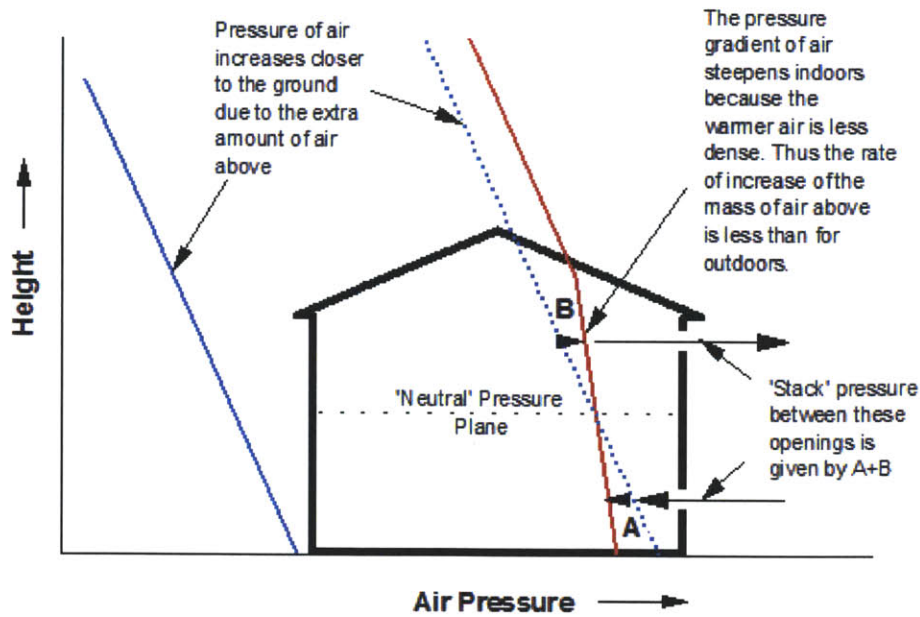
Air flow due the stack effect is caused by pressure differences and air buoyancy in the building. During the winter months, cold air tends to seep into the house from the lower levels, and then heated air escapes the building from the top. This is known as the stack effect. Because warmer air is lighter and more buoyant, a higher pressure results at the top of the house. The higher pressure at the top of the building creates a pressure differential, with the higher pressure warm air escaping the building to achieve a pressure balance. Meanwhile, the bottom of the house experiences a negative pressure where the pressure inside is lower than the pressure outside. This causes the cold air to seep in through the cracks. The effect is illustrated in Figure 6. It should be noted that there is a certain height in the building where the pressure of the air indoors matches the pressure of the air outdoors. This height is known as the neutral pressure level.

Figure 6: Illustration of the stack effect in a house (Veetech, 2010)

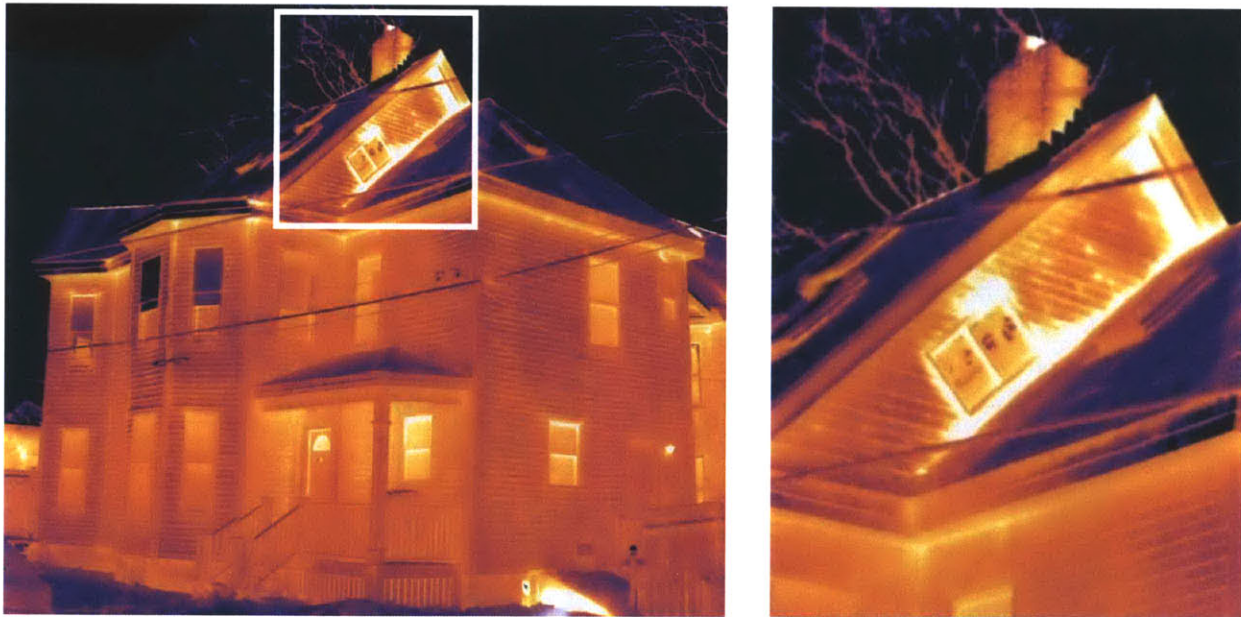
A sampling of infrared images of residential buildings is illustrative of the stack effect. Many images show bright spots near the rooftops and peaks of the houses, as shown in Figure 7 below. This is indicative of warmer, higher pressure air leaking out of the cracks at higher elevations.

Figure 7: Infrared image of a residential building and a close-up of the roof to highlight heat losses

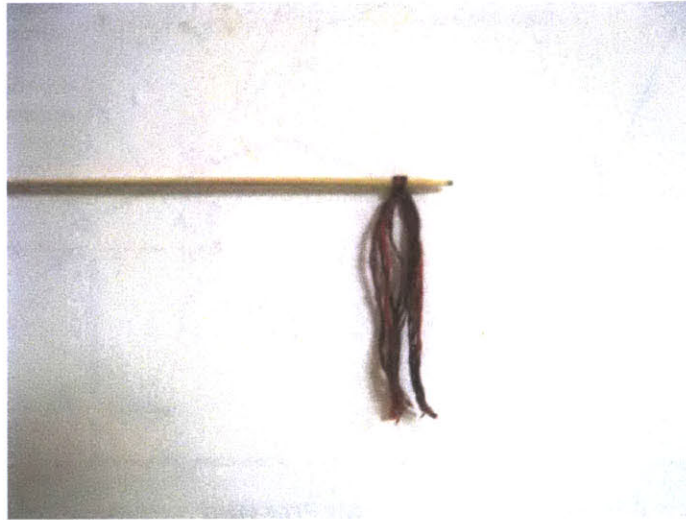
was constructed using a skewer and dark colored threads, shown in Figure 8. This allows for a pictorial understanding of air flow.

Figure 8: Thread tool constructed to identify air flow direction in 478 Commonwealth

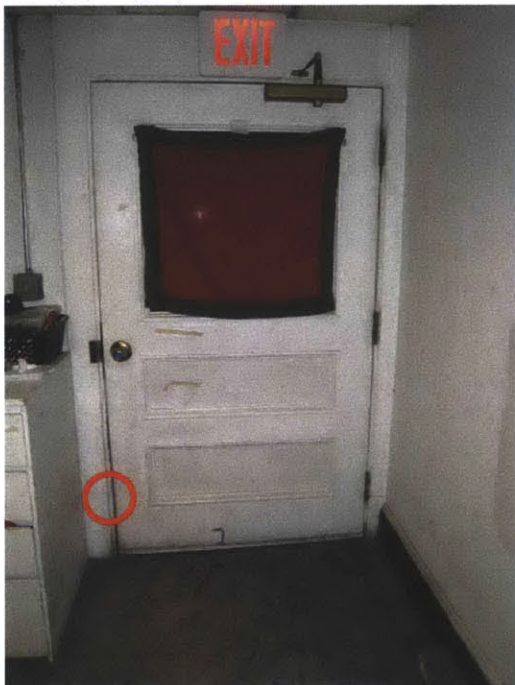
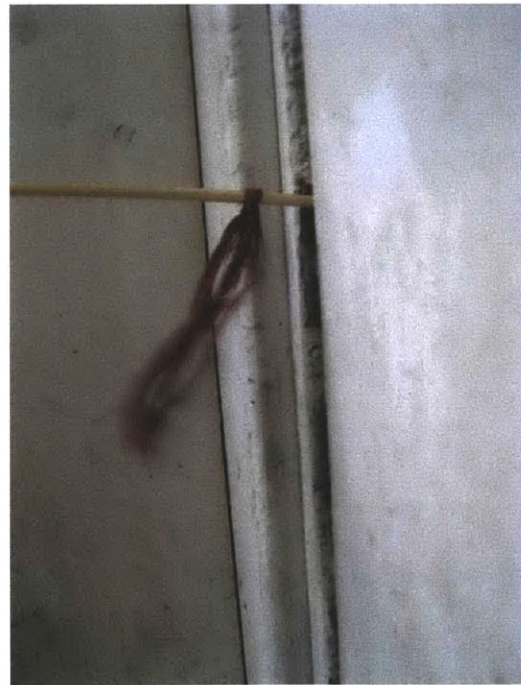
The first area of investigation was the basement. The basement is the lowest accessible part of the house. Because the pressure of the colder air is greater at this level, it is expected that the cold air will flow into the house. This was affirmed when placing one's hands by the basement door cracks, and can be seen in Figure 9.

Figure 9: The lowest accessible point of 478 Commonwealth was the basement. The highlighted circle is where the air flow was tested. The direction of the threads shows that air was blowing into the house.

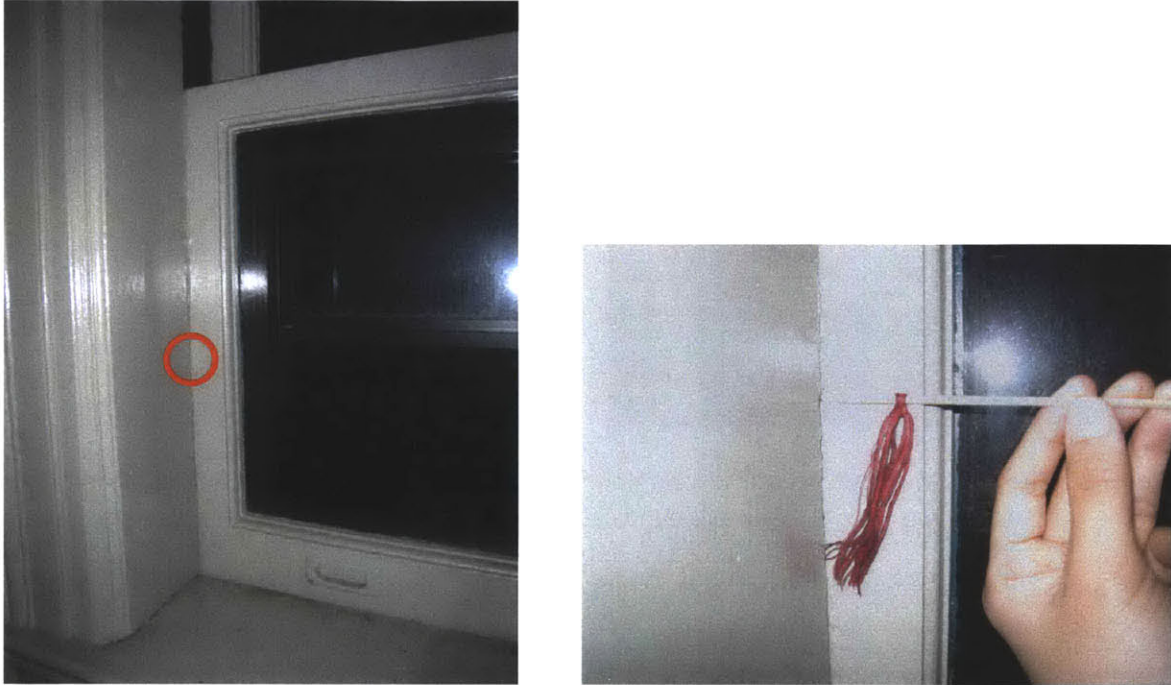
The next area analyzed was a window on the fourth floor of the building, the highest floor. Lighter, more buoyant warm air travels up to higher levels and results in a higher pressure compared to the air outside. When using one's hand to test air flow, there was a feeling of suction, which results from the warmer air flowing out of the house because of its relatively higher pressure. This was also indicated by testing with the thread tool.

Figure 10: The highest accessible point of 478 Commonwealth was the fourth floor. When placing the thread tool at the window crack, the threads were drawn towards the crack, indicating that the warm indoor air was escaping.

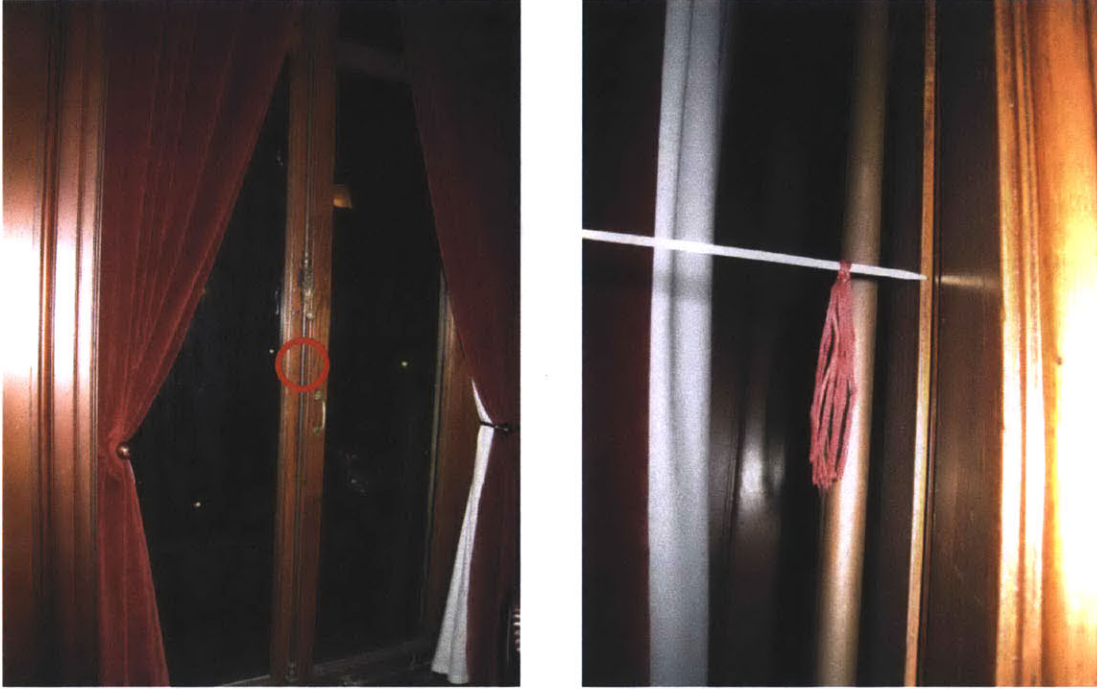
Finally, the large windows on the second floor of the building were tested to identify the neutral pressure plane. This is the height where the indoor air pressure matches the outdoor air pressure, and although there may be cracks, the stack effect states that the balance of pressures results in zero air flow. Using the thread tool, it was shown that the neutral pressure plane of 478 Commonwealth is located on the second floor, as shown in Figure 11.

Figure 11: The large windows on the second floor of 478 Commonwealth had substantial cracks, but when the thread tool was used there was no indication of air flow because of the neutral pressure plane.

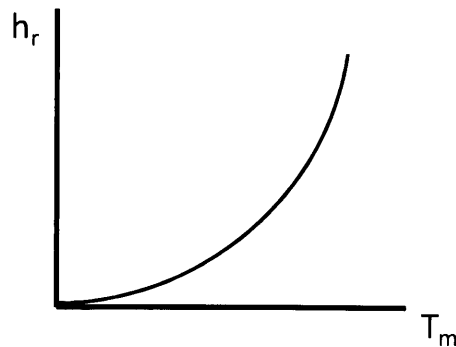
As shown in the equation above and the figure below, heat transfer due to radiation is a cubic function of the mean temperature of the surface in question and its surroundings. This non-linear relationship shows that the higher the temperature difference, the greater the heat transfer.

Figure 12: Cubic relationship between radiation heat transfer and mean temperature of surface of interest and its surroundings

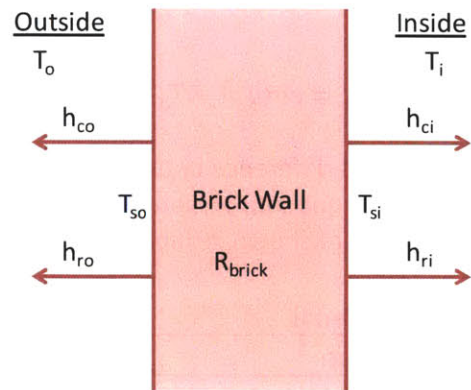
Combining the effects of radiation and conduction, the figure below illustrates a schematic of the heat losses from a cross section of a brick wall.

Figure 13: Schematic of radiation and conduction heat losses across a brick wall

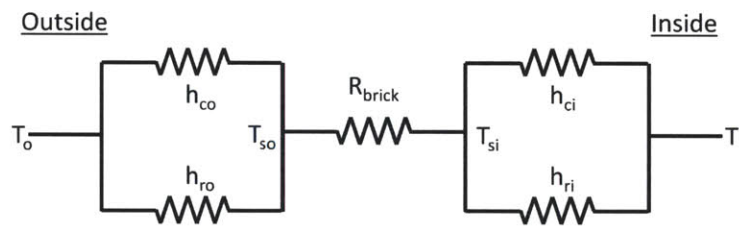
Thermodynamic theory allows conduction and radiation losses to be modeled as a circuit diagram, as shown below. The heat “resistances” can be added in series and parallel, similar to a circuit, to determine the equivalent heat “resistance”.

Figure 14: Equivalent radiation and conduction heat transfer circuit diagram

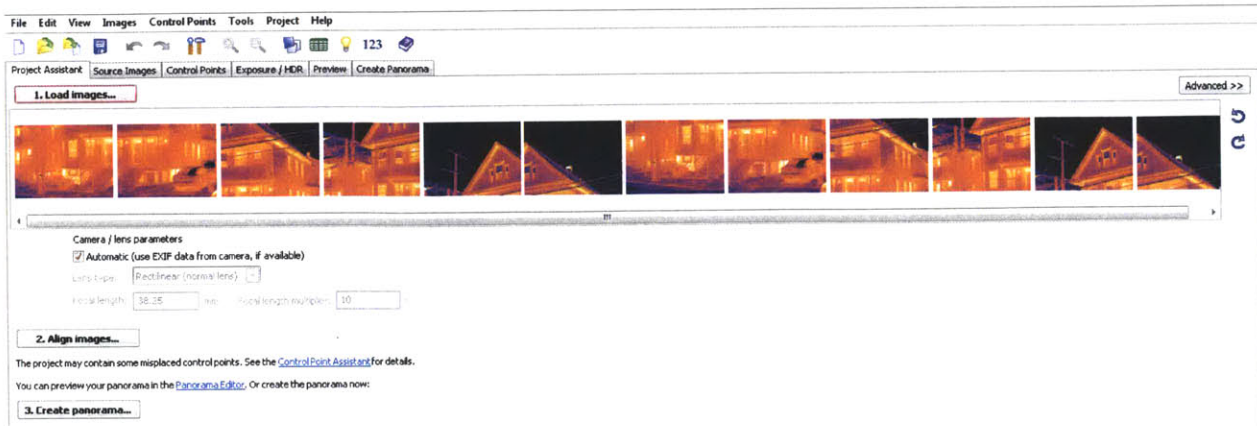
Figure 15: Screenshot of PTGui being used to stitch segmented images into a panorama

To understand the major sources of heat loss in residential buildings, infrared images were taken of hundreds of houses in the greater Boston and Cambridge area. The images were taken at night throughout the month of January 2010, one of the coldest months of the year, so that areas of heat loss would be clearly highlighted. The camera used was an infrared FLIR P660 (see Appendix B: FLIR P660 camera specifications). The camera had a low resolution of 640 x 480 per picture. However, the analysis required specific features of the houses to be clearly seen. To correct for the low resolution, focused

images of segments of the houses were taken. A software (PTGui) was used to stitch the segmented images together.

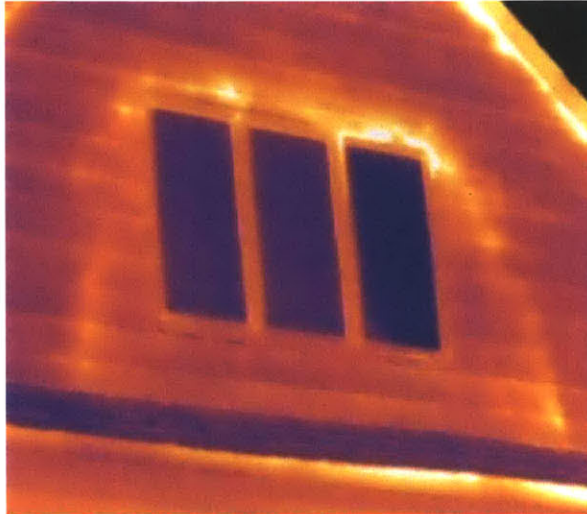
Window frame and casing loss: Heat loss can occur at the casing and frame of the windows if the spaces have not been properly sealed. Casings that are not tight allow for a lot of air to leak through, resulting in heat loss due to convection and air mass flow. When installing windows, these gaps should be sealed using caulk (Harley, 2002).

Figure 17: Infrared image of window frame and casing loss

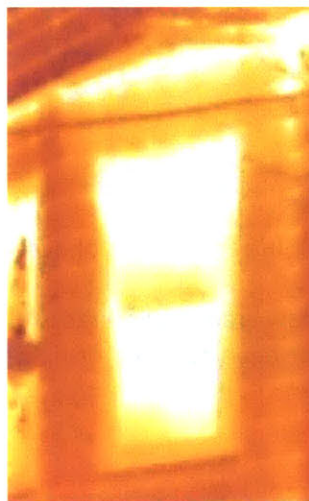
Window surface loss: Glass windows are common sources of heat loss because of conduction, airflow by the glass, as well as radiation (dependent on the emissivity of the glass). Several standards are used to measure energy efficiency of windows. The U-factor represents the conductive heat loss, where the smaller the value the less conductive, which means less heat loss (NFRC, 2005). The solar heat gain coefficient (SHGC) measures the amount of direct solar radiant heat that enters through a window. A higher SHGC value increases solar heat gains in the winter (Harley, 2002).

Figure 18: Infrared image of window surface loss

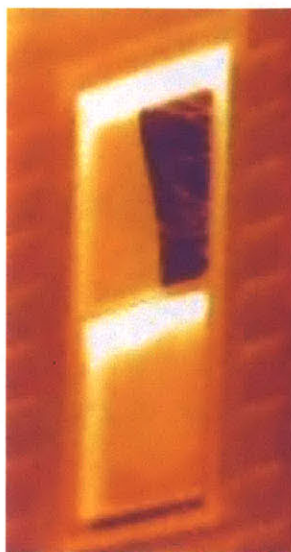
Window crack loss: Older buildings have experienced decades of harsh winters and hot summers. The extreme temperatures have expanded and contracted the building materials for years, resulting in weaker materials. This creates cracks in areas around the perimeter of windows where the frame and glass join together. These cracks allow for heat to be lost due to air mass flow, or what is commonly known as a draft.

Figure 19: Infrared image of window crack loss

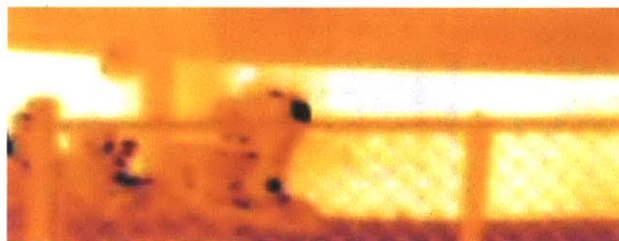
Basement loss: Conductive and radiation heat losses result from poorly or un-insulated basements (Yost, 2002). Air leakage can also occur along the top of the basement wall where the cement contacts the wood frame (Energy Star, 2000). The perimeter framing (rim joist) creates cavities along the basement wall that allows for leakage to occur.

Figure 20: Infrared image of basement loss

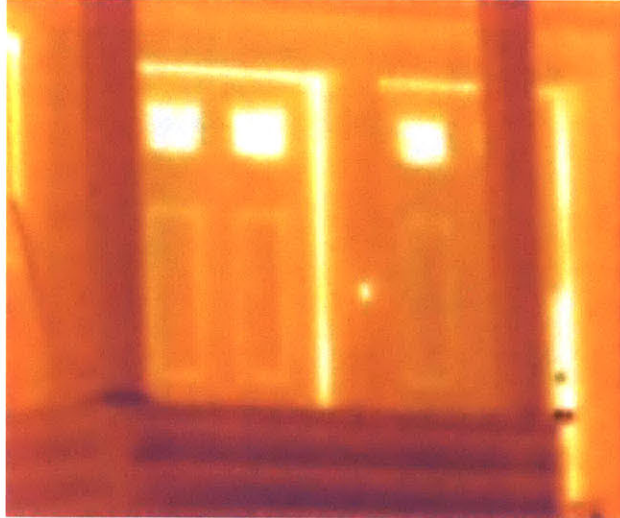
Door crack loss: Similar to the window crack leaks, cracks form around doors that have experienced many years of weather and have not been repaired or tightened. These cracks lead to air mass flow and convective heat loss.

Figure 21: Infrared image of door crack loss

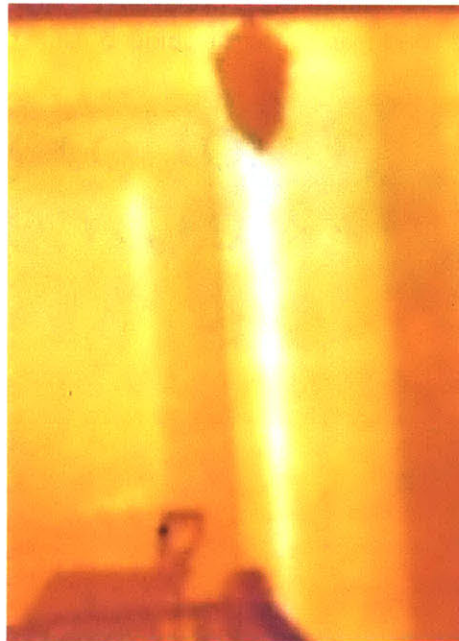
Corner loss: Heat loss can occur at the corners of walls when a gap is created in the thermal boundary. This can be caused by either a discontinuous air barrier or poor insulation. When two walls come together to form a corner, the joining point may not be as tight, resulting in a gap.

Figure 22: Infrared image of chimney loss

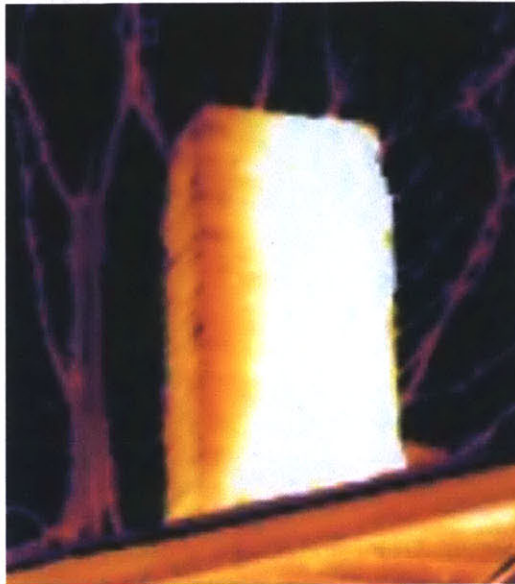
Chimney loss: A chimney that protrudes above the ceiling has a higher neutral pressure zone than the rest of the house. Combined with the stack effect, this results in a flow of air into the fireplace and out of the chimney, even if there is no fire burning. Although dampers are installed to seal the chimney flue when not in use, many dampers do not close tightly and could even be installed incorrectly. Heat losses due to air mass flow could be significant depending on the leakage area.

Figure 23: Infrared image of chimney loss

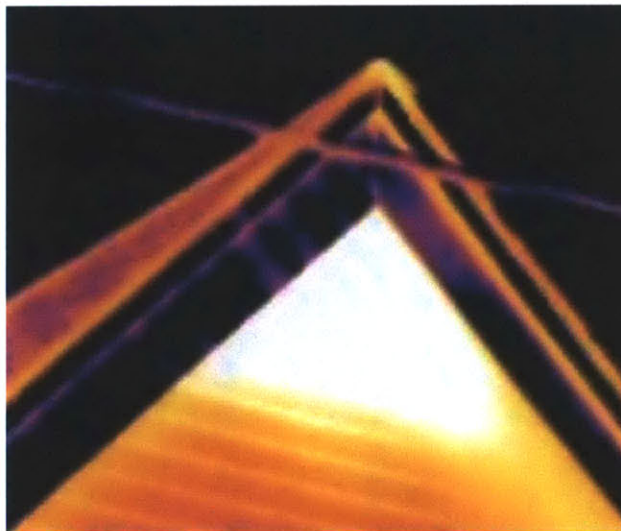
Roof ridge loss: Because of the stack effect, warm air travels up toward the attic in a house. If there are gaps in the thermal boundary around the roof ridge area, heat loss will occur due to warmer air flowing out (stack effect), and conduction with the colder outside surface.

Figure 24: Infrared image of roof ridge loss

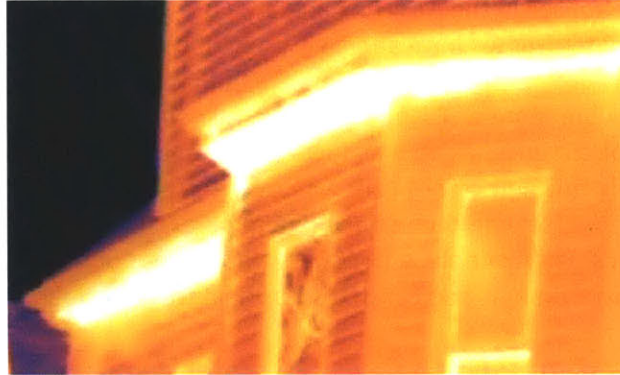
Soffit loss: Heat loss can occur near the soffits if the area around the joists are not properly insulated or sealed. Because the soffits are located higher up on the house, gaps allow for convection (air mass flow), while poor insulation results in losses due to conduction.

Figure 25: Infrared image of soffit loss

Many houses experience heat losses along the soffits as well, at the underside of roofs where the walls join the ceiling, with just over 70% of houses experiencing this type of heat loss. These thermal losses result from air mass flow through the leaks that develop over years of weathering. A common fix to these issues is to improve insulation and to reseal areas around the joists.

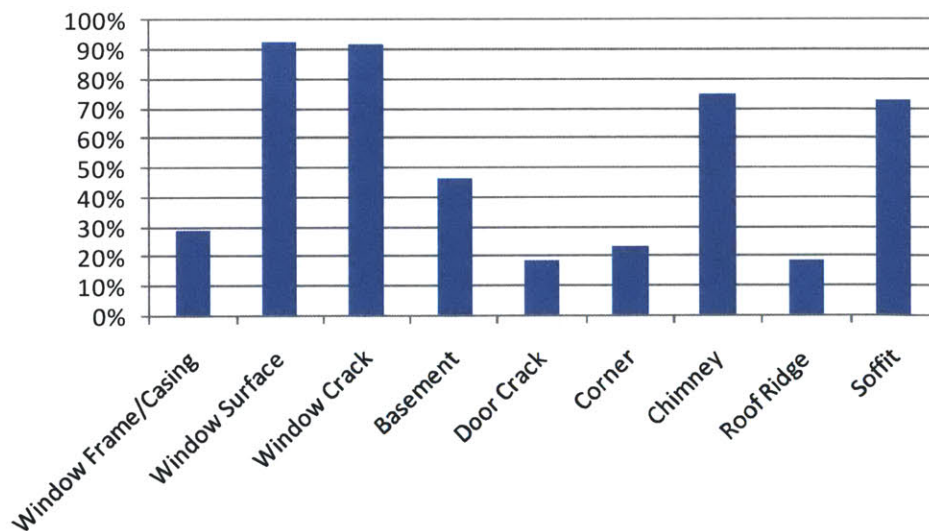
Tallying the nine major problem areas for 135 images of residential buildings resulted in a clearer understanding of what heat loss issues are most common in residential buildings. (see specific images in Appendix C: Table of residential building mapping for sources of heat loss)

Figure 26: Percentages of major sources of heat loss for 135 houses

The results show that the most common problems are related to windows, whether it is heat loss due to conduction through window surfaces, or air leaking out of the cracks of the window edges. This is

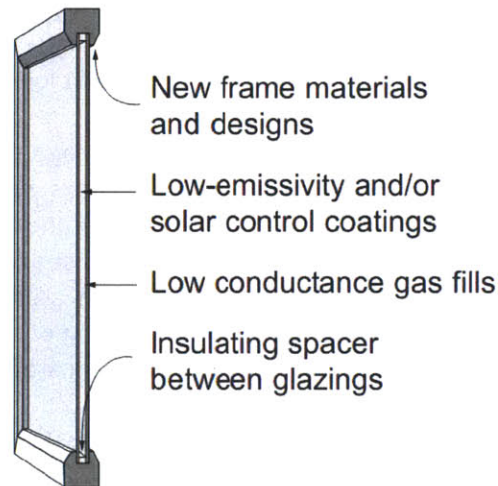
Over the past few decades, window technology has improved to offer consumers high-efficiency windows that feature double panes. From a conduction standpoint, these windows include low emissivity and solar control coatings, as well as low conductance gas fills such as argon or krypton. To minimize leakage of hot air through cracks, the windows are installed with improved thermal breaks, edge spacers, and better edge sealing techniques (Energy Star, 2000). Some window installations also use different window frames. For example, a fiberglass frame is not only more dimensionally stable than vinyl and wooden frames over time, it also conducts less heat than its older predecessors.

Figure 27: Higher thermal efficiency window that is becoming more common (Energy Star, 2000)

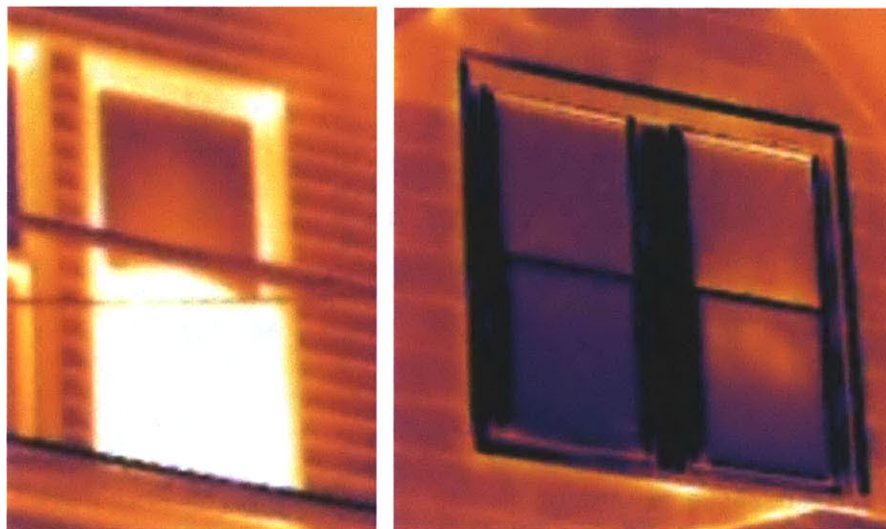
While analyzing images of residential buildings, it was evident that some houses had changed their less thermally efficient single pane windows for more efficient ones. When counting the number of houses that had at least one well-insulated window, the overall percentage was 82%, although for most homes, the majority of windows were poorly insulated.

Figure 28: Infrared images contrasting highly conductive windows and more thermally efficient windows

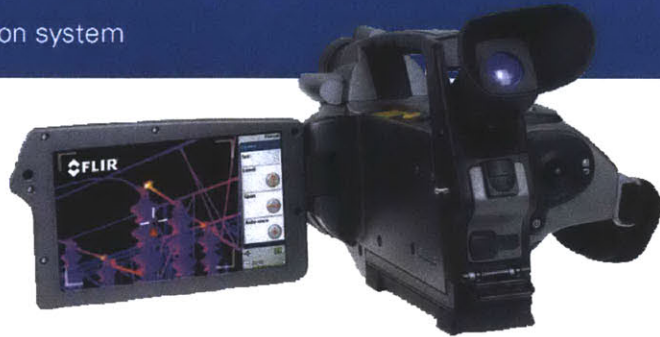
FLIR P660 is the highest performing infrared inspection system available. With its state of the art technology, including 640x480 detector resolution and unique ergonomic design it is the natural choice for professional thermographers that want the most efficient instrument producing professional results. There are three standard set available for option:

1. The camera is equipped with standard 24° lens.
2. The camera is equipped with a 12° telephoto lens with 2x higher magnification
3. The camera is equipped with a 45° wide angle lens particularly useful when studying large areas at close distance.

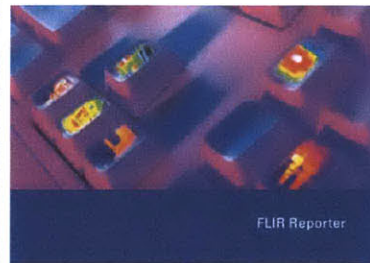
FLIR Reporter software - powerful yet easy-to-use tool to generate comprehensive and professional infrared inspection reports.
