The Effect of Carburetor Refurbishing on
Emissions, Performance, and Fuel Economy in a Classic Pickup
Tested Using Real-World Tests

This project investigated how refurbishing the carburetor of a 1952 Chevrolet Pickup would affect emissions, performance, and fuel economy. The test used were real-world tests that anyone, with or without access to a laboratory, can perform. The design of the real-world tests is important for ascertaining good results. Thought should go into how to perform the tests safely while still eliminating as many variables as possible.

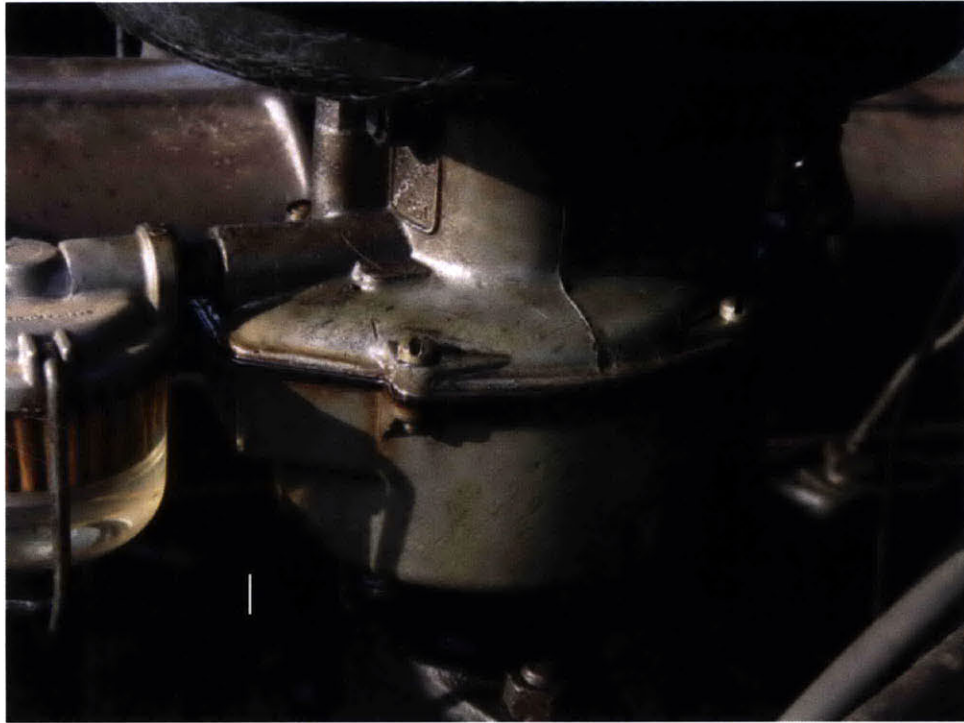
Figure 2: Carburetor installed on the engine before refurbishing. The outer surface had a shine that could have been caused by fuel leakage.

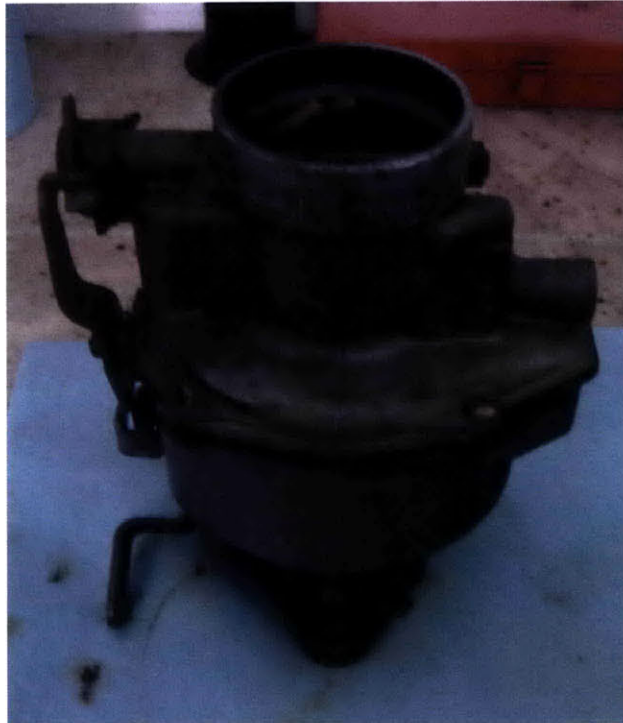
Figure 4: Carburetor removed from the engine before refurbishing. There is noticeable buildup on the surfaces of the carburetor.

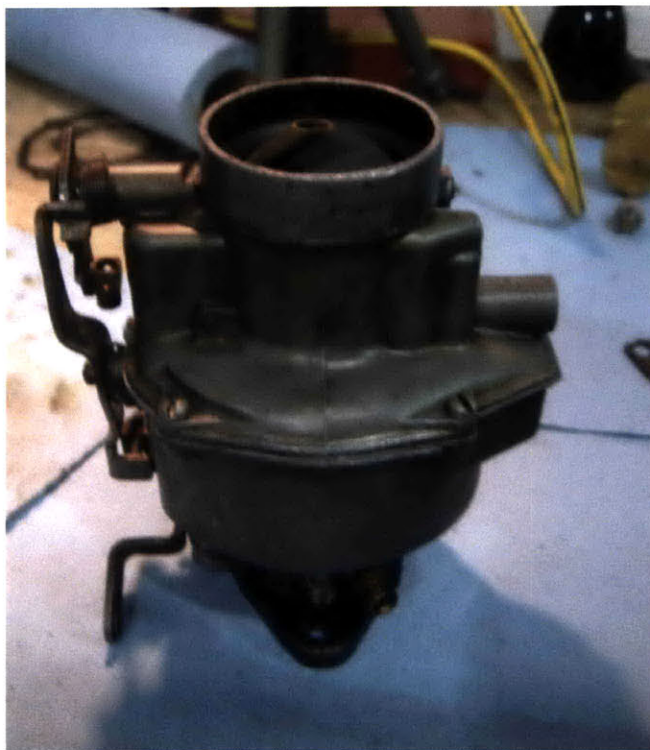
Figure 5: Carburetor after refurbishing.

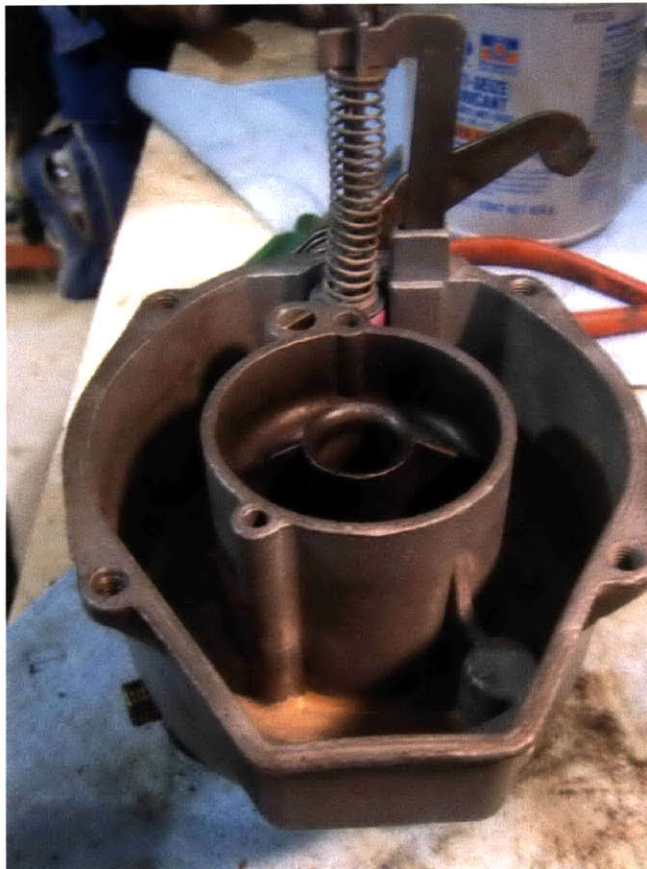
Figure 7: Carburetor bowl with sediment removed.

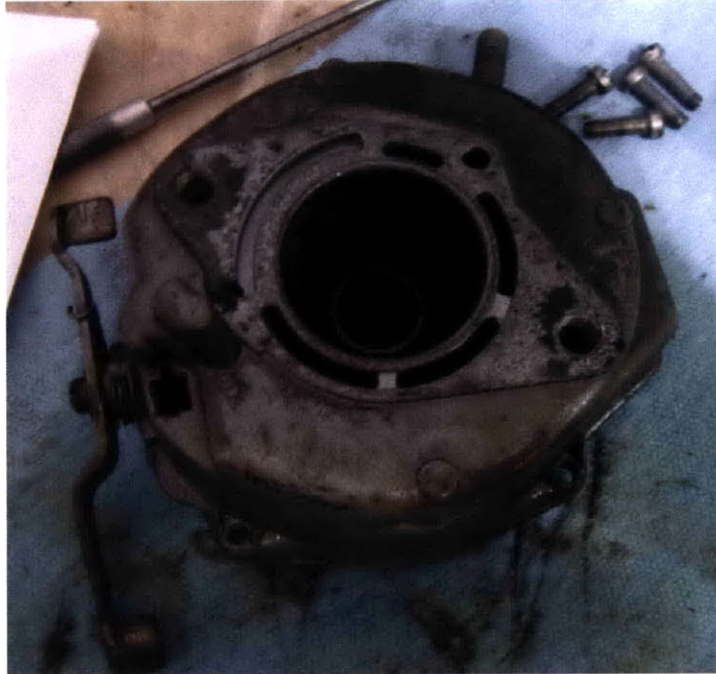
Figure 8: Bottom of carburetor before refurbishing. Notice gasket had stuck to the surface.

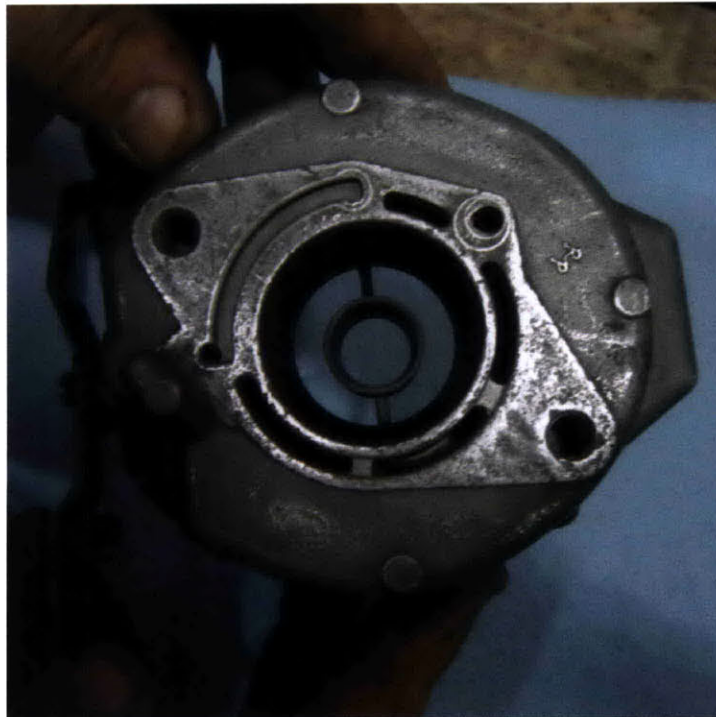
Figure 9: Bottom of carburetor after refurbishing. Old gasket removed, and surface cleaned.

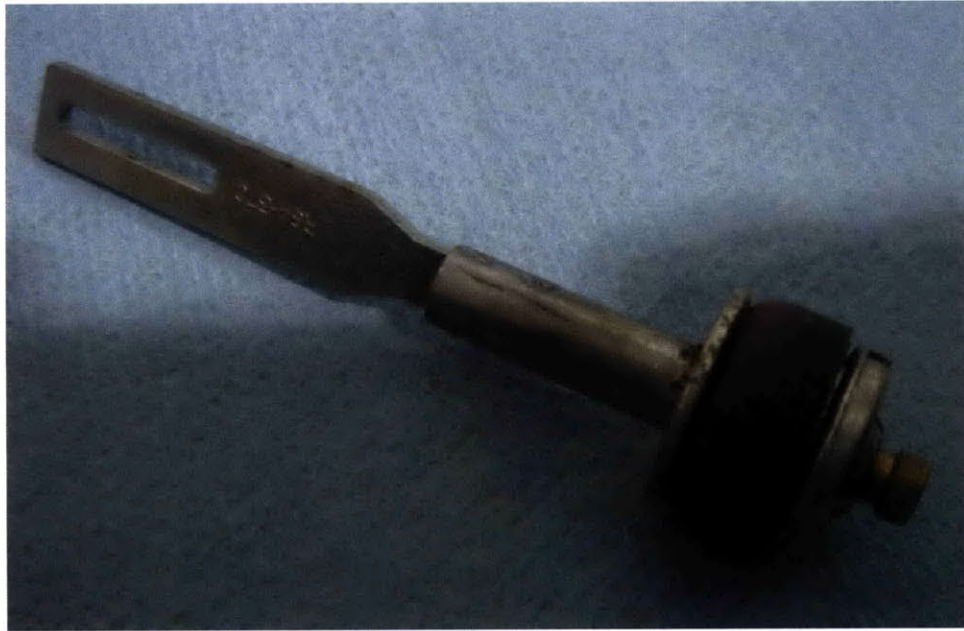
Figure 10: Old pump plunger with signs of wear.

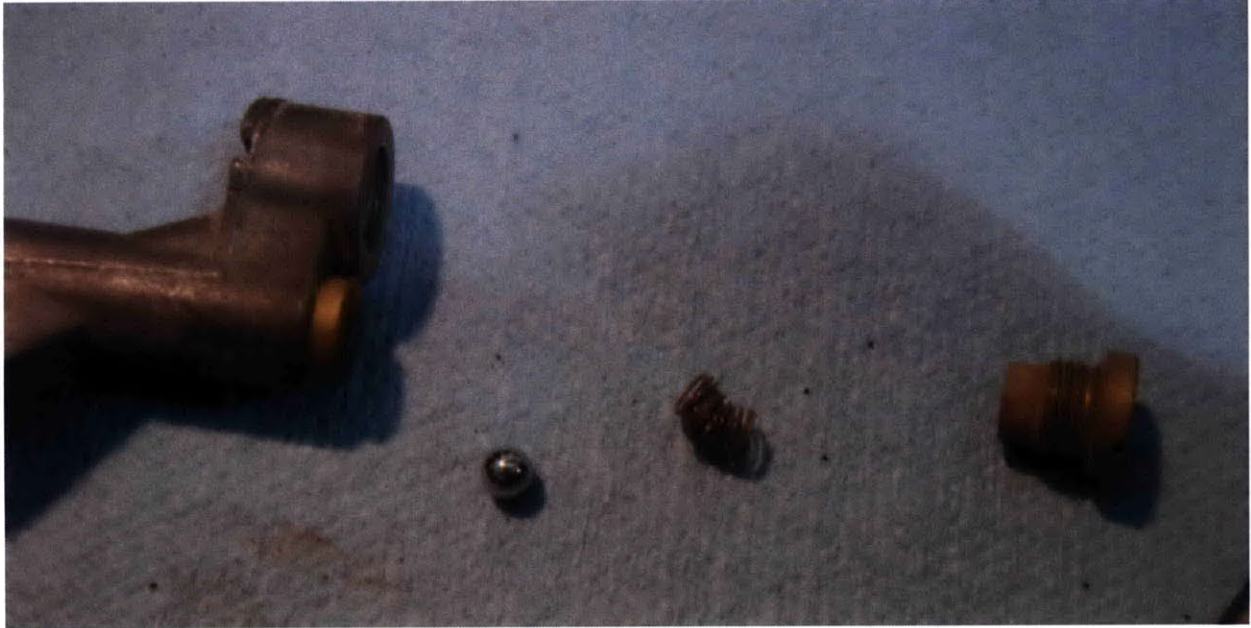
Figure 12: Exploded view of old power valve assembly. Notice spring failure.

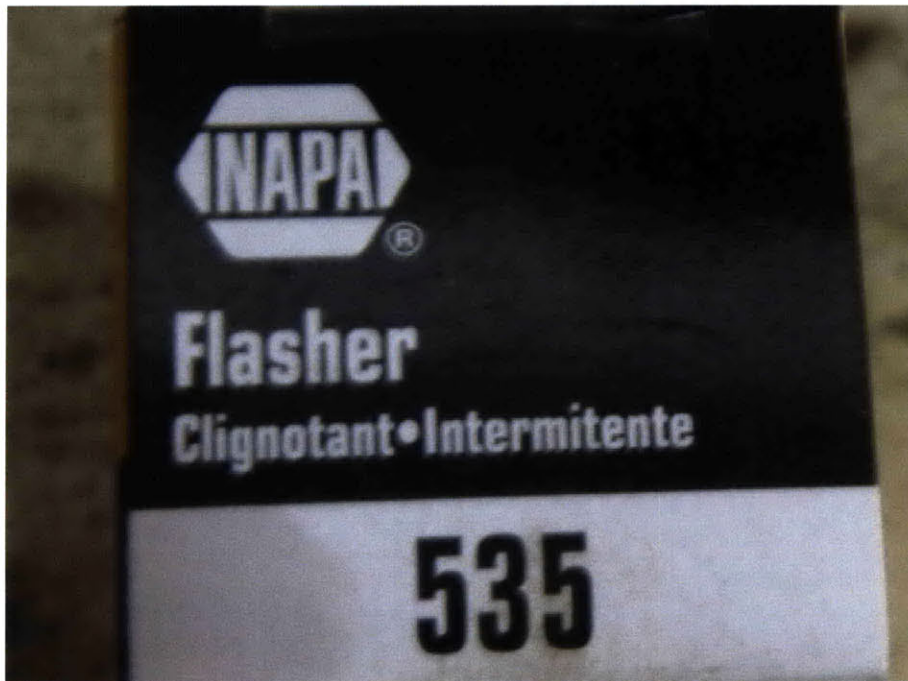
Figure 14: New flasher used to fix the turn signals.

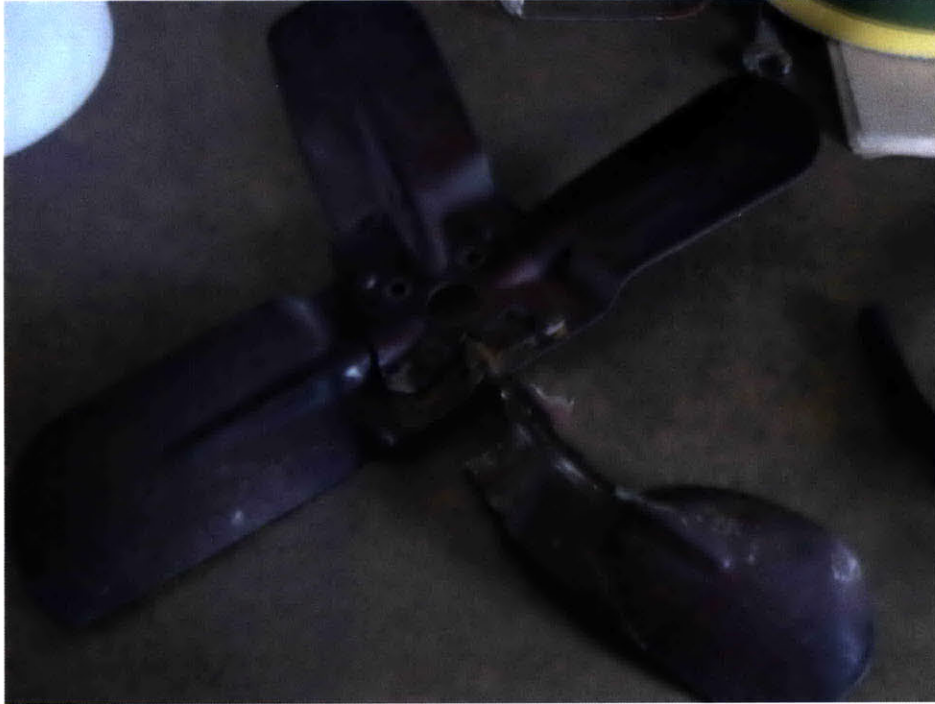
This test proved to be very difficult. While running the “before tests” the fan broke and severed the fan belt. The heating coil then was leaking an excessive amount. This occurred on the seventh run of the initial testing, and caused the engine to heat up. The broken fan was discovered to be from a 1955 model engine. It was replaced with the correct 1952 version from Ed Pollard. The heating coil was bypassed for the “after tests.”

Figure 15: 1955 model fan that broke during testing.

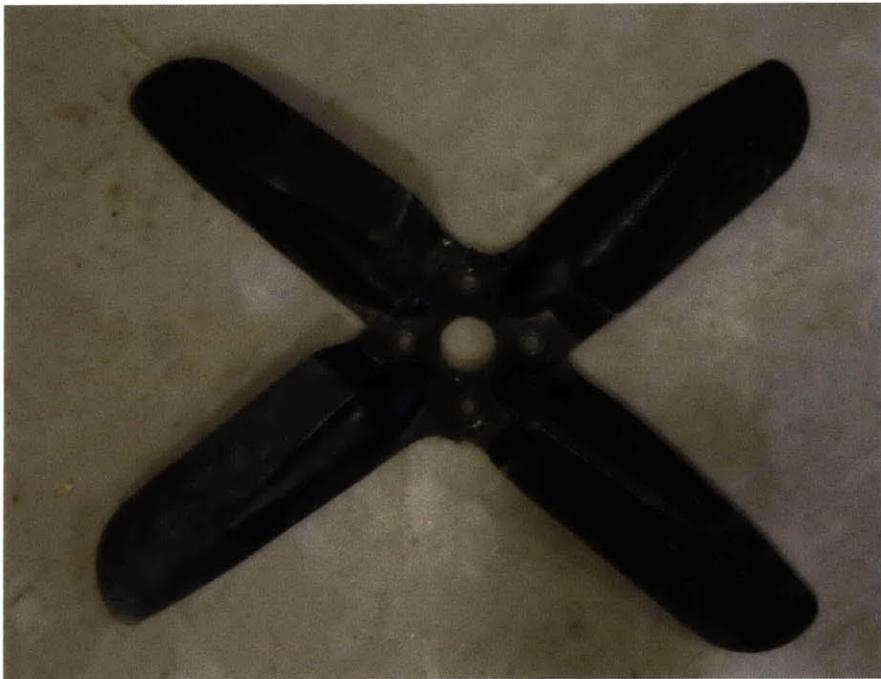
Figure 16: 1952 model fan obtained from Ed Pollard.

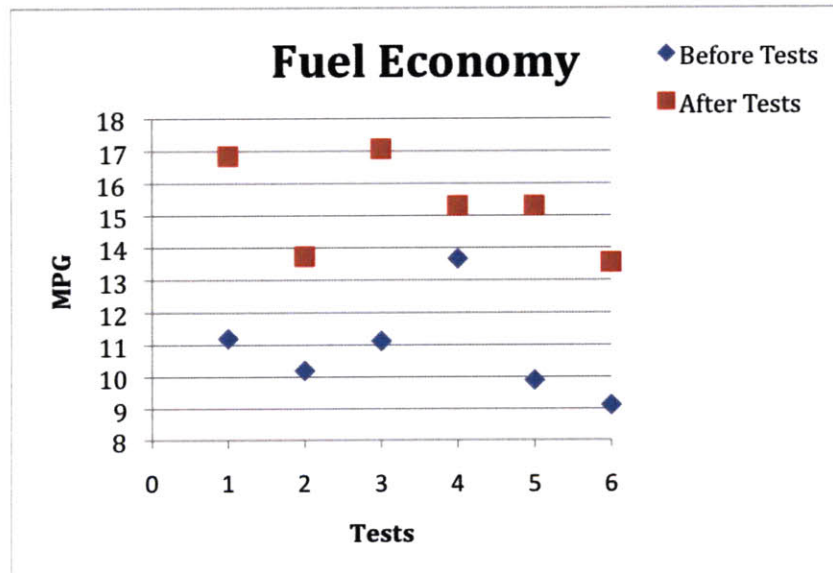
Figure 17: Graphical representation of the MPGs calculated for each test run. This shows the variation in the tests runs.

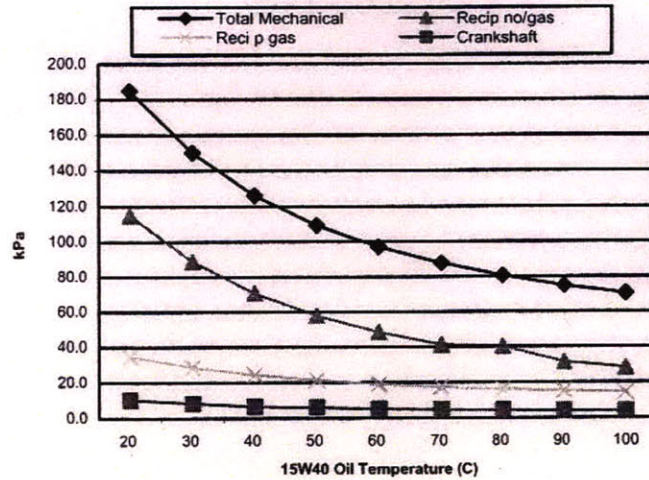
The smaller replacement fan and removing the heating coil in the cab caused the engine to run warmer during the after tests. The engine was running about 15 degrees warmer. This would heat the oil making it less viscous which would reduce the friction in the engine. The smaller fan would also cause less friction when it is running. The older engine will have higher friction than new engines by about 30-50 %. Figure 18, shows how friction mep (kPa) changes with varying oil temperatures. During the before tests the vehicle was running about 68 C and after was about 76 C, this corresponds to a mechanical friction reduction of about 8% from Figure 18. Multiplying 8% by 1.4 (in order to scale to an older engine) gives a reduction of mechanical friction of 11%. The reduced friction helped improve fuel economy.

Figure 18: Friction mep (kPa) for varying oil temperatures. This is Figure 11 in *An Improved Friction Model for Spark-Ignition Engines* Sandoval and Heywood (2003).

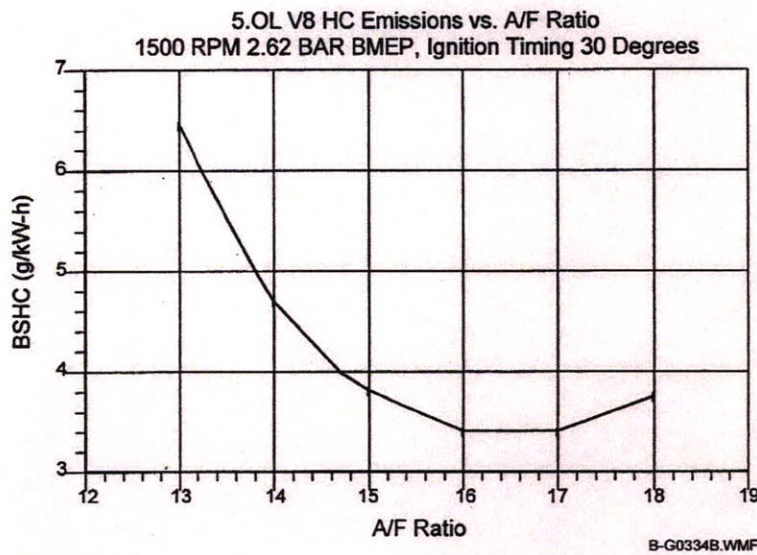
Now that we have an A/F ratio, Figure 19 can be used to find the break specific heat consumption (bsHC). However, the vehicle was running on the rich side of the graph, so the curve was extended out to give an estimate for the bsHC.

Figure 20: BSHC vs A/F Ratio. Note. Graph from *Effects of A/F, EGR, and Spark on HC* from John B. Heywood’s course 2.61 at MIT (2009).

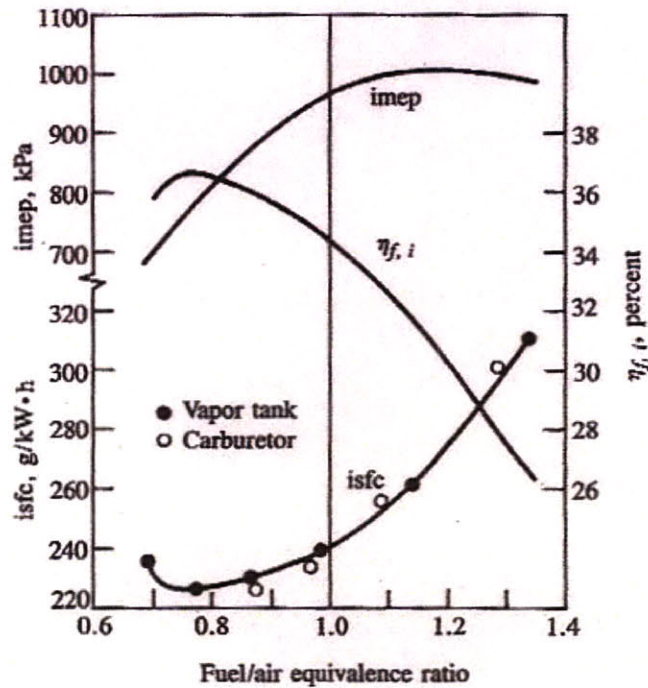
Figure 21: This is Figure 15.4 in John B. Heywood's book *Internal Combustion Engine Fundamentals* (1988, p 831). Use this graph to find the indicated specific fuel consumption (isfc) from a given fuel/air ratio (ϕ).
