RESTORATION AND ADAPTIVE USE
OF AN URBAN CHURCH

This thesis presents a case study for restoration and adaptive use of the First Baptist Church, Cambridge, Massachusetts. The thesis was sponsored, in part, by the Albert Farwell Bemis Fund.

and REPAIR

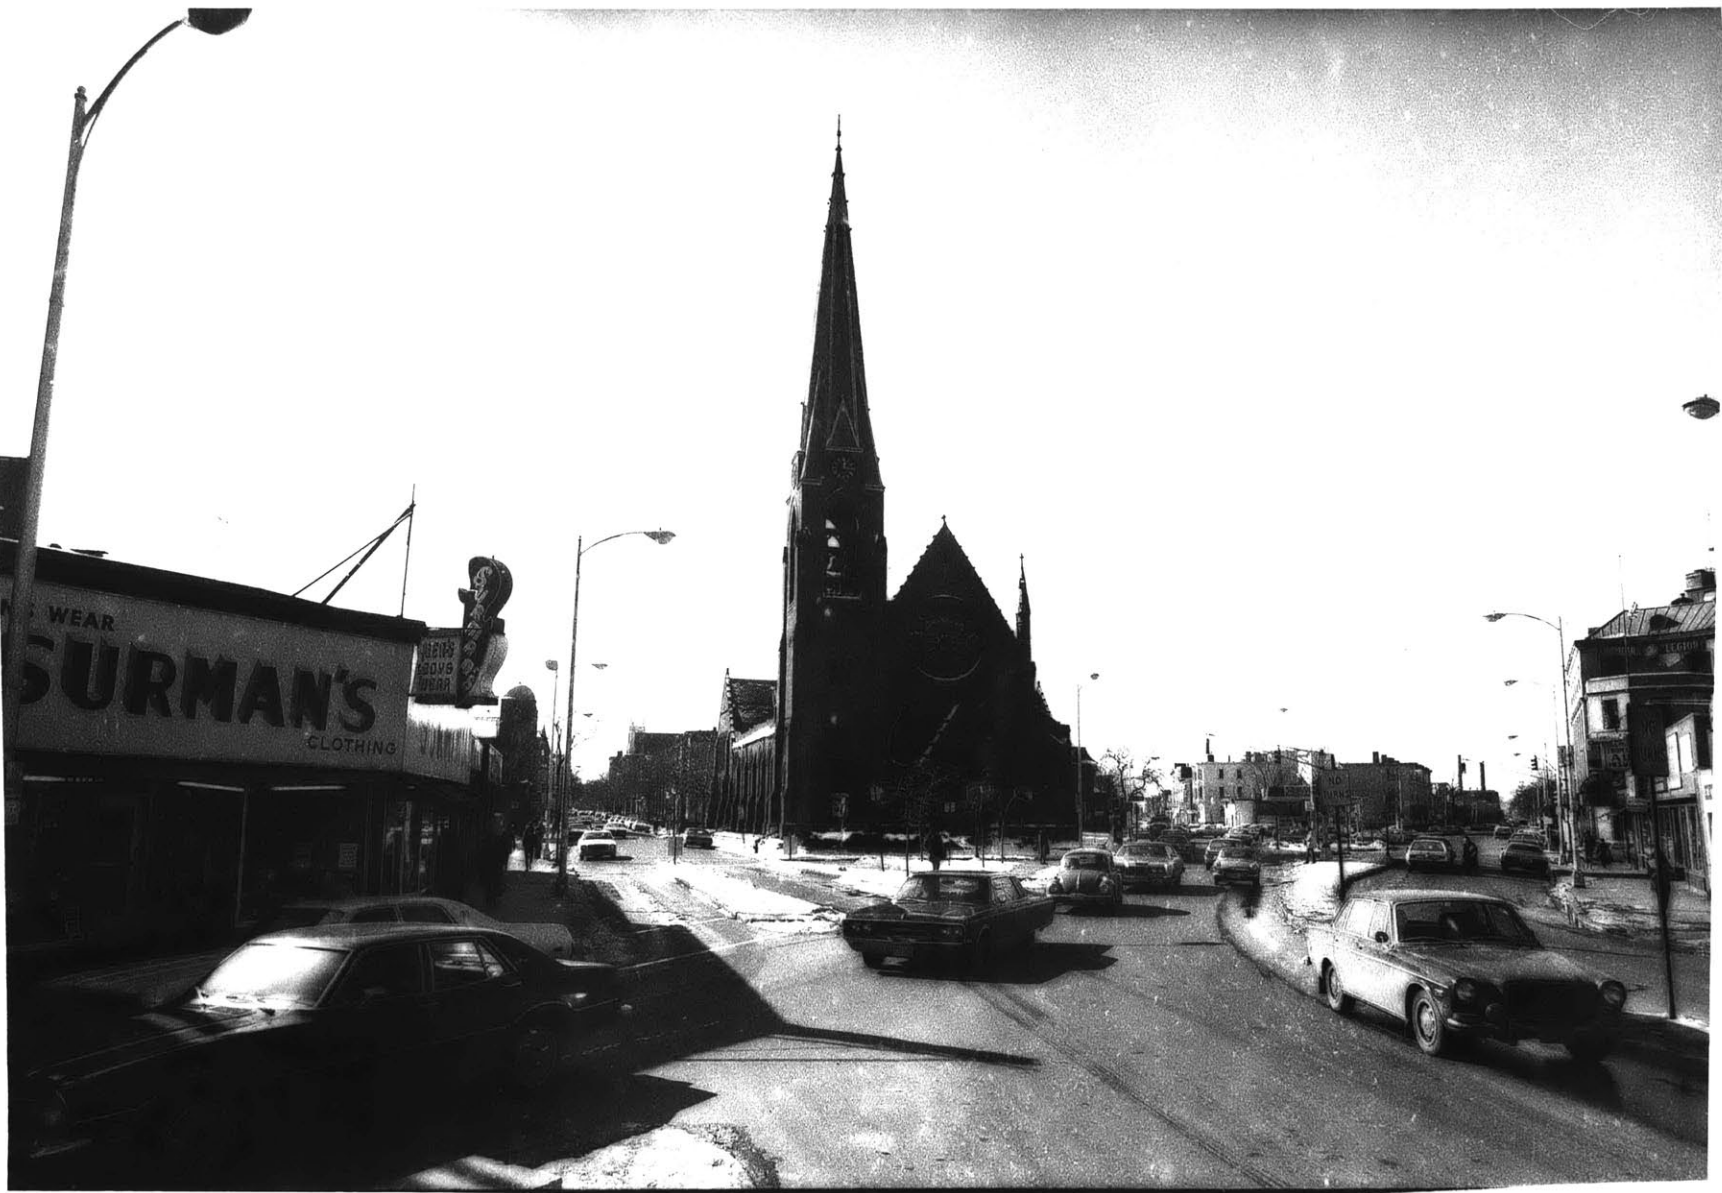
Plate 2

1. Site Plan
2. View of the front facade of the church, with some of the neighborhood and retail areas surrounding
3. Front elevation of the church
4. Interior of sanctuary, with rose window, looking toward Massachusetts Avenue
5. Interior of sanctuary, facing altar, looking toward ell
6. Ell partition system of stained and patterned glass in operable sash windows
7. Process: measuring the ceiling height of the ell, using a helium balloon
8. Drawings: Basement Plan
9. Ground Floor Plan
10. Second Floor Plan (balcony level)
11. Sections through sanctuary and ell
12. Sections through steeple
- 1 3. Current Financial Statement, Building Study Fund

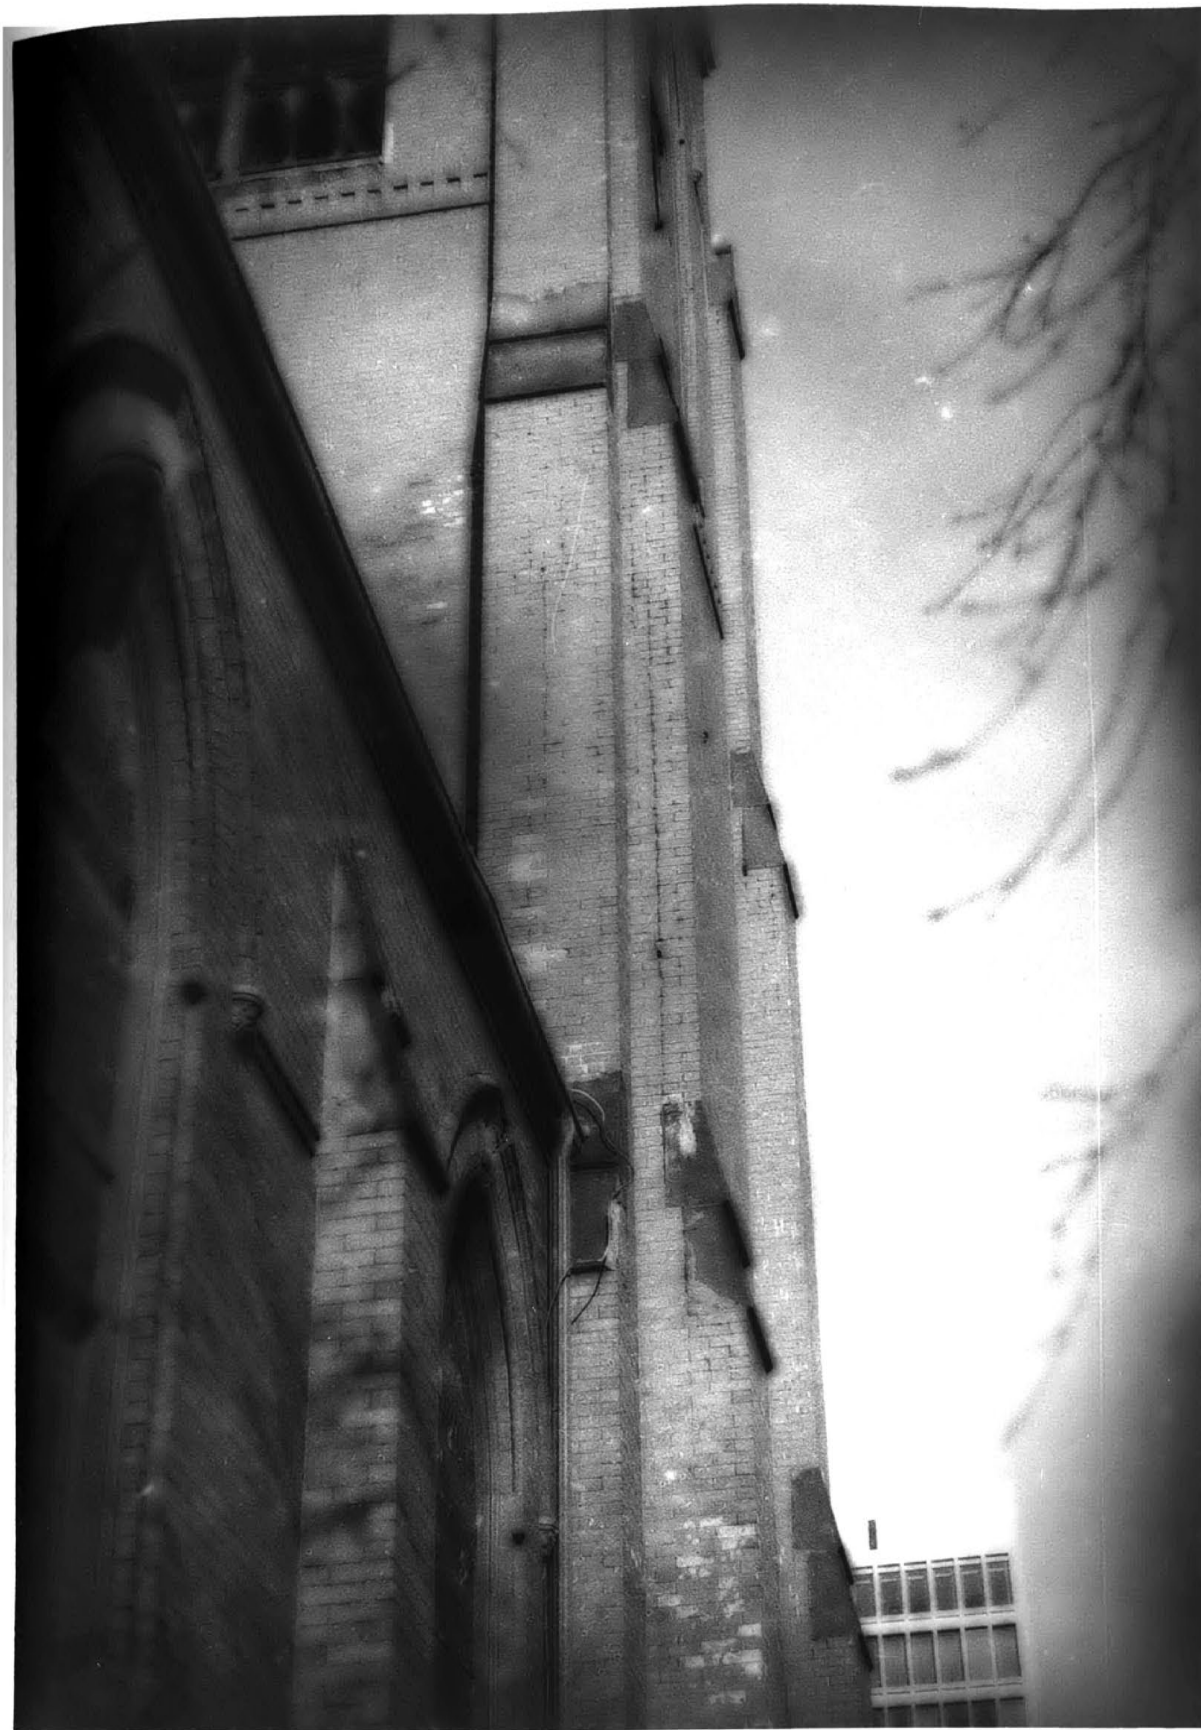
Plate 1

1. Steeple buttress cracks, long view at back of steeple.
2. Further buttress cracks at base of steeple.
Note condition of brick, which shows mortar loss and freeze-thaw damage.
3. Buttress crack at bell tower level of the steeple.
4. Buttress crack, showing exfoliation of sandstone cap.
5. Replacement brick in a buttress; note spalling of some of original brick.
6. Brick wall, front facade of building, showing ice sitting on the wall on a cold January day. The gutter above is broken.
7. View of brick inside steeple, where severe efflorescence has resulted in powdery deposits on brick and deterioration of mortars.
8. View of interior of steeple at basement level.
After a rain of thaw, this interior wall literally runs with water. There is no evidence of damage to the foundations, however.
9. Caving of stained glass windows.

Repointing, caulking, epoxying: A combination of masonry treatments is suggested for the steeple cracks. Repointing with lime mortar is recommended for the facades and the steeple masonry; and epoxy and caulking compounds should be carefully selected for use on the steeple. This combination of treatments raises a number of issues. First, where replacement material is used, such as new bricks and mortar, the new material must be carefully matched to the old. This is not just an issue of appearance. Each type of brick or mortar compound has distinct material properties. When dissimilar materials are used, their respective coefficients of thermal expansion must be recognized. Forces exerted by materials on other materials may cause further cracking and deterioration of the materials. We can already see some evidence of this in previous repointing and replacement work on the facade, where cracks have developed at the edges of the brick and through the mortar. It will be necessary to replace some of the exterior brick, particularly where deterioration is very advanced,
