THESIS.

THE CAUSE OF FAULTS IN ELECTROPLATED SPRINGS.

May 27, 1916.

Course XIV.

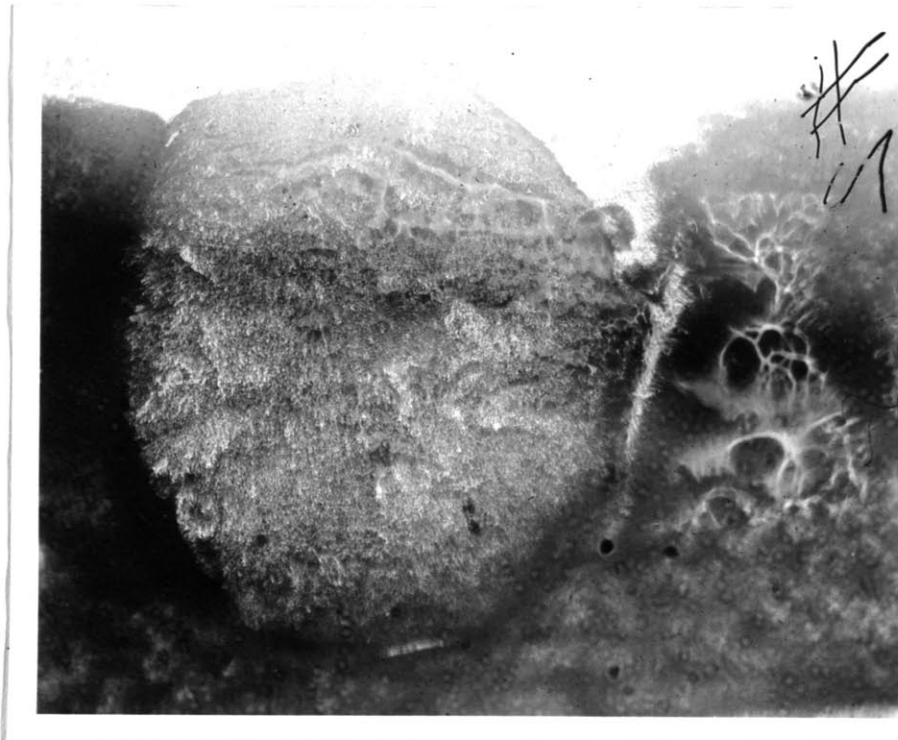
Magnification 175 Diam.

Photomicrograph of wire
which has been electrolysed.

0.7 % Carbon.

The springs were etched with a four percent solution of nitric acid in alcohol. The examination showed no noticeable difference between the structure of wire which had been electrolysed and that which had not been. The microscope was fitted with a camera attachment, so that photomicrographs could be taken. This was done, and the pictures are shown on the next page. The picture of the electrolysed spring appears slightly different from that of the other, but the difference is not in the structure. It is probably caused by improper developing or fixing, or the plate may have been slightly jarred during exposure.

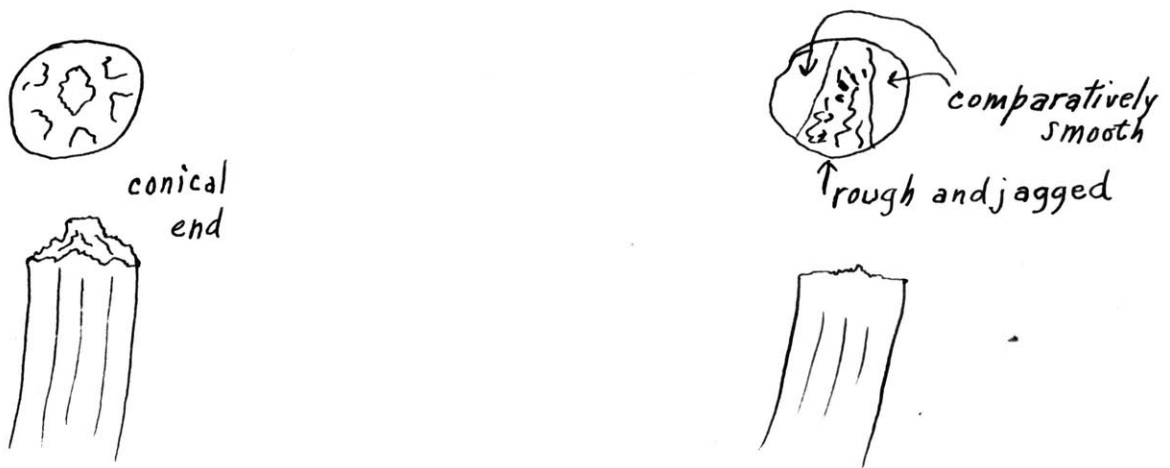
Occasionally, however, fractures of a different type occurred. The one on the right is similar to the type called "fracture in detail" in metallography. (see p.17)
