Tool Selection and Kitting: Technical and Organizational Issues

Master of Business Administration
and
Master of Science in Mechanical Engineering

In conjunction with the Leaders for Global Operations Program at the
Massachusetts Institute of Technology

June 2013

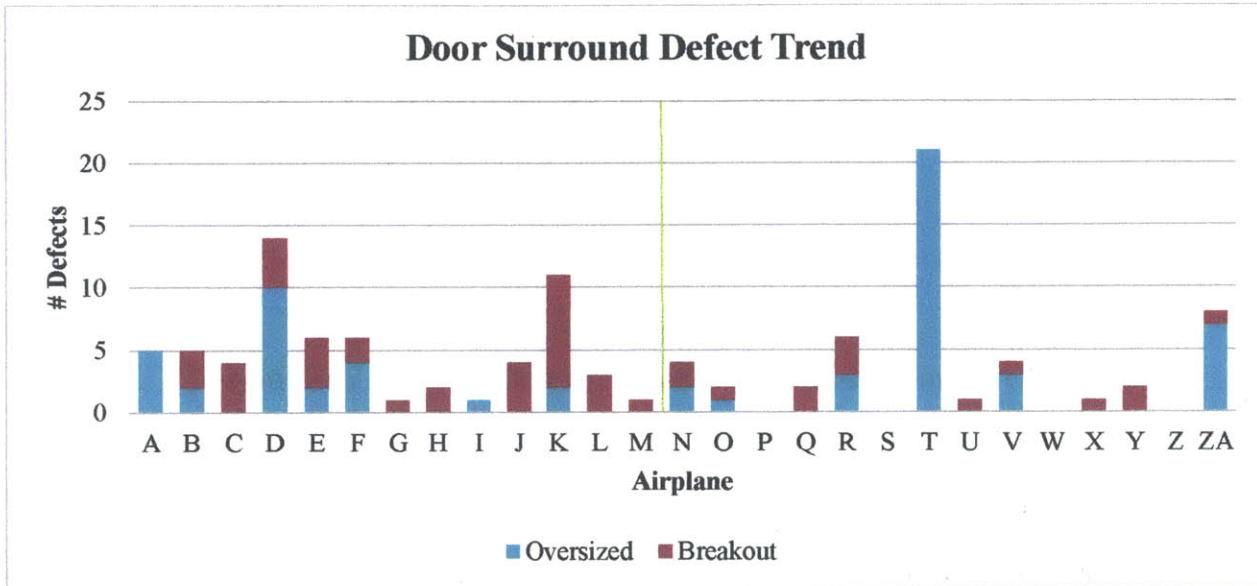
Figure 18: Door Surround Defects Before and After Tool Change

Figure 18 shows the number of defects recorded per airplane for the 13 airplanes before the tool change, and the 14 airplanes after the tool change. The green line indicates where the tool change occurred.

Except for the two outliers, airplanes T and ZA, one can see that the frequency of defects decreased since the tool change. To make a fair comparison, the exclusion of airplanes T and ZA must be justified. For airplane T, it was found that a damaged cutter (containing a chipped chisel edge) was used. Although this may be surprising to the reader, it is actually easy to chip a cutter if it is not handled properly. The cutter may have been chipped when setting up the drill, or if the drill were mishandled when the cutter point was exposed through the end of the bushing. Having a chipped chisel edge, which is at the very tip of the cutter reduces the cutter’s ability to advance without deflecting perpendicular to its axis of rotation. Consequently, it makes sense that every defective hole drilled with this cutter was oversized; fortunately no breakout occurred.

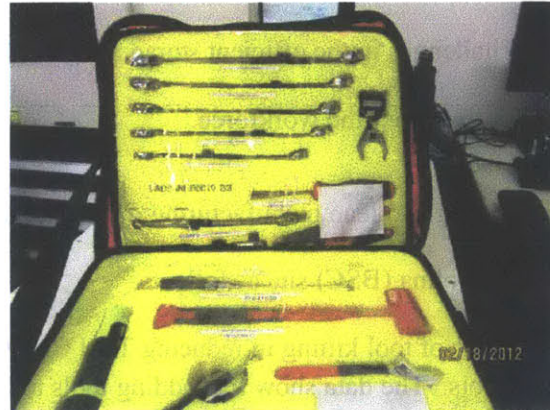
Figure 19: Tool Kit

available inventory. Boeing has chosen to pursue a strategy that distributes tools to mechanics in packages called kits, most of which are approximately the size of a laptop bag, as shown in Figure 19. These kits are stored “plane-side”, near the mechanic’s point of use. The main objective of this strategy is to reduce the “non-value-added” time it takes mechanics to retrieve the tools needed to perform their work.

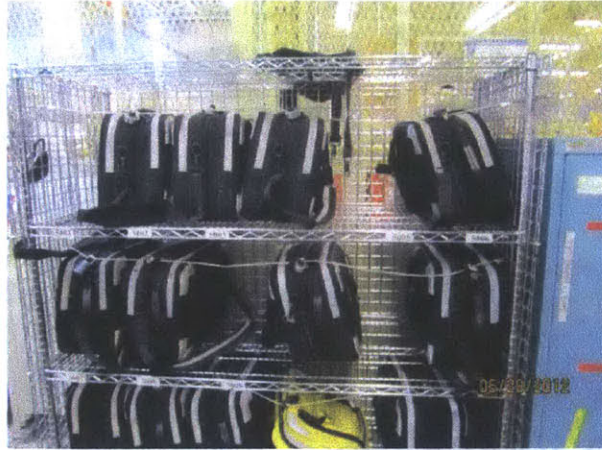
Figure 21: 777 Kit Rack

The 777 line uses an approach to durable tool kitting most similar to BSC. Tools are kitted in similar cases and kept in cages as shown in Figure 21. However, some cages are not located in manufacturing cells. Instead, they are located off the line, requiring mechanics to travel further to retrieve their tools. The 777 program has most of its durable tools kitted, but there is still some Tool Crib traffic for consumable items such as cutters. In addition, the 777 program has implemented some kitting for hazmat supplies, parts, and cutters, which is out of scope for this discussion.

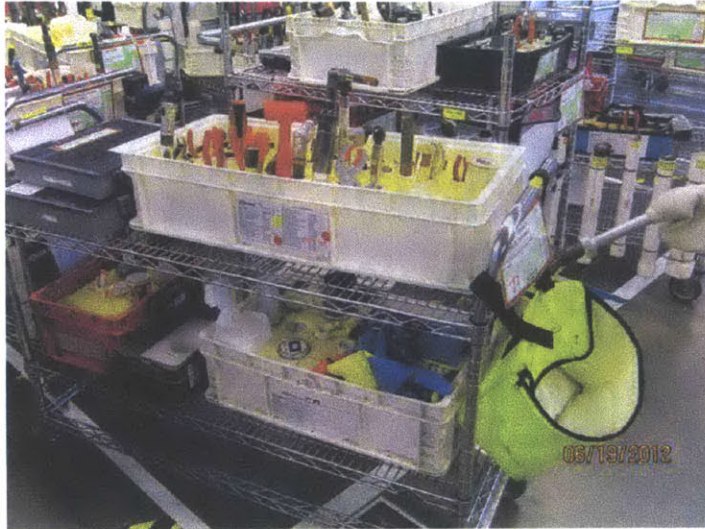
Figure 22: 737 Tool Kit Cart

A bit more interesting is the approach to kitting used at the 737 assembly facility, which currently has the highest production rate of any Boeing airplane program, producing more than one airplane per manufacturing day. The 737 plant has achieved a nearly 100% kitted operation. Both durable and consumable tools are staged in carts that function like movable toolboxes shown in Figure 22. Carts are delivered to the appropriate manufacturing cell for each shift and retrieved at the end of the shift. This operation is effective in keeping mechanics at their work station and able to perform their work. Tool Cribs in the 737 plant are rarely used and contain considerably less inventory than Tool Cribs in other airplane programs. While approach to staging and delivering tools reduces the waste associated with mechanics retrieving tools, it also requires additional overhead to prepare, replenish, and deliver kits for each shift. On the other hand, staging and delivering tools reduces the floor space consumed by tools in the mechanics' work areas. Only one shift's tools are stored on the floor at any given time.

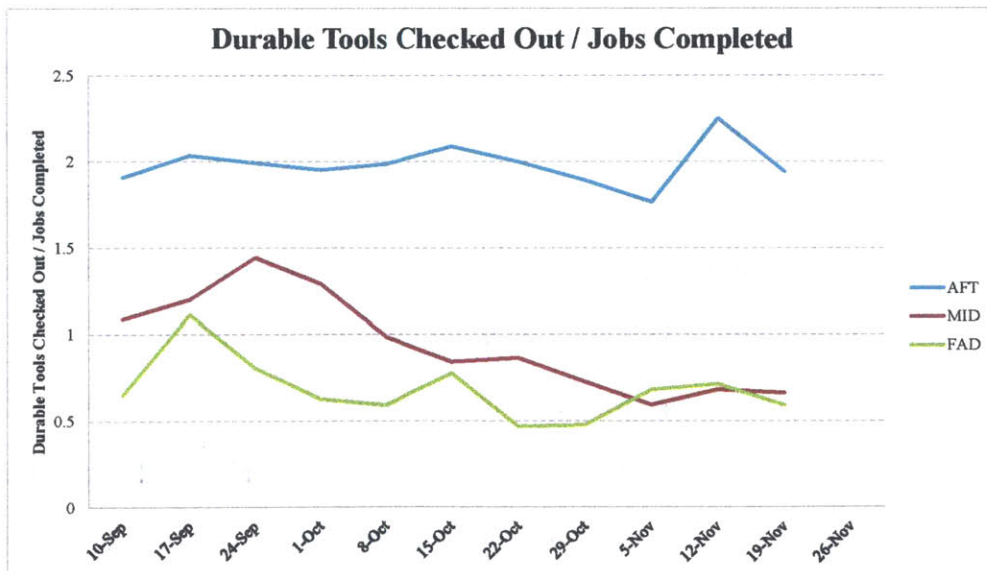
Figure 28: Durable Tools Checked Out/Jobs Completed over 12-Week Period since Formation of SWAT Team¹⁸

Figure 28 shows the normalized tools checked out metric trend for each building. Aft body shows a stable metric, meaning that the production rate increases were nearly perfectly correlated with the number of tools checked out. Mid body and final assembly both show improvements over this time period.

¹⁸ Due to the lack of job completion data available during the week of the US holiday of thanksgiving, the last week in the graph has an undefined metric. This week is left on the graph for the sake of consistency with Figure 27.
