Repair of Partially Penetrated Weld Joints in Copper-Nickel Seawater Piping on Naval Ships

Massachusetts Institute of Technology

September 2000

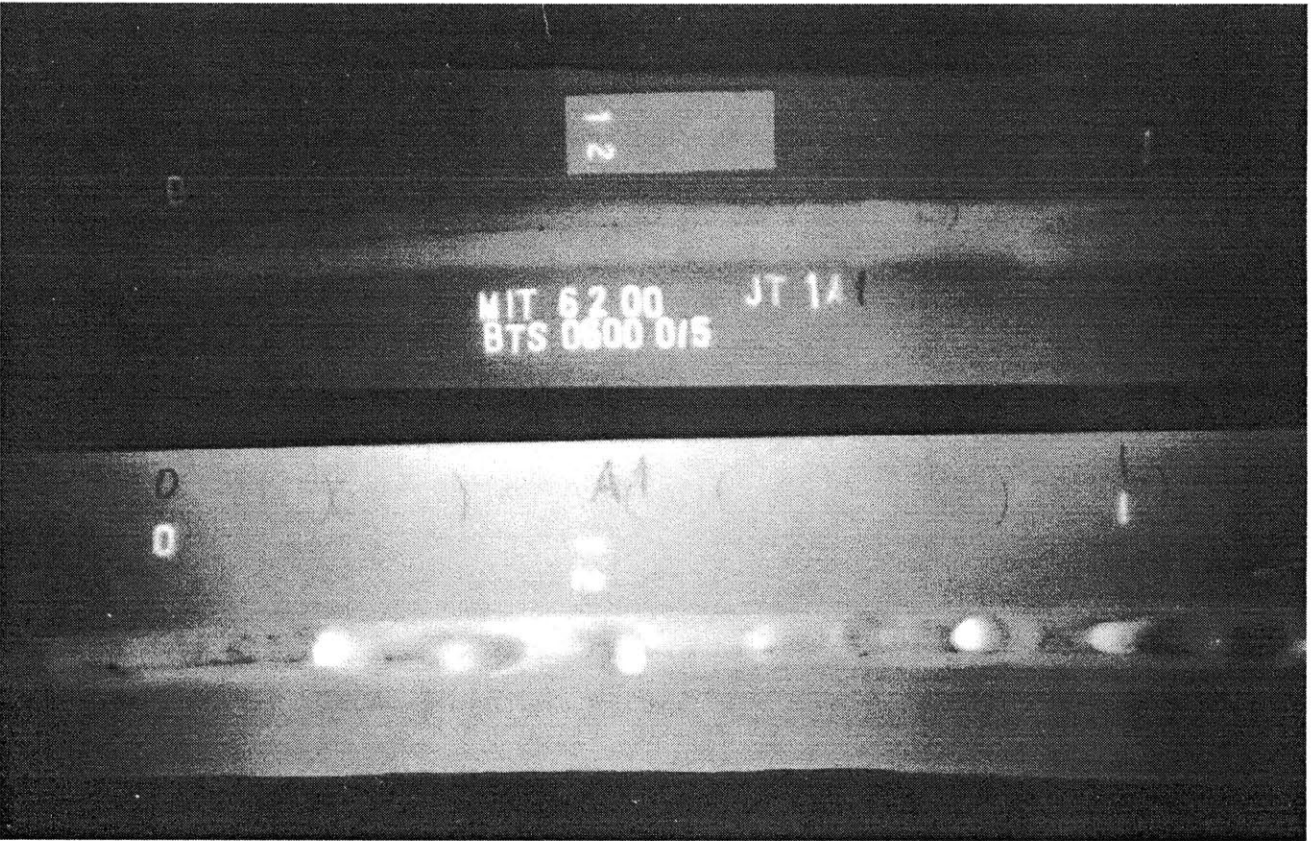
Figure 4-1: Weld A1, Section 0-1

The figures on the next several pages show X-rays of all the joints. Small dark spots are pores, larger dark patches are thin patches, usually due to concavity, dark lines are partially penetrated seams. Figures 4-1 through 4-12 show the original condition of the weld on the left and the condition after welding on the right. The numerals 0, 1 and 2 are indices around the circumference; the index 3 on the right of Figures 4-10 and 4-12 is equivalent to the index 0 on the left. Weld C1 is on the left of Figure 4-13, C2-A is in the center, C2-B is on the right. Figure 4-14 shows welds C3-A, C3-B and C3-C from left to right. Welds D and C in Figure 4-15 are continuations of welds C4-A and C4-B, respectfully, from top to bottom. The four vertical welds in Figure 4-16 are welds C5-A, C5-C, C5-D and C5-B from left to right; weld C5-E runs horizontally across the bottom. Figures 4-17 and 4-18 use circumferential indices 0,

Table 4.4 indicates that all the welds in the A-series pipes were unsatisfactory. Since these are the welds that most closely reflect the practical situation, this result would seem a conclusive condemnation of weld repair without cleaning the root surface. However, it actually shows the practical difficulty of performing this sort of repair. Examination of the X-rays in Figures 4-1 through 4-12 alongside the pipes themselves shows that whenever the repair weld lay on top of the flawed weld, and fully penetrated the pipe wall, the resultant weld is whole and not flawed. It was difficult to obtain this, however. Small misalignment was sufficient for the repair weld to miss the seam. Obtaining full penetration without burning through was a delicate matter, especially when starting the weld. Most of the incomplete penetrations are at starting points before the welder obtained full penetration. This is another facet that depends

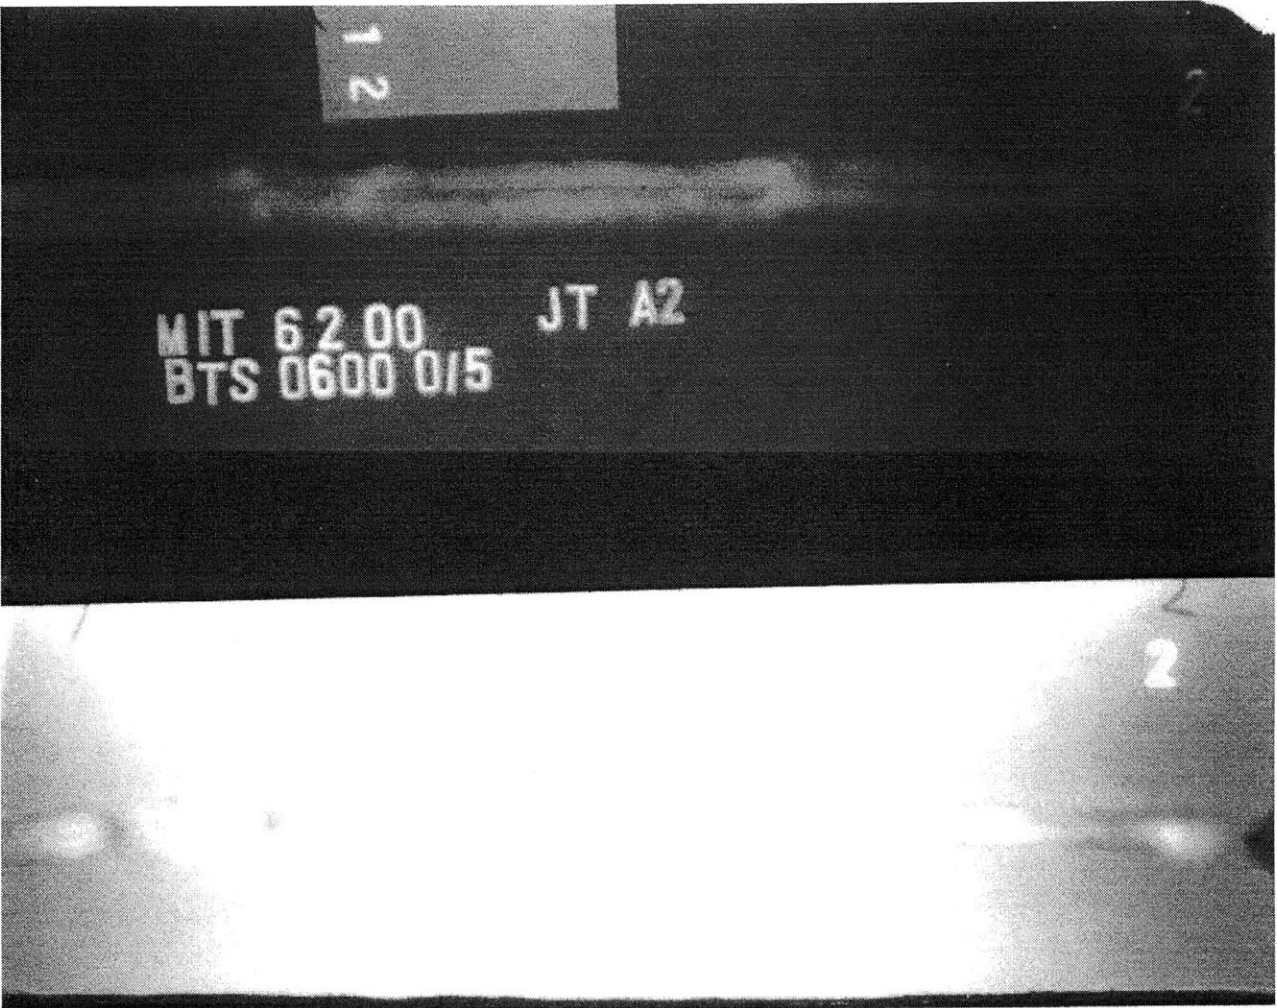
Figure 4-21: Close-up of Weld A2, Section 1-2

on the individual welder's proficiency. Figures 4-21 through 4-24 show close-ups of the X-rays showing locations where the repair weld did indeed fill the flawed weld. Figures 4-25 through 4-27 are photographs of the root surface of effectively repaired welds, cleaned of scale. The black lines show where the partial penetration had been; the arrows indicate the extent of the full penetration. The protruding bead has filled the crevice.

Weld A2 shows little difference between the composition of the weld bead and the base metal. Weld A3 shows little difference in the common elements. The appearance of chlorine
