History and Technology of Lemuel Chenoweth's Covered Bridges

SUBMITTED TO THE DEPARTMENT OF CIVIL AND ENVIRONMENTAL
ENGINEERING IN PARTIAL FULFILLMENT FOR THE DEGREE OF

MASTER OF ENGINEERING IN CIVIL AND ENVIRONMENTAL ENGINEERING
AT THE
MASSACHUSETTS INSTITUTE OF TECHNOLOGY

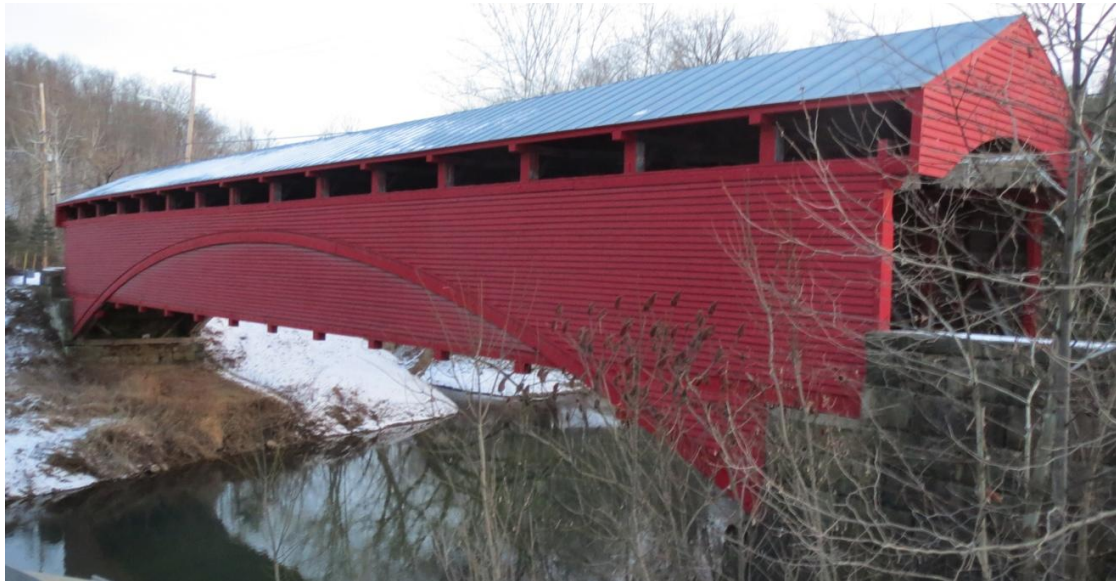
Figure 1.1: Barrackville Covered Bridge (photograph by author, 2014)

1975). It spans 145' 5" over Buffalo Creek and is a multiple King-post arch-truss (Figure 1.1), the system patented by Theodore Burr in 1817. The Historic American Engineering Record (HAER) conducted an extensive survey of the bridge in 1973, including photographs and measured drawings (HAER WV-8 2003). The survey shows the modifications made to the bridge in order to carry 20th century vehicle loads. The deck framing was strengthened with additional timber stringers. Iron rods were added that hang the roadway from the deck, though this has been shown to add redundancy to the structure, rather than strengthen it (Lamar and Schafer 2002). The bridge carried vehicle traffic on Marion County Rt. 21 until 1991, when a modern steel girder bridge replaced it. In 1999, the bridge was renovated so as to match its original appearance and currently serves only pedestrian traffic.

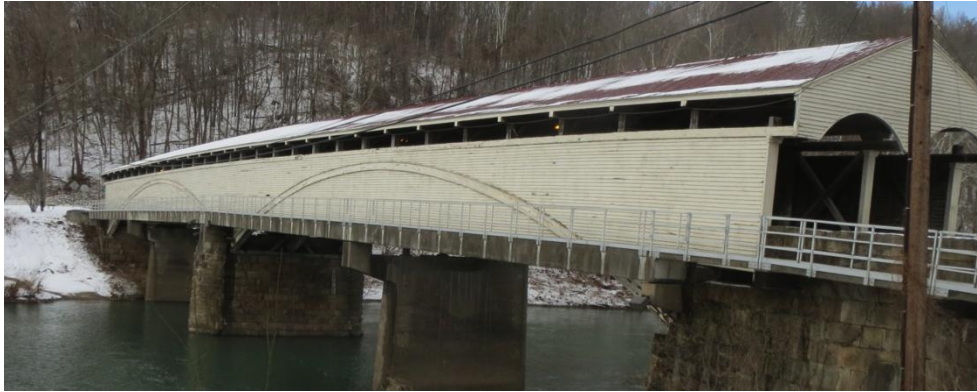
Figure 1.2: Philippi Covered Bridge (photograph by author, 2014)

The Philippi Bridge is the most well known Chenoweth structure, and is the only one that currently services vehicle traffic (Figure 1.2). It was opened in 1852 and originally consisted of two 138-foot spans that meet at a masonry pier in the Tygart River in the city of Philippi (Kemp 1992). The structure had two parallel carriageways and featured two crossing diagonal members at each truss panel. The bridge was the site of the first Civil War land battle in 1861. A major renovation of the bridge was undertaken in 1938, when a concrete pier was added in the middle of each clear span in order to support steel beams and a new concrete deck needed to support highway loadings. This modern deck carries the full live load, and the original timber supports only itself and the cover. The bridge was nearly destroyed by an accidental fire in 1989 caused

by a gasoline spill from a nearby storage tank. The bridge was restored by 1991 and retained as many of the original timbers as possible. It currently services U.S. Route 250 and is the only timber bridge that is a part of a federal highway (Ibid.).

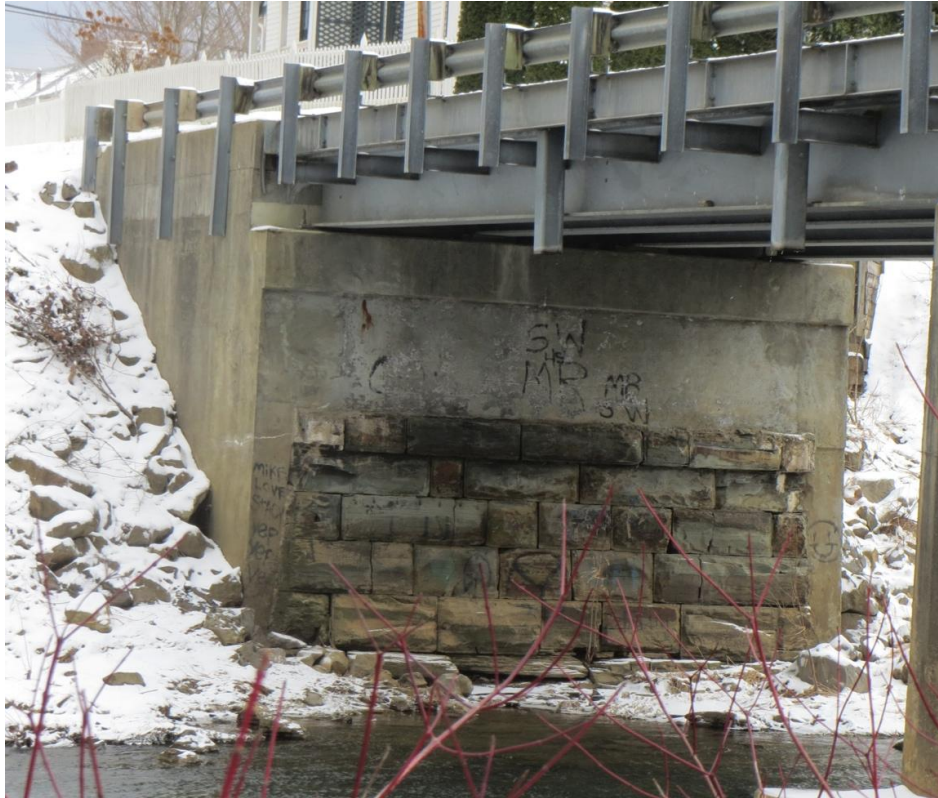
Figure 2.1: Existing Beverly Bridge Abutment (photograph by author, 2014). The concrete abutment for the current bridge was cast around the original masonry structures.

Observations were performed by the author in January 2014 of the current bridge at Beverly and the two extant bridges built by Chenoweth. At Beverly, the stone abutments are still present and are used to support the modern bridge (Figure 2.1). Concrete was added above the stone to extend the face of the abutments. This makes it impossible to measure the exact original span length. Concrete was also added along the sides of the abutments to allow for a two lane roadway, rather than the original 18-foot-wide passage. Intermediate concrete piers were also built in the Tygarts River. Lemuel Chenoweth's house is still standing at its original location overlooking the Beverly Bridge, and currently operates as a museum (Figure 2.2). Many buildings in the town have been maintained in their historical condition, and the Beverly Historical Society is active in preserving the elements of the town.

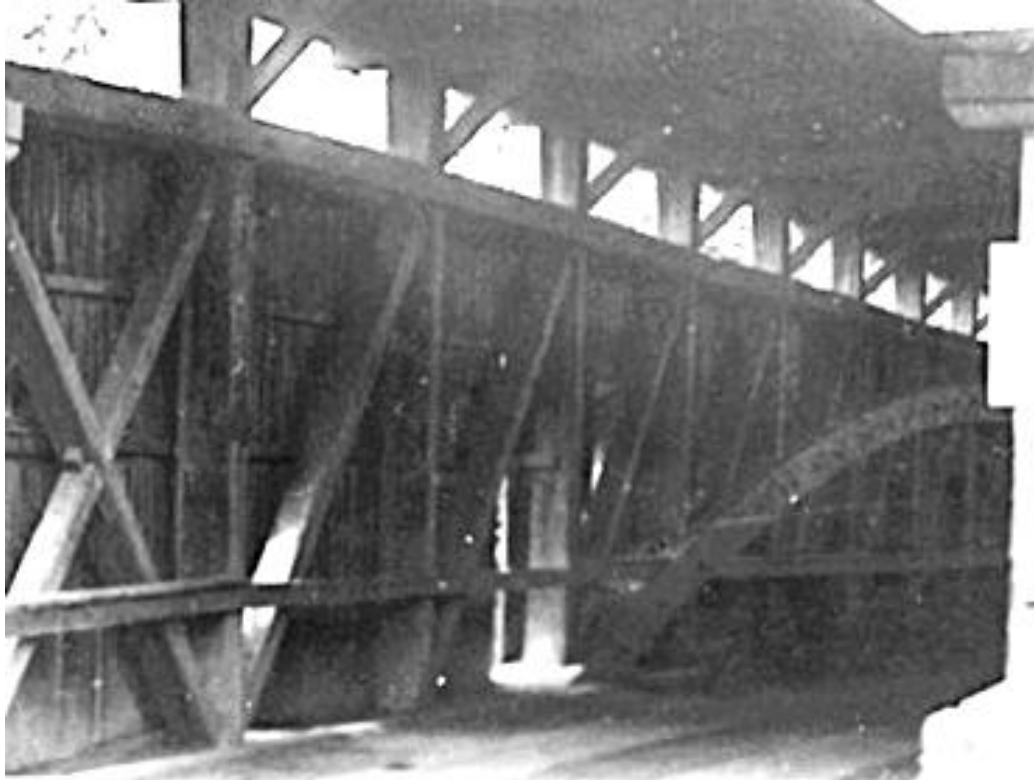
Figure 2.6: Beverly Bridge photograph detail, showing a Burr truss layout and typical connections

Historical photographs were examined in order to verify the general layout and location of the Beverly Bridge (Figure 2.4, Figure 2.5, and Figure 2.6). These show that the bridge was constructed as a Burr truss, with the diagonals in compression and cross bracing diagonals at the panel resting on the abutments. It also shows that the bridge entrance is adjacent to a railroad, as are the observed abutments. Additionally, the photographs show the bridge opening was changed from the traditional rounded shape to a square profile in order to accommodate large vehicles. The photographs show a posted load limit of three tons. It also appears that the bridge experienced significant sag over time. The photographs show that the arch crosses the bottom chord at the third panel of the truss. It can also be observed that there are sixteen truss panels, including the two that sit completely on the abutments. There are also iron bolts visible where the arch meets the diagonals and verticals of the truss. This construction makes the Beverly Bridge similar to the Barrackville, with the exception that Beverly has one additional truss panel. It is not clear if the bridge was cambered originally, and no exact date of the photographs is available.

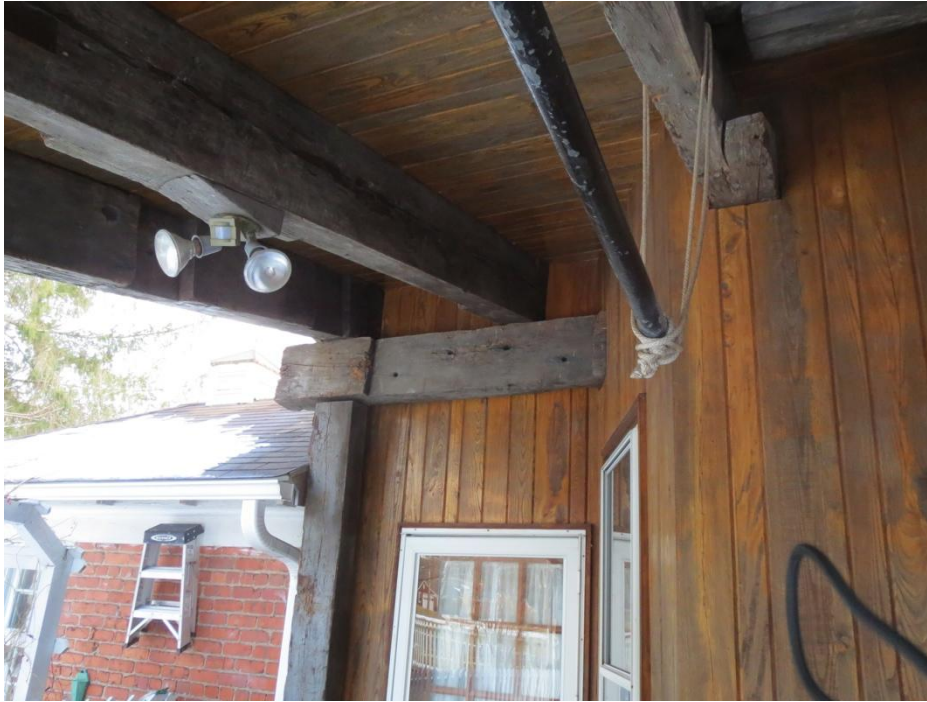
Figure 2.7: Portion of Beverly timbers in Biola house (photograph by author, 2014)

After the bridge was torn down, local townspersons scavenged the timbers from the river. Joseph and Heather Biola (a member of the Beverly Historical Society) own a house at 12 Prospect Street in Elkins that was partially constructed using the salvaged timbers (Figure 2.7). The members were examined with the help of Darryl Weiser, a local carpenter who has worked on several covered bridges in Virginia. They were inspected for signs of wear and damage, as well as to gain species and age information. Cross-sectional dimensions were also measured.

The individual elements show no signs of deformation, though the historical photographs show a bridge that is clearly lower in the middle than at the abutments. The ends of the members, where the tree rings are visible, were examined in order to determine the species and gauge the age of the timbers used. The members believed to be the bottom chord and vertical members are yellow poplar, which is an easily workable material when green, meaning freshly cut when alive. Care must be taken to account for shrinkage of the timbers as they dry out, or damaged members or unwanted initial stresses may be present.

At the ends of the timbers, the rings of the timbers were exposed. This provided useful information about the properties of the timber used in the bridge. The poplar had between 25 and 30 rings per inch. This is a high value for yellow poplar, which today typically has 10 rings per inch (Forest Products Laboratory). This high density of rings is typical of old-growth forests, where close spacing of neighboring trees led to slower growth. Based on the ring density and diameter of the timbers observed, it is estimated that the trees used in the Beverly Bridge were between 225 and 270 years old. According to Mr. Weiser, all of the forests containing trees that age or older were completely cleared by the 1920s. The denser wood would have a higher strength and lower modulus of elasticity than modern timbers of the same species. However, the modern wood would have a lower dead load if the same cross sections were used. For the

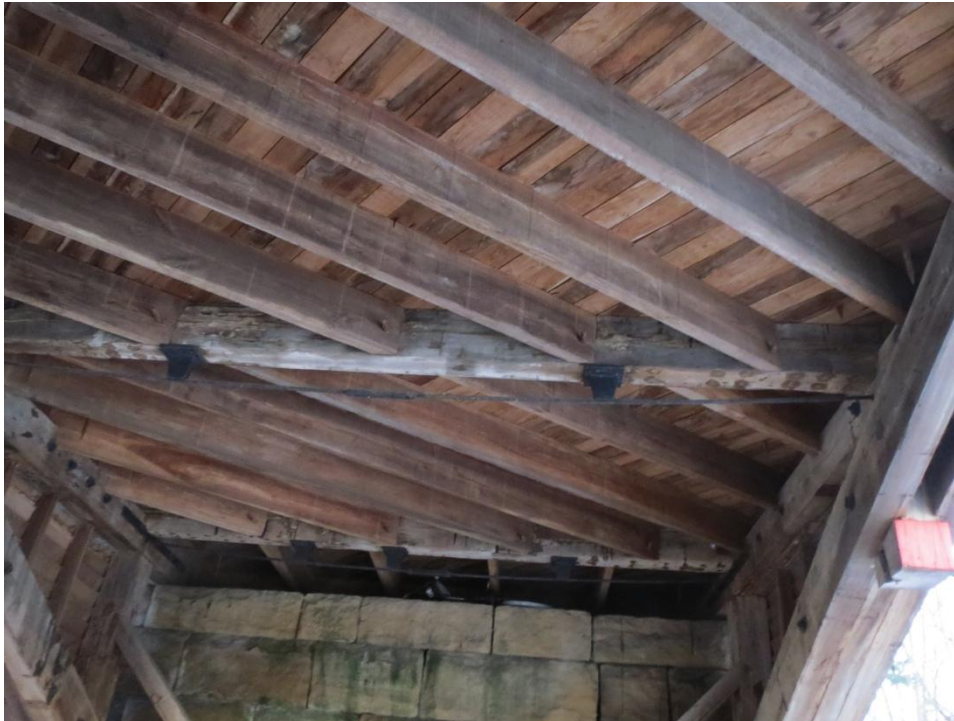
Figure 2.8: Barrackville Floor Framing (photograph by author, 2014)

Barrackville provides a useful point of reference as to how the floor framing of the Beverly Bridge likely changed over time. The bridge was renovated so as to match its appearance at the time of its construction in 1999, and its current floor framing is shown in Figure 2.8. There is one primary beam spanning between the trusses at each panel intersection, with a steel rod attached underneath to form a kind of shallow truss. Small secondary timber beams frame into the primary beams and truss bottom chords at roughly 45 degrees. These secondary beams support two layers of timber planks.

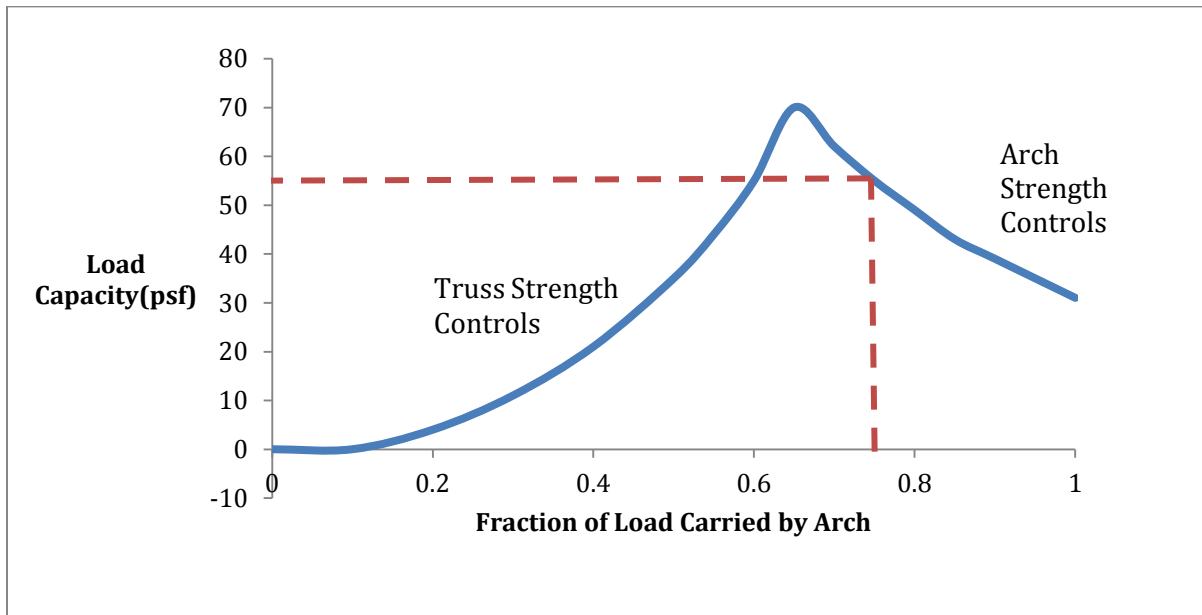
Figure 3.2: Beverly Bridge Load Capacity

A final study was performed in order to determine the maximum total load that can be carried by the system. According to Ron Anthony, a wood scientist at Anthony and Associates, ultimate strengths of timber structures could be evaluated by different methods than the design strength method shown above (personal communication with Anthony, 2014). The arch and

chords are both composed of parallel timbers, which add redundancy and resilience to the system. It would be reasonable to assume that the overall ultimate strength of these elements is higher than the maximum stresses given in the National Design Specification (Ibid.). However, since no specific strength values for the timbers are available, the design strengths are used to develop a conservative estimate of the ultimate capacity. Various values of percentage of load carried by the truss were used. The results of this study are shown in Figure 3.2.

At the assumed value of 75% of the weight distributed to the arch, the load capacity was found to be approximately 55 psf. At this point, compressive strength of the arch section controls the capacity. The above chart (Figure 3.2) shows that once the arch capacity is reached, additional load could be distributed to the truss. If this is the case, an ultimate load capacity of 70 psf could be attained. The critical portion of the truss is the bottom chord at the middle of the span, which fails in tension.

This ultimate load capacity does not account for the resiliency inherent in the system. Material strengths are based on a failure probability derived from physical testing. The design strength of the material is based on a specific probability of failure. If two members are used in parallel, the system will have a smaller standard deviation of strength and the same mean strength per unit of area. This means that the failure probability used to determine the design strength will occur at a higher strength value for two parallel members than for a single member

with the same total cross-sectional dimensions. This is similar to the concept that a glulam member of a given species will have a higher design strength than a sawn timber member of the same size. In this ultimate load test, failure occurs at either the bottom chord or in the arch, both of which consist of two parallel members. It stands to reason that the actual ultimate load is significantly higher than the value calculated above.

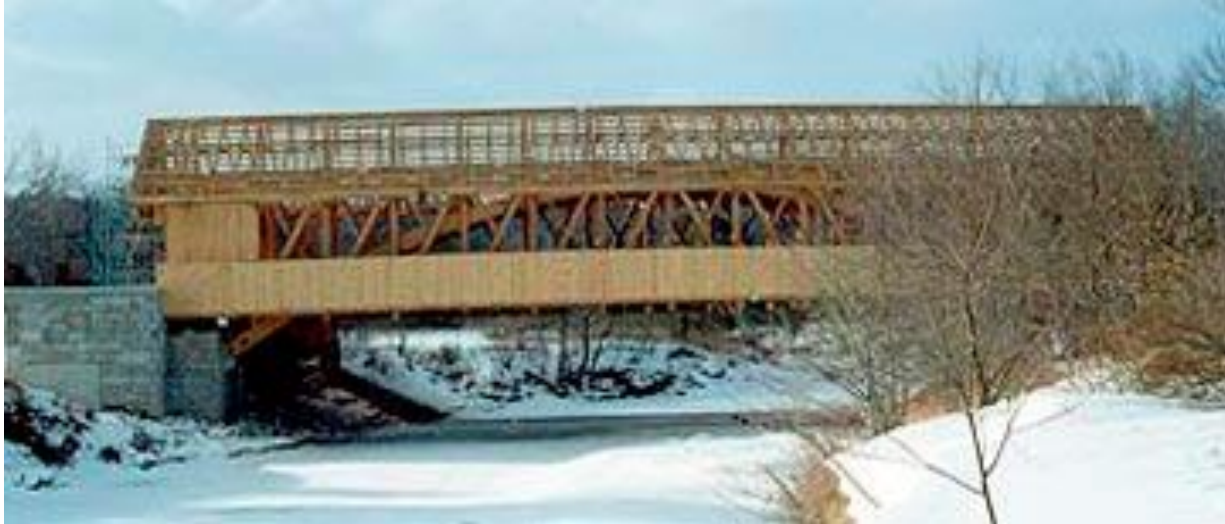
Figure 4.1: Smith Millennium Bridge (gratonconst.com)

The modern Smith Millennium Bridge was designed for the AASHTO HS-20 loading. It is the first covered bridge that meets this rating. This design loading required the use of southern pine glulam timbers, which have a much higher reliable strength than the equivalent sawn timbers. The deck is composed of 6.75-inch thick glulam, and a replaceable oak wearing surface was added on top. Thirty inch deep glulam beams support the deck. The bridge also has a fire alarm system, and most of the timbers are coated with a fire retardant.

The full bridge was constructed on falsework that had been erected in the river. Most of the bridge was assembled by lifting one member at a time into place with a crane. The total construction cost was \$3.1 million, which includes the construction of the abutments and the realignment of a portion of the connecting highway. The superstructure alone cost \$1.5 million. Of this, \$1.4 million was used for the procurement and fabrication of the glulam members. The construction was performed by 3G Construction Inc, the firm of the Graton family of bridge builders. An image of the completed bridge is shown below in Figure 4.1.

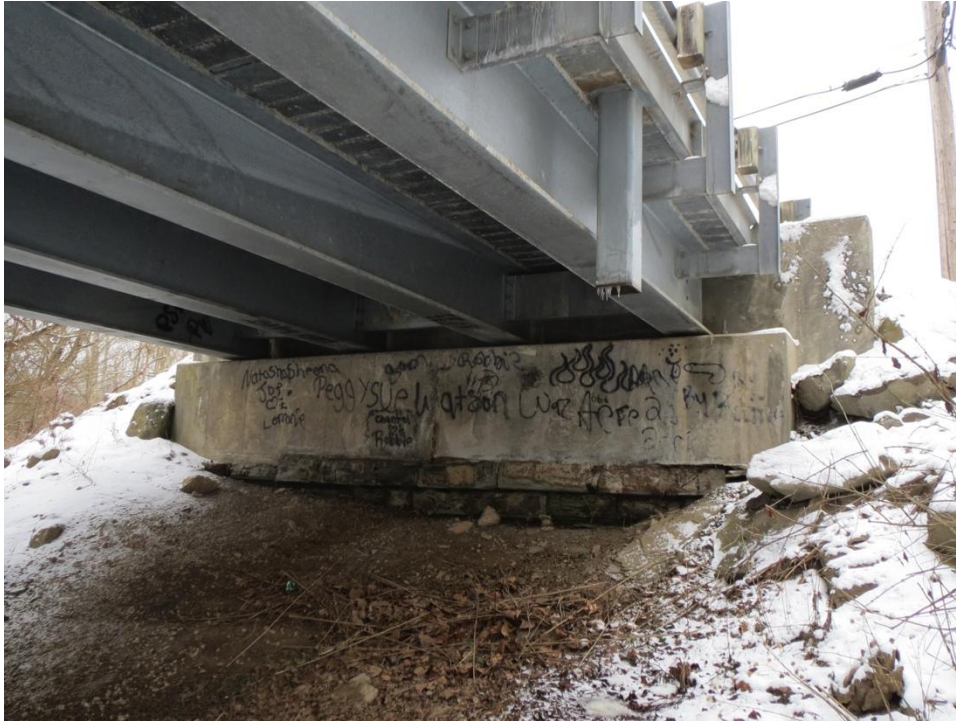
Figure A 4: West Abutment of the Beverly Bridge, mostly obscured by soil and new concrete

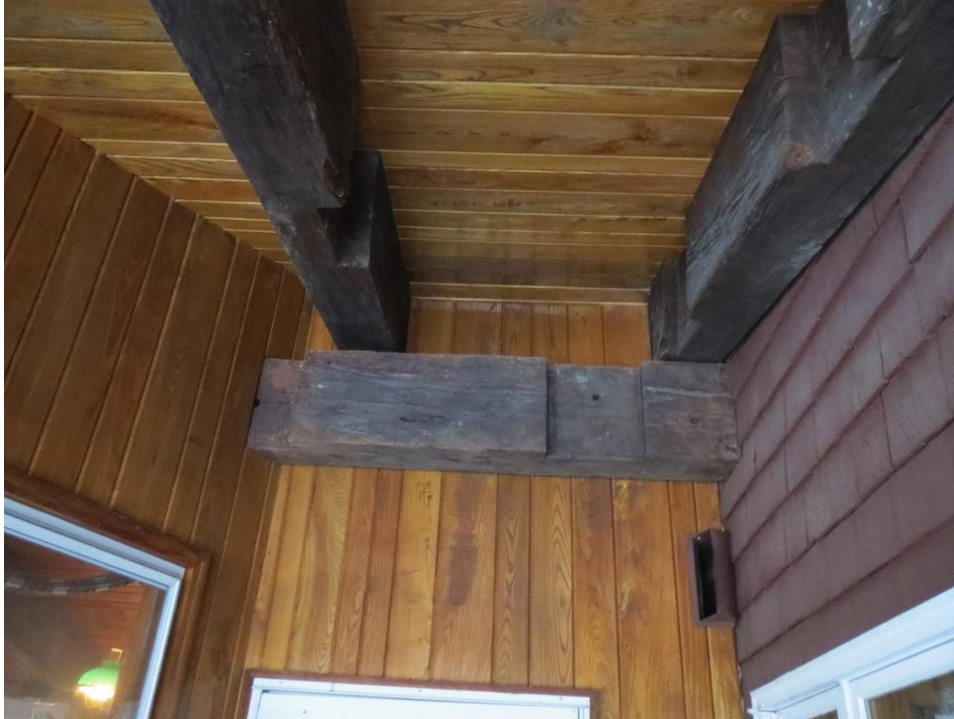
Figure A 12: Salvaged Beverly Bridge Timbers. Note the cut area and single bolt hole of the supporting member.

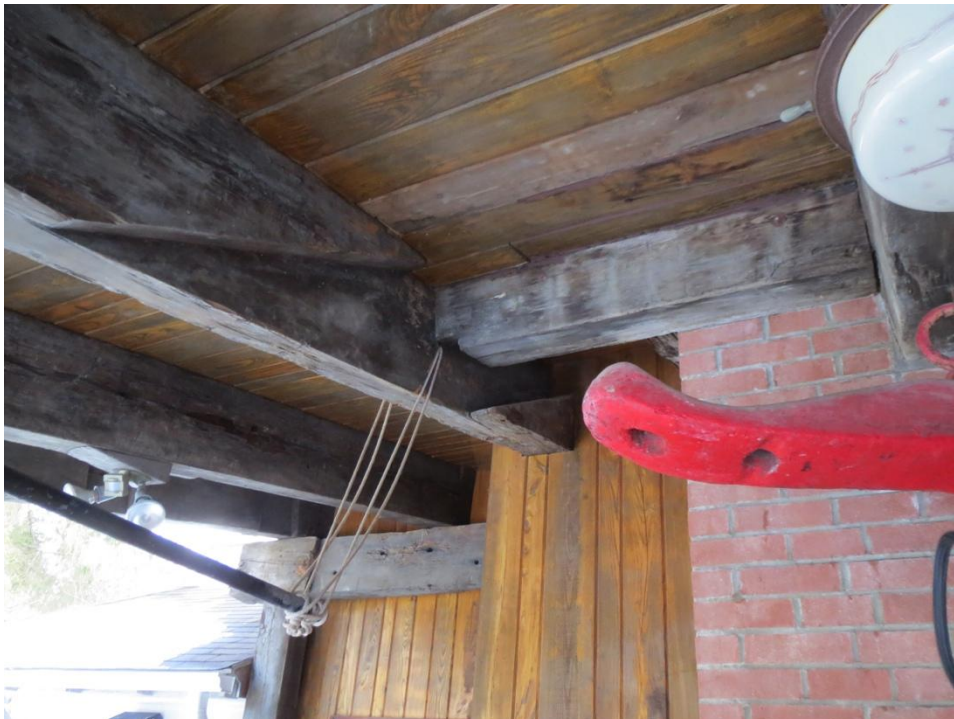
Figure A 13: Salvaged Beverly Bridge Timbers. Note the large transverse cut area, likely the location of an arch and bottom chord intersection

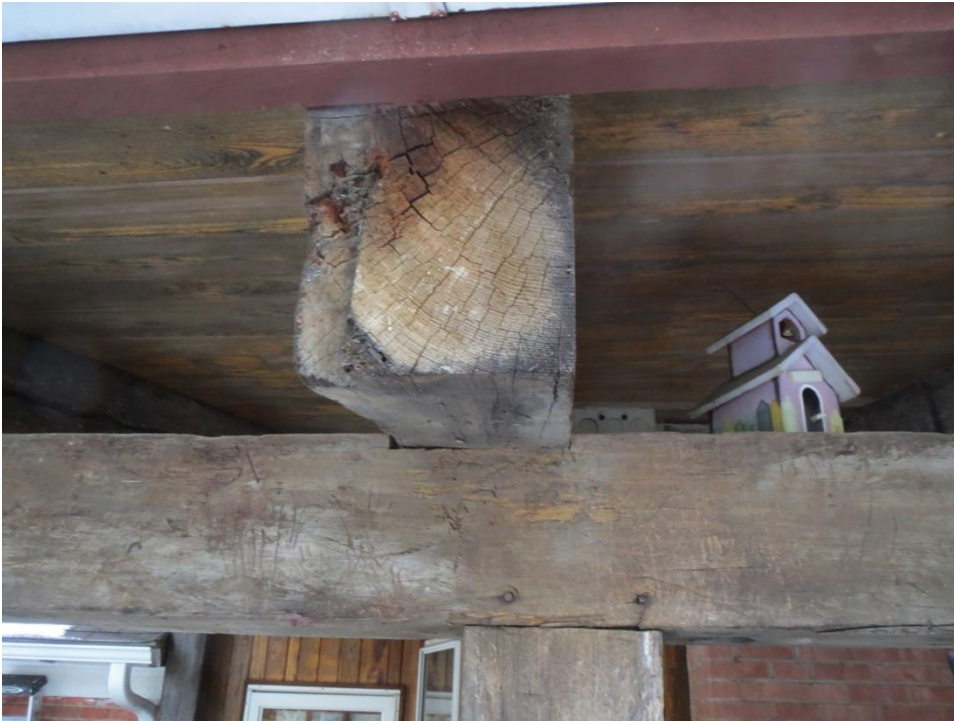
Figure A 15: Salvaged Beverly Bridge Timbers, showing growth rings of the member

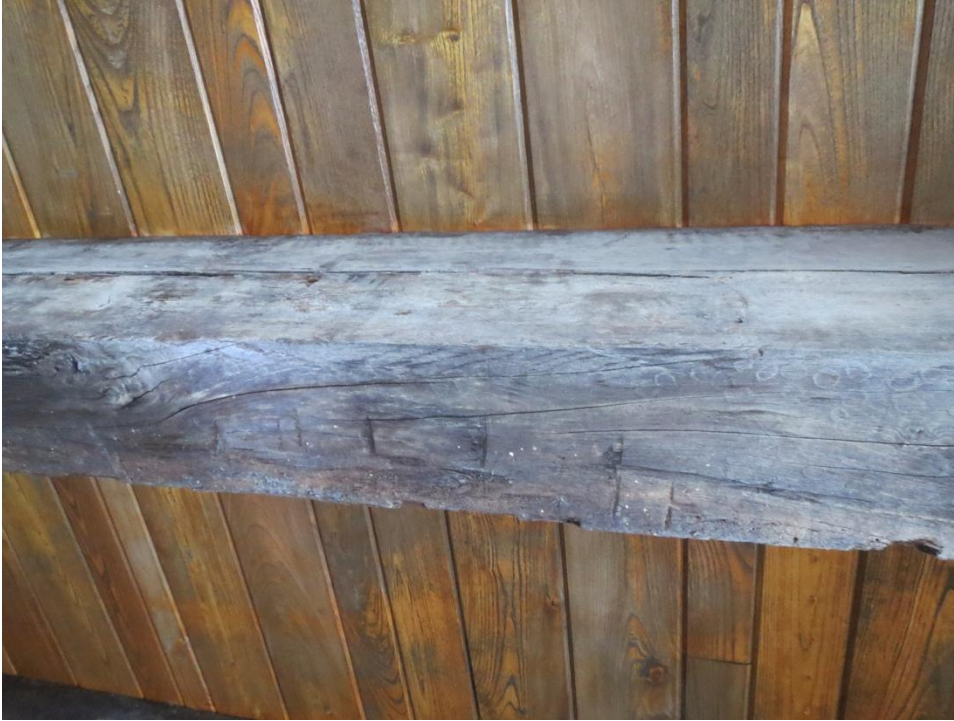
Figure A 16: Salvaged Beverly Bridge Timbers, showing axe marks

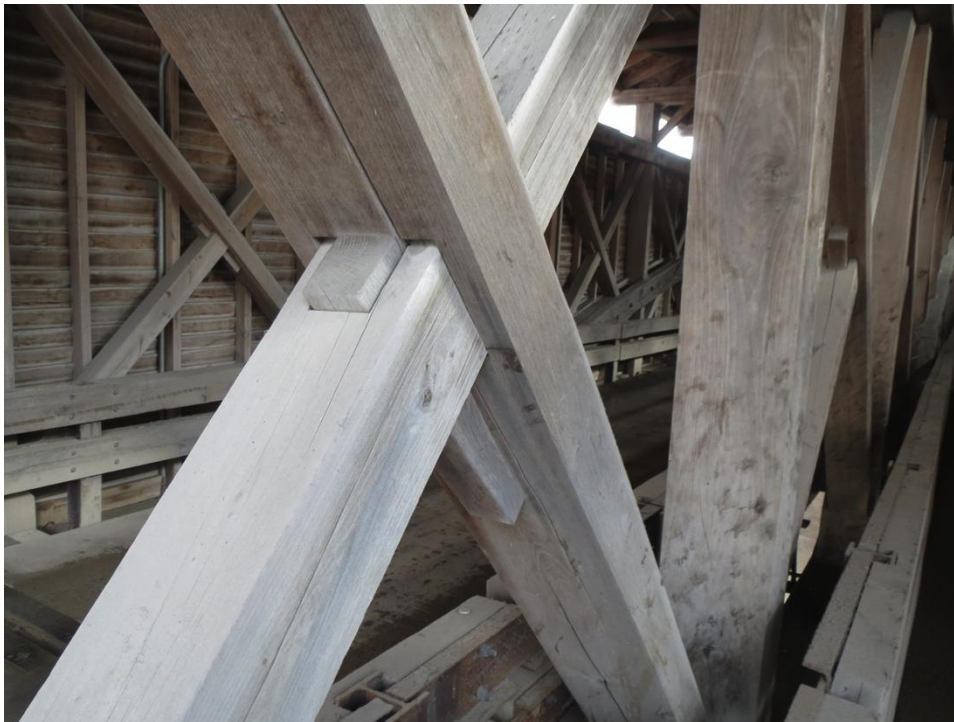
Figure A 30: Diagonal Intersection Detail. A similar connection would be used between the two diagonal elements of the panel resting on the abutments at Beverly.

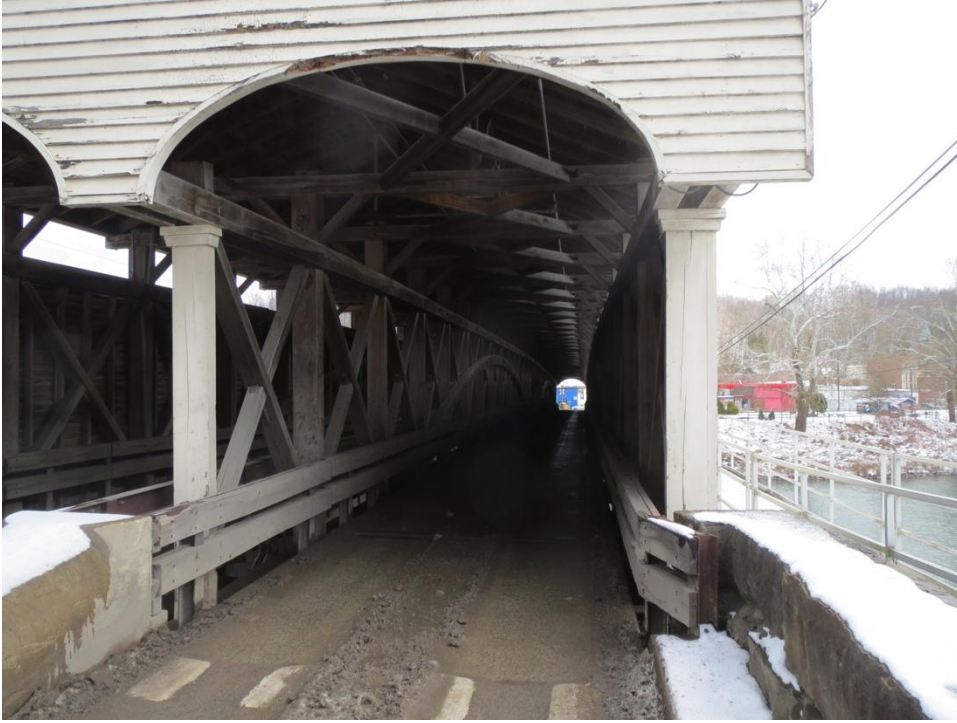
Figure A 31: Philippi Bridge Portal, showing the concrete deck and guardrails
