**MICROBIAL CONTAMINATION IN THE KATHMANDU VALLEY
DRINKING WATER SUPPLY AND BAGMATI RIVER**

MASTER OF ENGINEERING IN CIVIL AND ENVIRONMENTAL ENGINEERING

MASSACHUSETTS INSTITUTE OF TECHNOLOGY

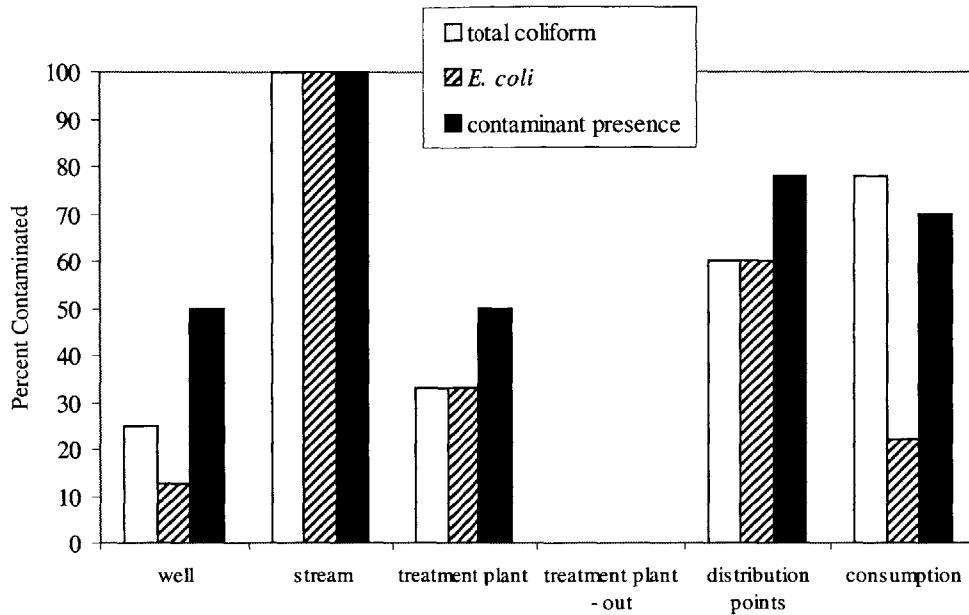
Figure 4: Microbial contamination in the Kathmandu Valley water supply system, January 2000

Figure 4 shows that the microbial contamination was not consistent throughout the Kathmandu Valley water supply system. Wells and streams had different contamination levels even though they are both direct sources. Wells were generally less contaminated although Figure 4 does show that over 50% of them had some sort of contaminant presence. Not surprisingly, streams had the highest contamination levels of all the sources tested, probably because it has many opportunities for exposure to contaminants.

Even though the treatment plants were found to be microbe-free, the distribution points were not. Almost 80% of the samples taken from distribution points, tap stands and faucets, showed some type of microbial contamination. About 60% of distribution point samples had *E.coli* presence. This suggests that most water distributed through Kathmandu Valley's water distribution system is polluted with fecal material. Considering that none of the water at the outflow of the treatment plants contained microbial contamination it appears that water was contaminated within the distribution system.

It has also been suggested that there is significant drinking water contamination during consumer handling.³³ Figure 4 shows that these analyses found little difference between contamination at distribution points and consumption points, though there was a little increase in contamination from wells to consumption points. This data indicates that most contamination was not originating at the household level. There also was a drastic decrease in *E.coli* levels between the distribution points to the consumption points (from 60 to 22%). This might be because people have improved their hygiene practices. That is not an unreasonable assumption given the attention focused on the need for consumer education about hygiene.³⁴ It is also possible that people are using some form of simple treatments in the restaurants and stores such as filtration or boiling.

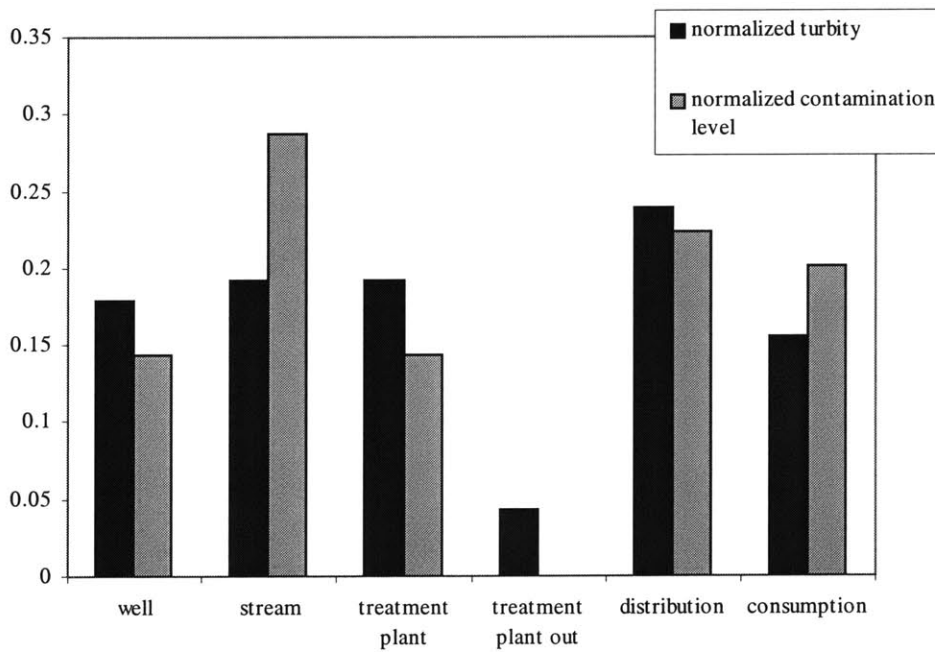
Figure 6: Normalized values for turbidity and microbial contamination level in the Kathmandu Valley water supply system – January 2000

The results shown in Figure 6 indicate there was a fairly good correlation between a source's turbidity and microbial contamination. While a direct relationship cannot be established from these data, in general it appears that when there was a higher turbidity level in a sample there was also a higher likelihood of microbial contamination. Conversely, when the turbidity level was low, there were fewer chances that the sample was contaminated.

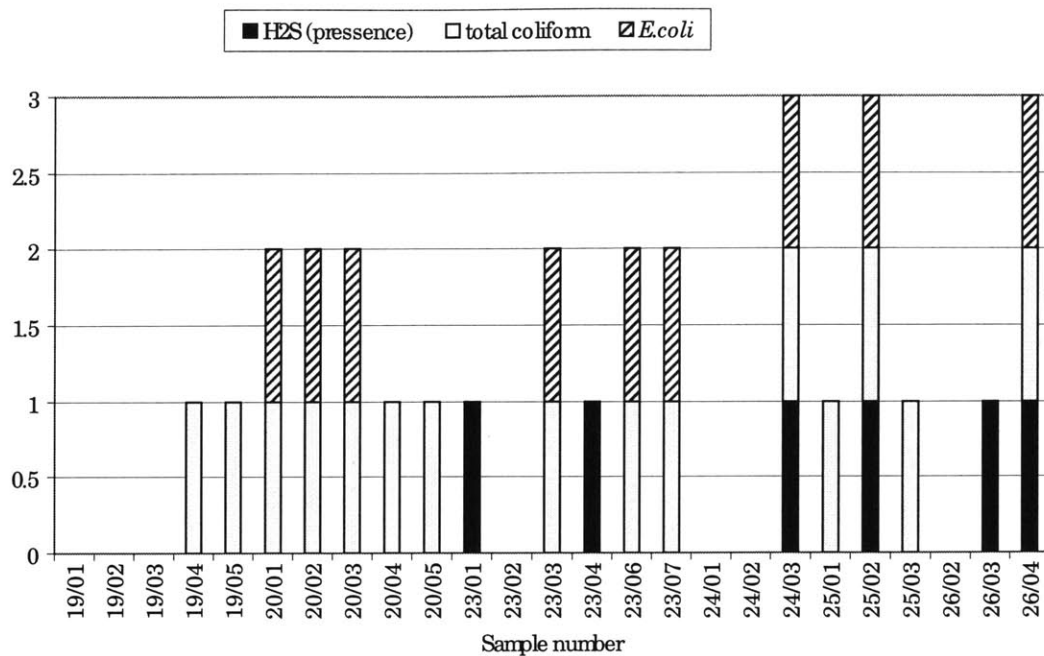
Figure 7: Correlation between the Hydrogen Sulfide test, total coliform, and *E.coli*.

Figure 7 shows that the nine times there was *E.coli* present in the sample, total coliform was also present in the sample. There were also six times where a sample was positive for total coliform but not for *E.coli*, indicating that contamination was perhaps not of fecal origin in those cases. However, of the six times that H₂S producing bacteria was found only half of those times corresponded to other indications of fecal contamination. The three samples that were positive for both H₂S bacteria and total coliform were also positive for *E.coli*. There were no samples found which were contaminated with both H₂S producing bacteria and total coliform but not *E.coli* and there were three samples that were positive for H₂S bacteria but no other types of bacteria. These results are hard to explain and it is unclear why some samples would show contamination with H₂S producing bacteria but not total coliform. The results from these tests is another suggestion that a correlation between H₂S producing bacteria and other fecal indicator bacteria might not be as straightforward as some research suggests.

Of the 39 tests performed on drinking water samples in January 2000, 25 were analyzed using both the H₂S and the total coliform/*E.coli* tests. In order to gain a better understanding of the correlation between the three types of tests, the results were plotted and can be seen in Figure 7. All bars in Figure 7 are of unit length and represent a positive result for a given test. For example, the results from 19/01 show that there was no H₂S, total coliform, or *E.coli* present; 19/04 only had total coliform; 20/01 had total coliform and *E.coli*; and 24/03 were positive for all three.

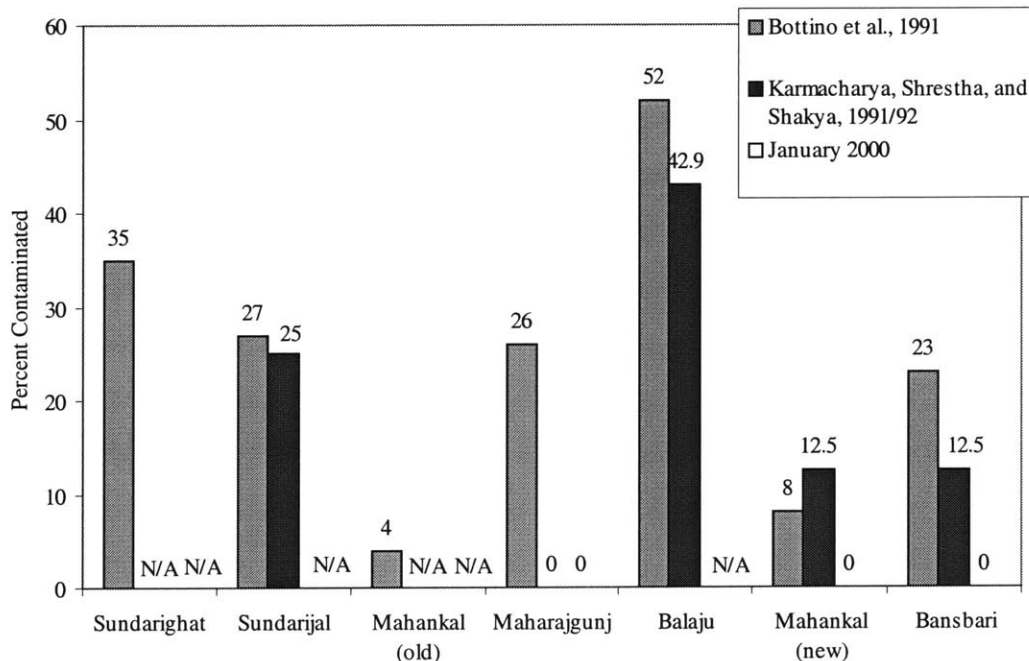
Figure 8: Percentage of contaminated samples found in the Kathmandu Valley water supply system.

Several other sources of data were examined to get a clearer idea of the water quality leaving the drinking water treatment plants.⁴⁶ The results from the January 2000 and other studies are plotted in Figure 8. Percent contamination was used so that all the results would be comparable.

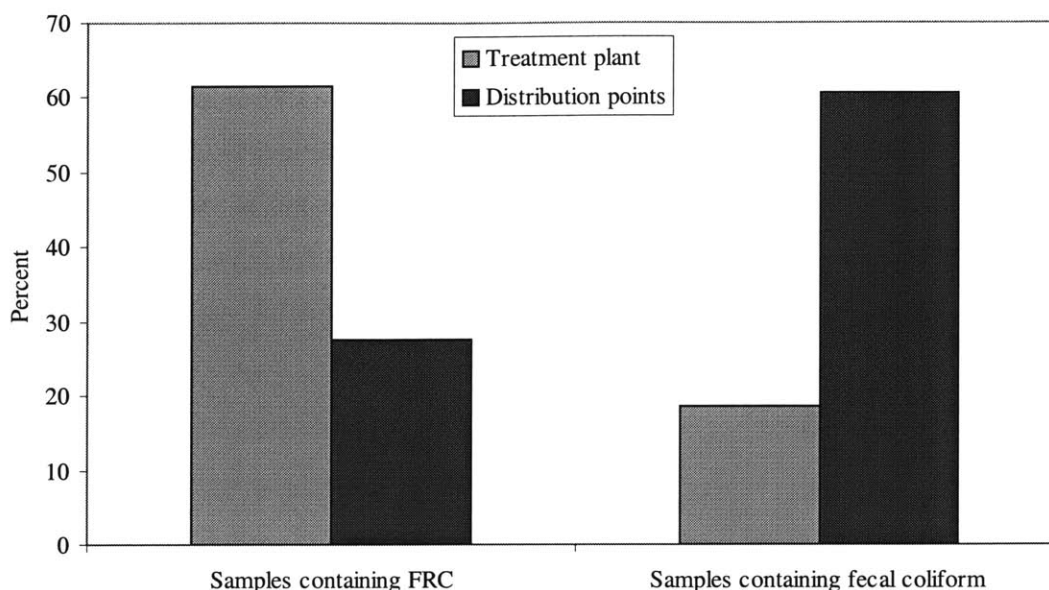
Figure 9: Relationship between free residual chlorine and fecal coliform.⁴⁹

This comparison is another indication of infiltration in the distribution system and shows that the consequence of declining levels of chlorine is increasing incidence of fecal coliform contamination. When samples contained FRC they were less likely to contain fecal coliform. Polluted water that infiltrates into the distribution system dilutes the purified water and introduces bacteria. Concentrations of FRC decline because of dilution, through depletion in during the disinfection process, and in the formation of chloro-organic compounds. Once the chlorine is depleted, coliform levels increase and there is a high level of bacterial contamination at the distribution points.

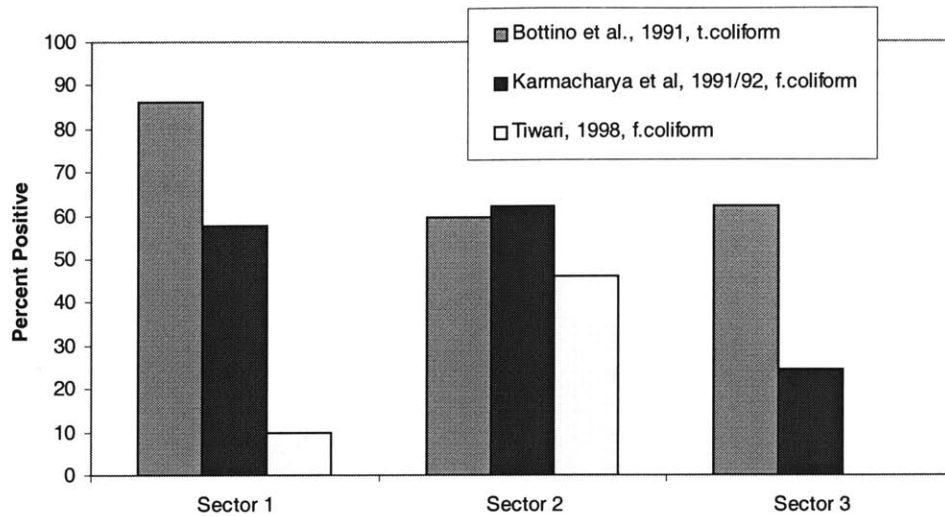
The data in Figure 11 indicate some differences in the microbial quality in different sectors of the city. Yet, it shows only a moderate trend towards decreasing the overall microbial contamination levels in the Kathmandu Valley's water supply system. The conclusion drawn from this data is that there are no significant sector variations.

Figure 11: Percent contamination at distribution points in different sectors of Kathmandu City

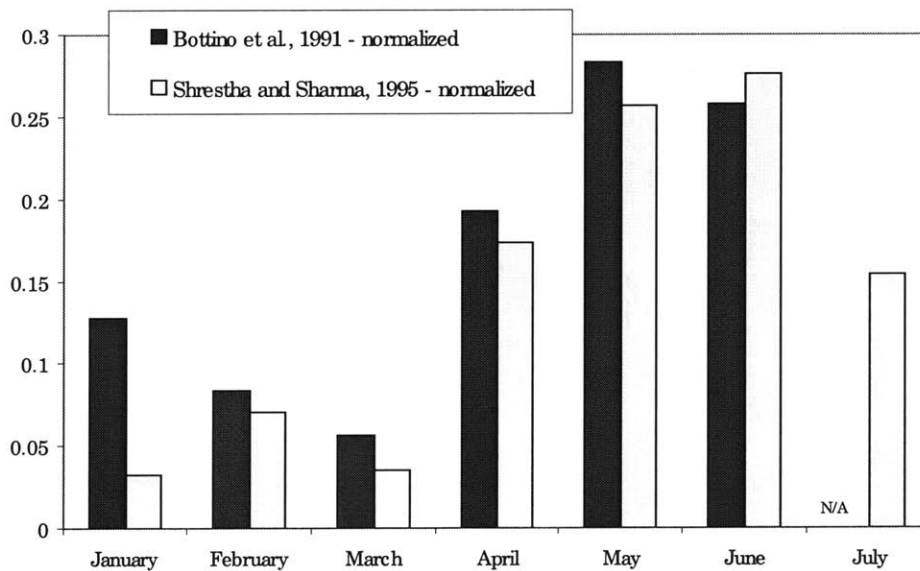
Figure 12: Normalized seasonal variation of total coliform at drinking water distribution points.

The data shown in Figure 12 was normalized to provide a better comparison between the two sets of data. The two studies both show highly seasonal variations in total coliform levels. The results indicate a fairly predictable pattern of contamination with more microbes found in the late spring than in the winter. This pattern makes it easy to predict when high contamination levels would be found.

One of the main problems with water quality in Nepal is that it varies a lot over the course of the year. In the dry season, there are often fewer incidences of pollution in the water supply system. In the wet season fecal contamination of drinking water increases significantly. Figure 12 shows the seasonal variation of total coliform contamination in drinking water from two different studies.

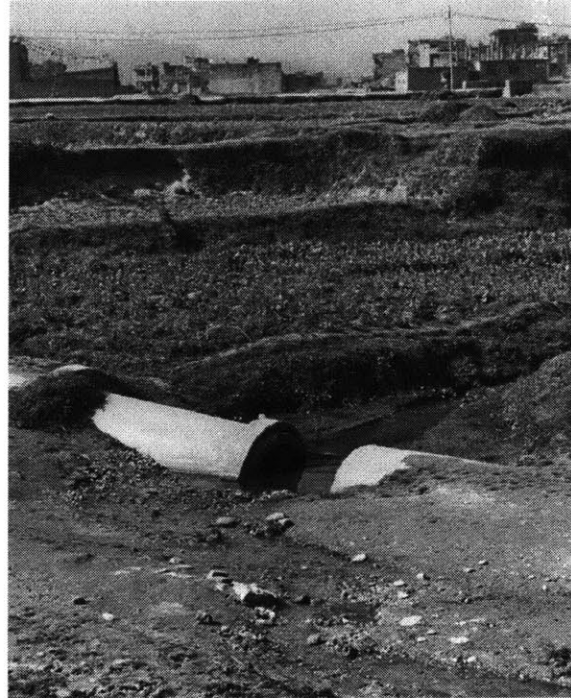
Figure 23: Picture of an open sewer in a field next to the Bagmati River.

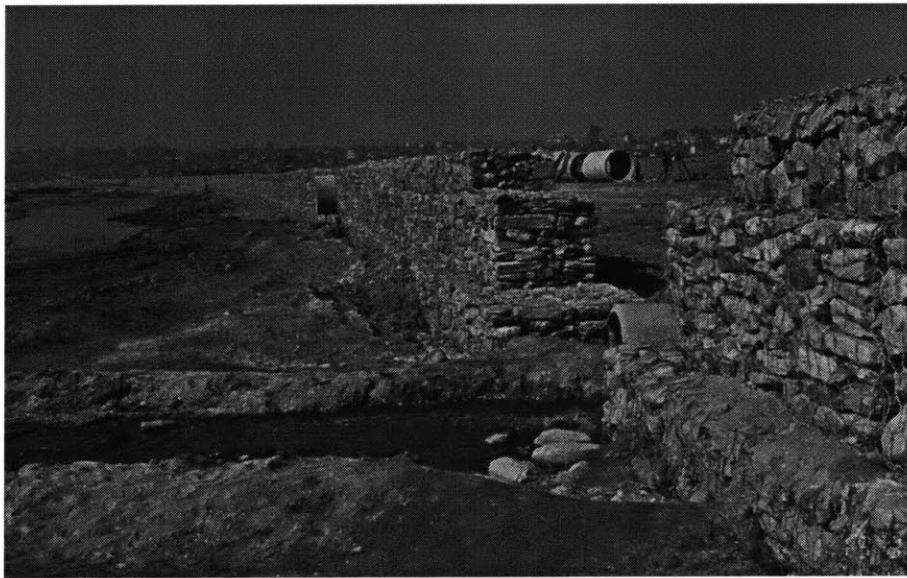
Figure 24: Picture of a large outfall discharging raw sewage into the Bagmati River.

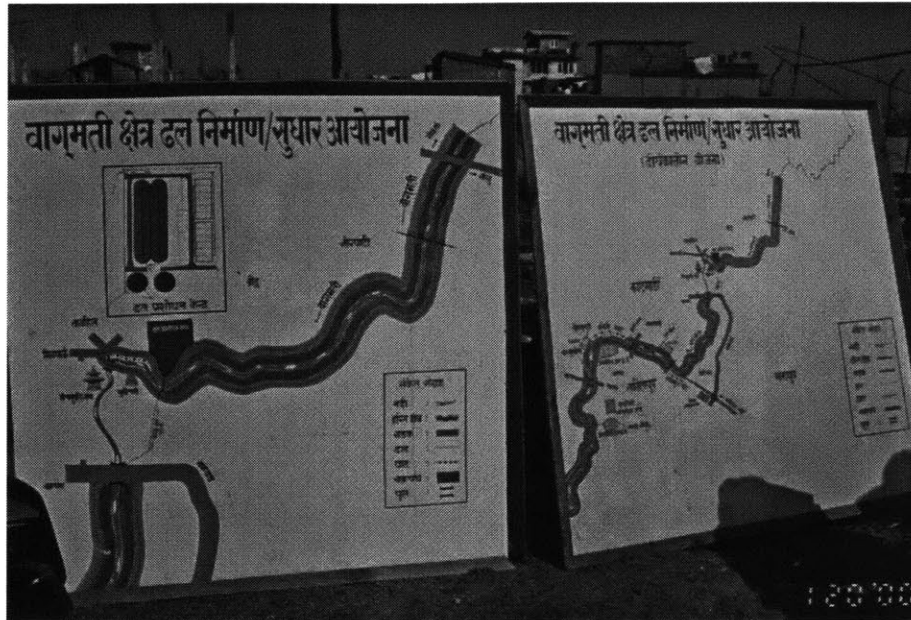
Figure 28: Picture of the sewage treatment plant plans.

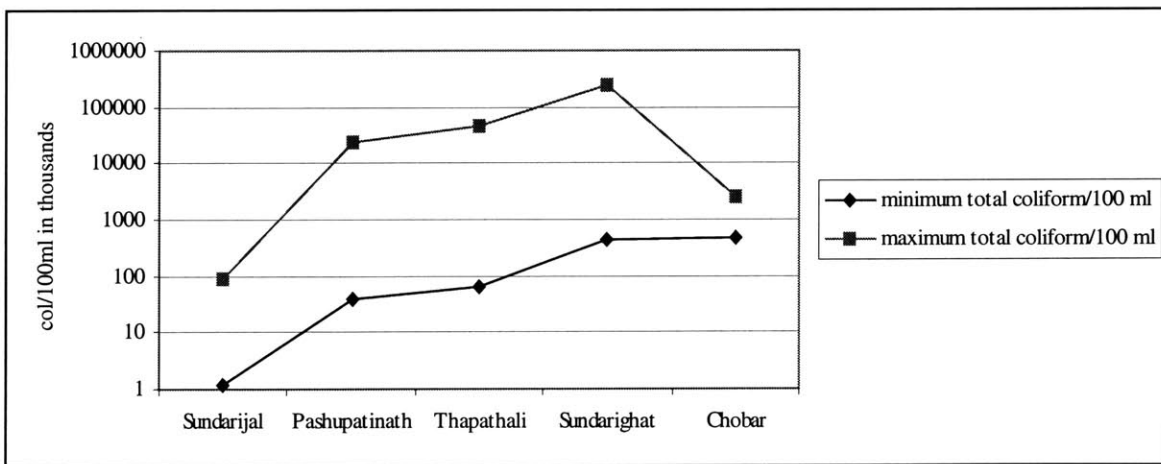
The coliform content of the Bagmati also gives an indication of increasing pollution as the river progresses downstream. Figure 35 shows the total coliform levels for five different sampling stations: Sundarijal, Pashupatinath, Thapathali, Sundarighat, and Chobar. Since the y-axis for this graph is on a log scale, it is obvious that the pollution increases drastically as it moves downstream. Worsening pollution occurs until Sundarighat. After that there are no major sewage discharges and the natural ability of the stream to recover and the dilution effect of some relatively clean tributaries lessen the Bagmati's total coliform concentration.

Figure 35: Minimum and maximum number of total coliform at progressive sampling stations.⁷⁰
