THE MECHANISM OF CRACK INITIATION IN
SILICON-IRON UNDER ELEVATED TEMPERATURE
FATIGUE CONDITIONS

SUBMITTED IN PARTIAL FULFILLMENT OF
THE REQUIREMENTS FOR THE DEGREE
OF MASTER OF SCIENCE
at the
MASSACHUSETTS INSTITUTE OF TECHNOLOGY

February, 1973

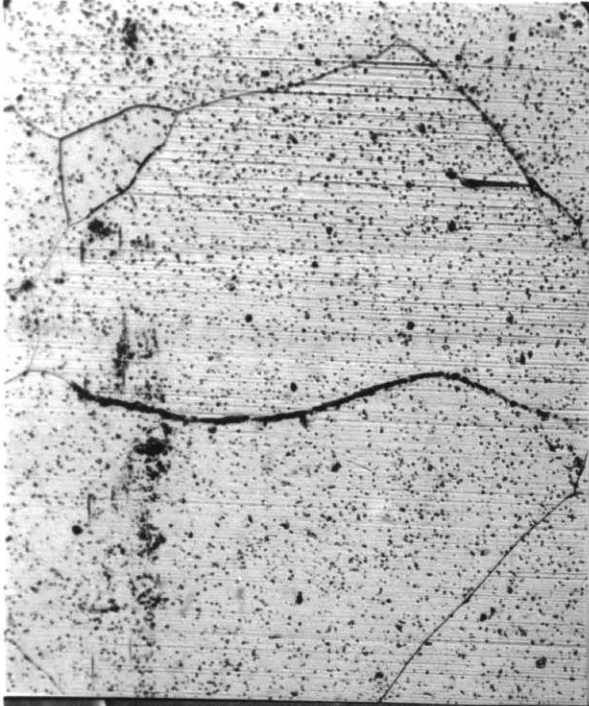
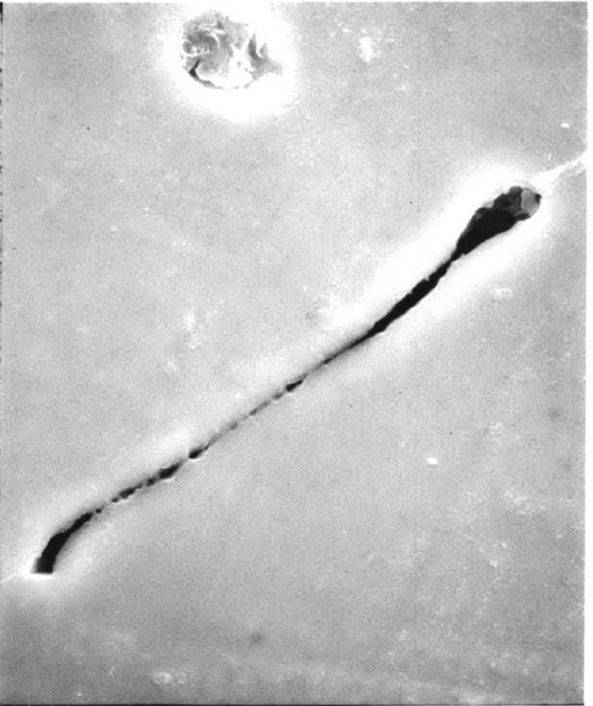
Fig. 7a. An Intergranular Crack Lying Perpendicular to the Tensile Axis on a Polished and Etched Section of a Sample Cycled 20,000 Cycles at .060 in. Amplitude (128x).

Fig. 7b. Interlinking of Voids to Form Intergranular Cracks as Revealed on a Polished and Etched Section of a Sample After 20,000 Cycles at .060 in. Amplitude (5000x).

Voids and cracks were observed along grain boundaries as shown in Fig. 6. It was confirmed that these cracks and voids resulted from the fatigue process because unstrained samples did not show these features. Many intergranular cracks were observed around the minimum section. In some cases these cracks were rather long, but in other cases they seemed to be nearly circular voids. Therefore, it may be assumed that the intergranular cracks originate as voids and grow as the voids link together. See Fig. 7.

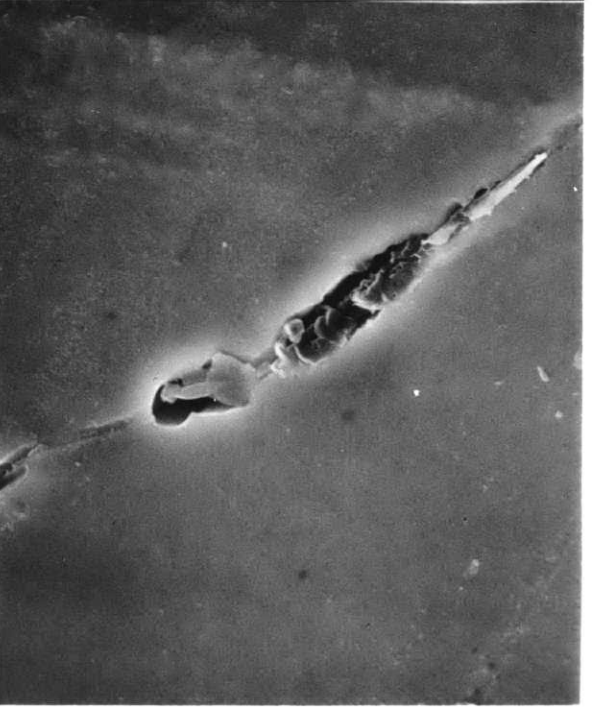
Fig. 8. Uncracked Particles Along a Grain Boundary on a Polished and Etched Section (2000x).

Fig. 9. Cracks Around Particles on a Grain Boundary Revealed by Sectioning, Polishing, and Etching a Sample After 20,000 Cycles at .060 in. Amplitude (5000x).

At high magnification in the scanning electron microscope, many particles were observed along grain boundaries as shown in Fig. 8. In some cases these particles showed no evidence of separation from the matrix. However, around many particles cracking was observed as shown in Fig. 9. A typical size of the voids is 1 micron diameter.

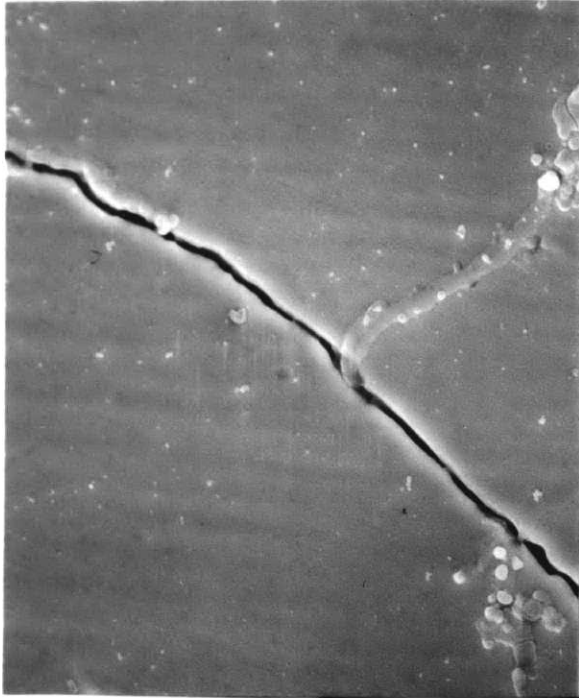
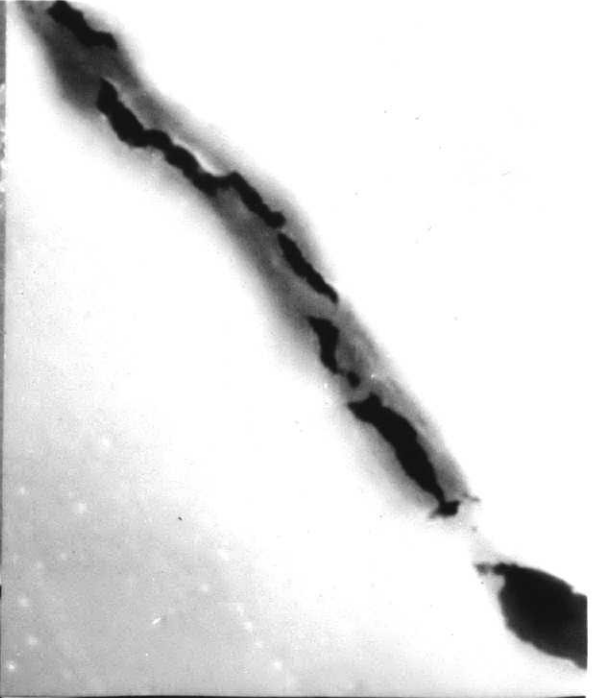
Fig. 10a. Intergranular Crack on a Large Grain Size Sample Fatigued for 20,000 Cycles at .060 in. Amplitude (2000x).

Fig. 10b. Holes Inside the Crack Shown in Fig. 10a.

Intergranular cracking was observed as shown in Fig. 10. When viewed at a magnification of 20,000 x, individual holes were observed at the bottom of the continuous crack along the grain boundary at the etched surface. Less particles were observed along grain boundaries in the large grain size sample than in the small grain size sample. Therefore, the cracking which was observed was often not associated with a particle. Polygonization was more wide spread than in the small grain size samples (Fig. 13a). However, polygonization seemed to be confined to those regions where large amounts of plastic strain inside the grains would be required to accommodate the grain boundary sliding. For example, more subboundary formation was observed around crooked boundaries (Fig. 13b) than along the straight grain boundaries. Again limited triple point cracking was observed.

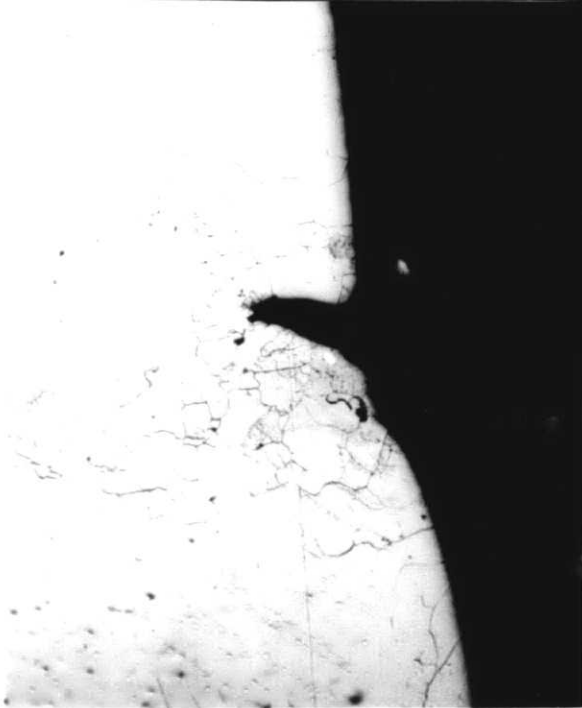
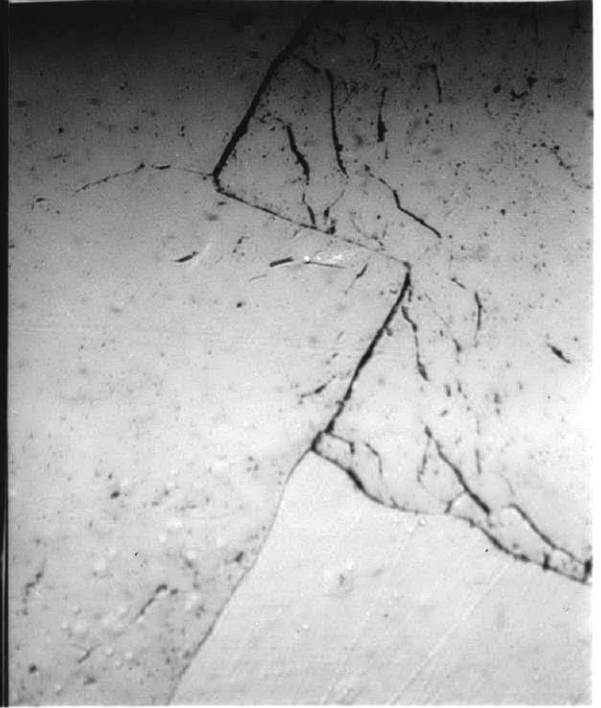
Fig. 11a. Subgrain Formation Around a Surface Crack in a Large Grained Sample After 20% of the Fatigue Life (80x).

Fig. 11b. Subgrain Formation Near a Crooked Grain Boundary in the Same Sample as Fig. 11a (400x).

Subgrain boundary formation was observed near the minimum section, but was confined to a smaller region than was the void formation and the intergranular cracking. A limited amount of triple point cracking was observed.
