A Contactless Multi-Modal Sensing Approach for Material Assessment and Recovery in Building Deconstruction

Citation: Cabral, S.; Klimenka, M.; Bademosi, F.; Lau, D.; Pender, S.; Villaggi, L.; Stoddart, J.; Donnelly, J.; Storey, P.; Benjamin, D. A Contactless Multi-Modal Sensing Approach for Material Assessment and Recovery in Building Deconstruction. *Sustainability* 2025, 17, 585.

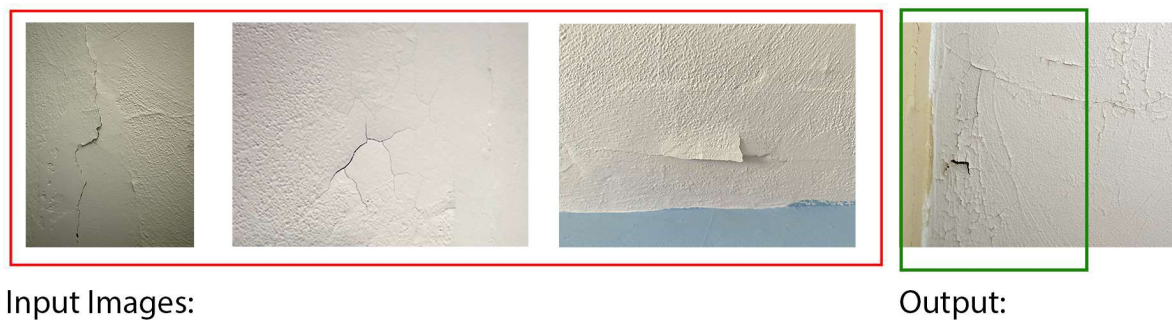
A damage detection system was implemented using TensorFlow version 2.9.1 with the Keras API to process and analyze RGB images of walls to identify potential areas of damage. The model architecture utilized ResNet50 as the feature extractor, imported with pre-trained ImageNet weights. This machine-learning model highlighted regions of discoloration by running a feature detection program trained on image data. The damage detection system implementation utilized image datasets with corresponding XML annotations for training. The dataset comprised 30 corresponding images and masks featuring various drywall conditions, including stains, cracks, and paint peeling. The damage detection program was more effective at identifying structural anomalies, such as cracks, than at detecting surface-level discolorations or stains because cracks generally have distinct edges and high-contrast features that feature detection algorithms can easily detect. Figure 3 illustrates the system's enhanced capability in identifying structural anomalies with distinct edges compared to surface discolorations.

Figure 3. Output from the TensorFlow-based damage detection model, highlighting areas of cracks in a previously unseen image. The red highlight outlines some of the training images that were provided as input. The green bounding boxes are drawn around detected crack regions on a test image.

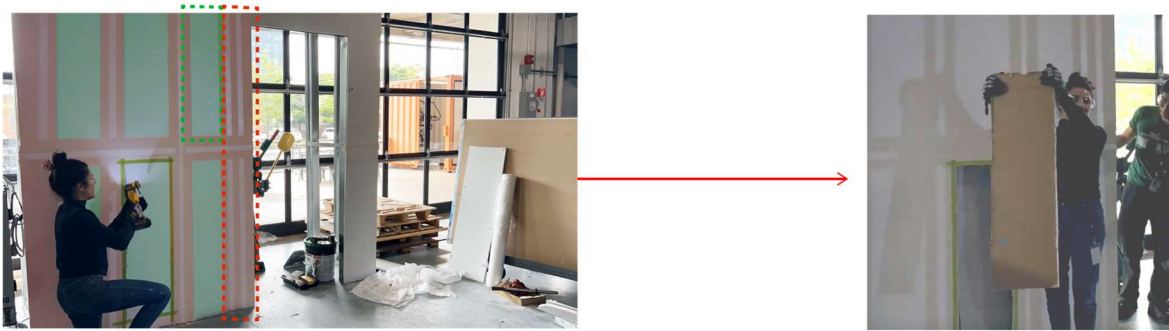
In this method, power saw cutting followed projected polygon boundaries between identified stud locations. This method achieved rapid drywall section removal but resulted

in smaller salvaged pieces due to necessary cuts near stud locations. Material recovery rates varied based on stud spacing and wall dimensions (Figure 4).

Figure 4. Testing site of polygon cutting from guided projection.
