Behavior of Triplex Silicon Carbide Fuel Cladding Designs Tested Under Simulated PWR Conditions

MASTER OF SCIENCE IN NUCLEAR SCIENCE AND ENGINEERING
AT THE
MASSACHUSETTS INSTITUTE OF TECHNOLOGY

June 2011

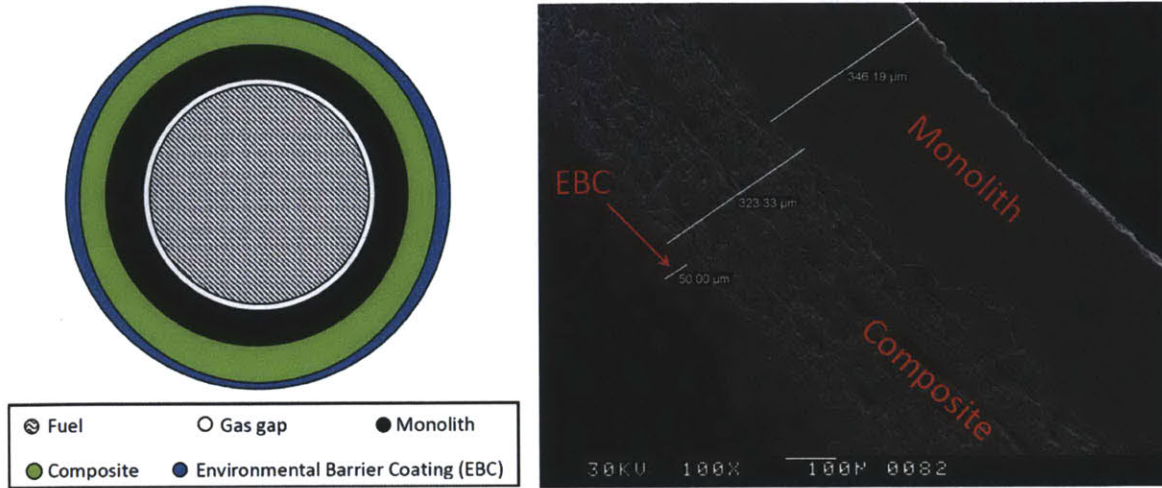
(a) Illustration of the Triplex cladding design. (Not drawn to scale.) (b) SEM micrograph showing the three layers of the Triplex tube.

In this work, samples consisting of only a monolith layer will be referred to as “monolith-only” samples. Samples consisting of the three layers described above, and depicted in Figure 2.4, will be called “Triplex” samples. The layer consisting of SiC fibers in a SiC matrix, will be referred to as the “composite” layer. This is consistent with the terminology used in [45], [46], and [47].

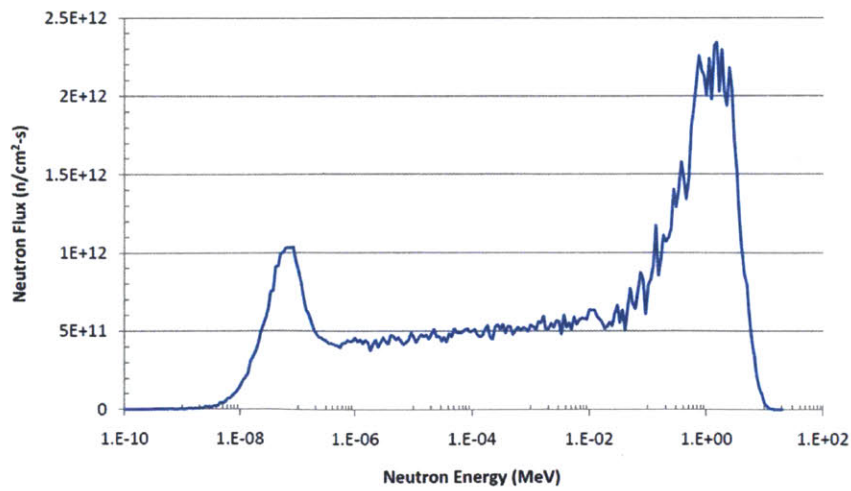
Figure 2.9: Axially averaged flux profile for the ACI irradiation location in MITR-II. Calculated with MCNP [47].

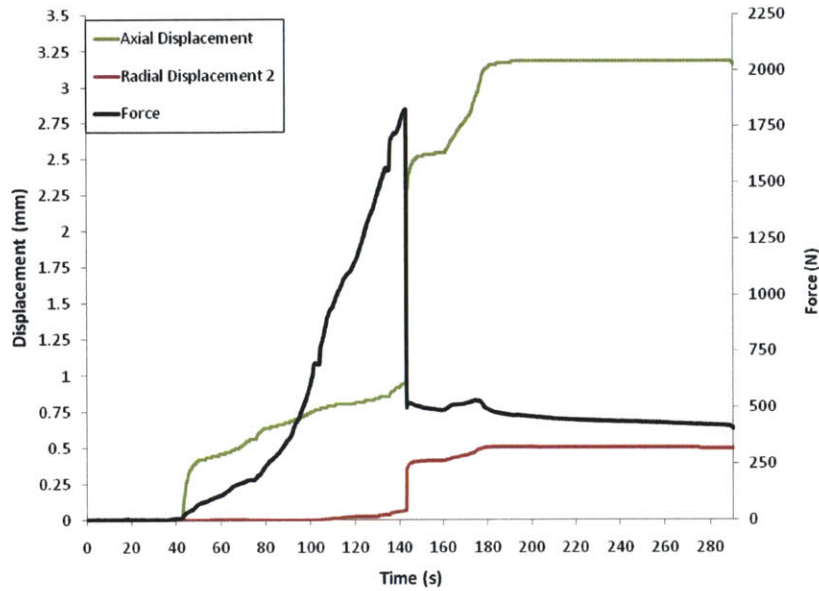
Figure 3.3: Hoop test data for un-irradiated Triplex sample 06-B.

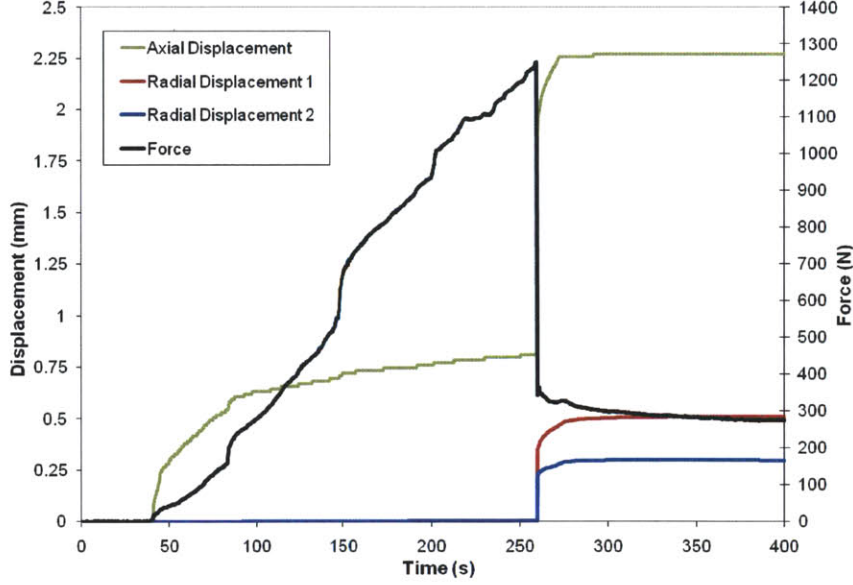
Figure 3.4: Hoop test data for Triplex irradiated sample 25-2.

The hoop test data for the irradiated (9 months in-core, 0.99 dpa) Triplex sample 25-2 is shown in Figure 3.4. Similar to Figure 3.3, the ram axial displacement increases steeply until the plug has begun to load the inner diameter

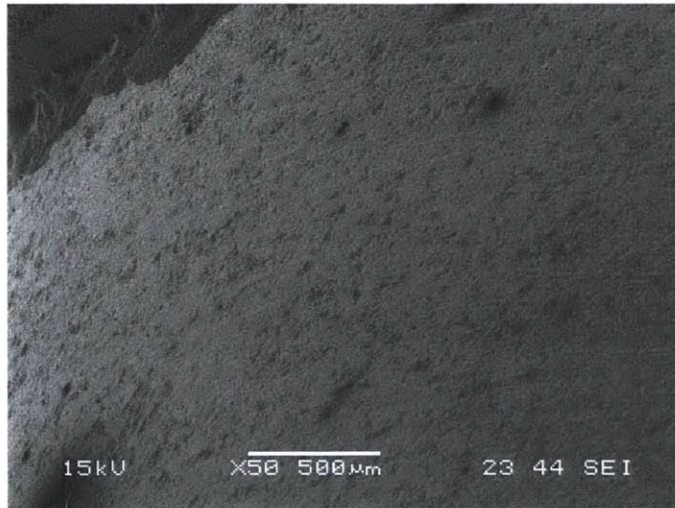
Figure 3.5: Sample 06-B dimpled monolith inner surface.

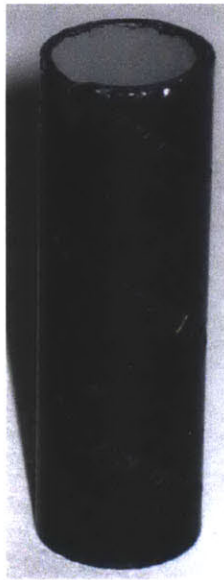
(a) 06-B Before hoop test.

Figure 3.7: Sample 06-B before and after hoop testing.

Various fracture patterns are evident even under simple visual inspection. Figure 3.7a shows the crisscrossing seams of the composite weave under the EBC. In Figure 3.10c sample 06-B displays a characteristic fracture pattern after hoop testing to failure. At both ends there are “V”-shaped cracks connected by a straight axial crack which has broken through all layers of the sample. Notice also that the fractured pieces are still connected as a whole, unlike the fractured monolith-only samples tested by Carpenter [47]. Figure 3.8 shows pictures of a sample (“T-2”) constructed with a monolith only. Prior to hoop testing, the sample appears very similar to the Triplex-type samples. After failure, however, T-2 has not maintained any integrity and clearly exhibits brittle failure.

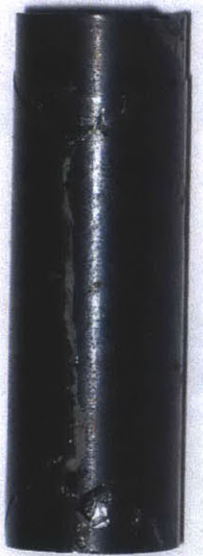
(c) 06-B after hoop test.

Another feature of the hoop fracture in the Triplex tubes is the axial crack in the center of the tube illustrated in Figures 3.7 and 3.9. SEM of this axial crack shows fiber pullout from the composite matrix and rupture of the fibers at angles nearly perpendicular to their length. Figure 3.13 compares the axial crack morphology between Triplex samples 06-B, 04-A, and 04-B. The fibers in sample 06-B (Figure 3.13a) were pulled farther out of their matrix before they ultimately fractured. In contrast, the fibers in samples 04-A and 04-B did not pull out nearly as far. Samples 04-A and 04-B fractured at higher internal pressures and hoop stresses than sample 06-B. It may be that greater pseudo ductility in 06-B (easier fiber/matrix debonding) allowed the fibers to pull out further before rupture while simultaneously compromising the ultimate strength of the tube. Stronger bonding between the fibers and the matrix in samples 04-A and 04-B would reduce the fiber pullout while perhaps affording a higher hoop strength.

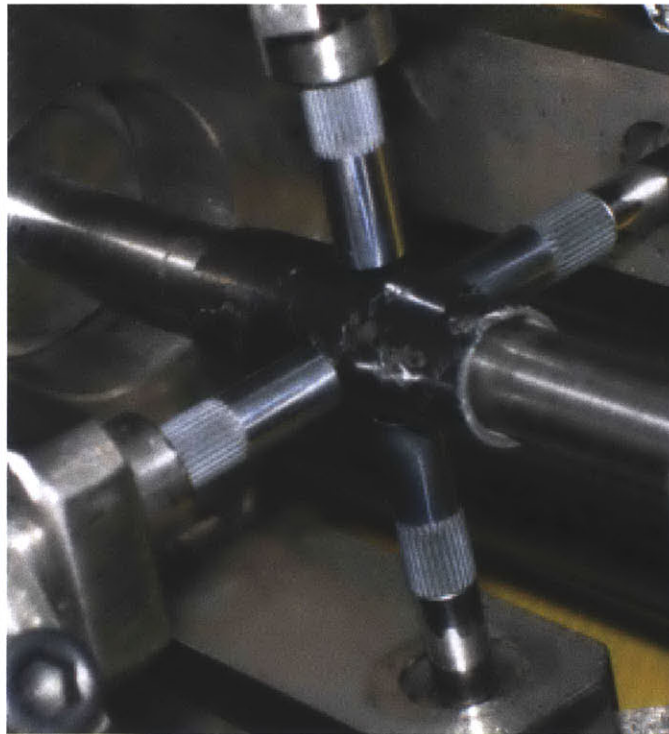
(d) 06-B after hoop test while still mounted on hoop test rig.

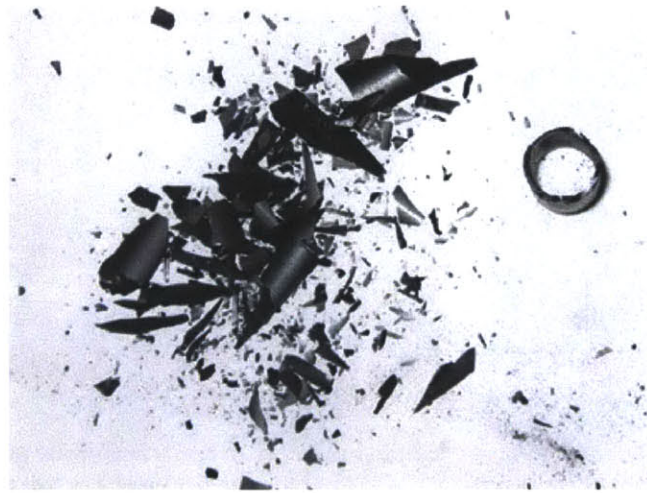
(b) Monolith only sample T-2 after hoop test. Catastrophic brittle failure.

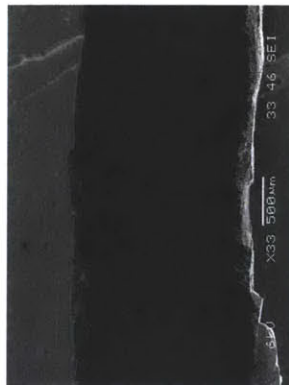
(a) Axial crack and fiber pullout in 06-B.

(b) Axial crack and fiber pullout in 04-A.

(c) Axial crack and fiber pullout in 04-B.

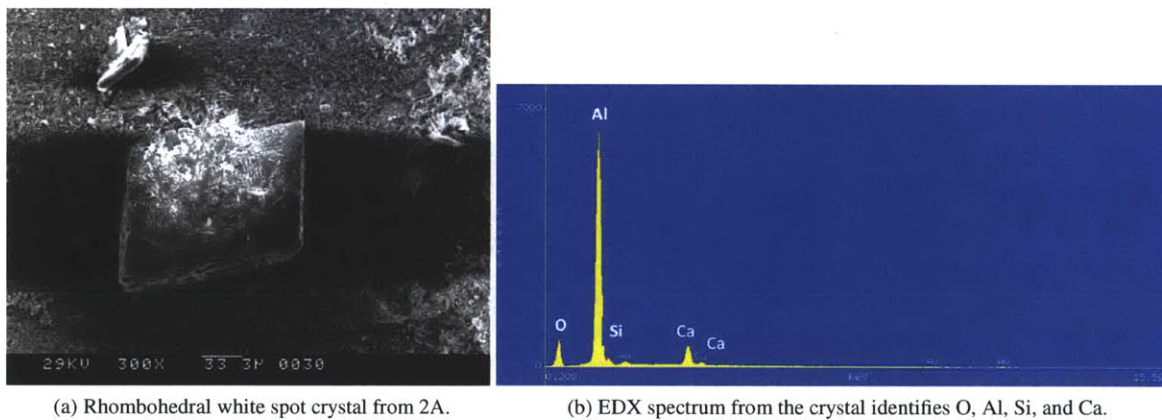
(a) Rhombohedral white spot crystal from 2A.

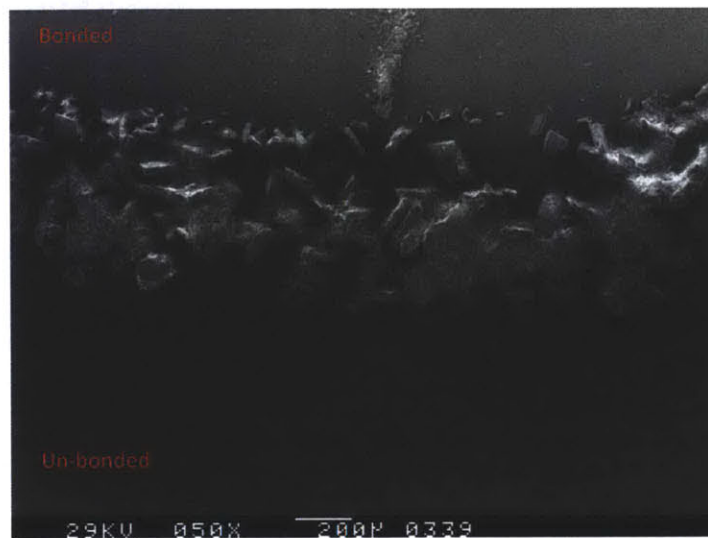
Figure 4.10: Rhombohedral calcium aluminate crystals on the bondline between the bonded and un-bonded regions of sample 5A.

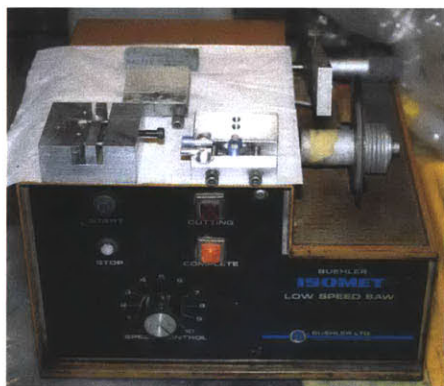
(a) Buehler Isomet saw with three sample clamps.

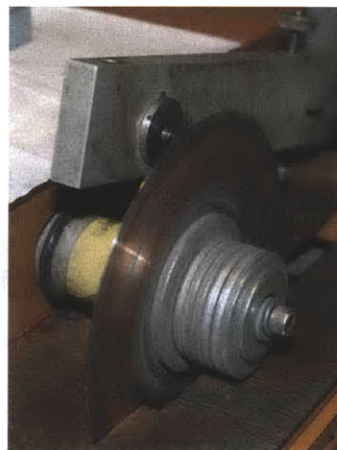
(b) Diamond-coated blade and clamp mounting arm.
