Impact of carbon impurities on the initial leakage current of AlGaN/GaN high electron mobility transistors

Abstract

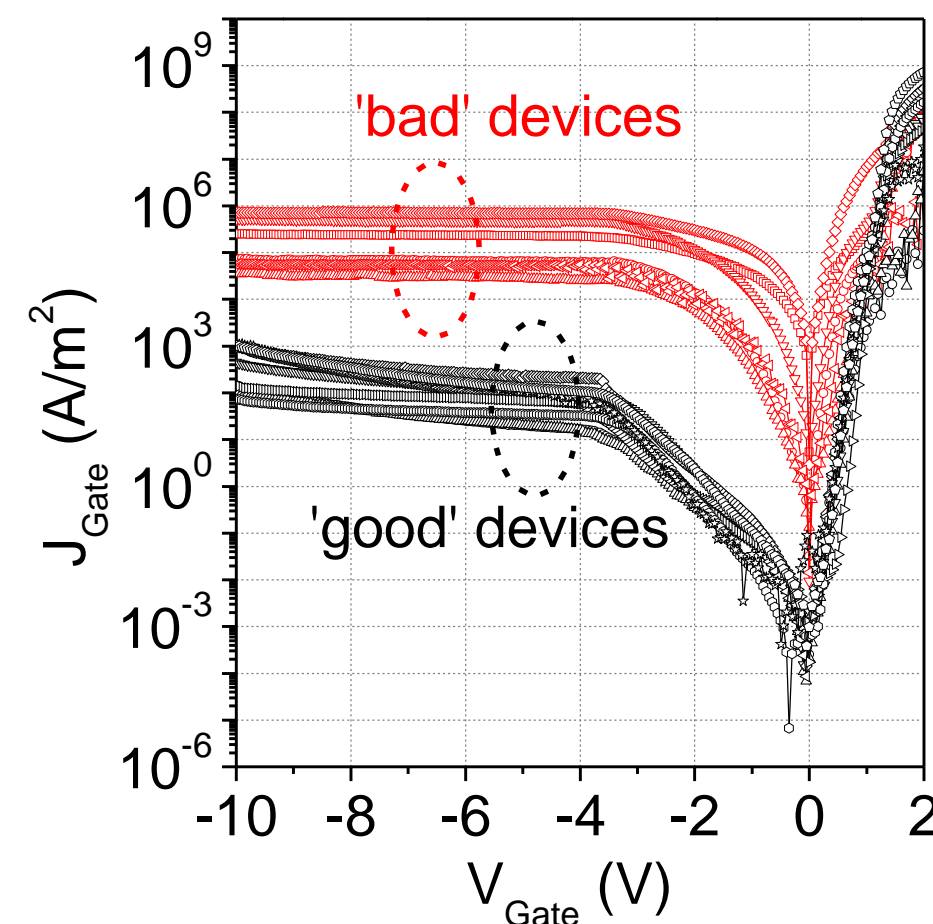
Figure 2. J_{Gate}-V_{Gate} curves (direct current, static) of bad devices (red) and good devices (black), measured at $V_{Drain} = 0\ V$ at room temperature.

We tested a total of 30 devices. 6 of these devices had a very high initial gate-leakage current density ($J_{Gate} > 5 \times 10^4$ A/m^2). We considered those to be 'bad' devices. The remaining had a very low leakage current density ($J_{Gate} < 2 \times 10^2$ A/m^2), and thus we considered those to be 'good' devices. J_{Gate}-V_{Gate} curves for these devices are shown in Figure 2.

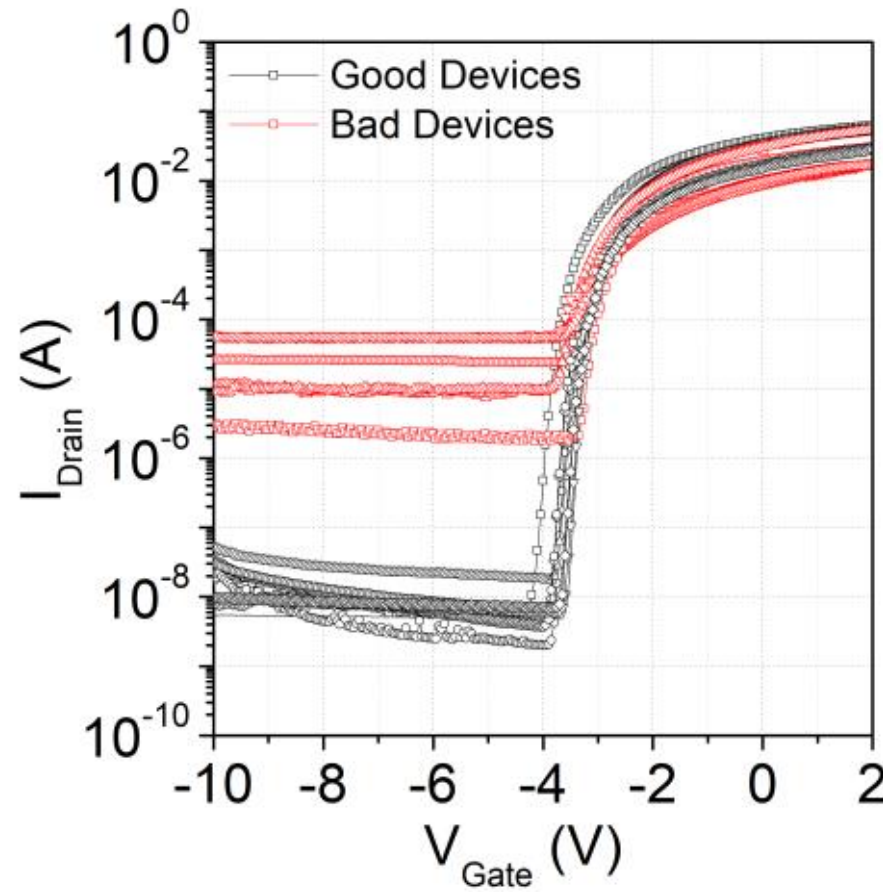
Figure 3 shows I_{Drain}-V_{Gate} curves of good and bad devices. We can clearly see that bad devices have a much higher initial drain leakage current than good devices. The threshold voltage of both types of devices is quite similar. Good devices have V_{th} = -2.6±0.2 V, while bad devices have V_{th} = -2.5±0.3 V. This suggests that there is no substantial difference in the trap level density below the gate.

Figure 3. I_{Drain}-V_{Gate} curves (direct current, static) of bad devices (red) and good devices (black), measured at V_{Drain} = 10 V, at room temperature.

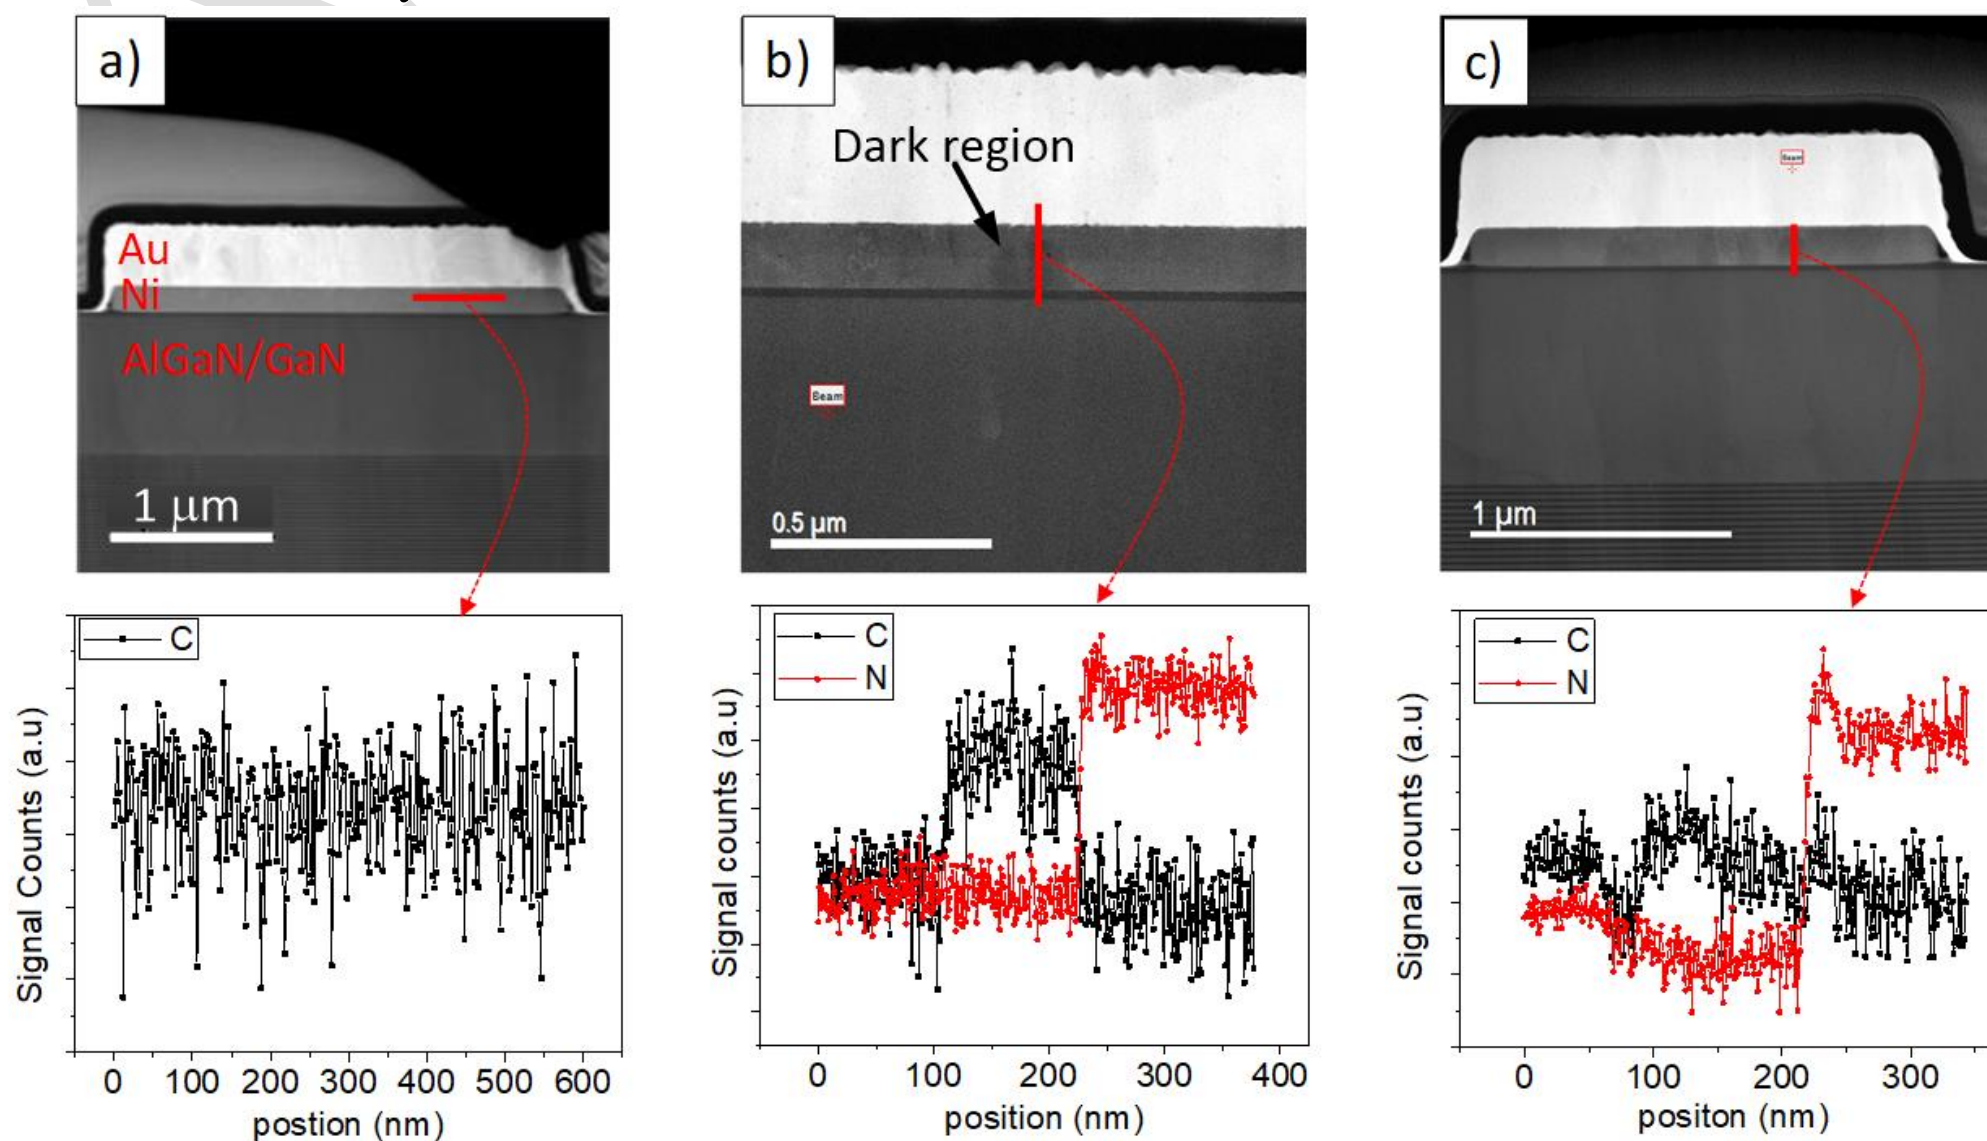
Figure 7. High angle annular dark field (HAADF) images and electron energy loss spectroscopy line scan of devices at different locations. a) A good device, b) a bad device at a hotspot, and c) a bad device at a non-hotspot location.

Knowledge of the location of the hotspots guided us in sample preparation for transmission electron microscopy analysis. Figure 7 shows a series of high angle annular dark field (HAADF) images and respective elemental composition analyses made using electron energy loss spectroscopy (EELS). In bad devices at hotspots, we consistently observed dark regions in the nickel layer. These dark regions contain a significant amount of carbon as an impurity in the nickel (Fig. 7b). In good devices, we did not observe these dark regions (Fig. 7a).

Carbon has a lower work function (ϕ_{Carbon} = 4.6 eV) than nickel (ϕ_{Nickel} = 5.2 eV) [20]. It has also been reported that the effective work function decreases as carbon content increases in Nickel [21]. In a Schottky metal-semiconductor contact like in the case of devices used in this work, zero-bias barrier heights (ϕ_{B0}) decrease with decreasing work function (ϕ_m) according to equation (2) [14],

where χ is the electron affinity of the semiconductor. Work function lowering due to carbon impurities explains why bad devices have lower effective barrier heights and therefore higher gate-leakage currents.

We postulate that one possible source of carbon is photoresist residue (hydrocarbon) from the lift-off gate formation process. Etching and cleaning processes prior to nickel deposition might not be optimum and it could leave hydrocarbon residue on the AlGaN surface. Upon annealing at 225°C for 500 h, carbon atoms from decomposed hydrocarbons could diffuse into the nickel layer and cause an increase of leakage current. This is supported by the diffusion distance (δ) calculated for carbon in nickel via lattice diffusion:

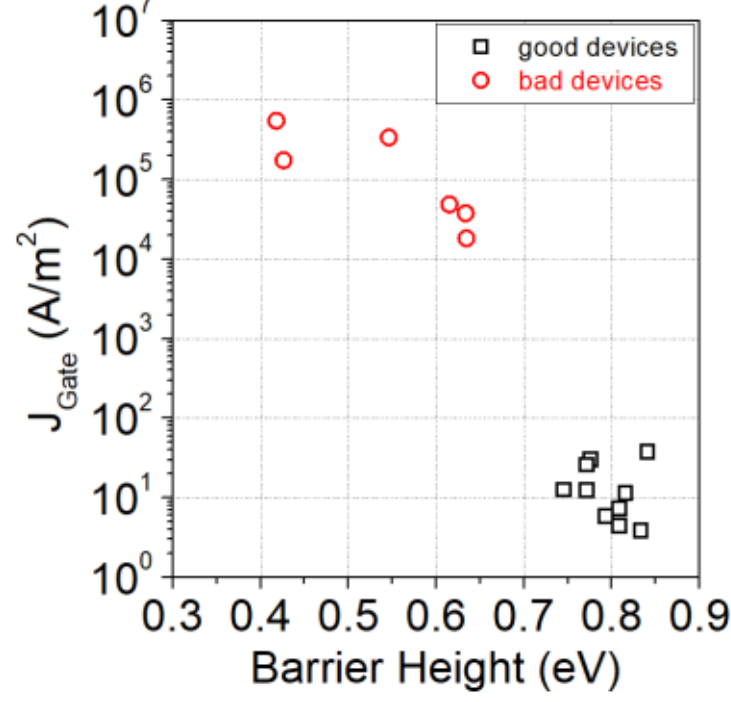
Figure 5 shows the calculated apparent zero-bias Schottky barrier height plotted against the measured J_{Gate}. It is apparent that J_{Gate} increases exponentially with a decrease of ϕ_{B0}. This is consistent with the well accepted understandings of current transport mechanisms in Schottky diodes. As the zero-bias barrier height decreases, it is easier for electrons to flow across the interface via some of the possible current transport mechanisms, which include Schottky

Figure 5. J_{Gate} as a function of the apparent zero-bias barrier height (ϕ_{B0}). J_{Gate} values were measured at V_{Gate} = -3 V.

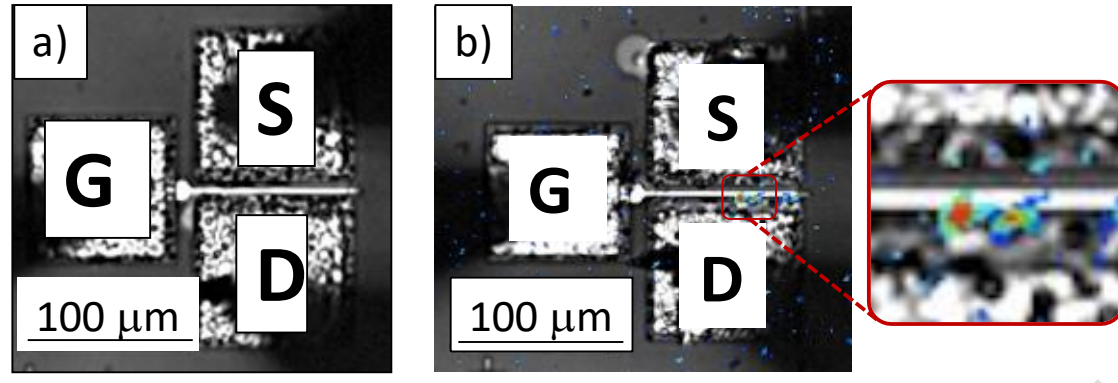
Figure 6. Photon emission microscopy images of devices operating at V_{Gate} = -10 V, V_{Drain} = 0 V at room temperature. a) A good device that has a low gate leakage current, b) A bad device that has a high gate leakage current.

To further investigate the physical origin of high initial leakage currents, we used photon emission microscopy to spatially localize high gate leakage current regions. Figure 6 shows a comparison of a good device with a bad device operating under a constant reverse bias. In good devices, we did not observe photon emission under constant reverse bias. However, in bad devices we consistently observed one or more localized sites of high photon emission, commonly referred to as hotspots. The locations of these hotspots were random along the gate.
