The World Trade Center Disaster: Analysis and Recommendations

Jeremy Abraham Kirk

MASTER OF ENGINEERING  
IN CIVIL AND ENVIRONMENTAL ENGINEERING  
AT THE  
MASSACHUSETTS INSTITUTE OF TECHNOLOGY

JUNE 2005

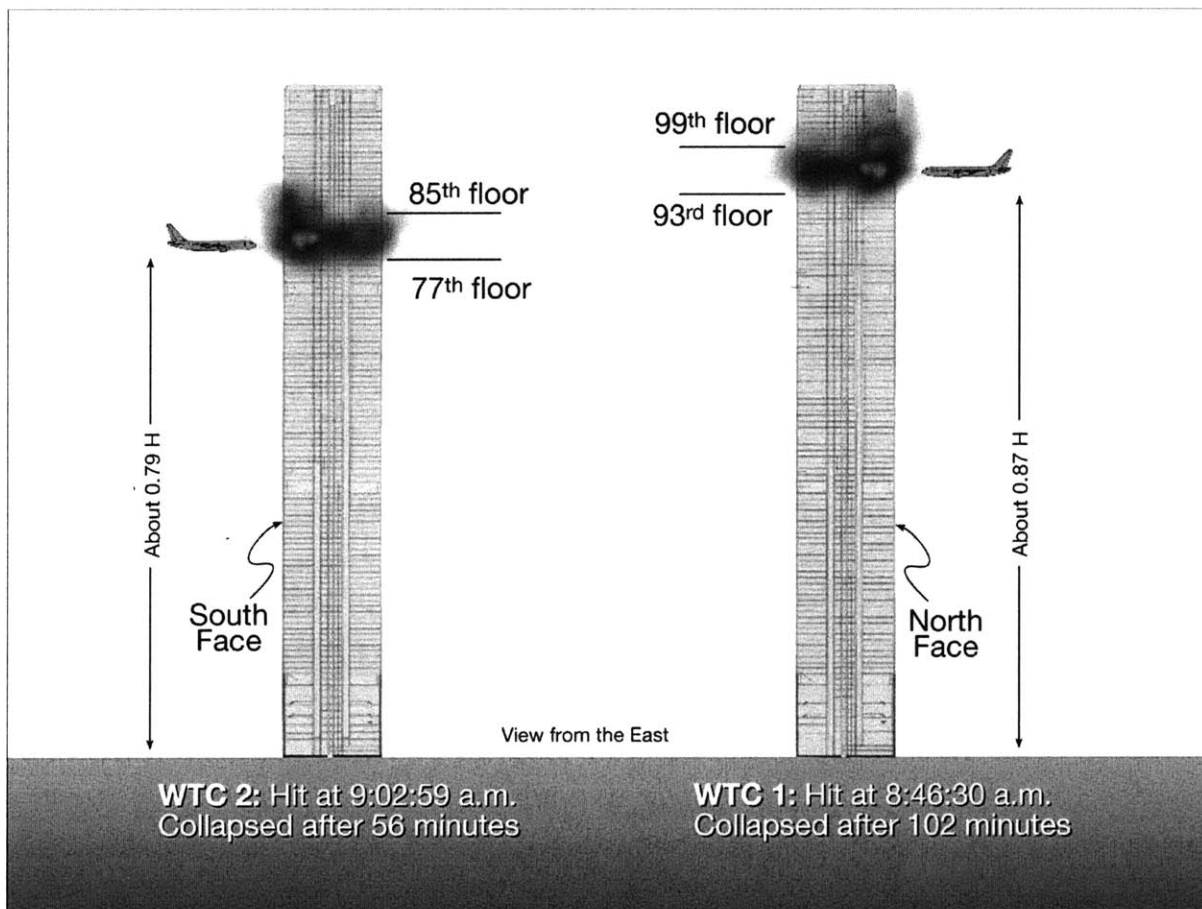
At 8:46 am on September 11, 2001, the first airplane, a Boeing 767-200 ER was flown into the 96th floor of the North tower, WTC 1. Amazingly, the event was captured on video by some bystanders. The plane hit nearly in the center of the north face of the tower at a roll of 25°. A short while later, at 9:02 am, the second airplane, also a Boeing 767, impacted the south face of the south tower (WTC 2), at the 80th floor level. This impact was more eccentric to the building center. The plane's lateral approach angle was 13° off of a directly perpendicular impact, and its roll angle was about 38° (see Figures 7 and 8). Large fireballs were seen to exit each tower at the moment of impact (NIST 2005a). Pertinent data is summarized in Table 1.

Figure 7. Elevation of impact locations (NIST 2005a).

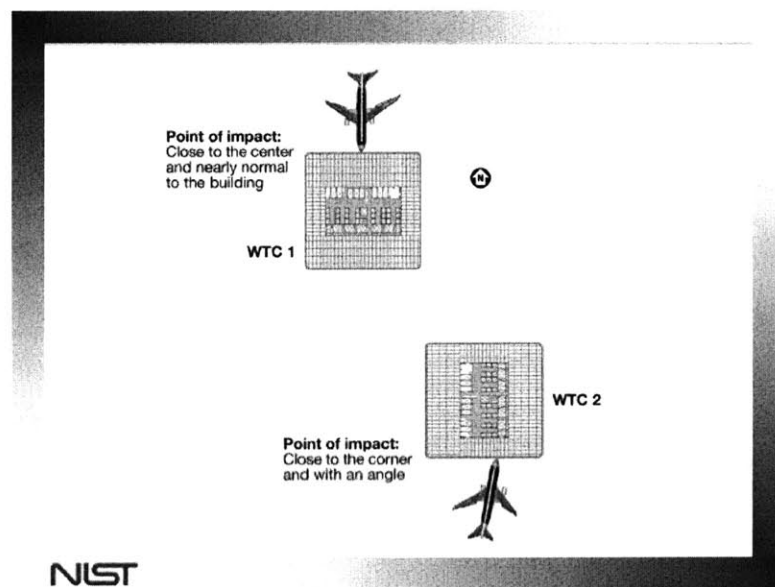
**Figure 8. Impact location and orientation for each tower (NIST 2005b).**

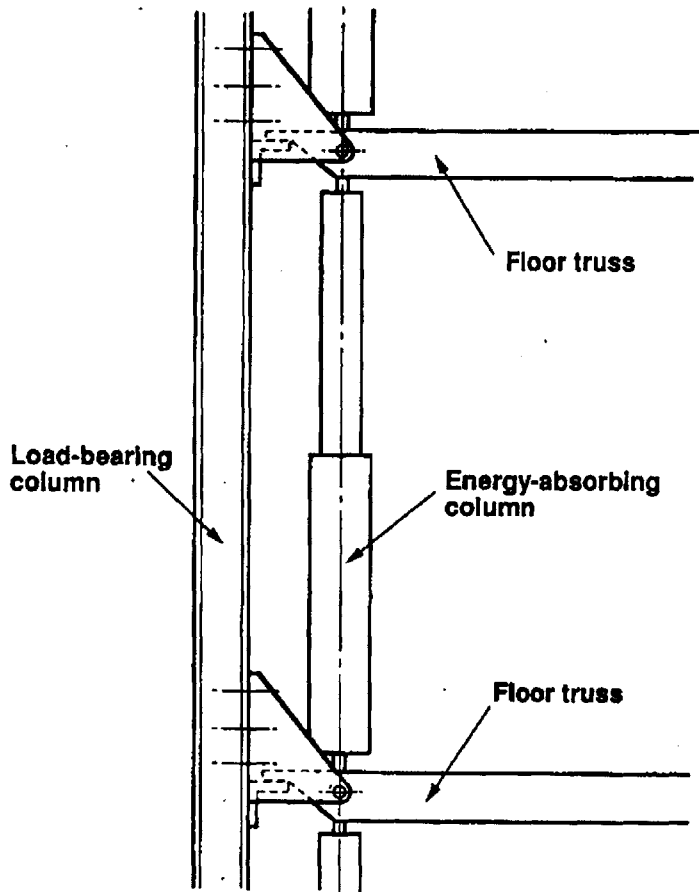
Figure 13. EA device (Newland & Cebon 2002).

The location of the collapse barriers is an important consideration. They must fully engage the falling mass (if bypassed, they would be ineffective), and they must be far enough away from the main columns that they are not compromised when those columns collapse or buckle. Placing the foam in a telescoping cylinder is one possible configuration (see Figure 13). The top end of the cylinder can be connected to the floor above, and the lower end connected to either the lower floor or the bottom of the structural column. An alternative would be to place the foam in a metal tube which will crush along with the foam, using the tube as a second absorption mechanism. Hydraulic dampers are yet another method of stopping collapse.

The authors estimate that the cost of this foam system in the WTC would have been about \$0.65 million per floor, or about \$72 million total. This would represent an increase of 11% in the total cost of the buildings. The decision has to be made whether this cost is justifiable in terms of the added safety.

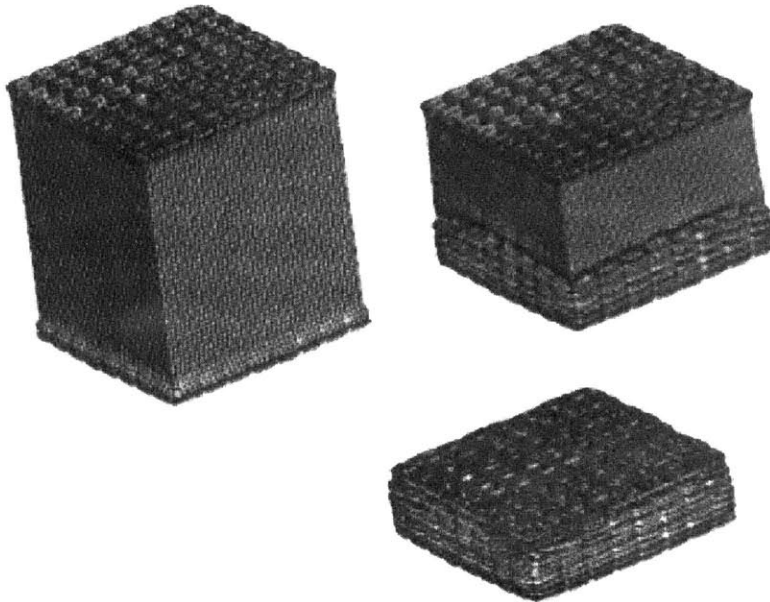
**Figure 14. Crushing of aluminum honeycomb (Zhou and Yu 2004).**

The required properties of a good absorbing material are that it is porous, and can therefore bend, rotate, buckle, etc., thereby absorbing energy. There is generally a tradeoff between crushing force and compaction ratio. The authors consider here a metal honeycomb as a device to absorb energy (see Figure 14). It could be either steel or aluminum. They performed a finite element analysis of an aluminum honeycomb, 400×400 mm square by 600 mm high, with cells

that were 50 mm square with 4 mm thick walls. This device compacted to 71.4%, much more than the foam in Newland and Cebon's scheme. The compressive strength was 27.5 MPa, less than the 40% MPa of Newland and Cebon. The authors state that such devices are relatively easy to fabricate, either by simple fabrication methods or by extrusion.

Using their example system in the WTC towers, the authors estimate that the absorption devices would have taken up about 4% of the available floor space, and added about 4.25% to the building mass. In the case of WTC 1, if the upper stories fell a distance of three floor at the initiation of global collapse, four floors below the impact zone would collapse before the fall was arrested. In comparison to Newland and Cebon's (2002) example with aluminum foam, the current authors predict a halt to the collapse in just 4 stories, compared to 6 stories for Newland and Cebon.
